Work completed between 12/10/2017 and 12/22/2017 includes the following:

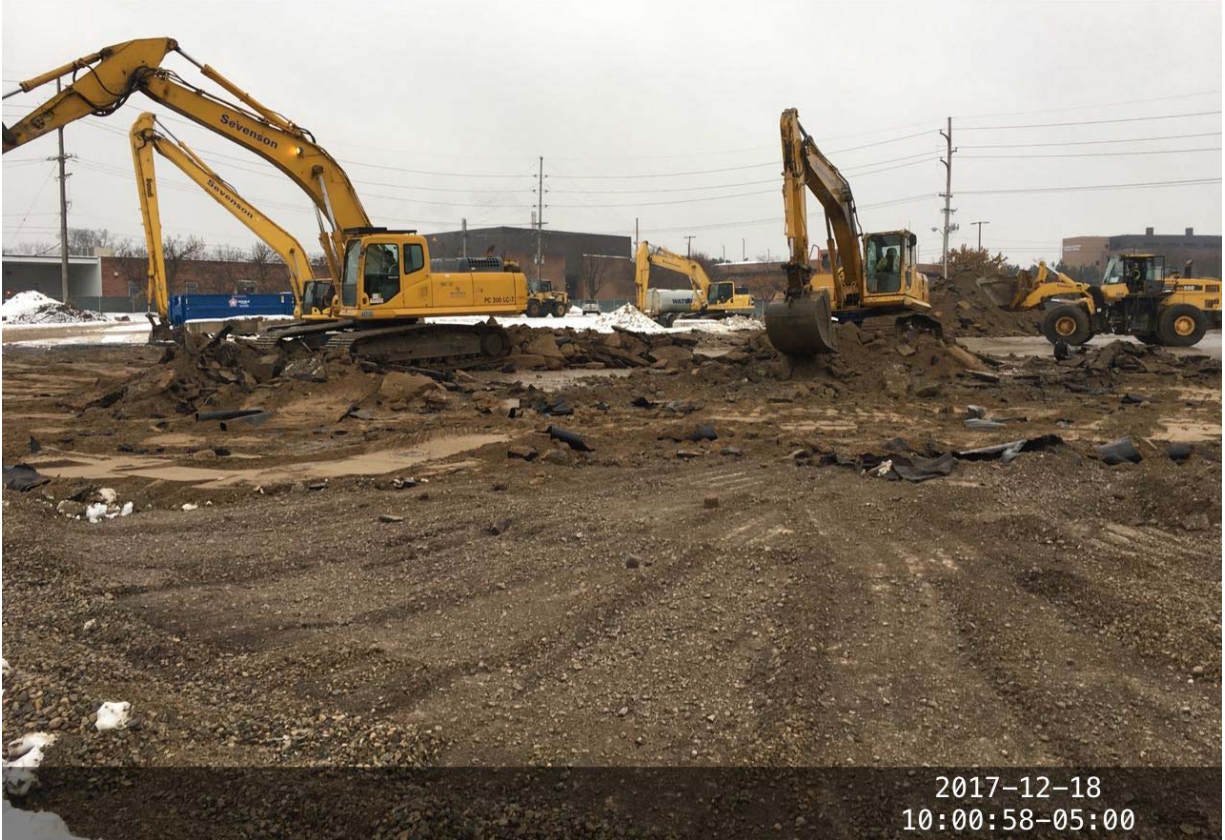
Picture No. 1.

Removing material used to construct the dewatering and material handling pad
(photo taken facing southeast).

- Continued treating water generated from decontamination activities, runoff from the material handling pad, and water pumped from subdrainage sump.
- Began removing material used to construct the dewatering and material handling pad (see Photo 1).

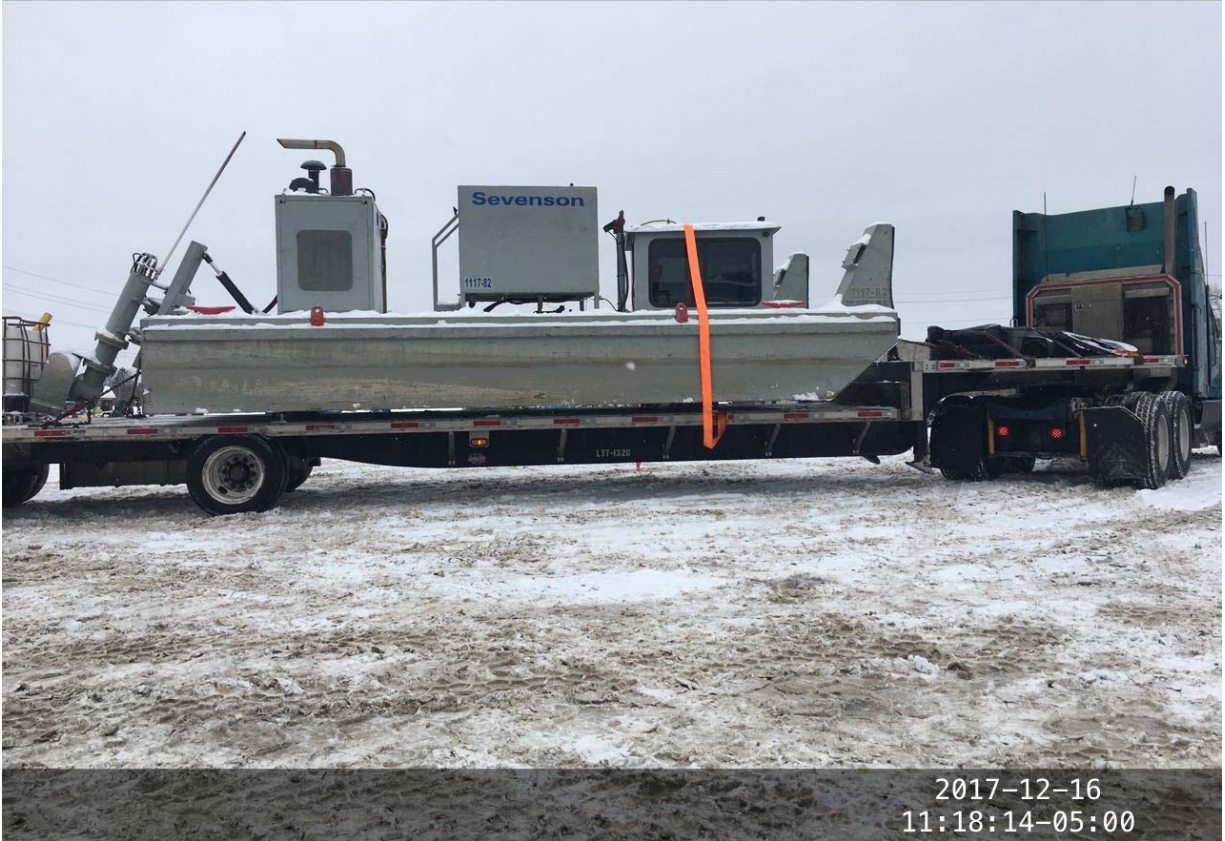
Picture No. 2.

Demobilizing equipment from the site
(photo taken facing northwest).

- Continued installing geomembrane liner along the eastern riverbank.
- Continued construction of a temporary bike path along the eastern riverbank.
- Continued decontaminating and demobilizing equipment (see Photo 2), including the wastewater treatment system.

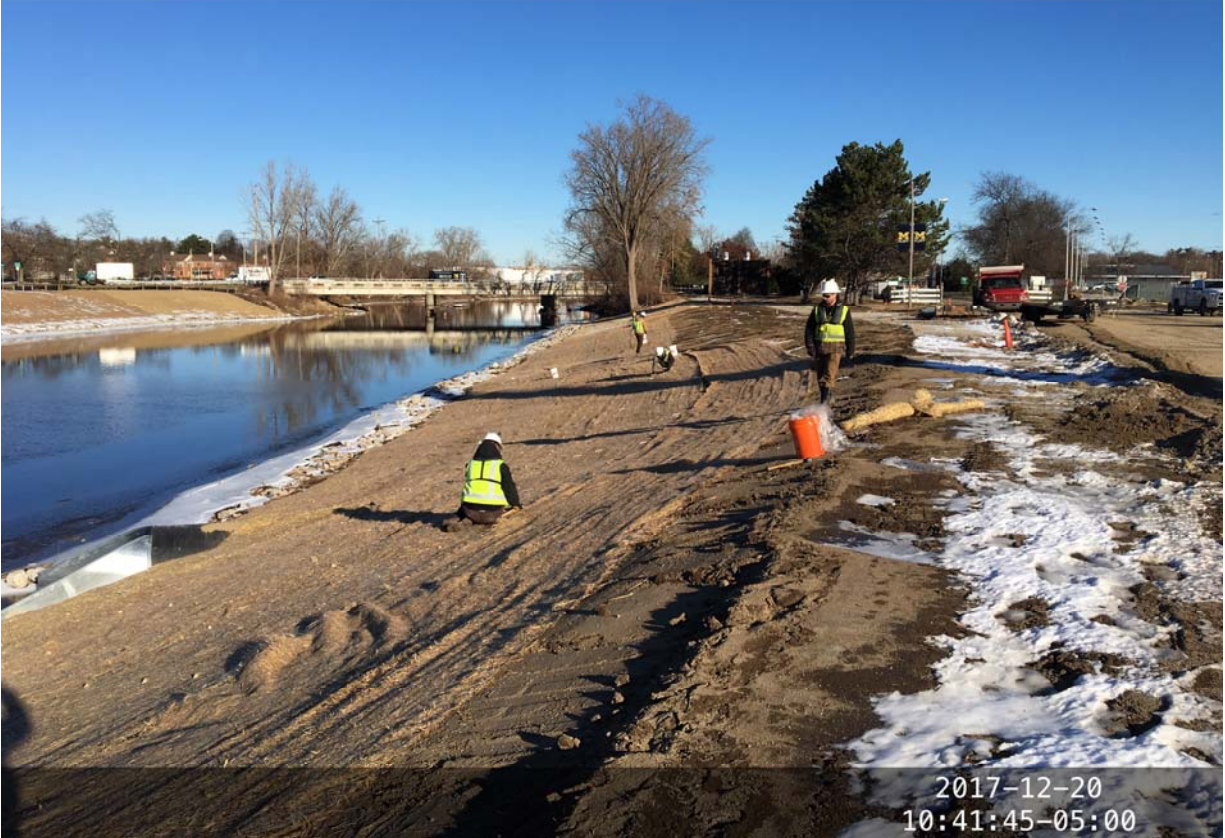
Picture No. 3.

Placing seed and installing erosion control blanket on the eastern riverbank
(photo taken facing north).

- Continued restoring riverbanks by placing seed and installing erosion control blanket along the riverbanks (see Photo 3).
- Poured concrete for sidewalks leading to the new Pedestrian Bridge approaches.

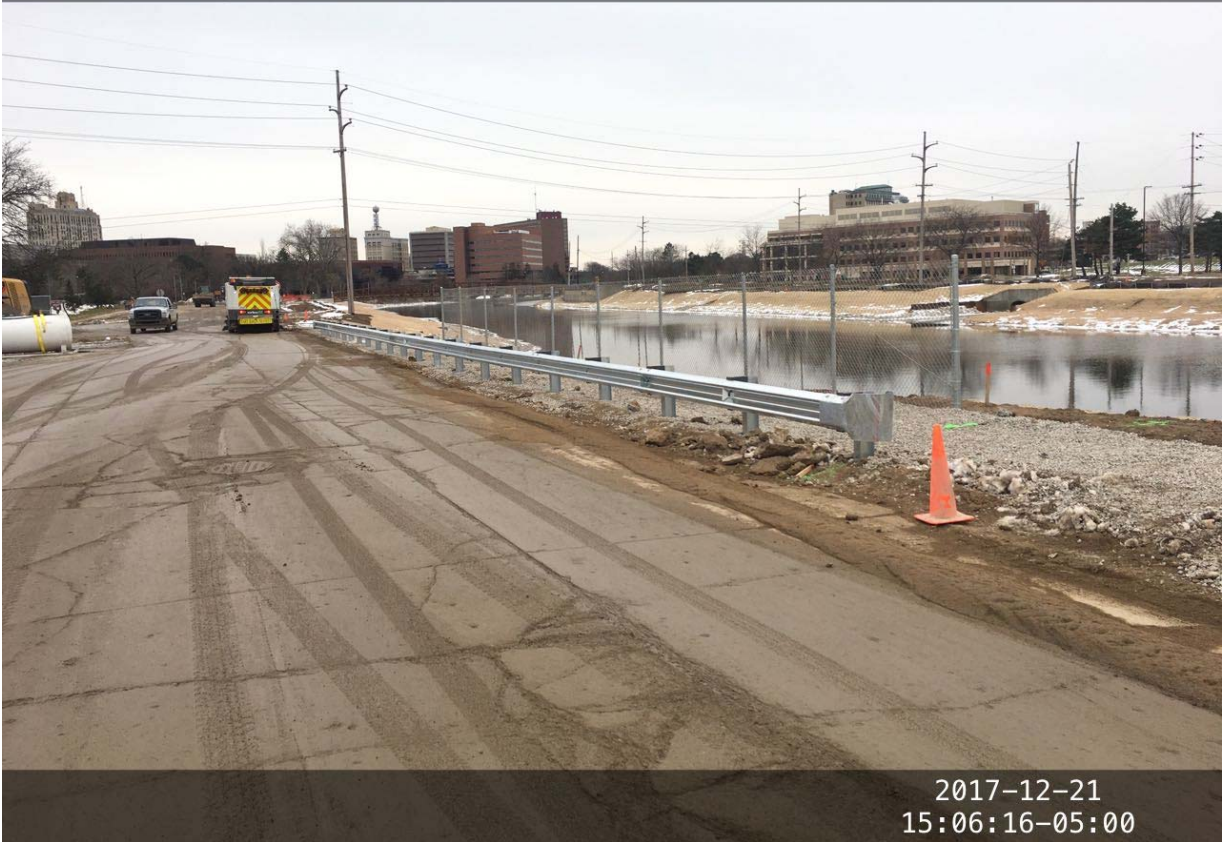
Picture No. 4.

Guard rail and chain link fence installed along East Boulevard Drive
(photo taken facing southwest).

- Installed a new guard rail and chain link fence along East Boulevard Drive (see Photo 4).
- Removed site security fence from the perimeter of the Work Area, and opened East Boulevard Drive and James P Cole Boulevard to public access.
