# Structural Stability and Safety Factor Assessment Report

## B.C. COBB GENERATING FACILITY

## PONDS 0-8 STRUCTURAL STABILITY AND SAFETY FACTOR ASSESSMENT REPORT

October 2016

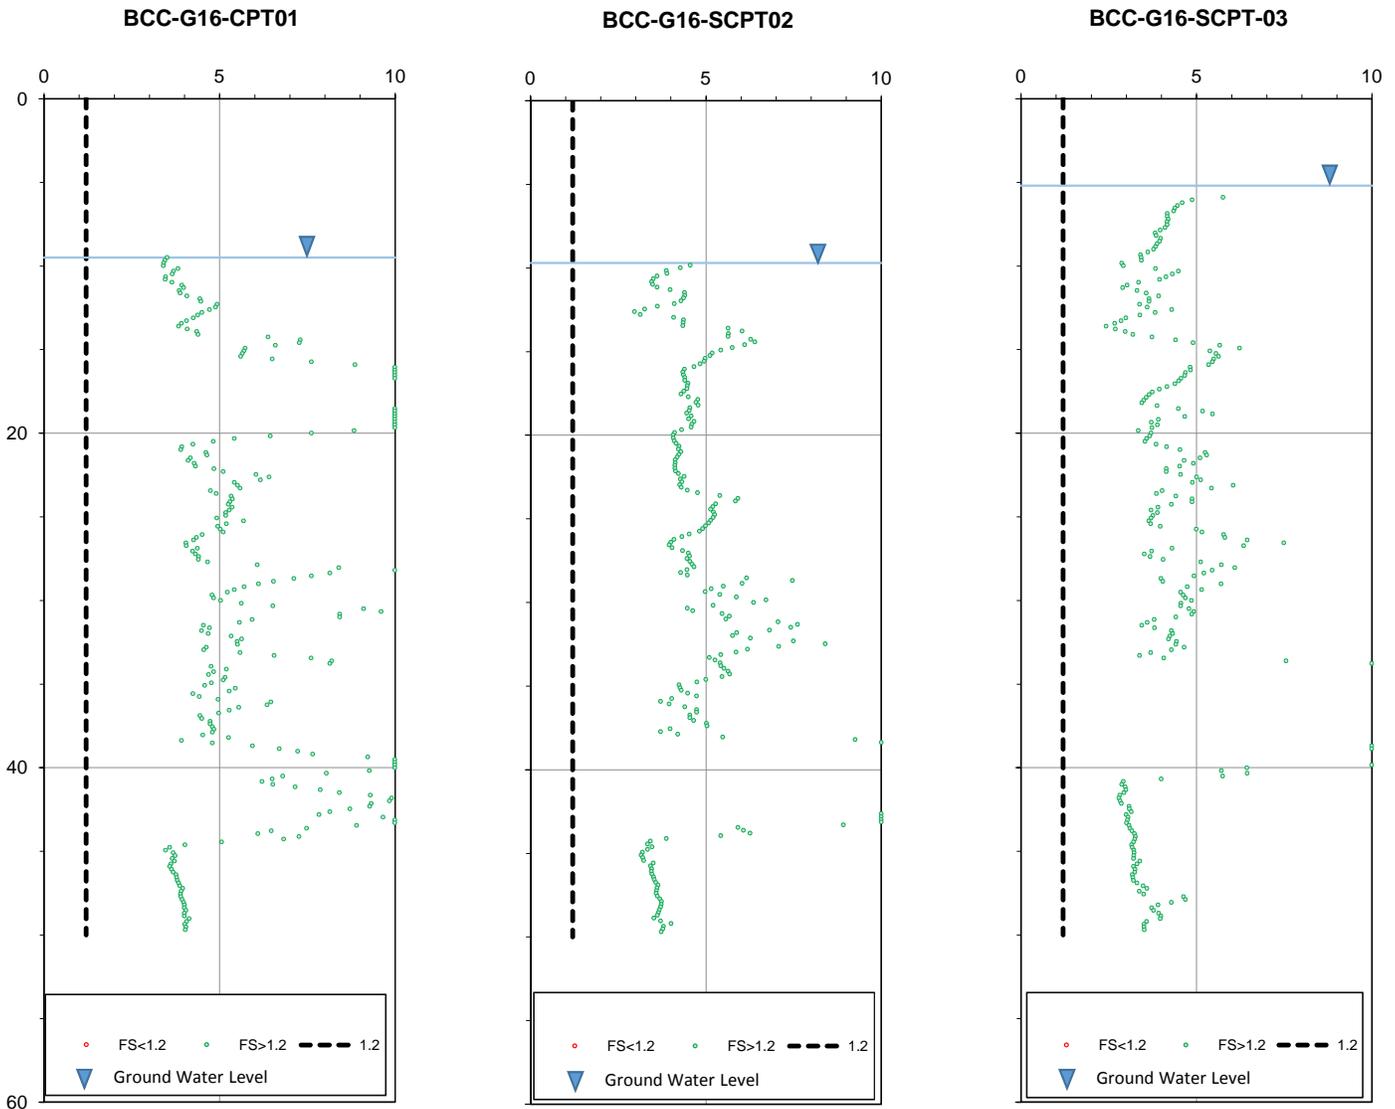
Embankment and foundation soils were screened for seismically-induced liquefaction susceptibility using methods recommended by the National Center for Earthquake Research (NCEER), which uses Cone Penetrometer Test (CPT) data (Youd and Idriss 2001; Robertson and Wride 1998). The calculated factor of safety against seismically-induced liquefaction is shown in Appendix C and was calculated to be greater than 1.20 throughout the depth of the embankments and underlying foundation in the evaluated CPT soundings for the considered earthquake loading. These screening-level results indicate that the CCR in the embankments and foundation soils for Ponds 0-8 is not susceptible to seismically-induced liquefaction for the seismic loading considered.

## FACTOR OF SAFETY AGAINST LIQUEFACTION
