J.H. CAMPBELL GENERATING FACILITY

BOTTOM ASH POND 3 HAZARD POTENTIAL CLASSIFICATION ASSESSMENT REPORT

West Olive, Michigan

October 2016 1654923

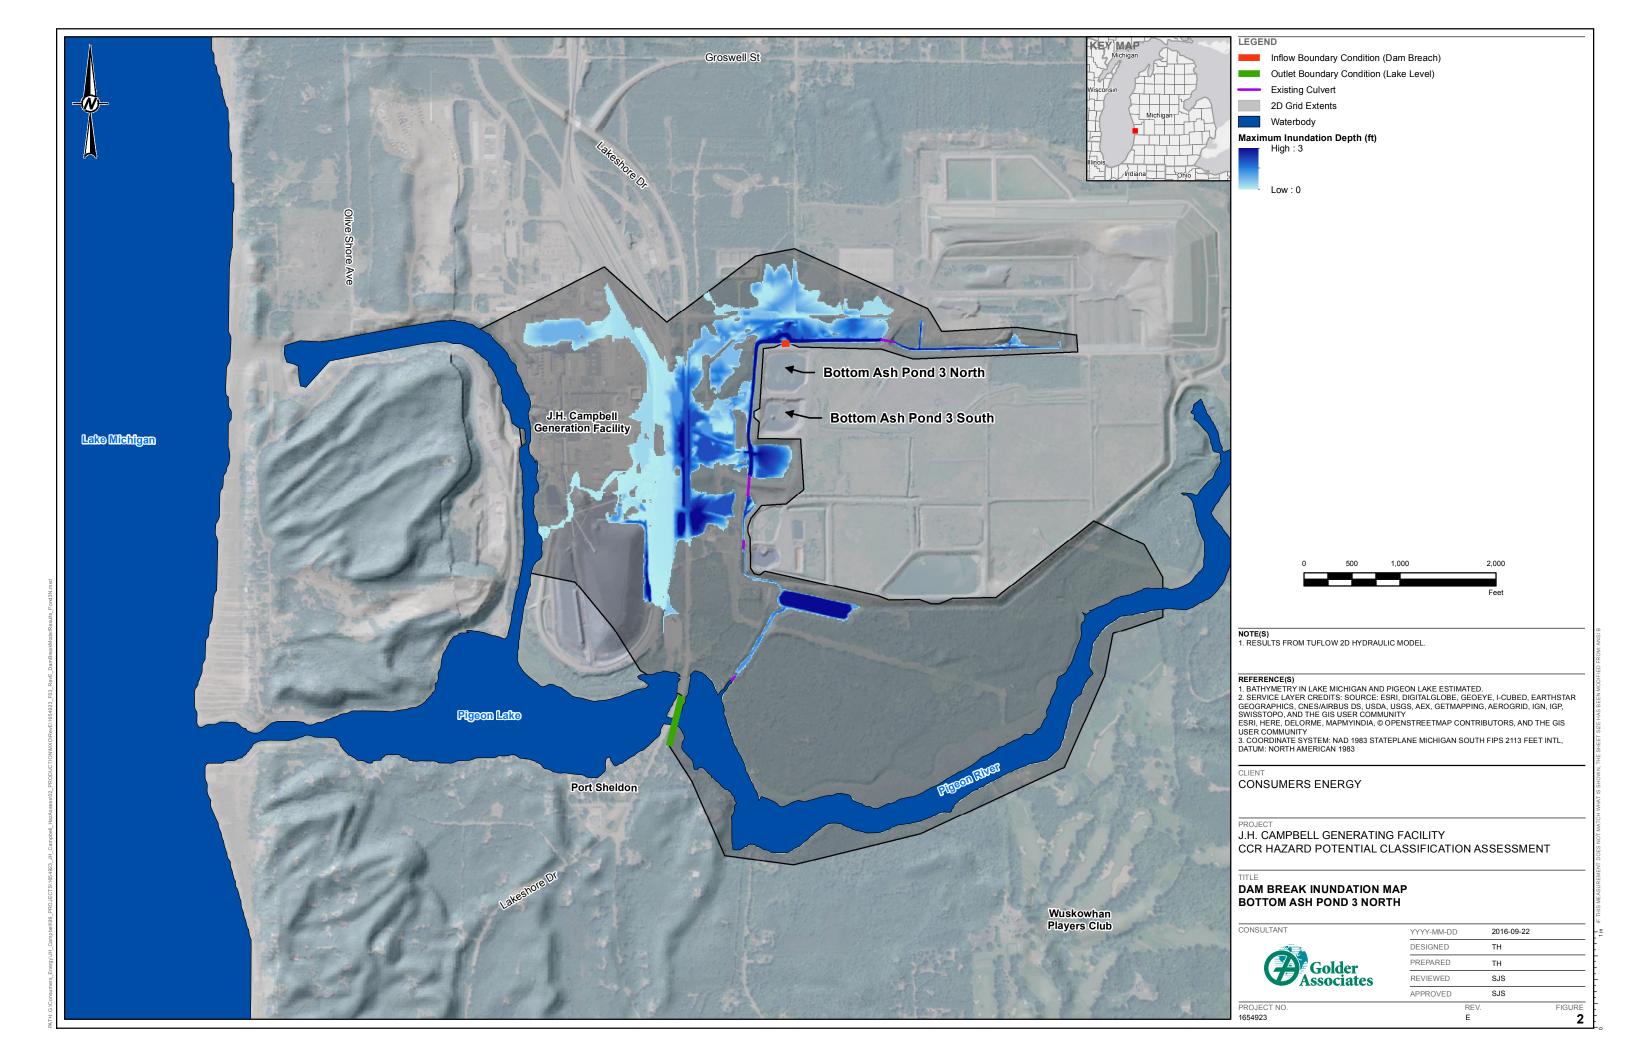
Dam break flood routing was run assuming that the four culverts remained open to flow. The resulting dam break inundation maps are presented in Figure 2 – Dam Break Inundation Map Bottom Ash Pond 3 North and Figure 3 - Dam Break Inundation Map Bottom Ash Pond 3 South.

Flooding caused by a potential dam break of Bottom Ash Pond 3 North spreads east and west along a perimeter ditch on the north side of Bottom Ash Pond 3 North. The flood wave flows down the perimeter ditch to the south, through the recirculation pond, and out to Pigeon River. Approximately 18 acre-feet of the flood wave reaches the Pigeon River within the 10-hour model simulation. The peak discharge out of the recirculation pond is limited to 44 cubic feet per second (cfs) and reduces to 6 cfs by the end of the simulation. The flood wave also overtops the perimeter ditch in several locations and drains west across Lakeshore Drive. Most of the west flood wave ends within JH Campbell west of Lakeshore Drive with approximately 0.01 acre-feet (< 0.1 cfs) entering the north arm of Pigeon Lake.

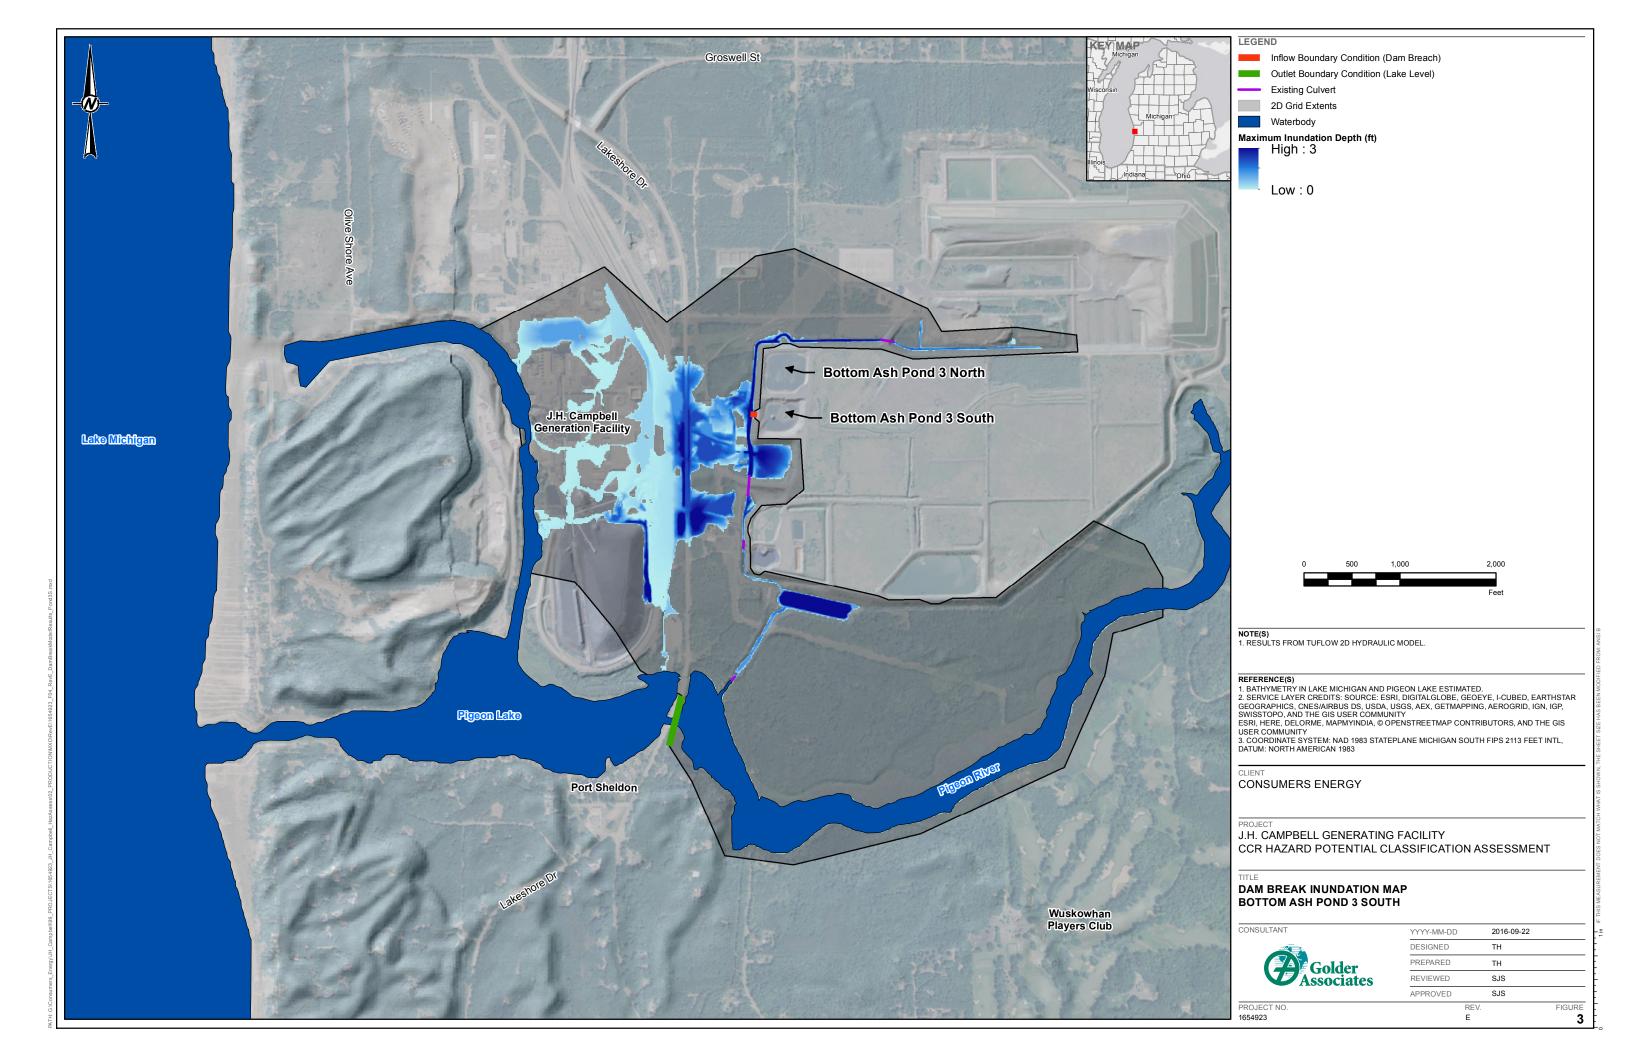
Flooding caused by a potential dam break of Bottom Ash Pond 3 South spreads north and south along a perimeter ditch on the west side of Bottom Ash Pond 3 South. The flood wave flows down the perimeter ditch to the south, through the recirculation pond, and out to Pigeon River. Approximately 16 acre-feet of the flood wave reaches the Pigeon River within the 10-hour model simulation. The peak discharge out of the recirculation pond is limited to 41 cfs and reduces to 3 cfs by the end of the simulation. The flood wave also overtops the perimeter ditch in several locations and drains west across Lakeshore Drive. Most of the west flood waves ends within JH Campbell west of Lakeshore Drive with approximately 0.35 acre-feet (< 0.9 cfs) entering the north arm of Pigeon Lake.
