Structural Stability and Safety Factor Assessment Report

D.E. KARN GENERATING FACILITY

BOTTOM ASH POND STRUCTURAL STABILITY AND SAFETY FACTOR ASSESSMENT REPORT

October 2016

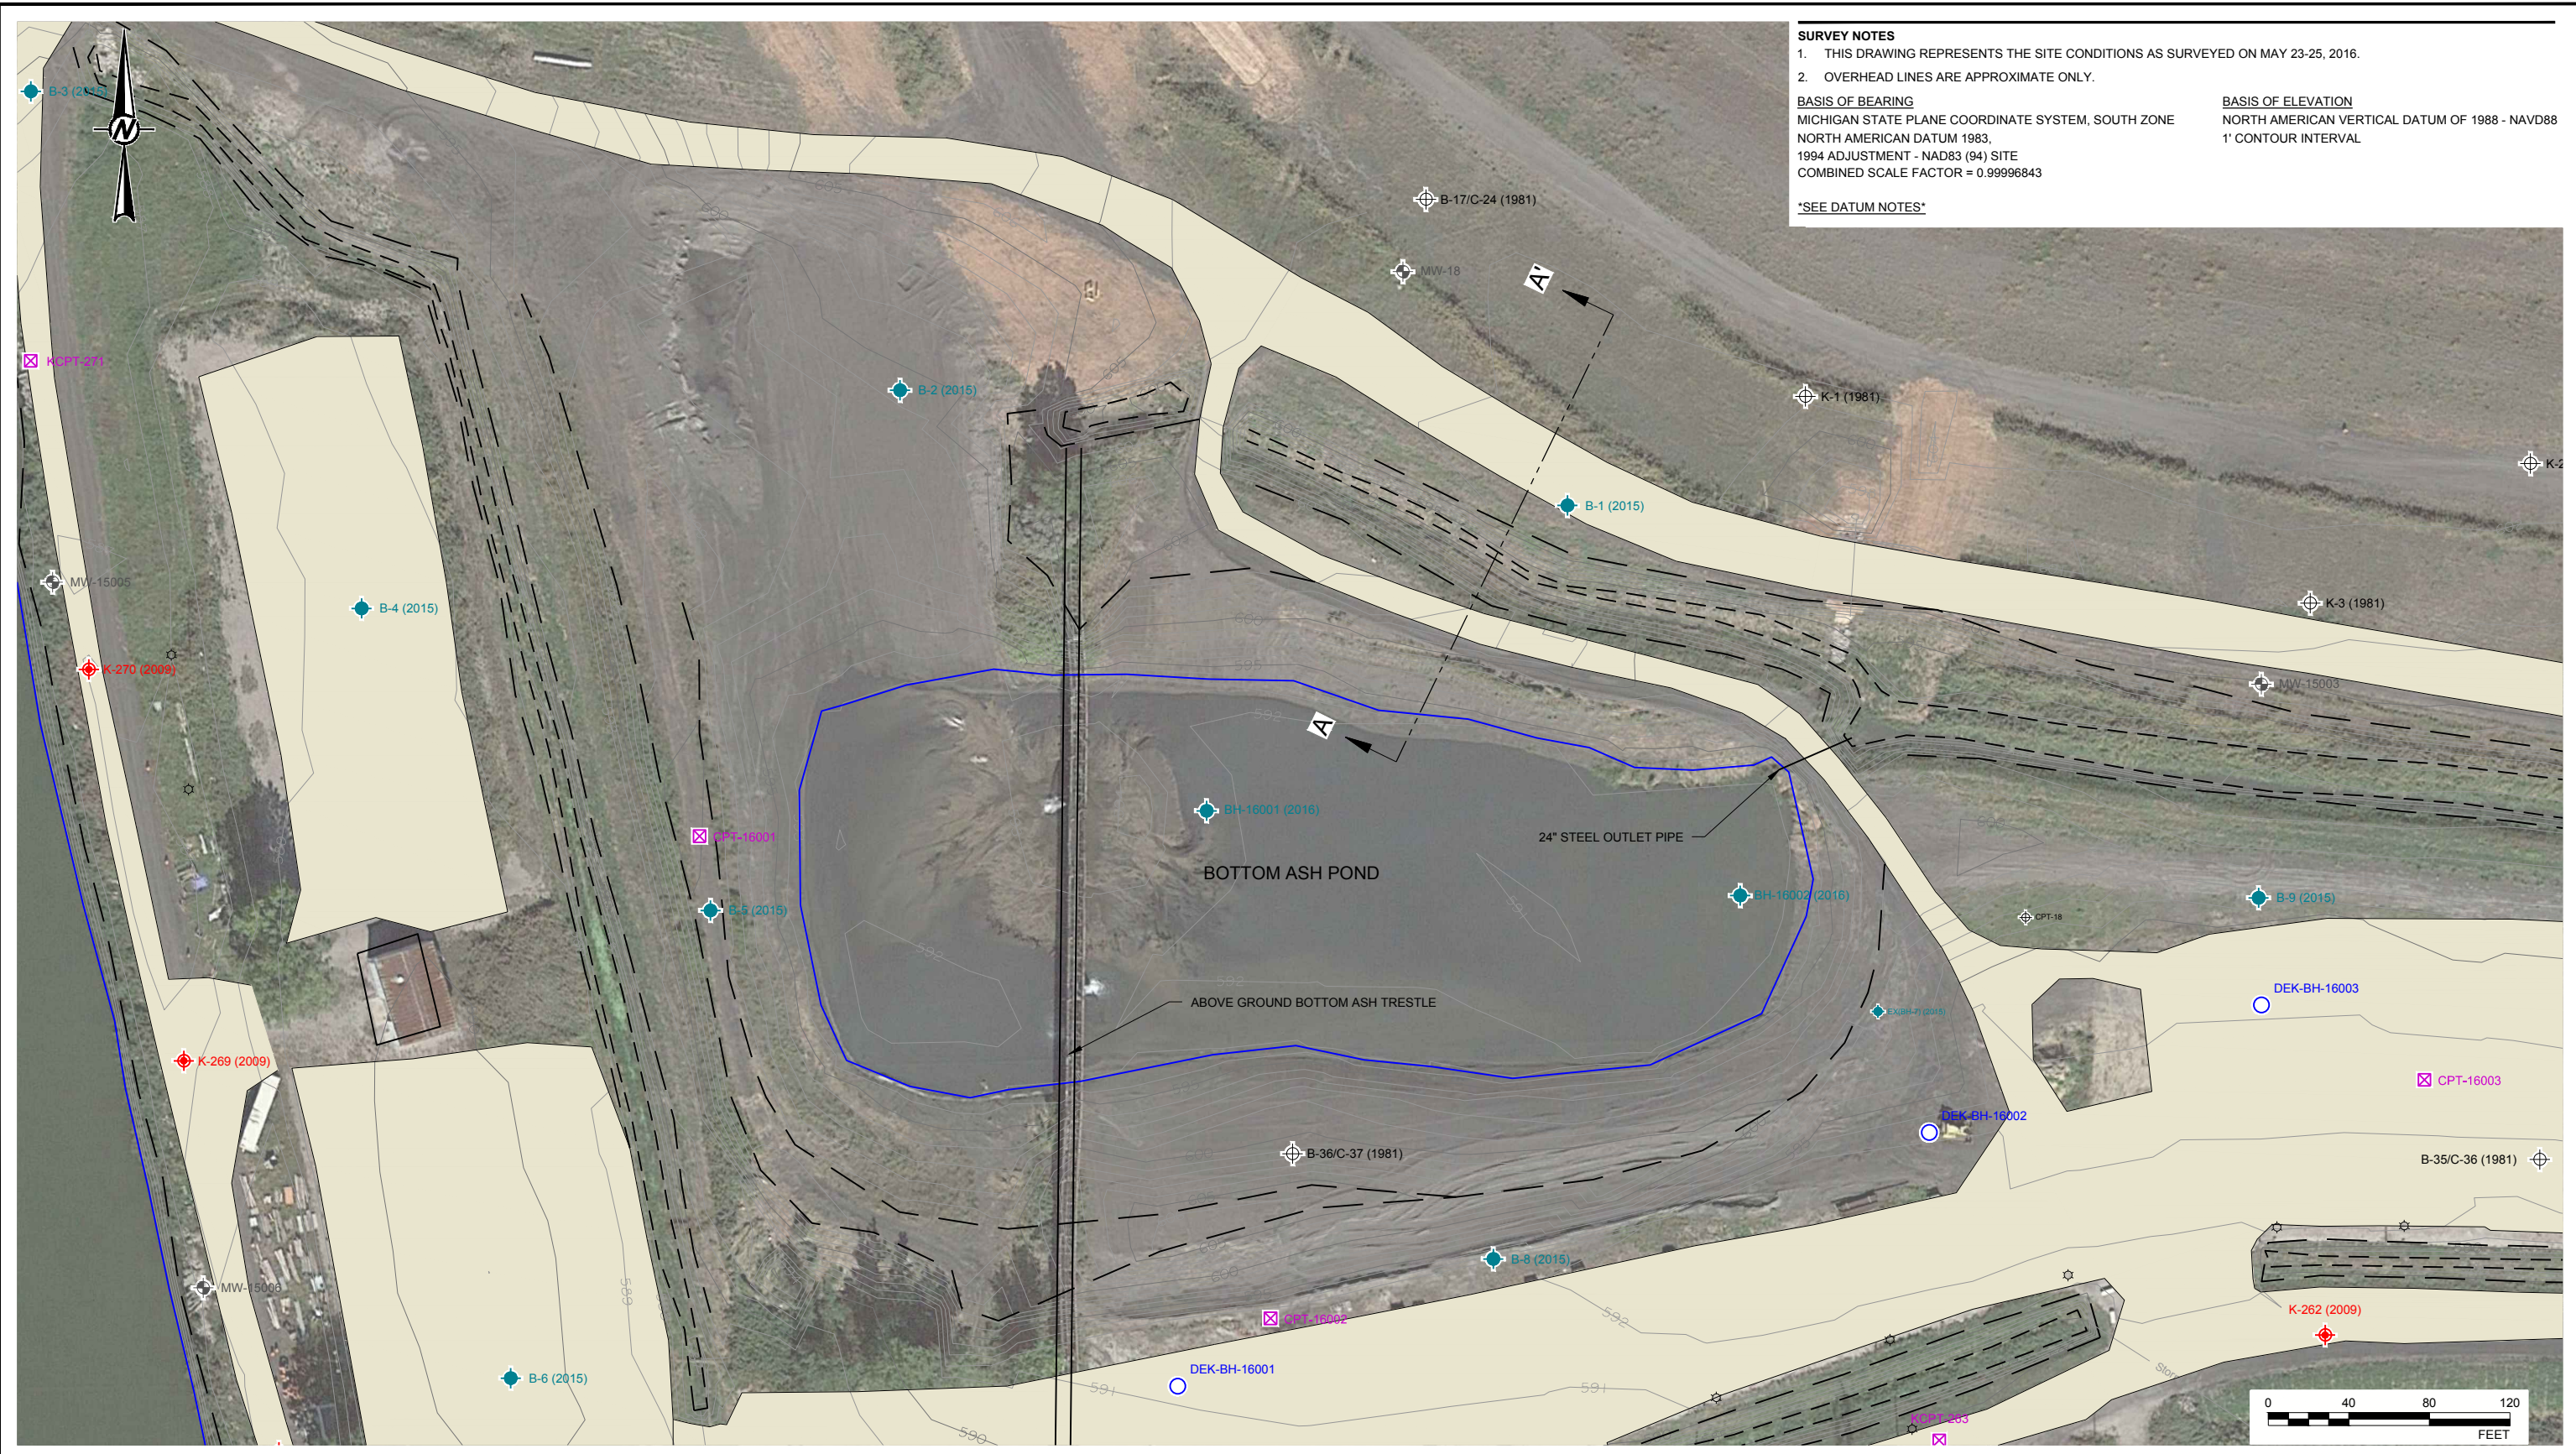
FIGURE
2

The critical section used for the slope stability analysis was located along the northern dike of the Bottom Ash Pond and is shown as Section A-A' on Figure 2.

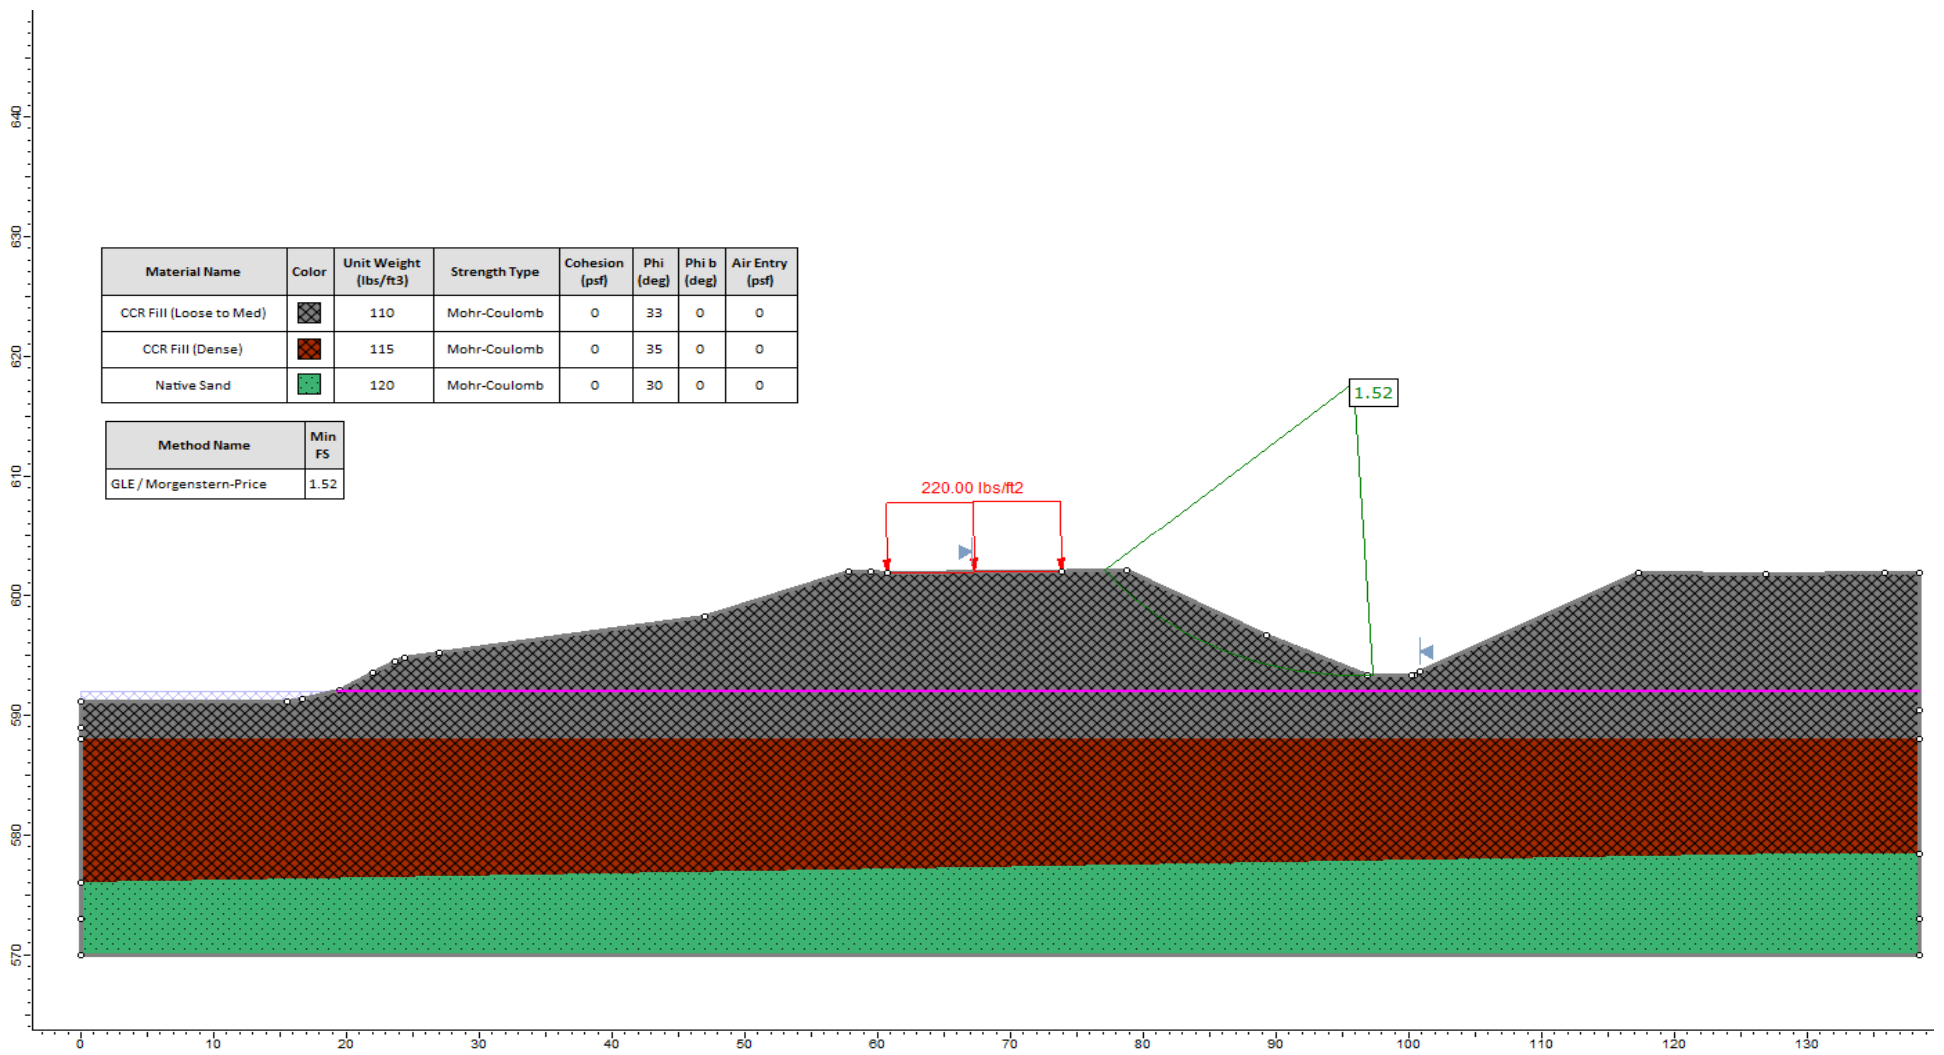
FIGURE	B-A1
--------	-------------

Scenarios	Maximum Pool Storage	Maximum Pool Surcharge	Seismic
Required Safety Factor	1.50	1.40	1.00
Section	Calculated Safety Factor		
Section A-A'	1.52	1.52	1.35

Method Name	Min FS
GLE / Morgenstern-Price	1.52

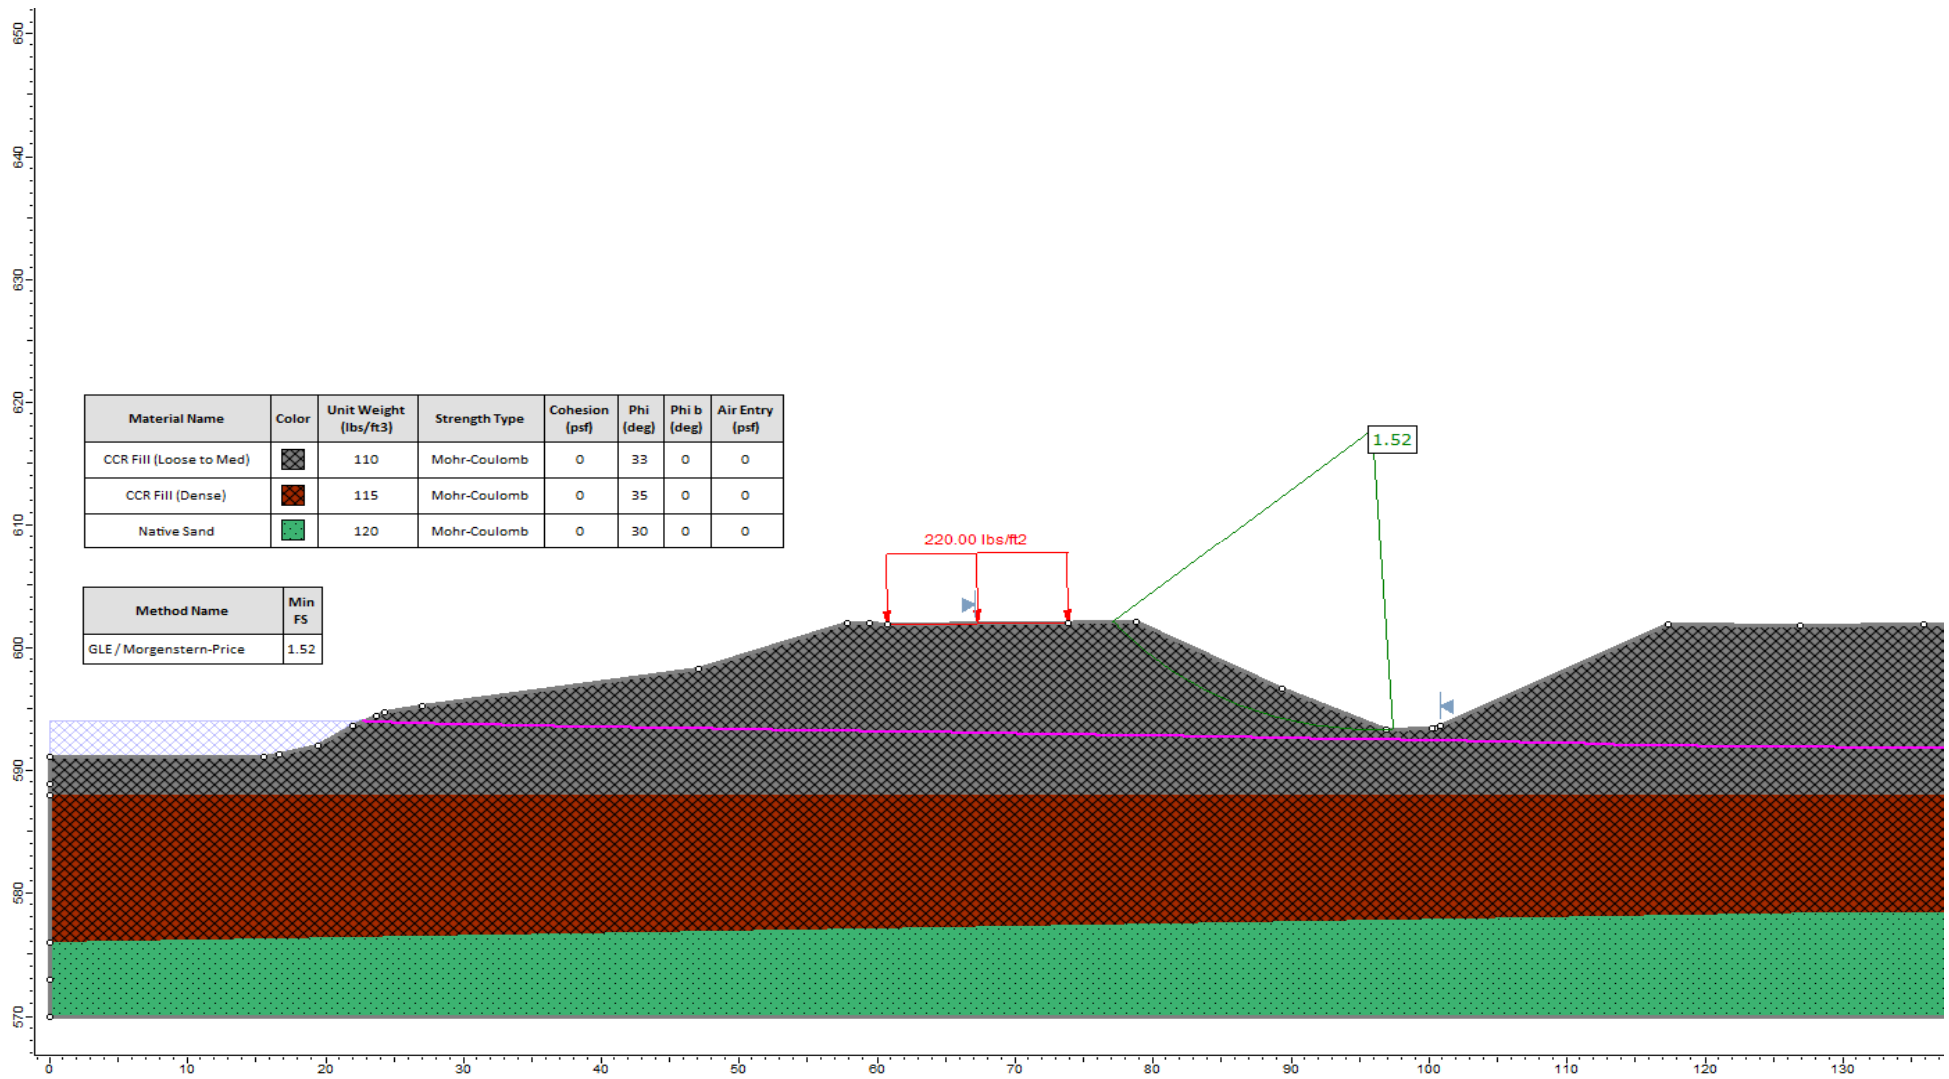
Method Name	Min FS
GLE / Morgenstern-Price	1.52

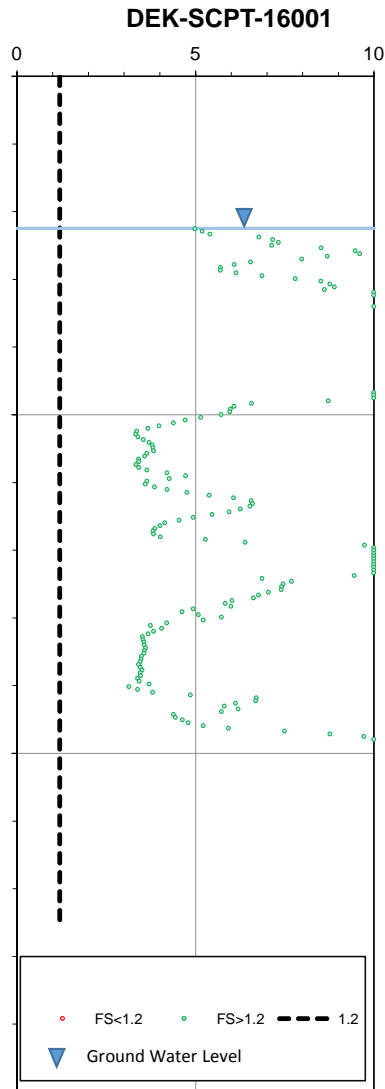
CPT ID: DEK-SCPT-16001
Test Date: 5/19/2016
Northing: 783008
Easting: 13262522
Elevation: 599.0 ft
a_{max}: 0.04 g
Water Table: 9.0 ft

Embankment and foundation soils were screened for seismically-induced liquefaction susceptibility using methods recommended by the National Center for Earthquake Research (NCEER), which uses CPT data (Youd et al. 2001; Robertson and Wride 1998). The calculated factor of safety against seismically-induced liquefaction is shown in Appendix C and was calculated to be greater than 1.20 throughout the depth of the embankments and underlying foundation in the evaluated CPT soundings for the considered earthquake loading. These screening-level results indicate that the embankments and foundation soils for the Bottom Ash Pond are not susceptible to seismically-induced liquefaction for the seismic loading considered.
