HAZARD POTENTIAL CLASSIFICATION
ASSESSMENT REPORT

D.E. KARN GENERATING FACILITY

KARN LINED IMPOUNDMENT HAZARD POTENTIAL CLASSIFICATION ASSESSMENT REPORT

June 2018

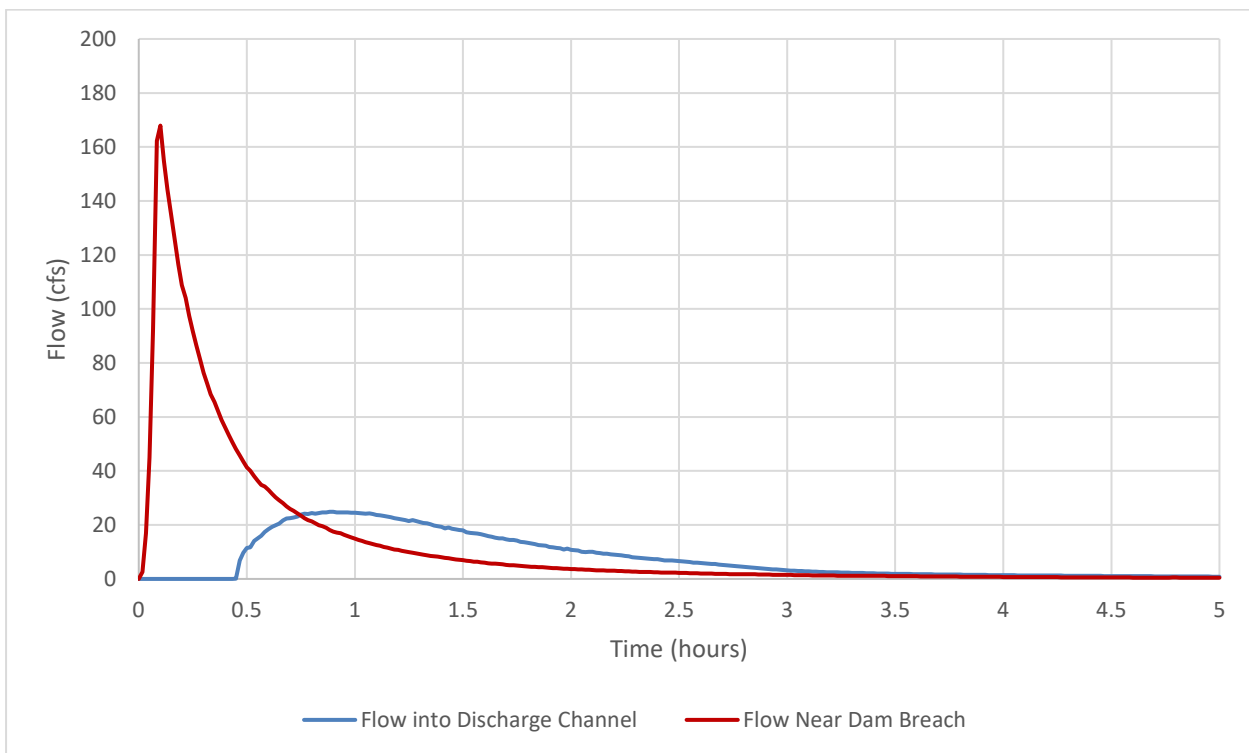
Figure 2.1: Discharge Hydrograph (With Downstream Culvert Open)

The resulting dam break maximum inundation maps are presented in Figures 2 and 3. Flooding caused by a potential dam break at the Karn Lined Impoundment enters a ditch directly south of the Karn Lined Impoundment. The majority of the flood wave overtops the ditch and spreads south and east through a canal, and discharges to the Discharge Channel through the 36-inch downstream culvert that outlets into the Discharge Channel. Approximately 3.2 acre-feet (peak discharge of 24.9 cfs) of stored water reaches the Discharge Channel.

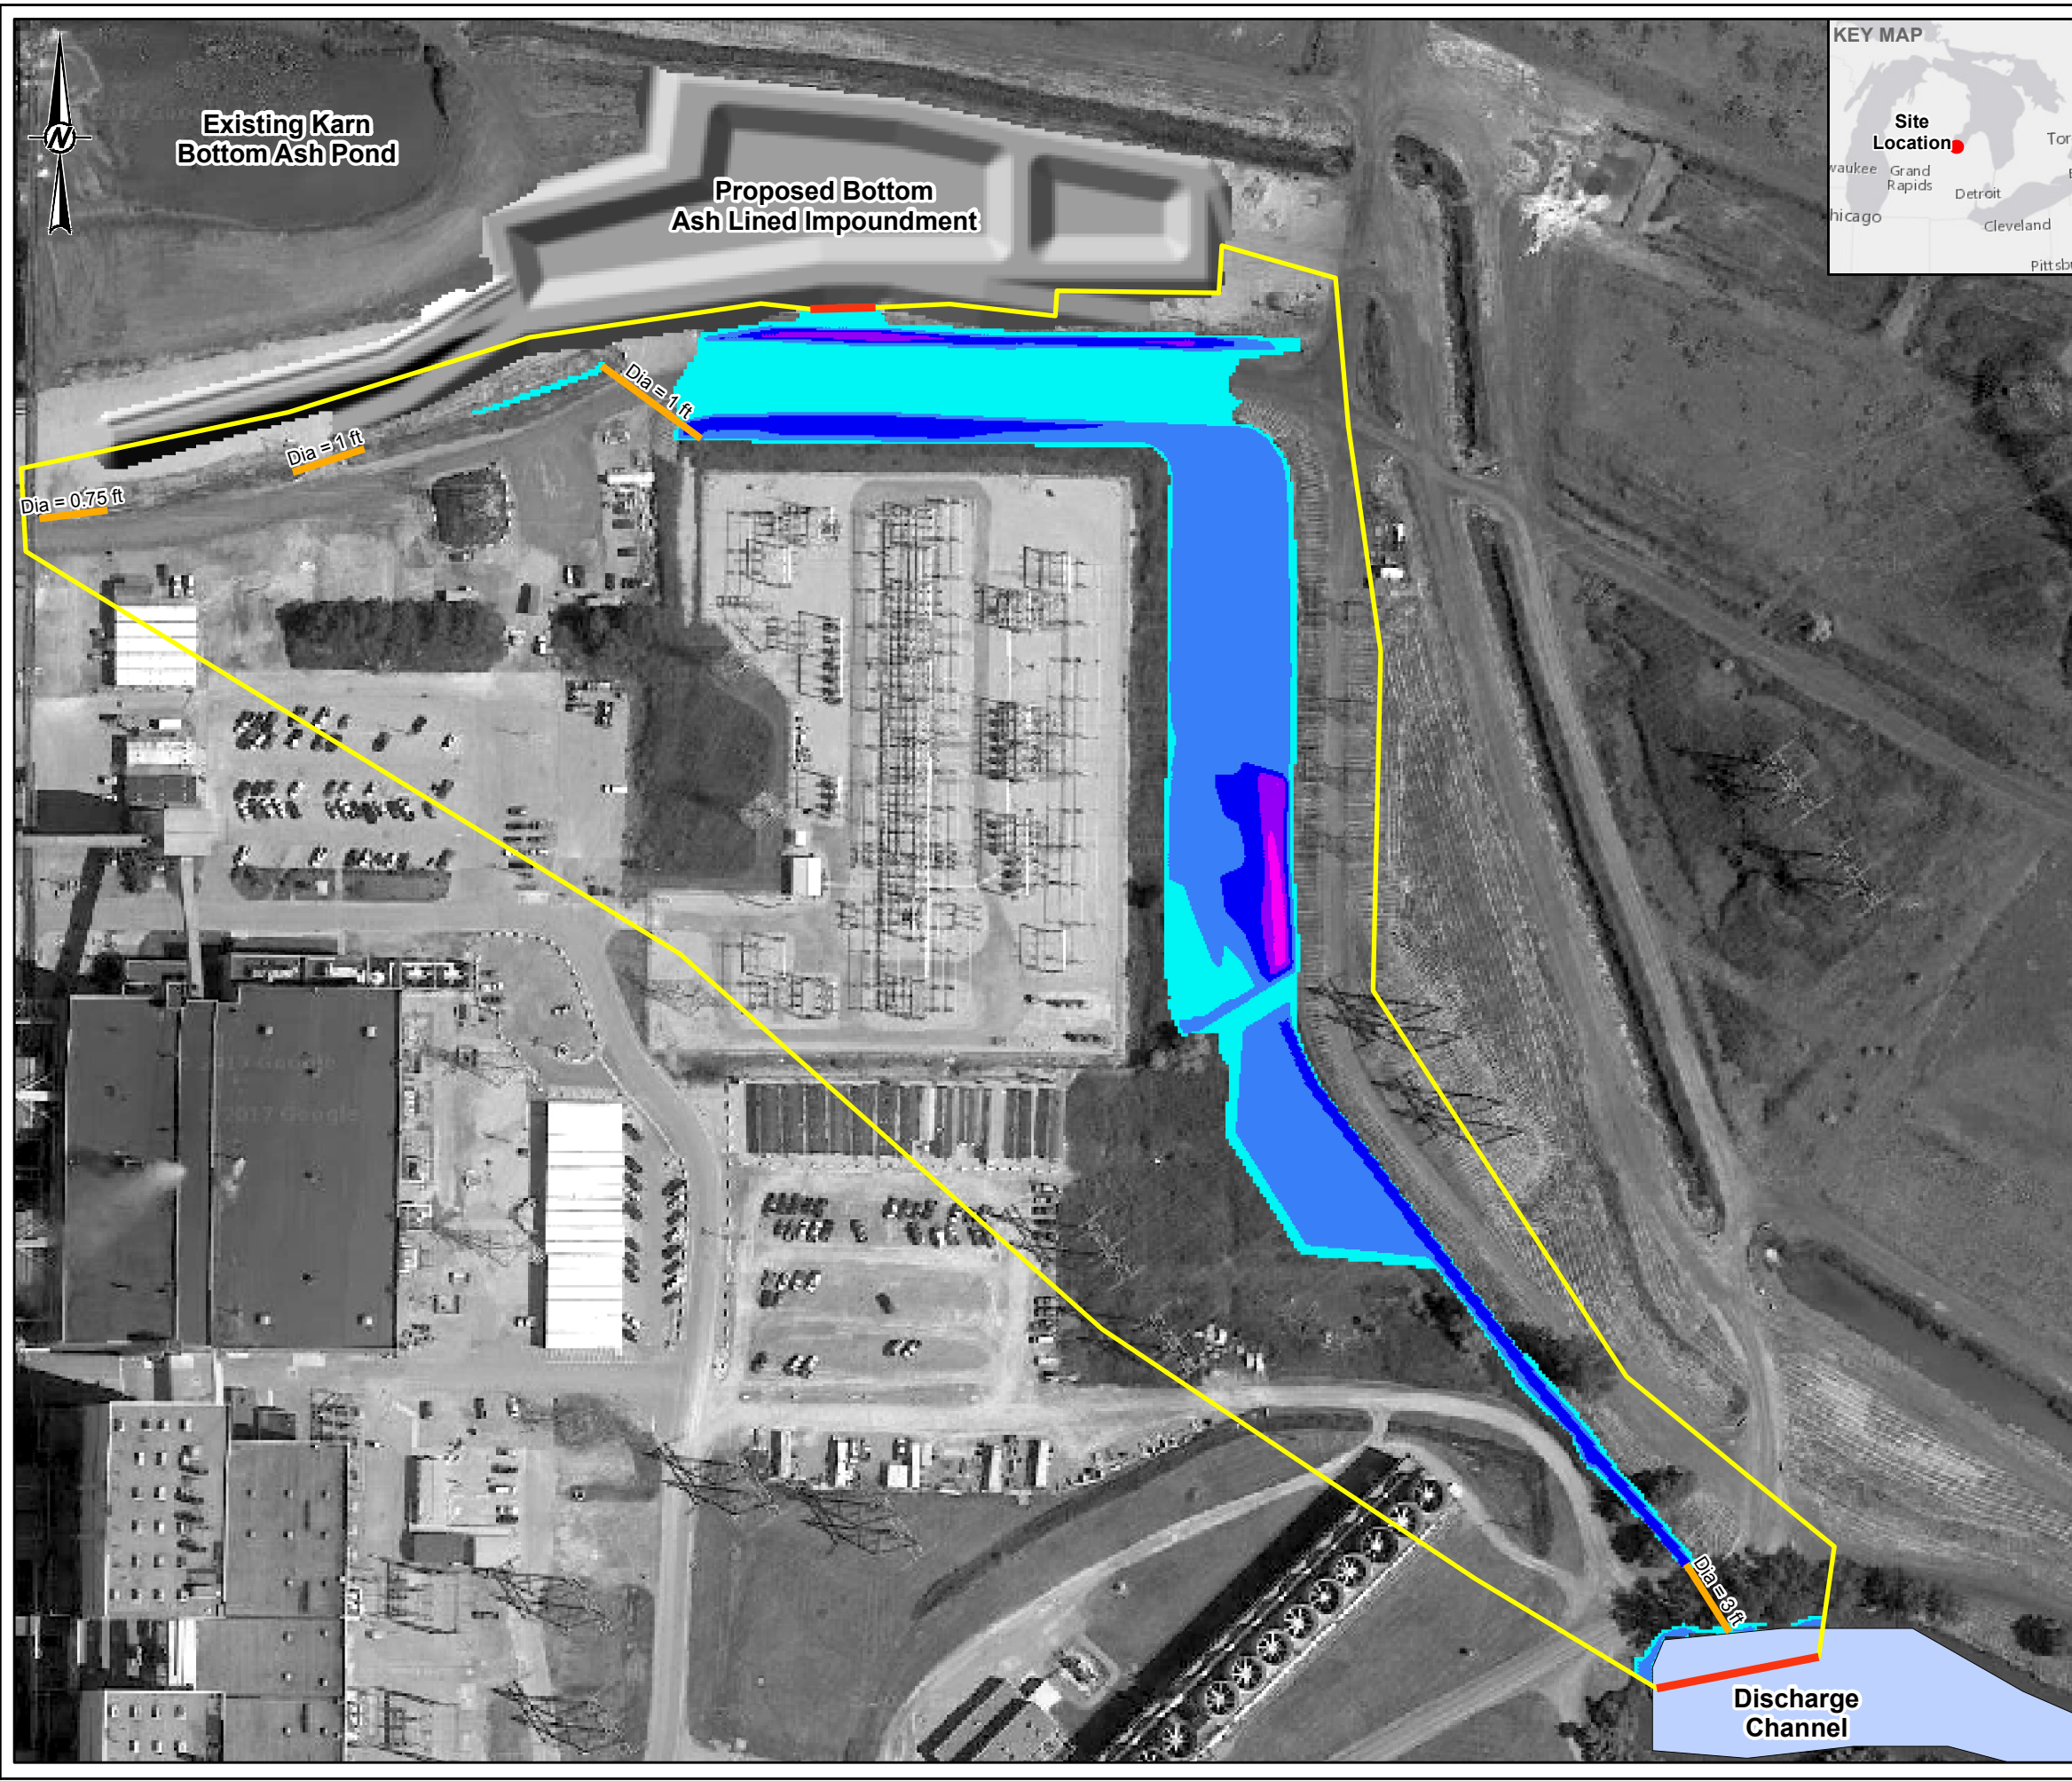
TITLE
 DAM BREAK MAXIMUM INUNDATION DEPTH
 (WITH CULVERTS OPEN)

If a release of stored water due to failure or mis-operation were to occur, the dam break analysis predicts that a relatively small volume of water and/or stored content would discharge across part of the DE Karn site and into the Discharge Channel. No probable loss of human life and low economic and/or environmental losses are expected. Any losses are principally limited to the surface impoundment owner's property. As a result, the Karn Lined Impoundment at DE Karn has been rated a low hazard potential classification.

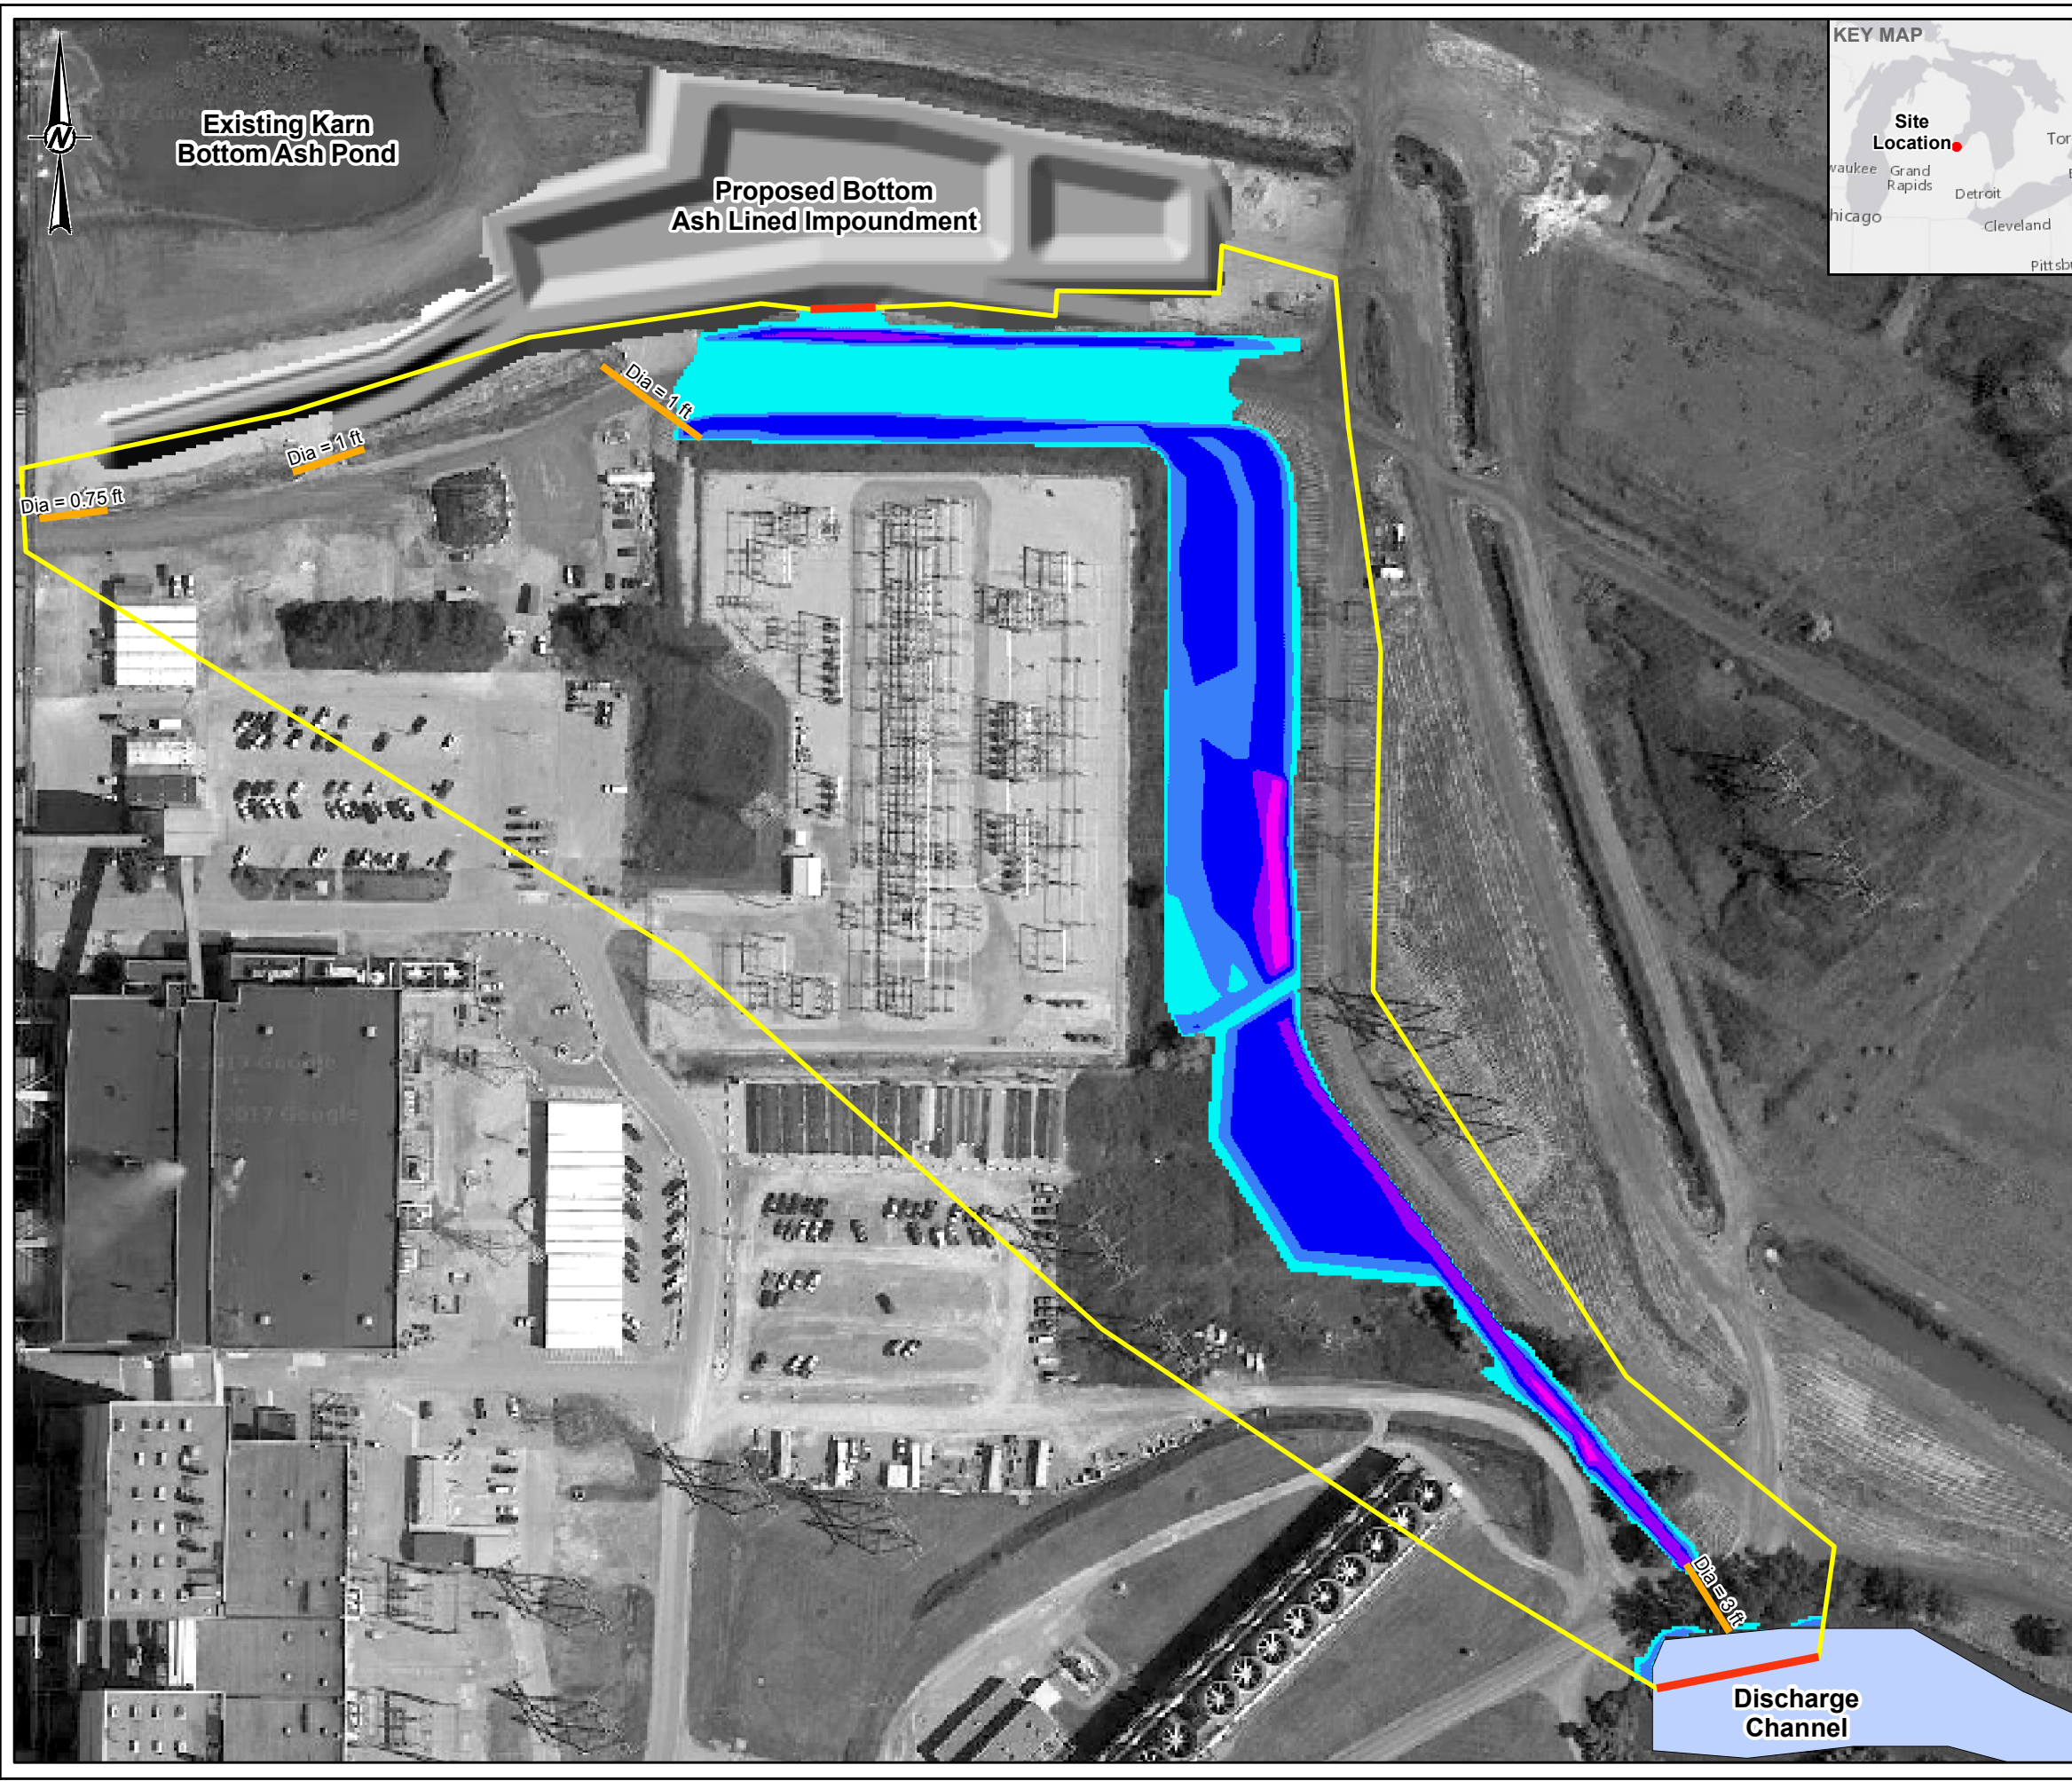
TITLE
DAM BREAK MAXIMUM INUNDATION DEPTH
(WITH CULVERTS BLOCKED)

Flooding caused by a potential dam break at the Karn Lined Impoundment with the downstream 36-inch culvert blocked enters the ditch directly to the south like the previous run. However floodwater backs up behind the blocked culvert. With the blocked culvert, no water enters the Discharge Channel. The backed up water surface rises to a maximum elevation of 584.8 feet, where the road over the 36-inch culvert holding back the water is elevation 586.5 feet. For this run, the downstream culvert to the Discharge Channel is shut off or blocked during the event of an embankment failure. Options to block or shut off the culvert may include: 1) CEC could maintain an excavator onsite at all times that could place a soil barrier at the inlet of the culvert or a steel sheet in front of the the culvert, or 2) install a shutoff valve at the culvert.

The Karn Lined Impoundment at DE Karn has been rated a low hazard potential classification, as a dike failure or mis-operation would result in no probable loss of human life and low economic and/or environmental losses. Any losses are principally limited to the surface impoundment owner's property. Furthermore, if a release of stored water due to failure or mis-operation were to occur, the owner could block the downstream culvert to prevent a discharge to the Discharge Channel.
