J.C. WEADOCK GENERATING FACILITY

BOTTOM ASH POND HAZARD POTENTIAL CLASSIFICATION ASSESSMENT REPORT

Essexville, Michigan

October 2016

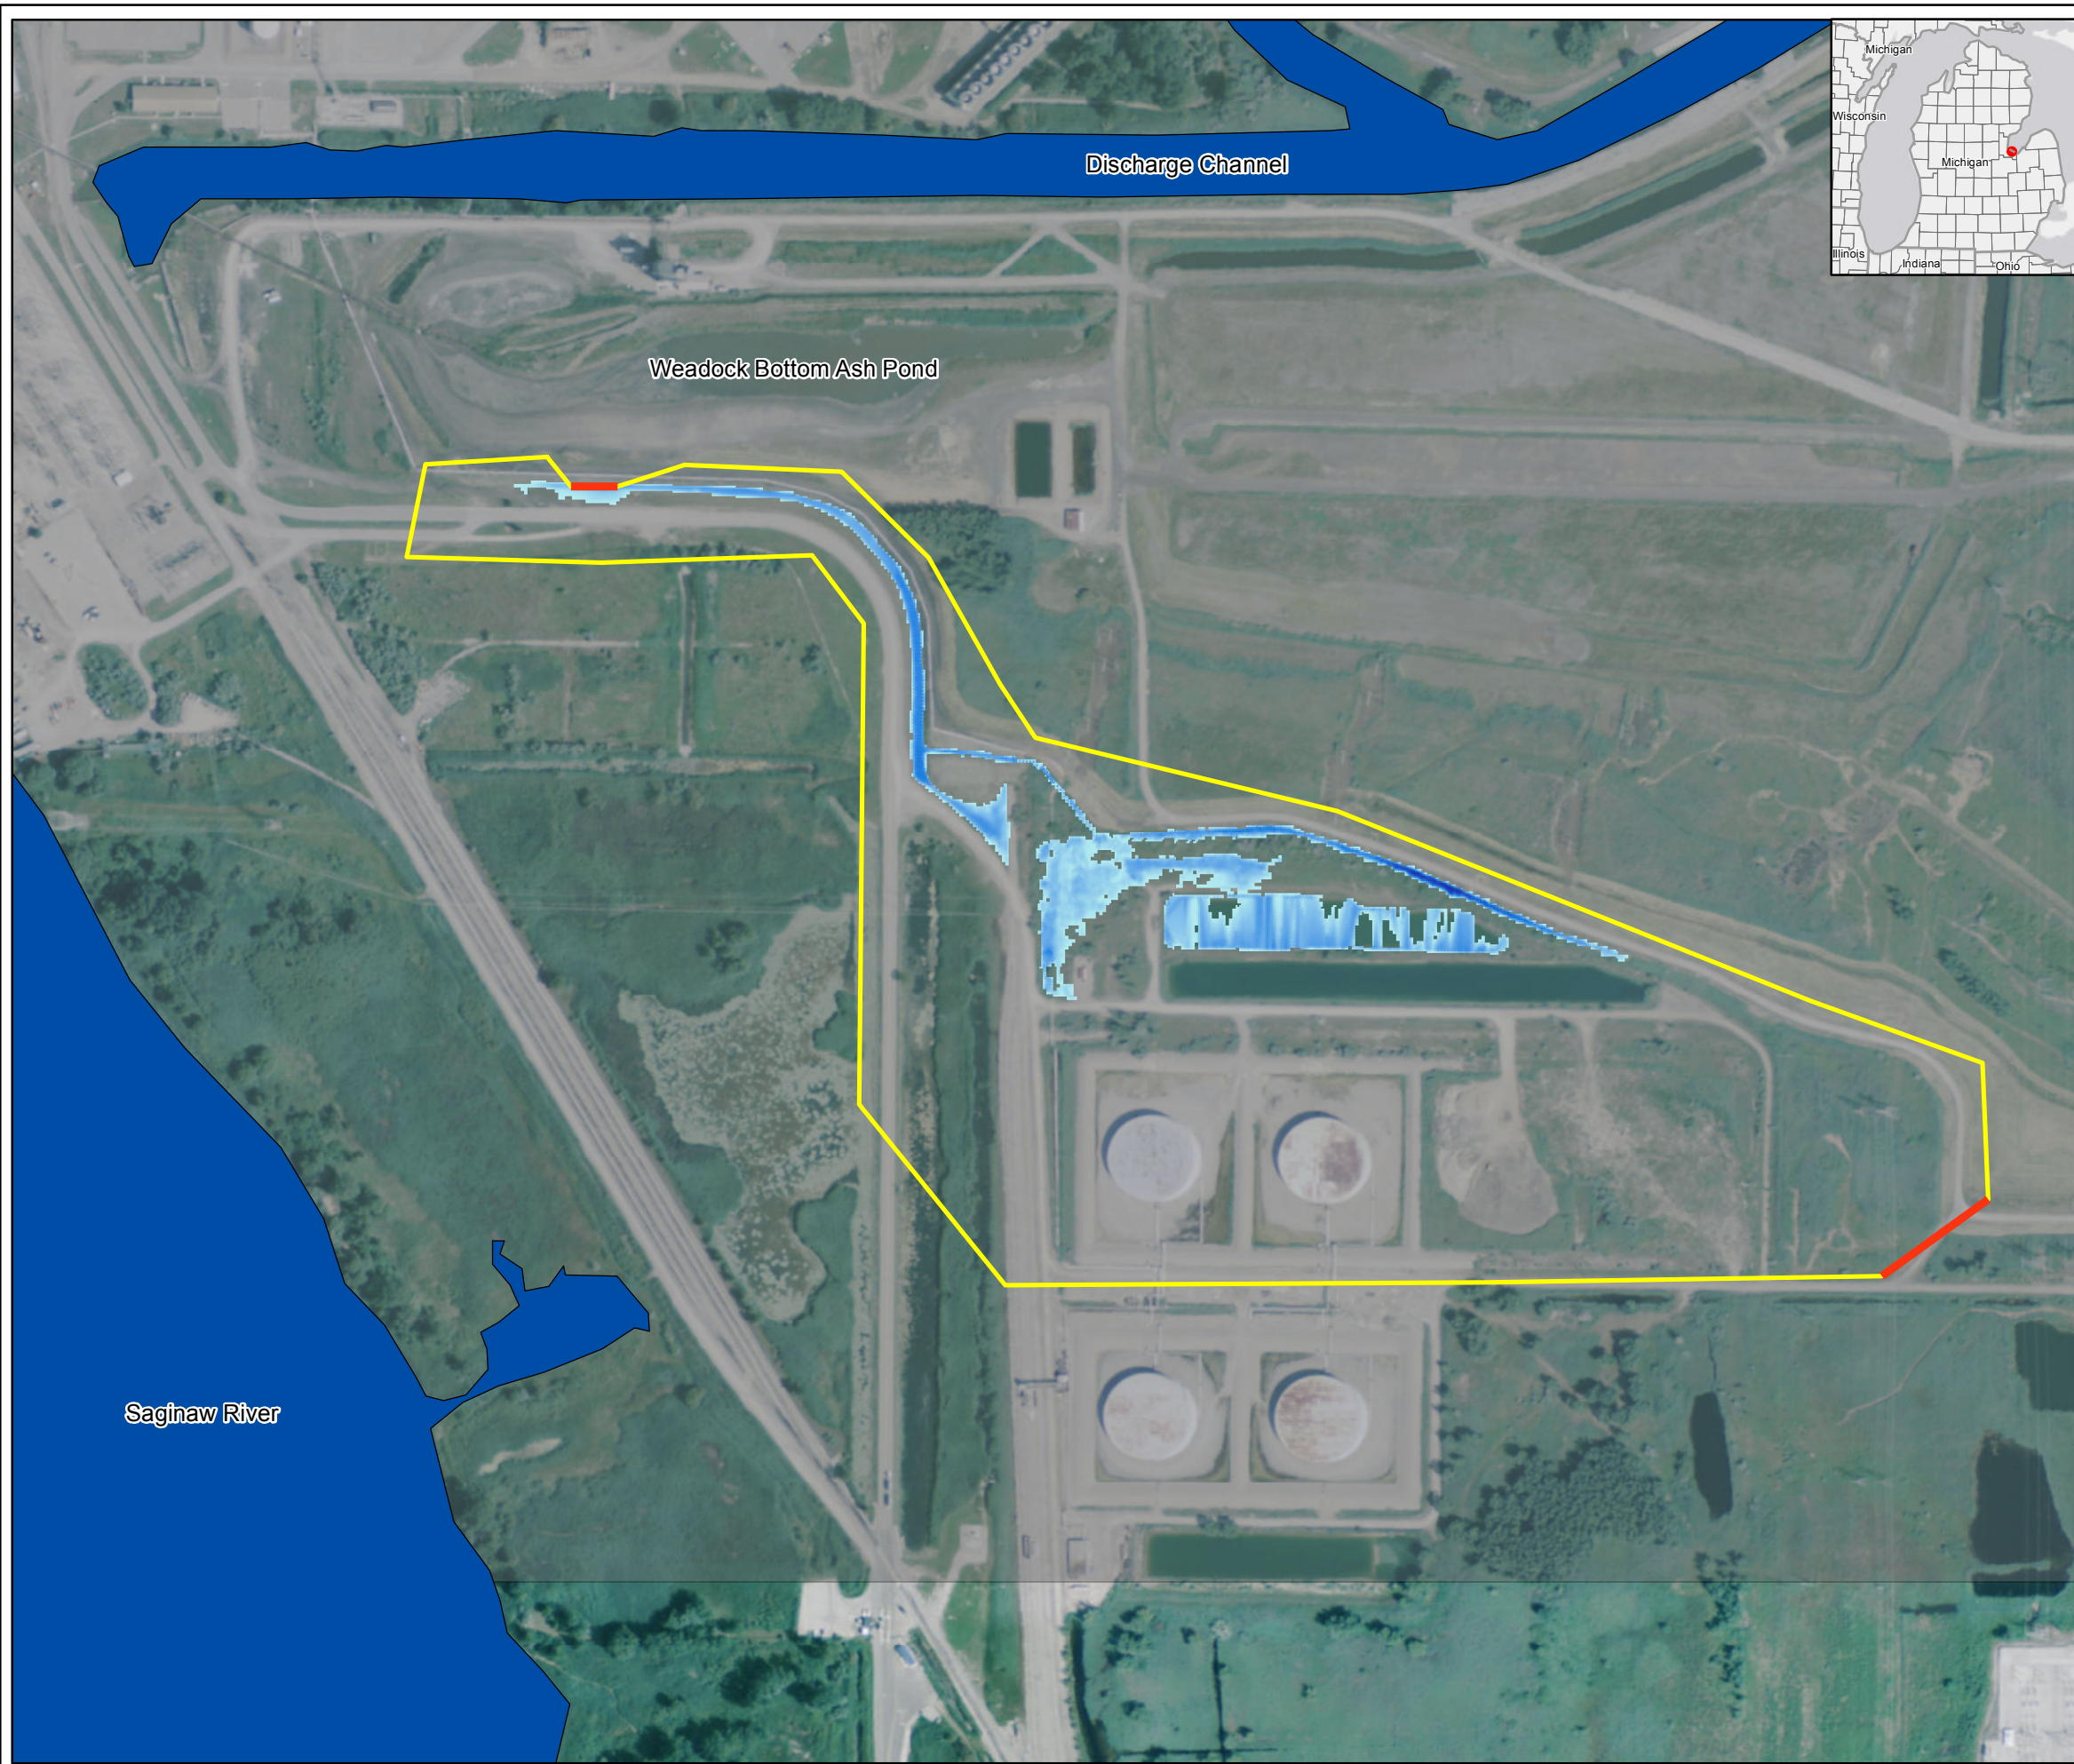
TITLE
**DAM BREAK INUNDATION MAP
 SCENARIO 1**

Flooding caused by a potential dam break of the Bottom Ash Pond on the southern perimeter dike (Scenario 1) enters a ditch directly south of the Bottom Ash Pond. The majority of the flood wave runs along the ditch to the east and then south, ending in a low area approximately 1,000 feet southeast of the Bottom Ash Pond.

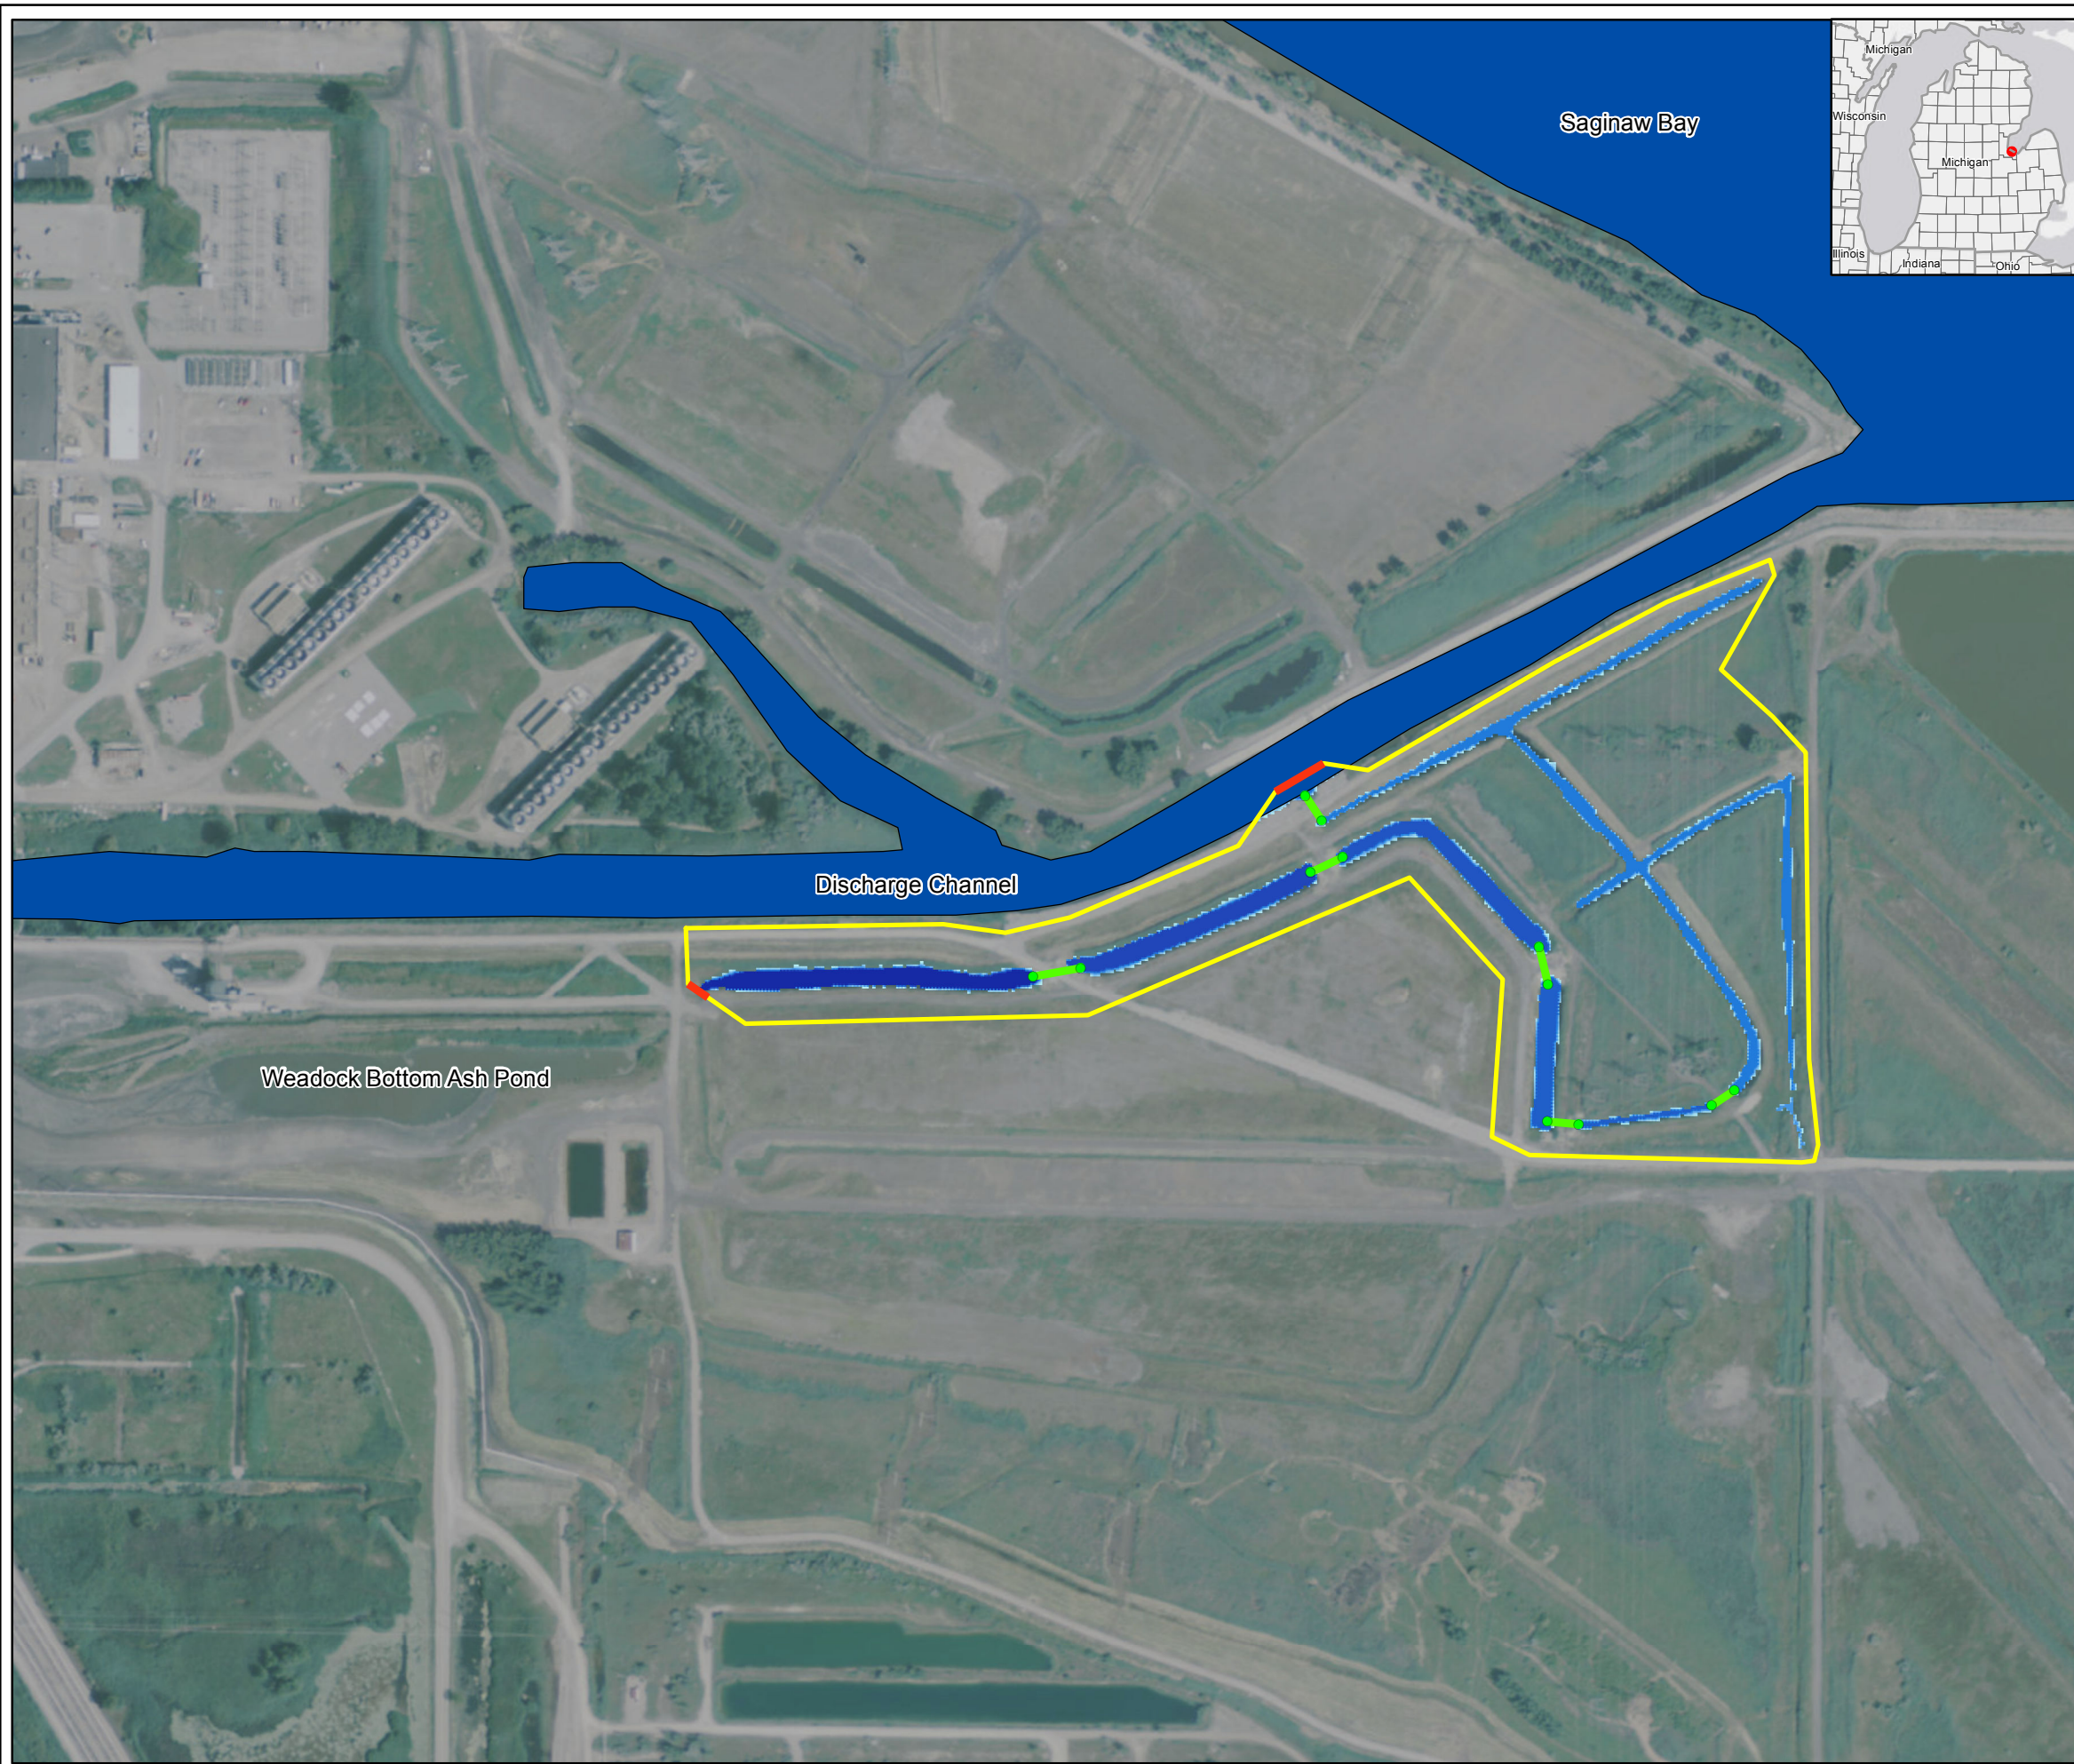
TITLE
**DAM BREAK INUNDATION MAP
 SCENARIO 2**

Flooding caused by a potential dam break at the Bottom Ash Pond at the outlet culvert on the east end of the pond (Scenario 2) enters the channel directly to the east. The flood wave continues through the outlet channel and culvert system out the Discharge Channel. The flood wave attenuates from approximately 25 cfs at the dam break to 1.6 cfs through the NPDES Outfall into the Discharge Channel. Approximately 0.6 acre-feet of stored water reaches the Discharge Channel within 10 hours of the dam break.
