Structural Stability and Safety Factor Assessment Report

J.C. WEADOCK GENERATING FACILITY

BOTTOM ASH POND STRUCTURAL STABILITY AND SAFETY FACTOR ASSESSMENT REPORT

October 2016

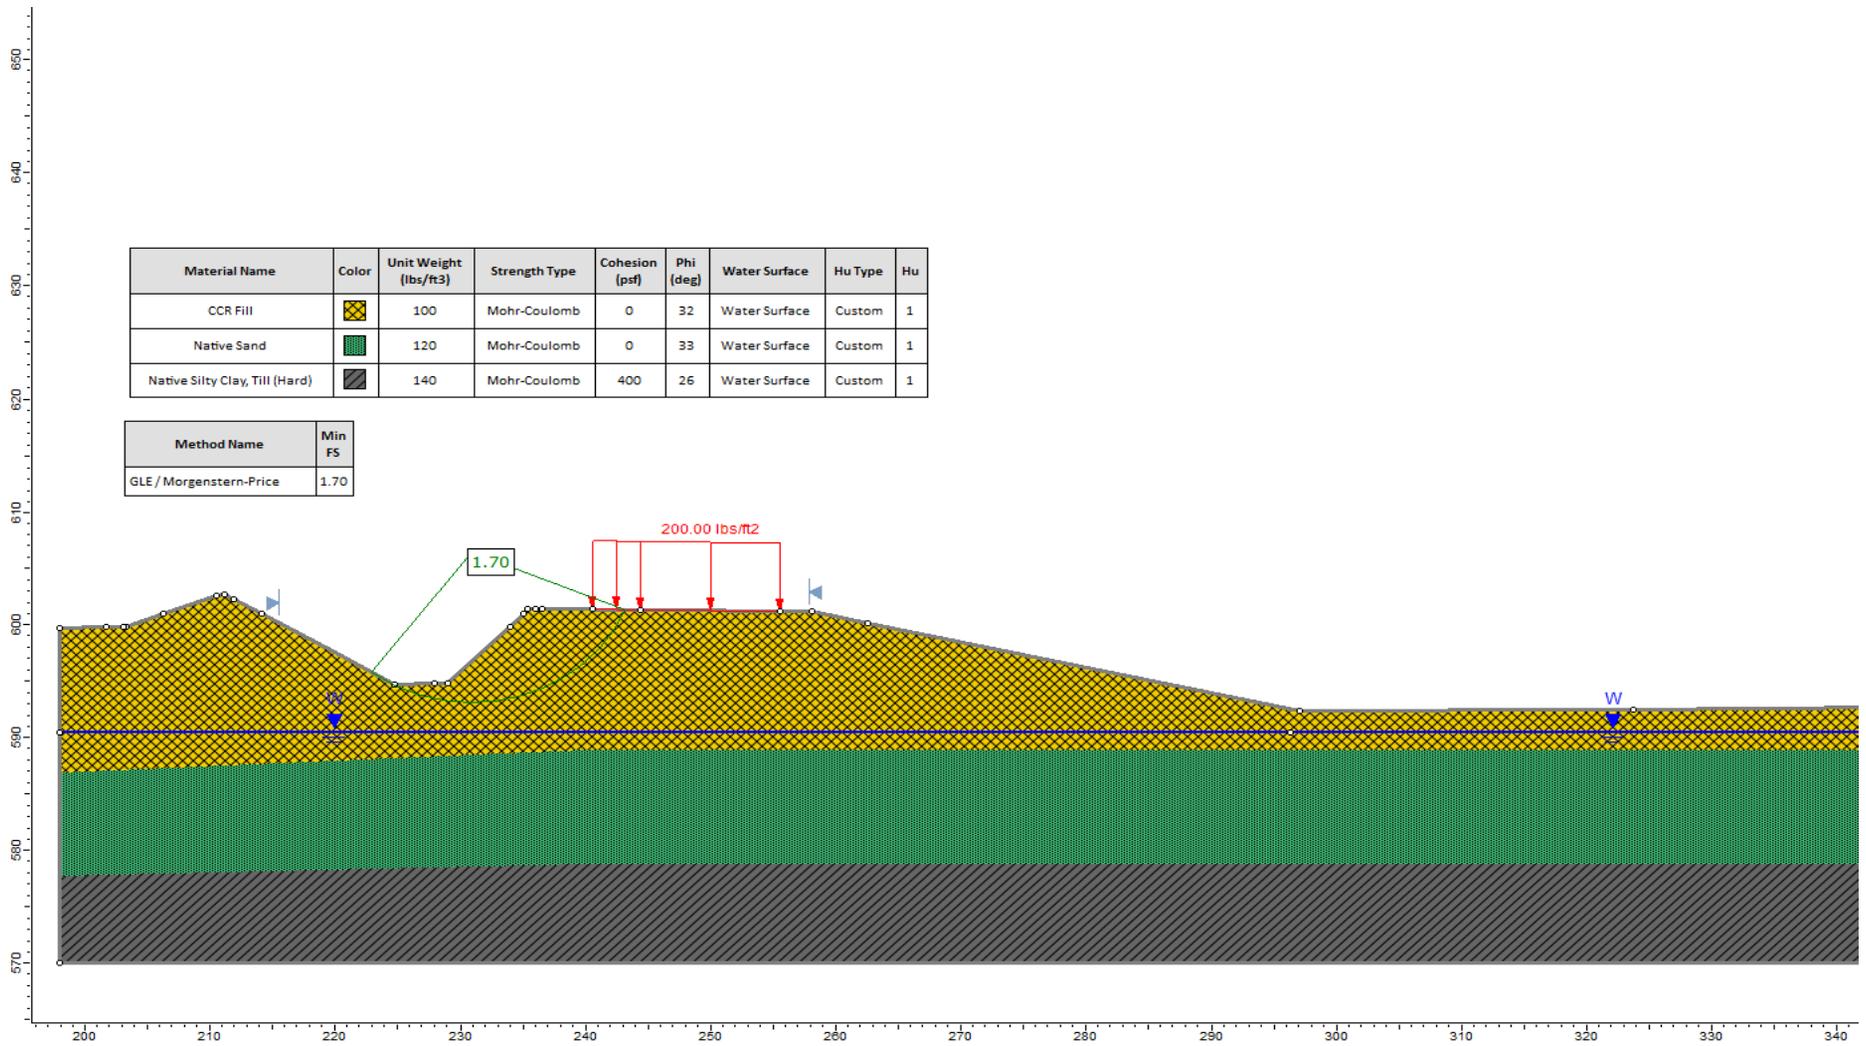
4.2 Stability Analysis Results

Safety factor assessments were performed for long-term static conditions for the critical cross section considered under maximum pool storage and maximum pool surcharge scenarios as well as pseudo-static seismic conditions. The results of the safety factor assessments are presented in Table 4.2.1, and critical failure surface result outputs are contained in Appendix B. The results indicate that the calculated

factor of safety through the critical cross section in the Bottom Ash Pond surface impoundment meet or exceed the minimum values listed in Section 257.73(e)(1)(i-iv).

| Scenarios | Maximum Pool Storage | Maximum Pool Surcharge | Seismic |
|---|---|---|---|
| Section A-A' | 1.70 | 1.70 | 1.64 |

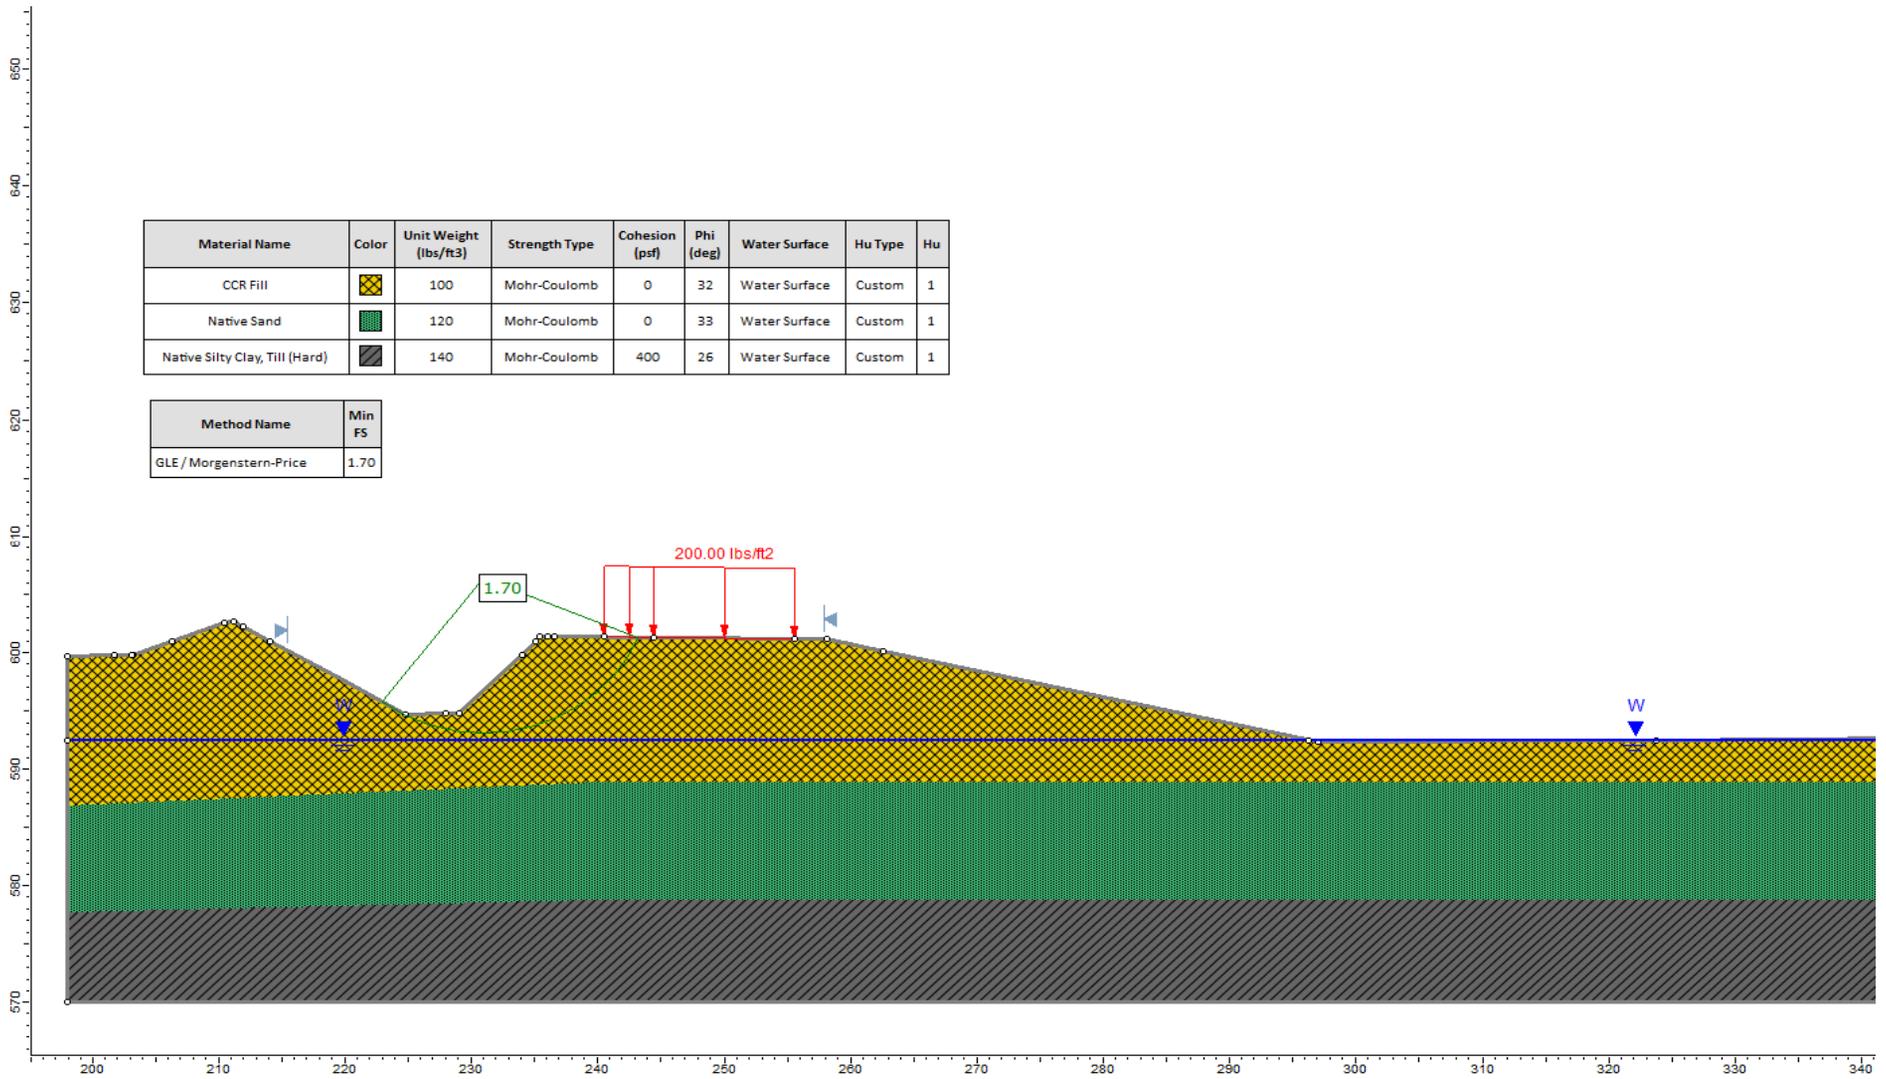
| Method Name | Min FS |
| GLE / Morgenstern-Price | 1.64 |

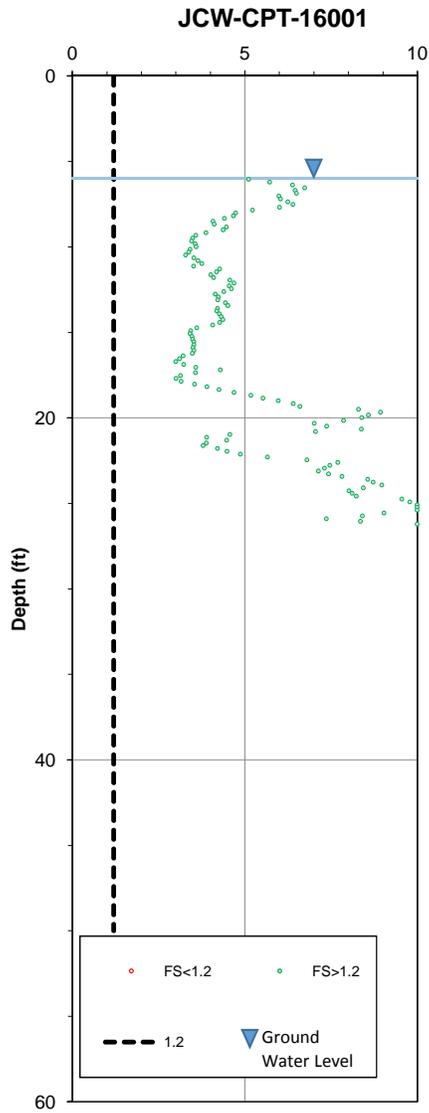
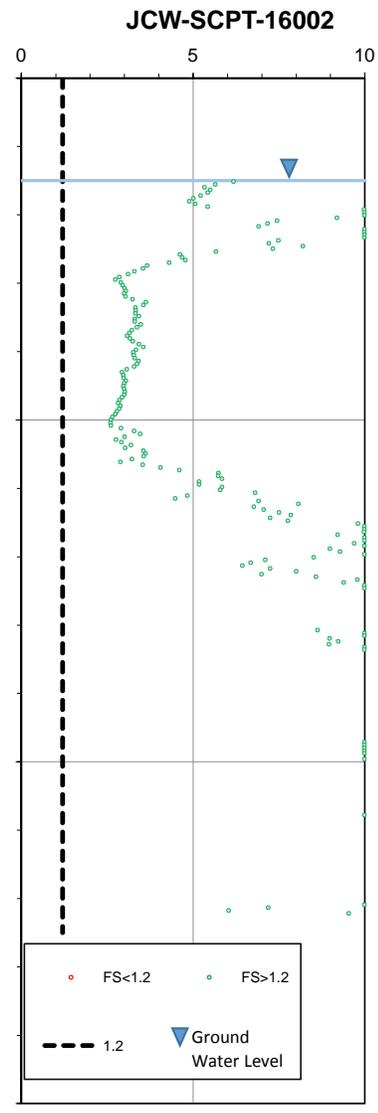
FACTOR OF SAFETY AGAINST LIQUEFACTION

Notes: Factors of safety (FS) greater than 10 are shown equal to 10.

NCEER (2001) method was used to calculate factors of safety against liquefaction.
