## J.H. CAMPBELL GENERATING FACILITY

### BOTTOM ASH PONDS 1-2 STRUCTURAL STABILITY AND SAFETY FACTOR ASSESSMENT REPORT

West Olive, Michigan

October 2016

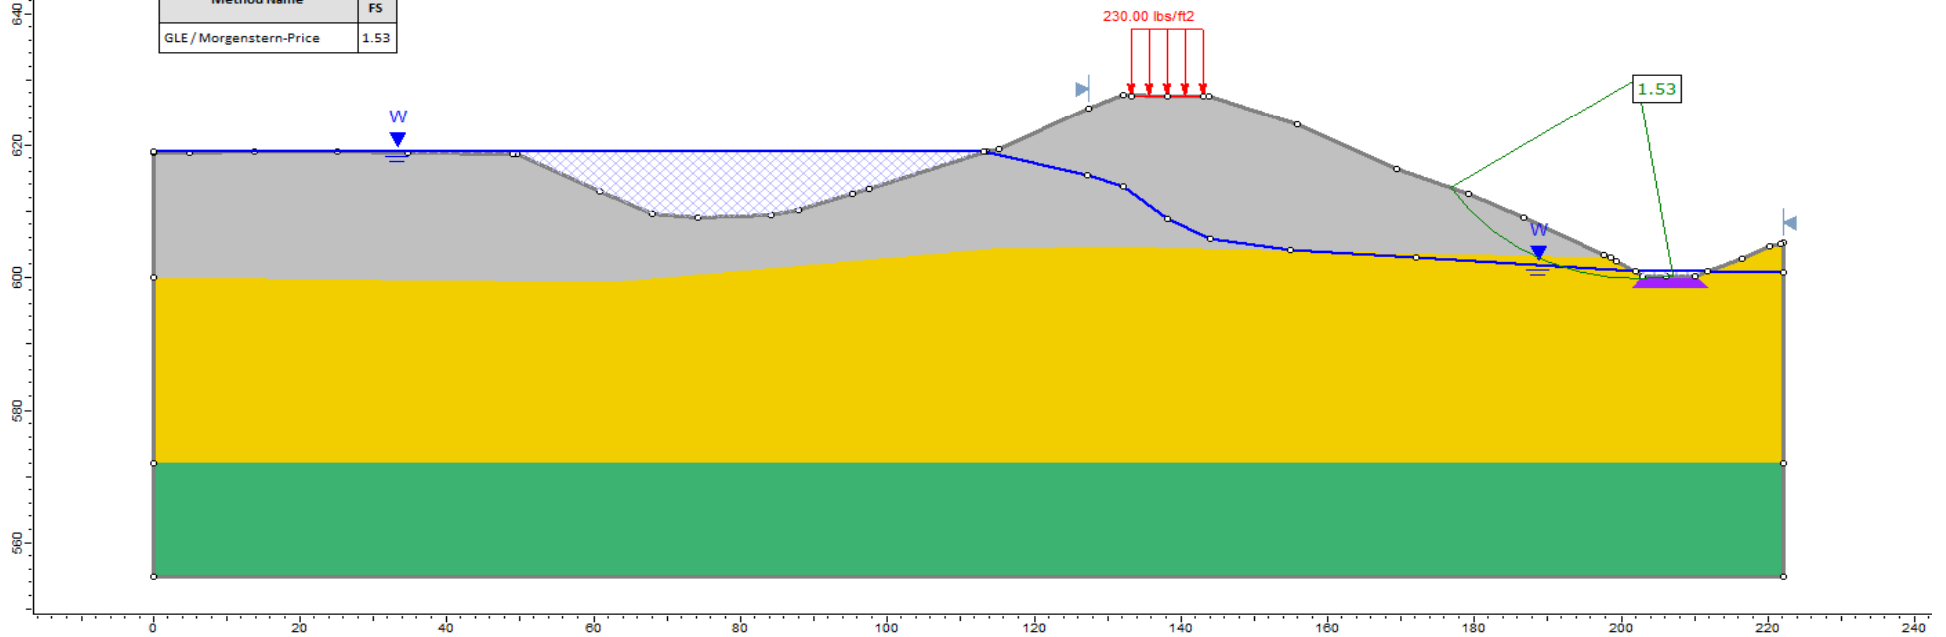
PROJECT	<b>J.H. Campbell Structural Stability Assessments</b>	
TITLE	<b>Unit 1-2 Bottom Ash Pond Section A-A' Slope Factor of Safety Max Pool Storage Scenario</b>	
CLIENT	<b>Consumers Energy Company</b>	FIGURE <b>B-A1</b>

Scenarios	Maximum Pool Storage	Maximum Pool Surcharge	Seismic
Required Safety Factor	1.50	1.40	1.00
Section	Calculated Safety Factor		
Section A-A'	1.53	1.49	1.36

Method Name	Min FS
GLE / Morgenstern-Price	1.53

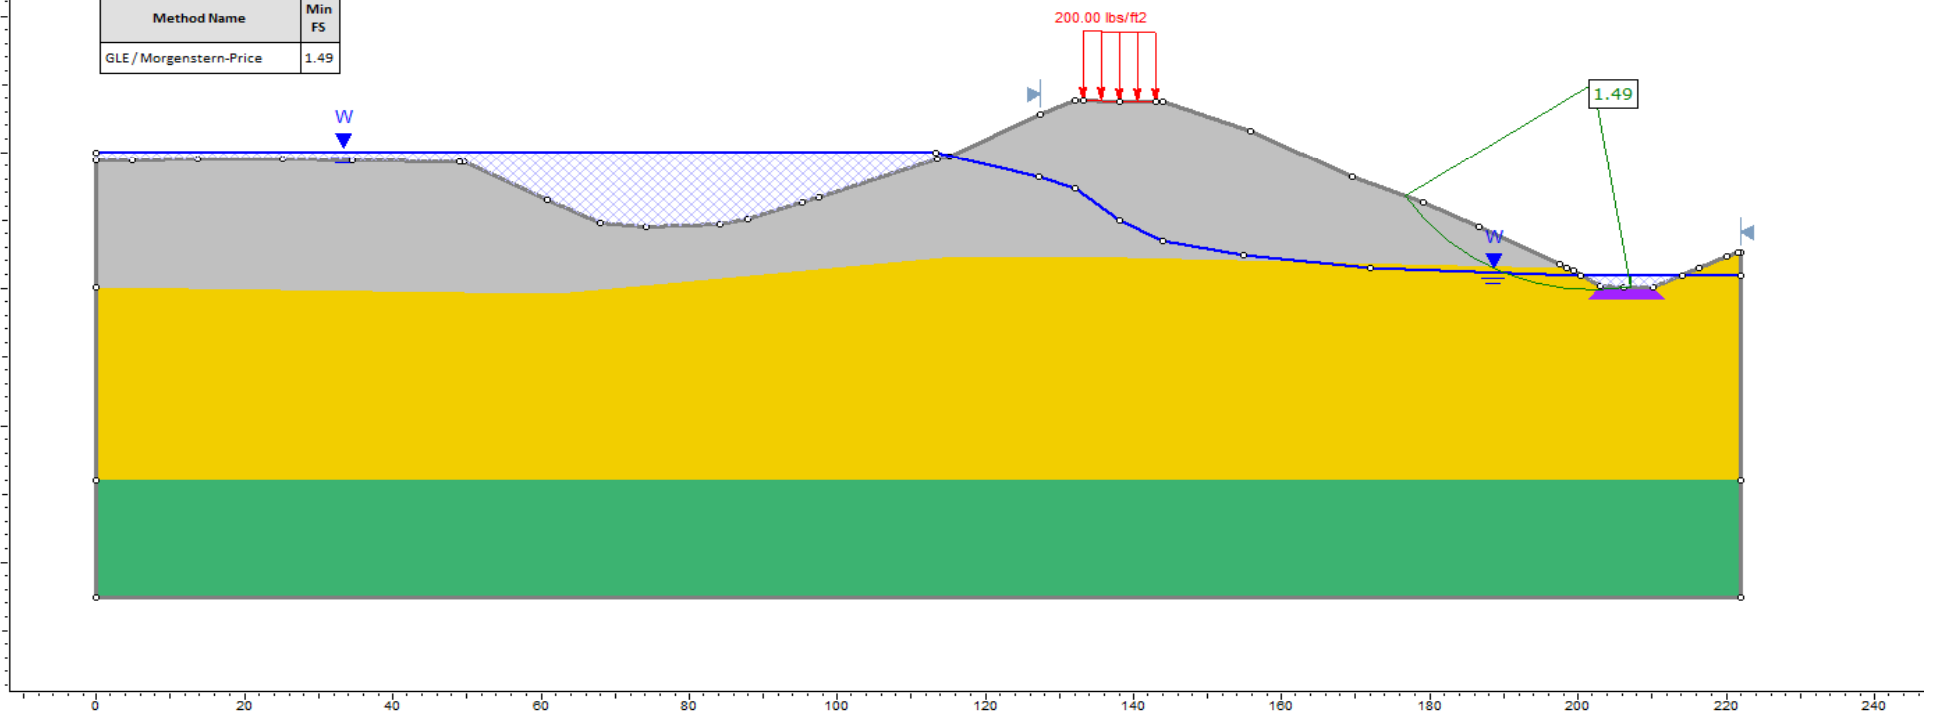
PROJECT	<b>J.H. Campbell Structural Stability Assessments</b>	
TITLE	<b>Unit 1-2 Bottom Ash Pond Section A-A' Slope Factor of Safety Max Pool Surcharge Scenario</b>	
CLIENT	<b>Consumers Energy Company</b>	FIGURE <b>B-A2</b>

Method Name	Min FS
GLE / Morgenstern-Price	1.49

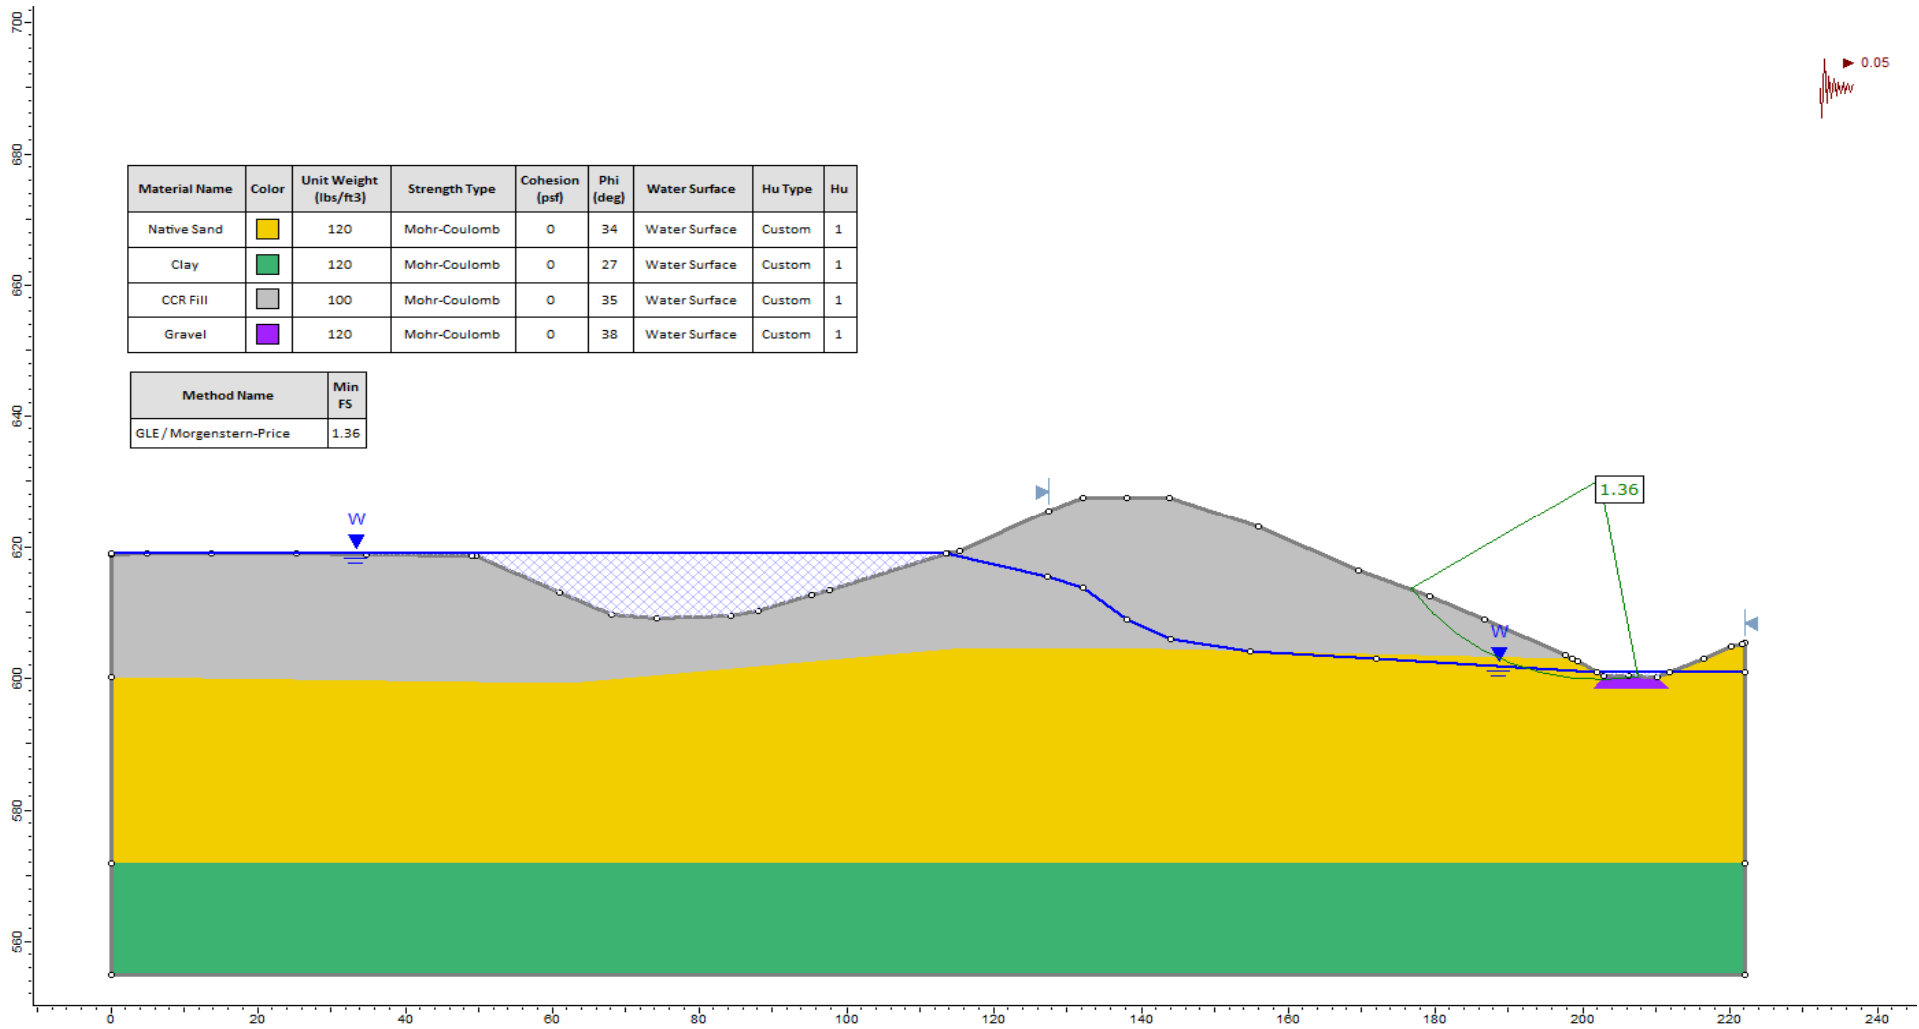
Method Name	Min FS
GLE / Morgenstern-Price	1.36

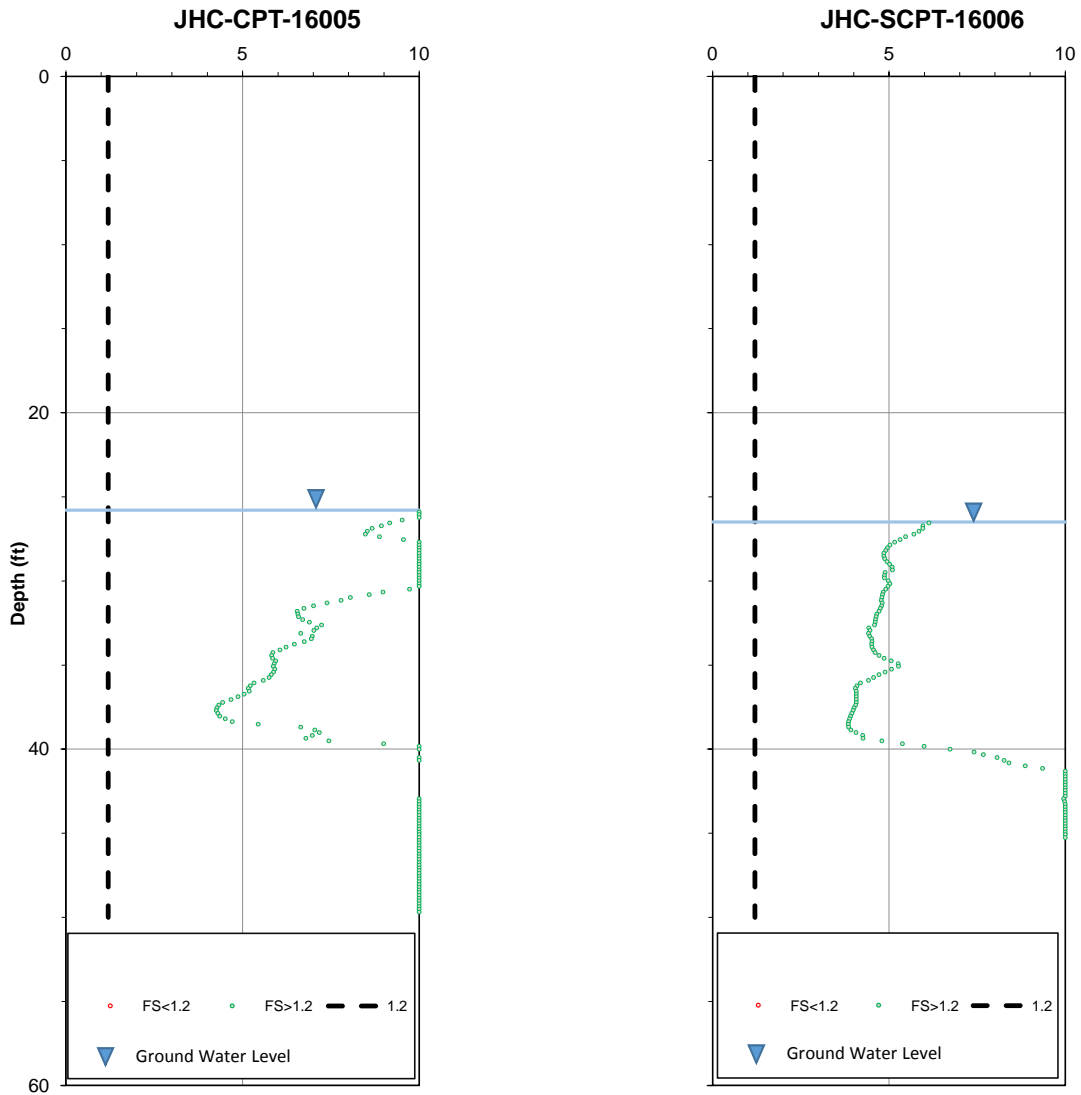
## FACTOR OF SAFETY AGAINST LIQUEFACTION

Embankment and foundation soils were screened for seismically-induced liquefaction susceptibility using methods recommended by the National Center for Earthquake Research (NCEER), which uses Cone Penetrometer Test (CPT) data (Youd et al. 2001; Robertson and Wride 1998). The calculated factor of safety against seismically-induced liquefaction is shown in Appendix C and was calculated to be greater than 1.20 throughout the depth of the embankments and underlying foundation in the evaluated CPT soundings for the considered earthquake loading. These screening-level results indicate that the embankments and foundation soils for Bottom Ash Ponds 1-2 are not susceptible to seismically-induced liquefaction for the seismic loading considered.
