J.H. CAMPBELL GENERATING FACILITY

POND A STRUCTURAL STABILITY AND SAFETY FACTOR ASSESSMENT REPORT

West Olive, Michigan

October 2016

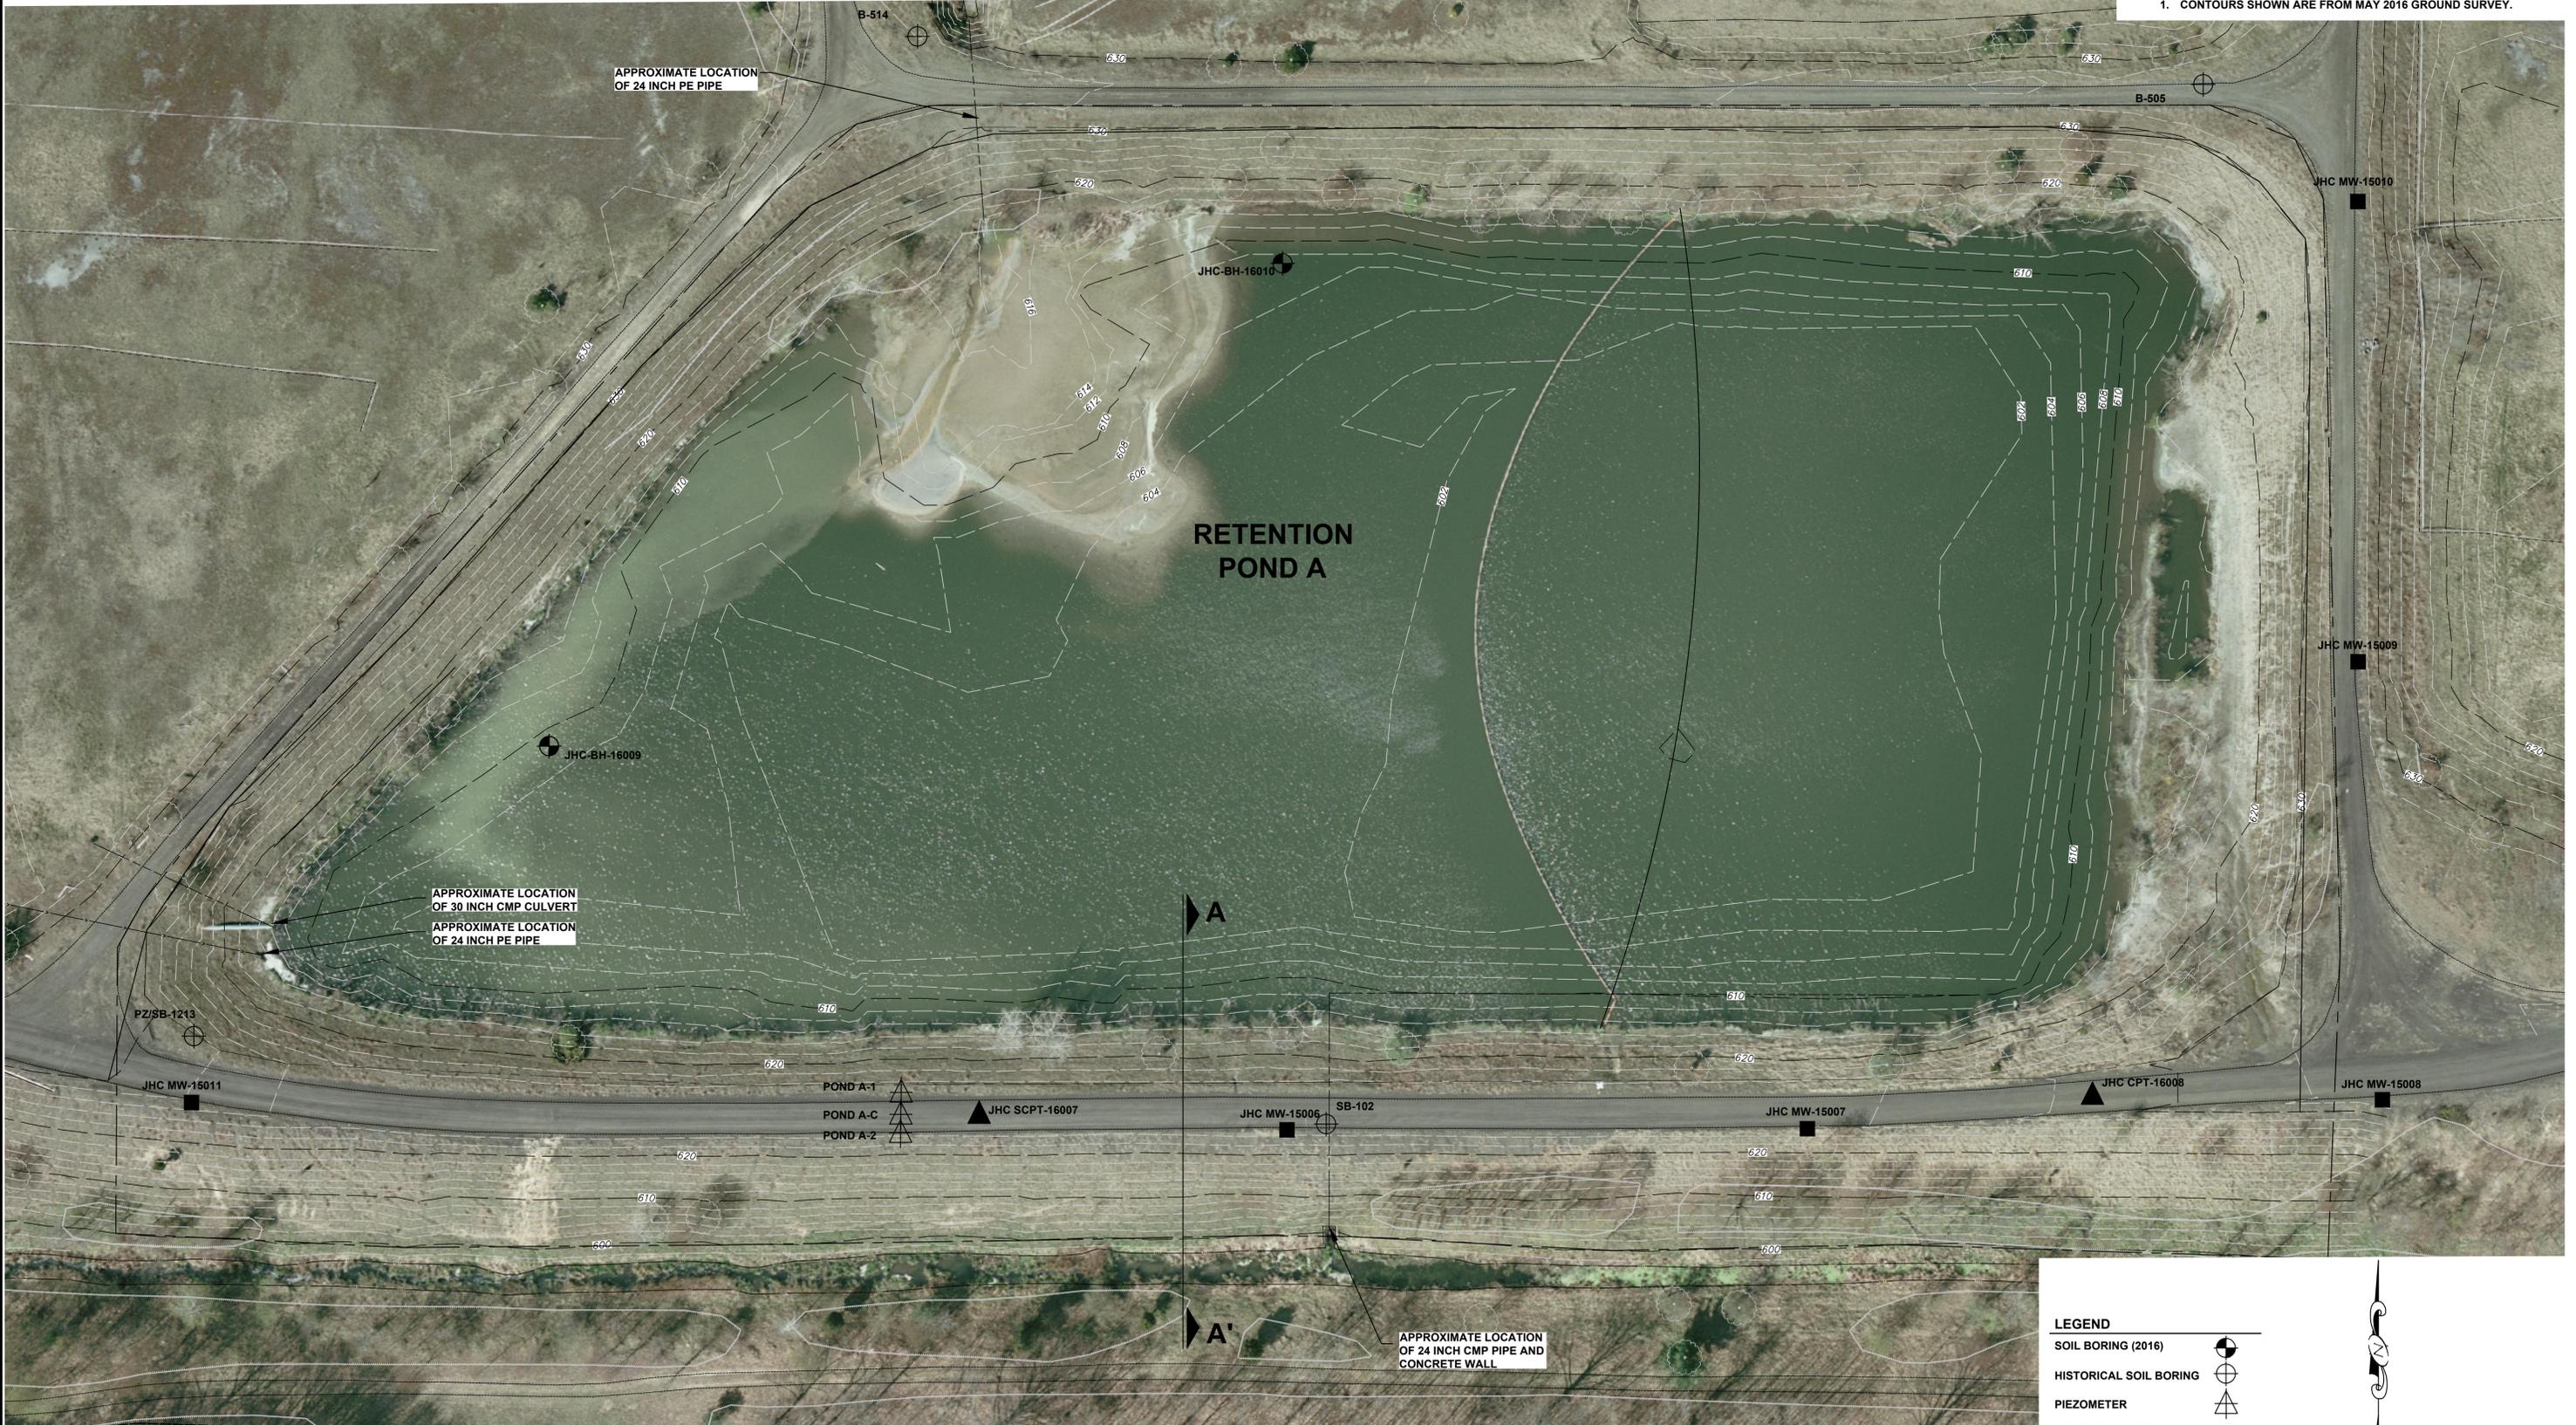
2016 RCRA COMPLIANCE FACTOR OF SAFETY ASSESSMENT			
POND A-BOREHOLE LOCATION & CROSS SECTION MAP			
SCALE	1" = 40'	DRAWING NO.	----
JOB	1654923	FIGURE	2
UNIT#		REV.	A

The critical section used for the safety factor assessment was located along the southern dike and is shown as Section A-A' in Figure 2.

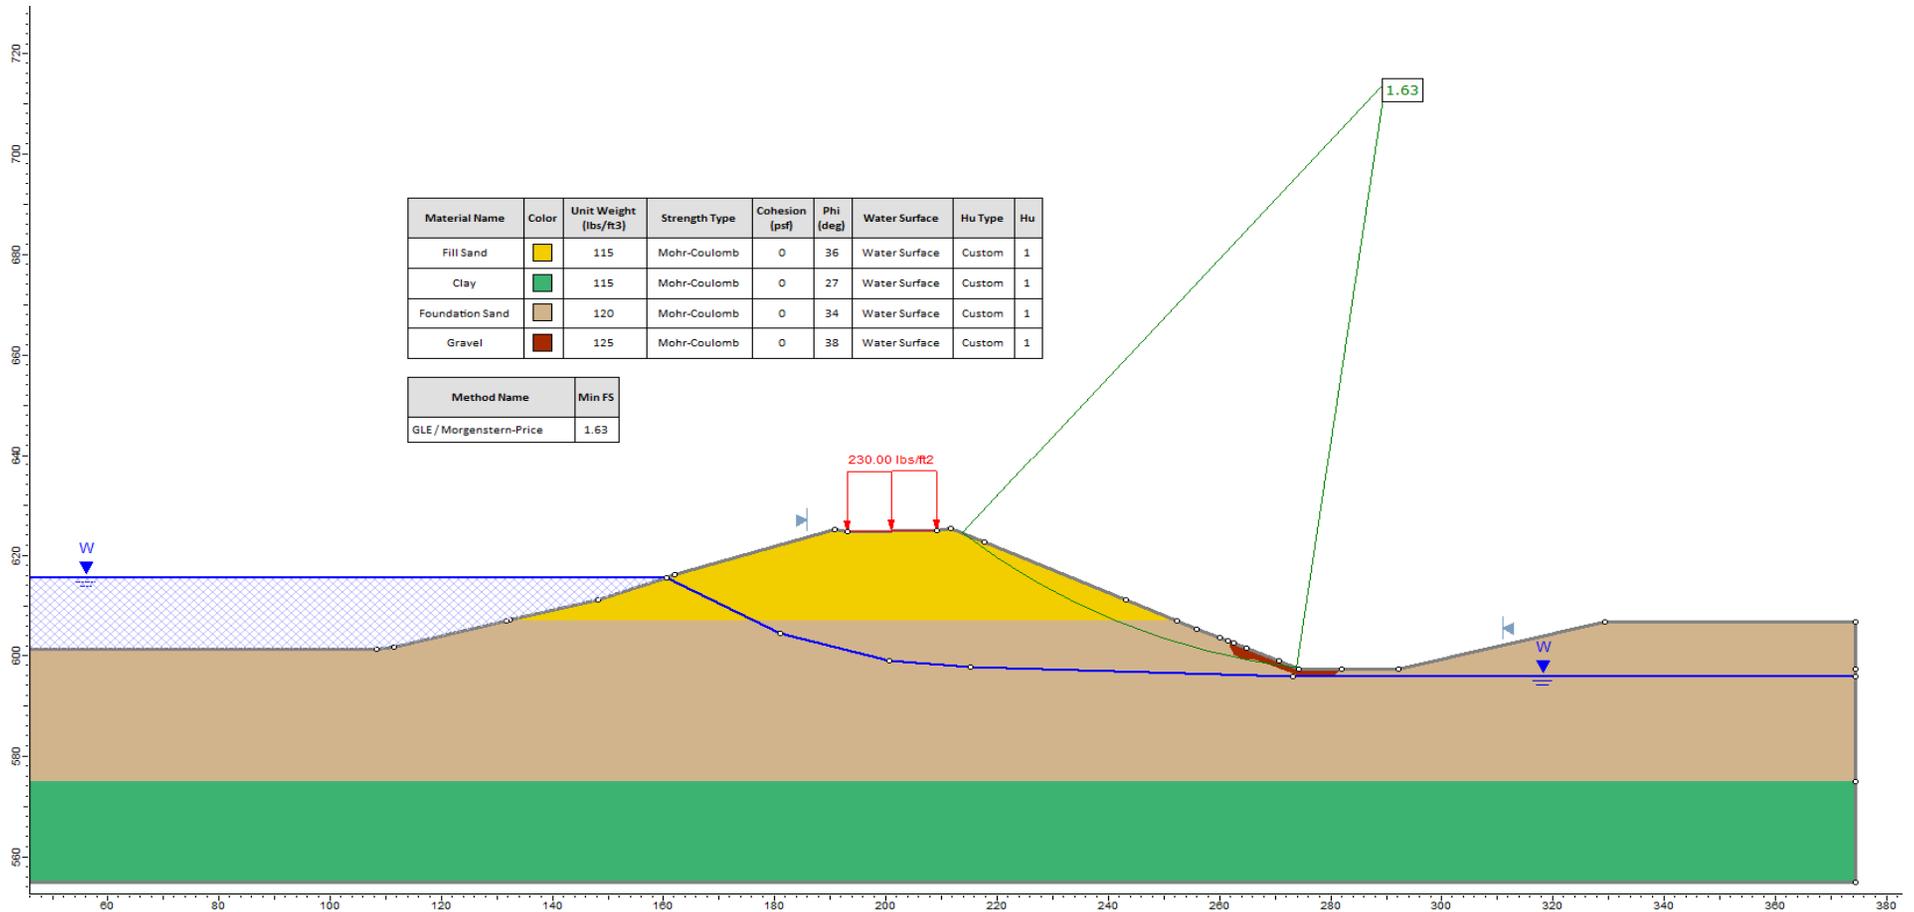
FIGURE **B-A1**

Scenarios	Maximum Pool Storage	Maximum Pool Surcharge	Seismic
Required Safety Factor	1.50	1.40	1.00
Section	Calculated Safety Factor		
Section A-A'	1.63	1.63	1.43

PROJECT **J.H. Campbell Structural Stability Assessments**
 TITLE **Pond A Section A-A'
 Slope Factor of Safety
 Max Pool Storage Scenario**

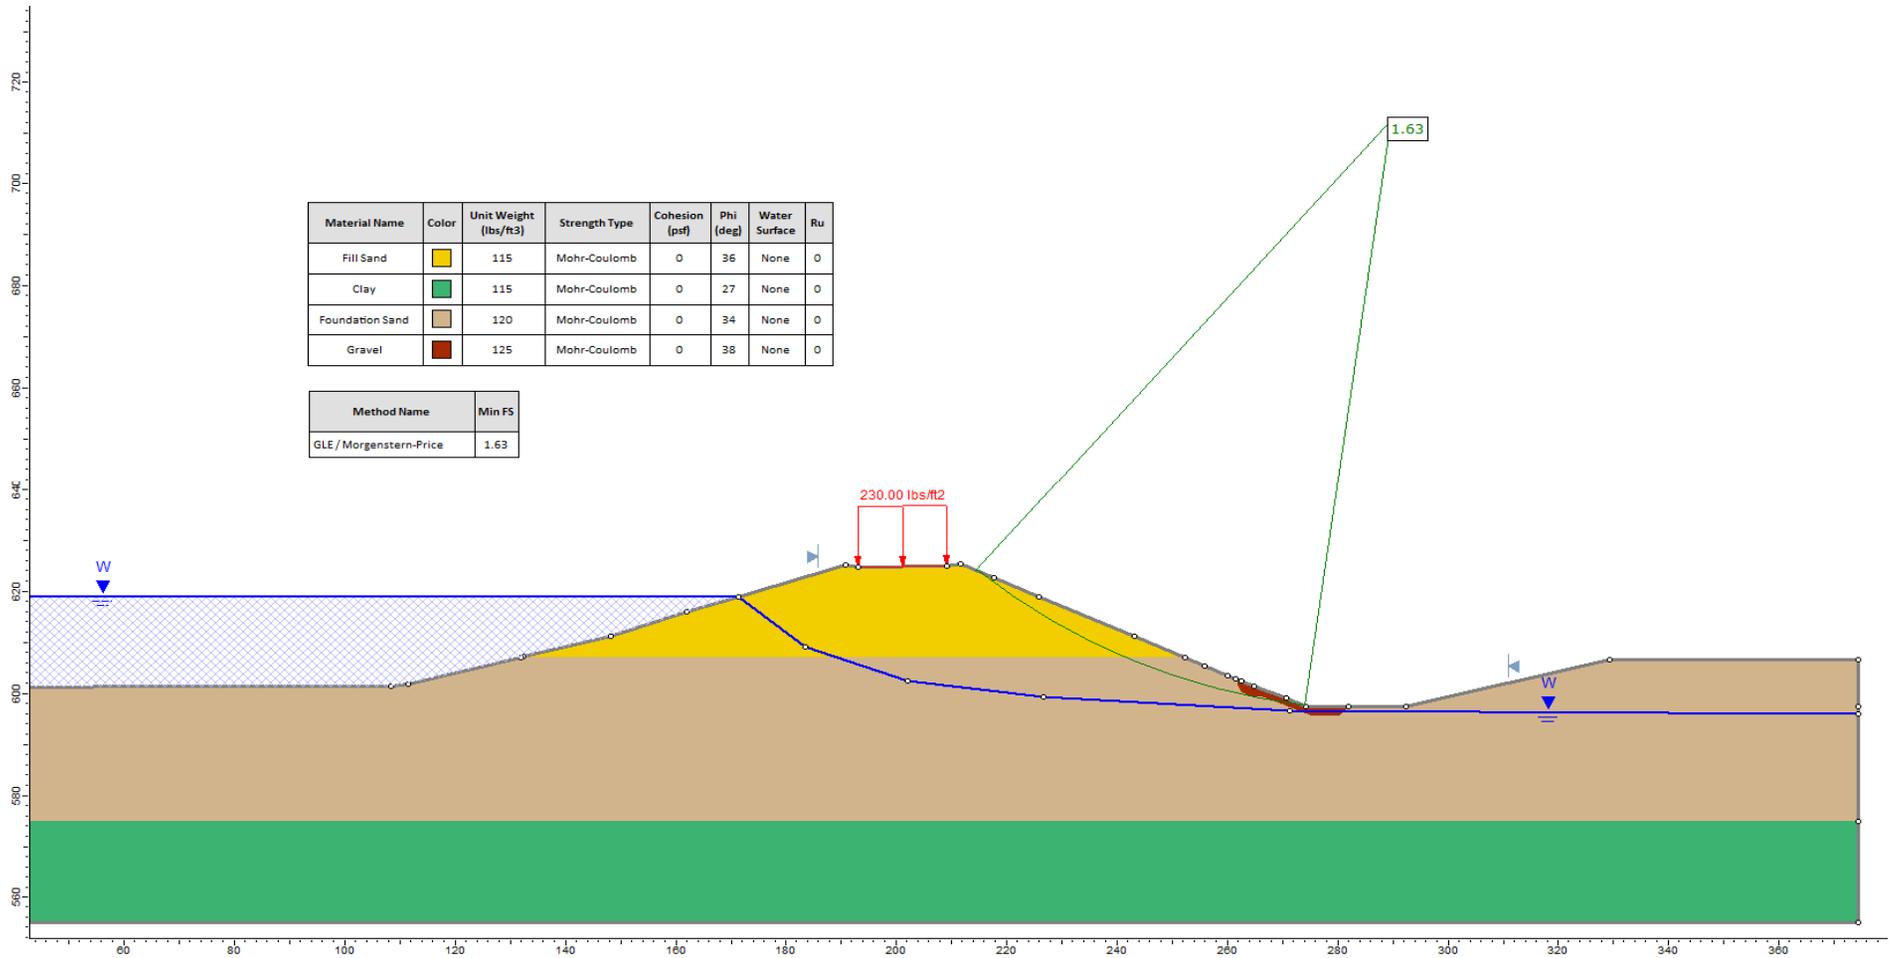
FIGURE **B-A2**

PROJECT **J.H. Campbell Structural Stability Assessments**
 TITLE **Pond A Section A-A'
 Slope Factor of Safety
 Max Pool Surcharge Scenario**

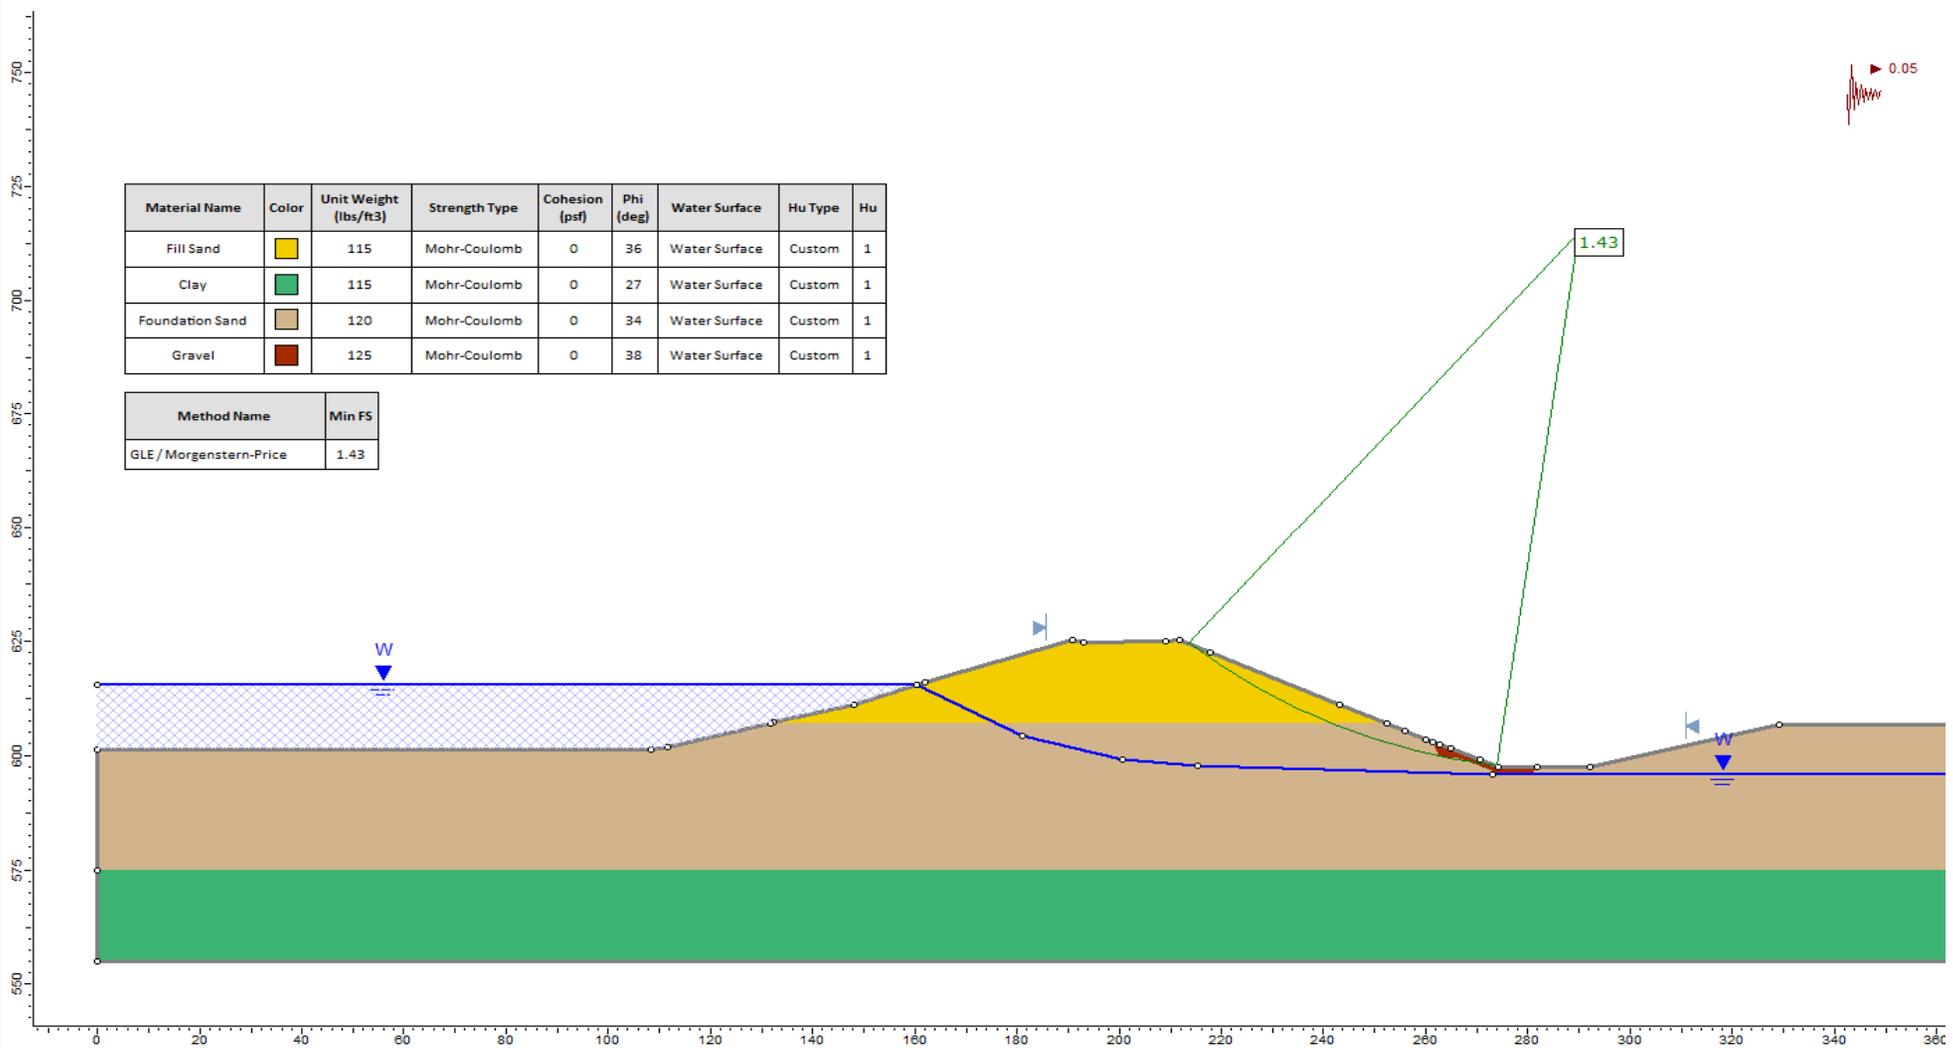
Method Name	Min FS
GLE / Morgenstern-Price	1.43

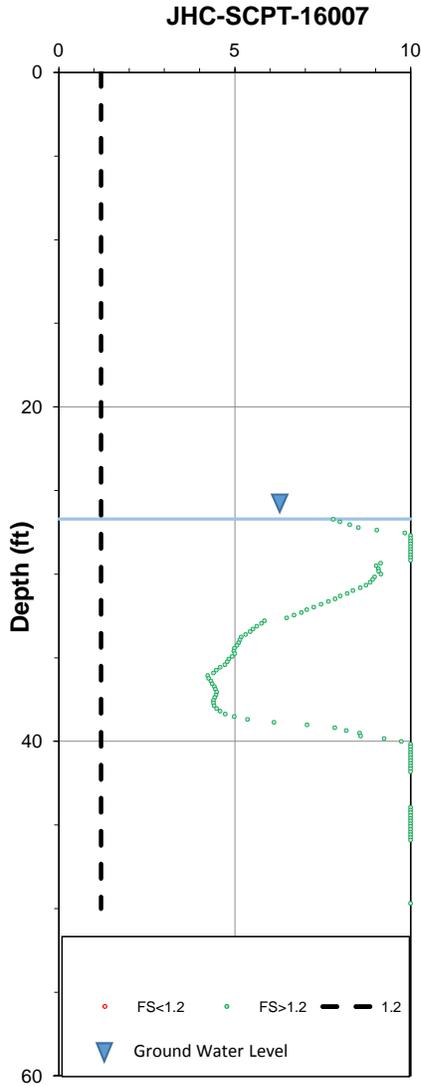
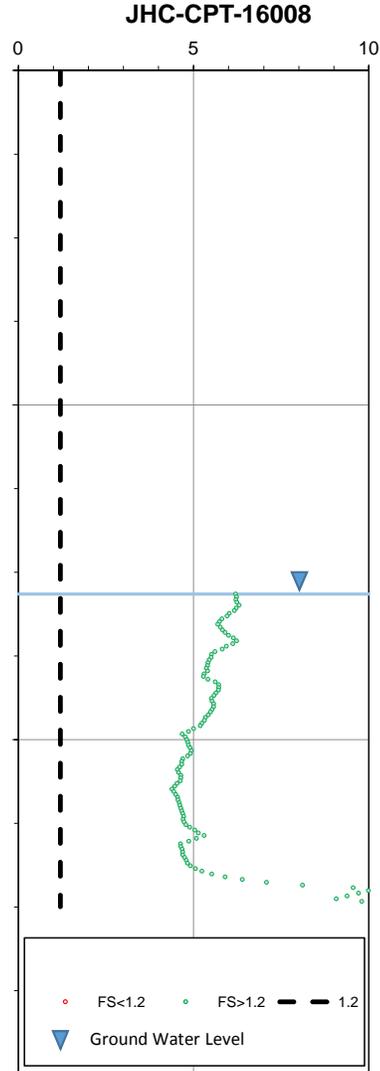
CPT ID: JHC-CPT-16008
Test Date: 5/17/2016
Northing: 517559
Easting: 12635886
Elevation: 628.9 ft
a_{max}: 0.05 g
Water Table: 31.3 ft

Embankment and foundation soils were screened for seismically-induced liquefaction susceptibility using methods recommended by the National Center for Earthquake Research (NCEER), which uses Cone Penetrometer Test (CPT) data (Youd et al. 2001; Robertson and Wride 1998). The calculated factor of safety against seismically-induced liquefaction is shown in Appendix C and was calculated to be greater than 1.20 throughout the depth of the embankments and underlying foundation in the evaluated CPT soundings for the considered earthquake loading. These screening-level results indicate that the embankments and foundation soils for Ponds A are not susceptible to seismically-induced liquefaction for the seismic loading considered.

Notes: Factors of safety (FS) greater than 10 are shown equal to 10.
