J.H. Campbell Generating Facility

Pond A - Construction Documentation Report

Golder Associates Inc.

October 1, 2019

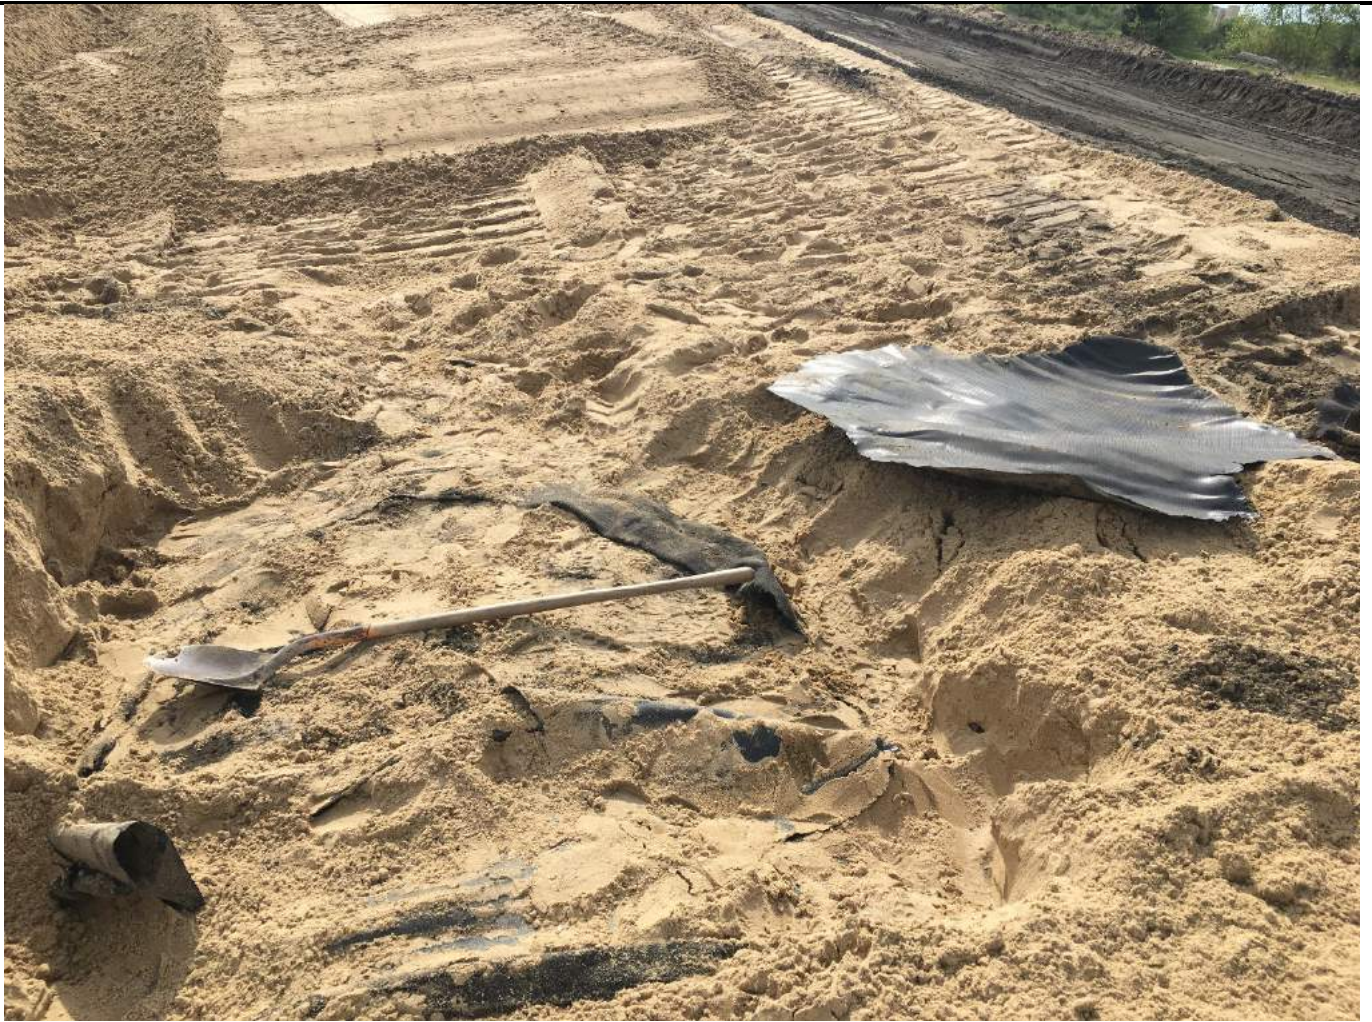
On May 30, 2019, a dozer's blade came into contact with the geotextile and geomembrane on the northeastern corner on Panel 11. This accident was the result of operator error while using a non-GPS guided dozer to grade cover material. May 30, 2019 was the first and last day that the non-GPS dozer was used to perform grading on the Pond A final cover. The area surrounding the damage was exposed to assess its condition. The damaged geotextile and geomembrane were repaired by CCS on June 5, 2019 (repair 24A). Non-destructive testing was completed on repair 24A and documented in accordance with the CQA Plan.

The shovel is laid over the damaged area of liner. The piece of liner the dozer blade cut is sitting on the right.

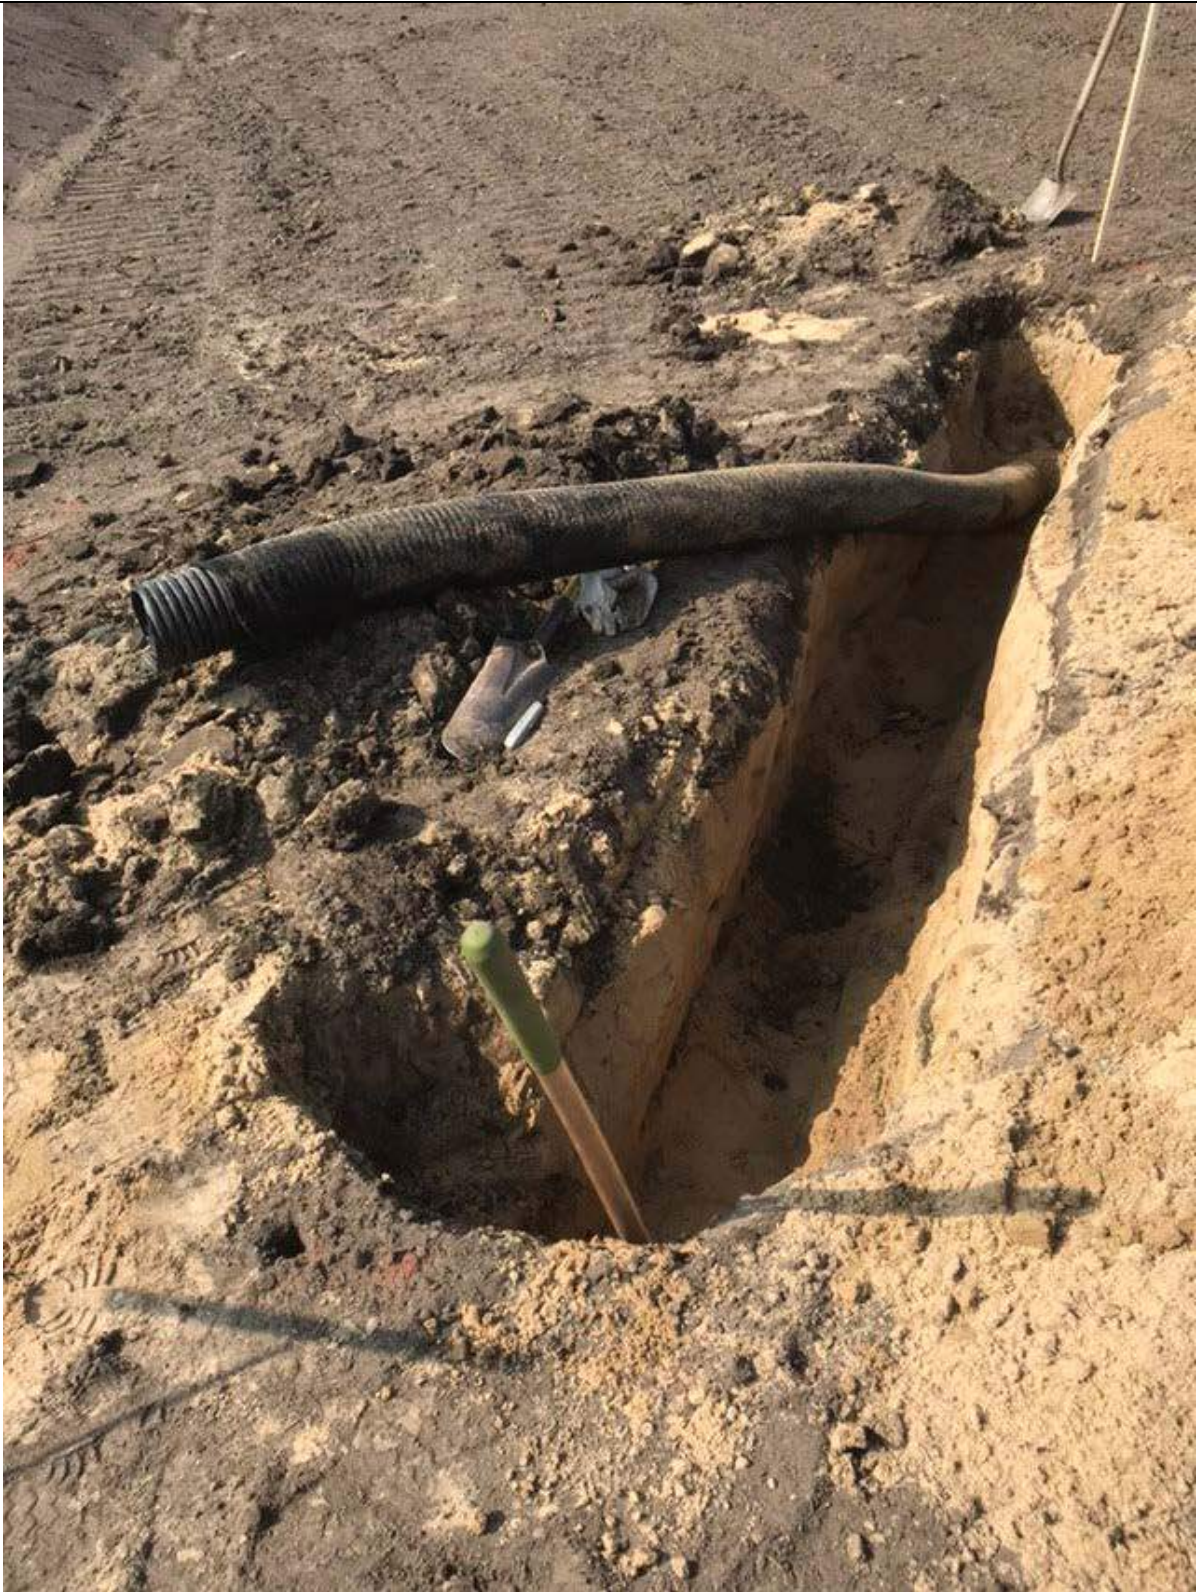
Exposed drain tile.
