Project Title: J.R. Whiting Ponds 1 Project Number: 1788523 Date: 6/24/2019

Client: Consumers Energy Site/Location: Erie, MI

and 2 Closure CQA

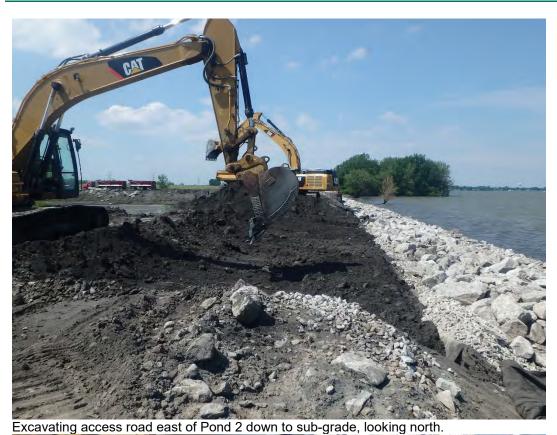
- Golder observed placement of 16 oz. geotextile used for shoreline into anchor trench east of Pond 2 and backfill.
- Golder monitored proof roll on 1st lift of onsite structural fill placed in the Chemical Ponds grading area. Proof roll was completed using a fully loaded Volvo A40G haul truck, no deflection or pumping observed during testing.

Proof roll of onsite structural fill placed over chemical ponds, looking west.

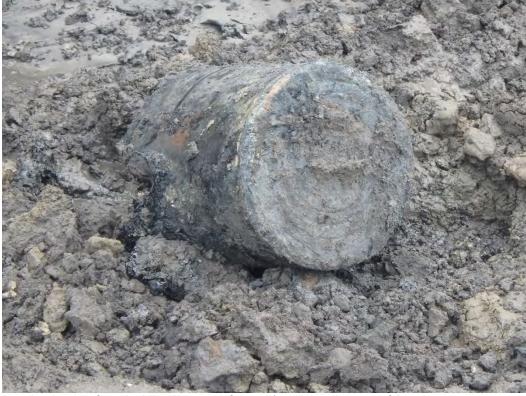
5 gallon bucket found while clean-up of the oil/tar like soils west of Pond 2.

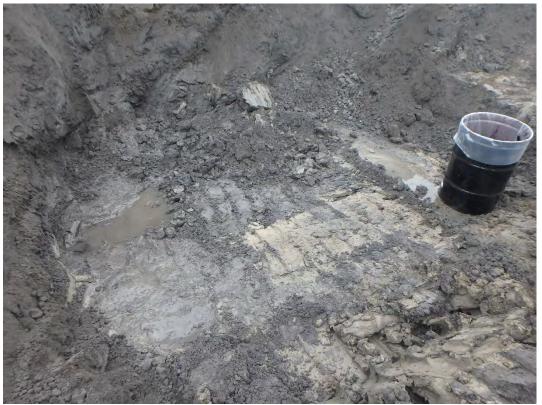
Area that the pool of oil/tar like matter soils after removal and placed in lined 55 gallon drum.
