**PROJECT OVERVIEW**

Project Title: J.R. Whiting Ponds 1 Project Number: 1788523 Date: 7/27/2019

and 2 Closure CQA

Client: Consumers Energy Site/Location: Erie, MI

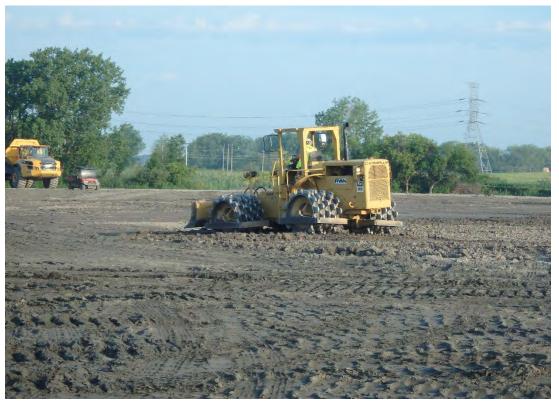
Compacting placed structural fill in Pond 1, looking northwest.

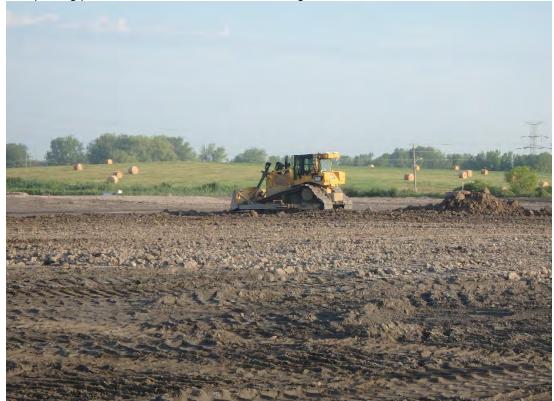
Placing structural fill in Pond 1, looking north.

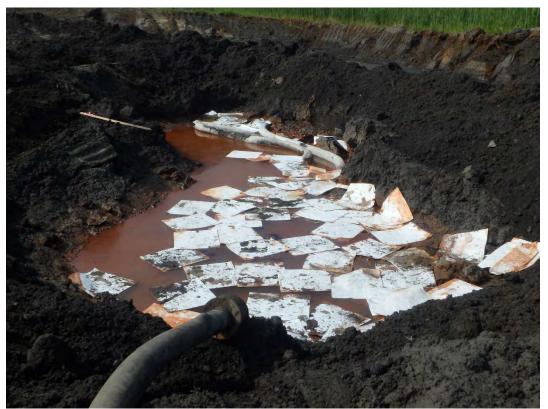
Preparing to pump contaminated water into baker tank.

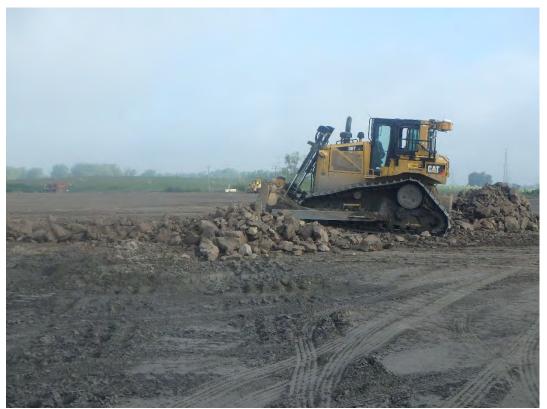
Compacting lift of structural fill in Pond 1, looking north.

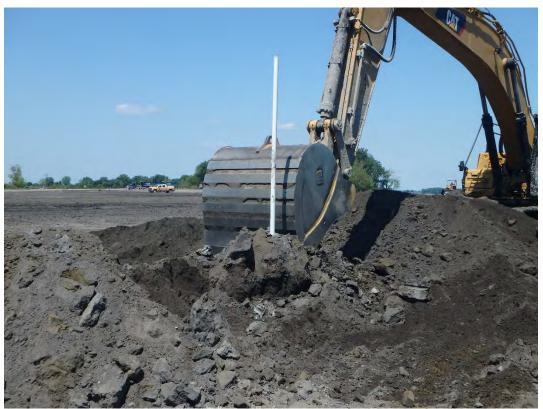
Removing protective casing from MW-15005, looking north.

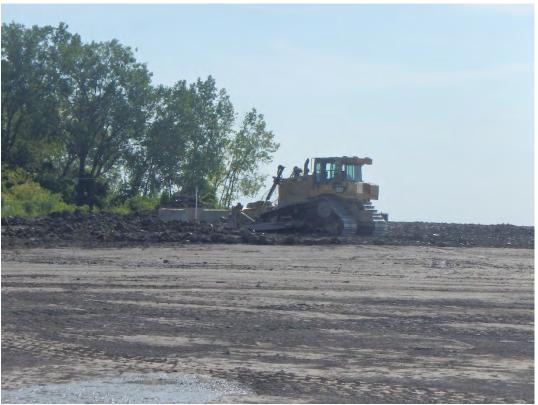
Re-grading of CCR in Pond 2, looking southwest.

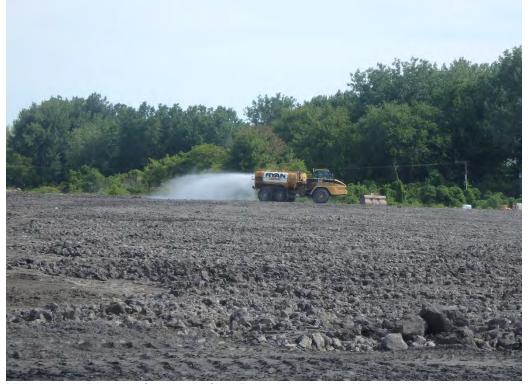
Placing 11 inch to 12 inch loose lift of structural fill in Pond 1, looking northeast.

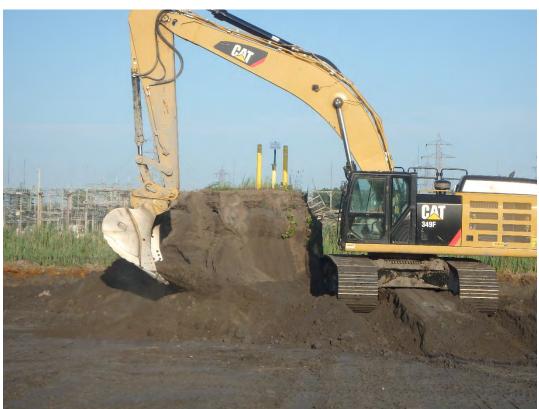
Moisture conditioning of structural fill in Pond 1, looking northeast.

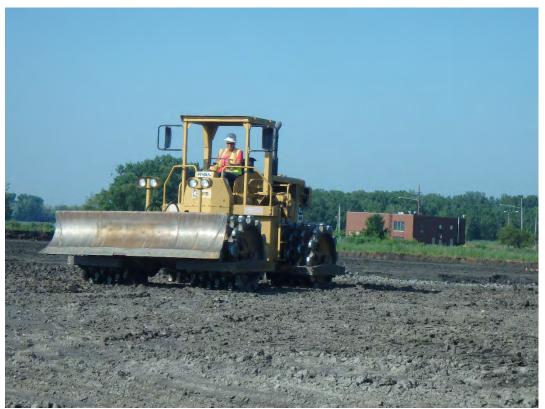
Structural fill lift being placed in Pond 1, looking west.

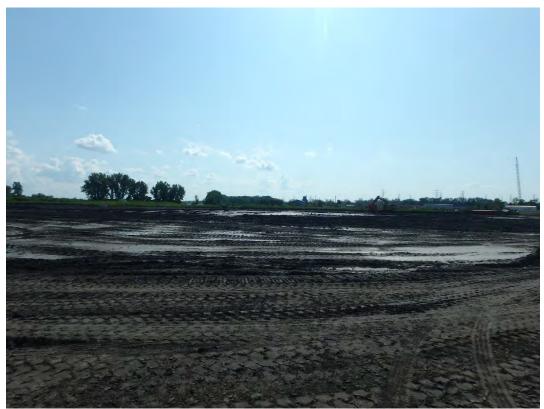
Proof rolling of bridging layer in Pond 2.

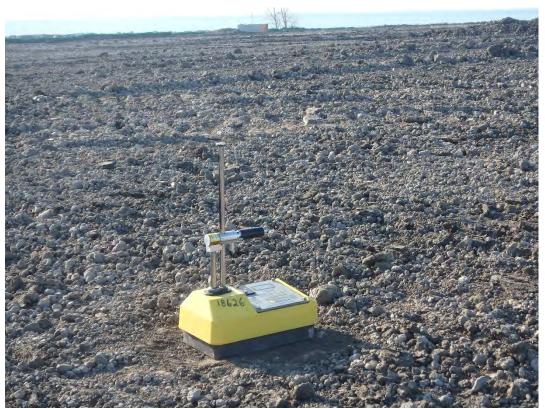
Compacting lift of structural fill in Pond 2, looking south.

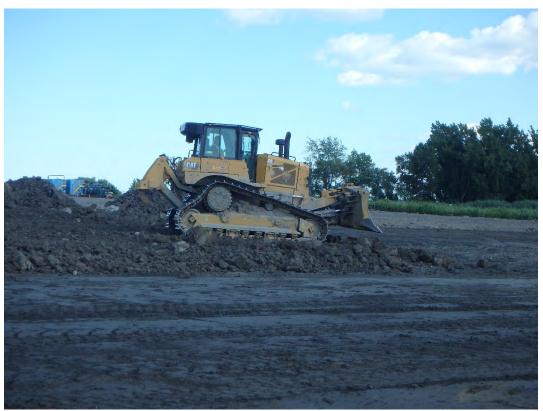
Finish grading of liner sub-grade in Pond 1, looking west.

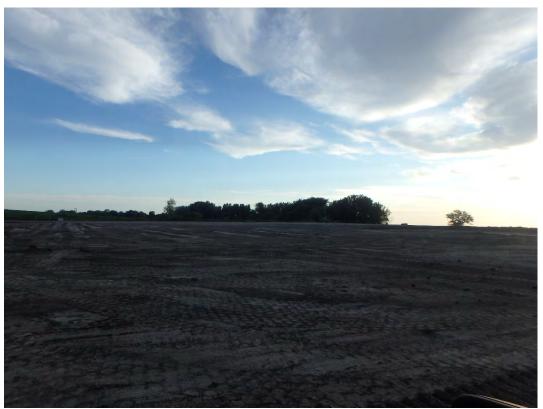
While over-ex of soft spot in Pond 2 area to the north was found also to be pumping while excavator was backfilling the over-ex area. Upon further investigation by over-excavating the area found that the material below bridging layer was saturated and not supporting the bridging layer above causing the whole 3 foot layer to pump. After discussion with CEC, Ryan and Golder site reps it was decided to berm off the excavation and discuss further on Monday with CEC and Golder engineers on how to proceed.

Over-ex of soft spot in bridging layer of Pond 2, looking south.

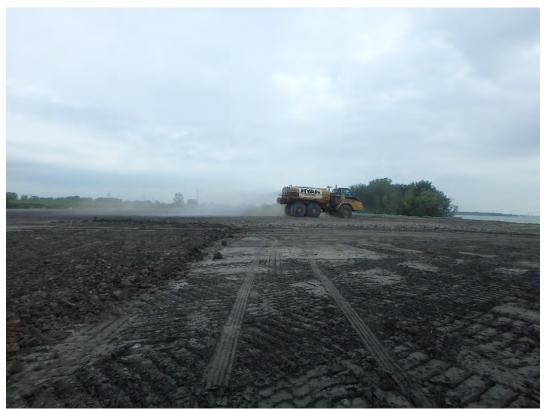
- Golder monitored proof roll of bridging layer in Pond 2 bounded by certification points; 1059, 1060, 1099.5 and 1101.
- Golder observed over-excavation of soft area in Pond 2, saturated material removed, textile deployed and backfilled with dry CCR.

Removal of saturated CCR from soft area found while proof rolling in Pond 2, looking southwest.

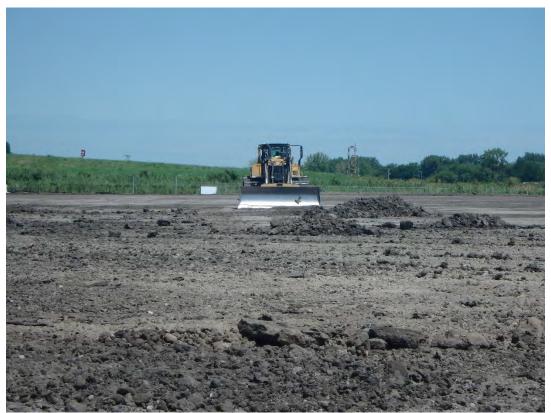
Proof roll of bridging layer in Pond 2, looking southeast.

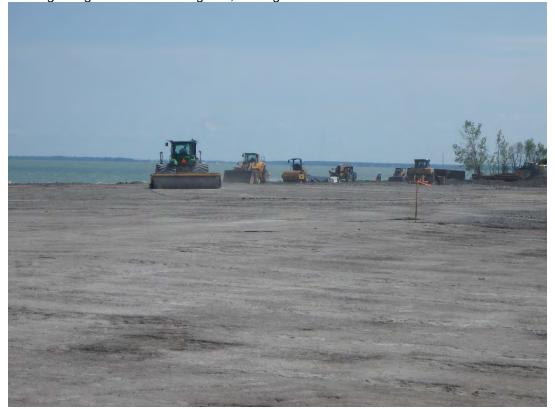
Finish grading Pond 1 liner sub-grade, looking north.

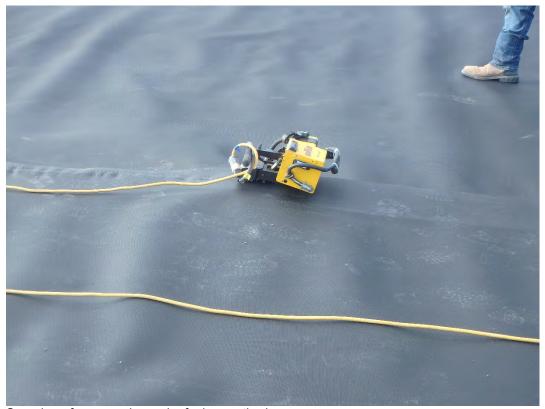
Testing of trial weld prior to start of seaming.

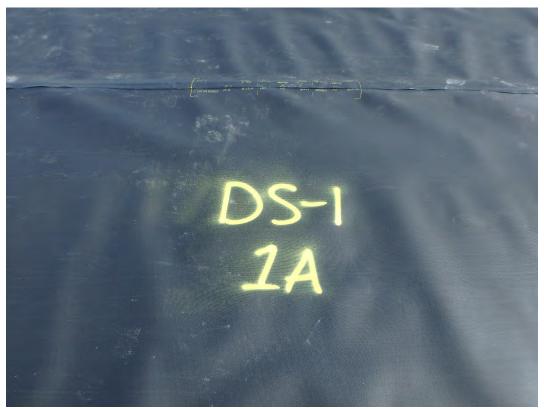
Seaming of geomembrane by fusion method.

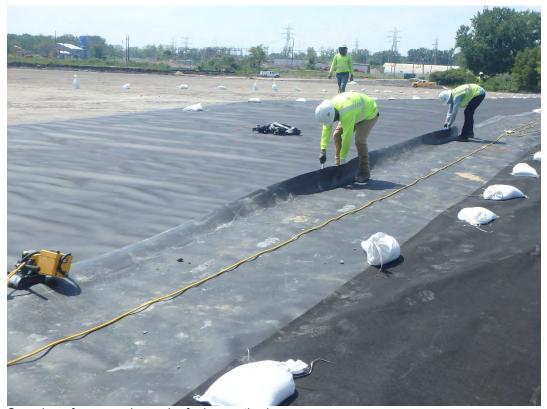
Overview of geomembrane deployed in Pond 1, looking west.

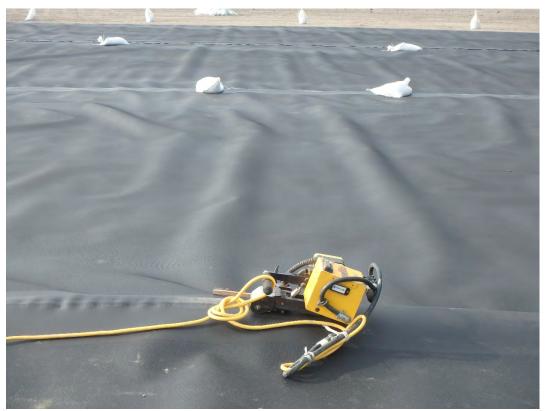
Deploying geomembrane in Pond 1, looking north.

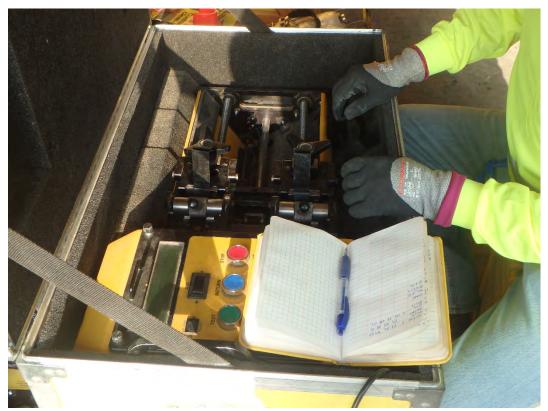
Fusion trial weld.
