PROJECT OVERVIEW

Project Title: J.R. Whiting Ponds 1 Project Number: 1788523 Date: 6/24/2019

Client: Consumers Energy Site/Location: Erie, MI

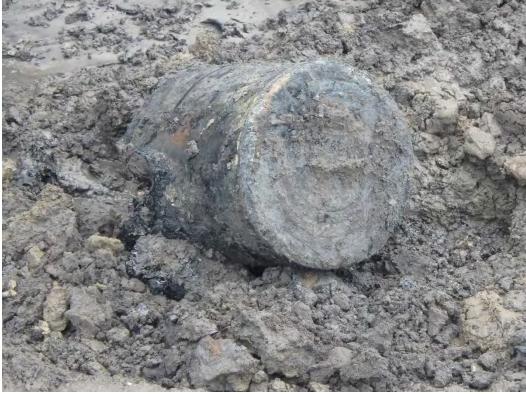
5 gallon bucket found while clean-up of the oil/tar like soils west of Pond 2.

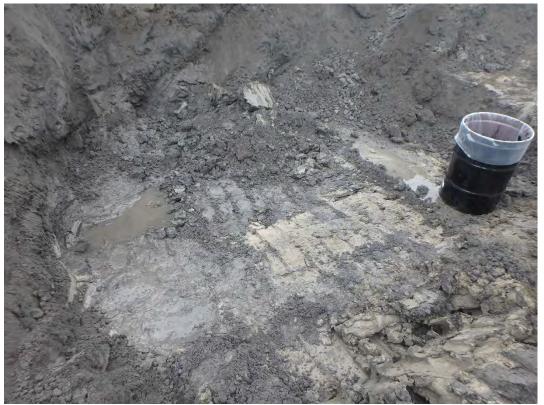
Area that the pool of oil/tar like matter soils after removal and placed in lined 55 gallon drum.
