J.R. Whiting Ponds 1 Project Number: 1788523 Date: 7/27/2019 **Project Title:**

and 2 Closure CQA

Client: Consumers Energy Site/Location: Erie, MI

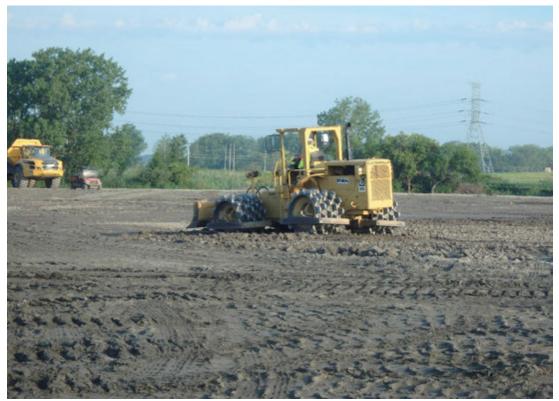
Compacting placed structural fill in Pond 1, looking northwest.

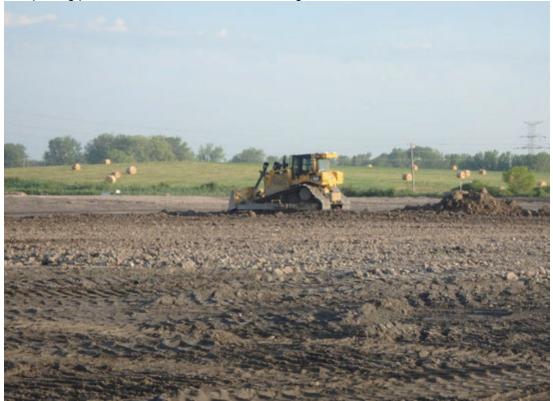
Placing structural fill in Pond 1, looking north.

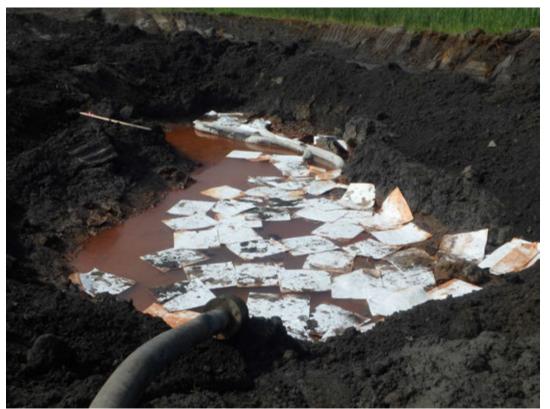
Preparing to pump contaminated water into baker tank.

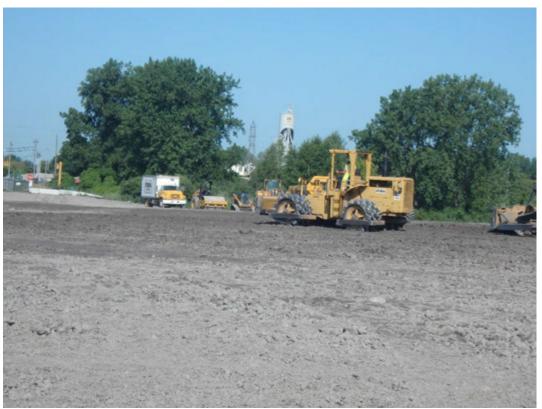
Placement of structural fill in Pond 1, looking north.

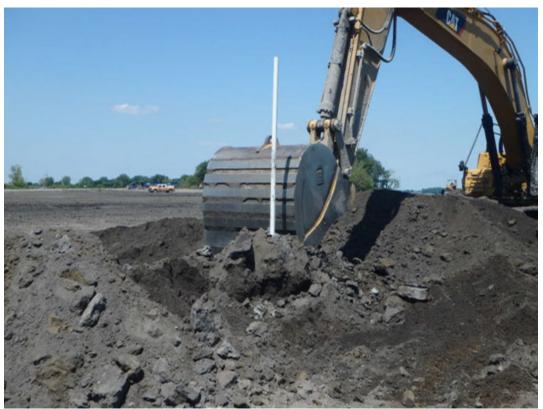
Removing protective casing from MW-15005, looking north.

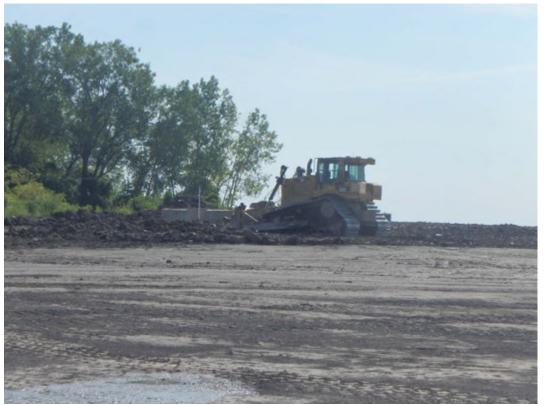
Re-grading of CCR in Pond 2, looking southwest.

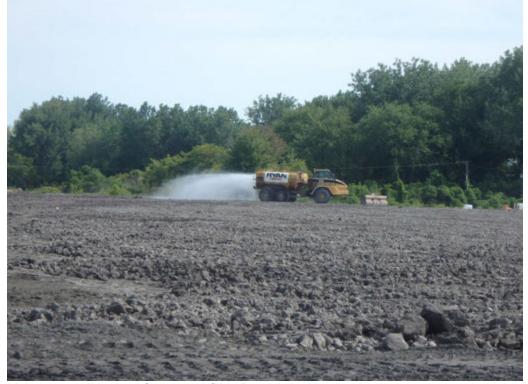
Placing 11 inch to 12 inch loose lift of structural fill in Pond 1, looking northeast.

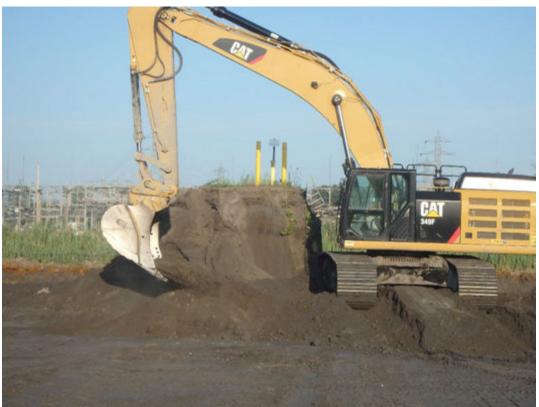
Moisture conditioning of structural fill in Pond 1, looking northeast.

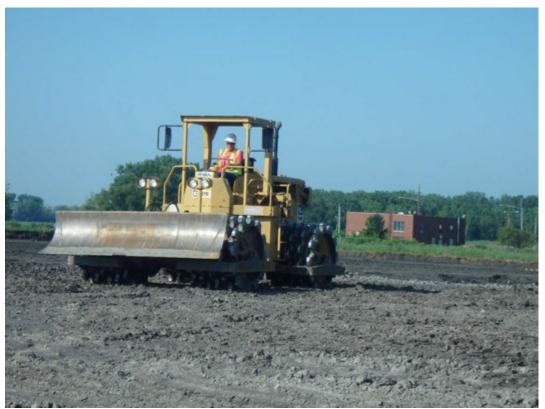
Structural fill lift being placed in Pond 1, looking west.

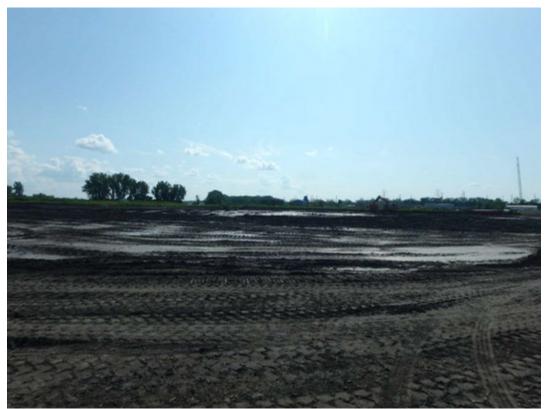
Proof rolling of bridging layer in Pond 2.

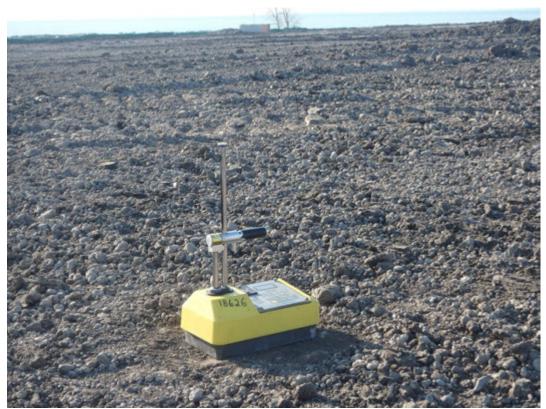
Compacting lift of structural fill in Pond 2, looking south.

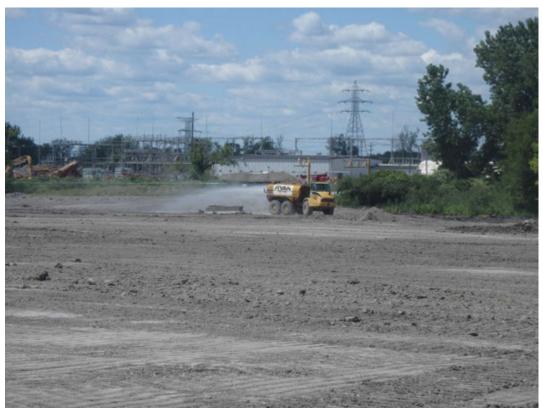
Survey of certification points for liner sub-grade in Pond 1, looking north.

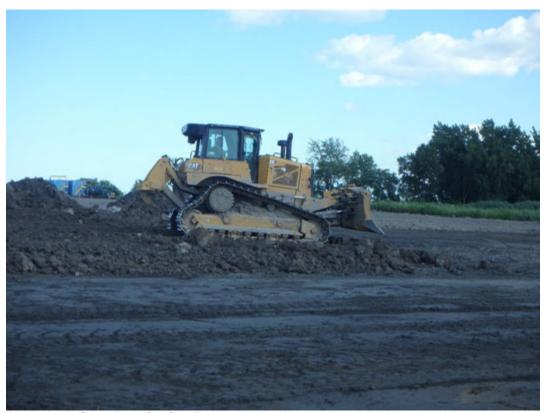
Finish grading of liner sub-grade in Pond 1, looking west.

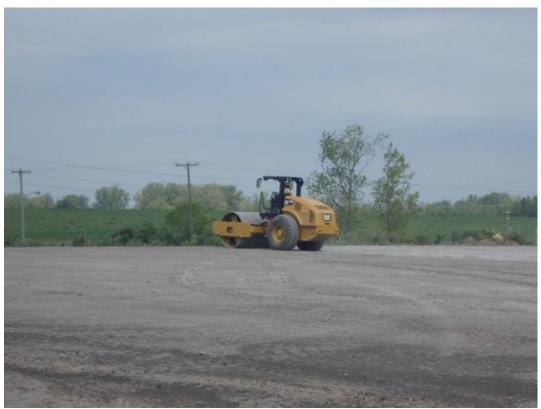
Proof roll of additional area of Pond 2 bridging layer, looking south.

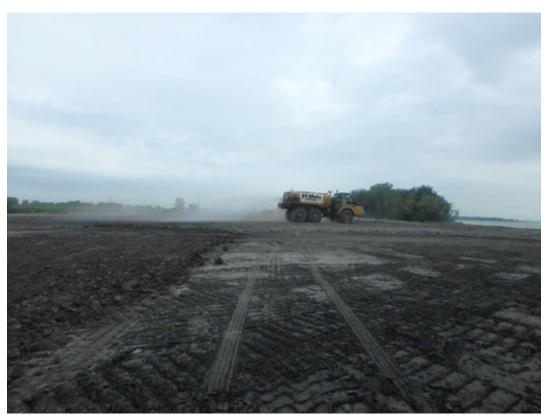
Removal of saturated CCR from soft area found while proof rolling in Pond 2, looking southwest.

- Golder monitored proof roll of bridging layer in Pond 2 bounded by certification points; 1059, 1060, 1099.5 and 1101.
- Golder observed over-excavation of soft area in Pond 2, saturated material removed, textile deployed and backfilled with dry CCR.

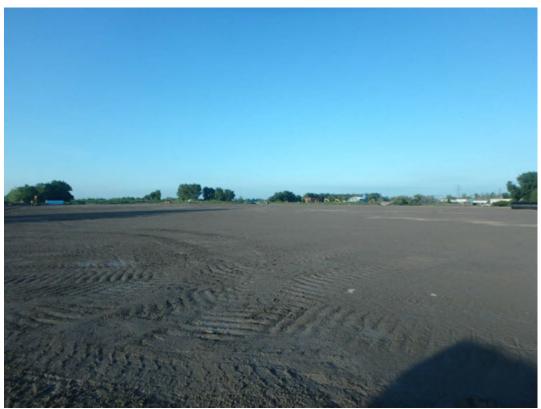
Dressing access road to Pond 2, looking southeast.

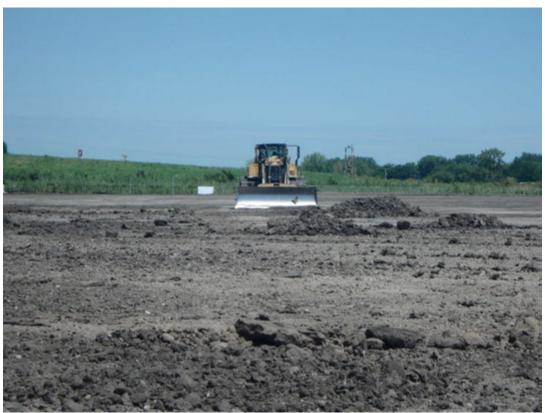
Proof roll of bridging layer in Pond 2, looking southeast.

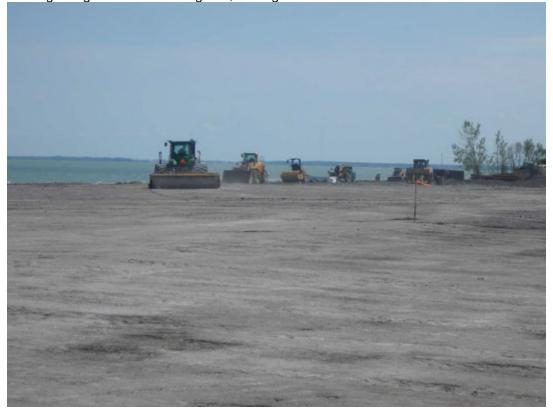
Finish grading Pond 1 liner sub-grade, looking north.

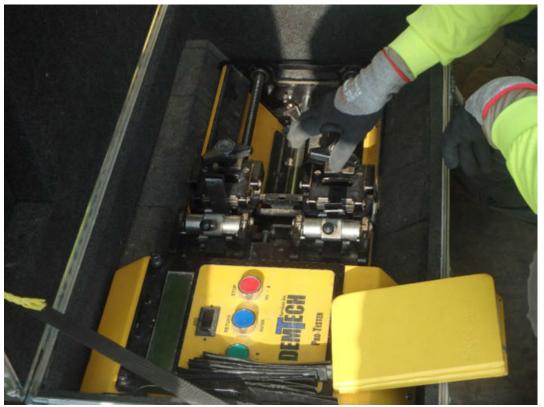
Producing trial weld for field testing.

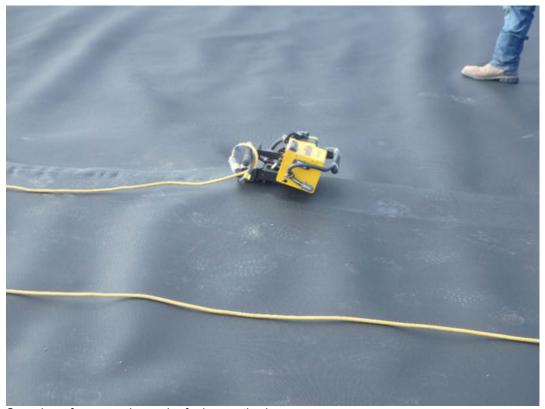
Testing of trial weld prior to start of seaming.

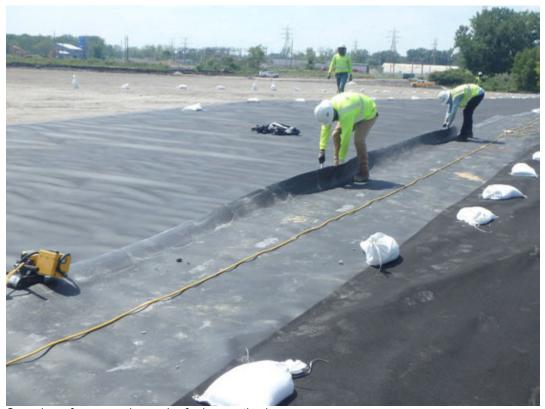
Overview of geomembrane deployed in Pond 1, looking west.

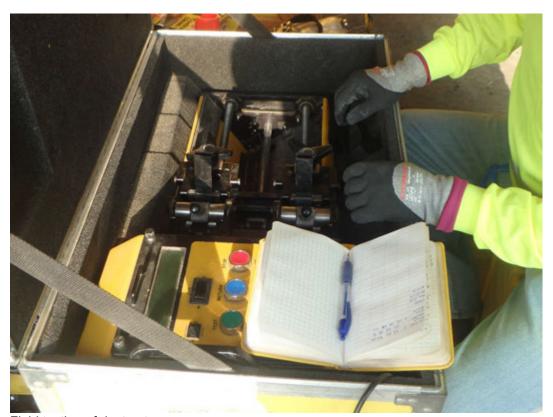
Fusion trial weld.
