D.E. KARN GENERATING FACILITY

BOTTOM ASH POND HAZARD POTENTIAL CLASSIFICATION ASSESSMENT REPORT

Essexville, Michigan

October 2016

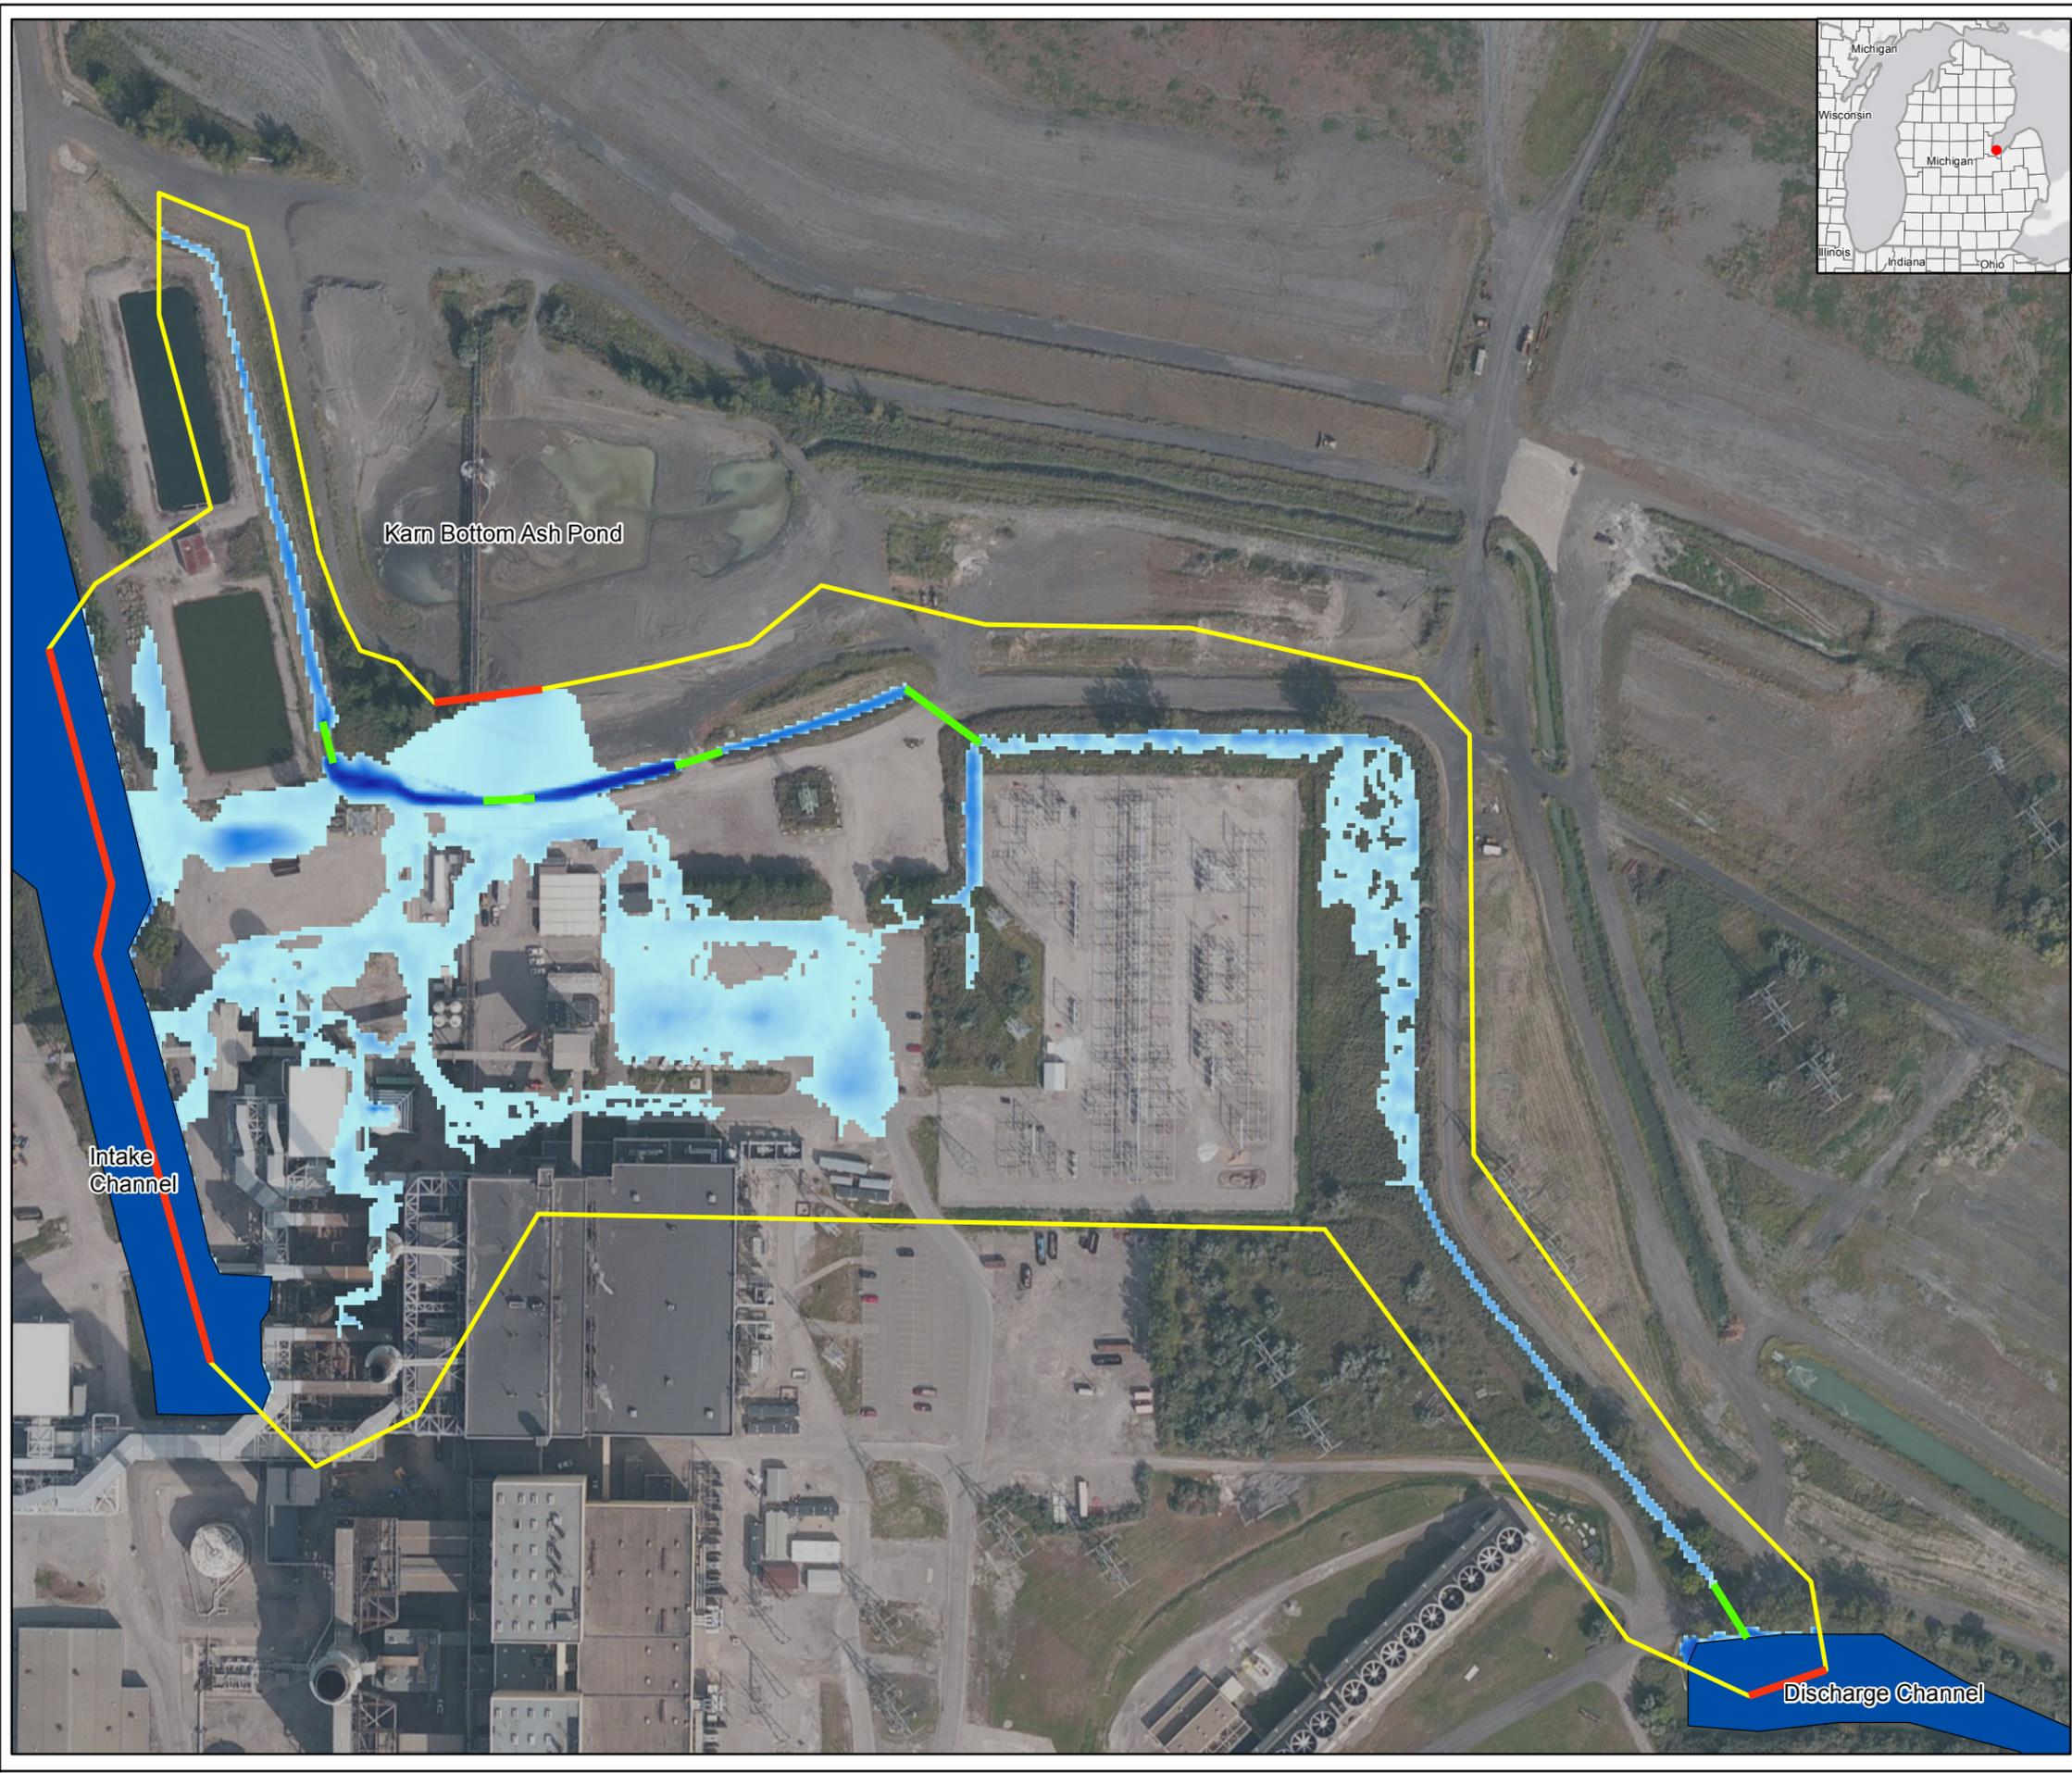
FIGURE
2

The resulting dam break inundation maps are presented in Figure 2 – Dam Break Inundation Map with Downstream Culverts and Figure 3 – Dam Break Inundation Map with Culverts Plugged. Flooding caused by a potential dam break at the Bottom Ash Pond (with downstream culverts open) enters a ditch directly south of the Bottom Ash Pond. The majority of the flood wave overtops the ditch and spreads south and west. Approximately 0.74 acre-feet (peak discharge of 5.3 cfs) of stored water reaches the Intake Channel. A lesser amount spreads east around the power substation and south into the Discharge Channel. Approximately 0.14 acre-feet (peak discharge of 1.2 cfs) of stored water reaches the Discharge Channel.

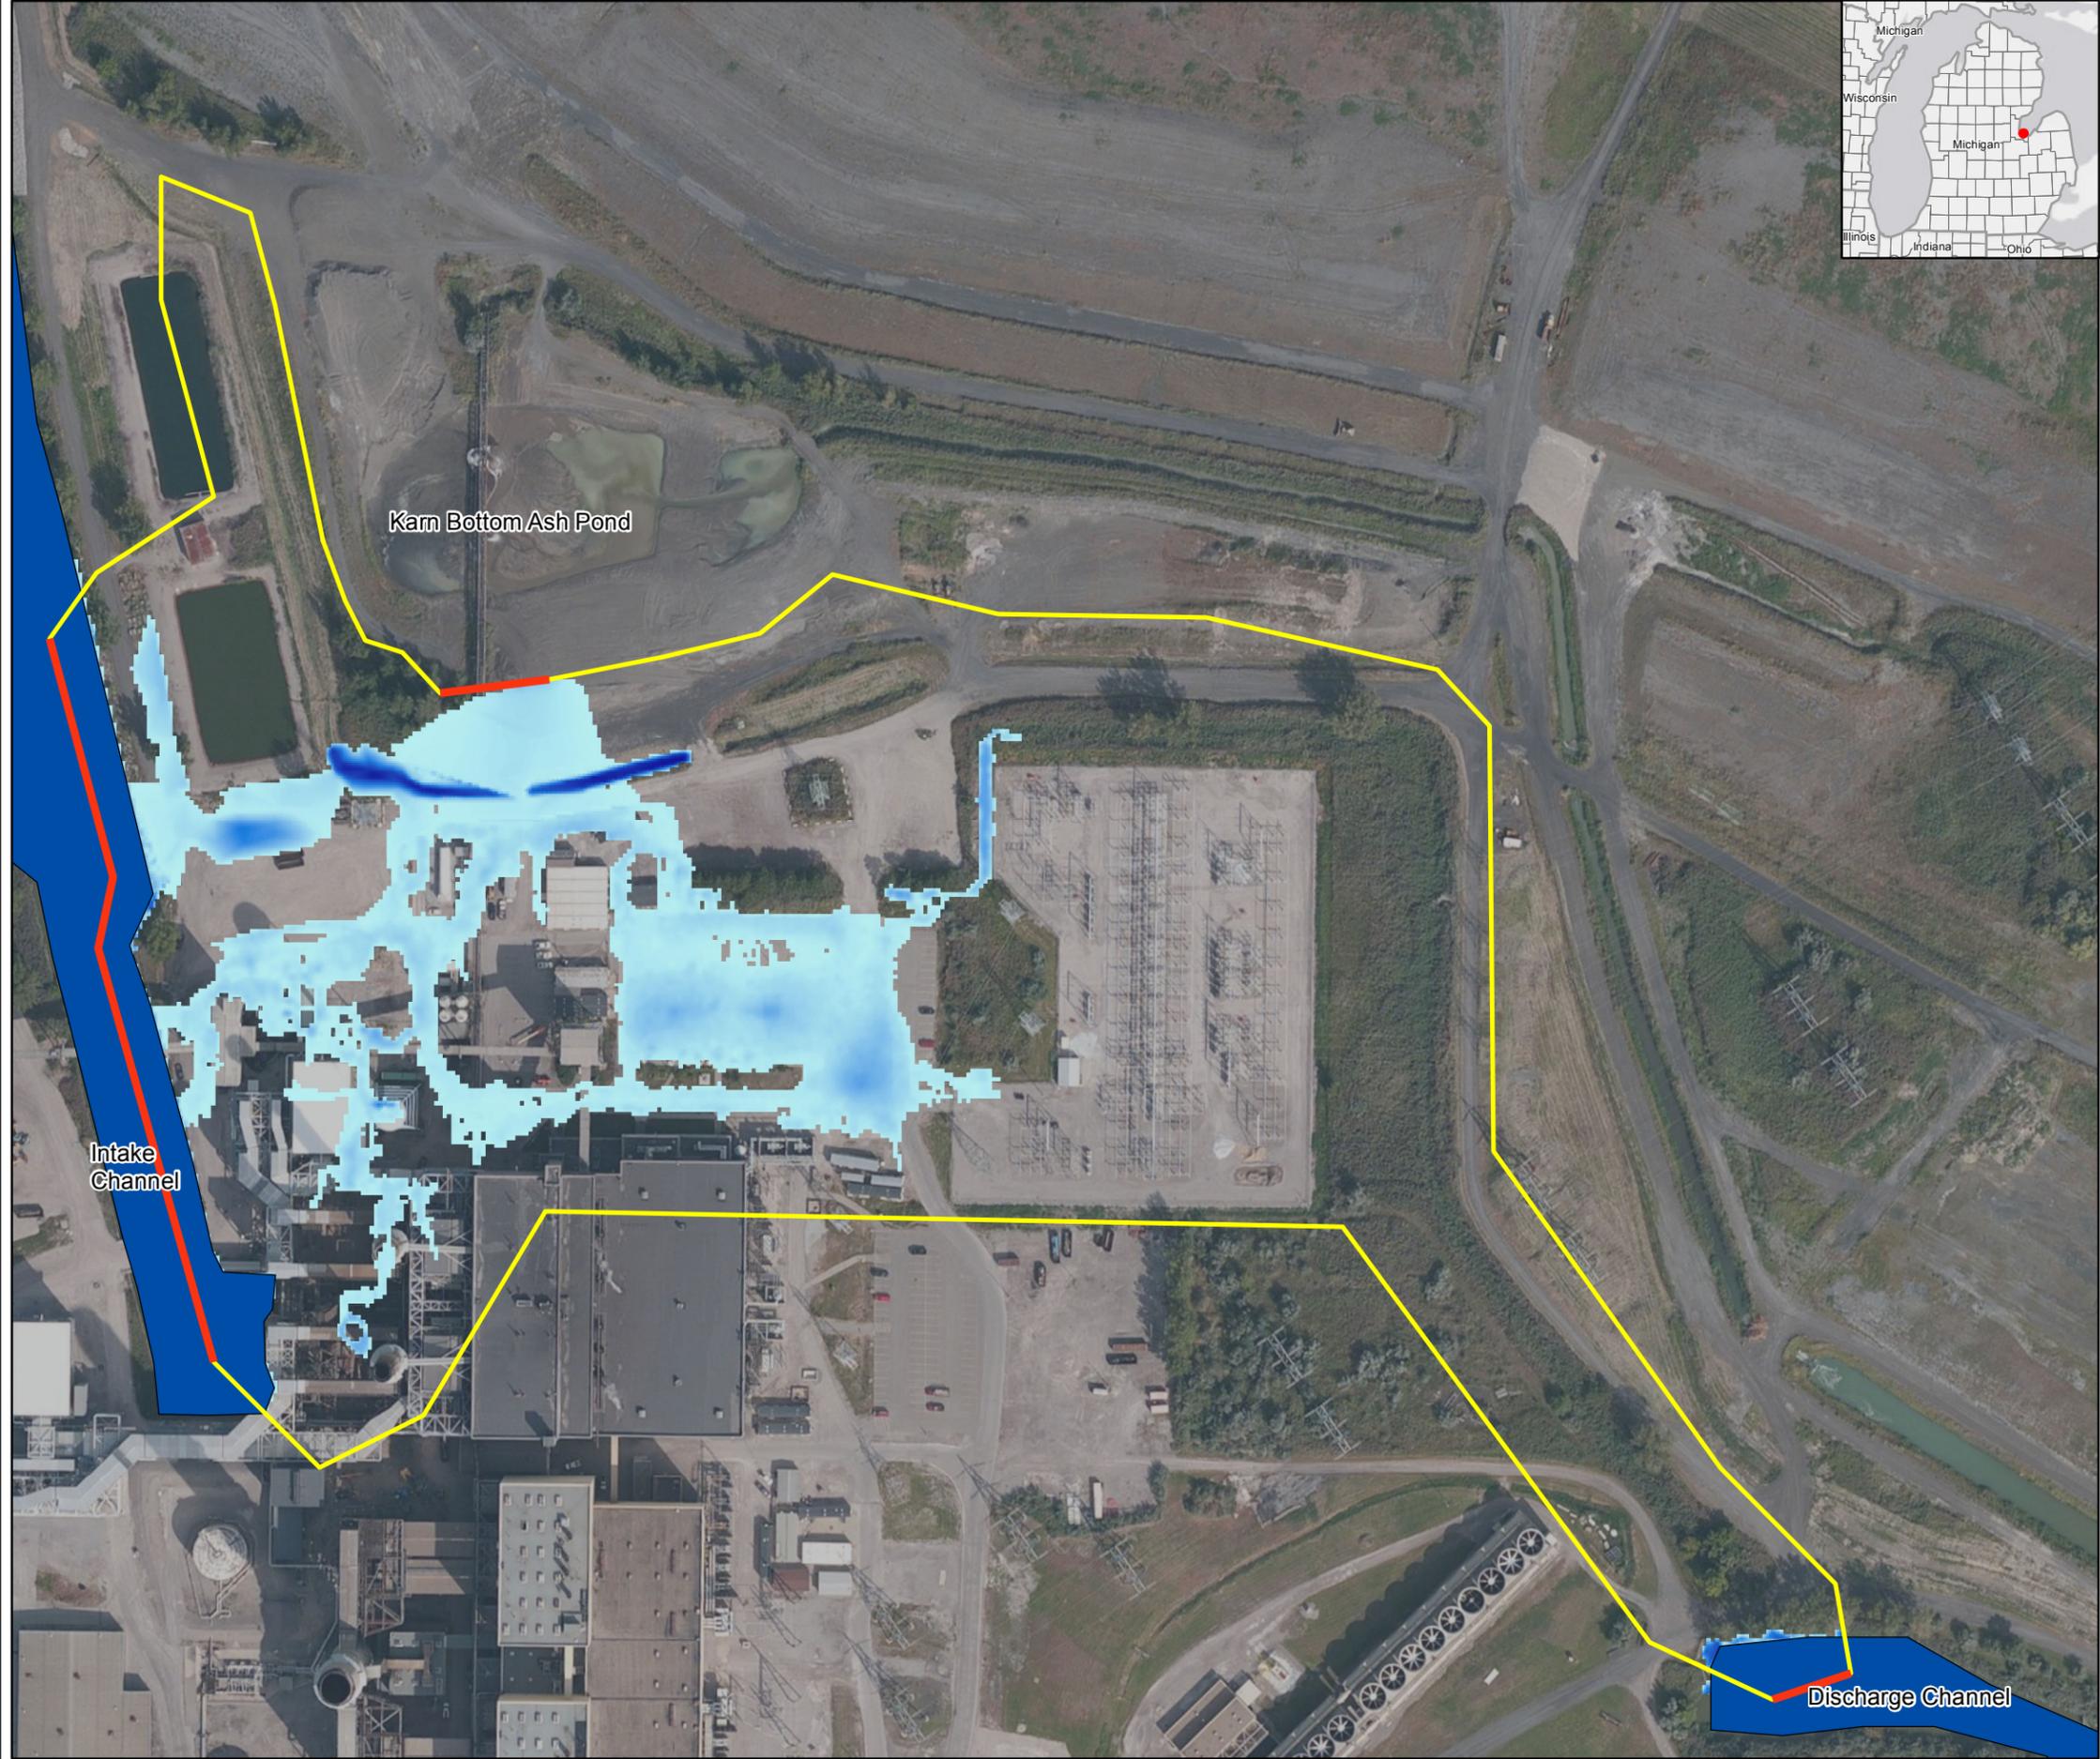
TITLE
**DAM BREAK INUNDATION MAP
KARN BOTTOM ASH POND (CULVERTS PLUGGED)**

Flooding caused by a potential dam break at the Bottom Ash Pond with downstream culverts plugged enters the ditch directly to the south, but quickly overtops it and spreads south and west, entering the Intake Channel. Approximately 1.1 acre-feet (peak discharge of 7.2 cfs) of stored water reaches the Intake Channel.
