J.H. CAMPBELL GENERATING FACILITY

BOTTOM ASH PONDS 1-2 HAZARD POTENTIAL CLASSIFICATION ASSESSMENT REPORT

West Olive, Michigan

October 2016

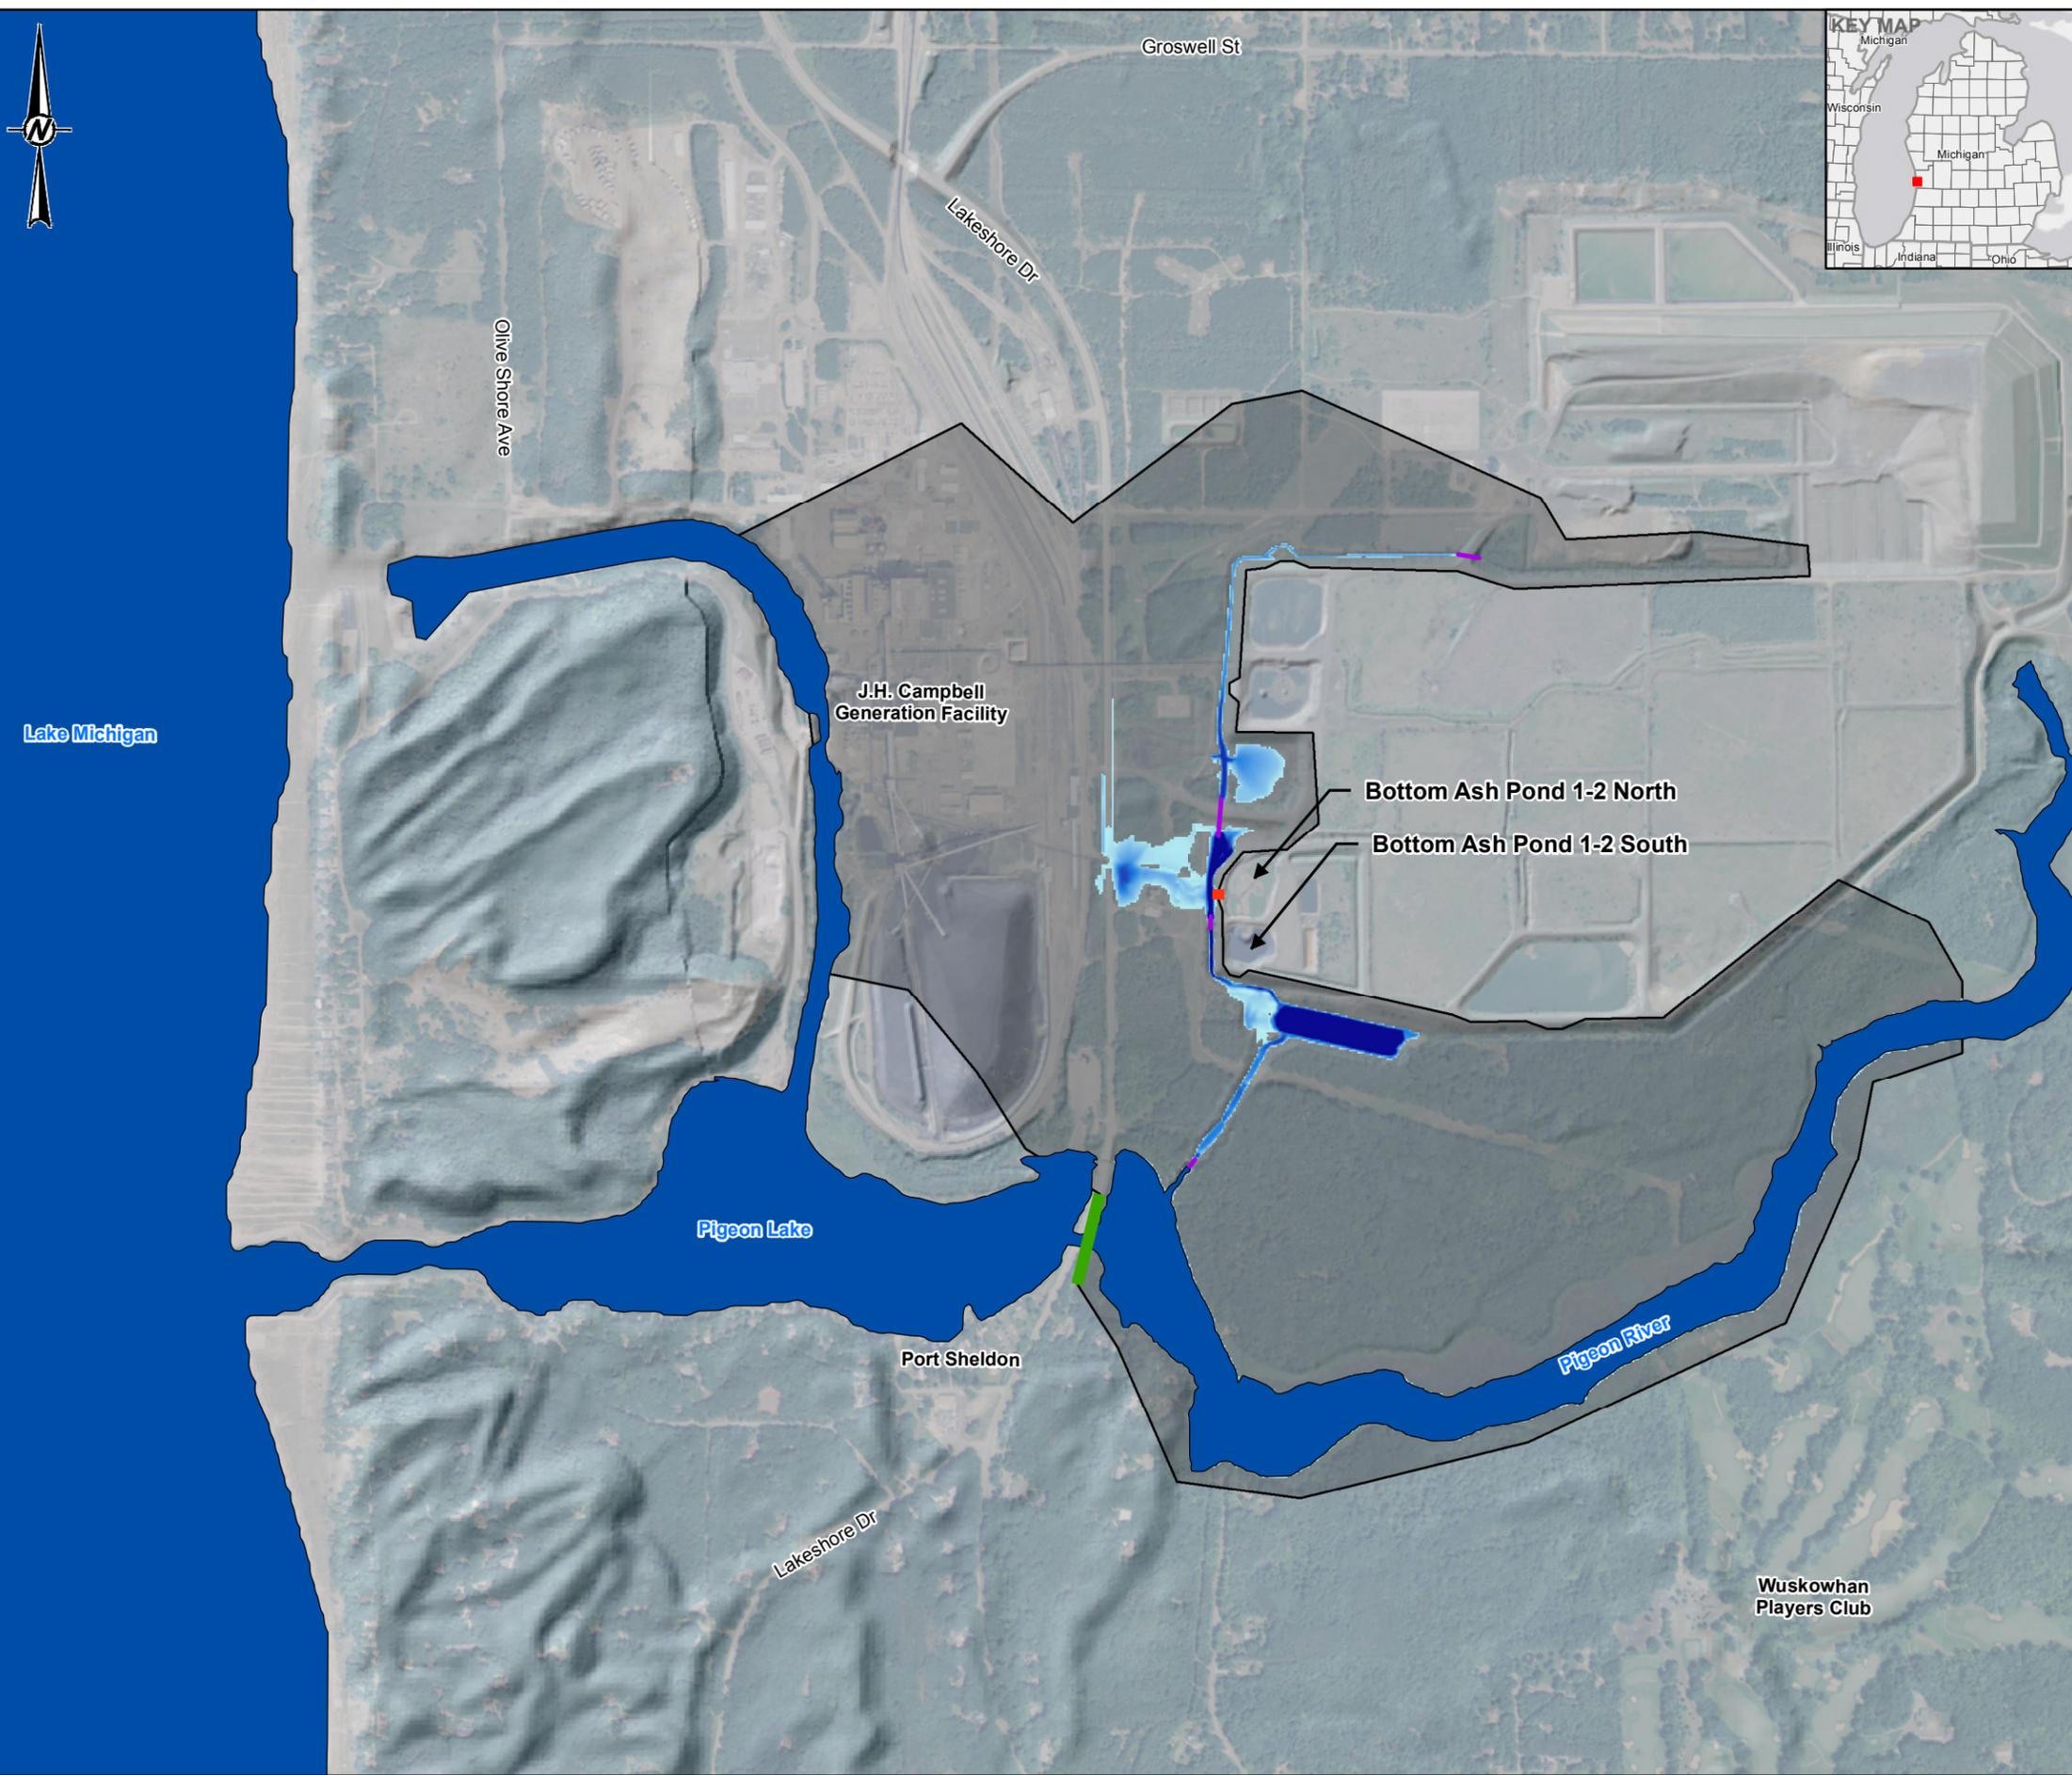
DAM BREAK INUNDATION MAP
BOTTOM ASH PONDS 1-2 NORTH

Flooding caused by a potential dam break of Bottom Ash Ponds 1-2 North spreads north and south along a perimeter ditch on the west side of Bottom Ash Ponds 1-2 North. Much of the flood wave flows down the perimeter ditch to the south, through the recirculation pond, and out to the Pigeon River. Approximately 10 acre-feet of the flood wave reaches the Pigeon River. The flood wave also overtops the perimeter ditch and drains west out onto Lakeshore Drive.

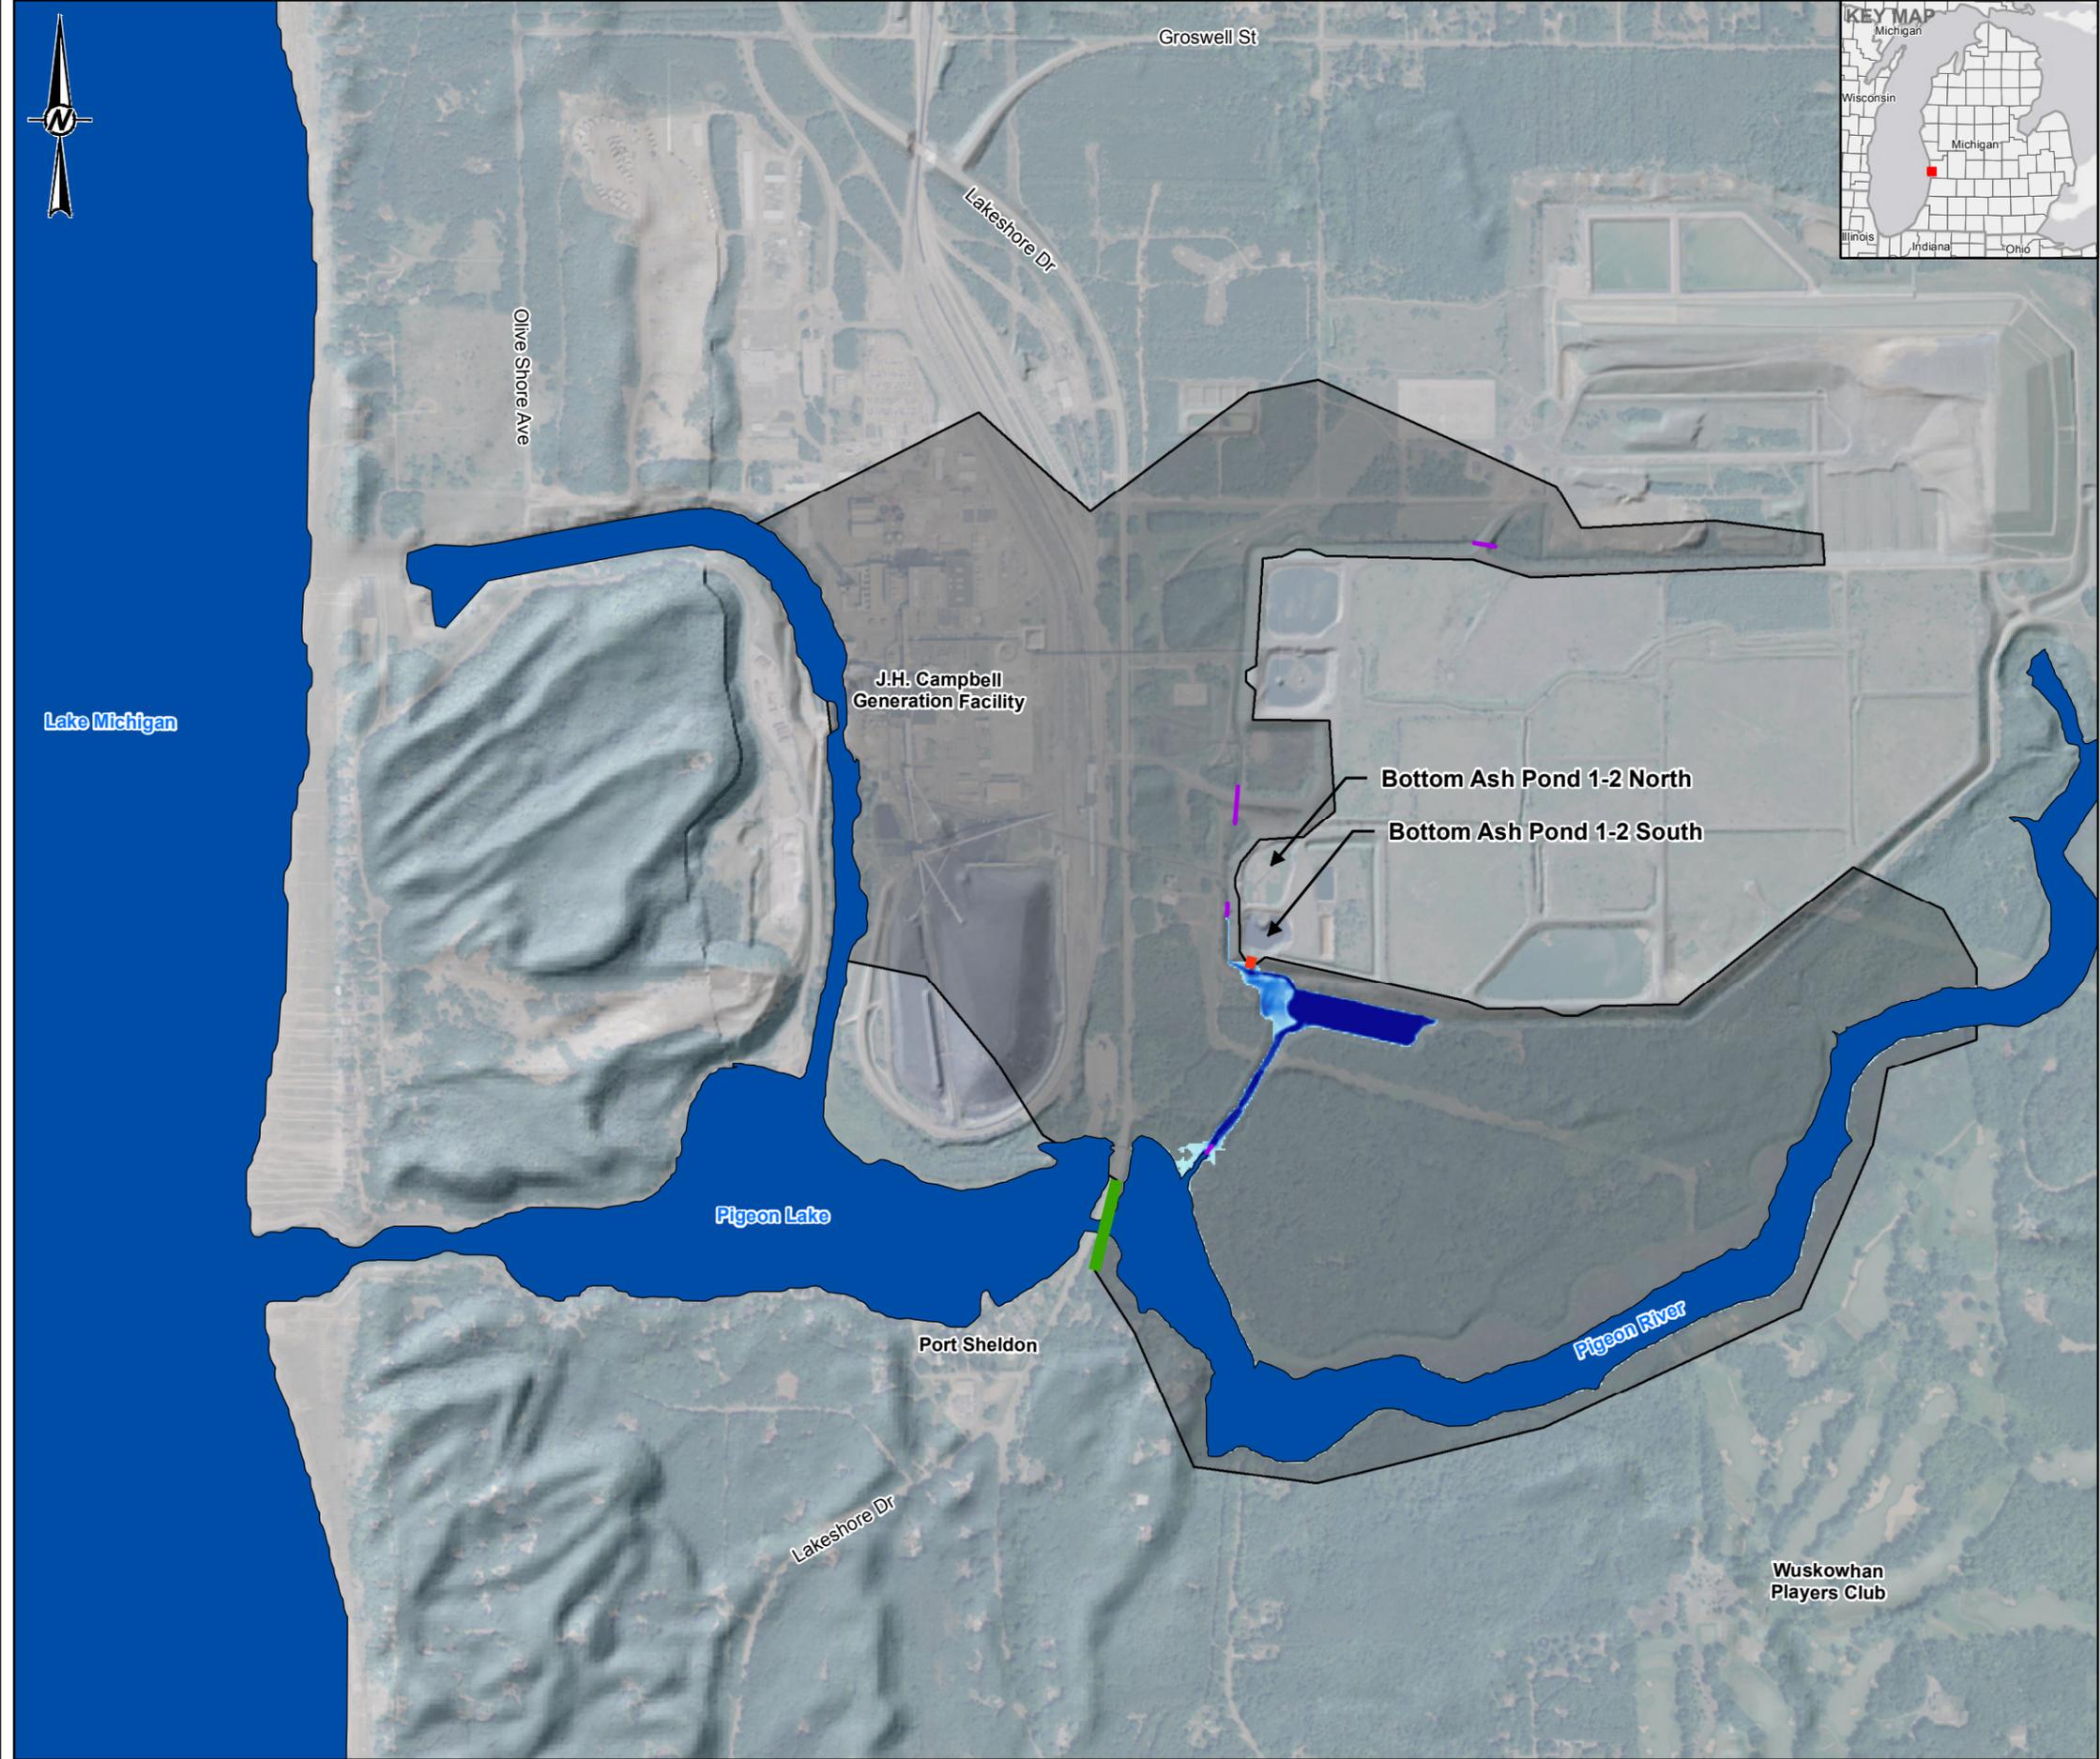
TITLE
DAM BREAK INUNDATION MAP
BOTTOM ASH PONDS 1-2 SOUTH

Flooding caused by a potential dam break of Bottom Ash Ponds 1-2 South drains entirely into the perimeter ditch and flows down through the recirculation pond and out to the Pigeon River. Approximately 17 acre-feet of the flood wave reaches the Pigeon River.
