Structural Stability and Safety Factor Assessment Report

J.H. CAMPBELL GENERATING FACILITY

BOTTOM ASH POND 3 STRUCTURAL STABILITY AND SAFETY FACTOR ASSESSMENT REPORT

October 2016

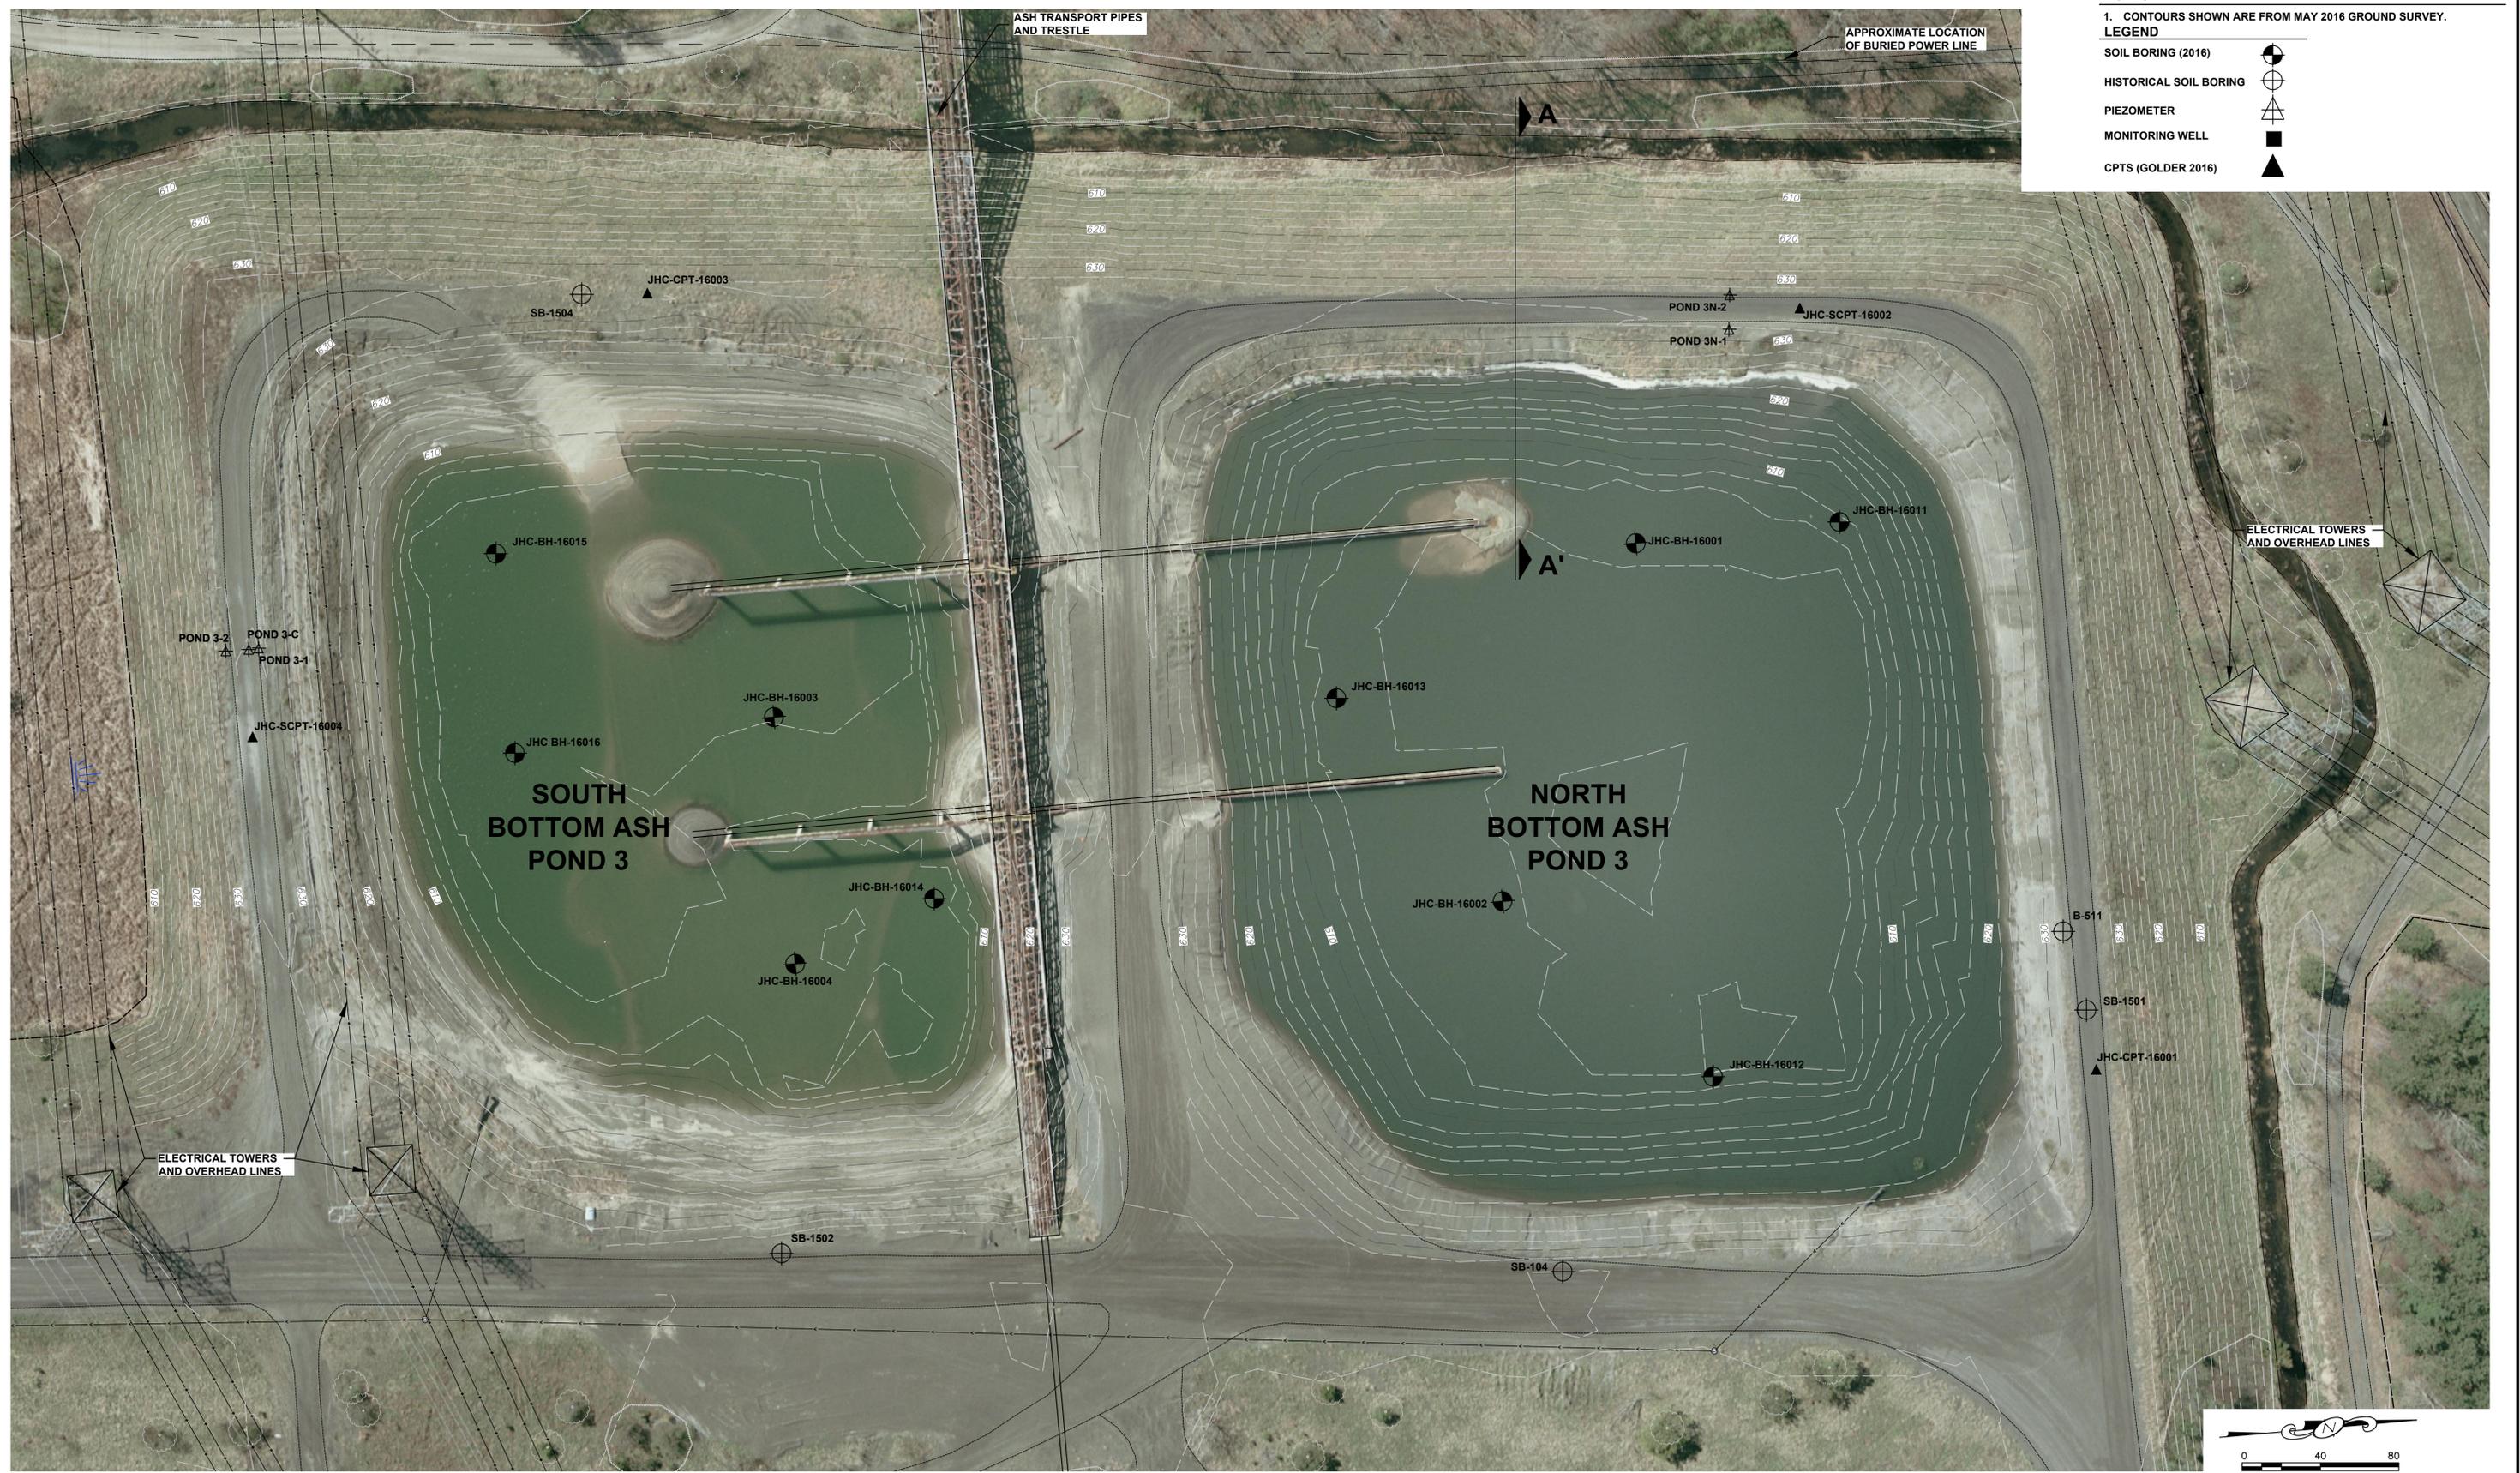
2016 RCRA COMPLIANCE FACTOR OF SAFETY ASSESSMENT			
BOTTOM ASH POND 3 PLAN VIEW			
BOREHOLE LOCATION AND CROSS SECTION LOCATION MAP			
SCALE 1" = 40'/1" = 4'	DRAWING NO. ----	FIGURE 2	REV. A
JOB 1654923

The critical section used for the slope stability analysis was located along the western dike of Bottom Ash Pond 3 North and is shown as Section A-A' in Figure 2.

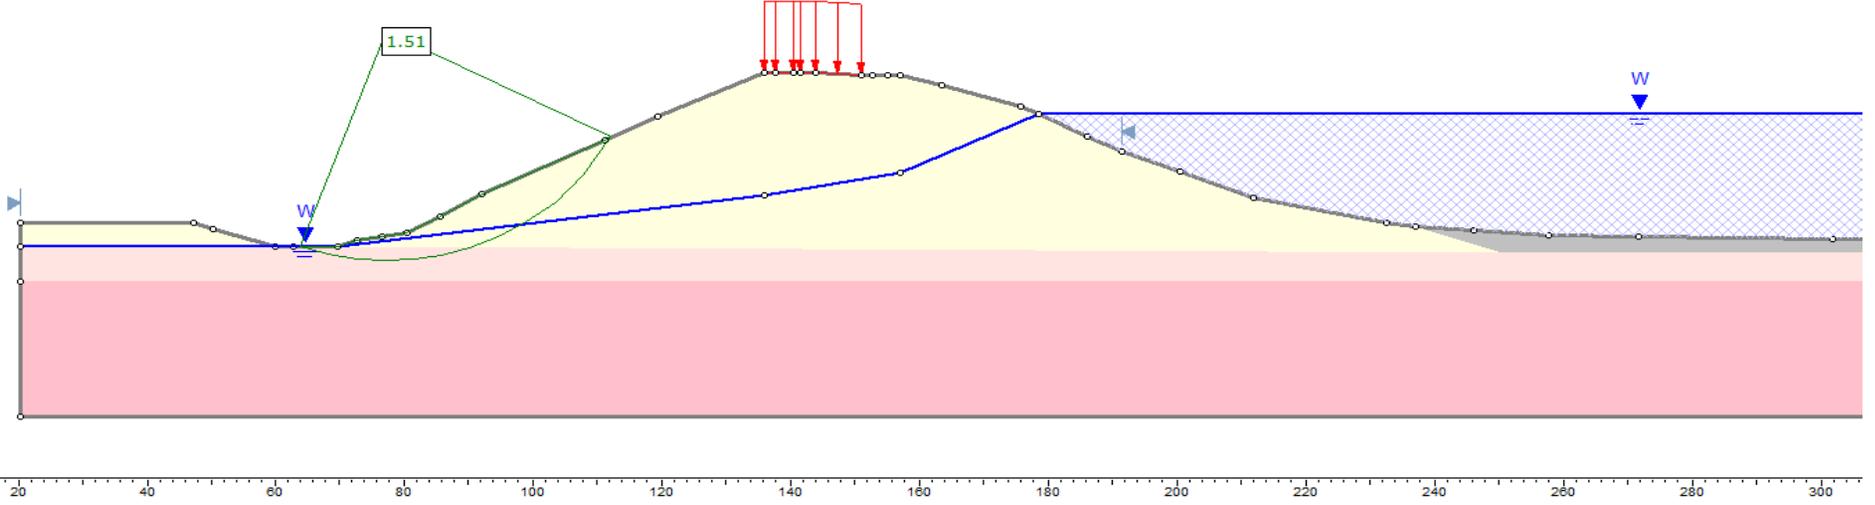
PROJECT	J.H. Campbell Structural Stability Assessments	
TITLE	Unit 3 Bottom Ash Pond Section A-A' Slope Factor of Safety Max Pool Storage Scenario	
CLIENT	Consumers Energy Company	FIGURE B-A1

Scenarios	Maximum Pool Storage	Maximum Pool Surcharge	Seismic
Required Safety Factor	1.50	1.40	1.00
Section	Calculated Safety Factor		
Section A-A'	1.51	1.48	1.33

Method Name	Min FS
GLE / Morgenstern-Price	1.51

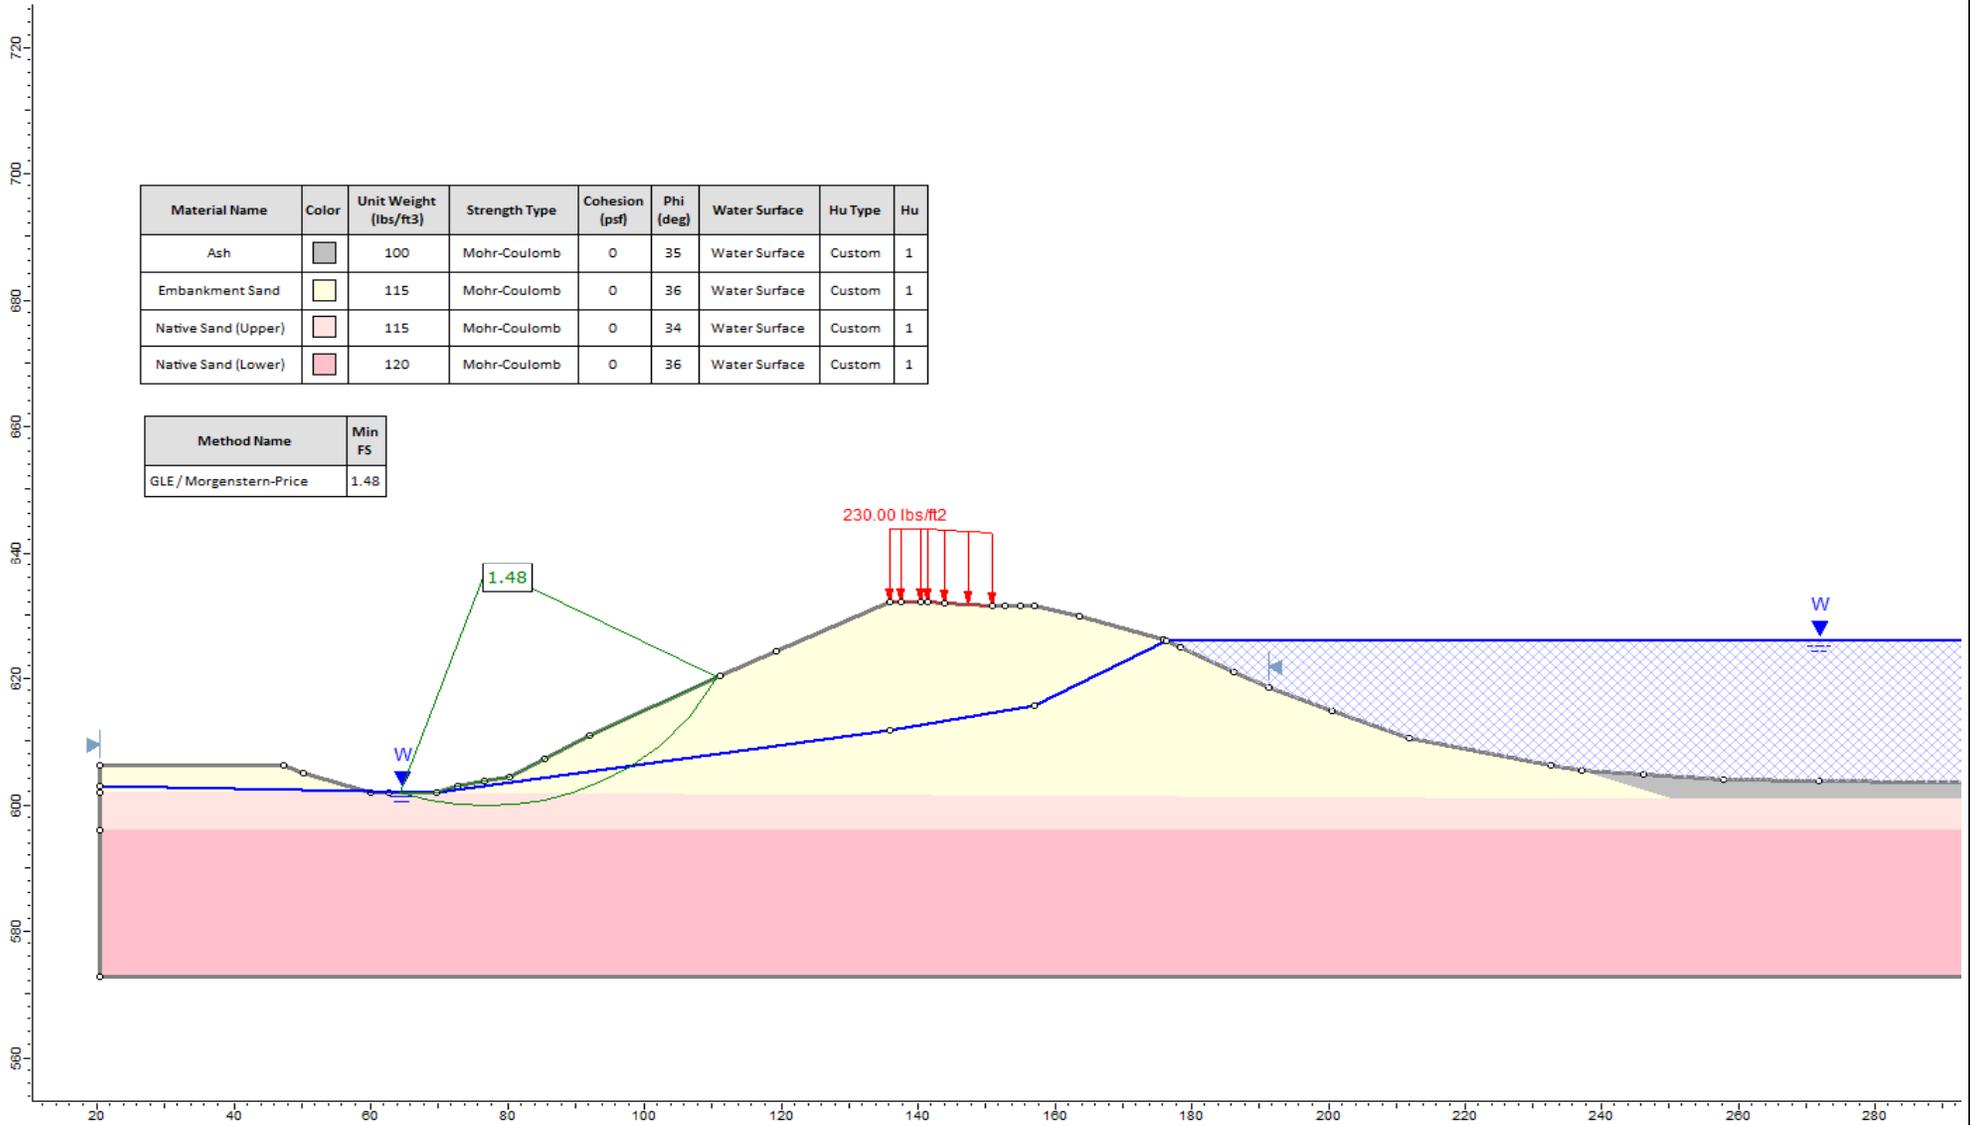
FIGURE	B-A2
--------	-------------

Method Name	Min FS
GLE / Morgenstern-Price	1.48

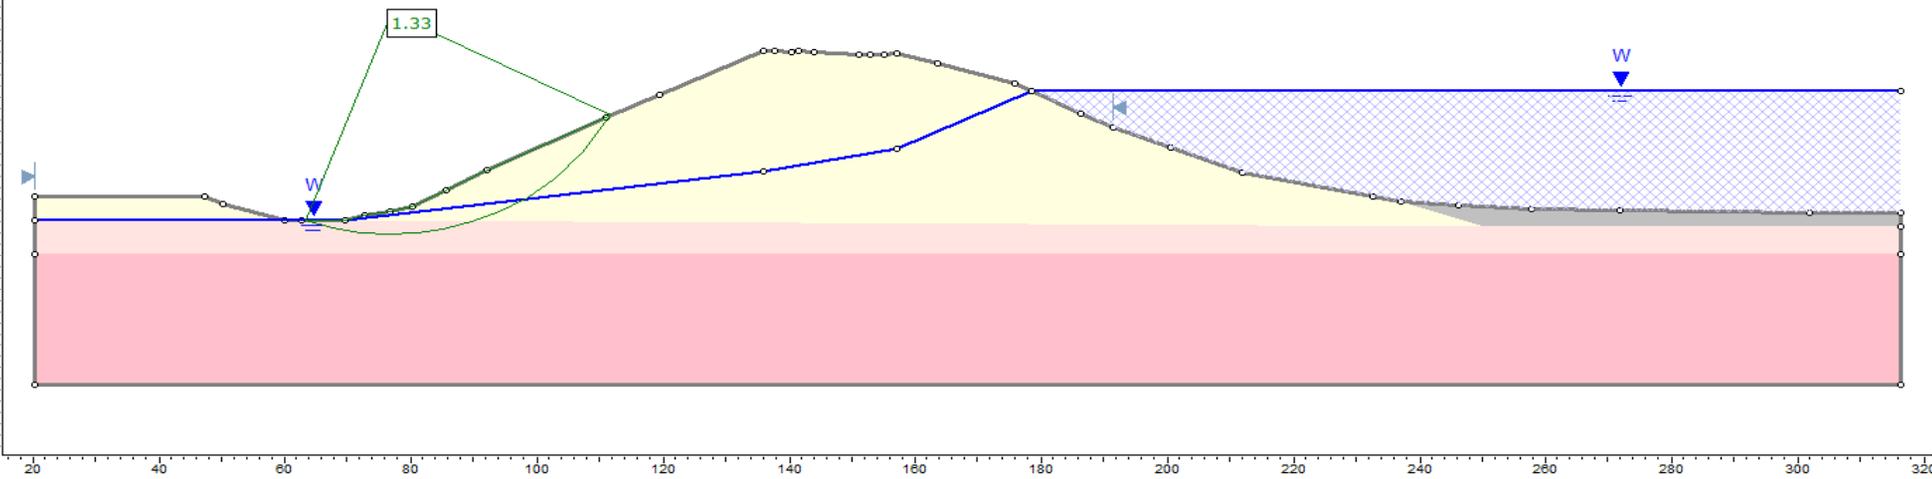
PROJECT	J.H. Campbell Structural Stability Assessments	
TITLE	Unit 3 Bottom Ash Pond Section A-A' Slope Factor of Safety Seismic Scenario

Method Name	Min FS
GLE / Morgenstern-Price	1.33

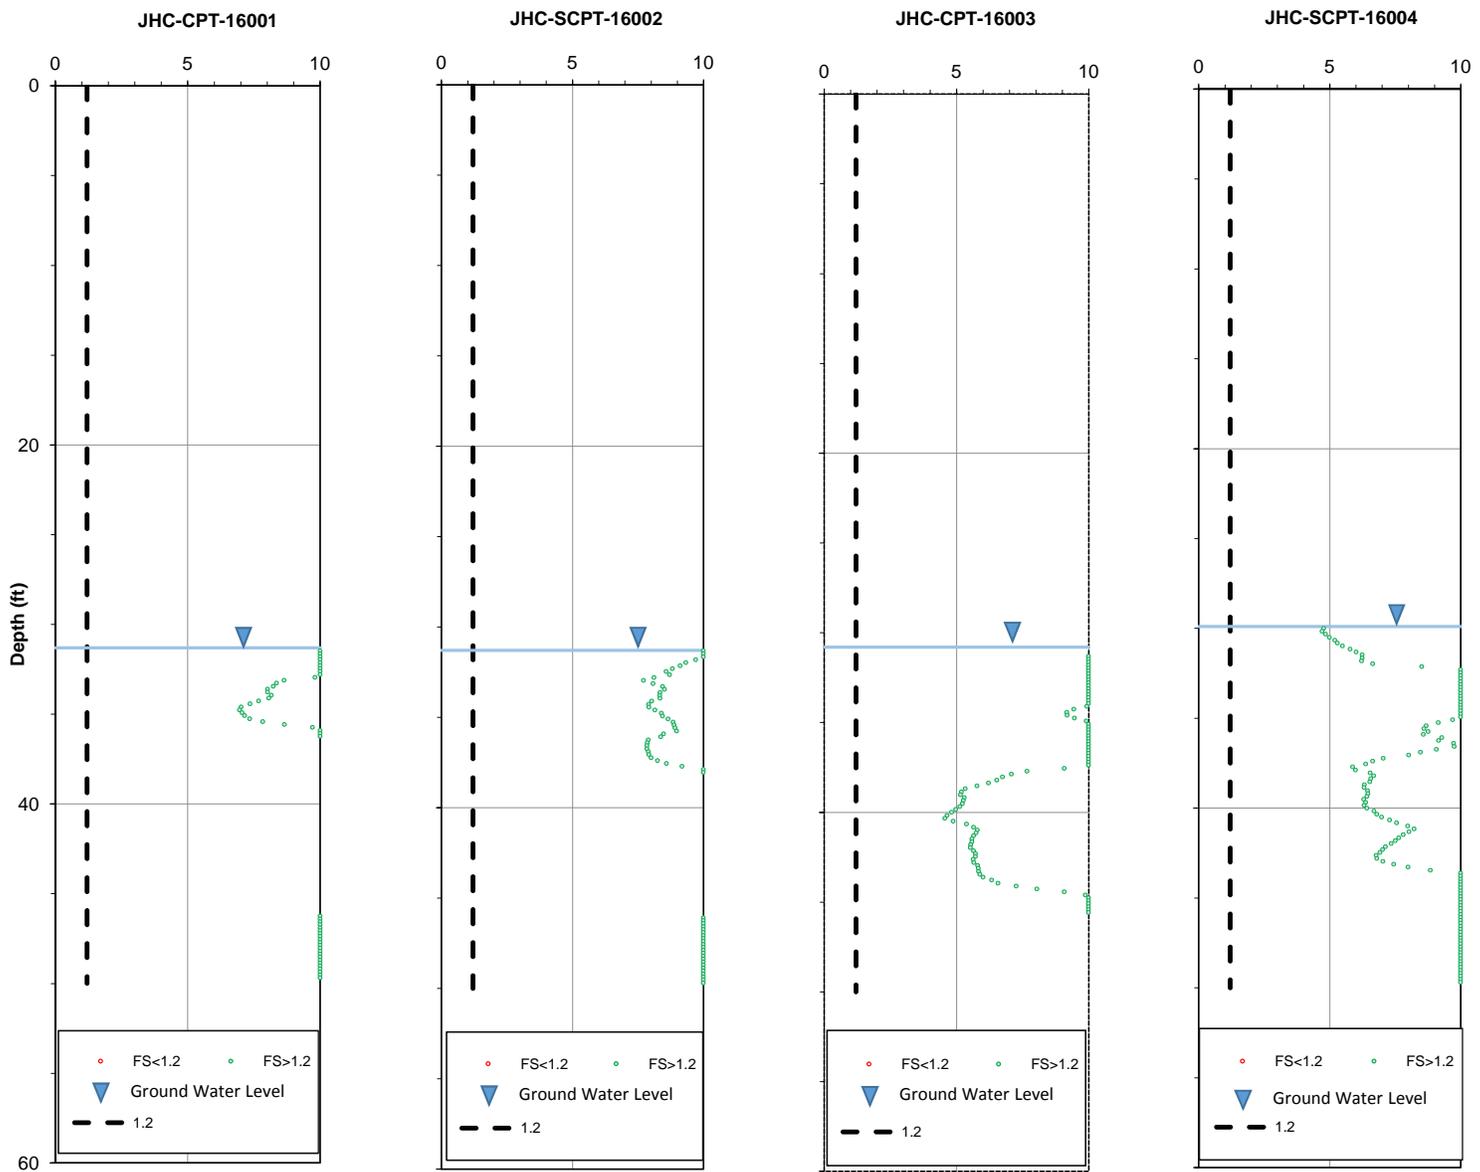
CPT ID: JHC-SCPT-16004
Test Date: 5/17/2016
Northing: 519226
Easting: 12633838
Elevation: 632 ft
a_{max}: 0.05 g
Water Table: 29.9 ft

Embankment and foundation soils were screened for seismically-induced liquefaction susceptibility using methods recommended by the National Center for Earthquake Research (NCEER), which uses Cone Penetrometer Test (CPT) data (Youd et al. 2001; Robertson and Wride 1998). The calculated factor of safety against seismically-induced liquefaction is shown in Appendix C and was calculated to be greater than 1.20 throughout the depth of the embankments and underlying foundation in the evaluated CPT soundings for the considered earthquake loading. These screening-level results indicate that the embankments and foundation soils for Bottom Ash Pond 3 are not susceptible to seismically-induced liquefaction for the seismic loading considered.
