PROGRESS UPDATE #17

FLINT EAST BOULEVARD FORMER MGP SITE

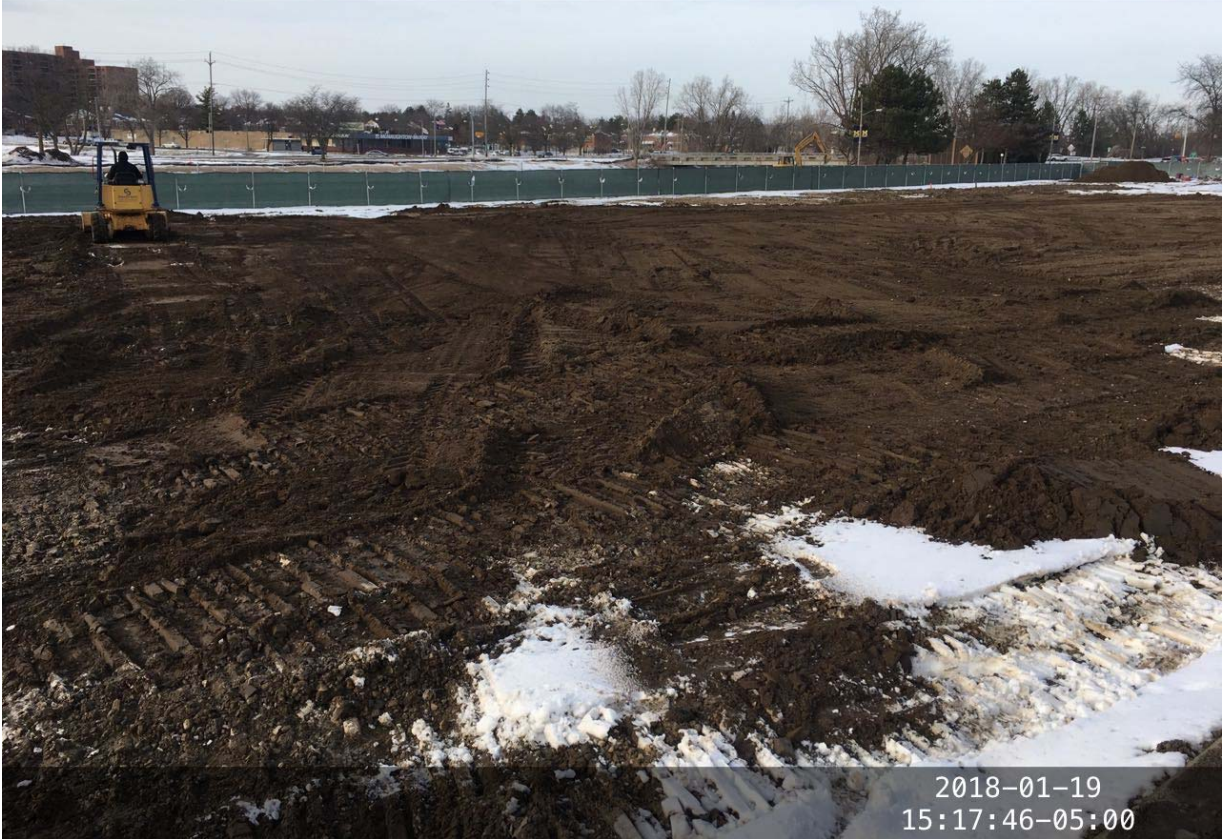
Picture No. 1.

- Placed and graded topsoil to restore riverbanks and upland areas of the site (see Photos 1 and 2).
- Continued restoring riverbanks and upland areas (see Photo 3).

Grading topsoil to restore upland area (photo taken facing northwest).

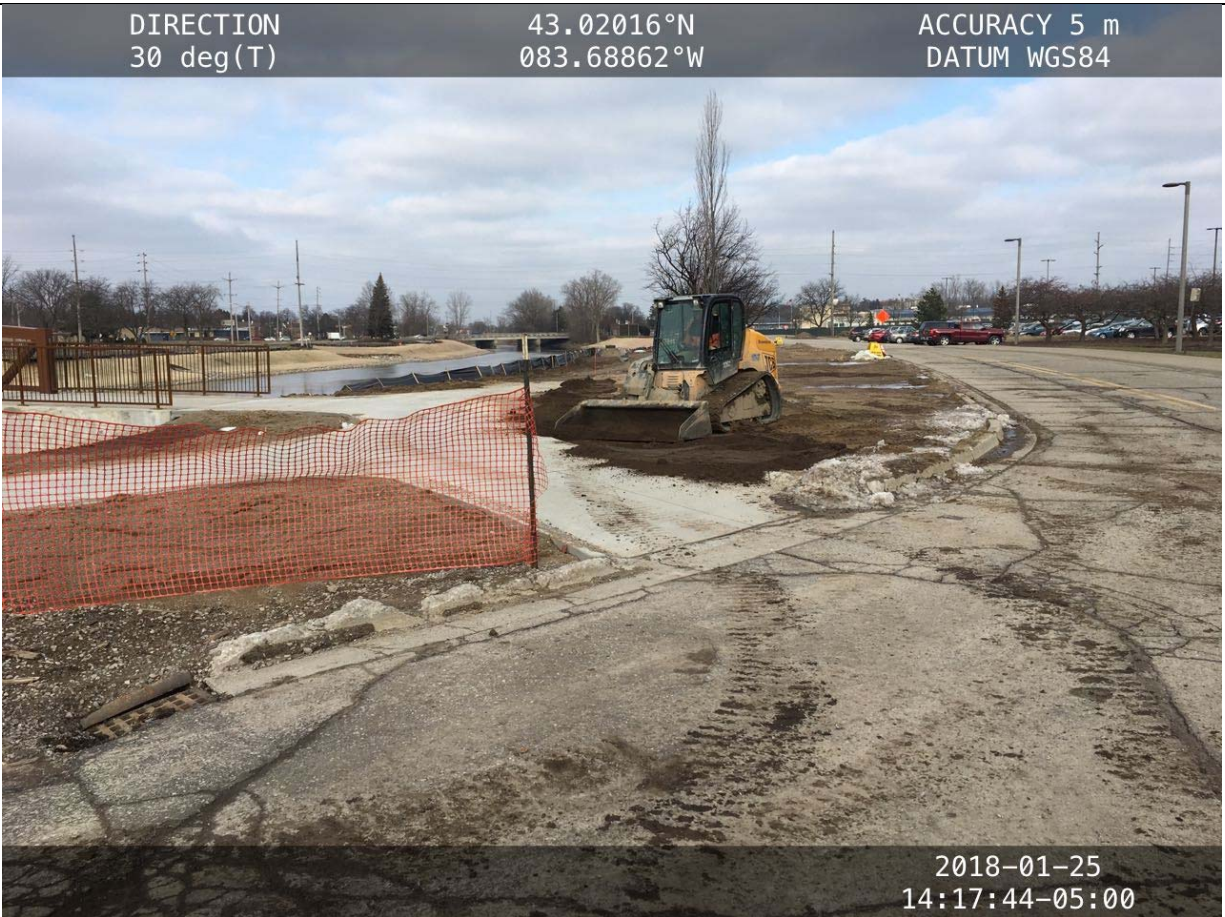
Picture No. 2.

Placing topsoil to restore area on eastern riverbank (photo taken facing northeast).

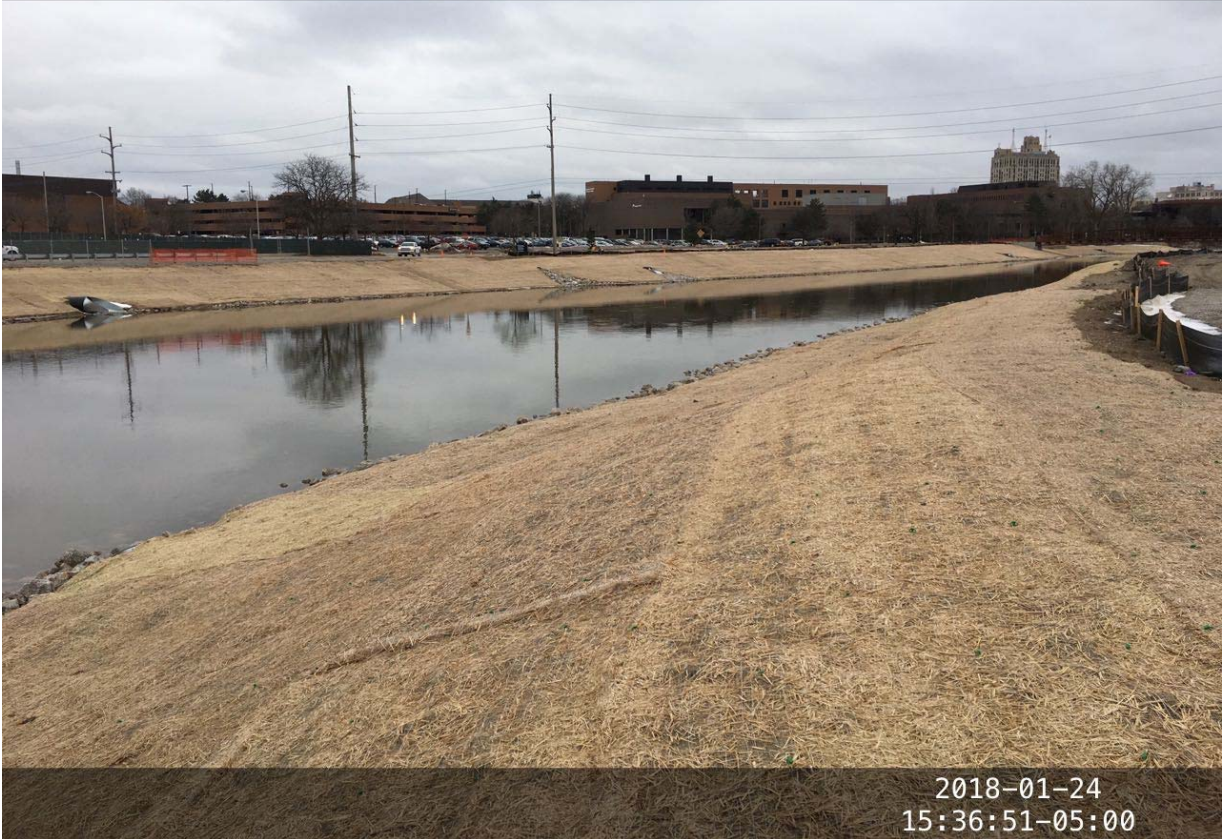
Picture No. 3.

General condition of restored riverbanks (photo taken facing southeast).

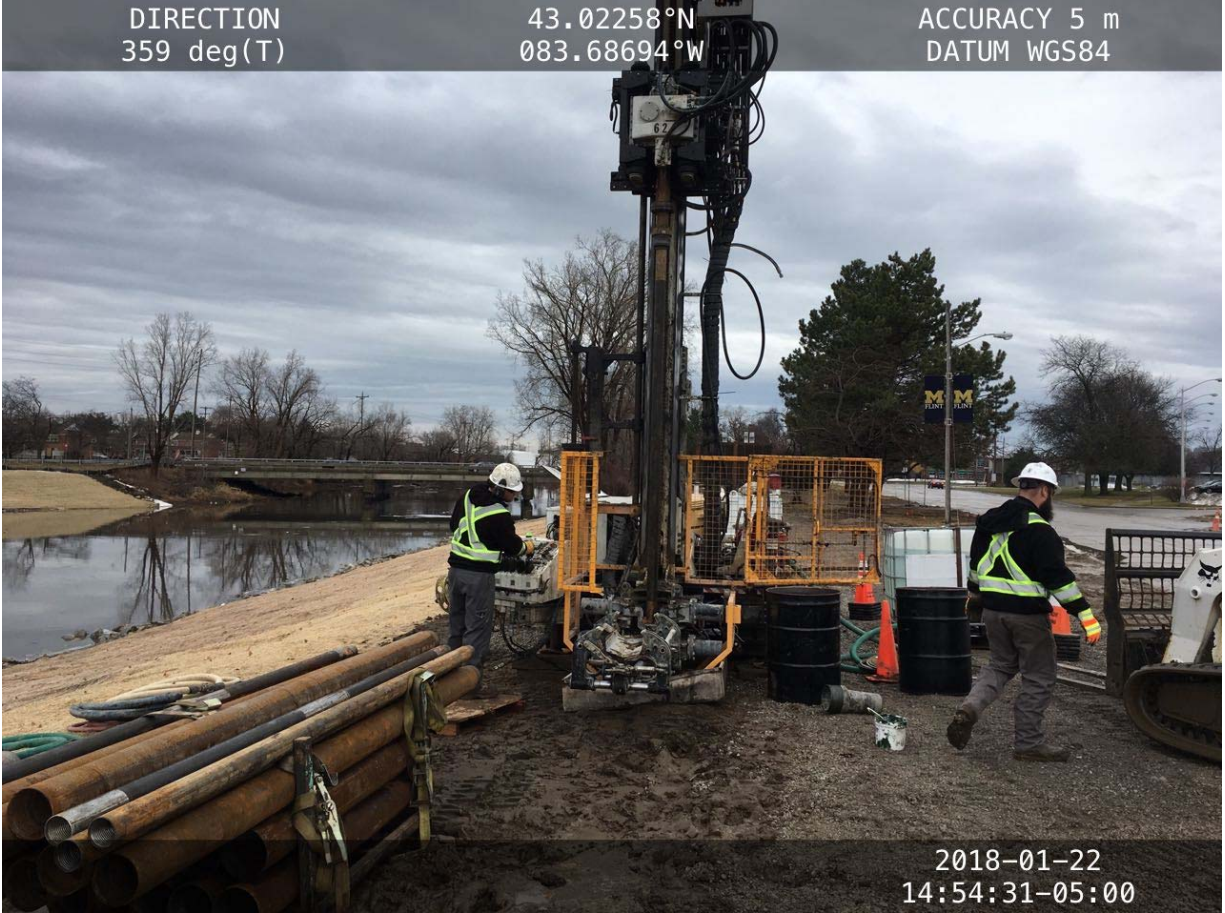
Picture No. 4.

- Installed monitoring wells to replace monitoring wells that were damaged during construction (see Photo 4).
- Installed additional erosion controls throughout the Work Area.

Installing replacement monitoring wells (photo taken facing north).
