New Lease on Life

How Overhauling the Ludington Pumped-Storage Units Will Extend Plant Life

Major Overhaul Boosts Performance at Ludington Pumped-Storage Plant

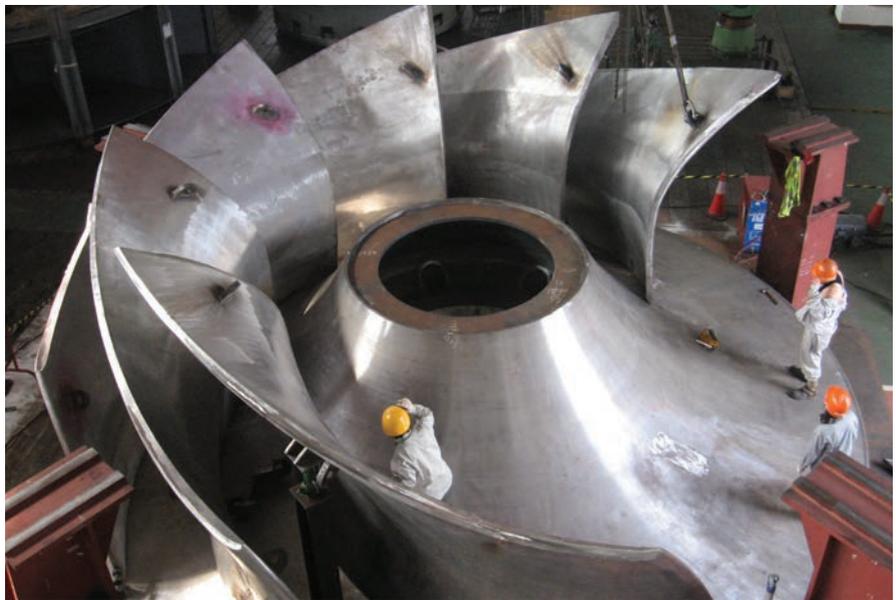
For the new runner, the blade length is longer than a typical nine-blade runner, reducing individual blade load.

A deeper runner means the apparatus has an extended outlet (pump inlet side) on its bottom. Thus, the runner blade length is longer than a typical nine-blade runner, reducing individual blade load.

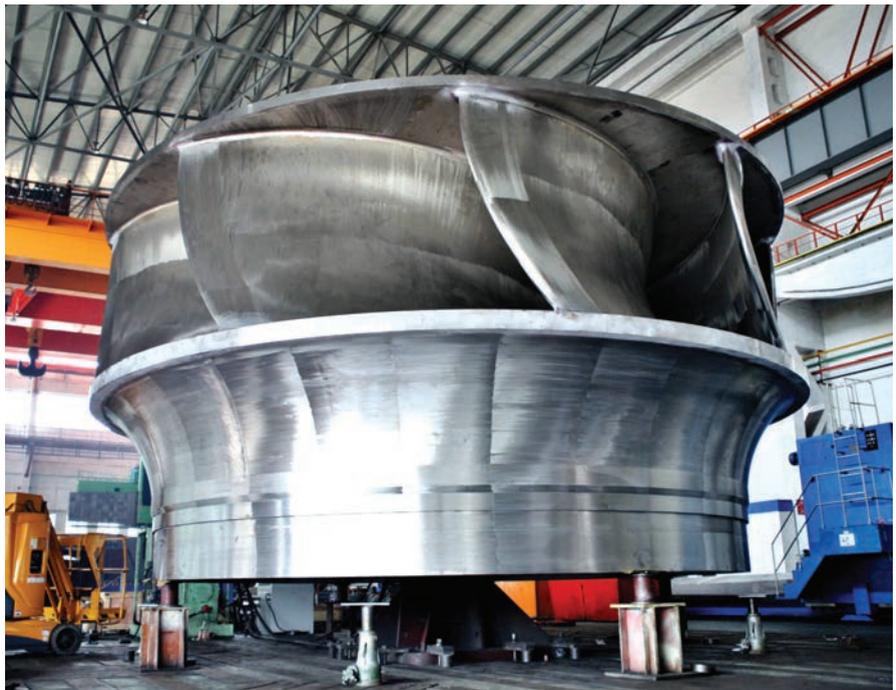
Finished, the Unit No. 1 runner assembly is a one-piece fabrication made of ASTM A487 CA6NM Class A stainless steel.

The original runner was made of carbon steel material and had two divided halves with a crown and band cover, which covered the bolt split flanges. The

new runner was made of ASTM A487 CA6NM Class A stainless steel and was designed as a one-piece fabrication. The new runner is large, about 8.4 m in diameter and weighing 270 tons, which are in the world's largest class as a pump-turbine runner.

One of Consumers Energy's concerns was the strength of welding seams on the fabricated runner. Consumers Energy and Toshiba decided full-penetration welding would be applied to all the new runner's welding seams to ensure sufficient strength and extended service life. To verify the strength of the prototype pump-turbine runner and the design life of 50 years, the strength and stress loaded in the runner was analyzed by Toshiba using FEA techniques and it was confirmed that the runner design meets all of the strength requirements as well as the extended service life.

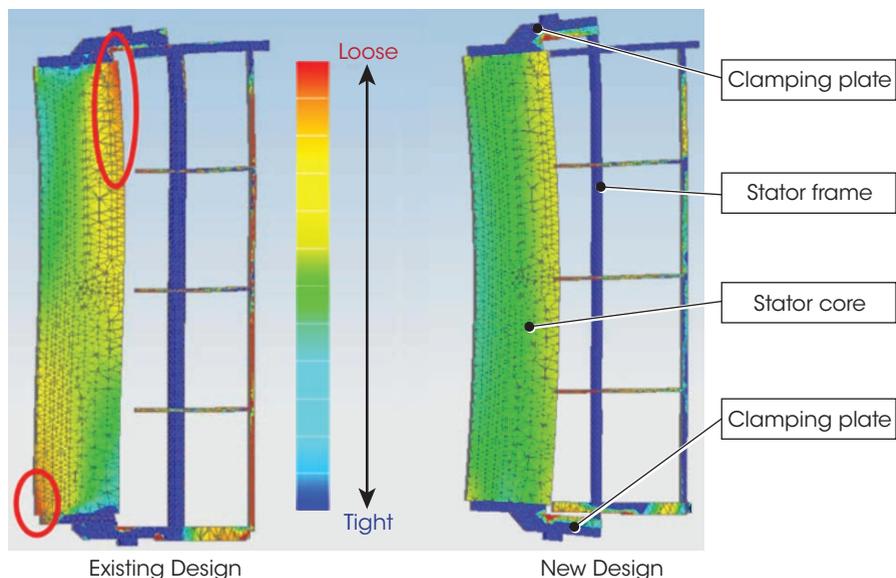
Figure 1 — Stator Frame

Engineers replaced the stator frame with independent bottom clamping plates. The new stator frame is constructed of welded steel plate, split into six sections and designed for site assembly by bolting to form a complete frame. The colors in the figure show the stress distribution, not components. The new stator core is constructed with high-grade, non-aging, thin silicon steel laminations.

FEA analysis was performed on original and modified structures to verify the differences and evaluate the modified structure. As part of prudent repairs, engineers replaced the stator frame with independent bottom clamping plates (see Figure 1).

The new stator core is constructed with high-grade, non-aging, thin silicon steel laminations. After it is machined, each lamination is coated on both sides with an insulating varnish to minimize eddy current losses.

The stator core lamination is stacked in the stator frame at the site to form a continuous core with joints between laminations overlapped. The stator core is clamped by segment-type clamping plates and fingers at both top and bottom, separated from the stator frame.

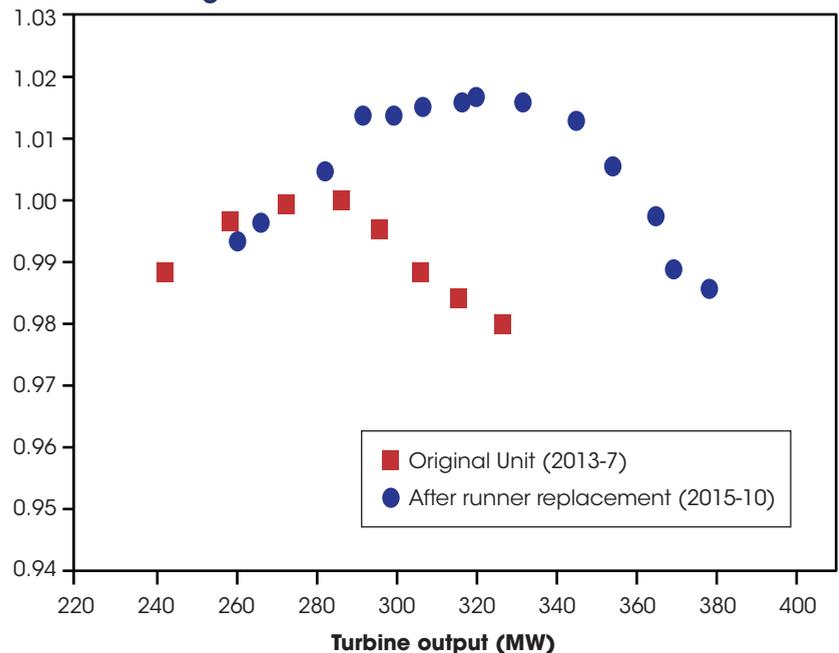
Figure 2 — New Design

This graph indicates comparative unit relative efficiency and turbine output between the existing and new design.

In 2015, operating performance of the upgraded pump-turbine was measured during performance test (see Figure 2). Comparative performance testing utilized an eight-path ultrasonic flow meter by Caldon in the same manner used to test the original machine in 2013.

Tests confirmed turbine efficiency performance against turbine output increased to a larger output range. Stable turbine operation can be continued at 360 MW turbine capacity with 320 feet of head. The original nominal turbine capacity at the same head was 312 MW. In addition, efficiency of the new runner is the same at partial load range as the original runner.

In the case of pump operation, the pump discharge of the new runner increased about 15% compared with the

original at all head ranges.

The new runner could start pumping operation at a static head of 354.1 feet, which is more than 15 feet higher than the original runner. This ability provided greater flexibility of the pumping operation and more convenient operation against grid demand.
