Work completed between 8/6/2017 and 8/19/2017 includes the following:

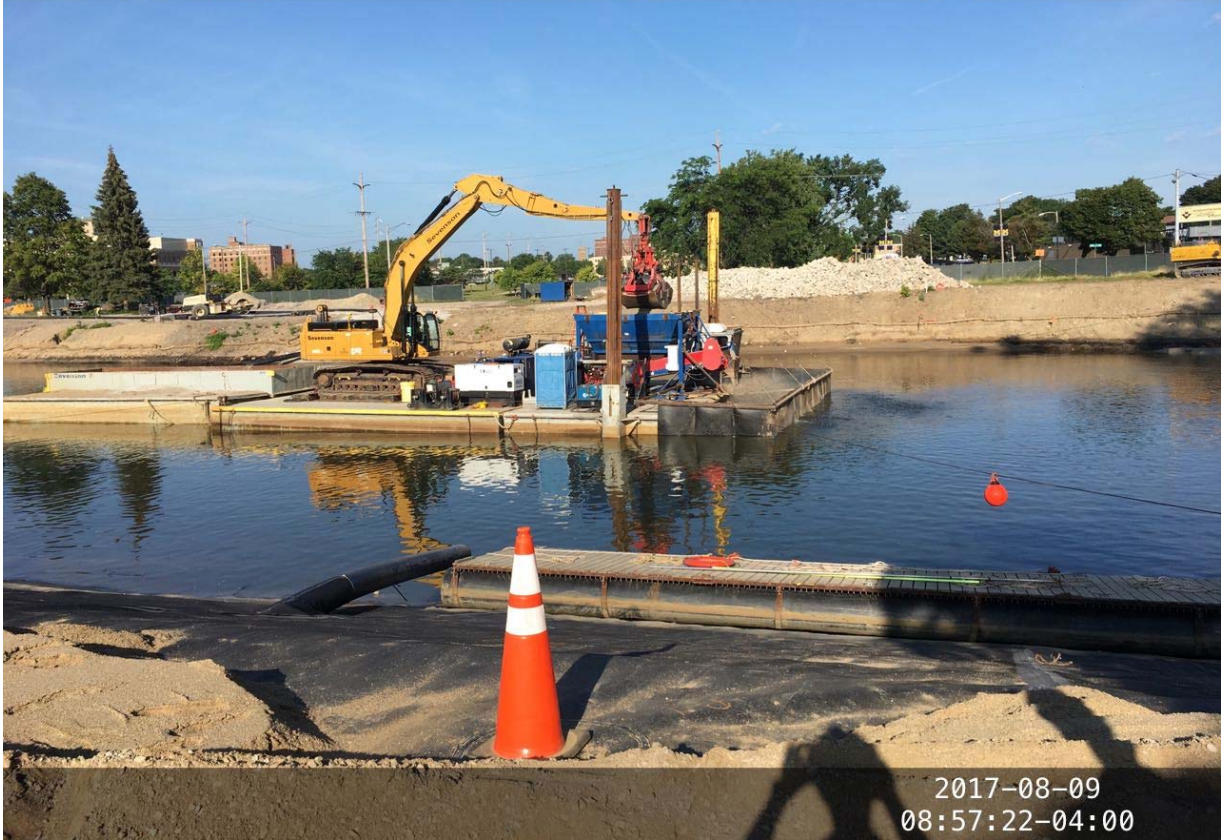
Picture No. 1.

- Continued capping activities including placement of the sand base layer from station 4+00 to 11+50 along the eastern riverbank, Blended Barrier from station 2+25 to 3+75, placement of sand on top of Blended Barrier from station 2+50 to 3+50, and placement of gravel from station 2+00 to 2+40 (see Picture No. 1). See project map for updated Active Cap Area.

Placing cap material in the upstream portion of the Work Area (photo taken facing west).

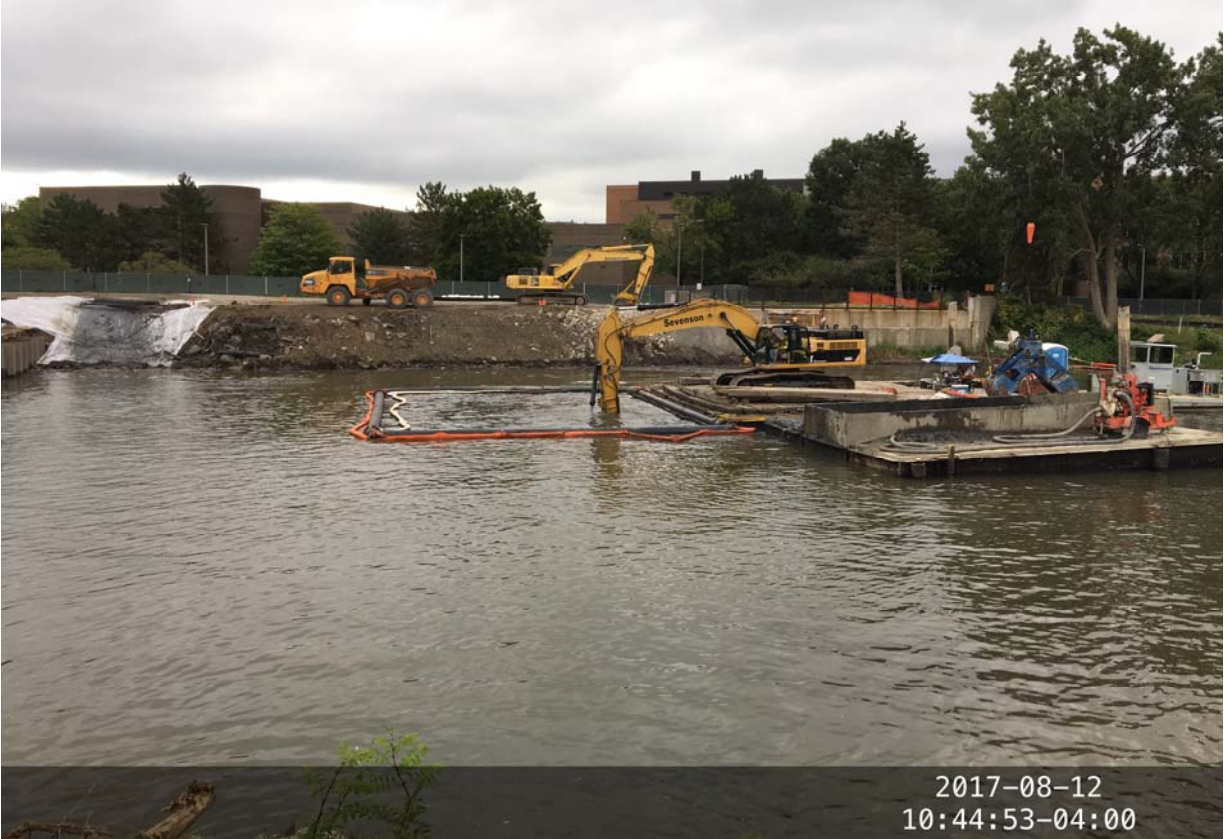
Picture No. 2.

- Continued dredging activities within the river channel and along the riverbanks. Dredging has occurred from station 2+00 to 17+50 within the river channel, station 2+25 to 19+00 along the western riverbank, and from station 2+25 to 14+00 along the eastern riverbank (see Pictures No. 2 and 3). See project map for updated Active Dredge Area.

Dredging in the river using the moon pool (photo taken facing south).

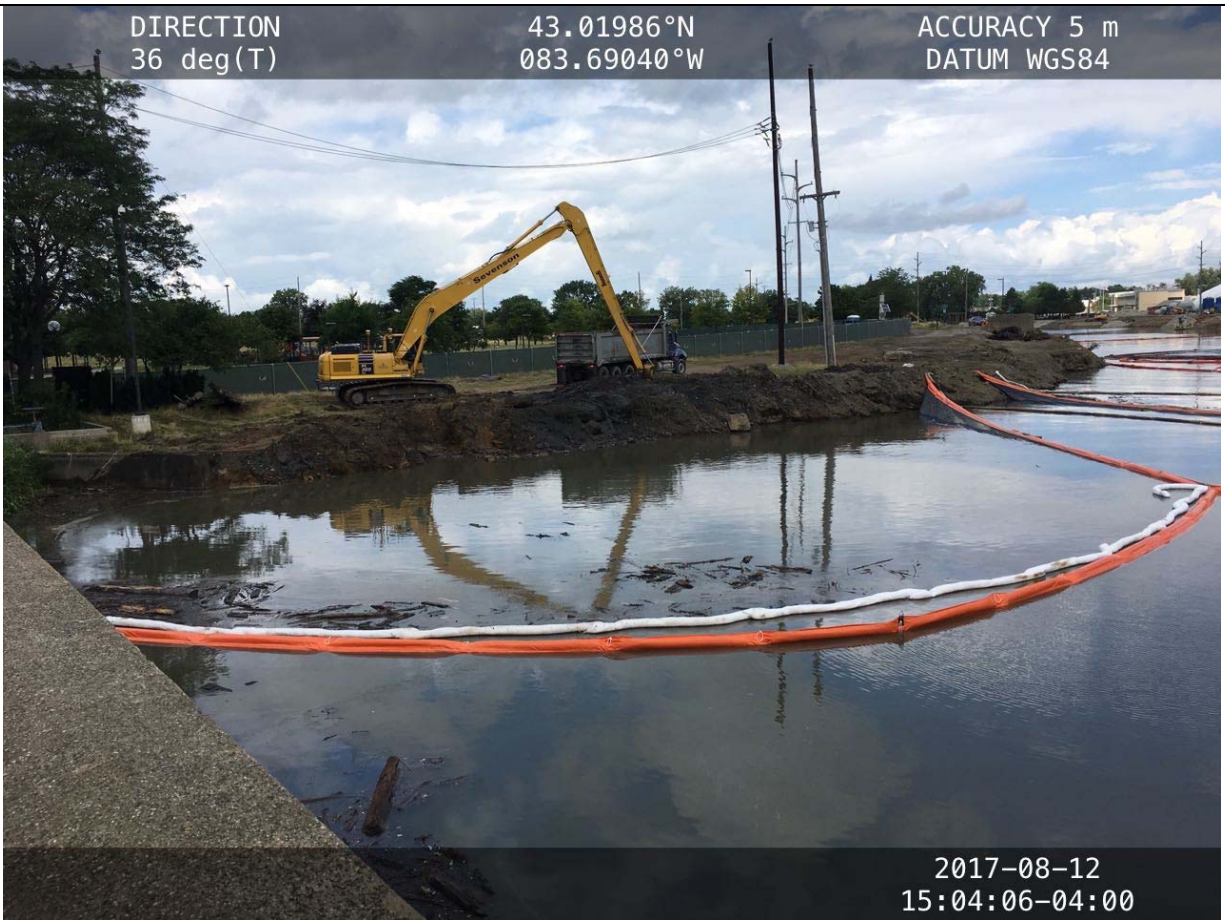
Picture No. 3.

Removing material from the western riverbank in the downstream portion of the Work Area (photo taken facing north).
