PROGRESS UPDATE #6

FLINT EAST BOULEVARD FORMER MGP SITE

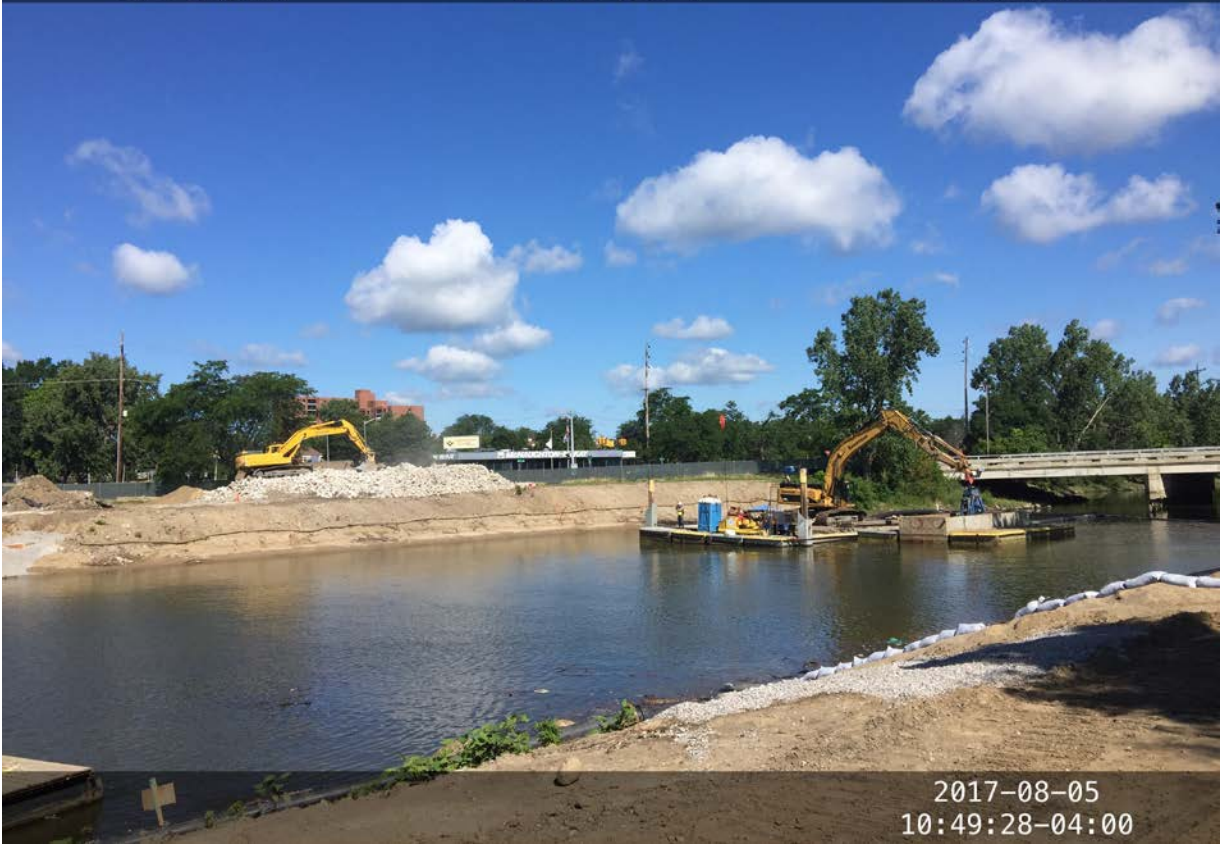
Picture No. 1.

Placing Blended Barrier in the upstream portion of the Work Area (photo taken facing northwest).

- Continued receiving cap materials.
- Continued capping activities including placement of sand from station 7+00 to 10+75 and placement of Blended Barrier in the upstream portion of the Work Area near station 2+50 (see Picture No. 1). See project map for updated Active Cap Area.

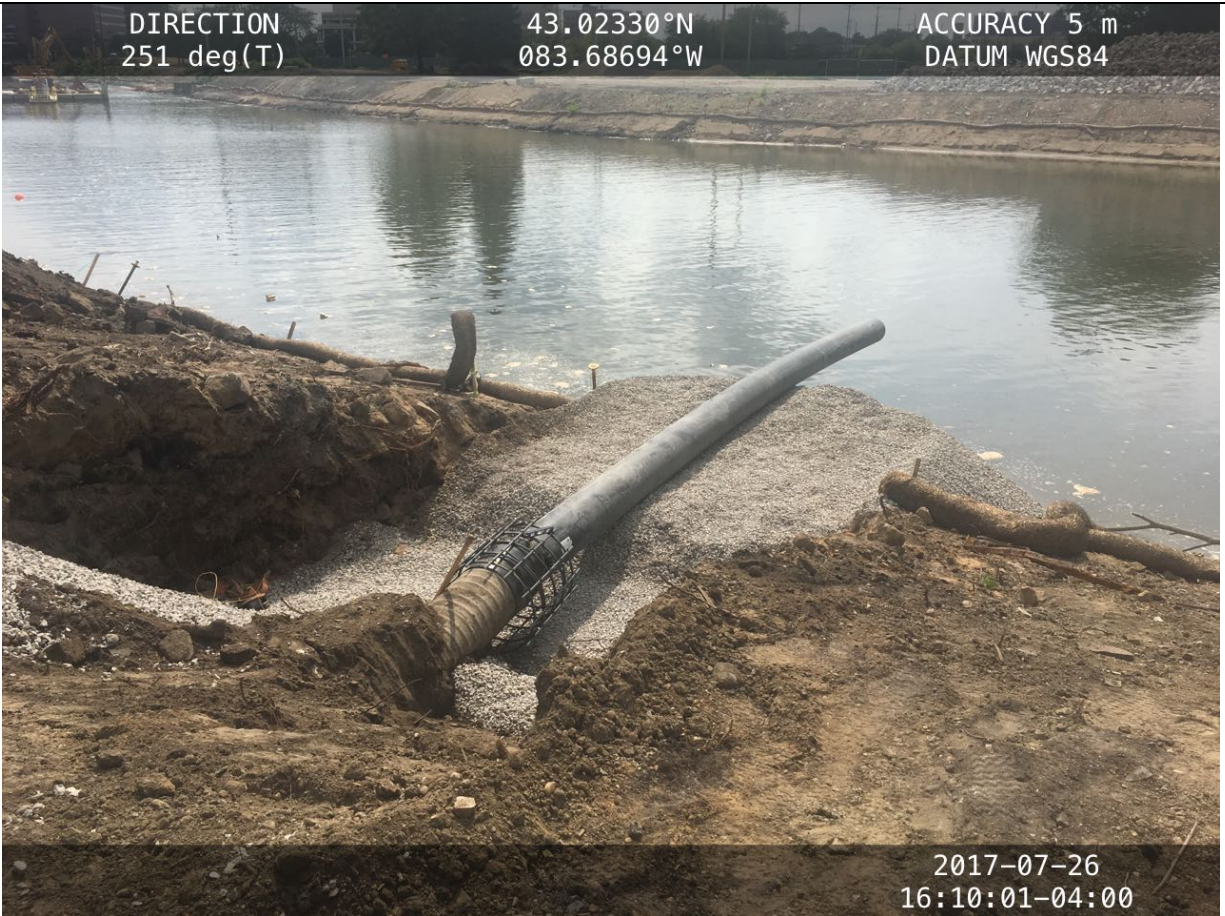
Picture No. 2.

Constructing modifications to a storm sewer outfall in the upstream portion of the Work Area (photo taken facing southwest).

- Began installing a subdrainage system along the eastern riverbank. Portions of the subdrainage system have been installed from station 2+75 to 5+25.
- Began making modifications to existing storm sewer outfalls in the Work Area (see Picture No. 2).

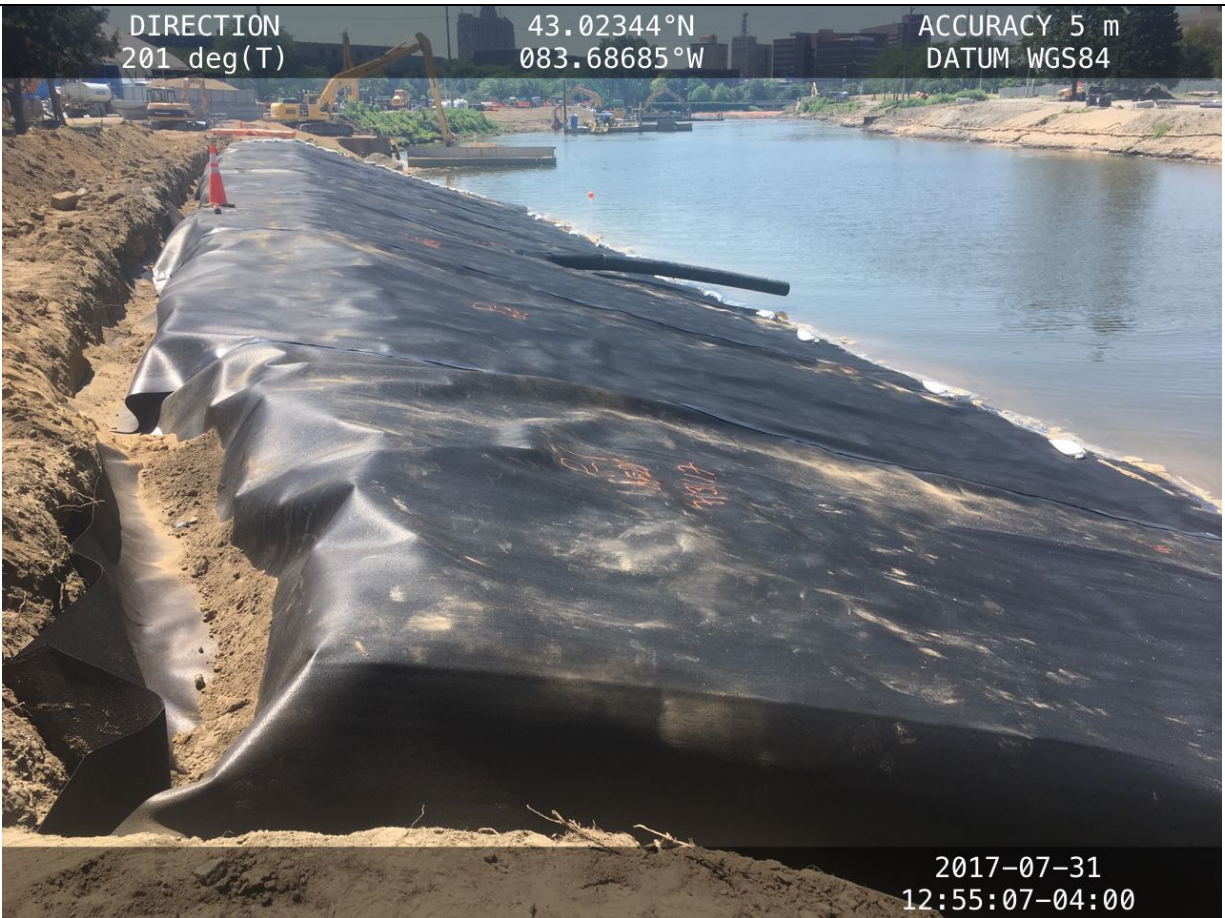
Picture No. 3.

Installing the geomembrane liner in the upstream portion of the Work Area (photo taken facing southwest).

- Began installing a geomembrane liner along the eastern riverbank. The geomembrane liner has been installed from station 2+50 to 4+25 (see Picture No. 3).

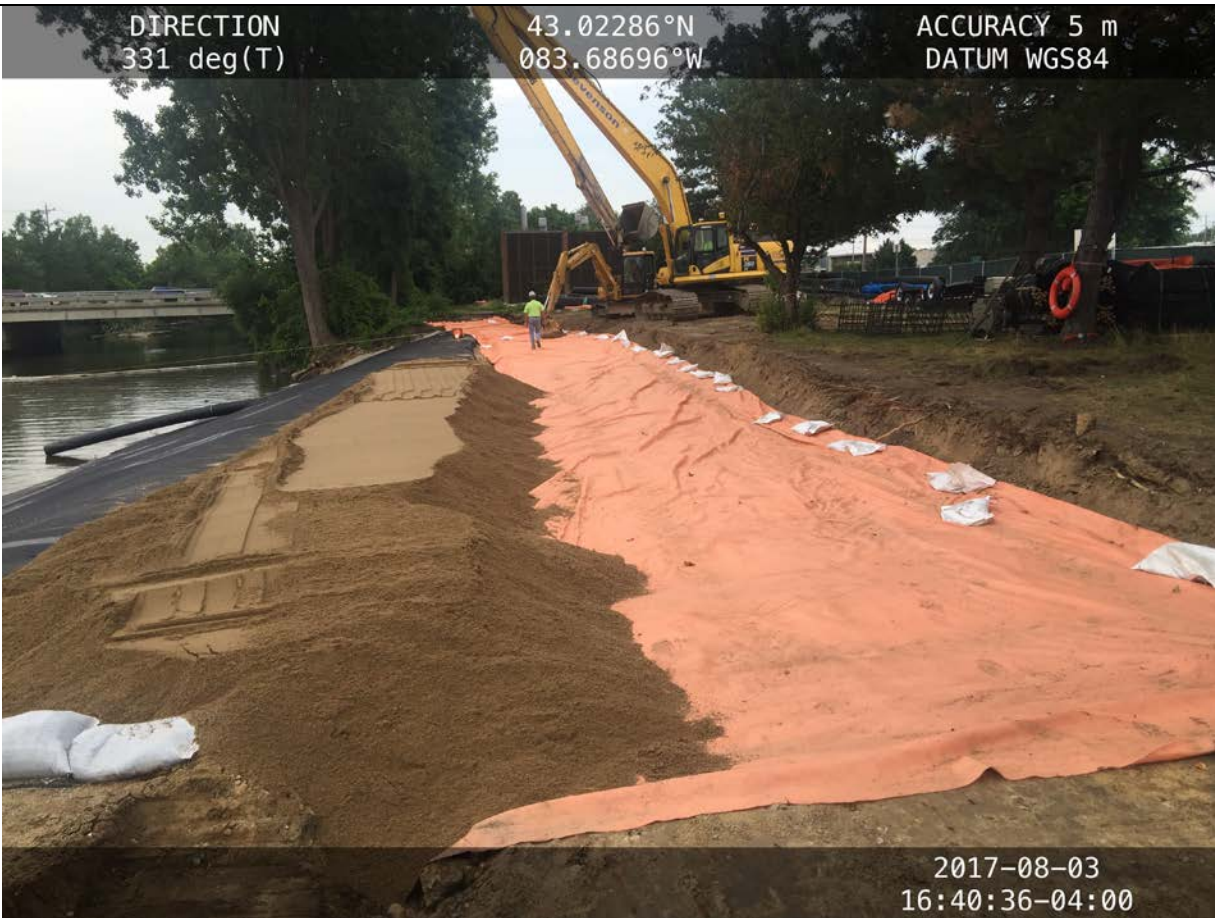
Picture No. 4.

Installation of a demarcation fabric along the eastern riverbank in the upstream portion of the Work Area (photo taken facing north).

- Began installing a demarcation fabric in the upstream portion of the Work Area along the eastern riverbank. The demarcation fabric has been installed from station 2+75 to 4+25 (see Picture No. 4).
