Work completed between 10/1/2017 and 10/14/2017 includes the following:

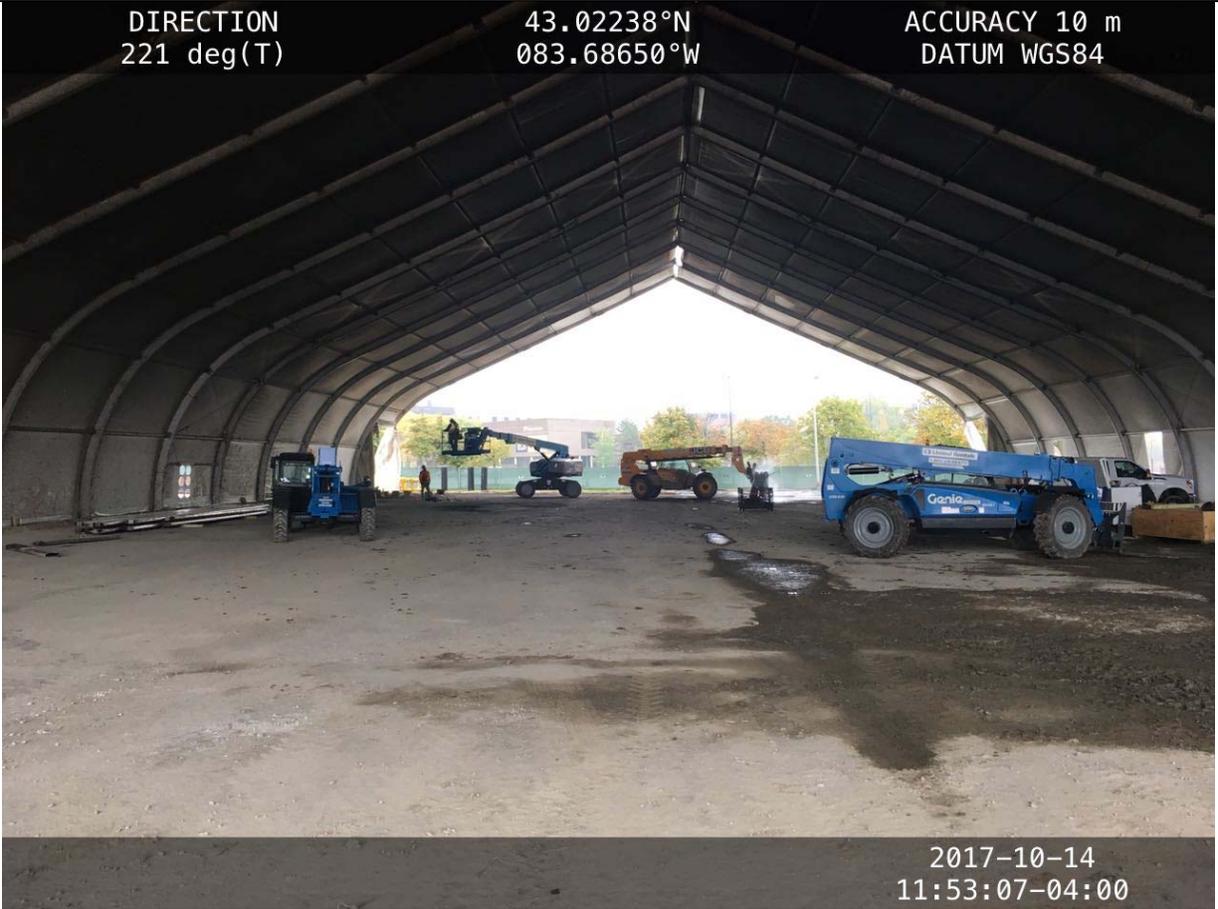
Picture No. 1.

Progress deconstructing the material handling structure (photo taken facing southwest).

- Continued decontaminating the inside of the material handling structure.
- Began deconstructing the material handling structure (see Picture No. 1).
- Continued collecting construction monitoring data including air, odor and construction noise monitoring; turbidity monitoring; and, structural monitoring.

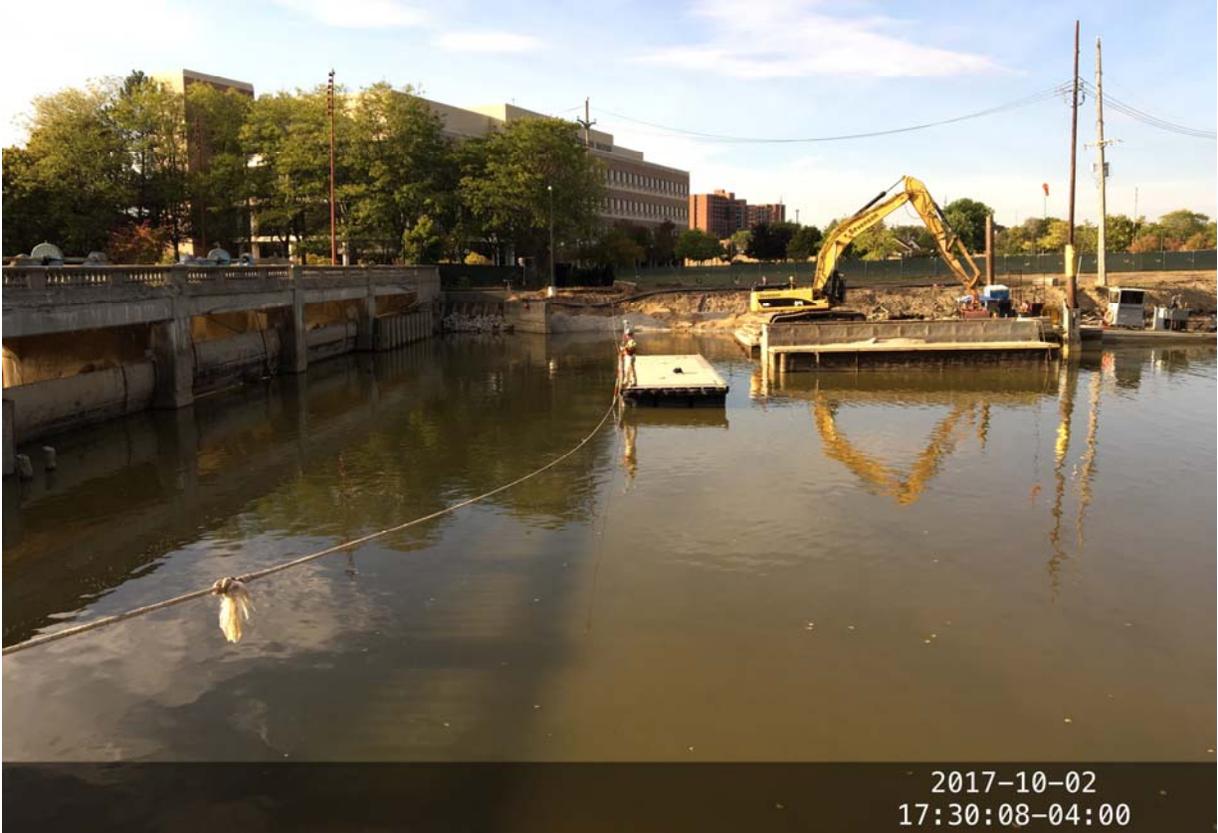
Picture No. 2.

Completing verification survey near the Hamilton Dam (photo taken facing northwest).

- Continued surveying activities to verify that capping layers have been placed to the design thicknesses (see Picture No. 2).
- Continued installing instrumentation to monitor the cap after construction (see Picture No. 3).

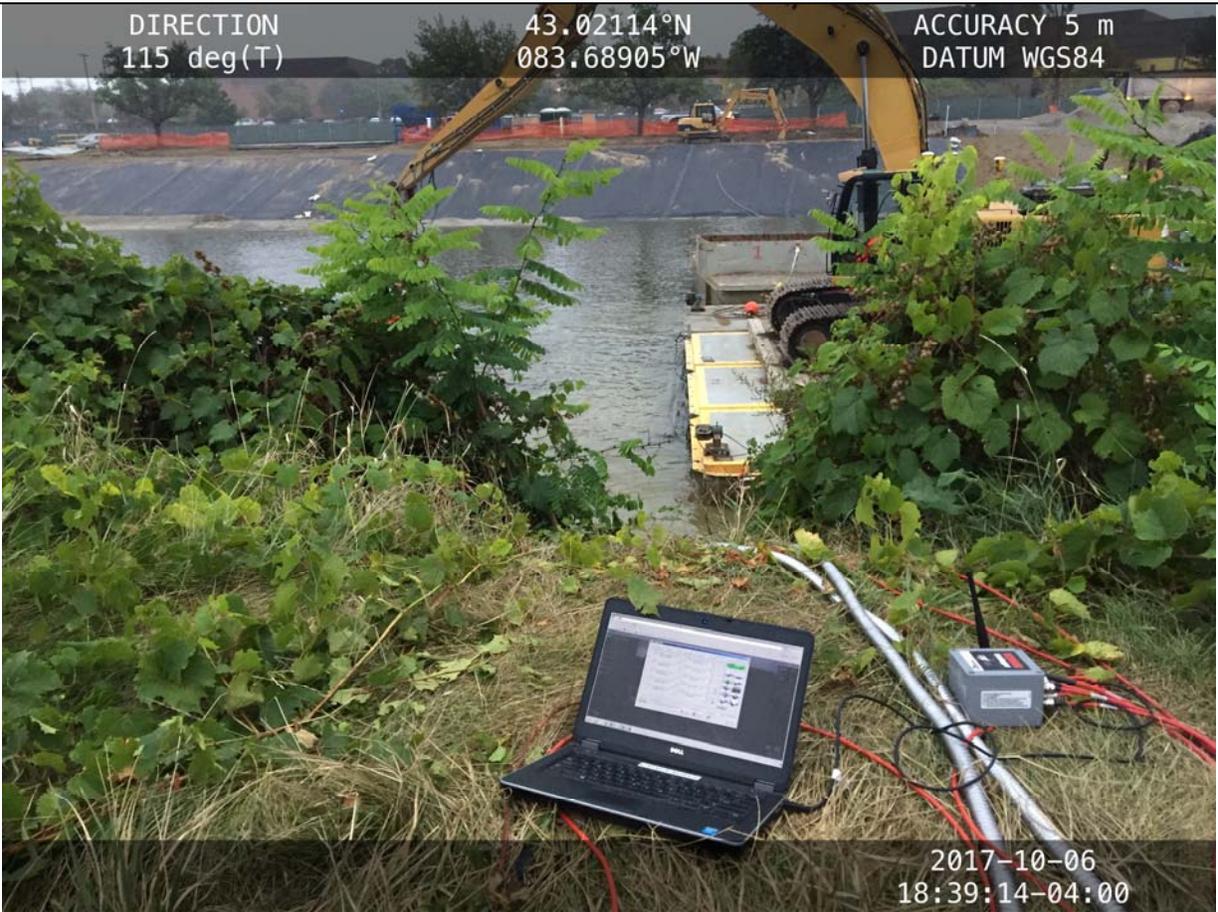
Picture No. 3.

Monitoring instrumentation installed in the river (photo taken facing southeast).

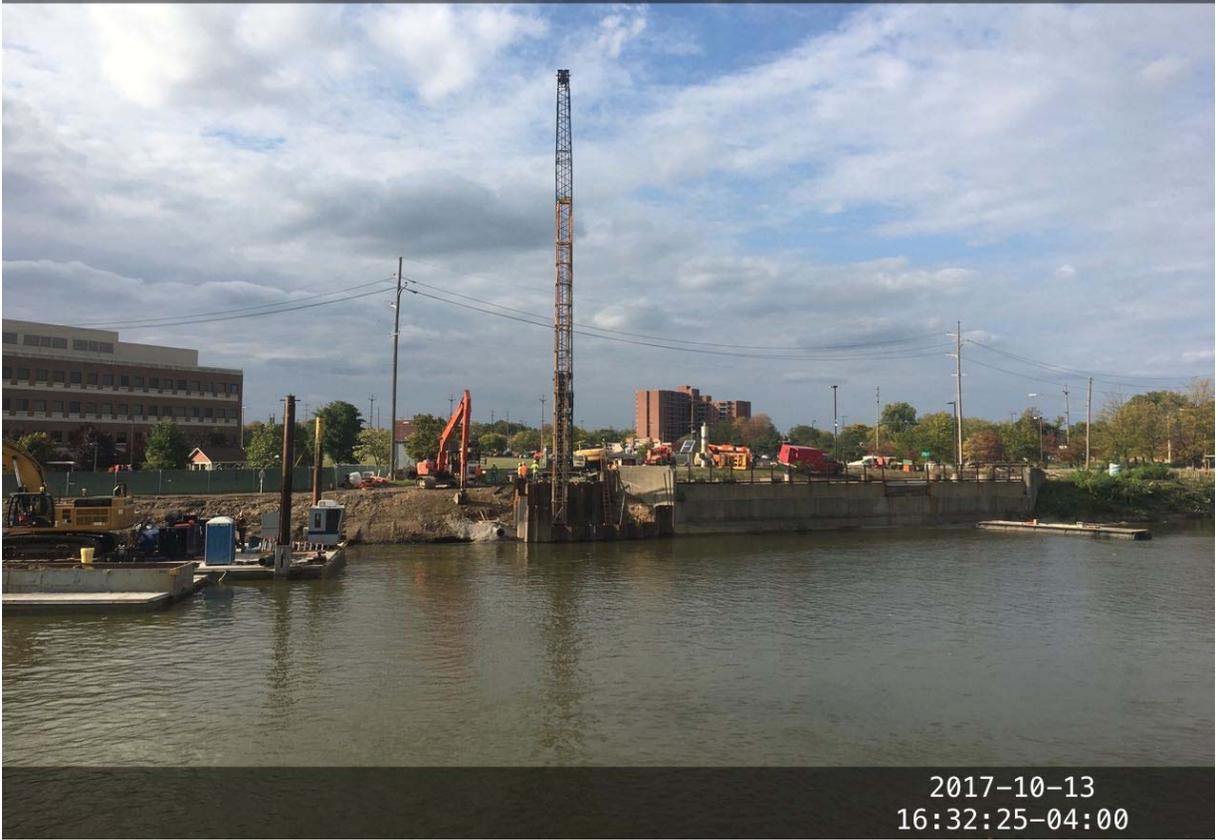
Picture No. 4.

Installing continuous flight auger pile on western riverbank (photo taken facing north).

- Continued mixing AquaBlok and gravel for Blended Barrier.
- Installed additional sections of the subdrainage system pipe along the eastern riverbank.
- Began constructing a new Pedestrian Bridge including installation of sheet piling and continuous flight auger piles on the western and eastern riverbanks (see Picture No. 4).
