Work completed between 8/20/2017 and 9/1/2017 includes the following:

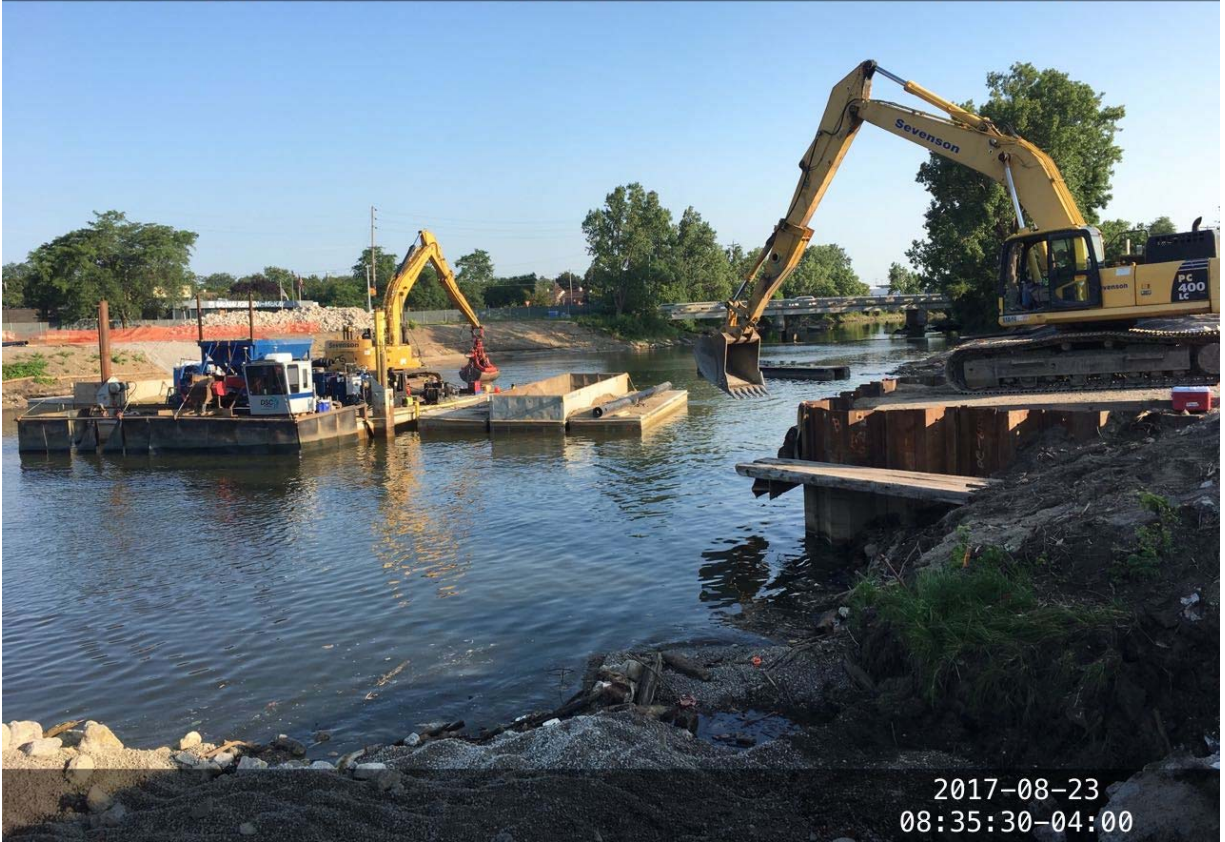
Picture No. 1.

- Continued capping activities including placement of: sand base layer from station 5+75 to 6+75 and 7+50 to 12+50 along the eastern riverbank; Blended Barrier from station 3+75 to 6+50; sand on top of Blended Barrier from station 3+50 to 6+25; and, gravel from station 2+40 to 6+00 (see Picture No. 1).

Placing cap material in the upstream portion of the Work Area (photo taken facing north).

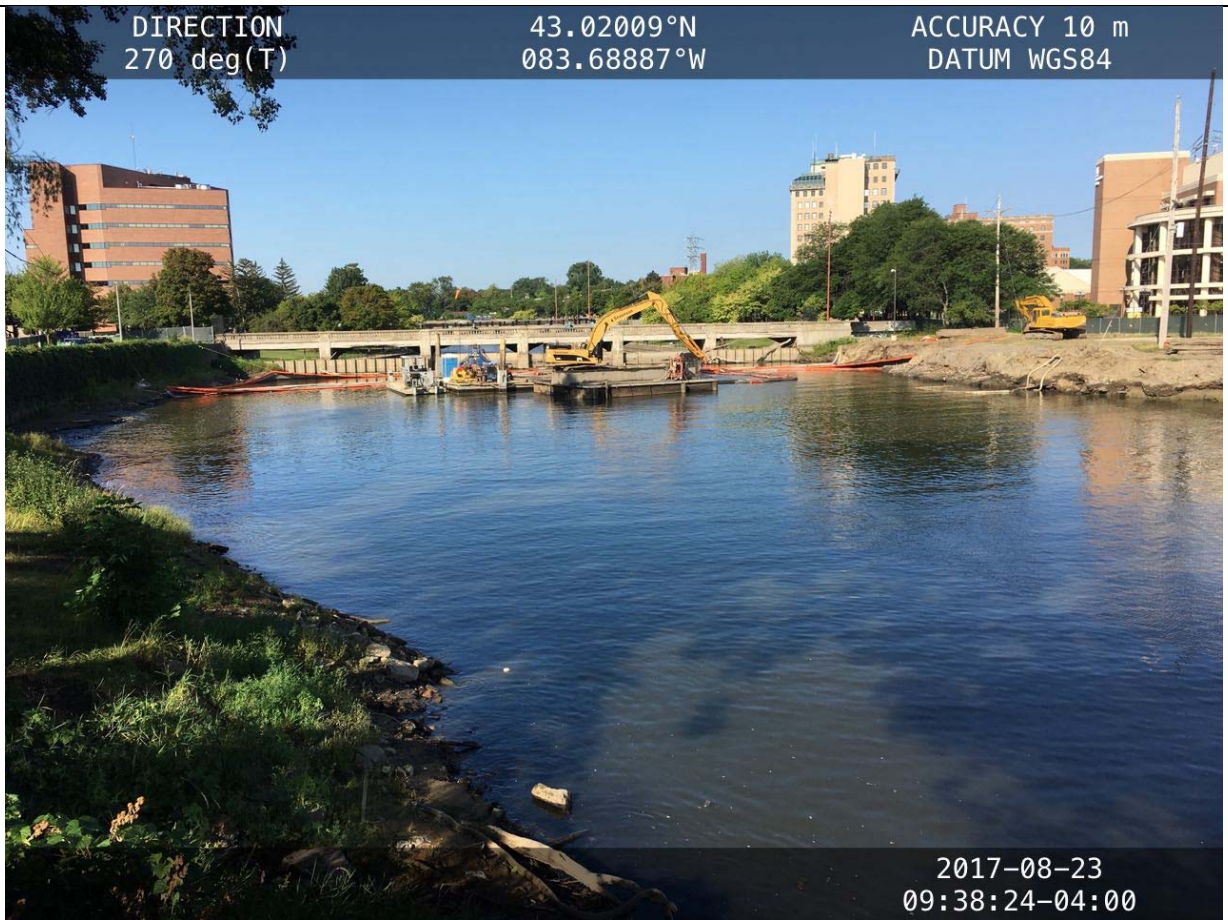
Picture No. 2.

- Continued dredging activities within the river channel and along the riverbanks. Dredging has occurred from station 2+00 to 18+60 within the river channel, station 2+25 to 19+00 along the western riverbank, and station 2+25 to 14+00 along the eastern riverbank (see Picture No. 2).

Dredging in the downstream portion of the Work Area near the Hamilton Dam (photo taken facing west).

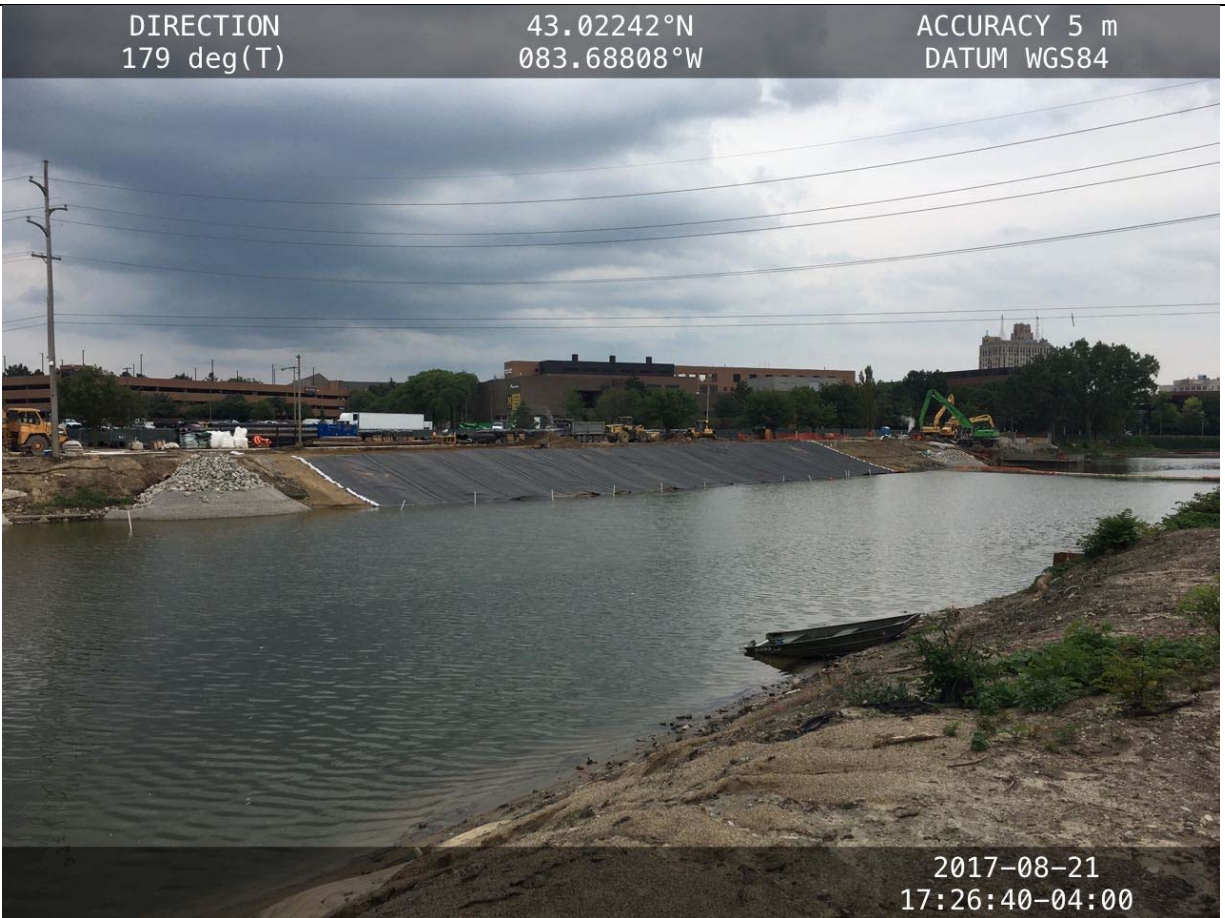
Picture No. 3.

- Continued mixing AquaBlok and gravel for Blended Barrier.
- Continued installation of the geomembrane liner. Sections of geomembrane liner were installed from station 4+00 to 5+25, 5+75 to 6+75, and 7+50 to 11+50 (see Picture No. 3).

Section of geomembrane liner installed from station 7+50 to 11+50 (photo taken facing south).

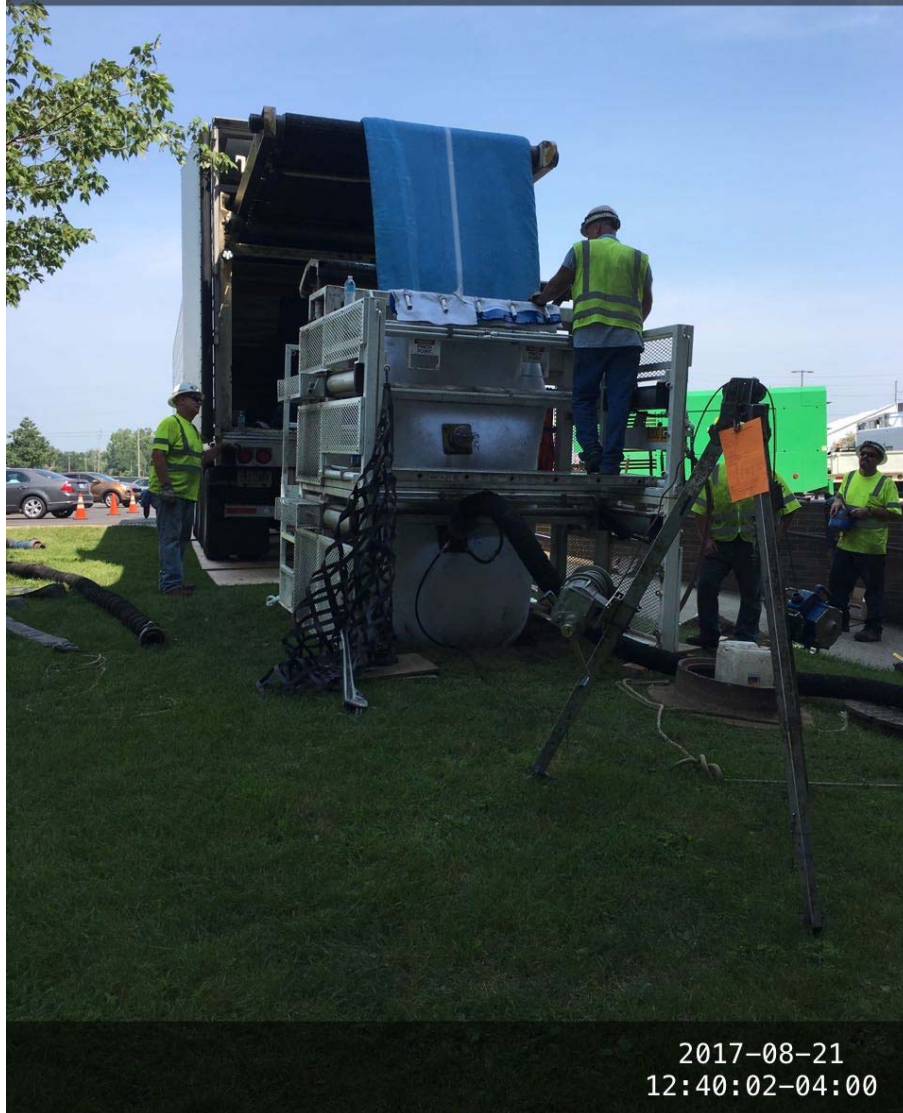
Picture No. 4.

- Installed a cast in place pipe liner in a section of storm sewer within the Work Area (see Picture No. 4).

Installing cast in place pipe liner (photo taken facing north).
