Work completed between 9/2/2017 and 9/15/2017 includes the following:

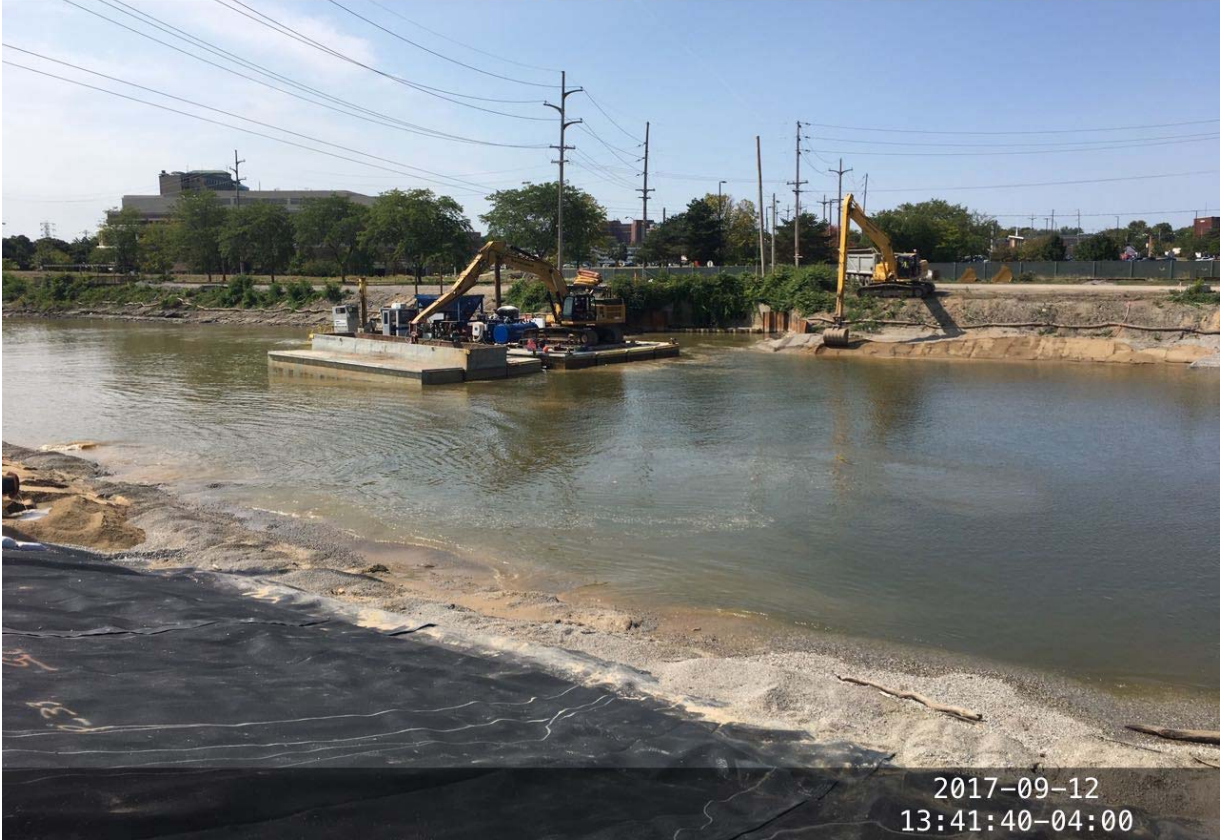
Picture No. 1.

- Continued capping activities including placement of: sand base layer from station 11+00 to 12+25; Blended Barrier from station 6+50 to 9+00; sand on top of Blended Barrier from station 6+25 to 8+75; gravel from station 6+00 to 8+50; and, rip rap in the storm sewer channel at station 8+00 (see Picture No. 1).

Placing cap materials from the river and western riverbank (photo taken facing west).

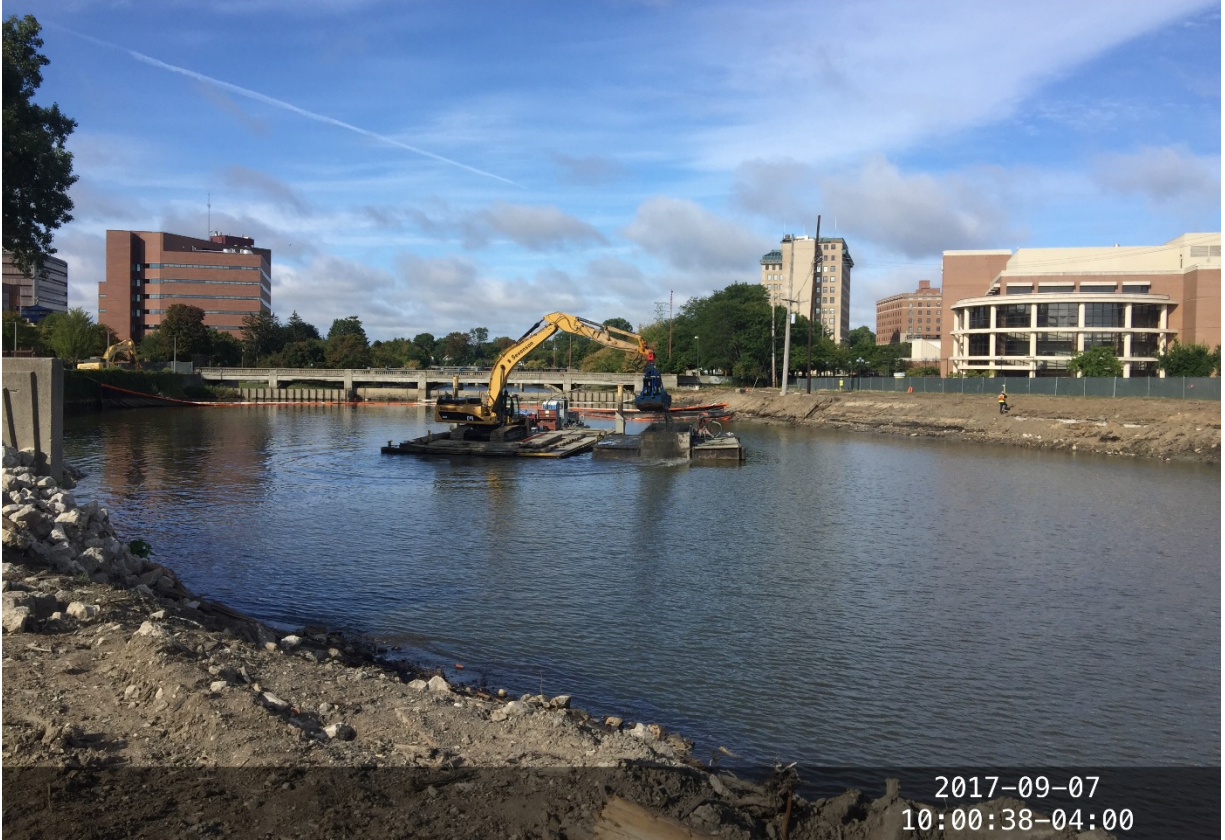
Picture No. 2.

- Continued dredging activities within the river channel and along the riverbanks. Dredging work completed from September 2 to September 15 included completing a cleanup dredging pass between station 14+50 and 18+60 and removal of soft sediments between station 11+00 and 11+60. Dredging has occurred from station 2+00 to 18+60 within the river channel, station 2+25 to 19+00 along the western riverbank, and station 2+25 to 14+00 along the eastern riverbank (see Picture No. 2).

Performing a cleanup dredging pass in the downstream portion of the Work Area
(photo taken facing southwest).

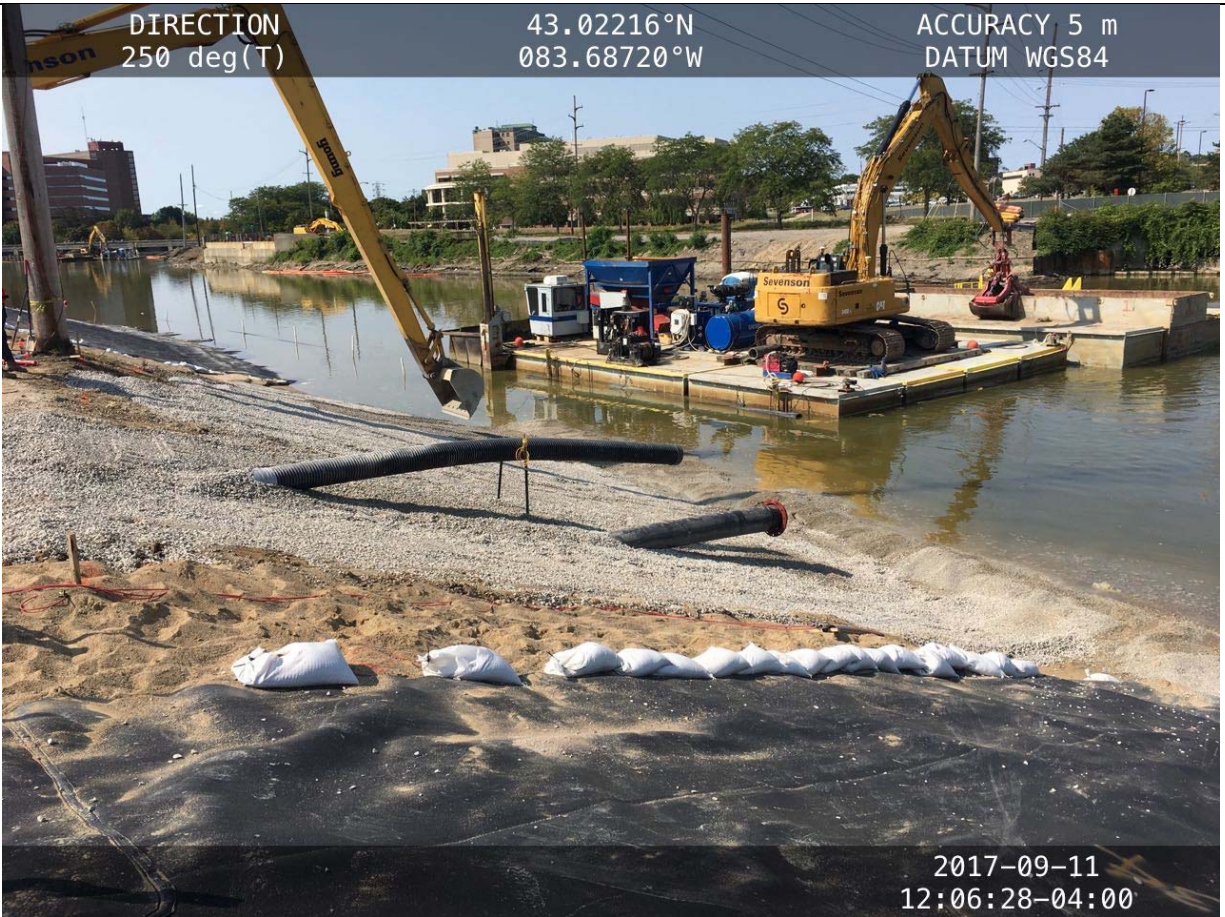
Picture No. 3.

- Continued installing instrumentation to monitor the cap after construction.
- Continued modifications to existing storm sewer outfalls in the Work Area (see Picture No. 3).

Making modifications to existing storm sewer outfalls (photo taken facing southwest).
