PROGRESS UPDATE #10

FLINT EAST BOULEVARD FORMER MGP SITE

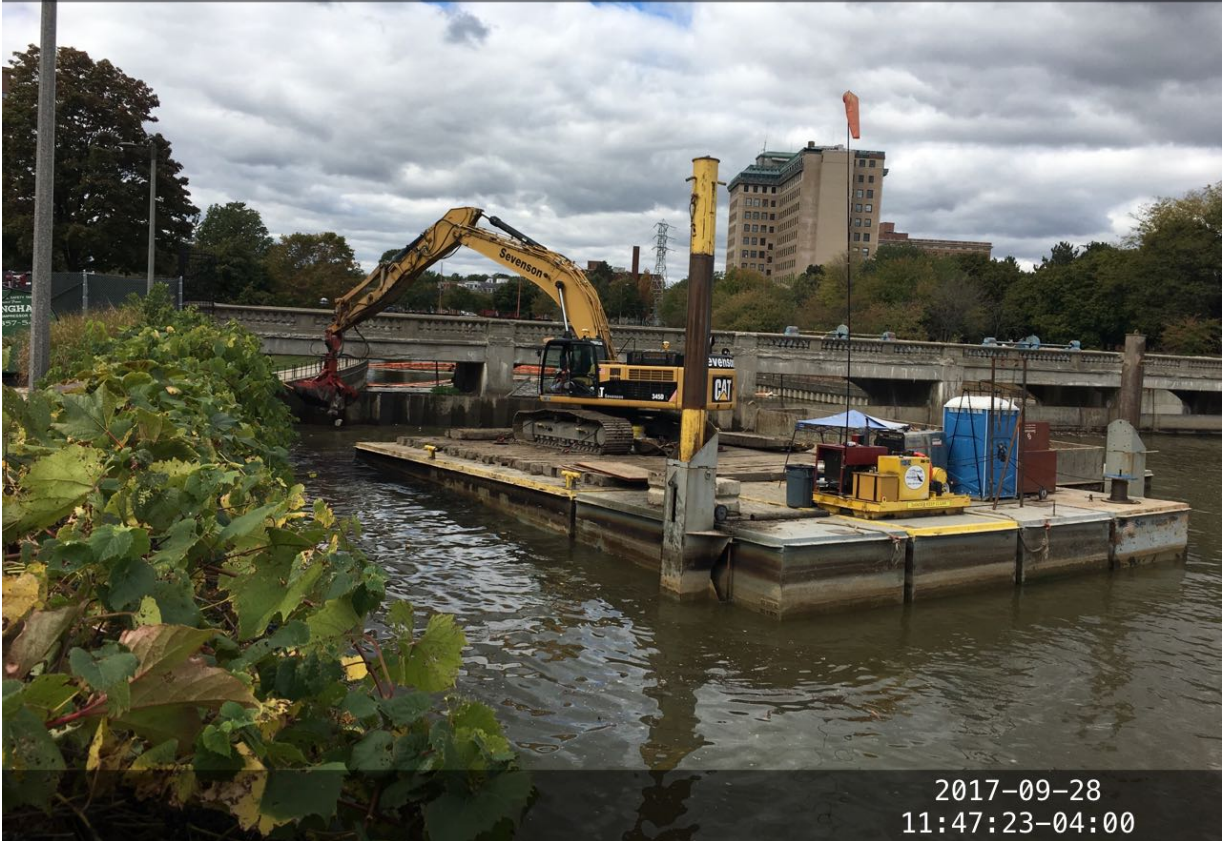
Picture No. 1.

- Continued capping activities including placement of: sand base layer from station 12+25 to the Hamilton Dam; Blended Barrier from station 9+00 to 11+25 and from 18+25 to the Hamilton Dam; sand on top of Blended Barrier from station 8+75 to 11+00 and from 18+50 to the Hamilton Dam; gravel from station 8+50 to 10+75; and, rip rap adjacent to the Hamilton Dam (see Picture No. 1).

Placing cap materials adjacent to the Hamilton Dam (photo taken facing southwest).

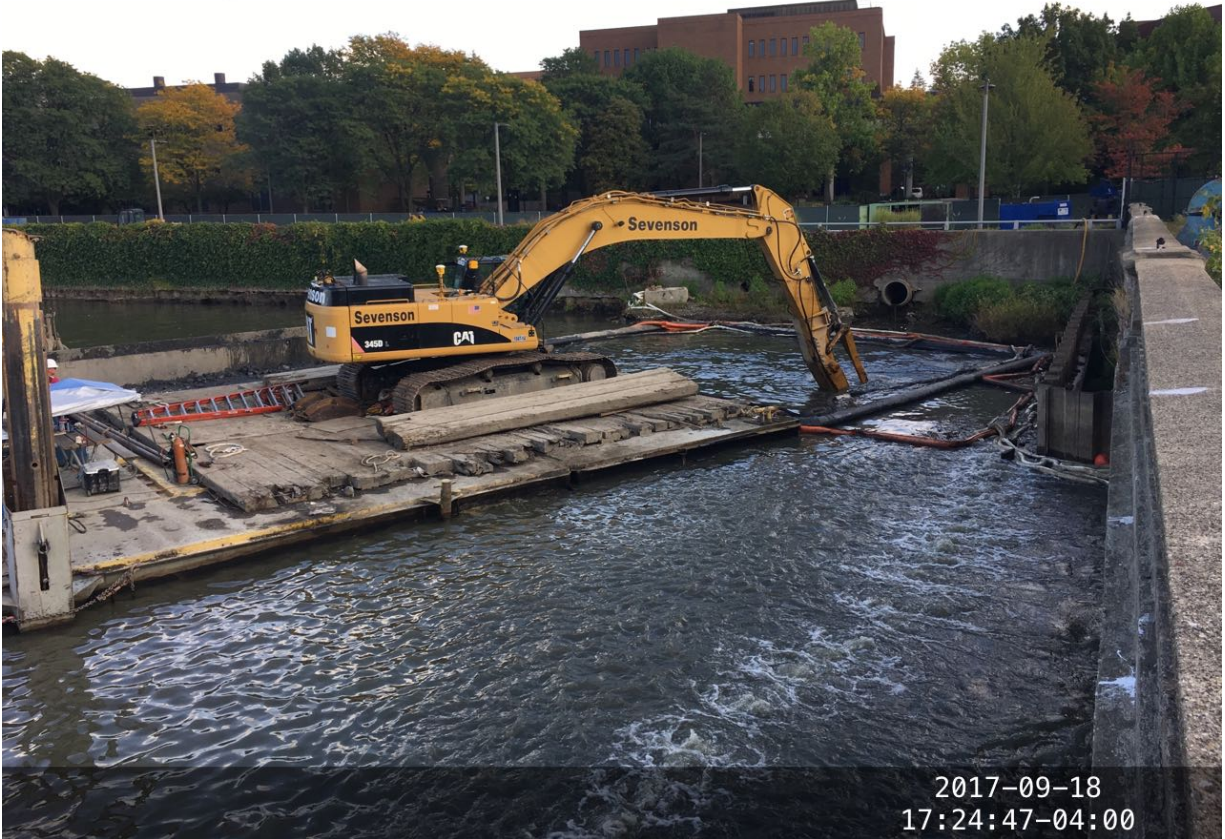
Picture No. 2.

- Completed dredging activities within the river channel and along the riverbanks. Dredging work completed after removing sediments from station 18+60 to the Hamilton Dam (see Picture No. 2).

Dredging adjacent to the Hamilton Dam (photo taken facing southeast).

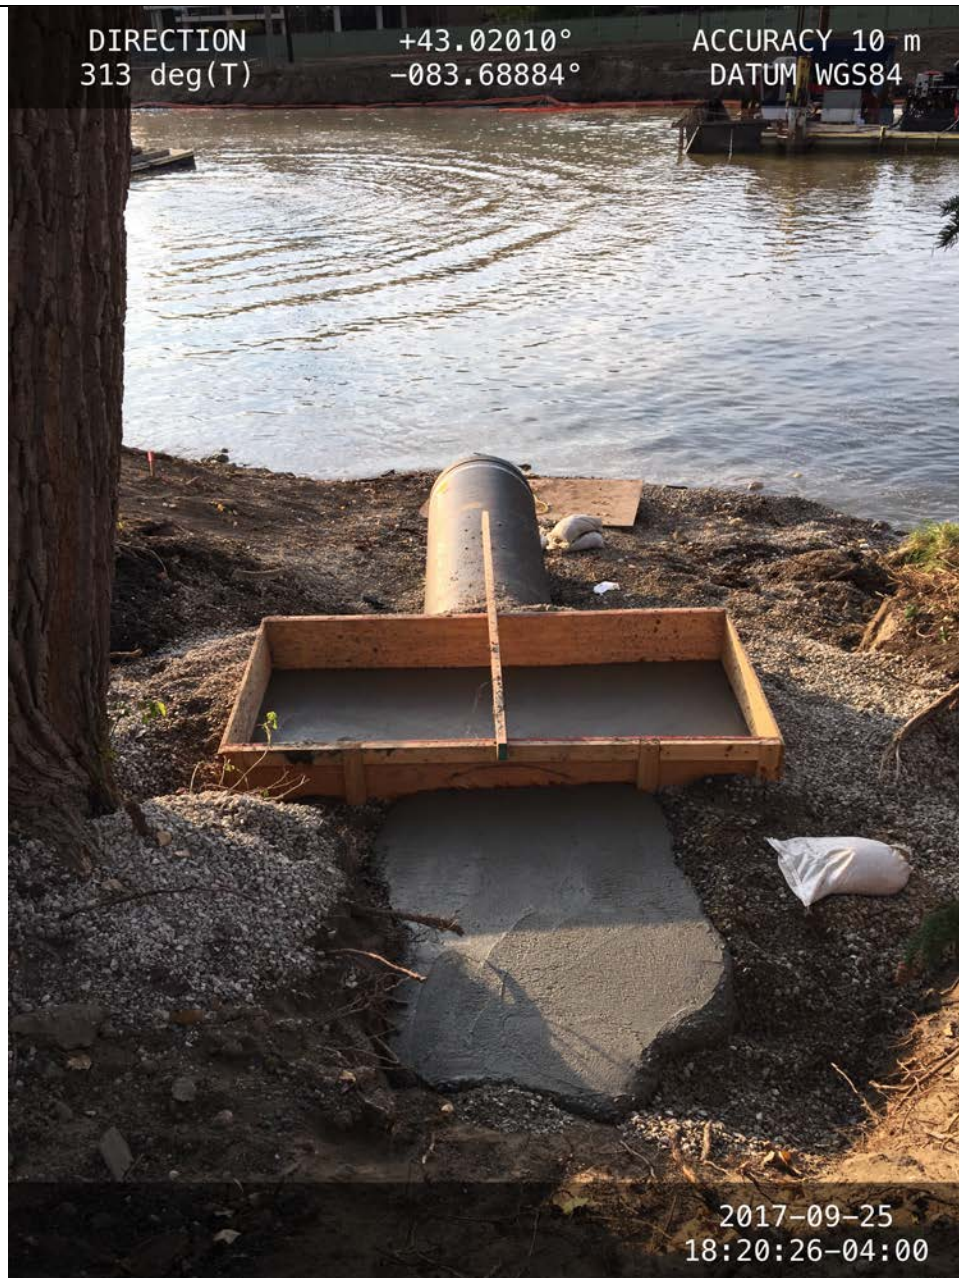
Picture No. 3.

- Continued installing instrumentation to monitor the cap after construction.
- Continued modifications to existing storm sewer outfalls in the Work Area (see Picture No. 3).

Extension of existing storm sewer outfall (photo taken facing northwest).

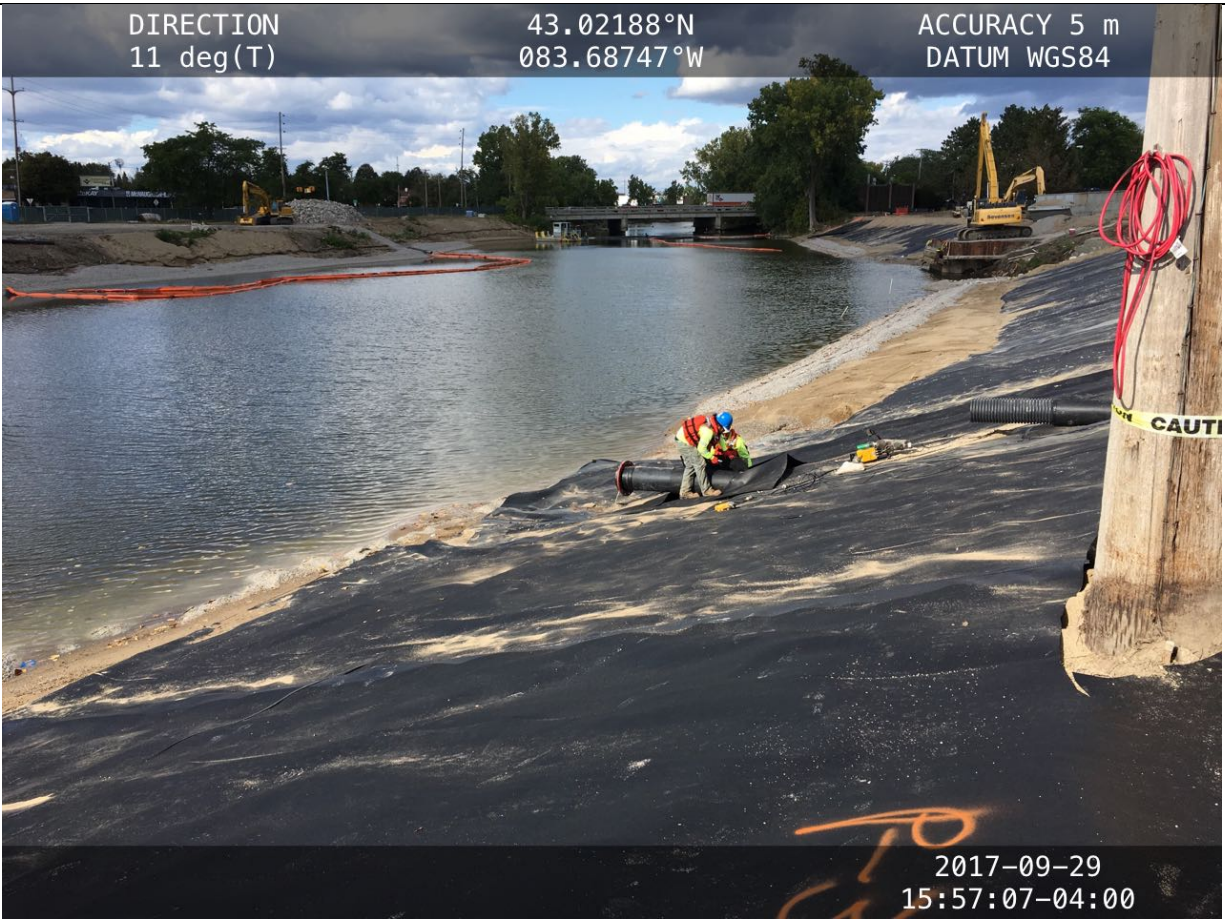
Picture No. 4.

- Continued mixing AquaBlok and gravel for Blended Barrier.
- Installed additional sections of geomembrane liner along the eastern riverbank (see Picture No. 4).

Installing sections of geomembrane liner around outfall extensions (photo taken facing north).
