Consumers Energy Memorandum

Subject: JH Campbell Unit 3 Bottom Ash Pond North/South
40 CFR 257.102(c) Closure by Removal Certification

This technical memorandum has been prepared to document the closure activities at the JHC U3 BAP and provide certification from a qualified professional engineer that closure of the surface impoundment has been successfully completed, per §257.102(f)(3).

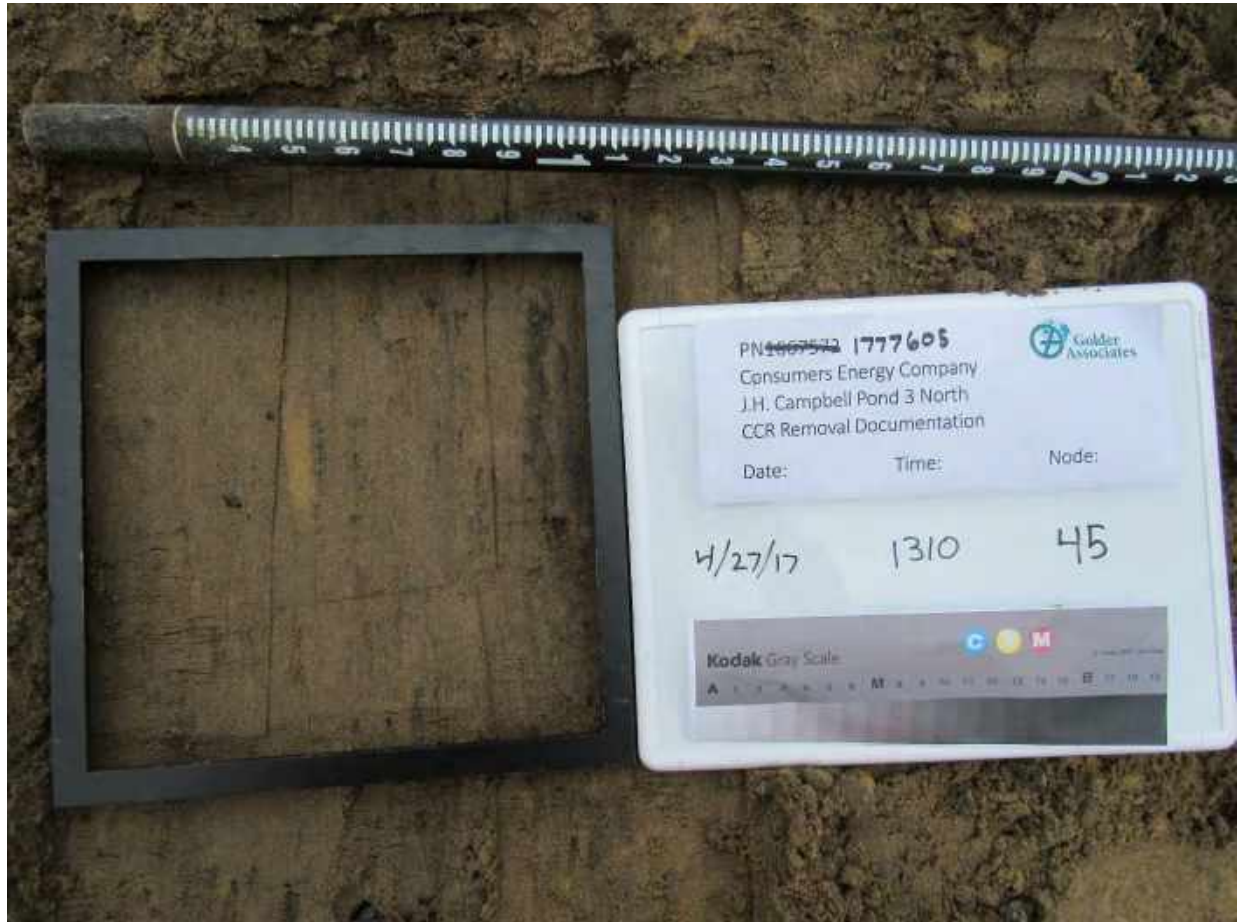
Photo 11 of 51

Node Number: 45

Notes: Dark brown to gray sand with clay, trace organics similar to material observed in Test Pits 3077 and 3078 (See Table 4).

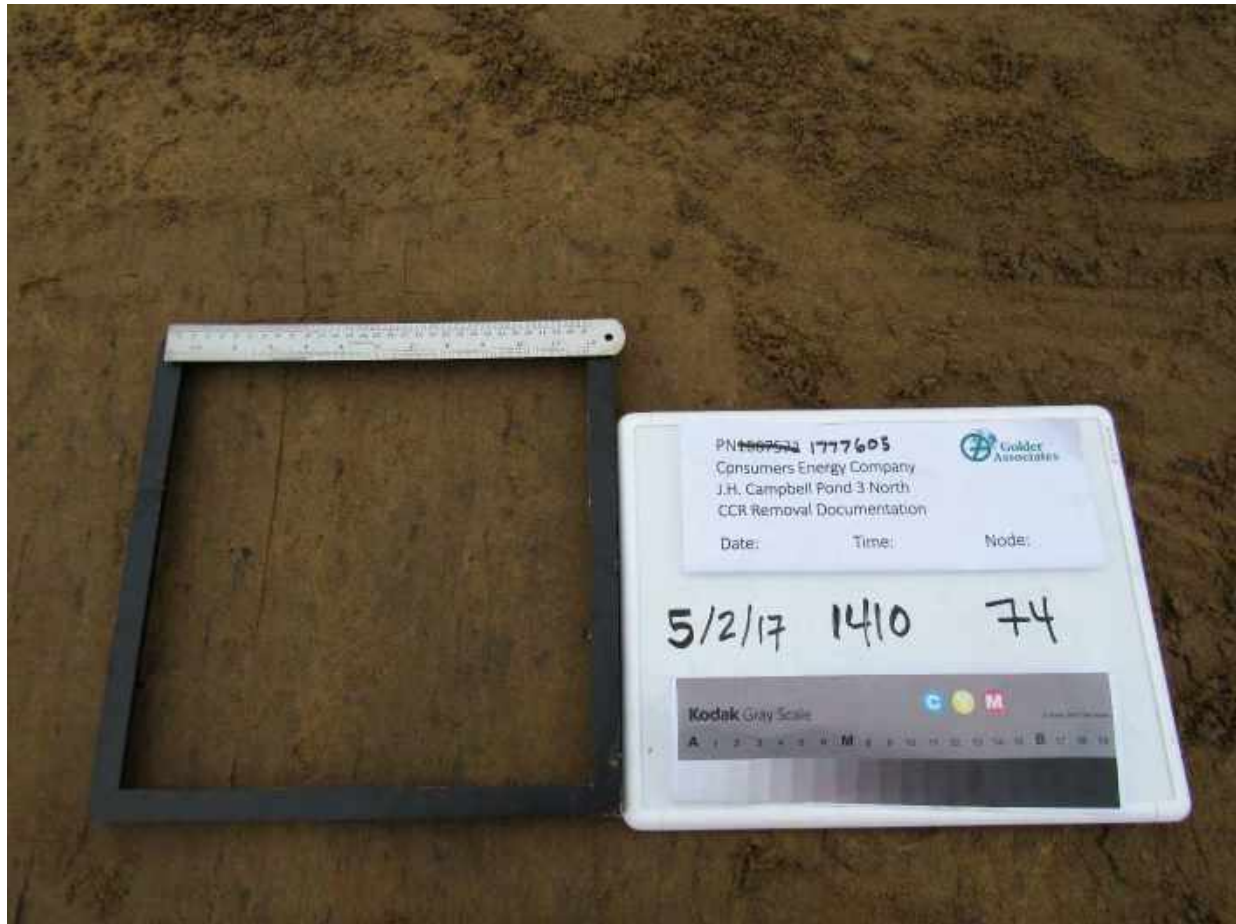
Photo 18 of 51

Node Number: 74

Notes: Dark brown sand, trace black silt similar to material found in Test Pit 3076 (See Table 4)

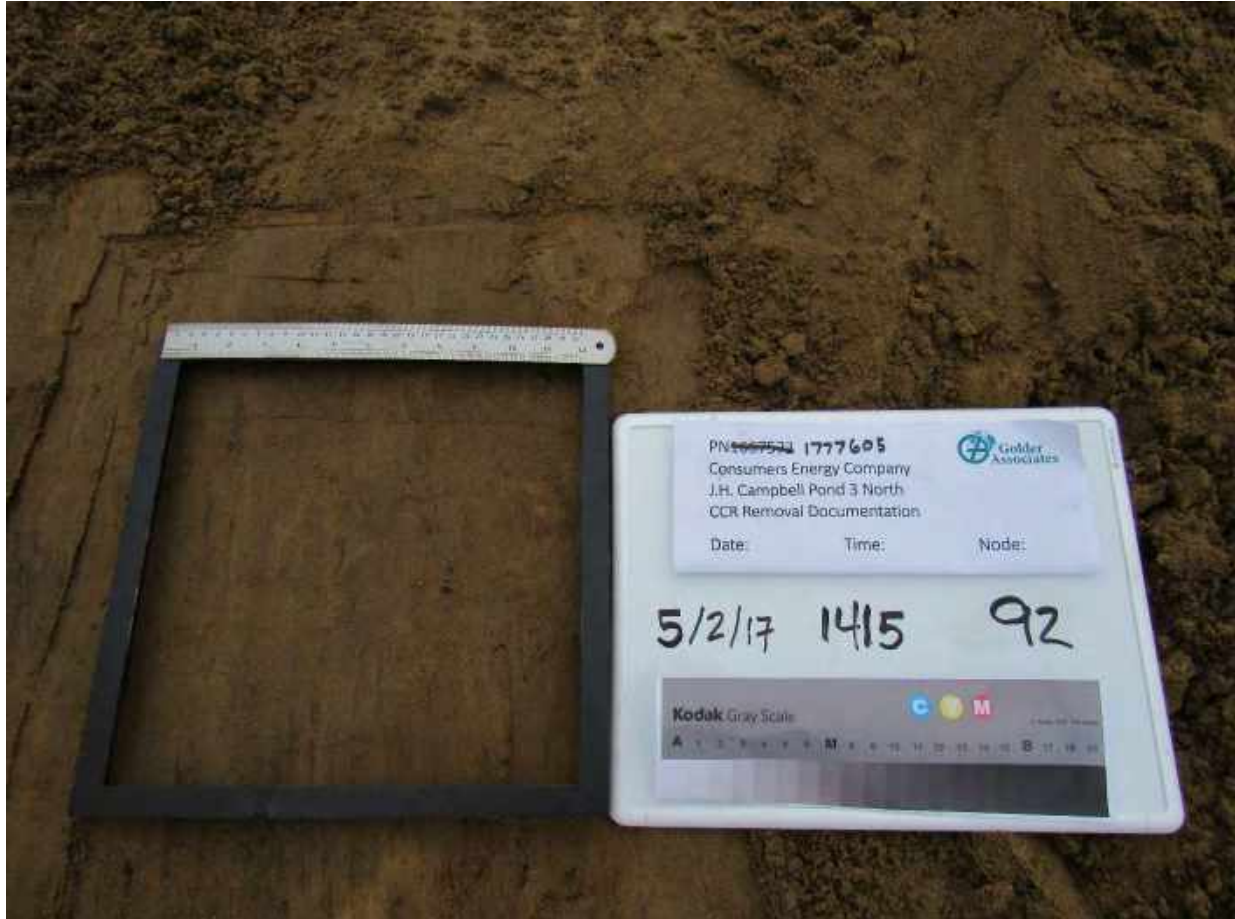
Photo 24 of 51

Node Number: 92**Location:** North 500, East 2300**Colorimeter Result:** N/A**Notes:** Dark brown sand, trace black silt similar to material identified in Test Pit 3076 (See Table 4).

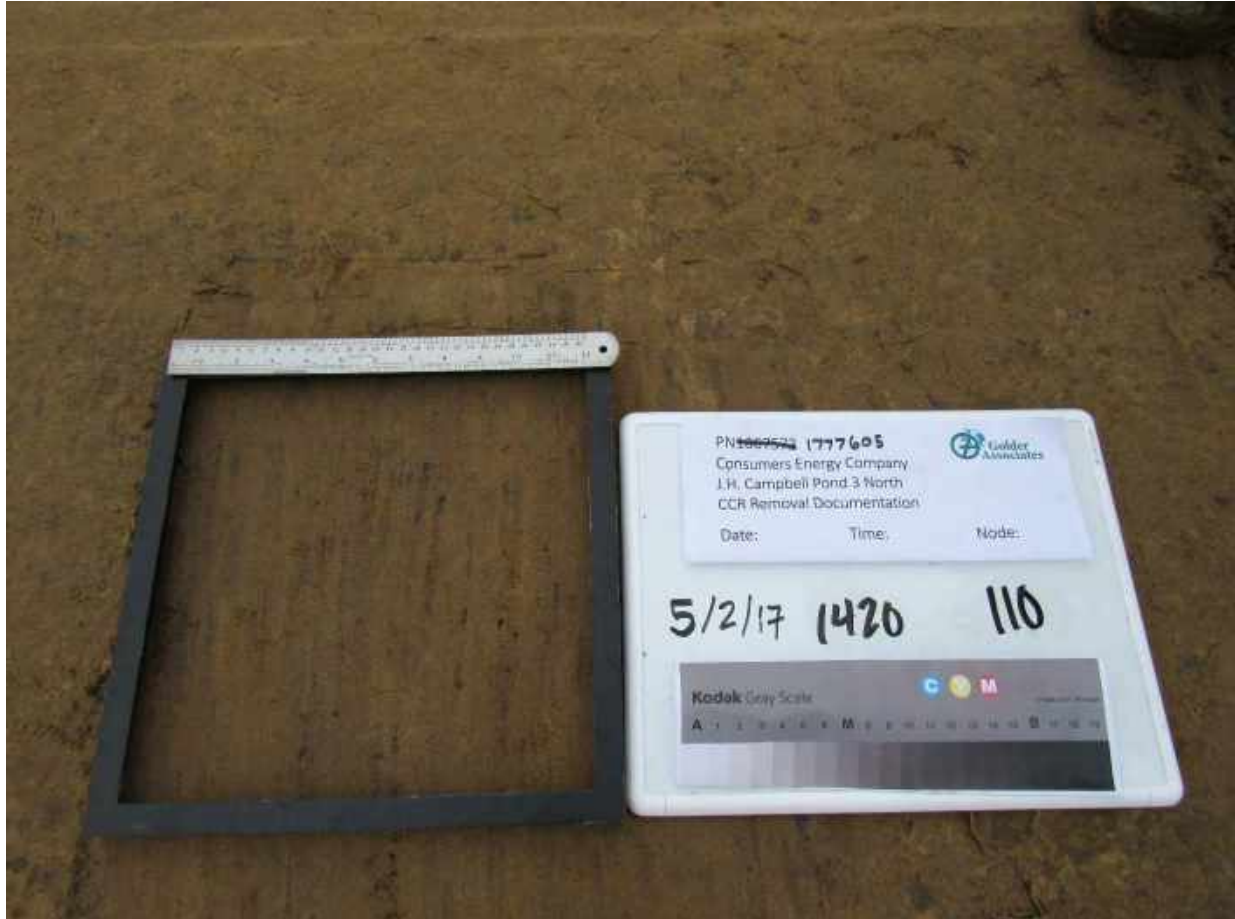
Photo 28 of 51

Node Number: 110

Notes: Dark brown sand, trace black silt similar to material found in Test Pit 3076 (See Table 4)

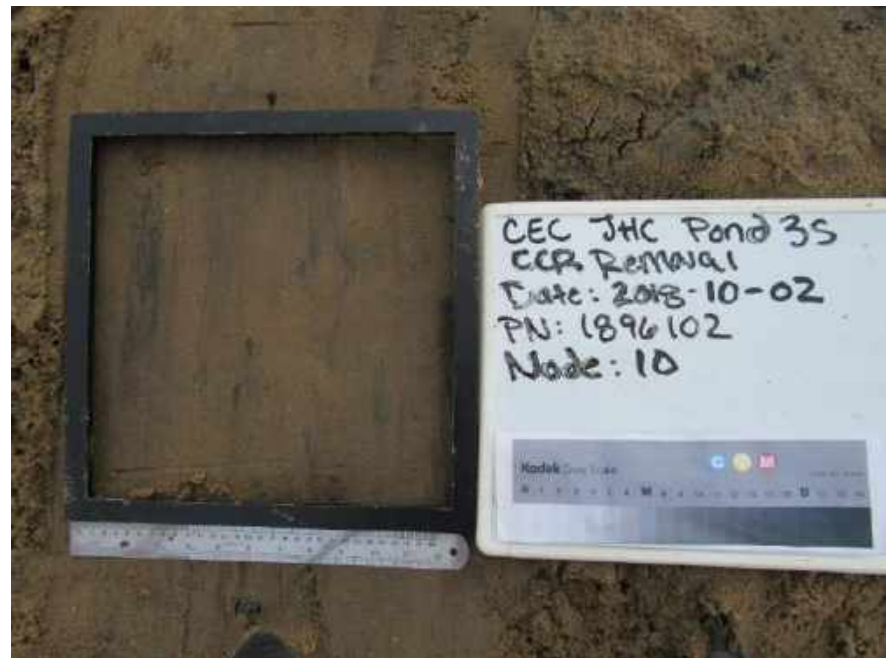
PHOTO 5

Node Number: 10
Location: North 0, East 2100
Colorimeter Result: N/A
Microscopy Result: N/A
Note: Node location near layer of dark brown silty sand and black organics, as sampled and analyzed in the test pit locations.

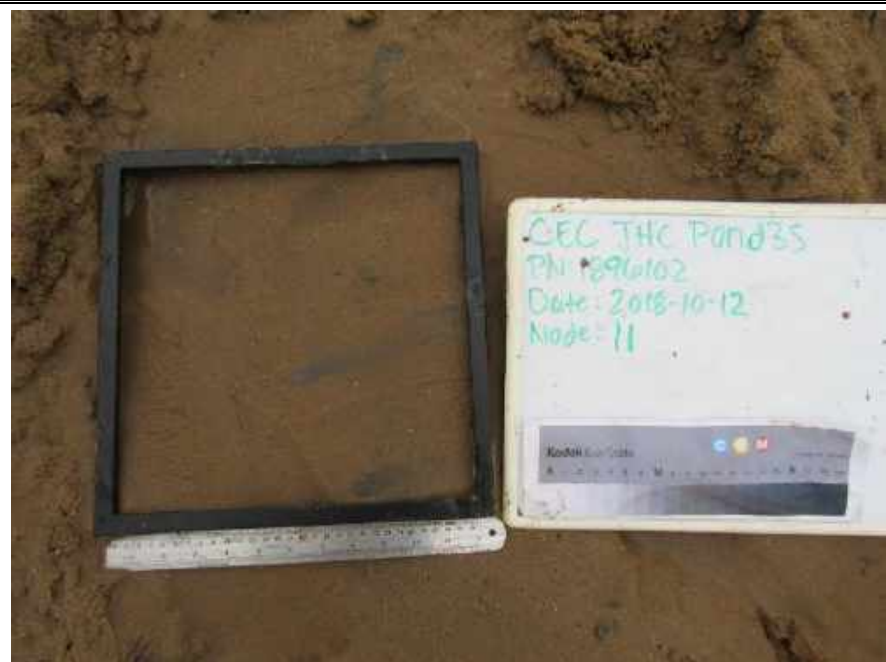
PHOTO 6

Node Number: 11
Location: North 50, East 2100
Colorimeter Result: 6.84 percent CCR
Microscopy Result: 3 percent CCR
Note: Residue occurs mainly as very fine, dark spheres of corroding magnetite.

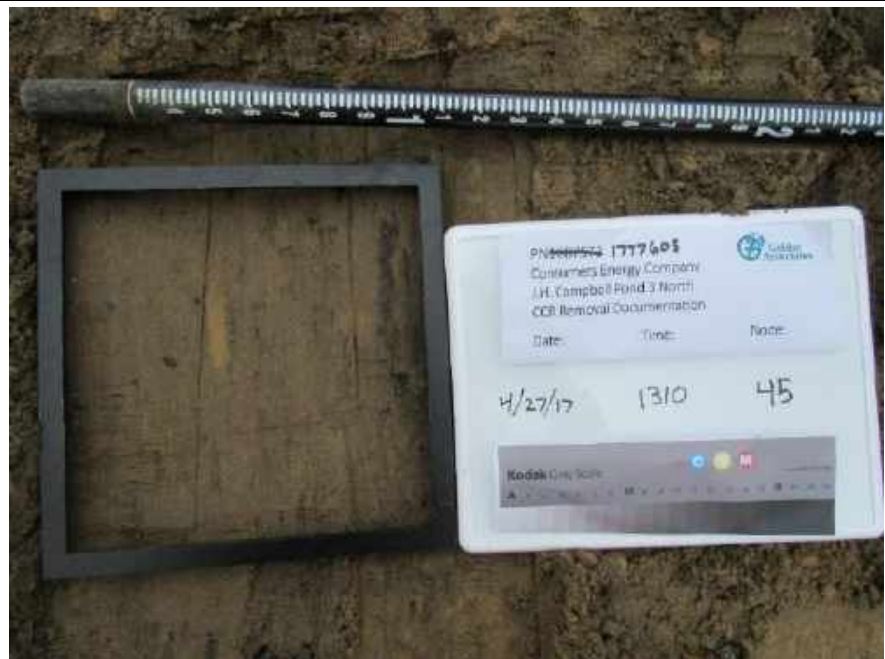
Colorimeter Result: N/A

Notes: Dark brown to gray sand with clay, trace organics similar to material observed in Test Pits 3077 and 3078.
*Surveying rod used for scale.

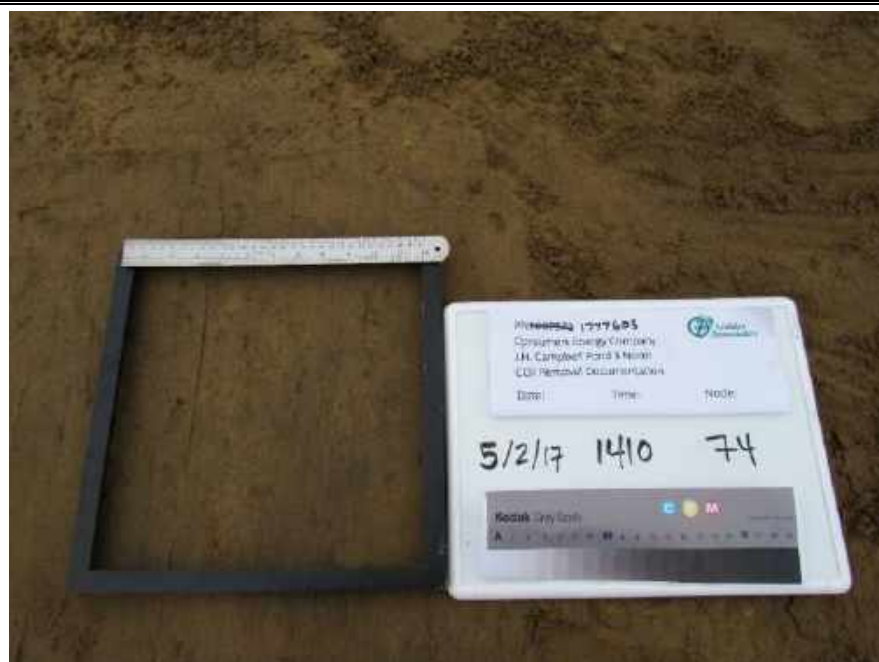
Colorimeter Result: N/A

Notes: Dark brown sand, trace black silt similar to material found in Test Pit 3076.

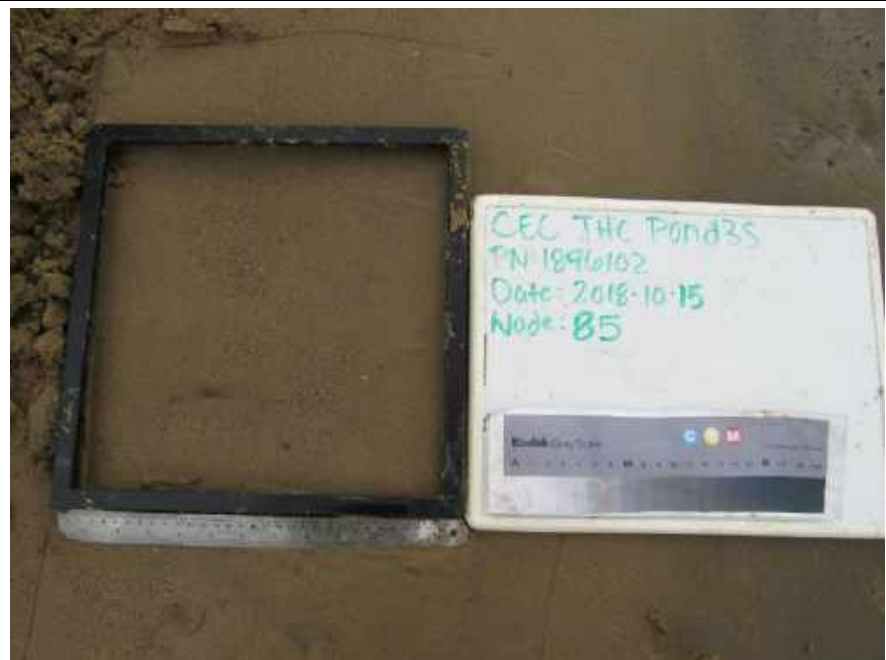
PHOTO 45

Node Number: 85
Location: North 150, East 2300
Colorimeter Result: 8.82 percent CCR
Microscopy Result: 2 percent CCR
Note: Coarser sand observed at node location. Sample also contains some dark organic debris.

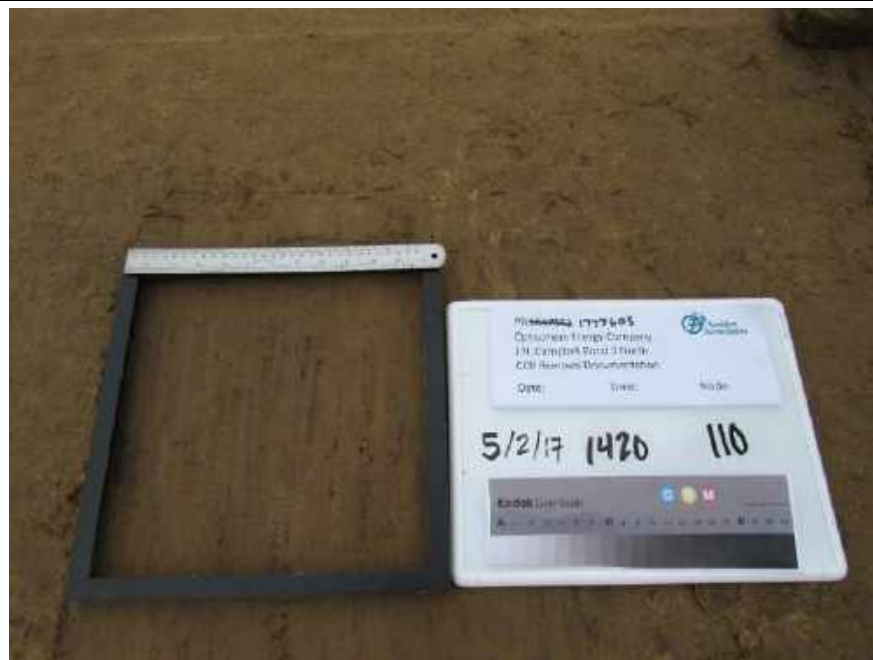
Colorimeter Result: 3.89 percent CCR

Notes: Dark brown sand, trace black silt similar to material found in Test Pit 3076.

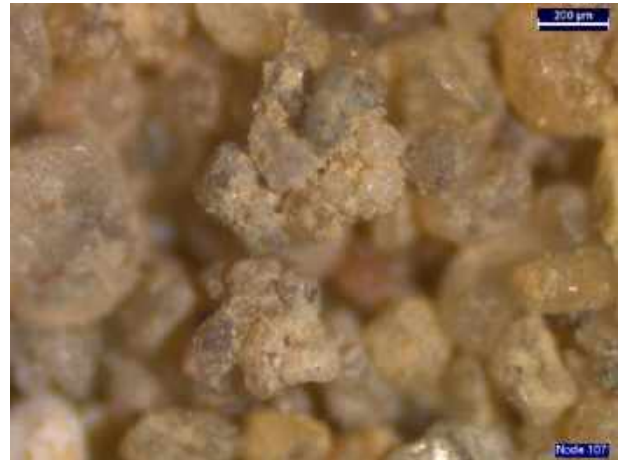
The sand is lightly coated with buff silty material and locally heavily coated with yellow silty material. Red arrow shows plant material. Yellow arrow shows CCR.

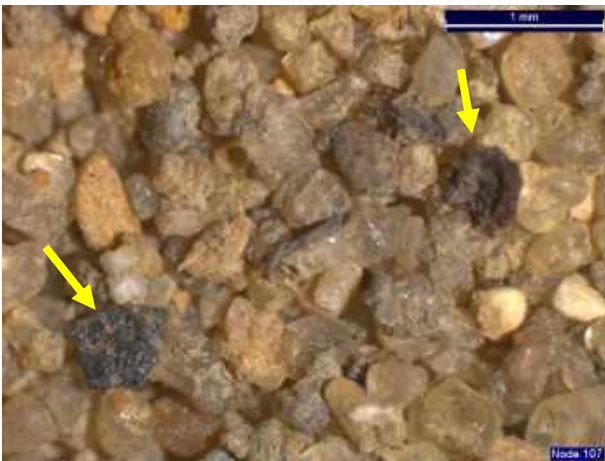
Some sand particles are loosely bound together by silty material.

Arrows show CCR particles.
