JH Campbell History of Construction Pond A

Initial Compiled History Certification by Owner or Operator

PROJECT
J.H. CAMPBELL PLANT GENERATING FACILITY
 HISTORY OF CONSTRUCTION

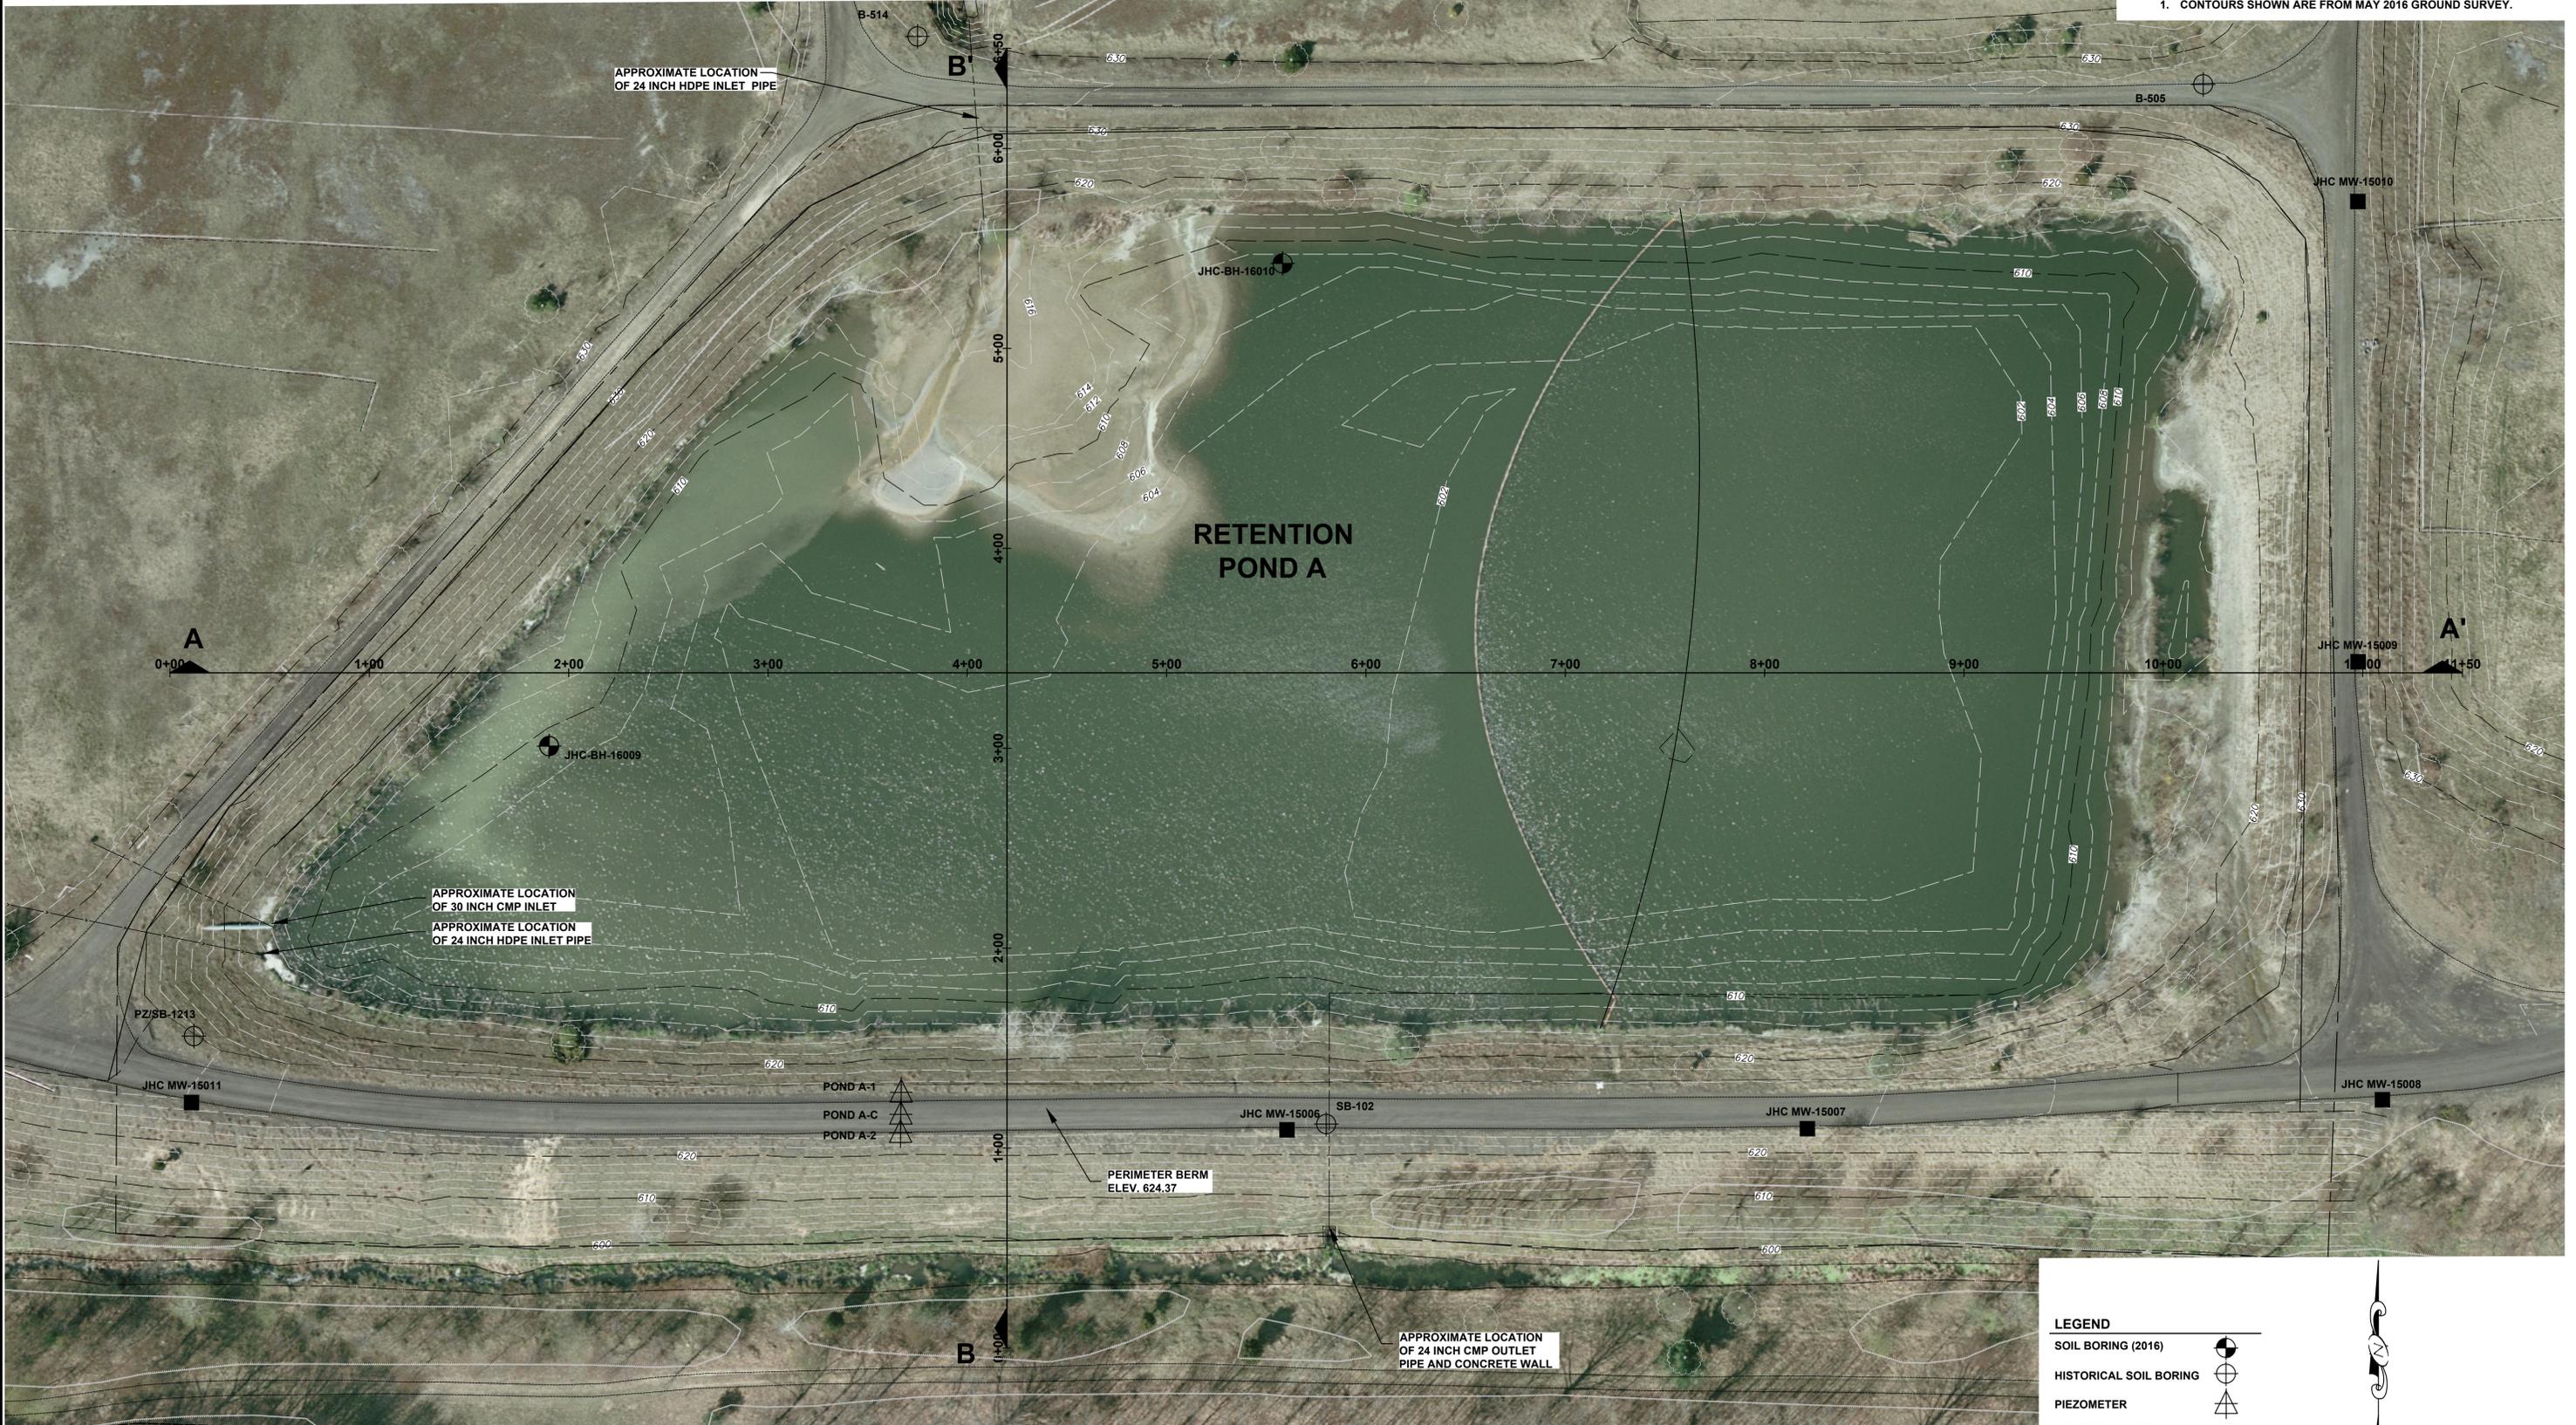
ASH POND CHARACTERIZATION
 POND A PLAN VIEW

The CCR RCRA Rule requires that a description of the type, purpose, and location of existing instrumentation be provided. Golder included the locations of the known instruments on **Figure 2 – Existing Conditions Site Map**.

- SOIL BORING (2016)
- HISTORICAL SOIL BORING
- PIEZOMETER
- MONITORING WELL

As part of a subsurface investigation and sampling program conducted by Golder in May 2016, soil samples were collected from beneath Bottom Ash Ponds 1-2, Bottom Ash Pond 3, and Pond A. Sampling locations are visually depicted on **Figure 2 – Existing Conditions Site Map**. Physical properties of the soil samples are included in **Appendix A – Soil Sample Data**.

- Figure 2 – Existing Conditions Site Map
- Figure 3 – Ash Pond Characterization Pond A Plan View
- Figure 3A – Ash Pond Characterization Pond A Cross Section A-A'
- Figure 3B – Ash Pond Characterization Pond A Cross Sections B-B'

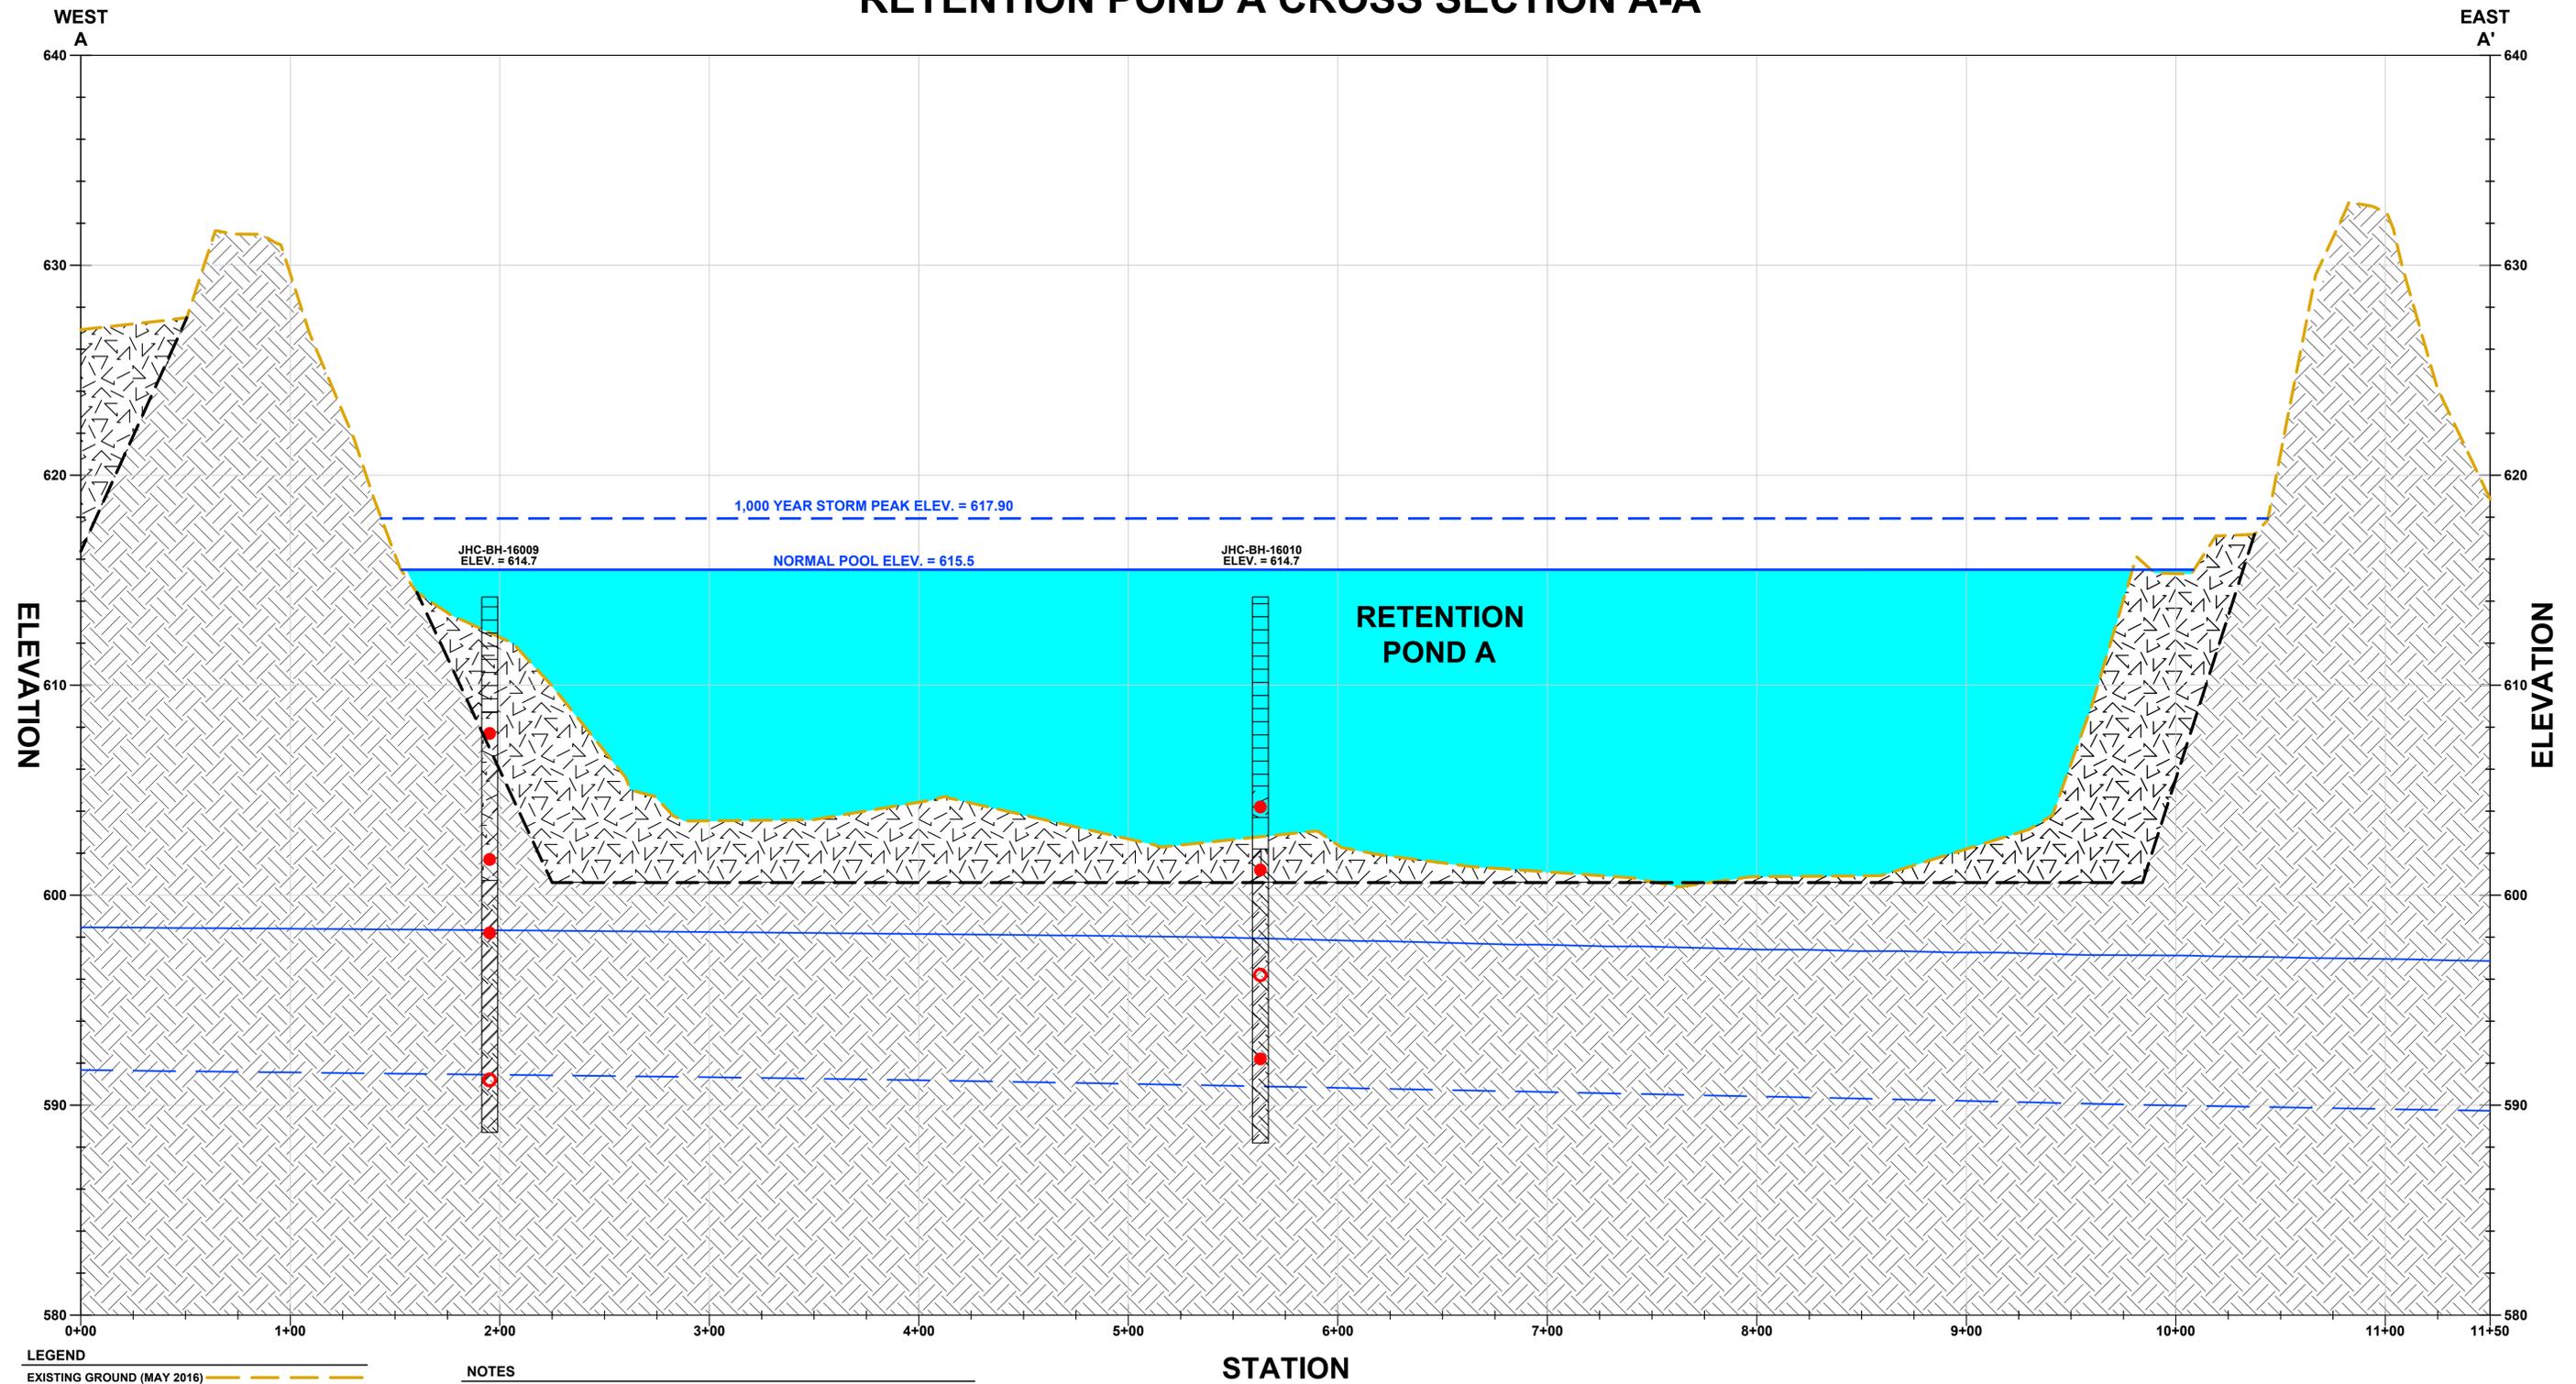
ASH POND CHARACTERIZATION
 POND A CROSS SECTION A-A'

Cross sections were developed based on an EES Survey (September 2016) and subsurface data collected and interpreted by Golder in 2015 and 2016. These cross sections are not intended to illustrate a comprehensive conceptual site model representing all data that may be available for Pond A.

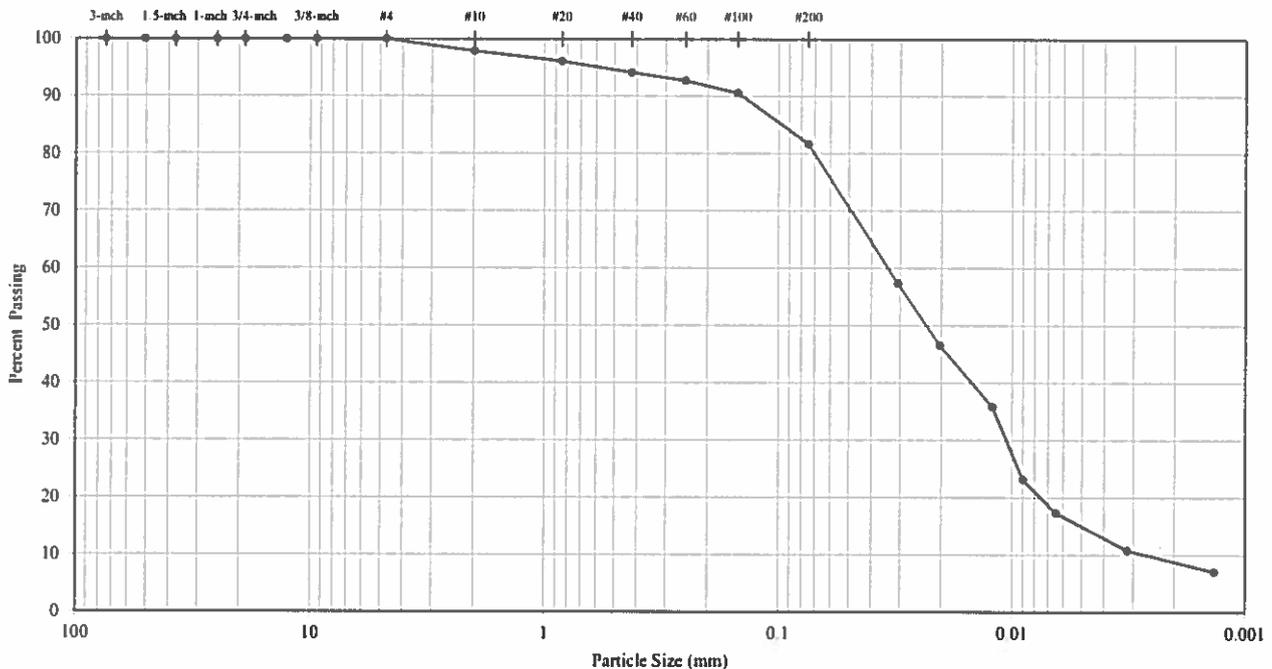
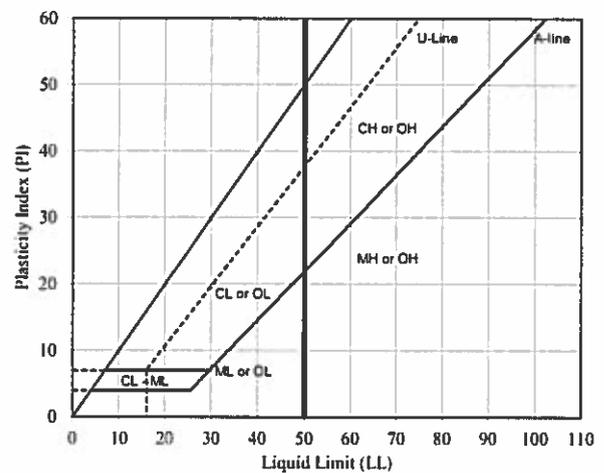
PROJECT NAME: **J.H. Campbell Ash Pond Characterization**
 SAMPLE ID: **JHIC-BH-16009 S-1**
 TYPE: **Jar**

Visual Description:
 Very dark gray, CCR

As-Received Moisture Content (%)
86.7

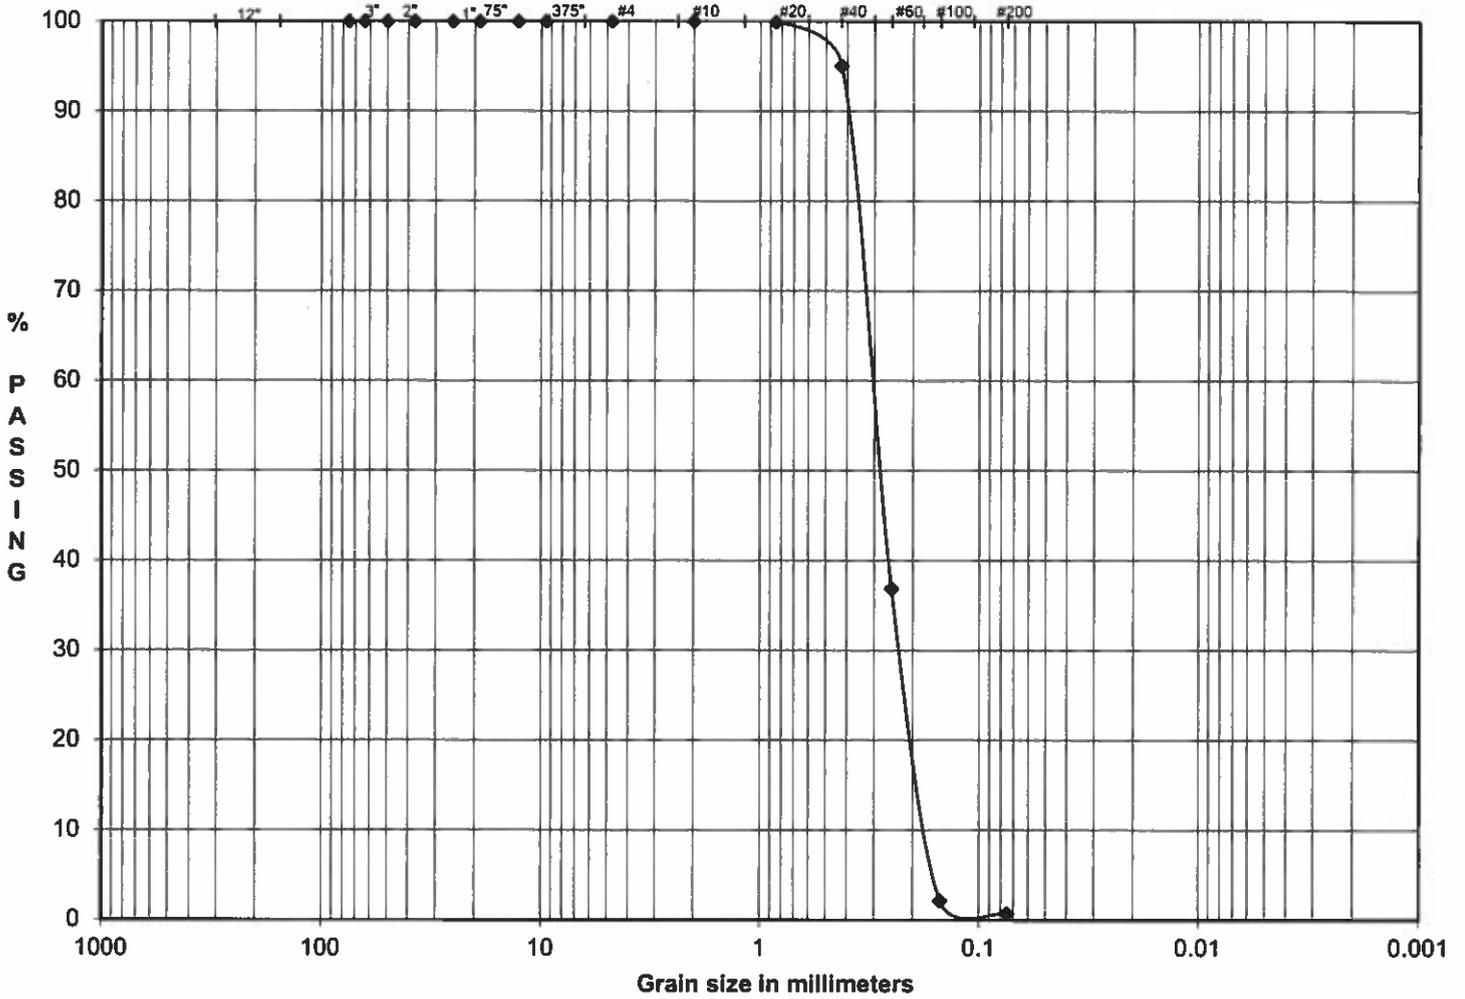
**PARTICLE SIZE DISTRIBUTION ASTM D 421 AND D 422
US STANDARD SIEVE OPENING SIZES**

DESCRIPTION: Brown, POORLY GRADED SAND, trace fines

USCS: SP

DESCRIPTION Brown, POORLY GRADED SAND, trace fines
