DAILY FIELD FORM – J.R. Whiting Ponds 1 and 2 Closure

PROJECT OVERVIEW			
Project Title:	J.R. Whiting Ponds 1 and 2 Closure CQA	**Project Number:** 1788523	**Date:** 9/24/2019
Client:	Consumers Energy	**Site/Location:** Erie, MI	
GAI Personnel:	David Hutchinson	**Arrival/Departure Time:** 0630/1300	
Contractor(s):	Ryan Central Inc.	**Contractor(s) Rep:** John Johnson (Ryan Central)

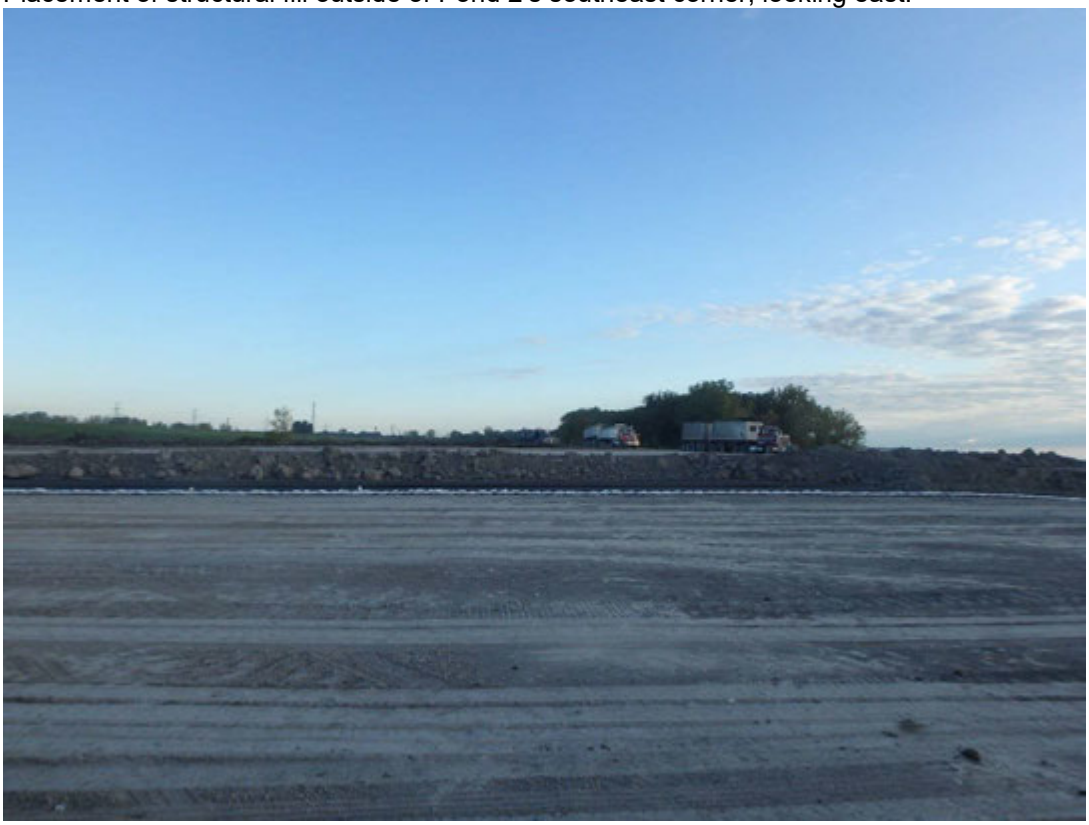
Placement of structural fill outside of Pond 2's southeast corner, looking east.

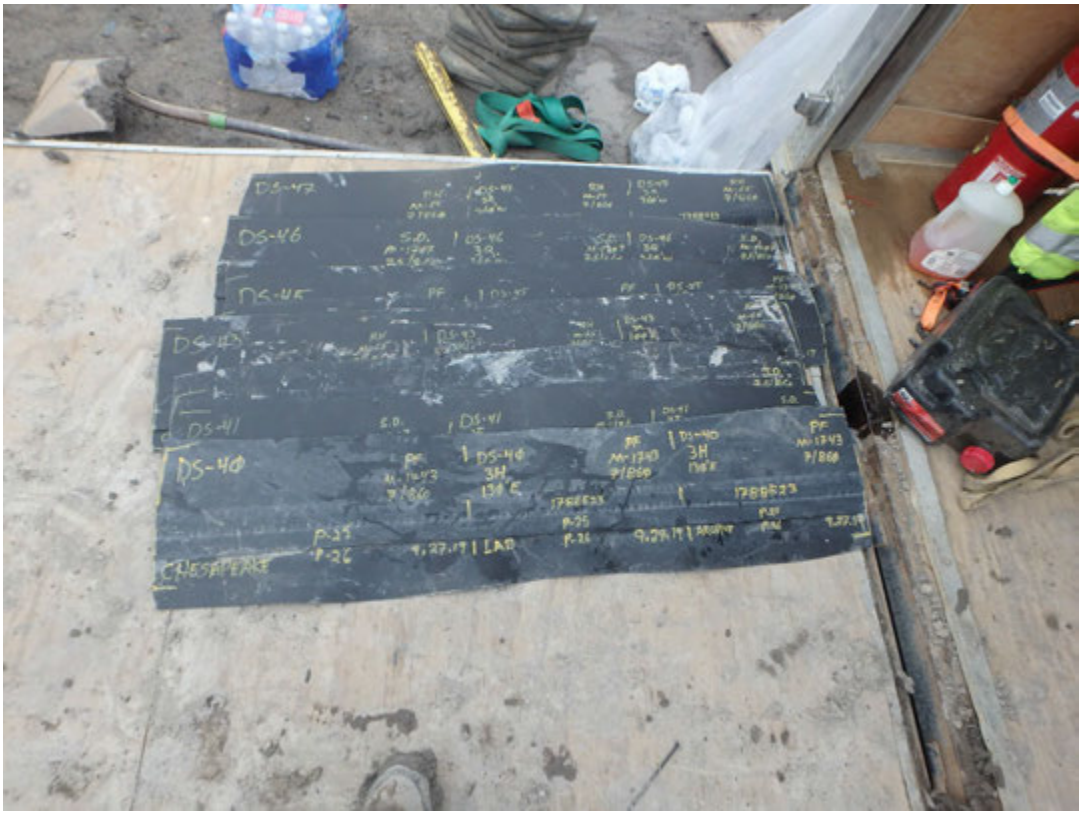
Preparing trial weld.

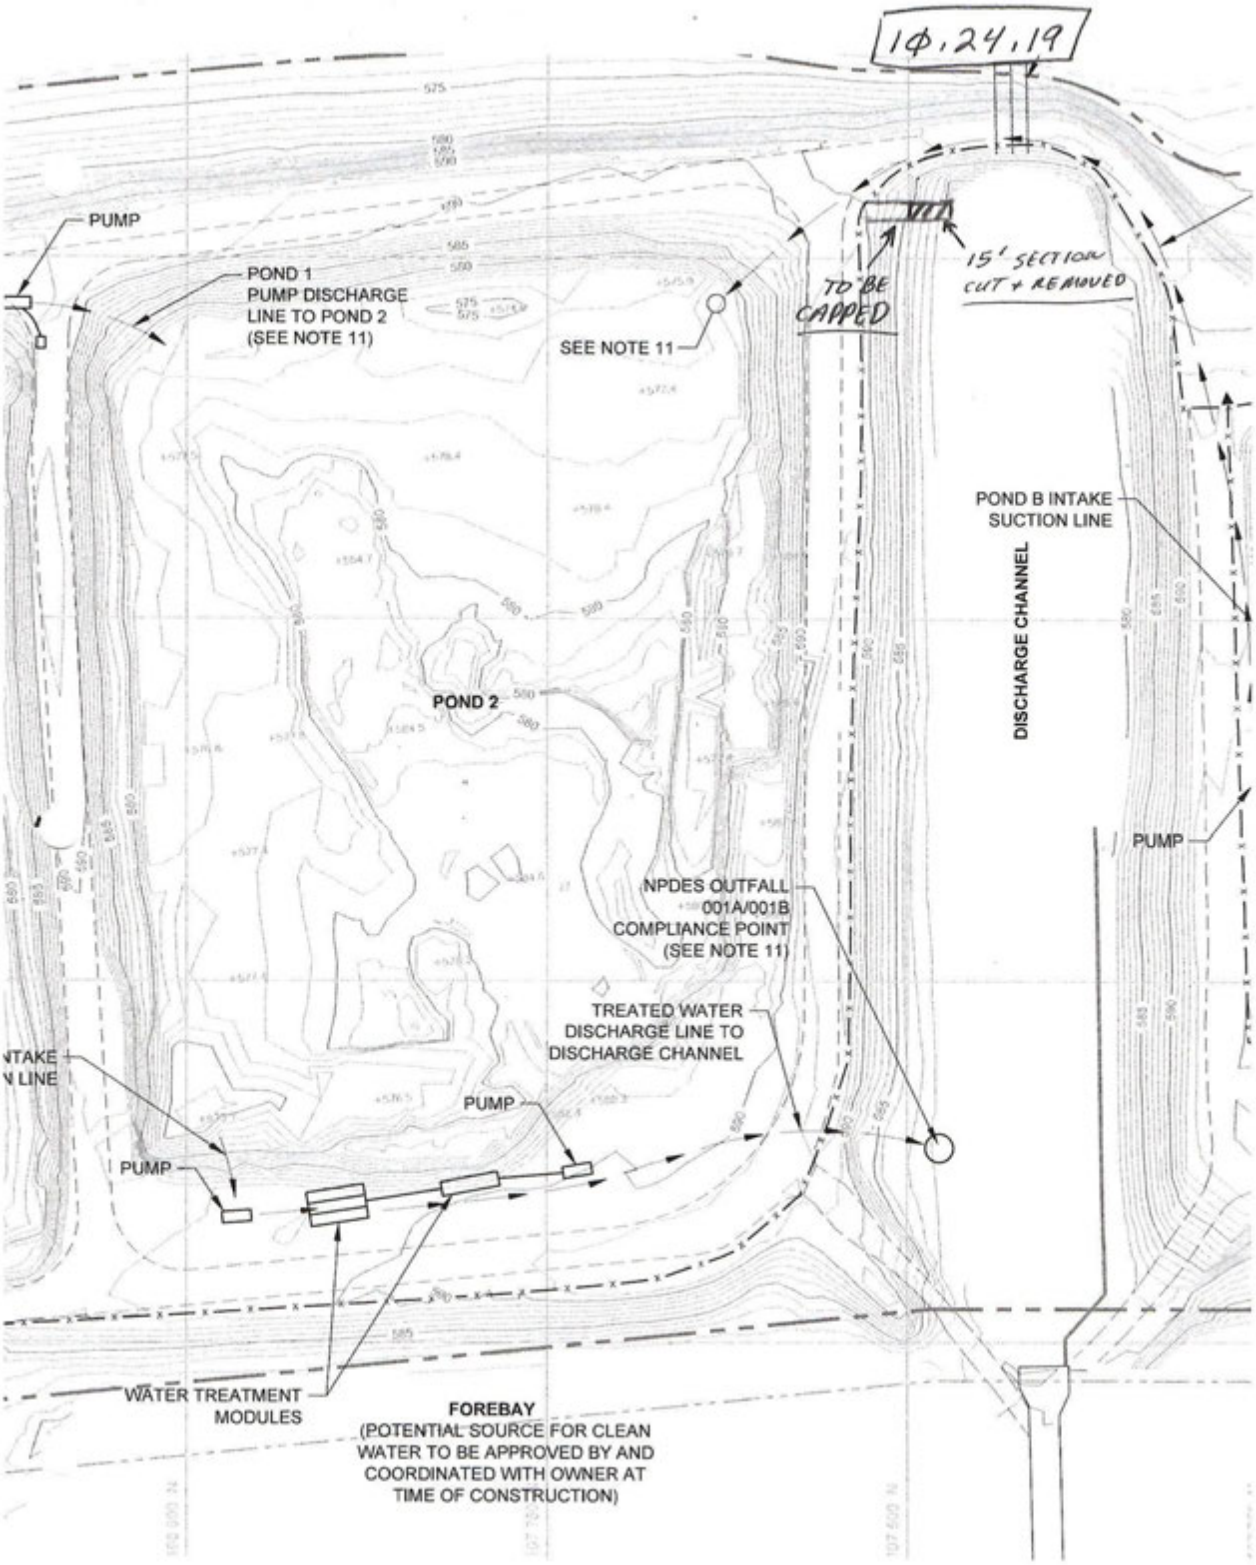
Location of 24 inch steel pipe found in discharge channel

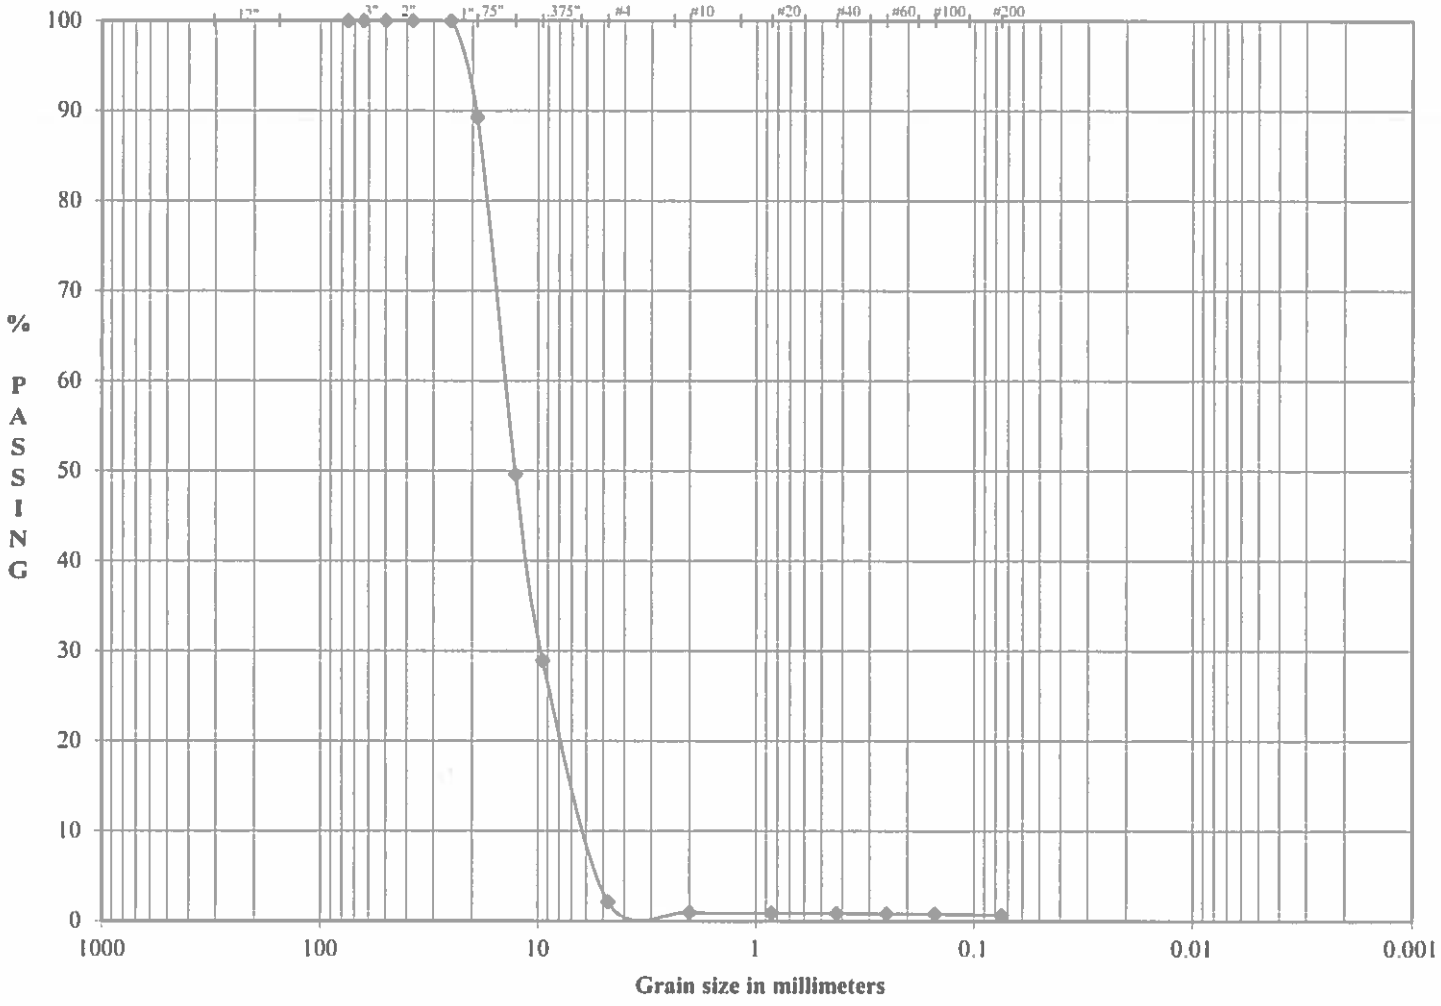
PARTICLE SIZE DISTRIBUTION ASTM D 421 AND D 422
US STANDARD SIEVE OPENING SIZES

Coarse	Fine	Cor	Med	Fine	SILT OR CLAY
Boulders	Cobbles	GRAVEL		SAND			FINES
	0.00	10.72	87.12	1.18	0.11	0.20	0.65
		97.84		1.50

SAMPLE ID	6AA-2
SAMPLE TYPE	Bulk
SAMPLE DEPTH (ft)	-
