Emergency Action Plan (EAP) for Coal Combustion Residuals (CCR) Units

B. C. Cobb Facility

Prepared for
Consumers Energy Company

June 2019

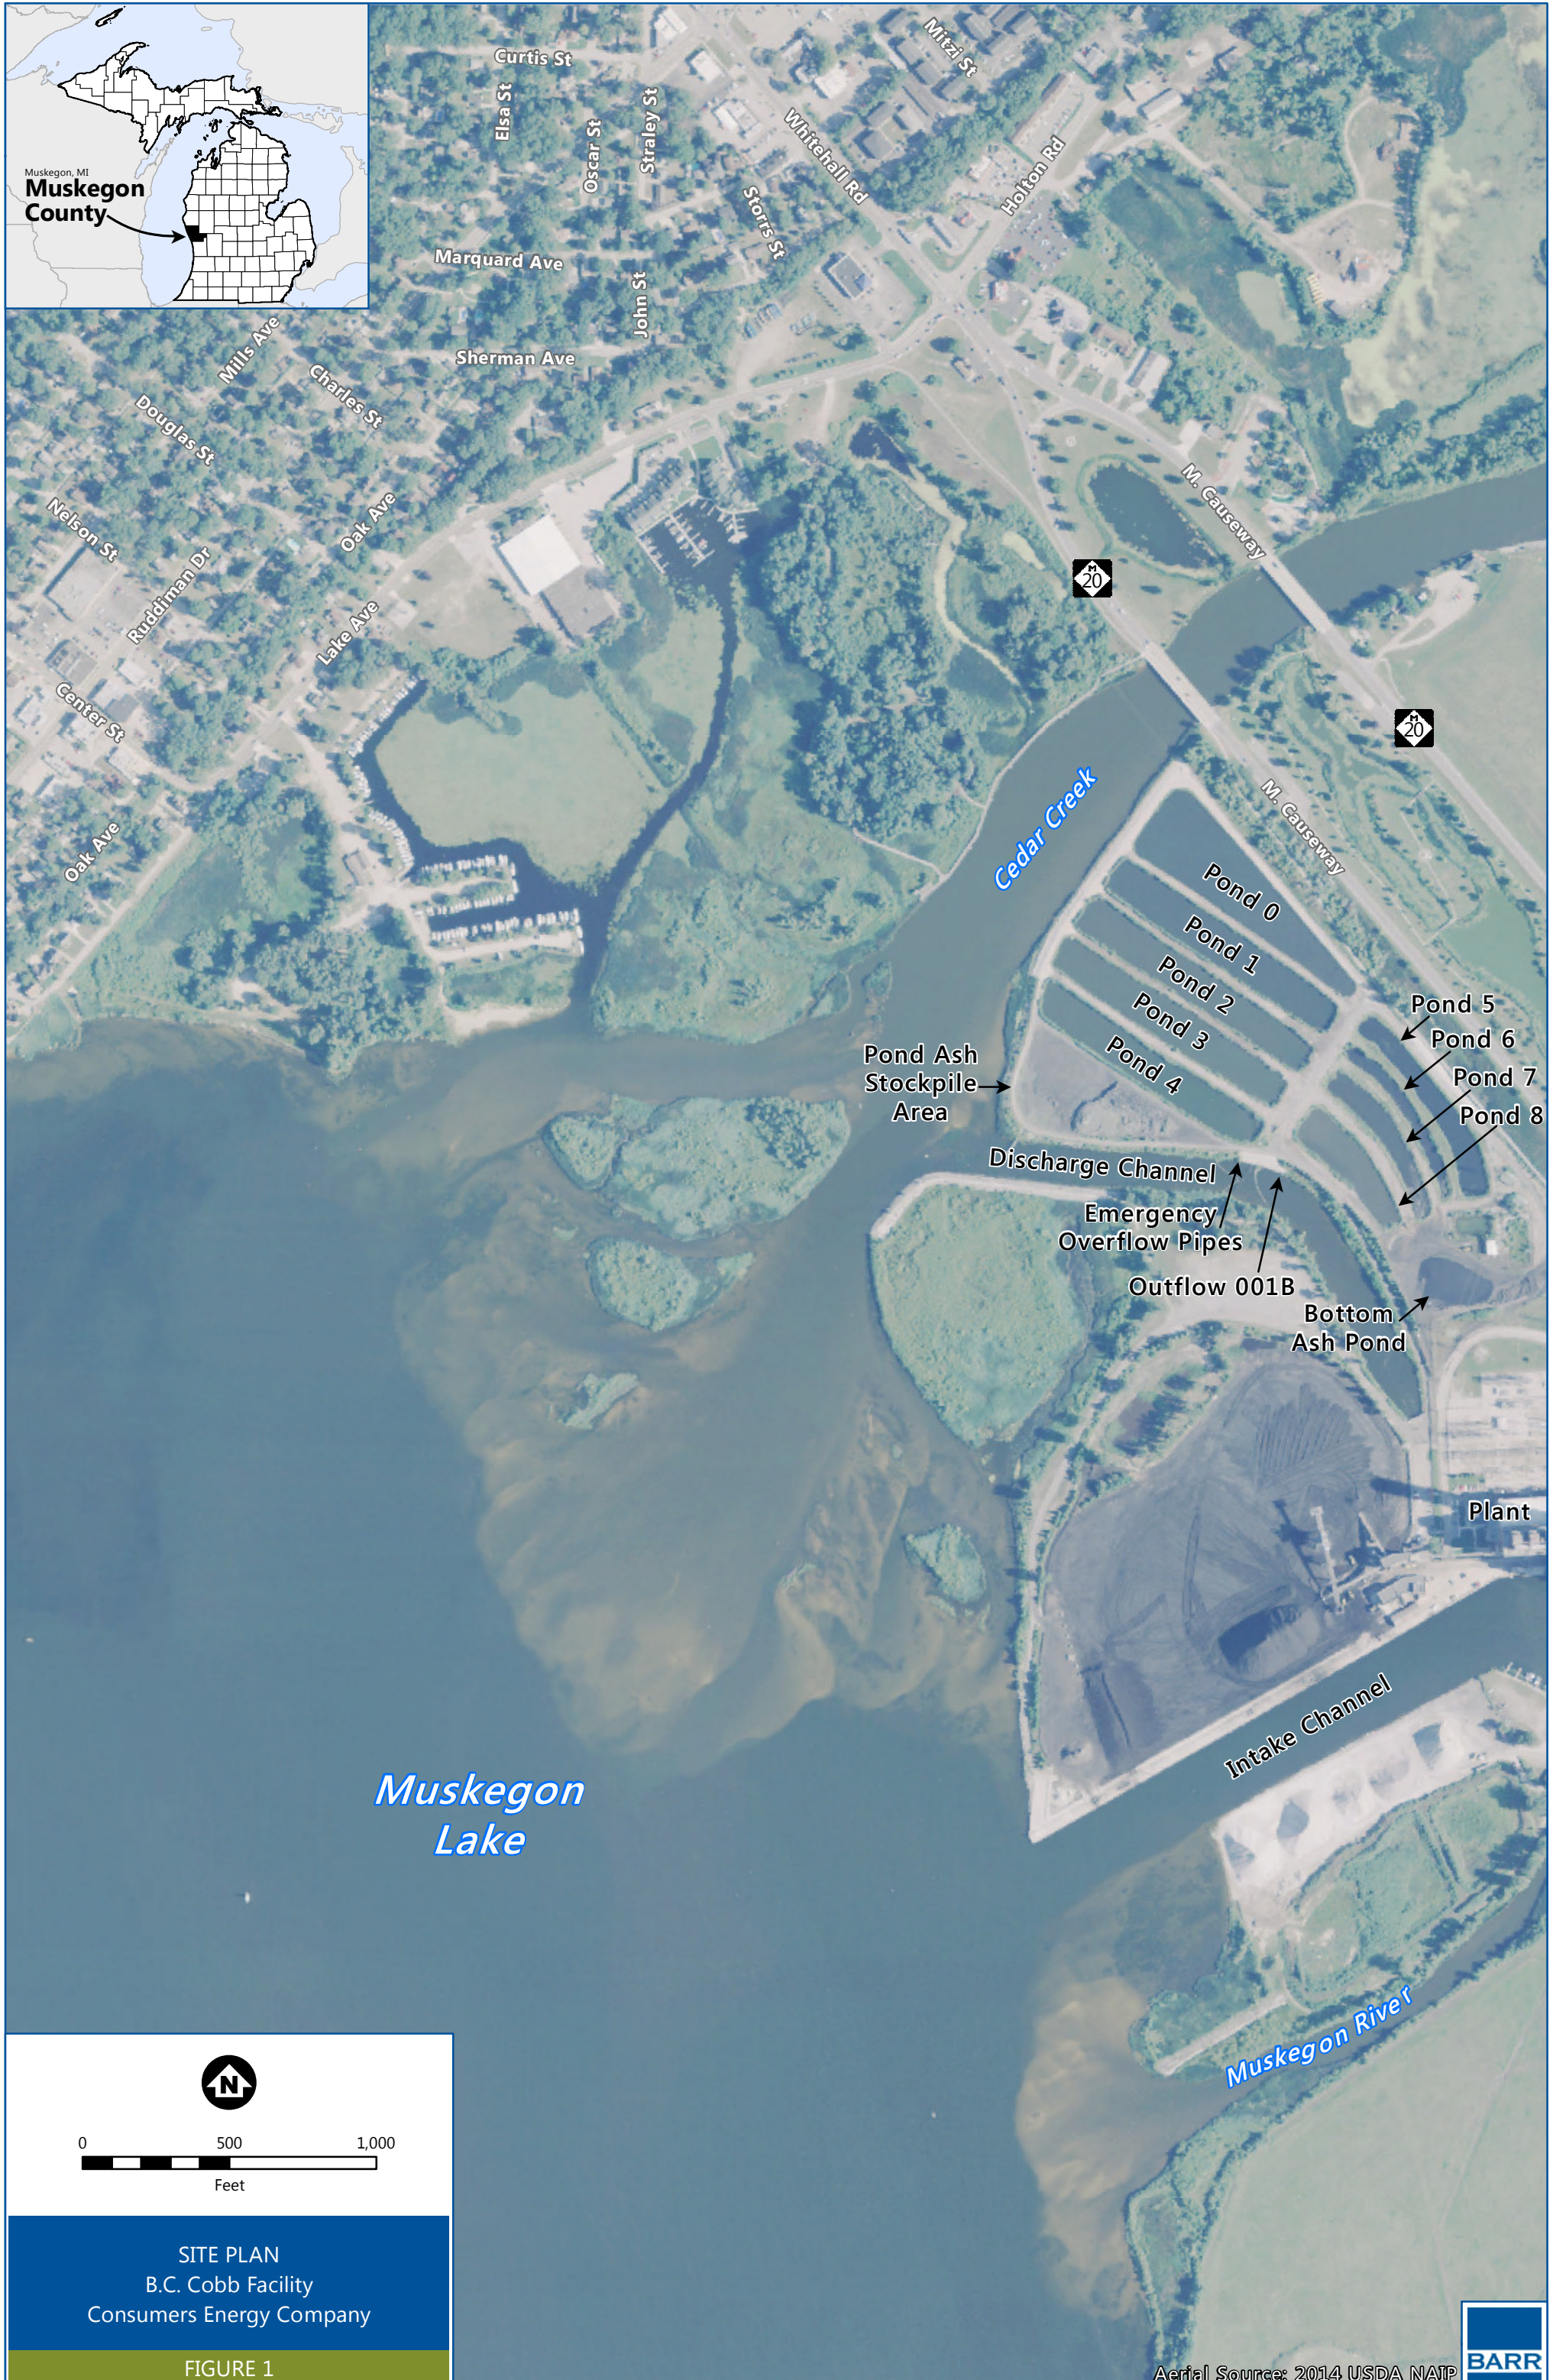
FIGURE 1

SITE PLAN
B.C. Cobb Facility
Consumers Energy Company

The B. C. Cobb facility is located in Muskegon, Michigan (shown on Figure 1). Two of BCC's CCR surface impoundments (CCR units), Ponds 0-8 and Bottom Ash Pond, have been classified as "significant hazard potential CCR surface impoundments" (Golder, 2016a and Golder, 2016b). The EAP provides CEC with a pre-planned and organized method to identify and implement a response to a safety emergency related to the CCR units. The impoundments are bounded on the west by Cedar Creek, the north branch of the Muskegon River as it empties into Muskegon Lake, and on the south by the generation facility's cooling water discharge channel. The generation facility no longer discharges water or CCR material to the impoundments. Only precipitation on the impoundments contributes to the volume of water in the impoundments.
