STRUCTURAL STABILITY ASSESSMENT REPORT

PONDS 1 & 2, JR WHITING PLANT
ERIE, MICHIGAN

OCTOBER 13, 2016

PREPARED FOR:
CONSUMERS ENERGY COMPANY

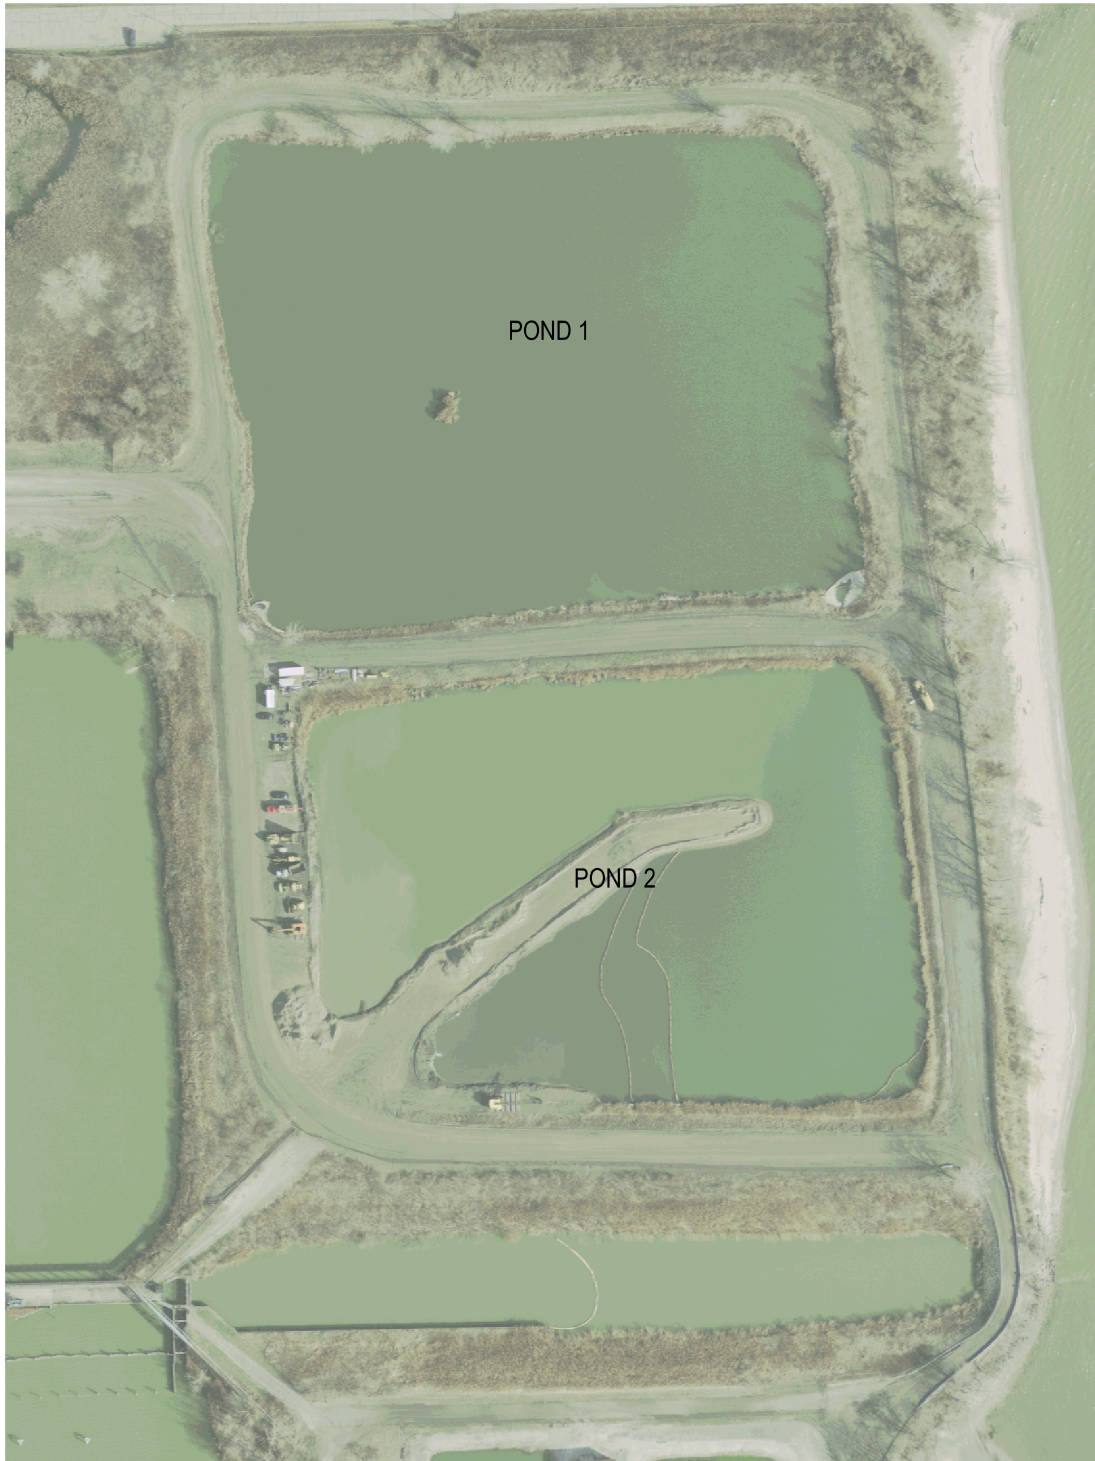
FIGURE 2

GENERAL SITE PLAN

JR Whiting is a coal-fired power generation facility located in Erie, Michigan as presented on Figure 1 – Site Location Map. JR Whiting formerly operated coal-burning baseload units but ceased electrical generation on April 15, 2016. Ponds 1 & 2 as presented in Figure 2 – General Site Plan, served two primary functions:
