Emergency Action Plan for Coal Combustion Residuals Unit

J. R. Whiting Facility

Prepared for
Consumers Energy Company

Emergency Action Plan for Coal Combustion Residuals Unit at J. R. Whiting Facility

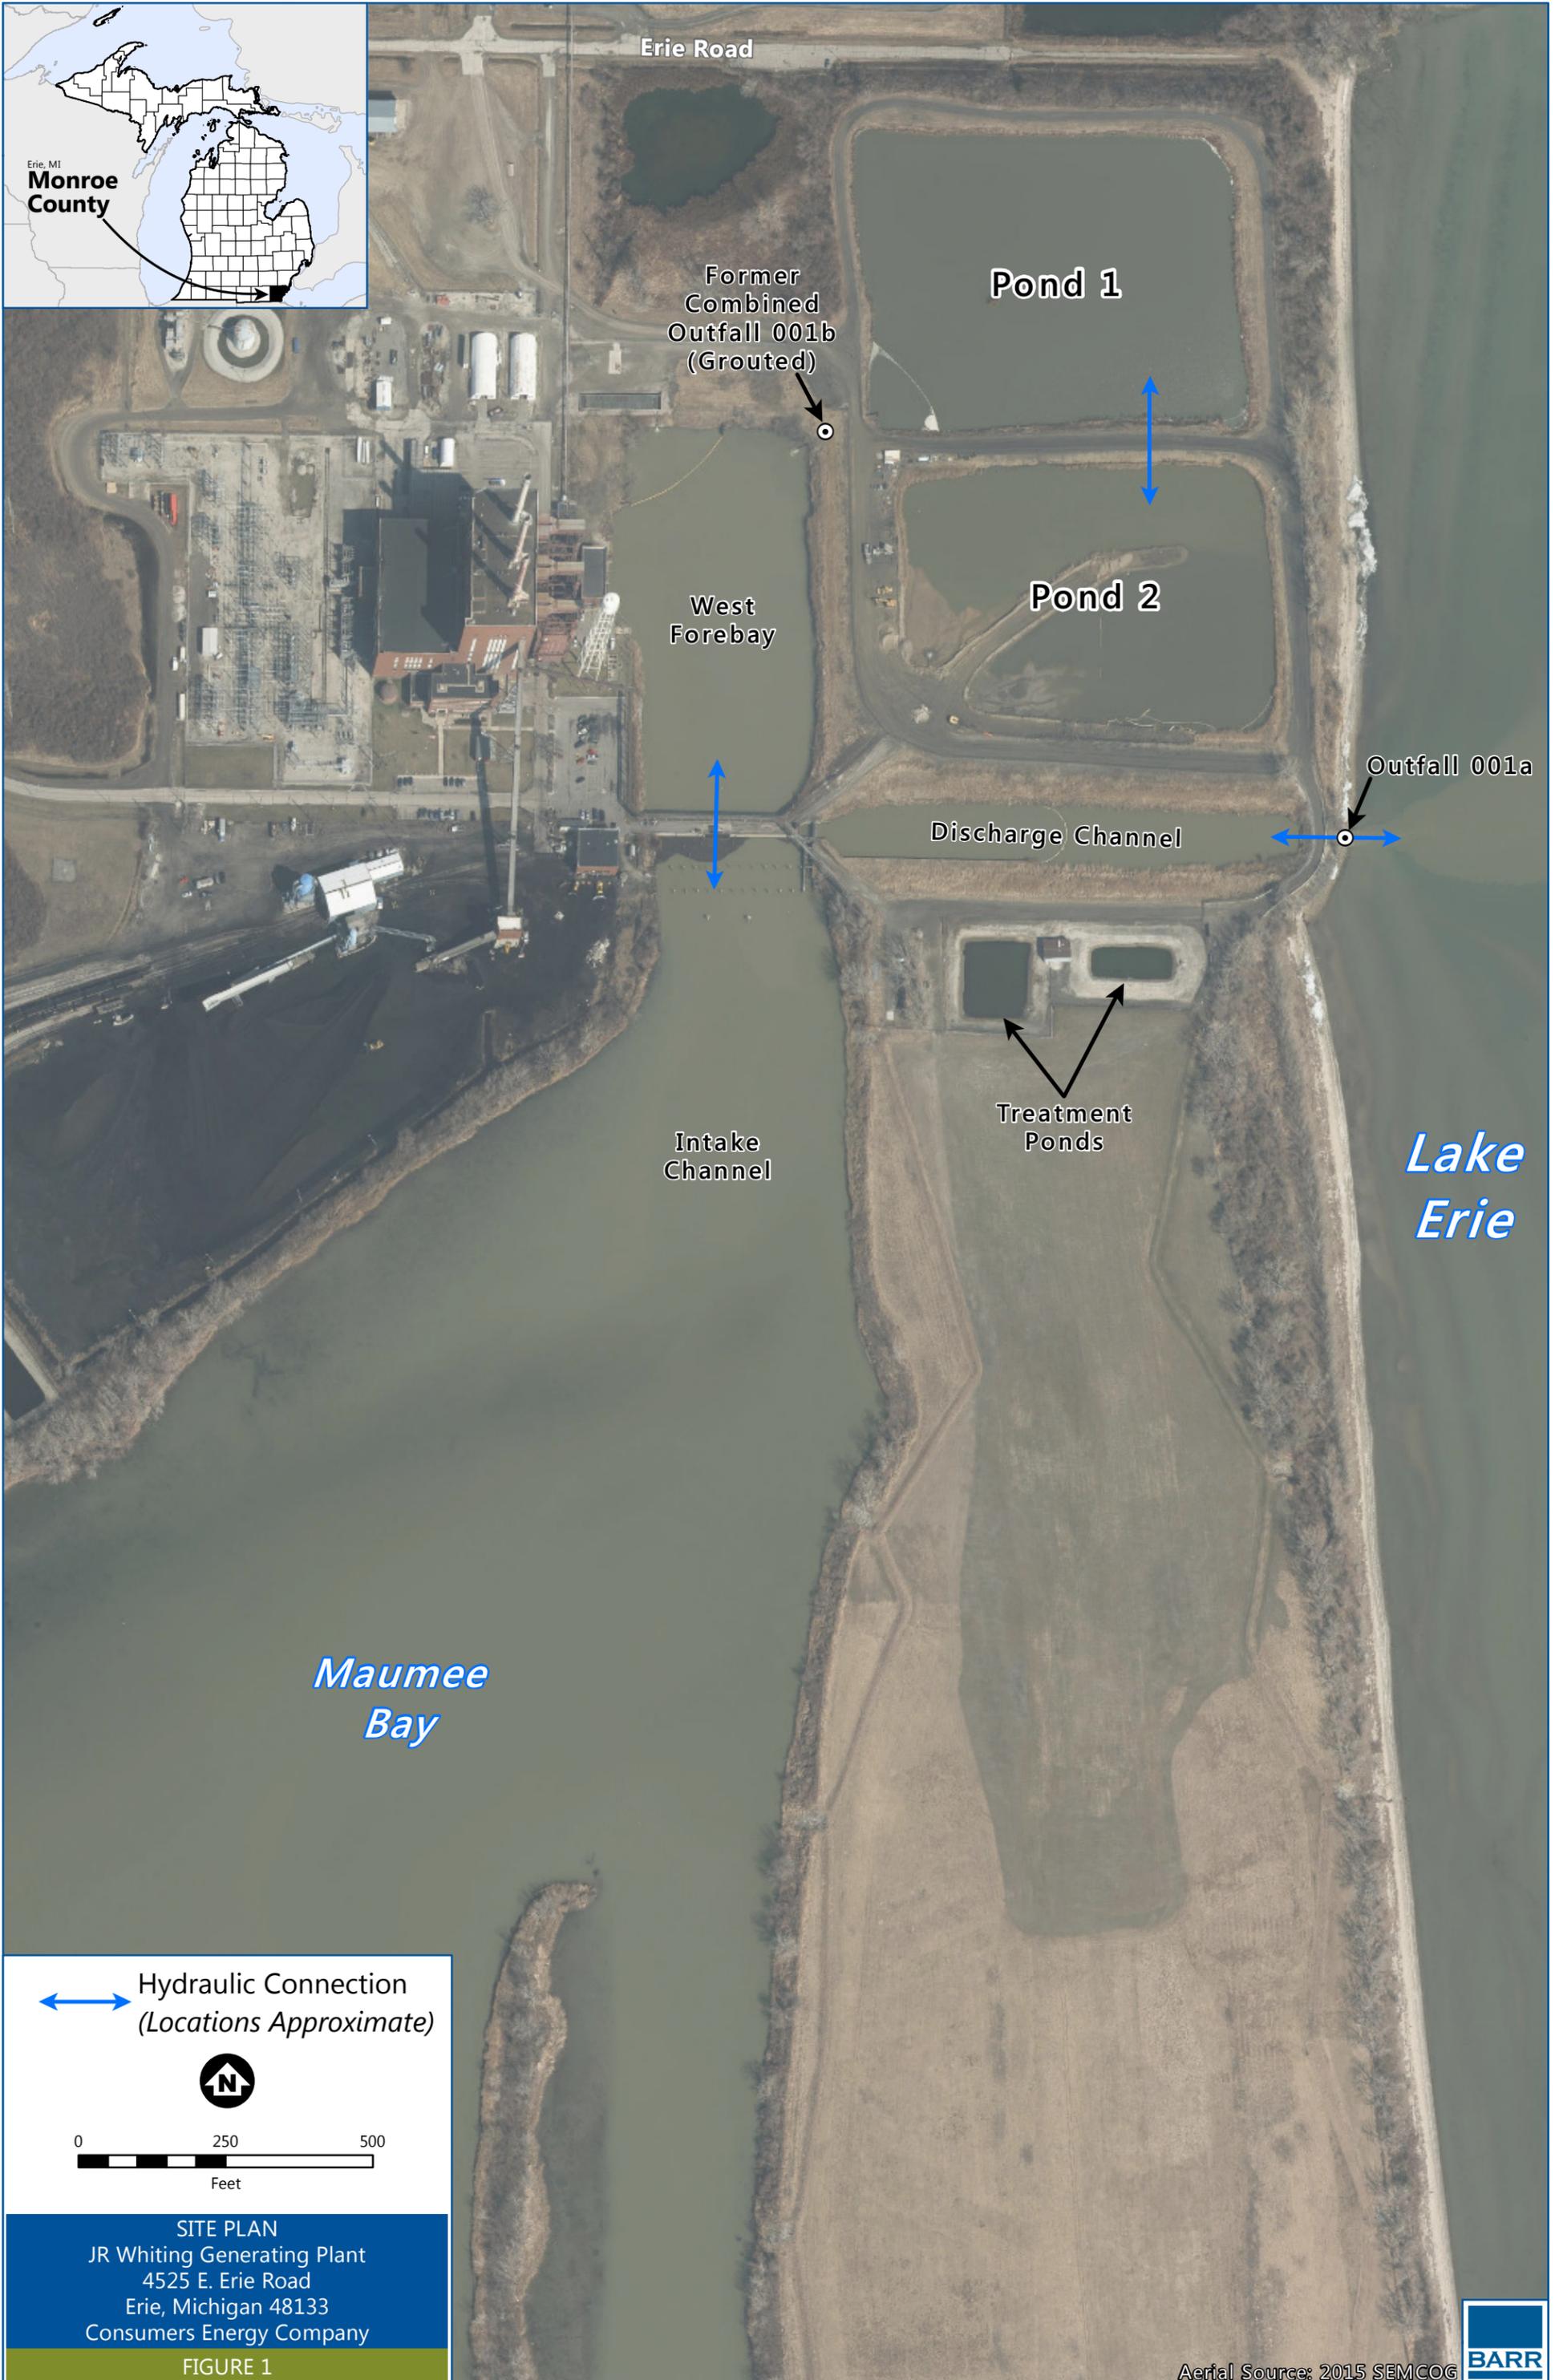
FIGURE 1

↔ Hydraulic Connection
(Locations Approximate)

The JRW facility is located in Erie, Michigan (shown on Figure 1). JRW's CCR surface impoundment (CCR unit), Pond 1&2, has been classified as a "significant hazard potential CCR surface impoundment" (Mannik Smith Group, 2016). The EAP provides CEC with a pre-planned and organized method to identify and implement a response to a safety emergency related to the CCR unit. The impoundments are bounded on the west by the west forebay, on the south by the facility's formerly used cooling water discharge channel, and on the east by a public beach on the shore of Lake Erie. The generation facility is not in operation and no longer discharges water or CCR material to the impoundments. Only rain which falls on the impoundments and potential, though unlikely, precipitation overflow from the nearby treatment ponds contribute additional water to the impoundments.

Key features and hydraulic connections of the waterbodies adjacent to the CCR unit are shown on Figure 1. As depicted, the west forebay is connected to the intake channel (Maumee Bay) through a concrete structure beneath the causeway. The discharge channel is connected to Lake Erie via culverts at the east end of the channel. Formerly, the west end of the discharge channel was connected to the intake channel via a recirculating gate structure, but this has been permanently closed and filled with concrete.

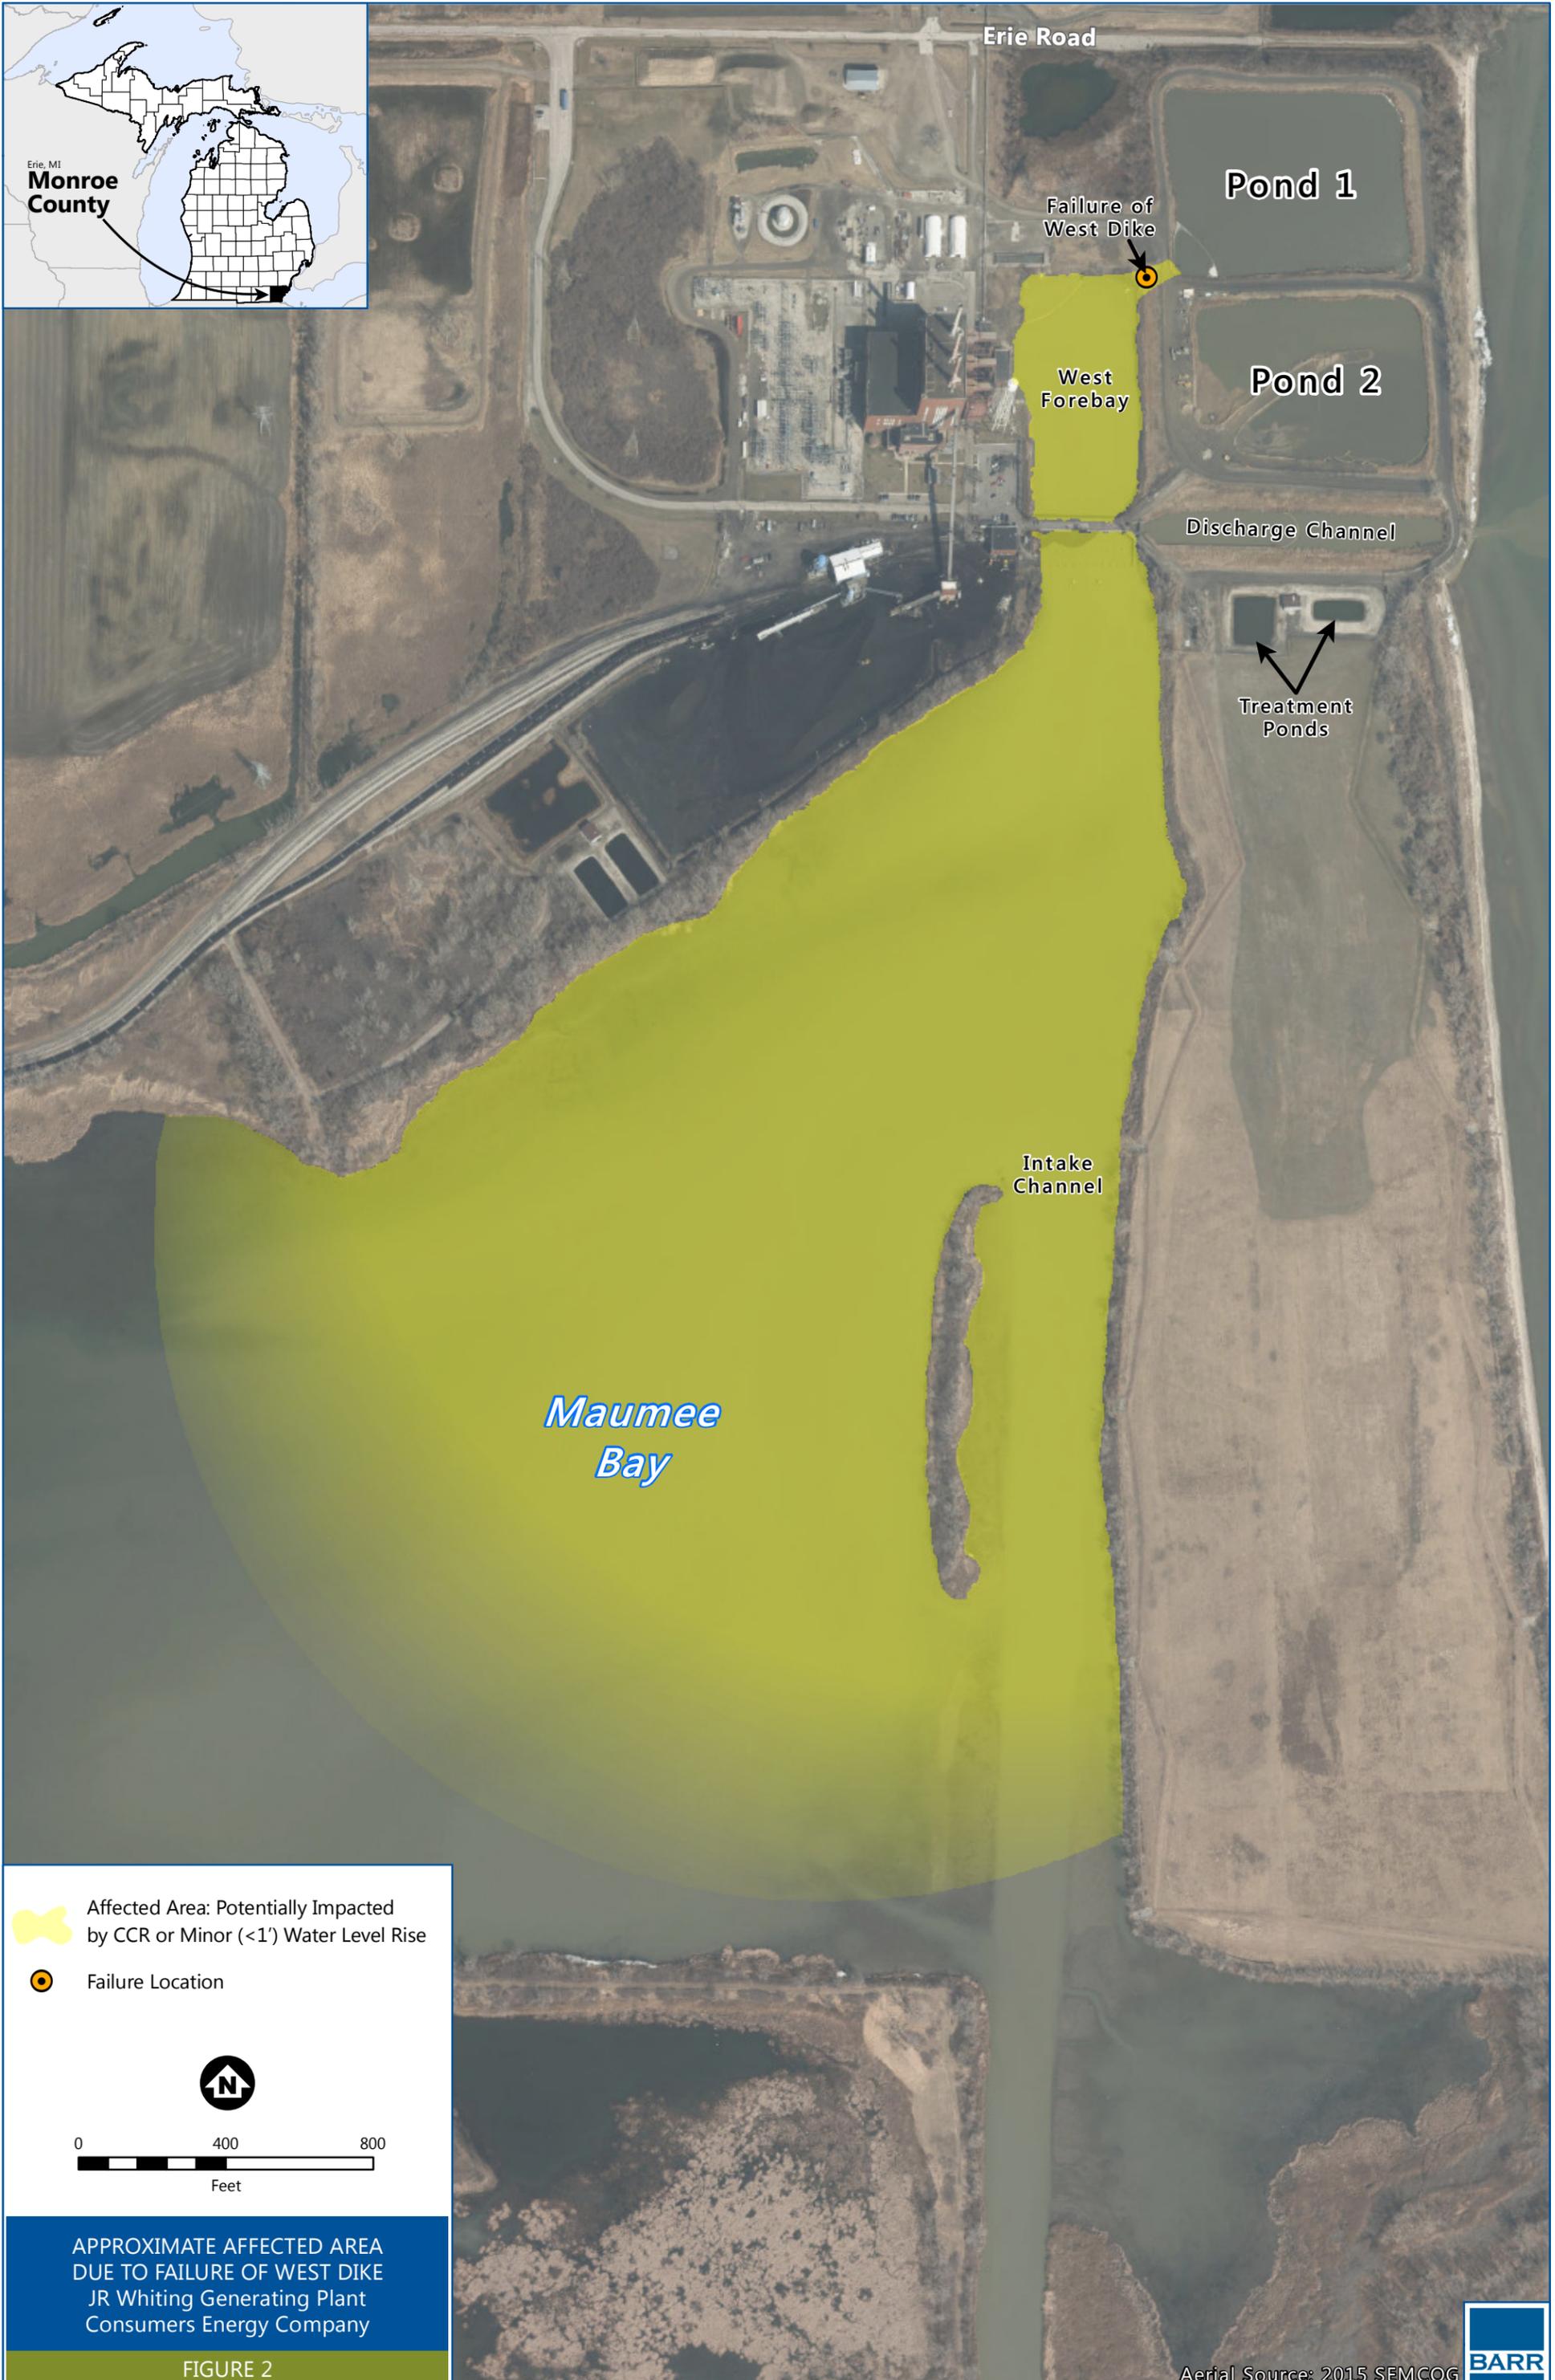
FIGURE 2

Affected Area: Potentially Impacted by CCR or Minor (<1') Water Level Rise

APPROXIMATE AFFECTED AREA DUE TO FAILURE OF WEST DIKE
JR Whiting Generating Plant
Consumers Energy Company

In development of the EAP for JRW pursuant to 40CFR§257.73, Barr created Figures 2, 3, and 4 to approximate the area which would be affected by a catastrophic discharge of CCR material and water from the impoundments to the potential receiving waters of the breaches. Based on a review of the surrounding topography, a breach of the west dike would presumably discharge to the west forebay (Figure 2), a breach of the south dike would discharge to the discharge channel then to Lake Erie (Figure 3), and a breach of the east dike would discharge to Lake Erie (Figure 4).

Using the conservative inundation area and topographic data for the adjacent areas (NOAA OCM, 2012) the approximate affected area shown on Figures 2, 3, and 4 depicts the water and shoreline which would be affected by the 1-foot inundation inclusive of the 150-acre area. The edges and general shape of this area are approximate.

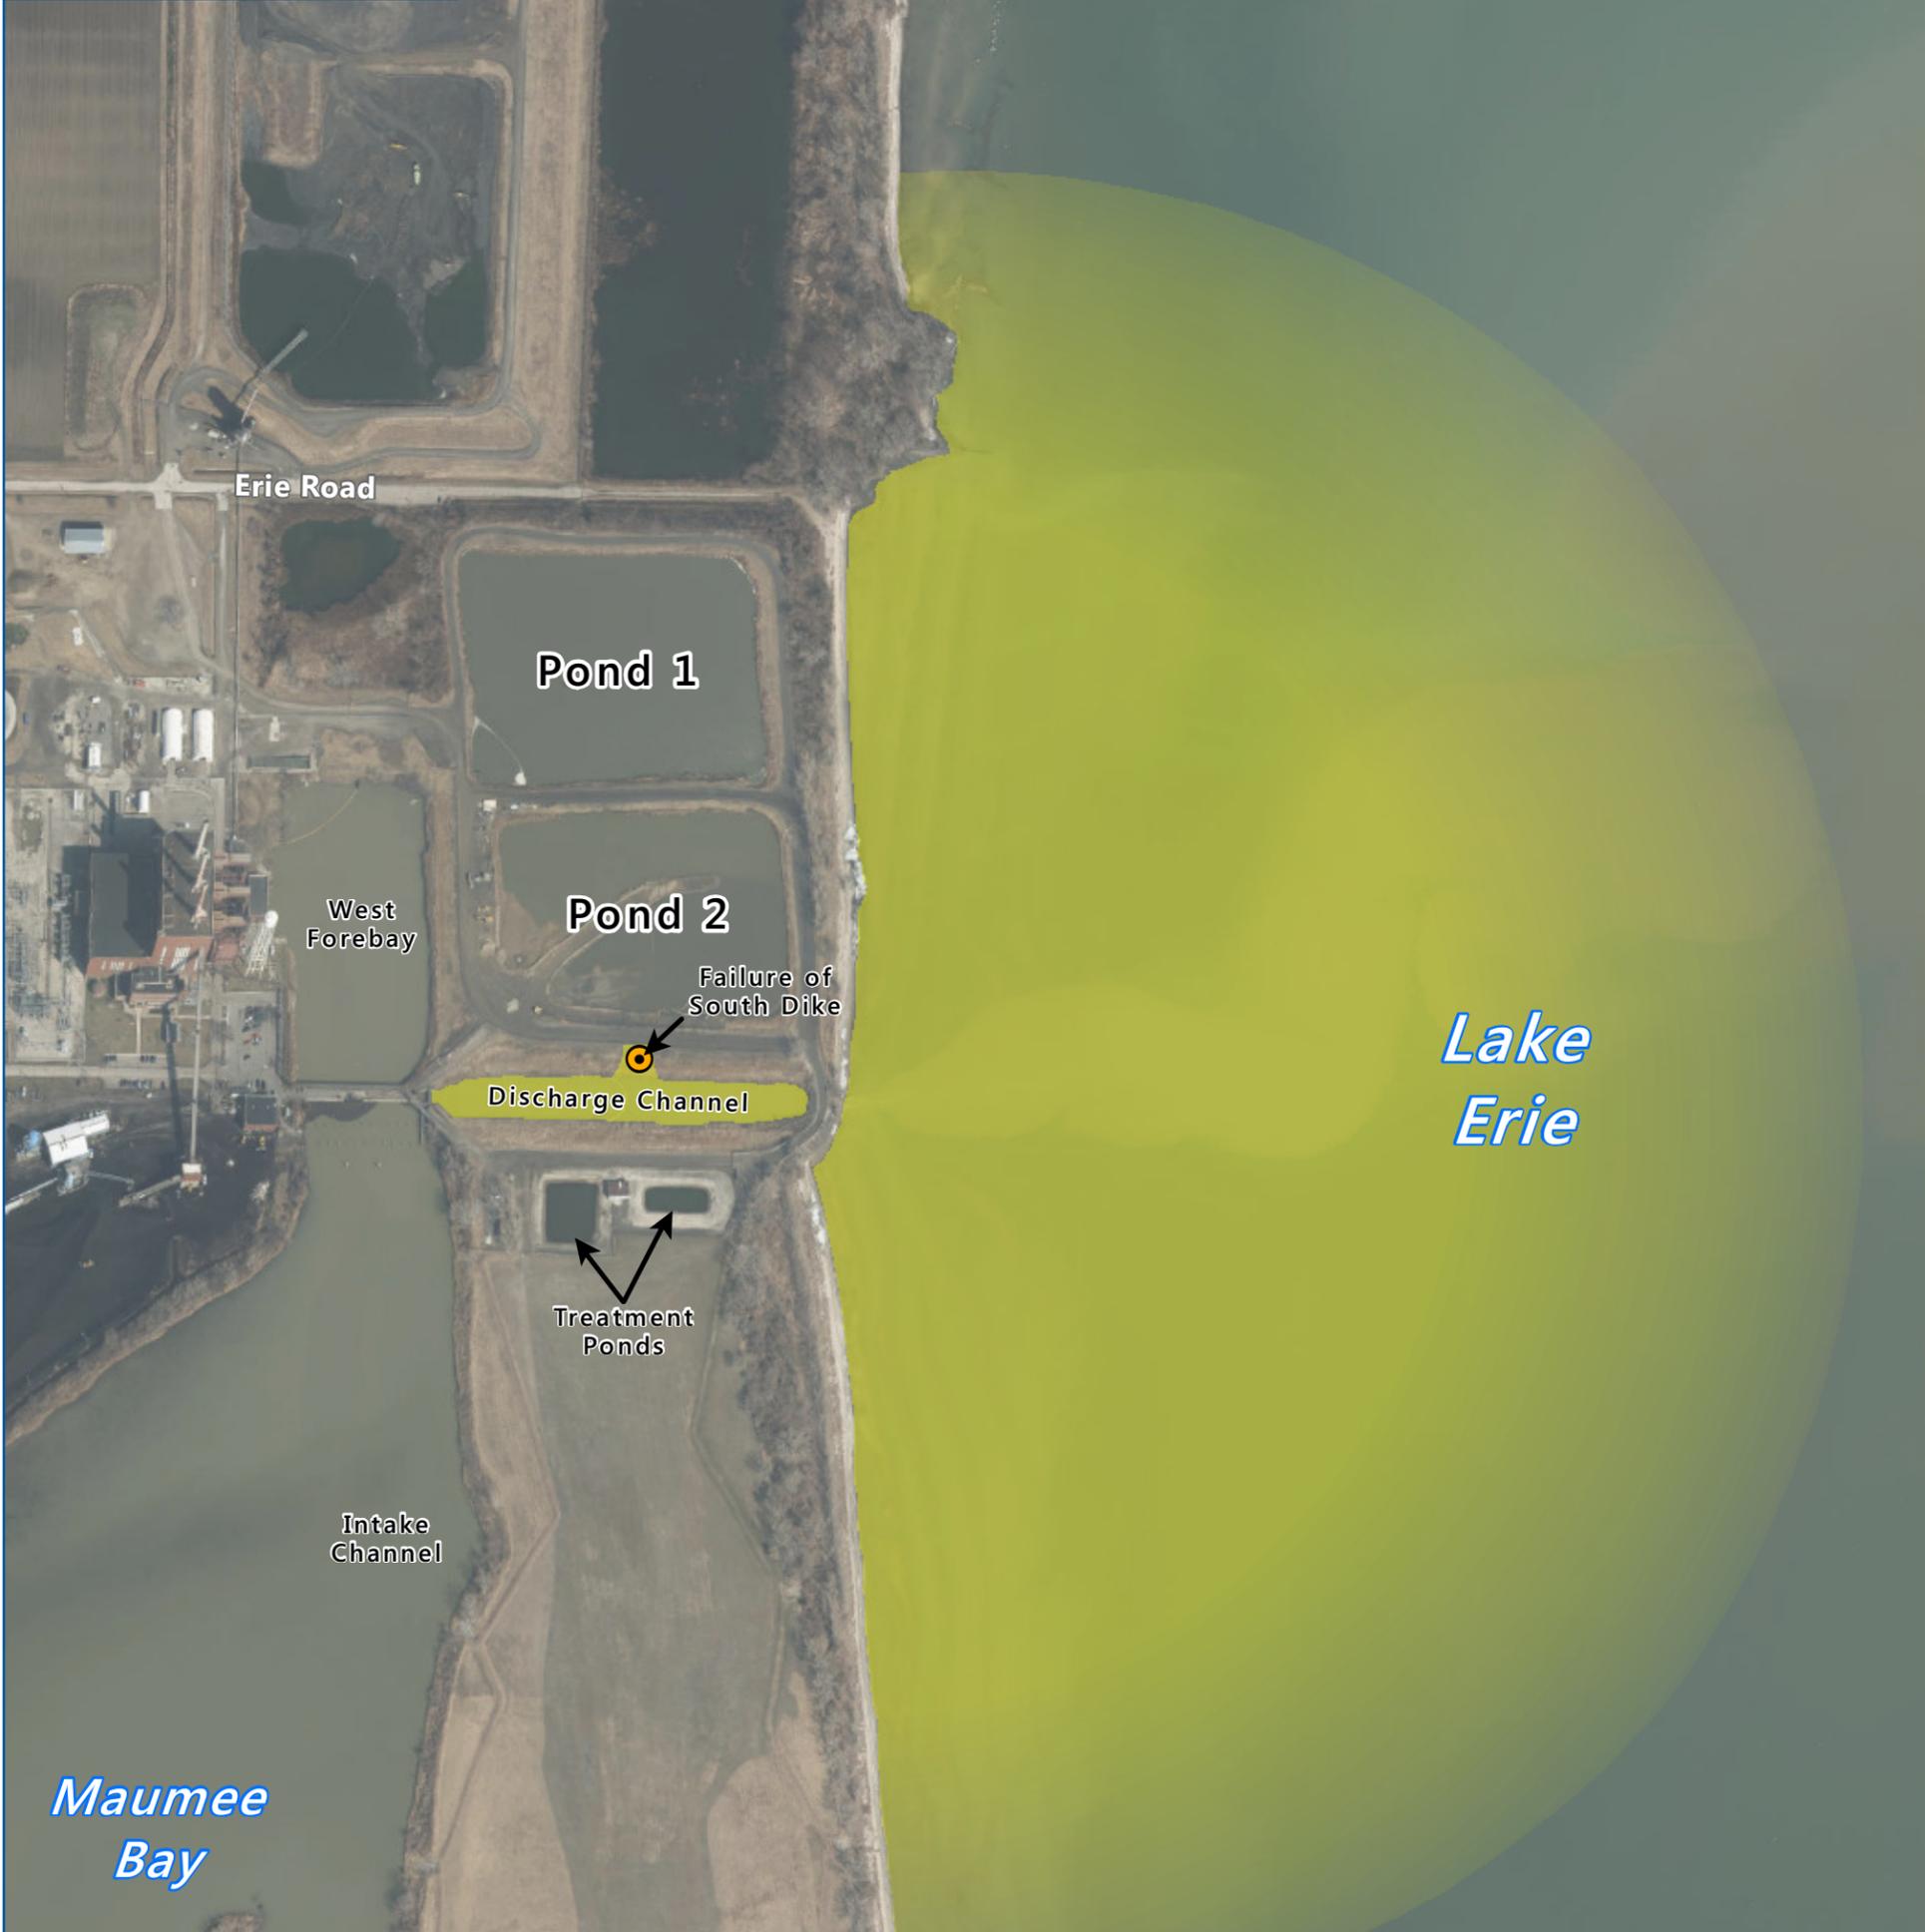
FIGURE 3

Affected Area: Potentially Impacted by CCR or Minor (<1') Water Level Rise

APPROXIMATE AFFECTED AREA DUE TO FAILURE OF SOUTH DIKE
JR Whiting Generating Plant
Consumers Energy Company

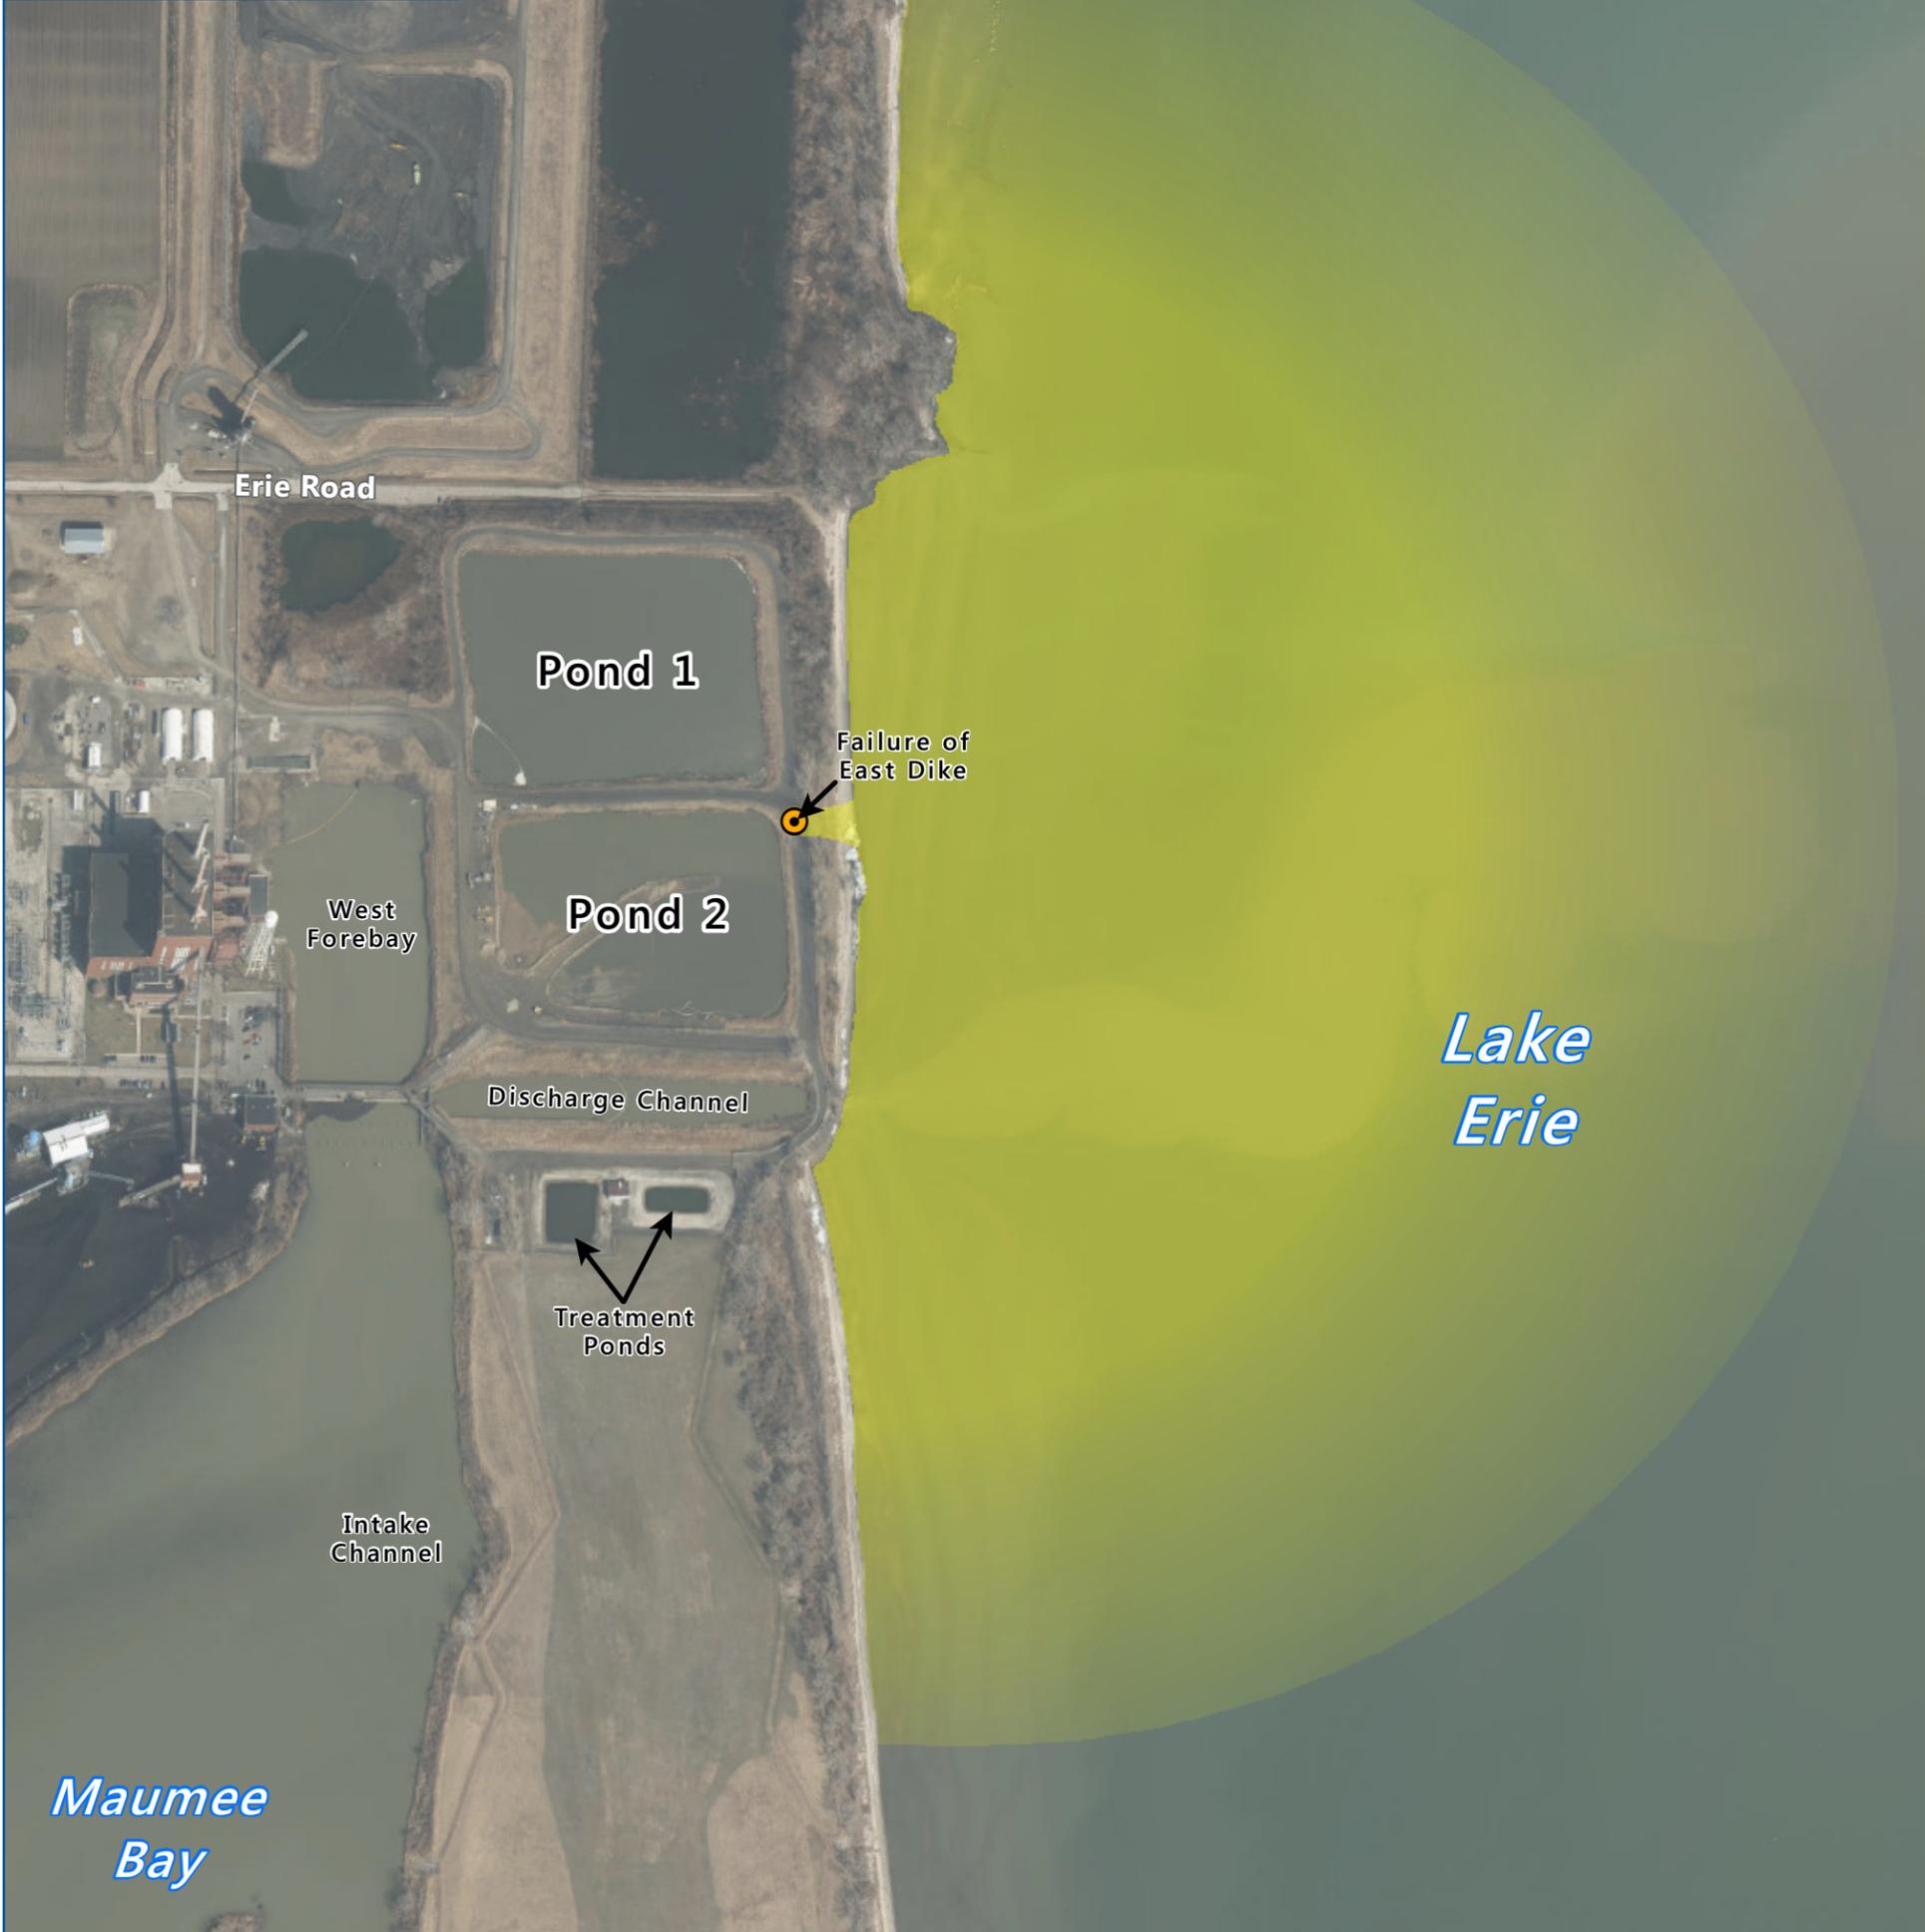
FIGURE 4

Affected Area: Potentially Impacted by CCR or Minor (<1') Water Level Rise

APPROXIMATE AFFECTED AREA DUE TO FAILURE OF EAST DIKE
JR Whiting Generating Plant
Consumers Energy Company
