# **Emergency Action Plan for Coal Combustion Residuals Unit**

## ***J. R. Whiting Facility***

Prepared for  
Consumers Energy Company

# Emergency Action Plan for Coal Combustion Residuals Unit at J. R. Whiting Facility

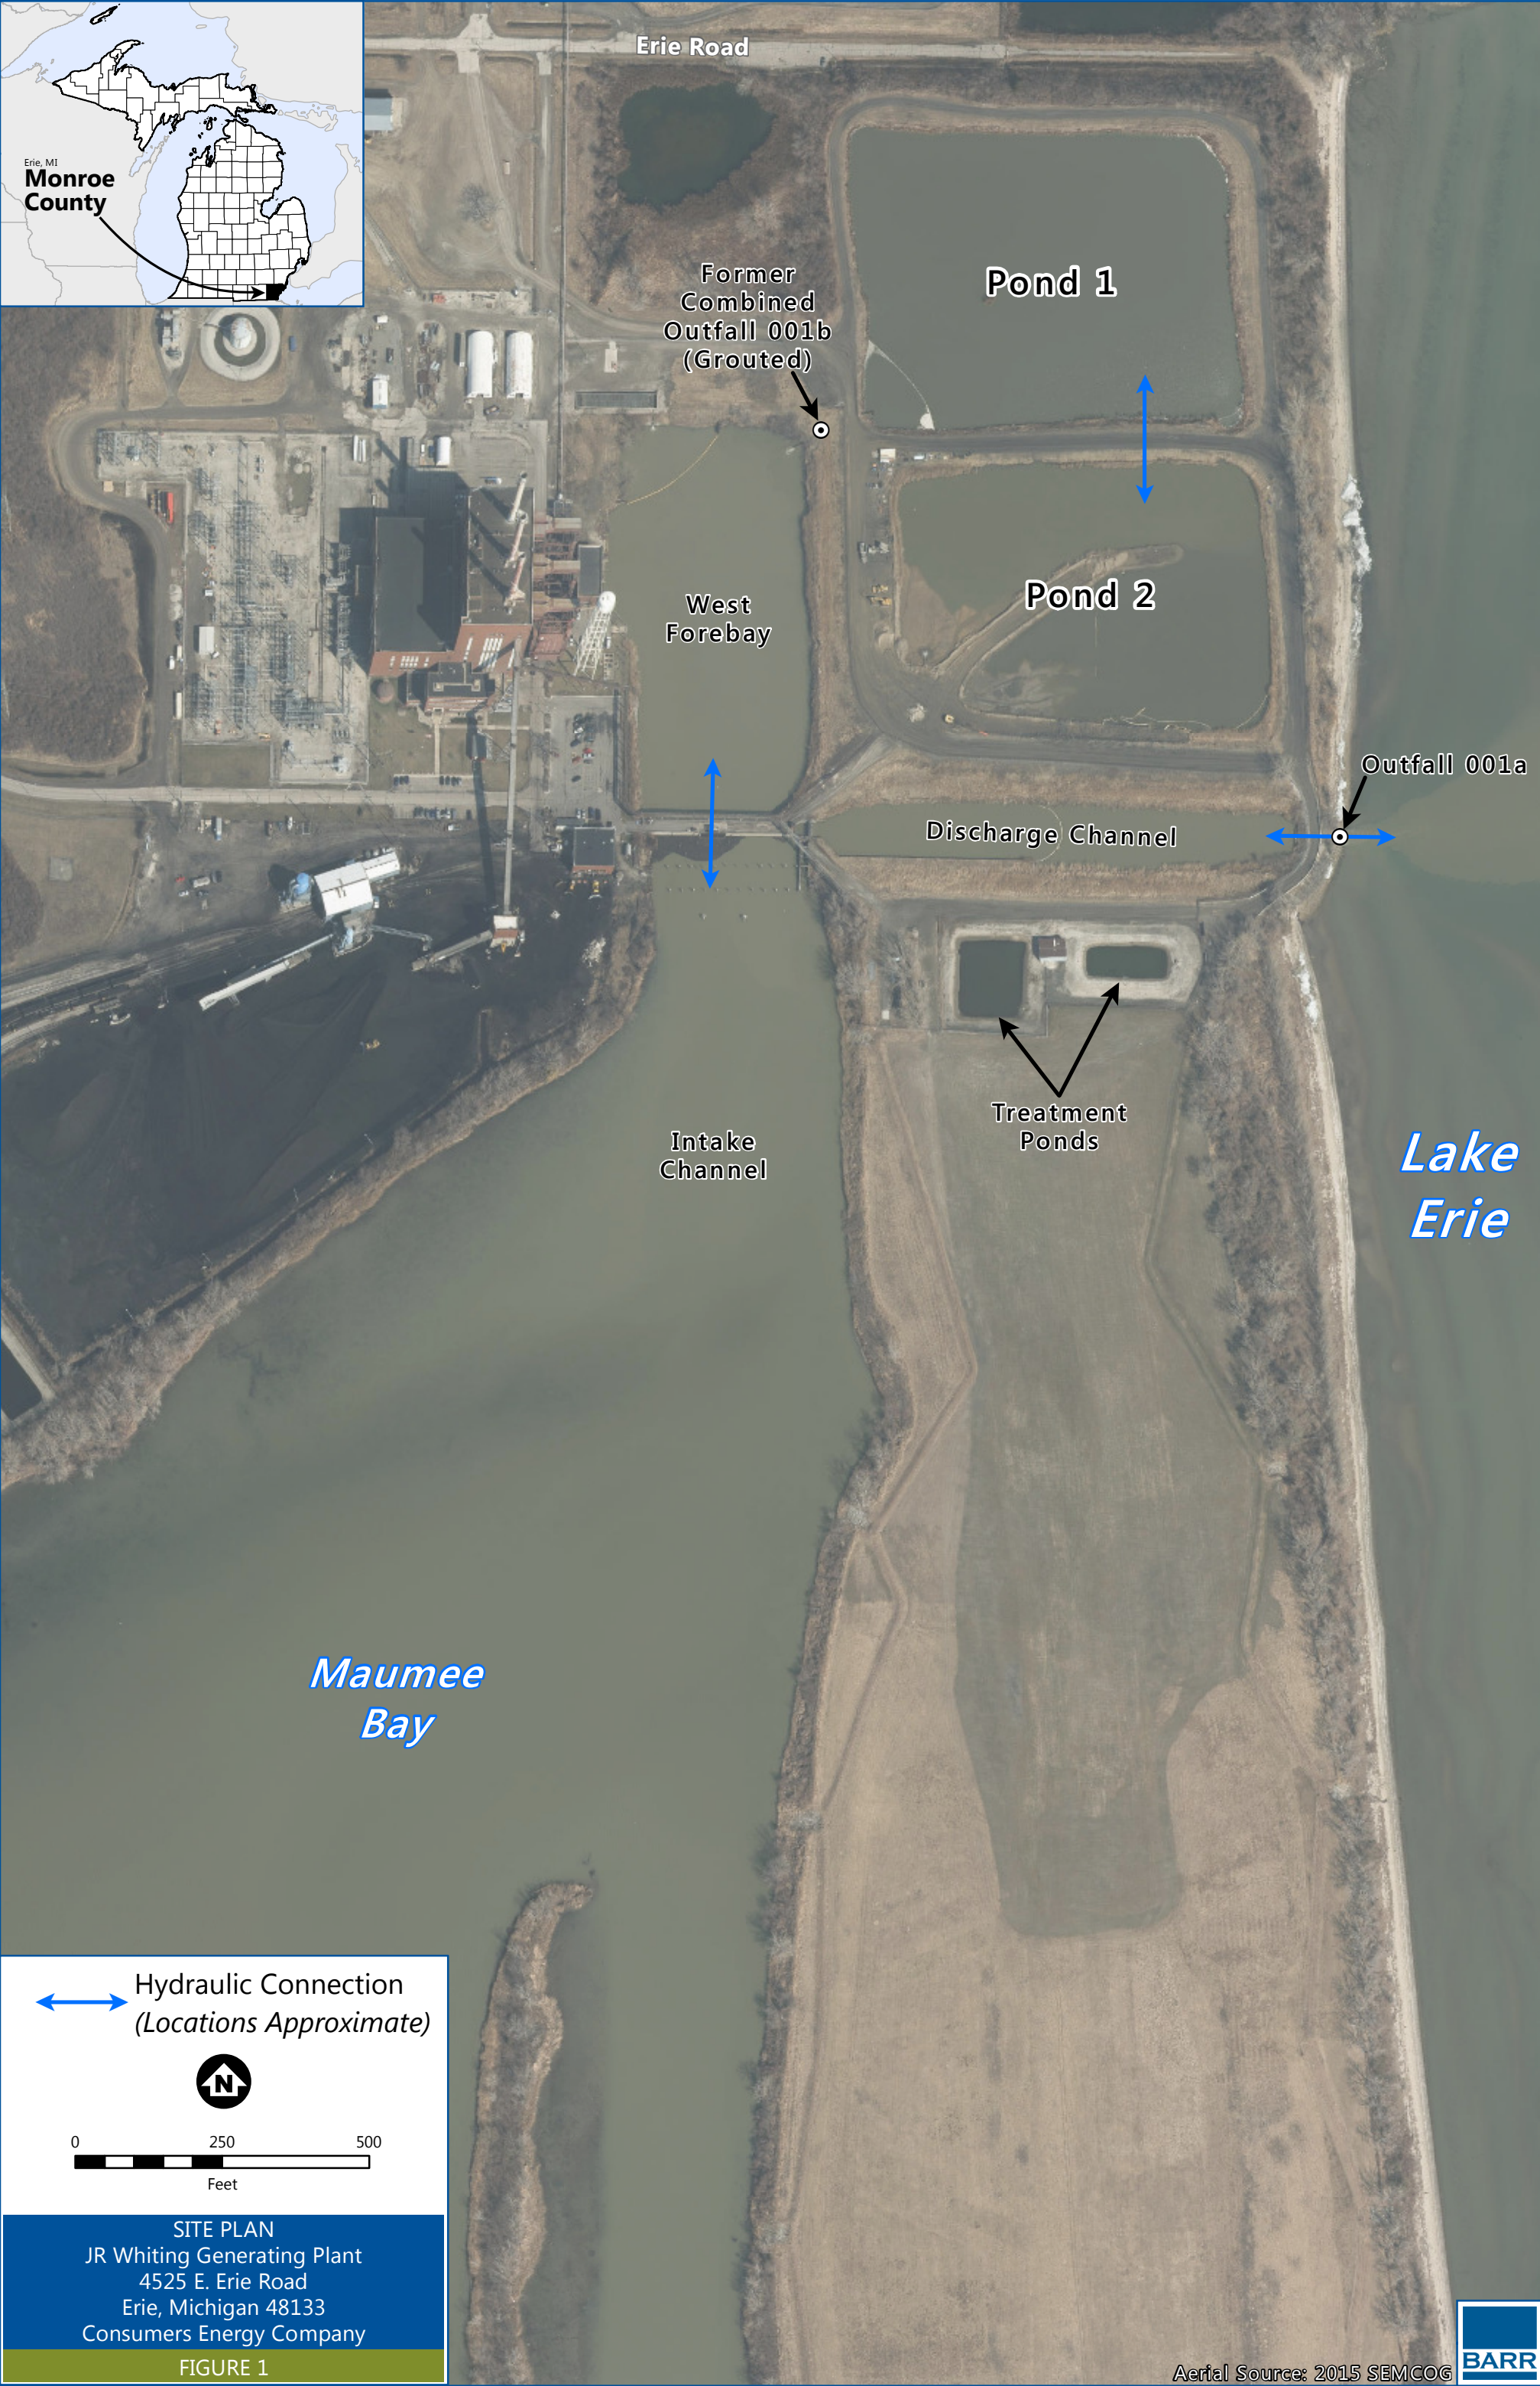
| Figure 1 | Site Plan |

The JRW facility is located in Erie, Michigan (shown on Figure 1). JRW's CCR surface impoundment (CCR unit), Pond 1&2, has been classified as a "significant hazard potential CCR surface impoundment" (Mannik Smith Group, 2016). The EAP provides CEC with a pre-planned and organized method to identify and implement a response to a safety emergency related to the CCR unit. The impoundments are bounded on the west by the west forebay, on the south by the facility's formerly used cooling water discharge channel, and on the east by a public beach on the shore of Lake Erie. The generation facility is not in operation and no longer discharges water or CCR material to the impoundments. Only rain which falls on the impoundments and potential, though unlikely, precipitation overflow from the nearby treatment ponds contribute additional water to the impoundments.

Key features and hydraulic connections of the waterbodies adjacent to the CCR unit are shown on Figure 1. As depicted, the west forebay is connected to the intake channel (Maumee Bay) through a concrete structure beneath the causeway. The discharge channel is connected to Lake Erie via culverts at the east end of the channel. Formerly, the west end of the discharge channel was connected to the intake channel via a recirculating gate structure, but this has been permanently closed and filled with concrete.
