J.H. Campbell Generating Facility

Pond A - Construction Documentation Report

Golder Associates Inc.

October 1, 2019

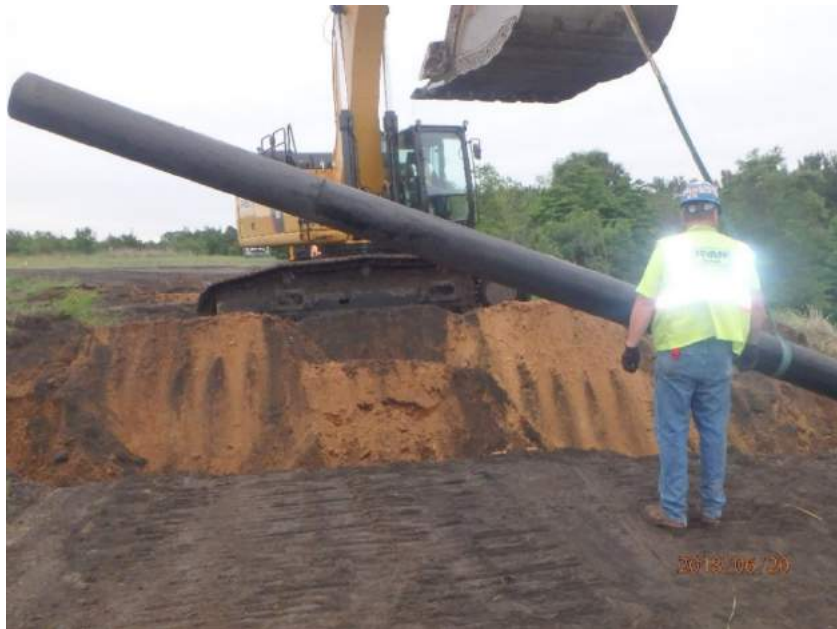
Location: Installing 12-inch pipe through road from pond A to the south perimeter ditch.

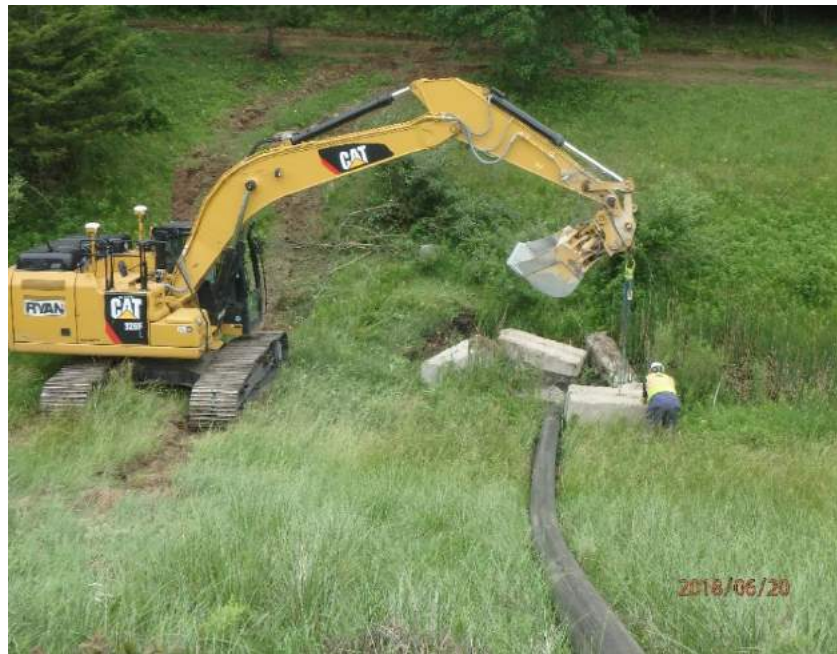
Photo 2:

Location: Installing concrete blocks for erosion control at outfall of 12-inch pipe in south perimeter ditch.

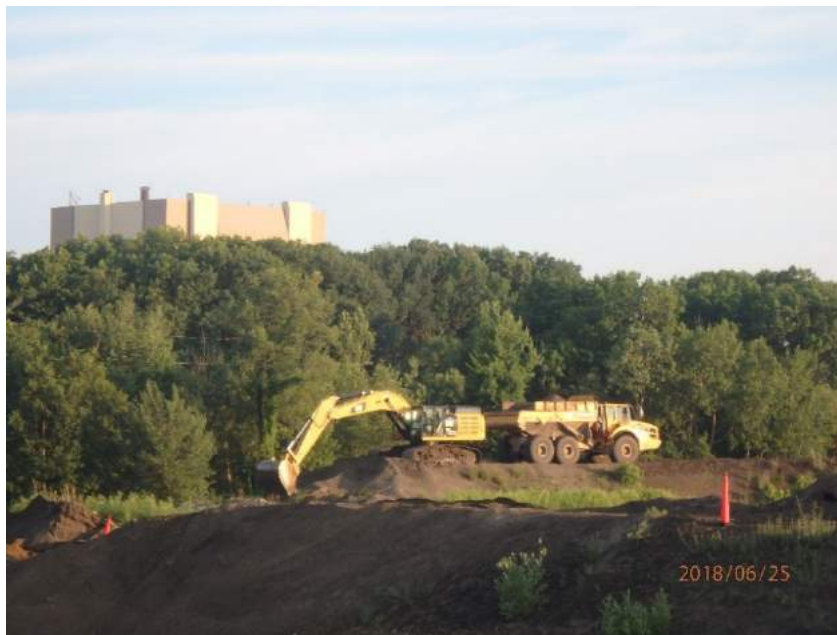
Location: Loading bottom ash from west slope of Pond 1-2N.

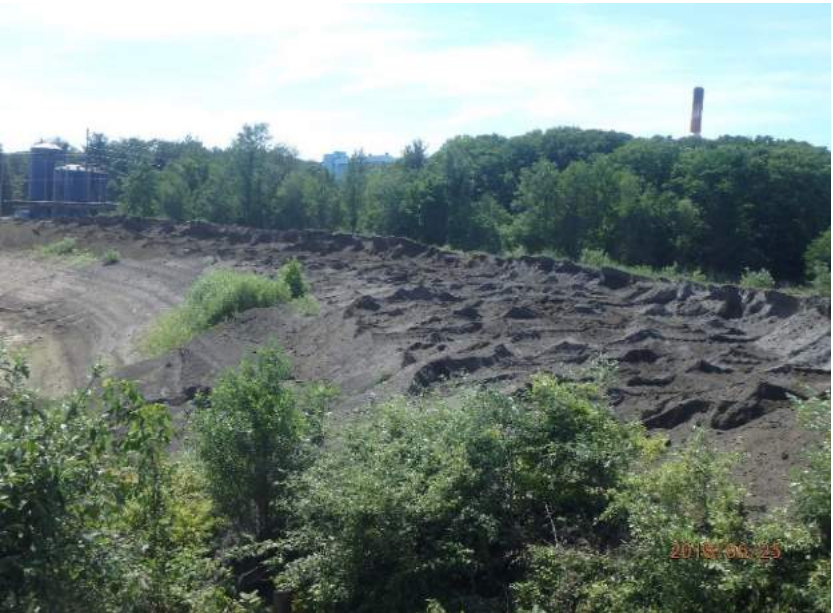
Daily Photographic Overview	
Description	Photo
Photo 3:

Direction: W	
Location: North slope of Pond 1-2N after day's excavation of bottom ash from the slope.

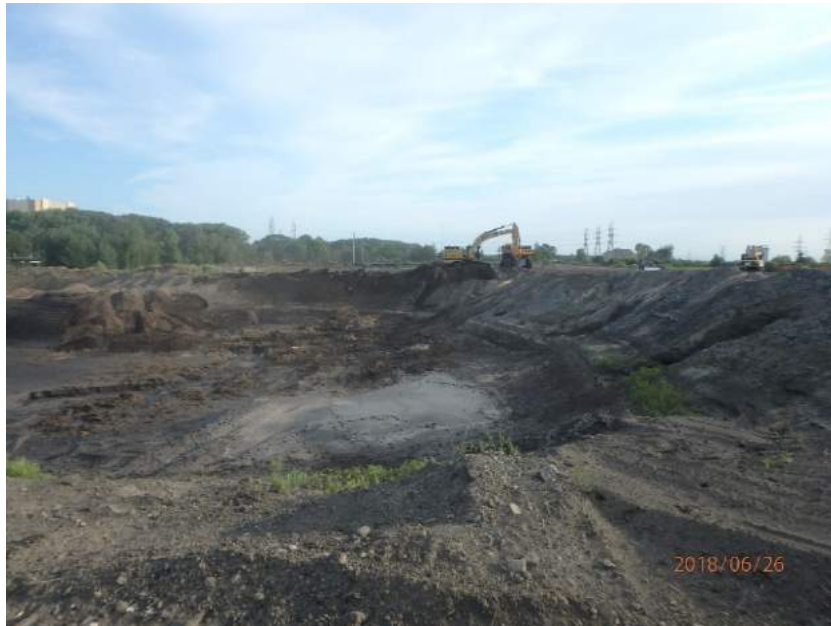
Location: Excavation of berm
between Pond 1-2S and 1-2N.

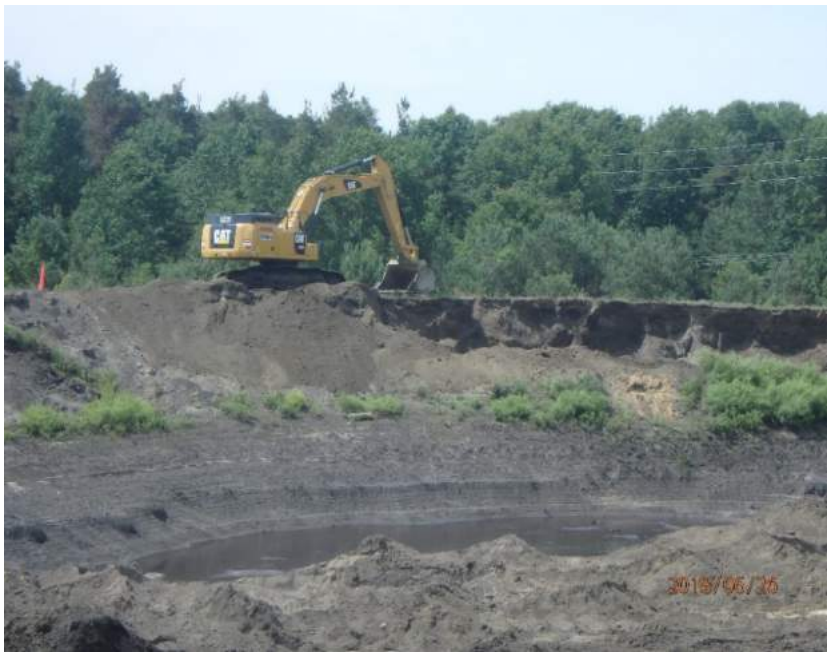
Photo 2:

Location: Excavation of southern
slope of Pond 1-2S.

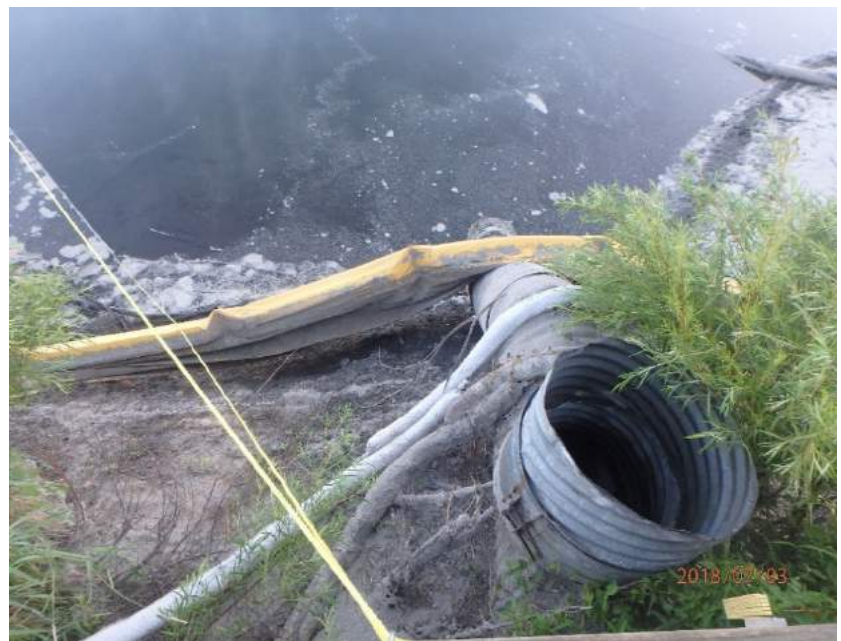
Photo 2:

Location: Existing overflow pipe in pond A

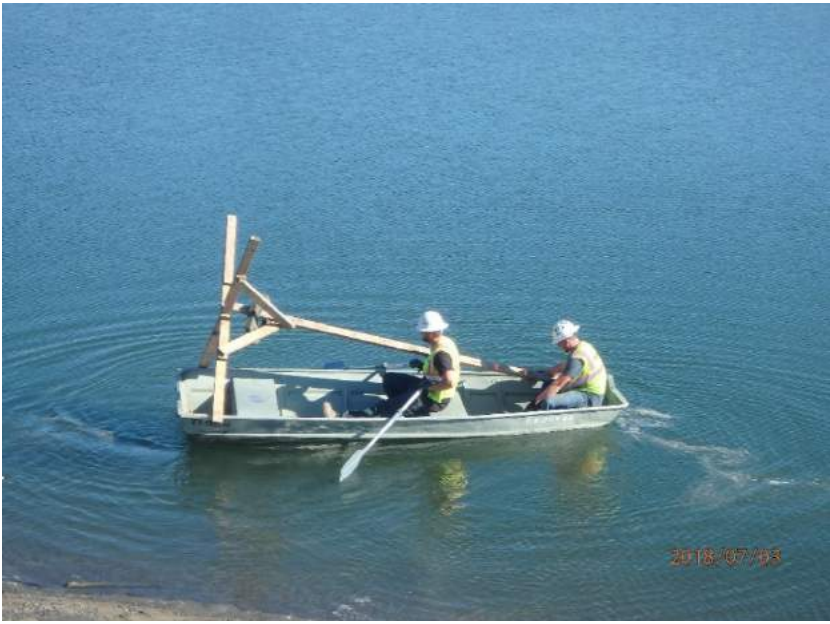
Description	Photo
Photo 3:

Direction: N	
Location: Installing a water level indicator in Pond A.	
Photo 4:

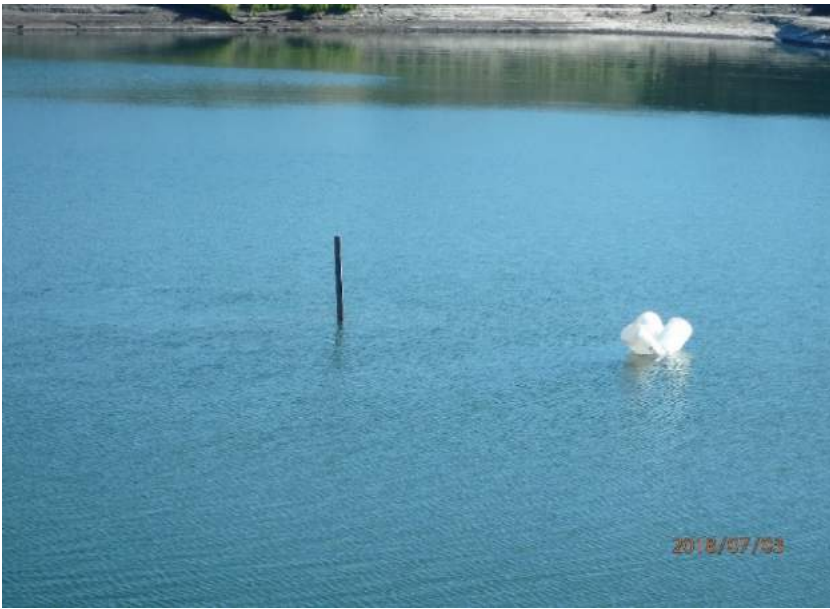
Direction: N	
Location: Water level indicator in Pond A.

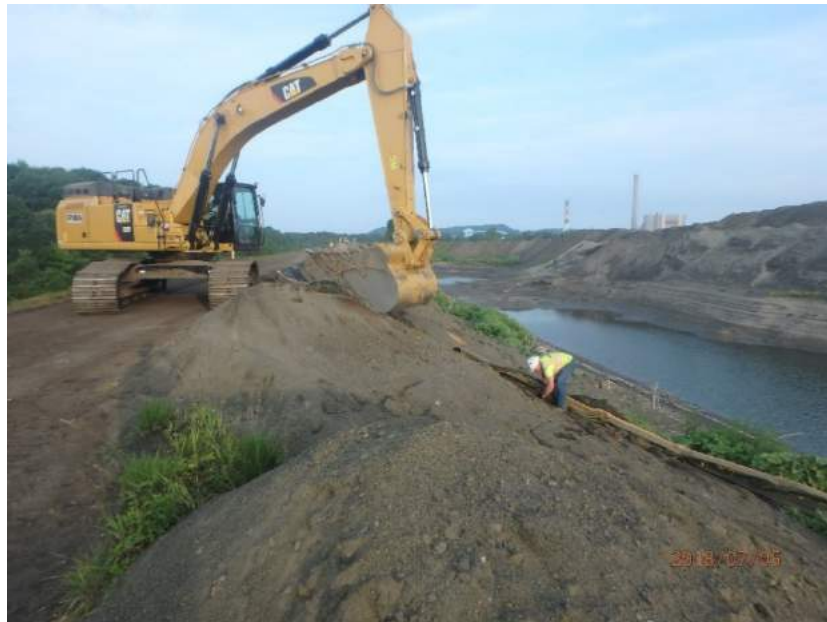
Location: Removal of the turbidity curtain from Pond A.

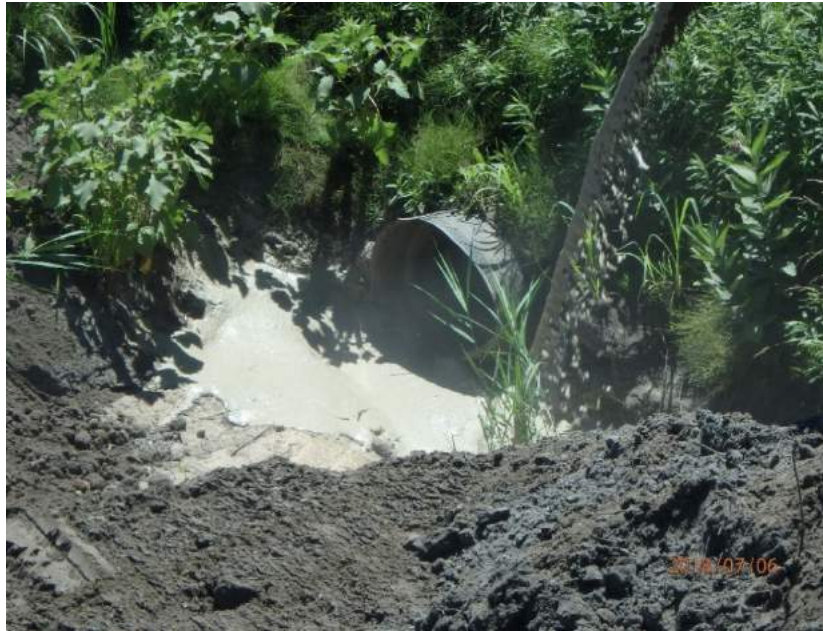
Location: Backfilling of the 24-inch PE pipe with flowable fill.

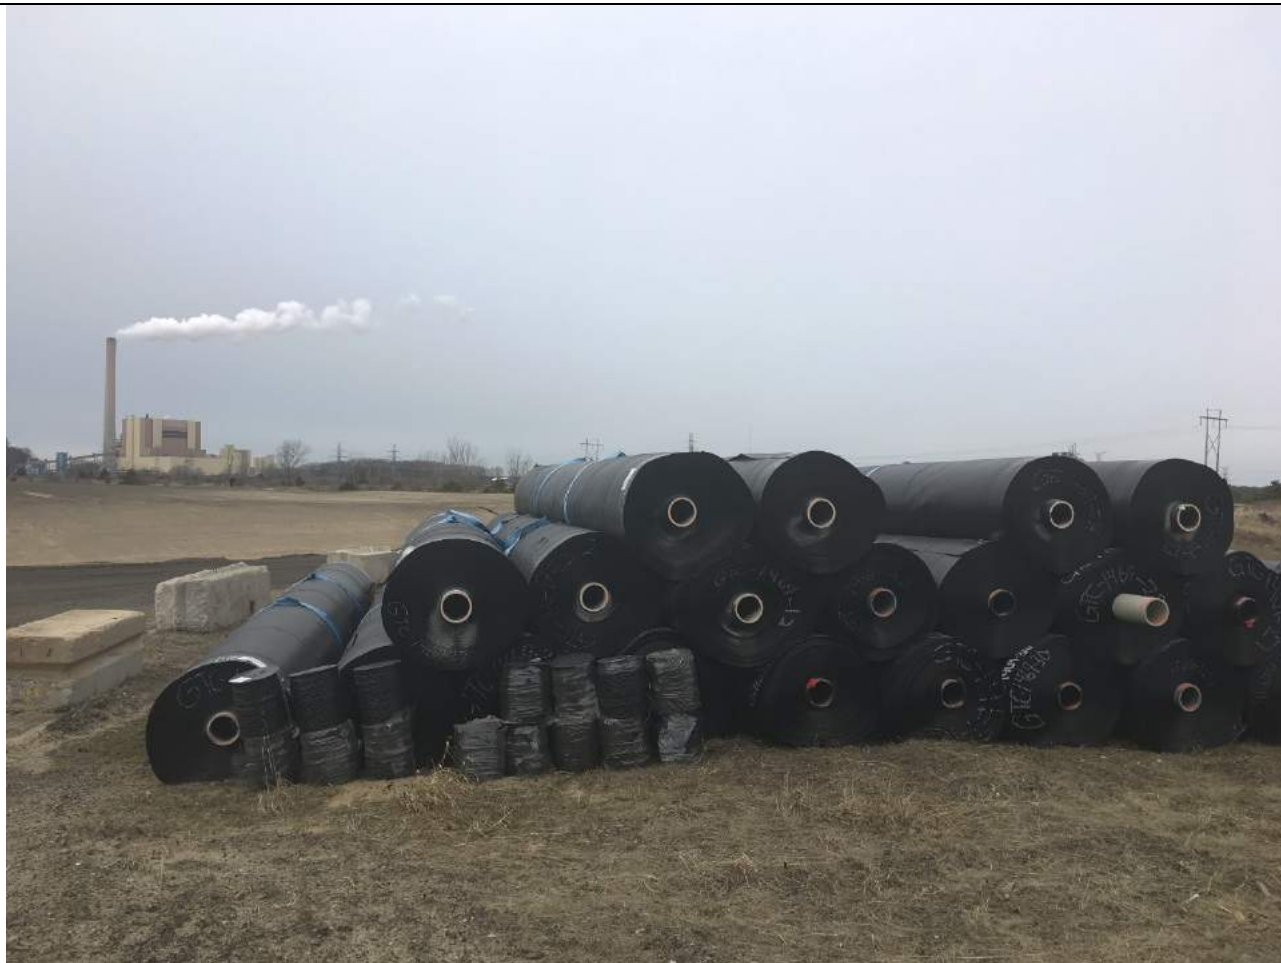
Stockpiled Geosynthetic Material for Pond A.

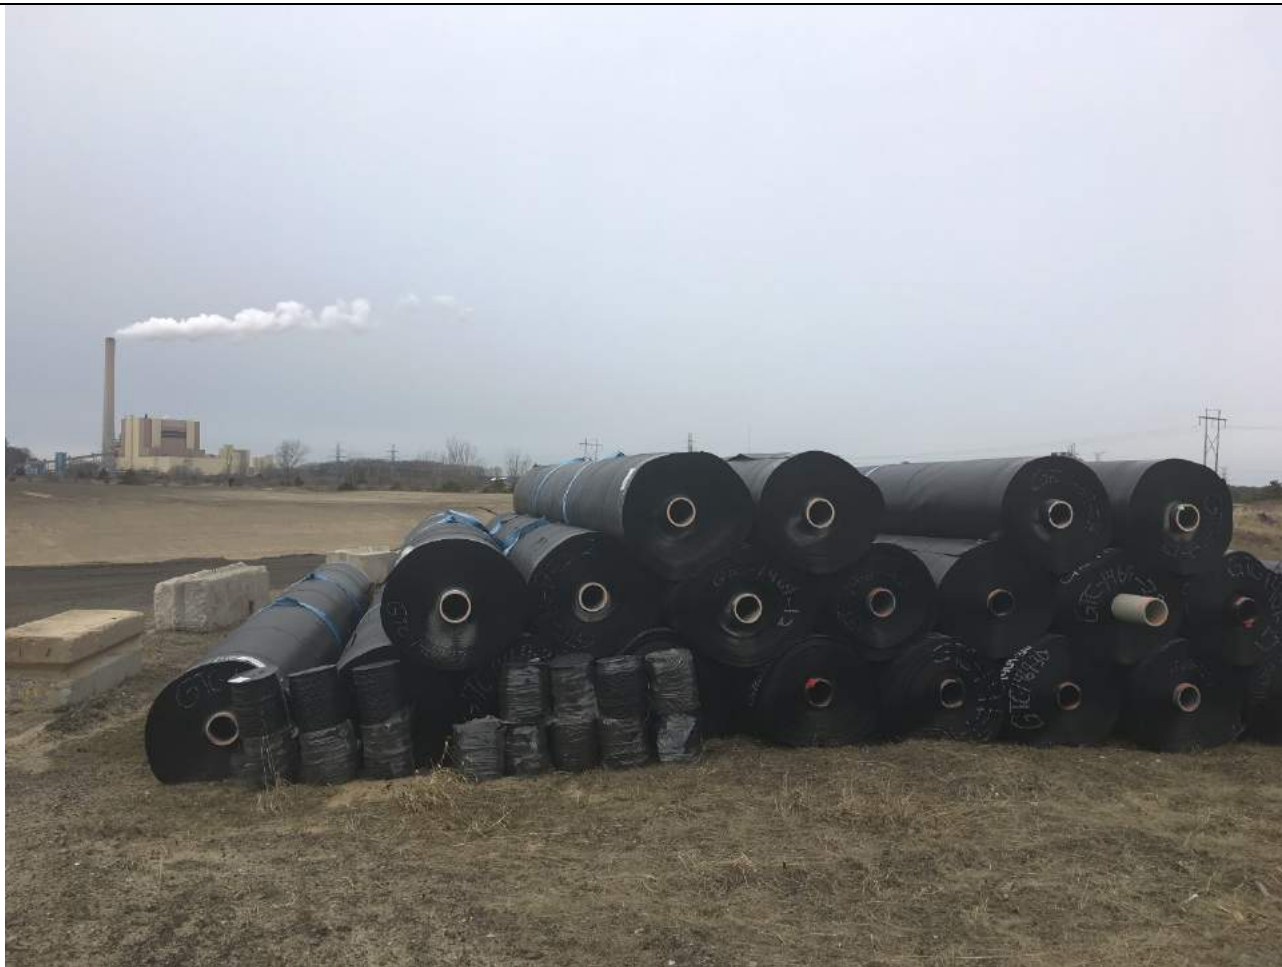
Stockpiled Geosynthetic Material for Pond A.

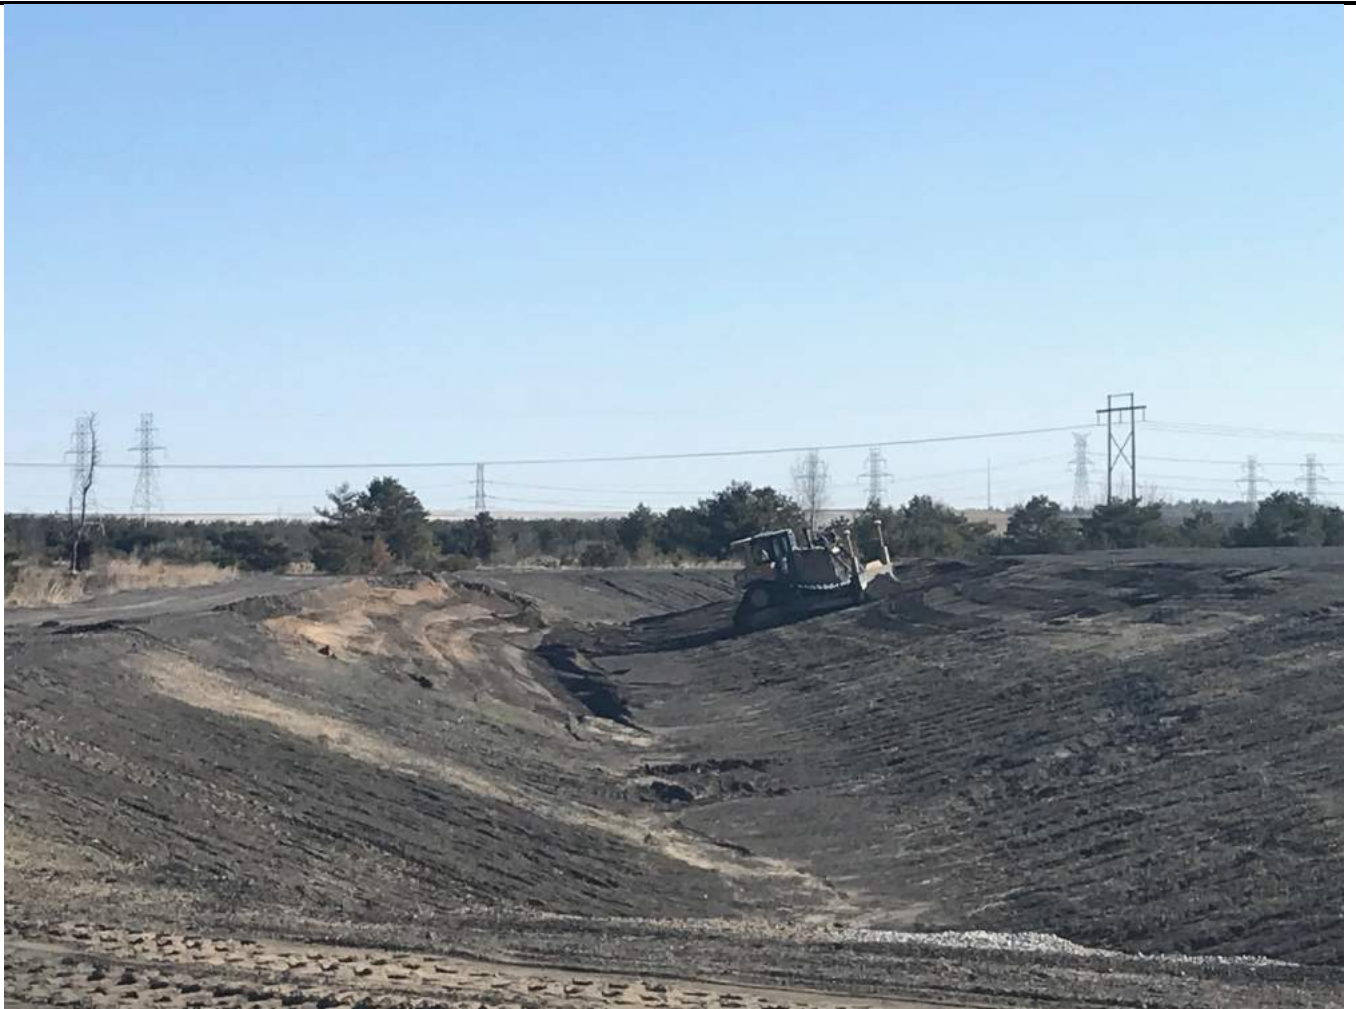
Dozing subgrade to meet grade tolerance.

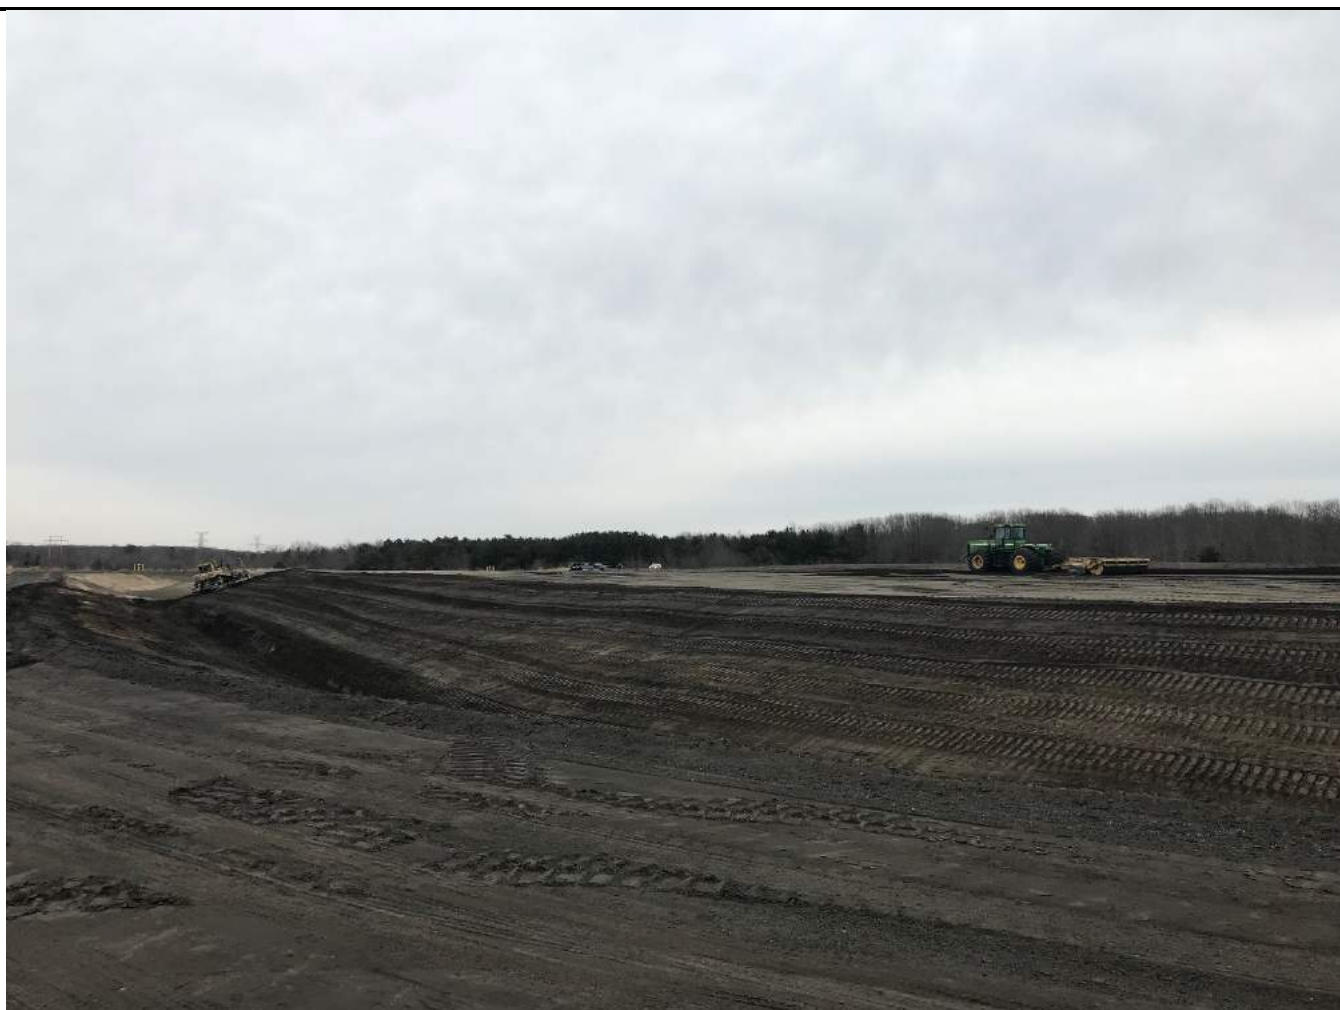
Dozer and Tractor w/ rollerblade preparing subgrade.

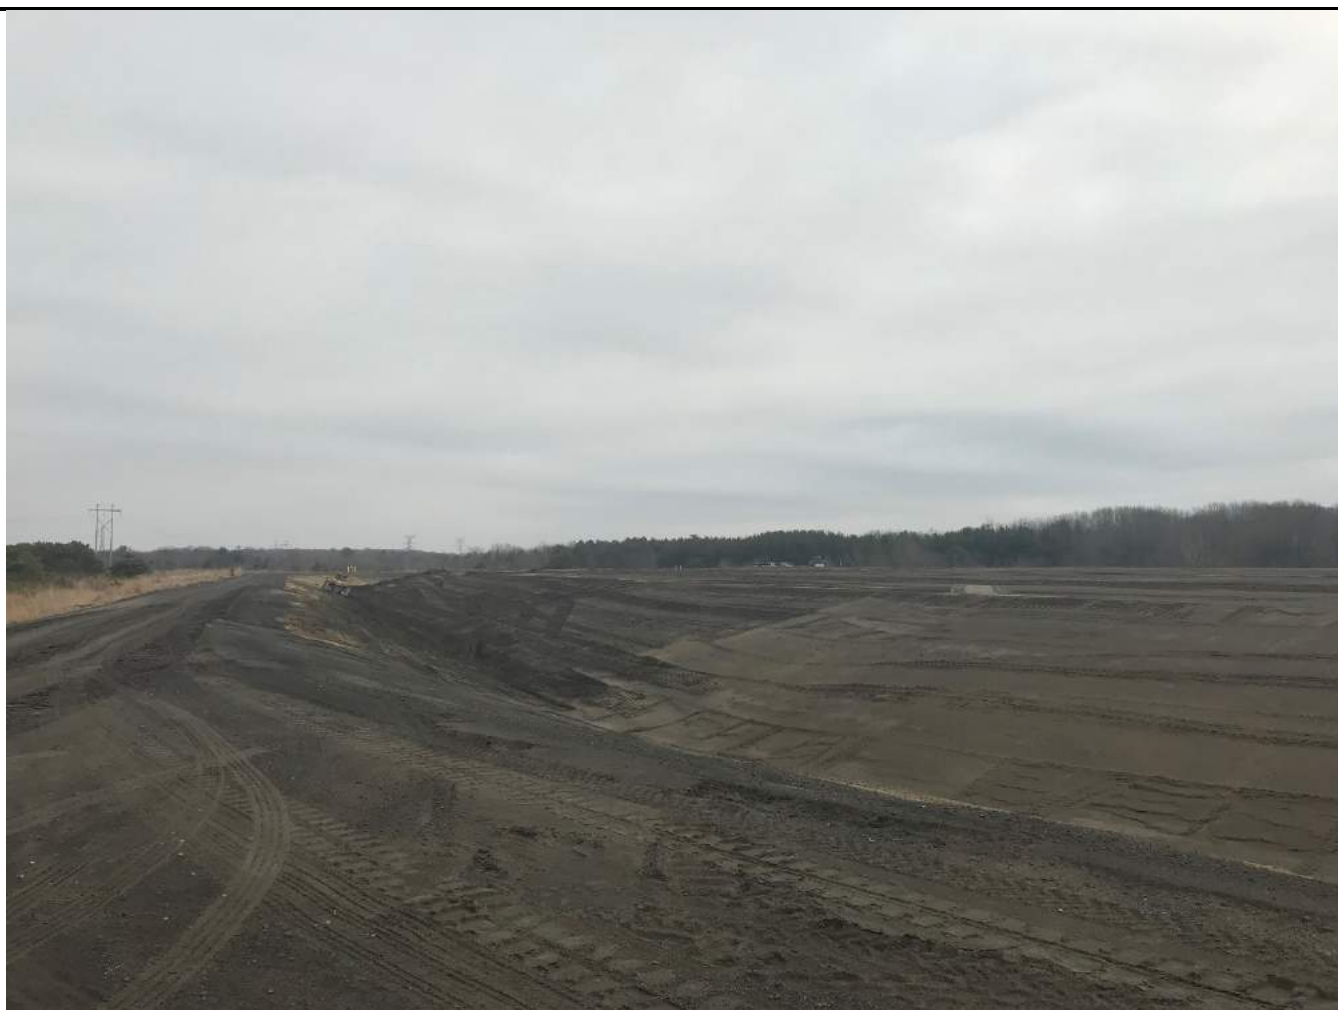
Dozer preparing subgrade.

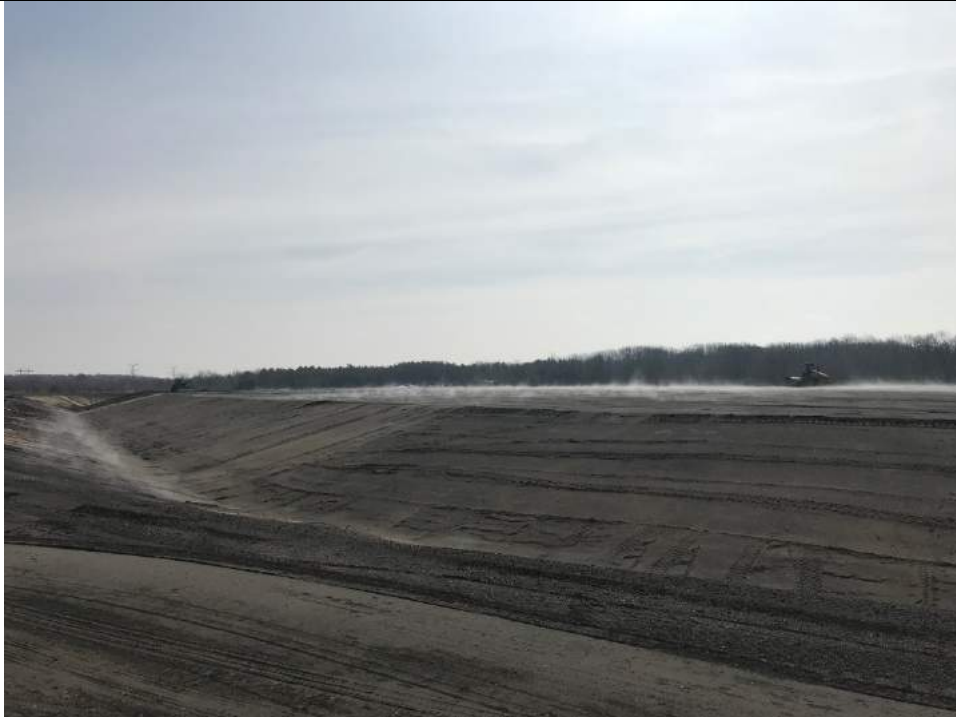
Dozer and drum roller preparing subgrade.

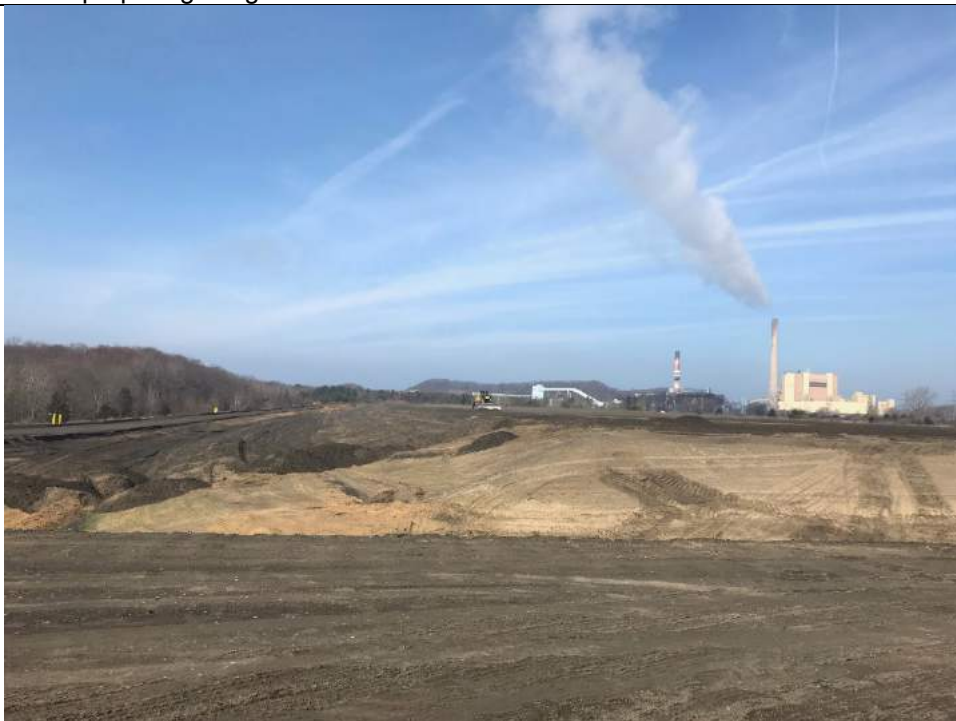
Dozer preparing subgrade.

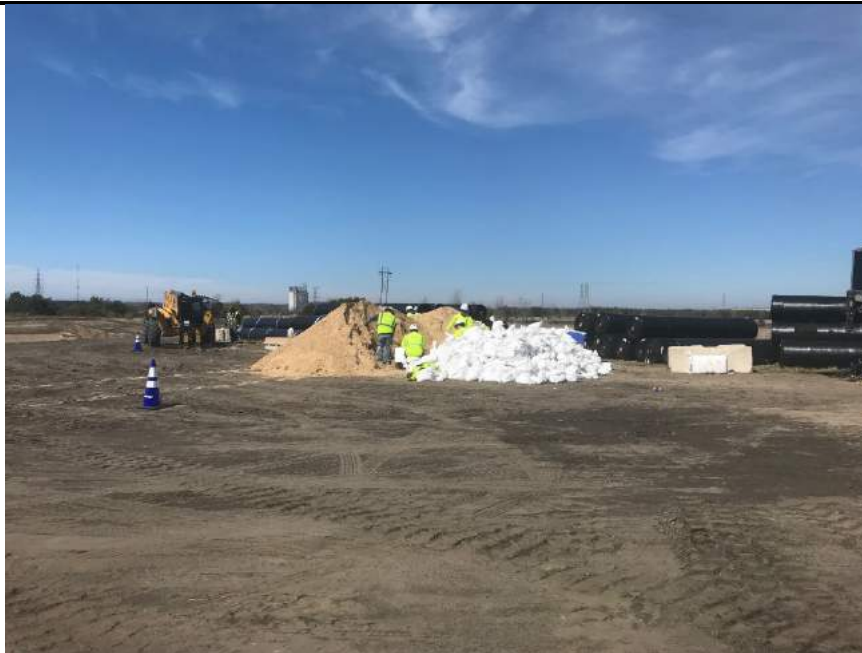
CCS laborers filling sand bags

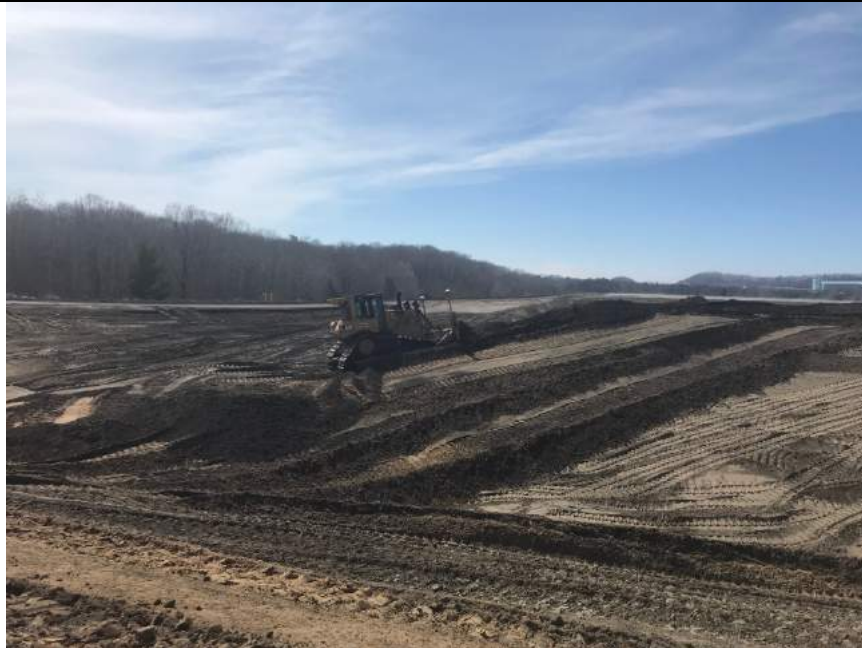
Dozing subgrade to meet tolerance.

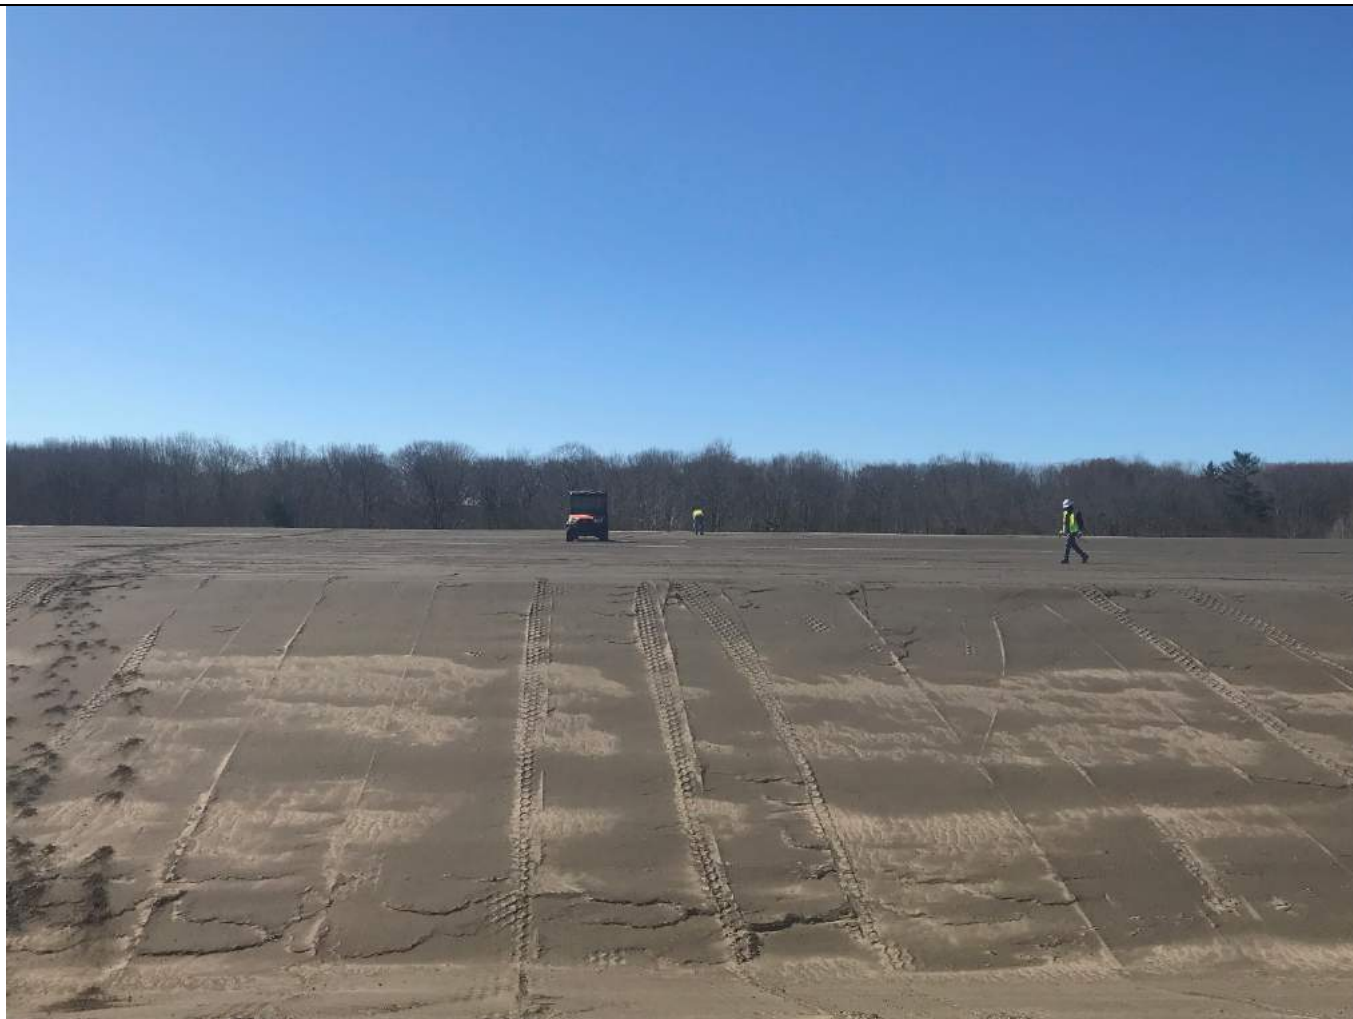
Ryan laborers rock-picking Pond A subgrade

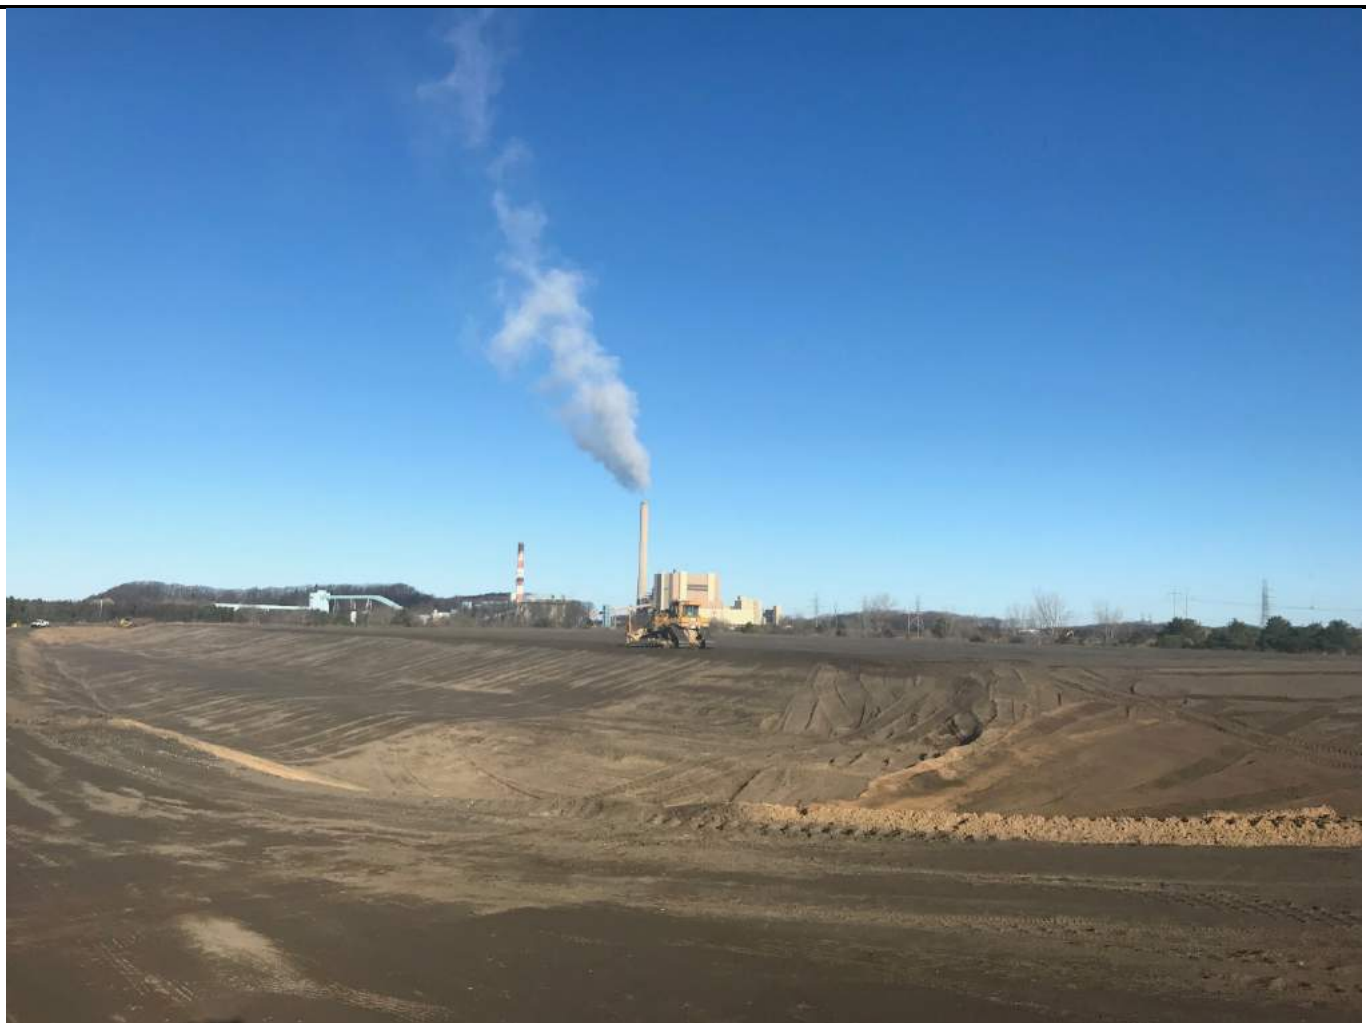
Dozer preparing subgrade.

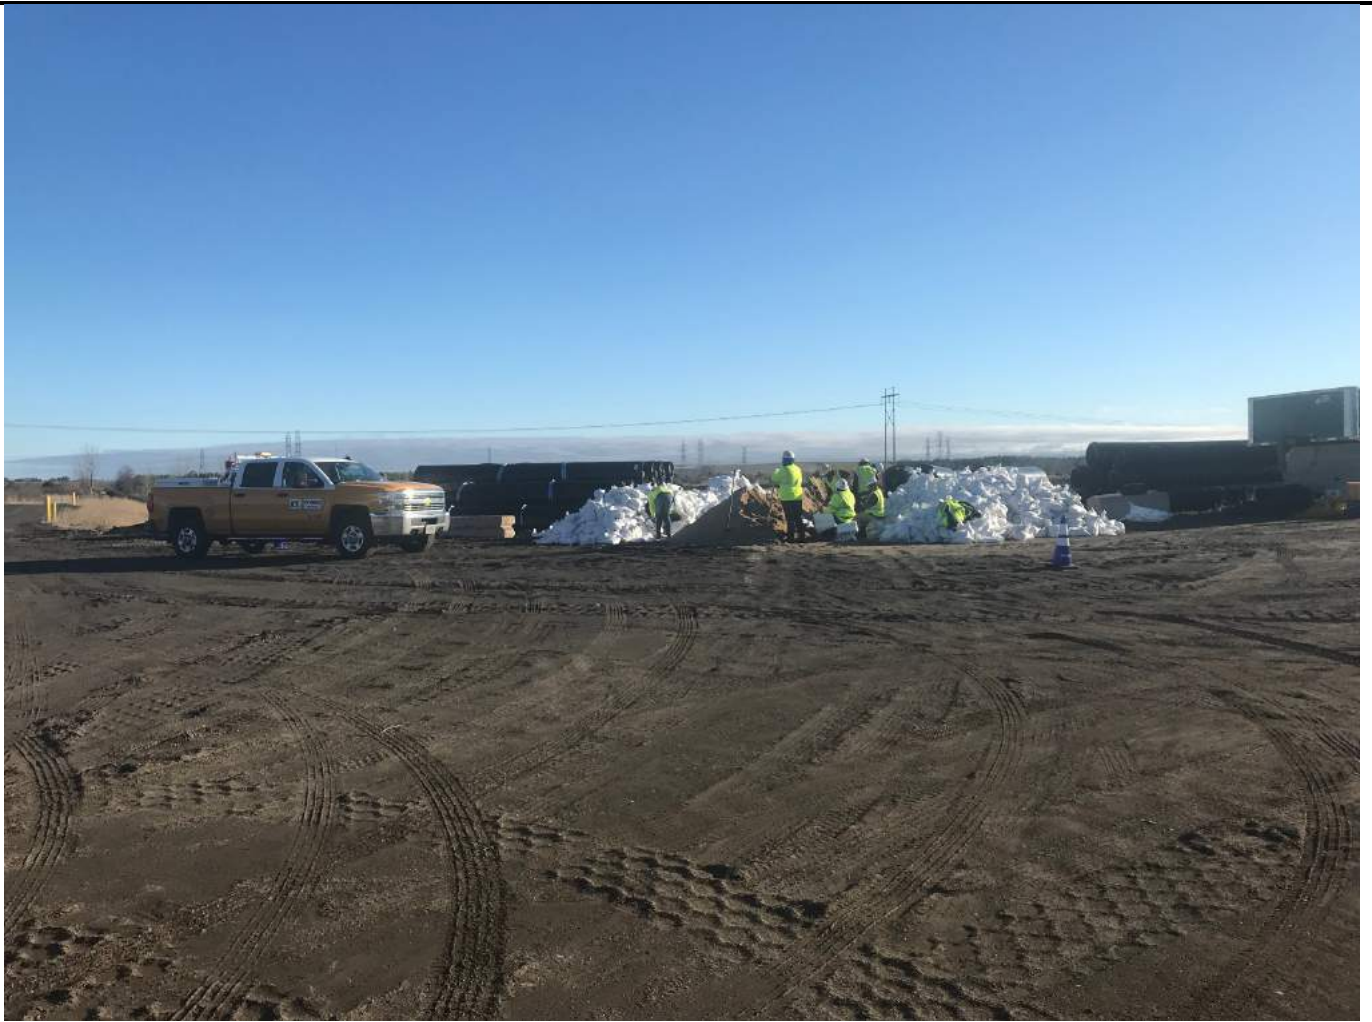
CCS laborers filling sand bags

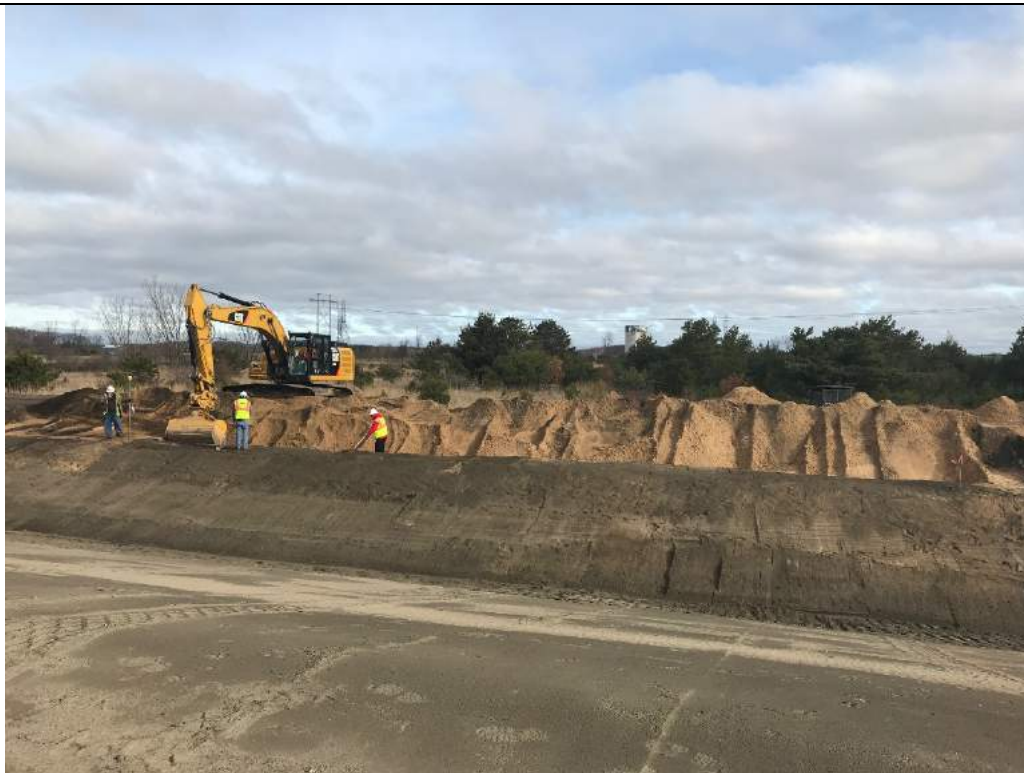
Ryan excavating anchor trench on the north side of Pond A.

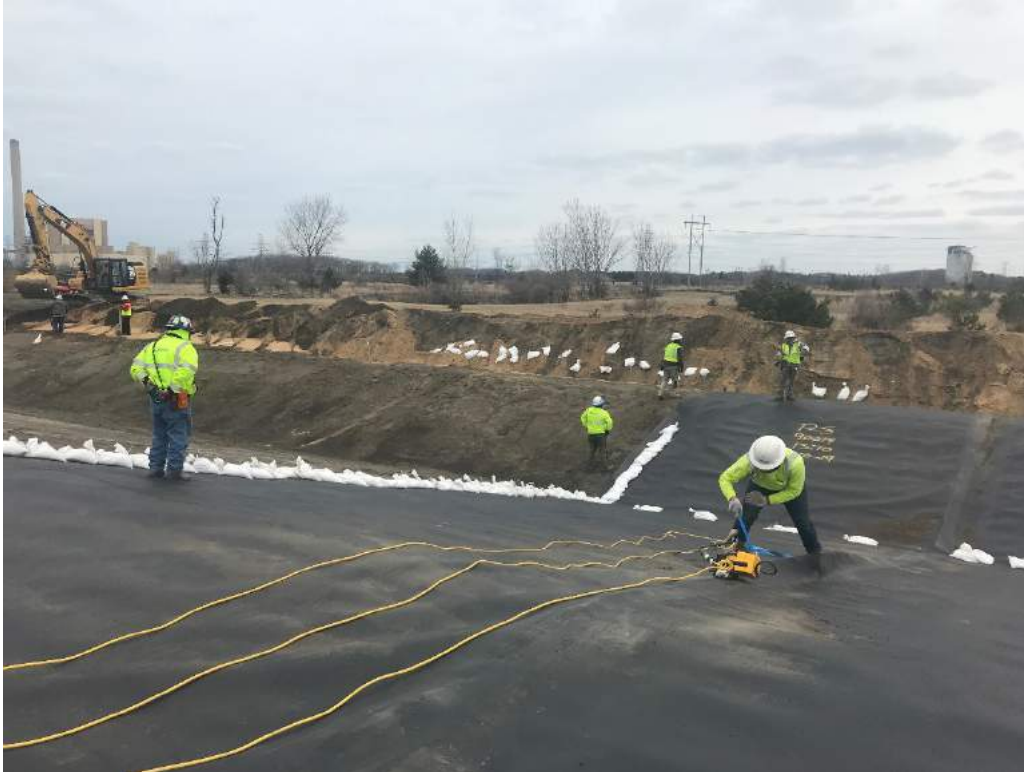
Fusion seaming along the north slope of Pond A.

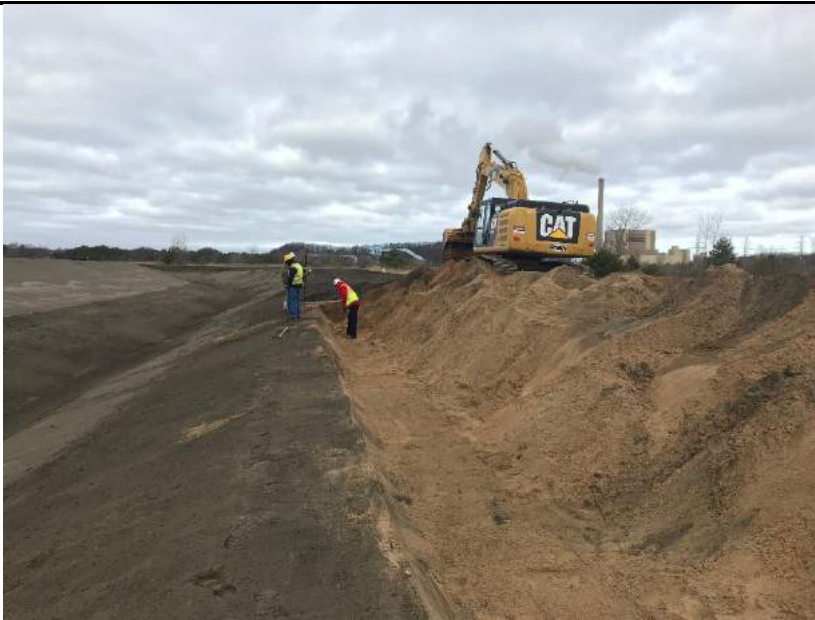
Anchor trench along the north side of Pond A.

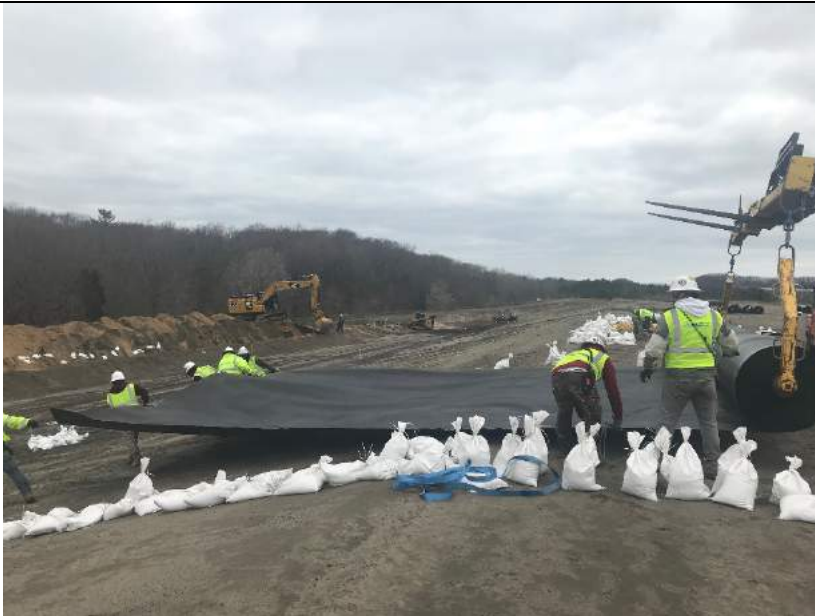
Deploying Panel 1.

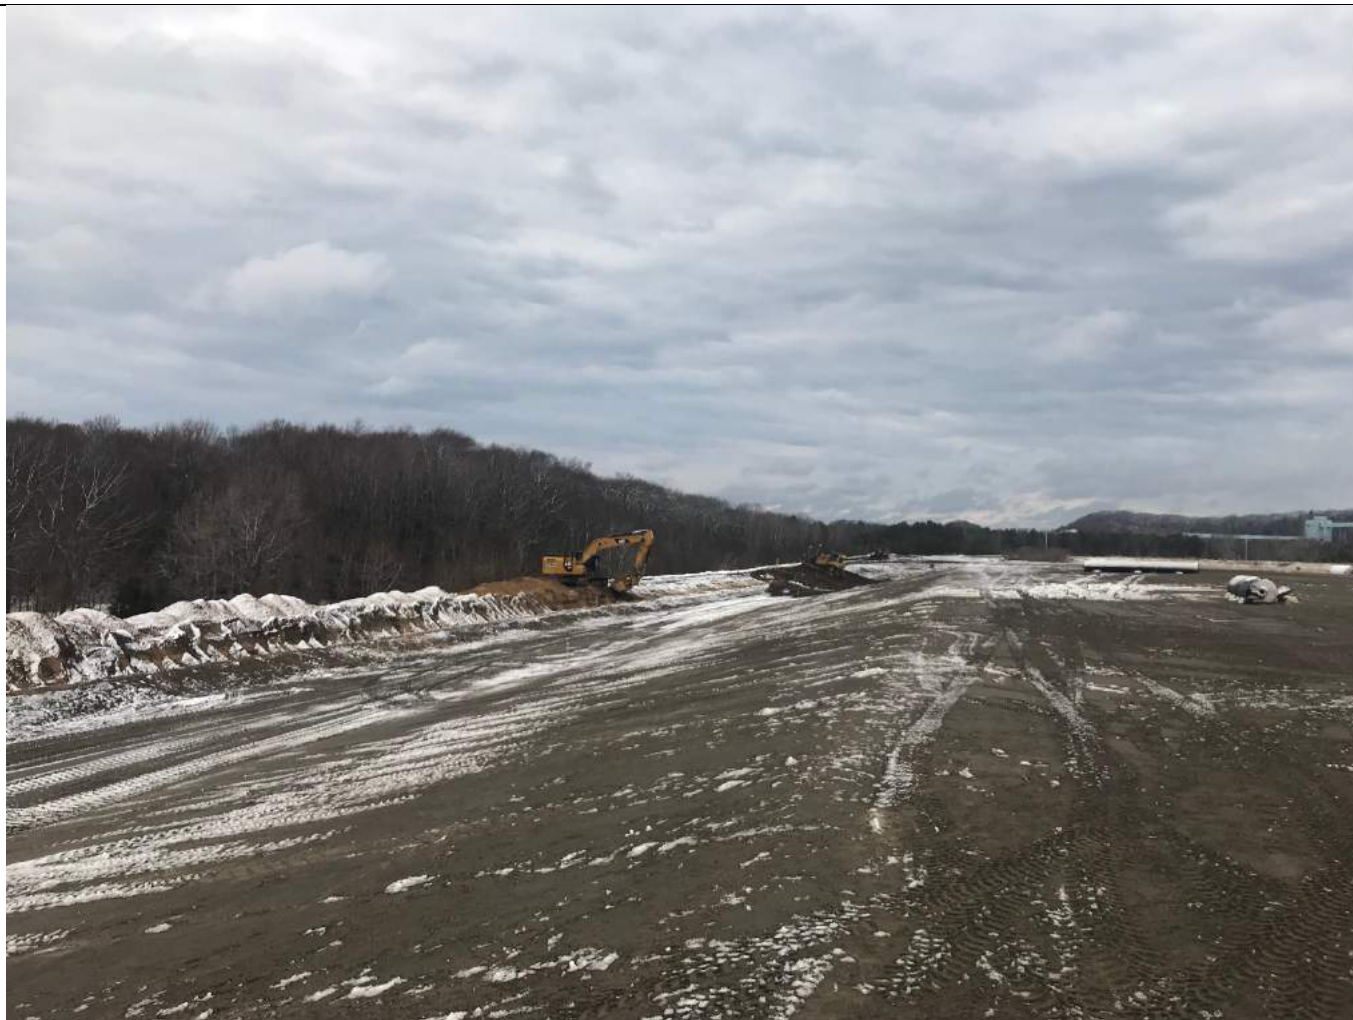
Ryan excavating the anchor trench on the south side of Pond A.
