J.H. Campbell Generating Facility

Pond A - Construction Documentation Report

Golder Associates Inc.

October 1, 2019

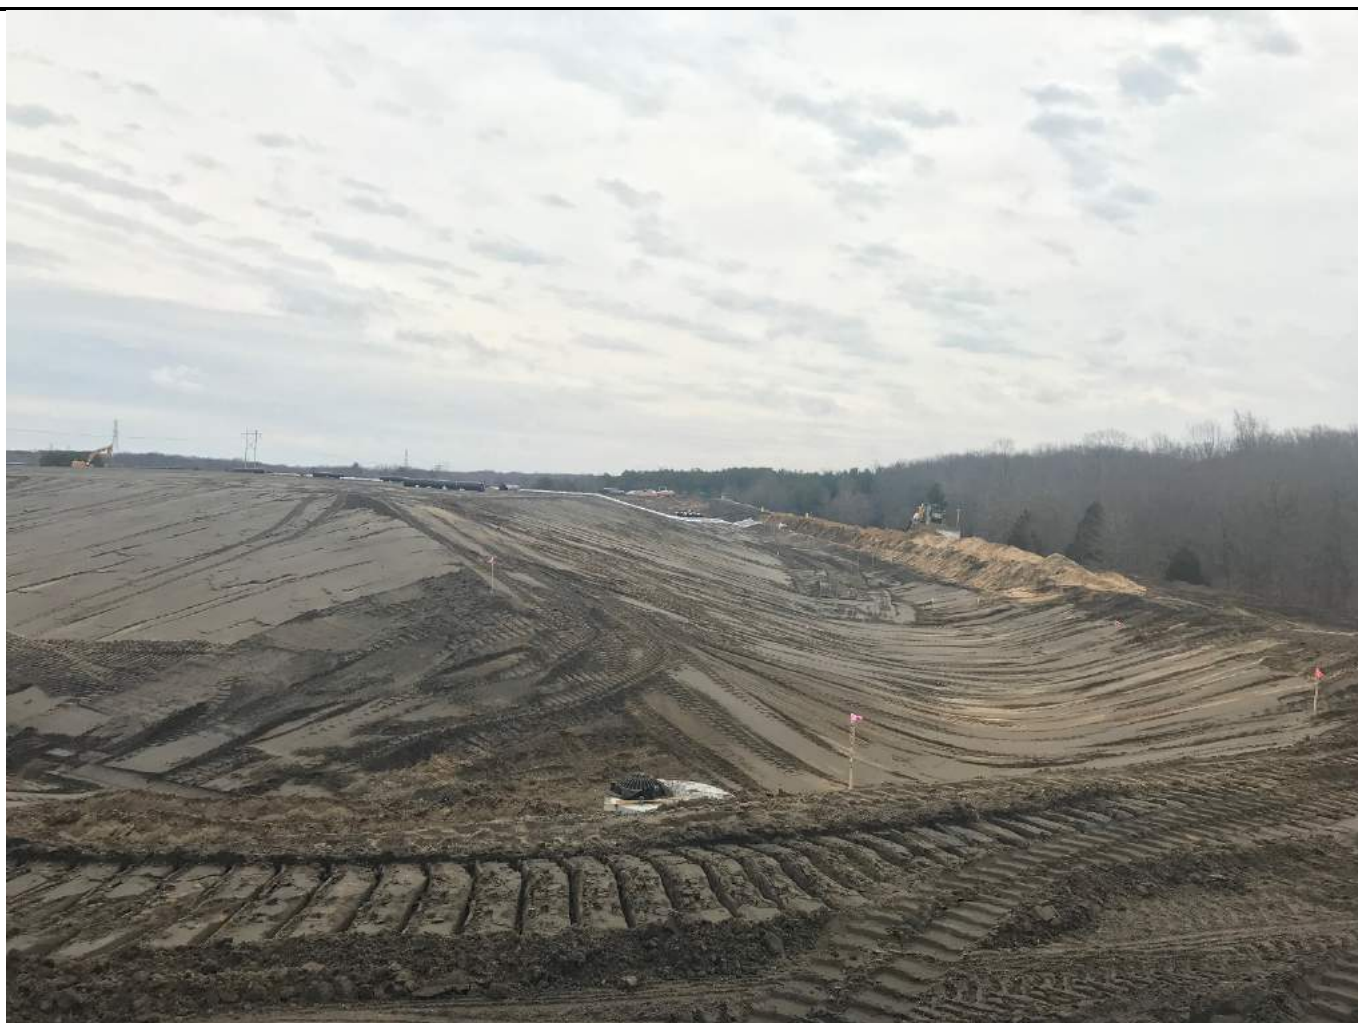
Southern slope of Pond A shot from the southwest corner.

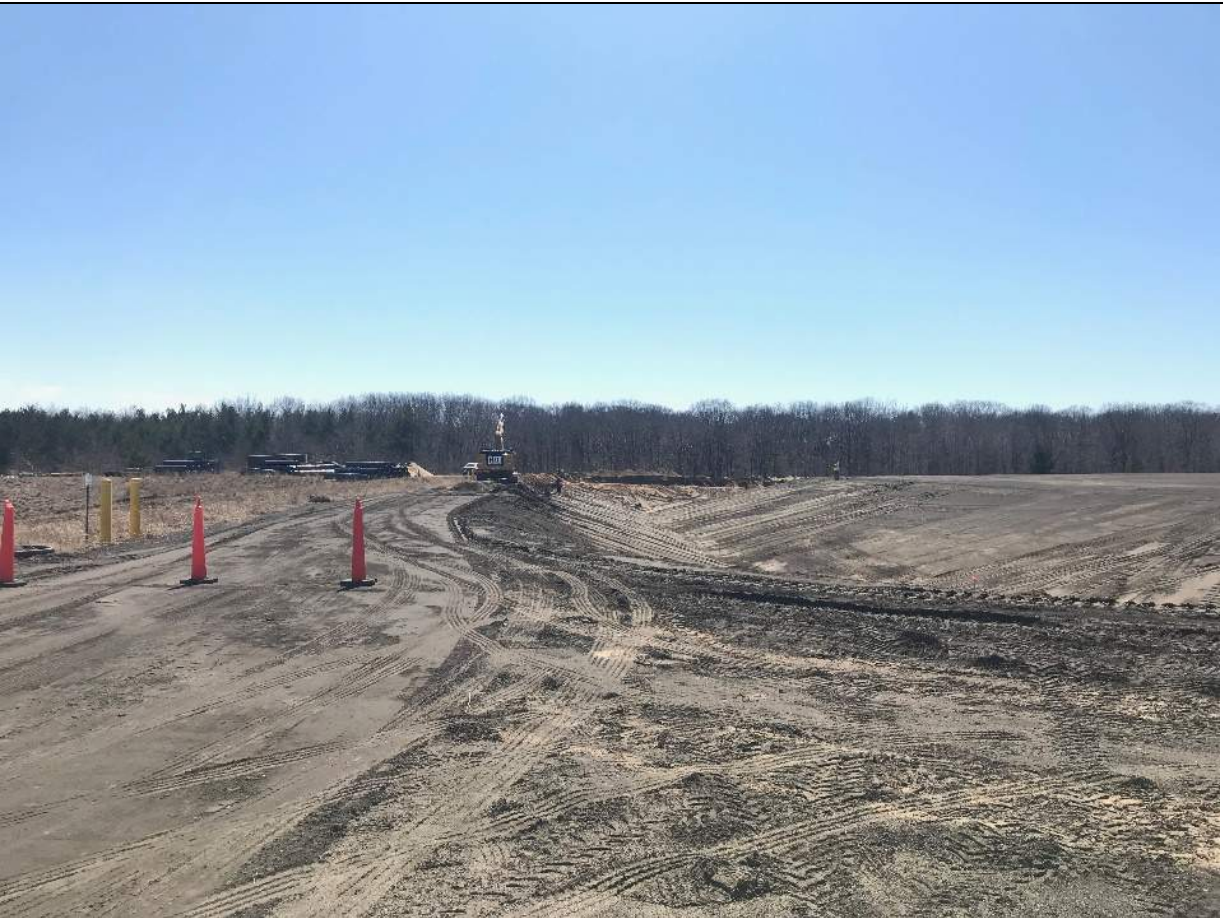
Ryan excavating the anchor trench on the east side of Pond A.

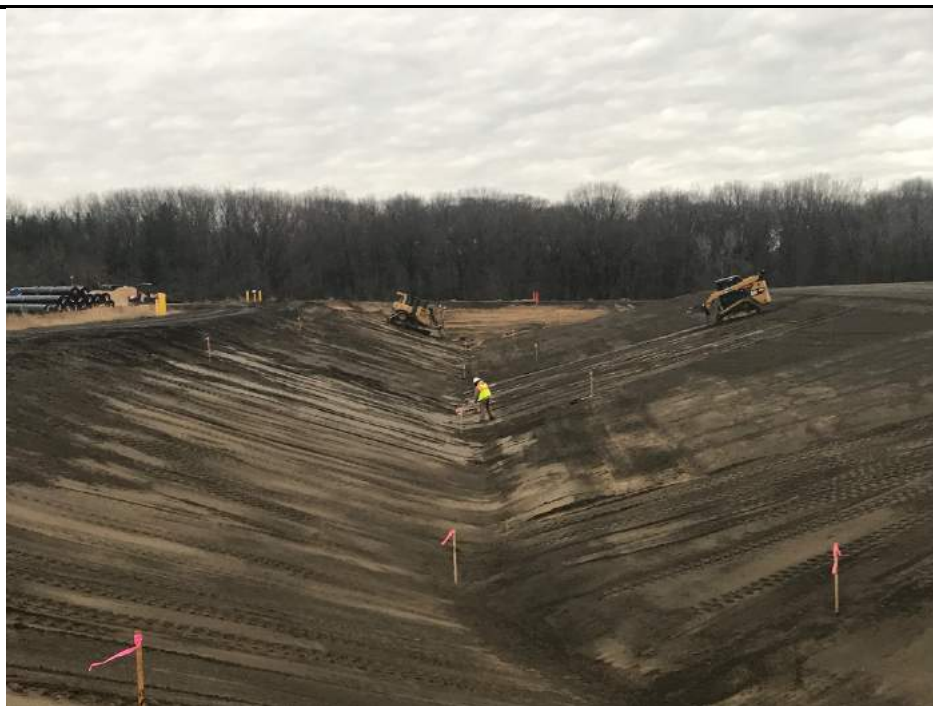
Ryan preparing subgrade along the eastern slope of Pond A.

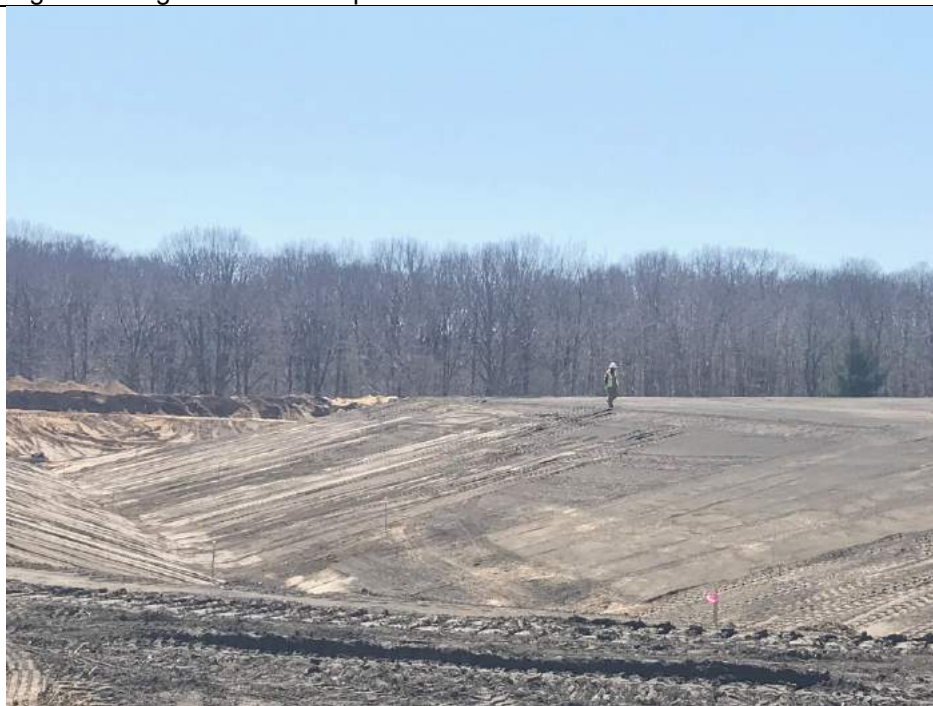
Ryan laborer rock-picking subgrade.

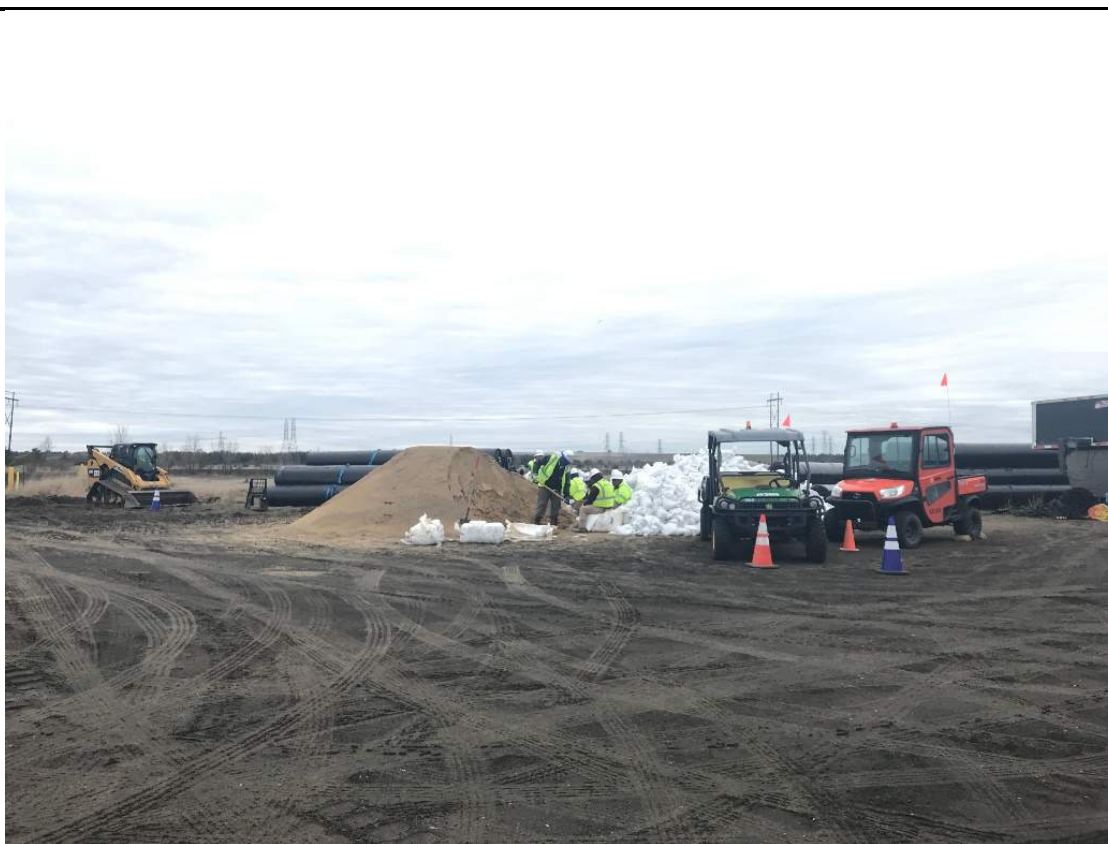
CCS filling sand bags.

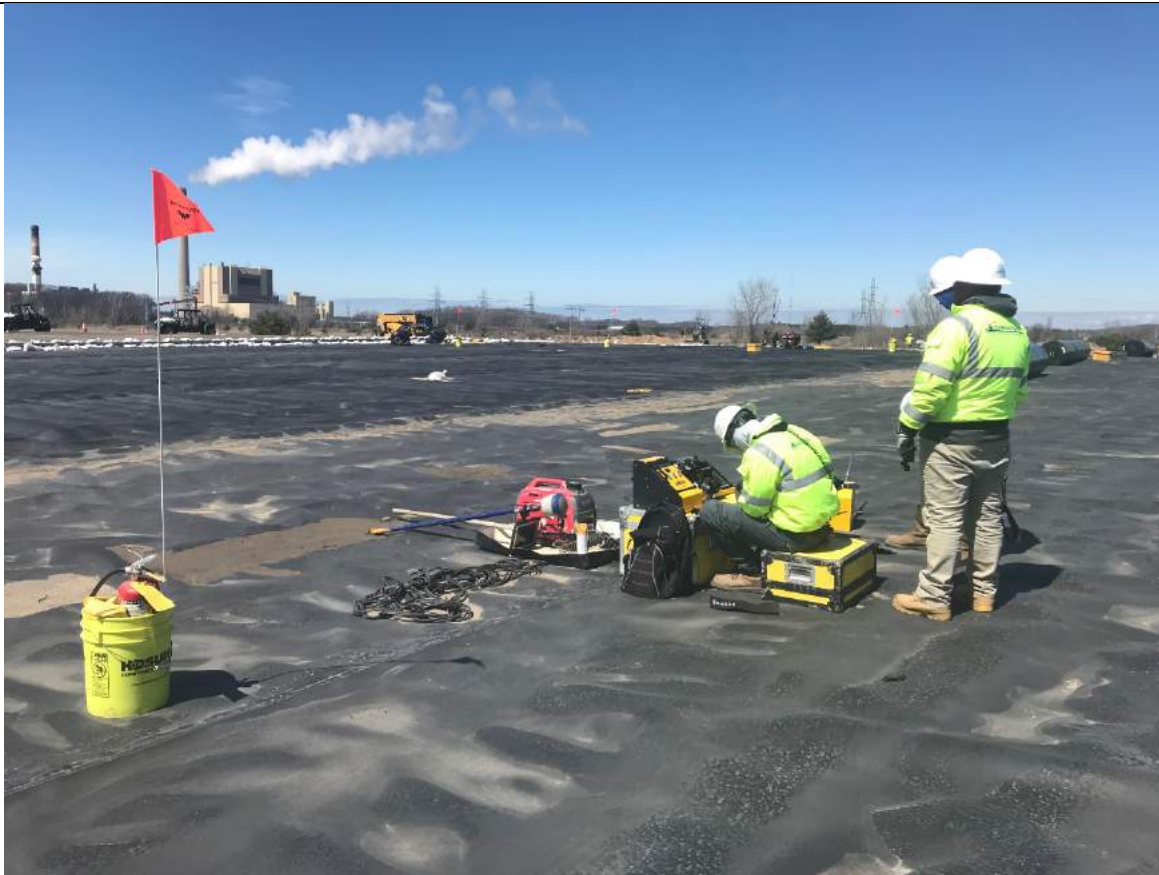
Testing fusion trial seams.

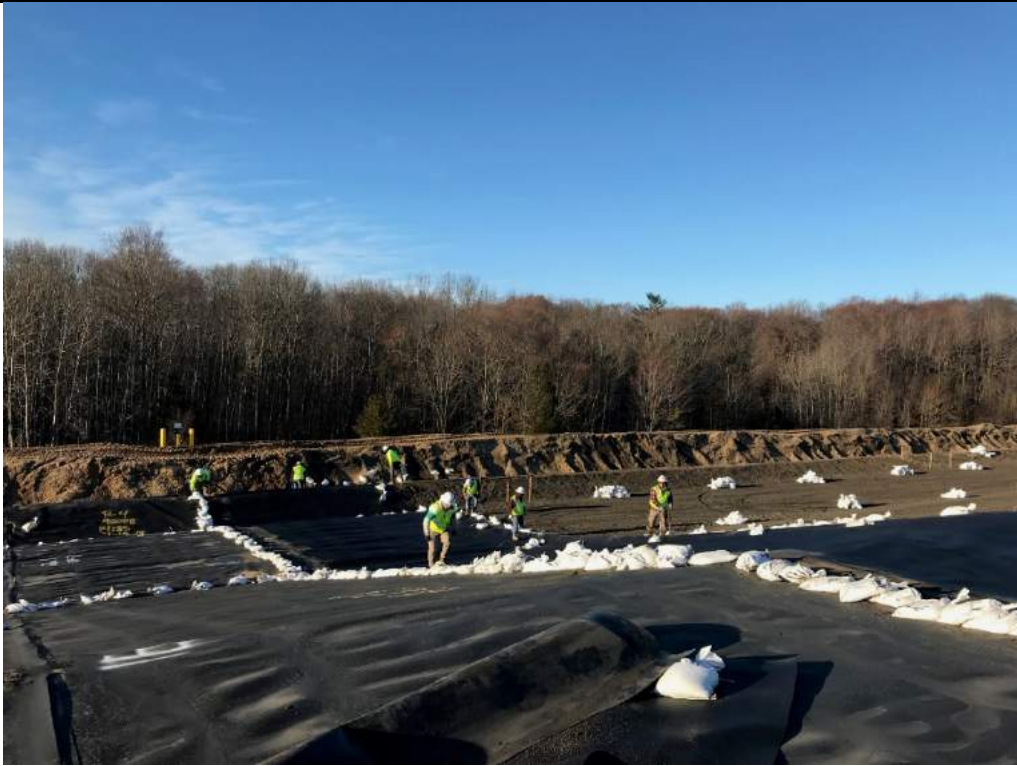
Deploying liner.

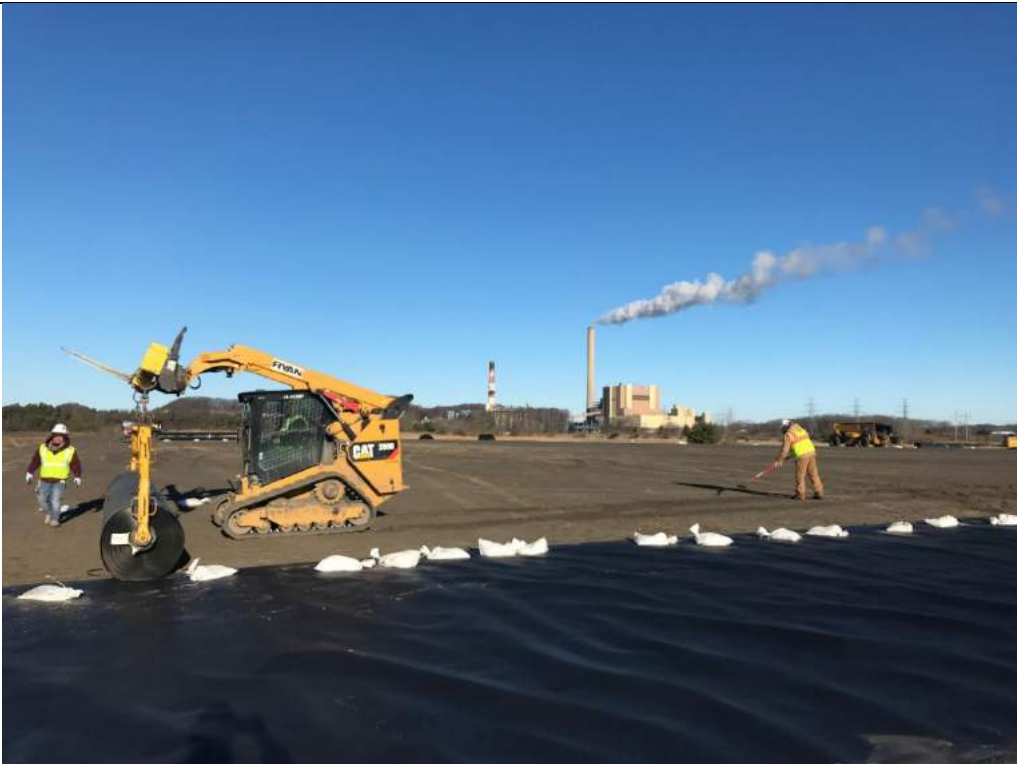
CAT Skid-steer about to deploy liner and Ryan laborer raking subgrade prior to deployment.

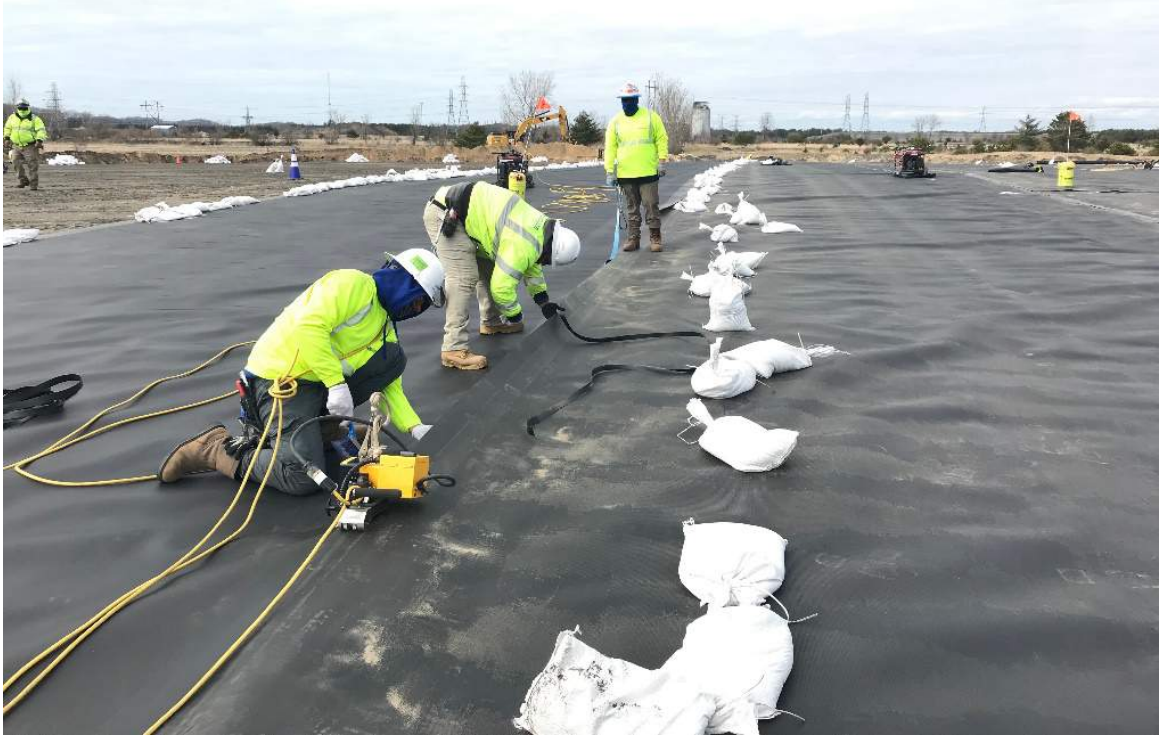
CCS fusion welding seams.

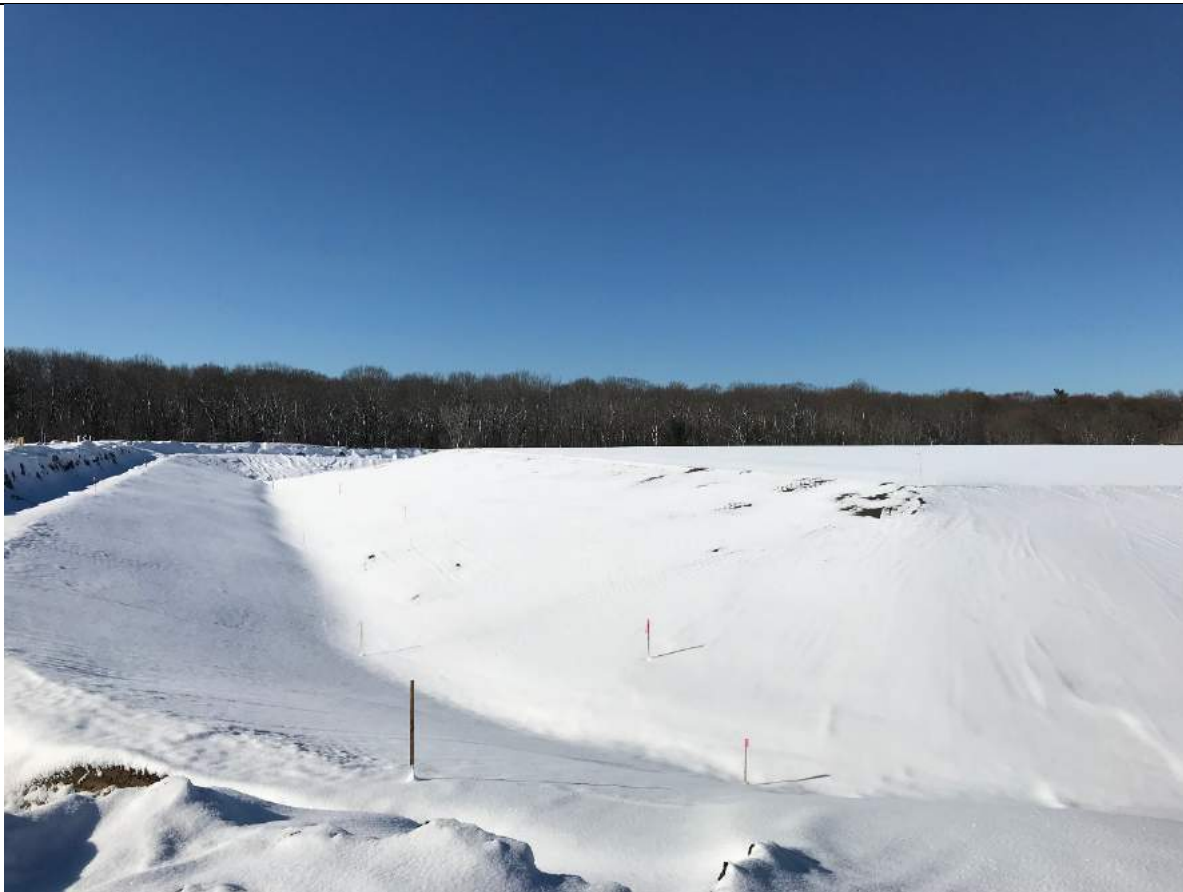
Pond A as seen from the north east corner.

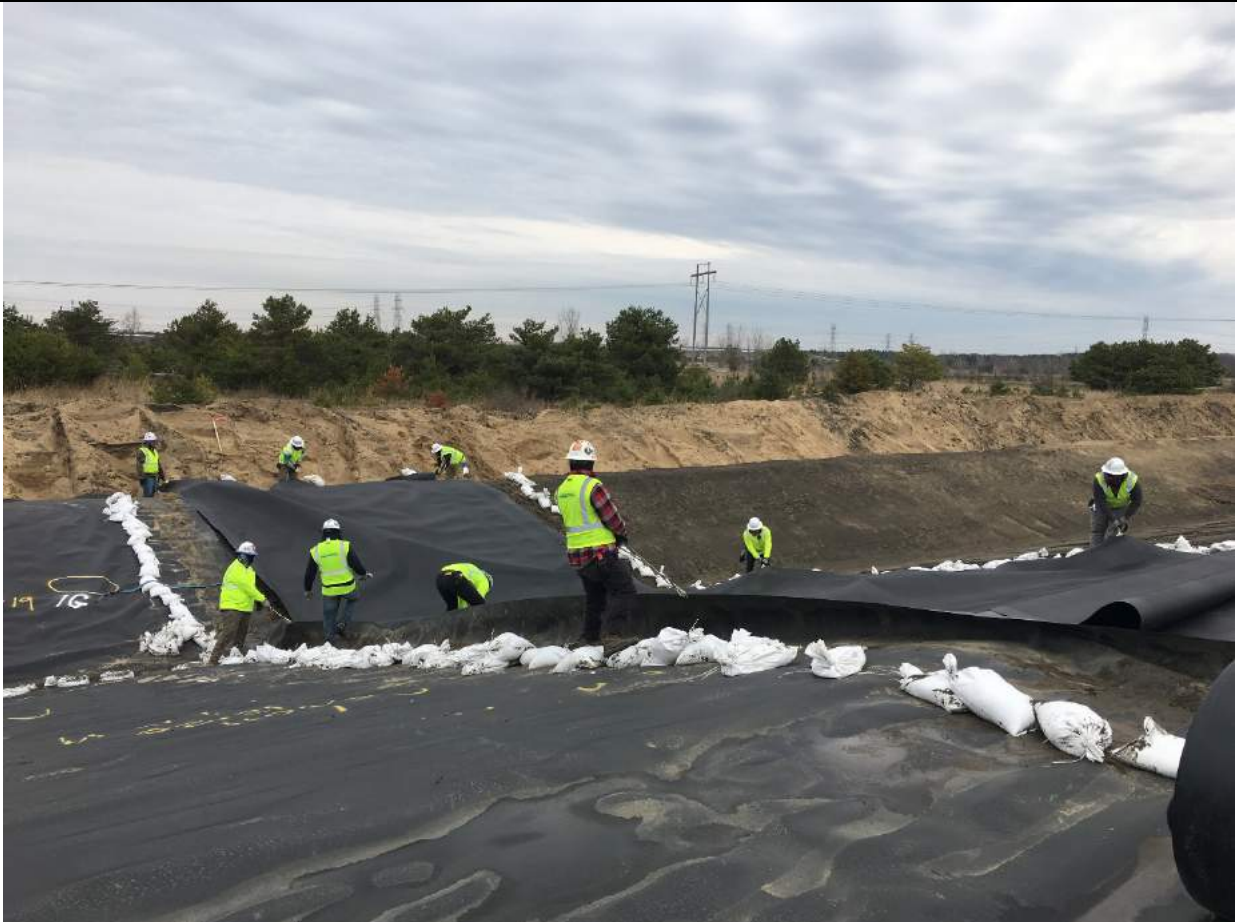
Deploying geomembrane.

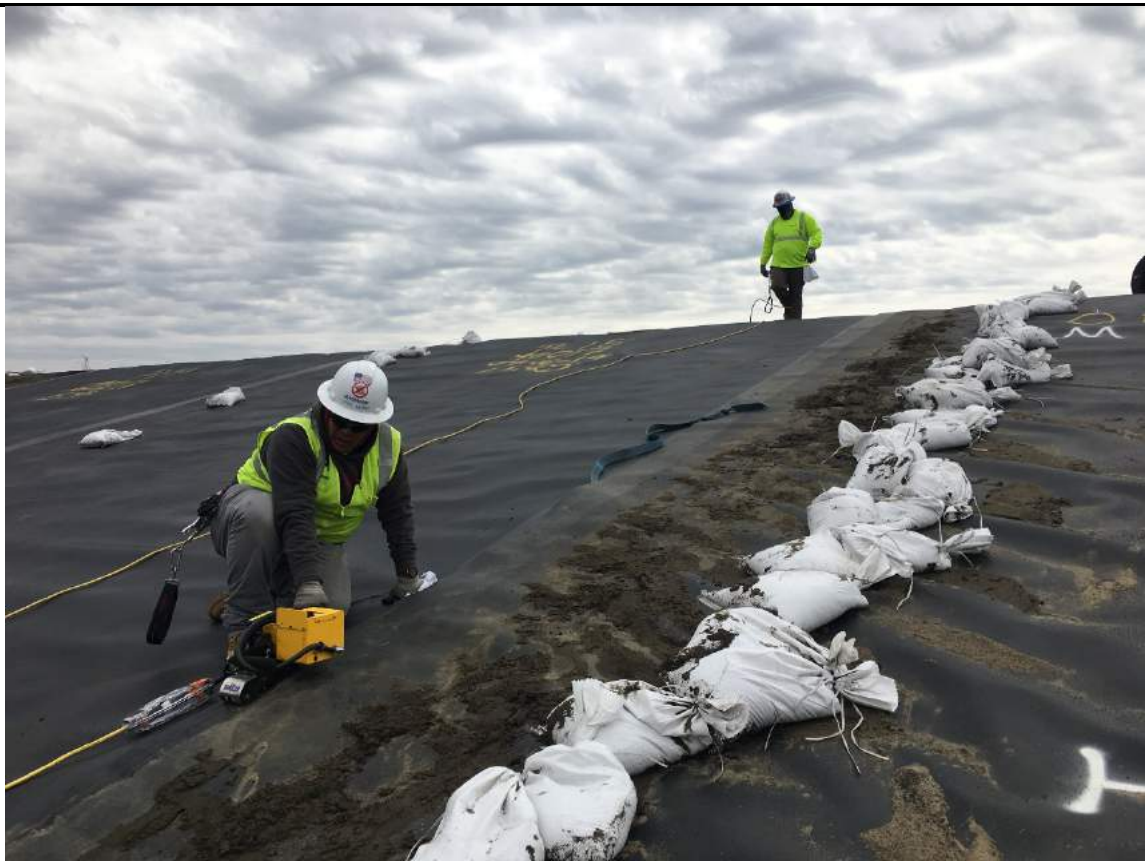
Fusion seaming.

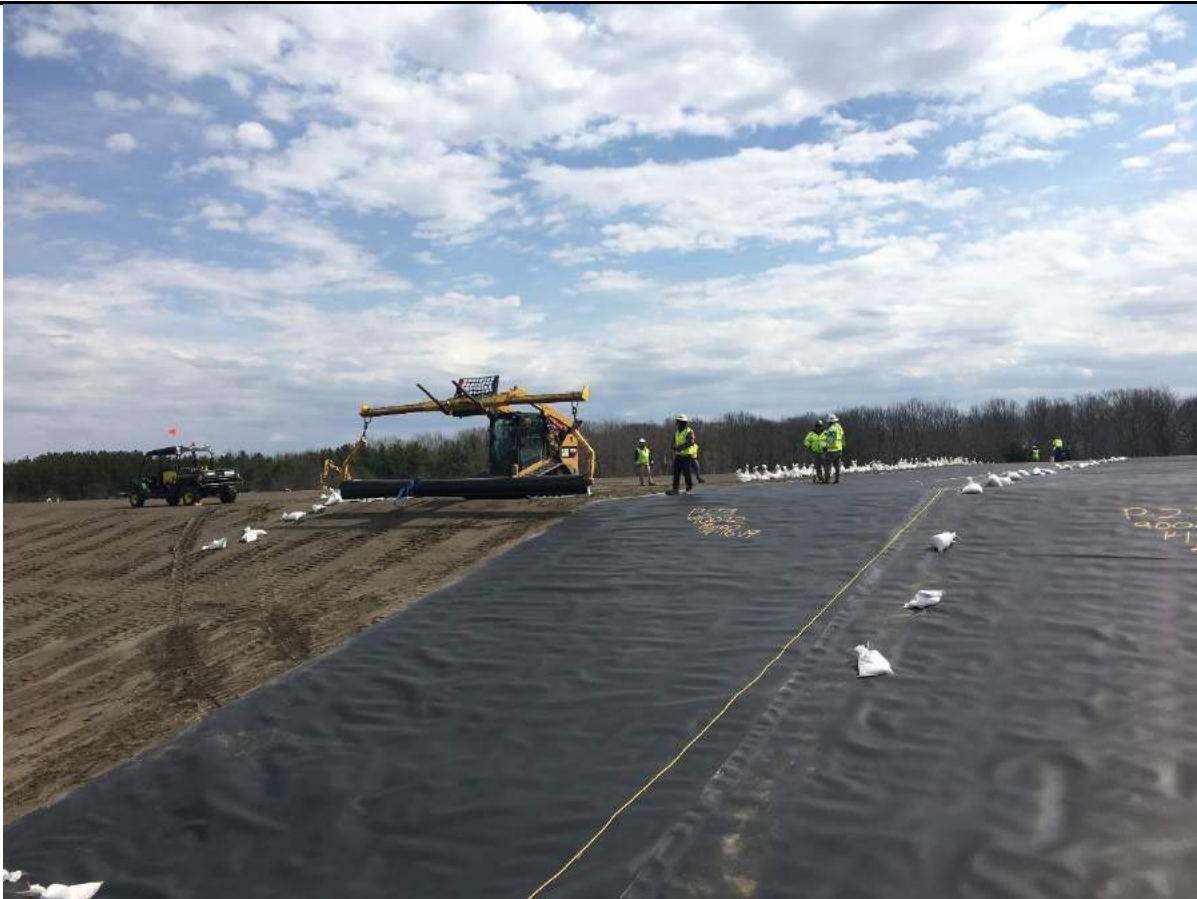
Cat skid-steer deploying geomembrane.

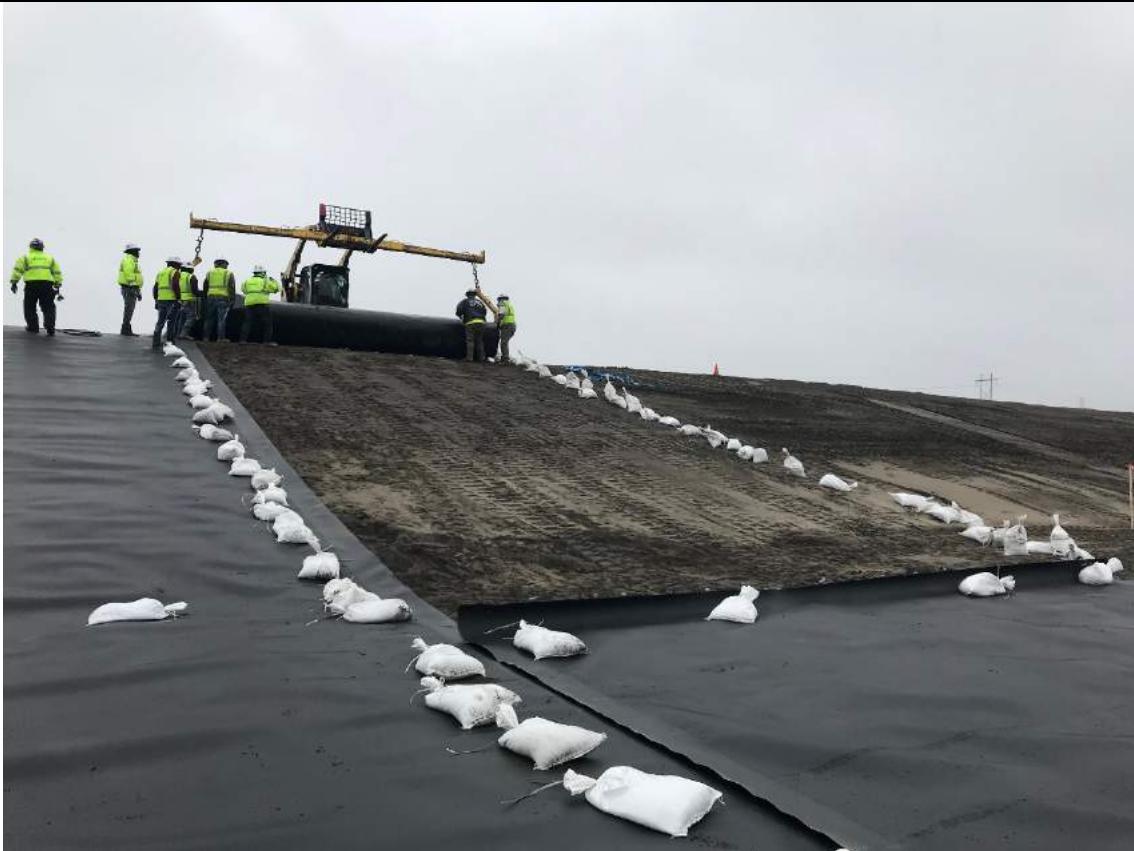
CAT Skid-steer deploying geomembrane.

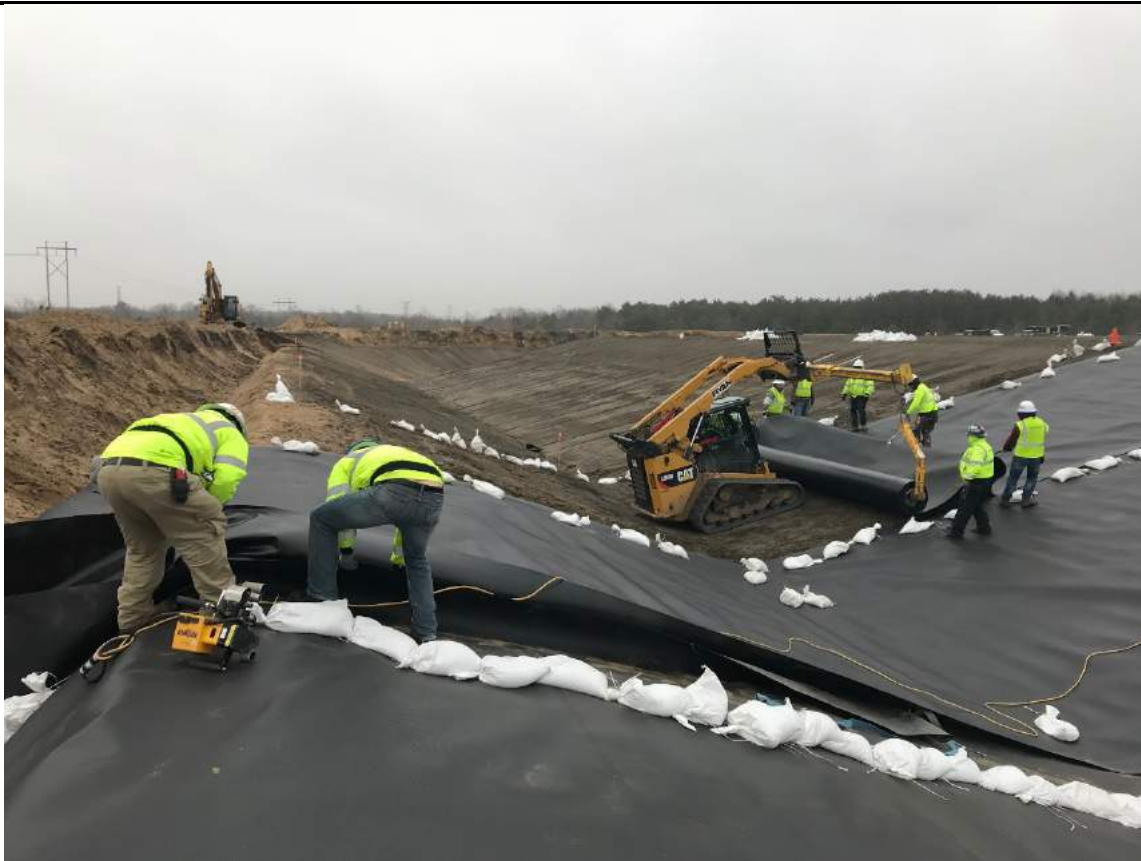
Fusion seam and deploying geomembrane.

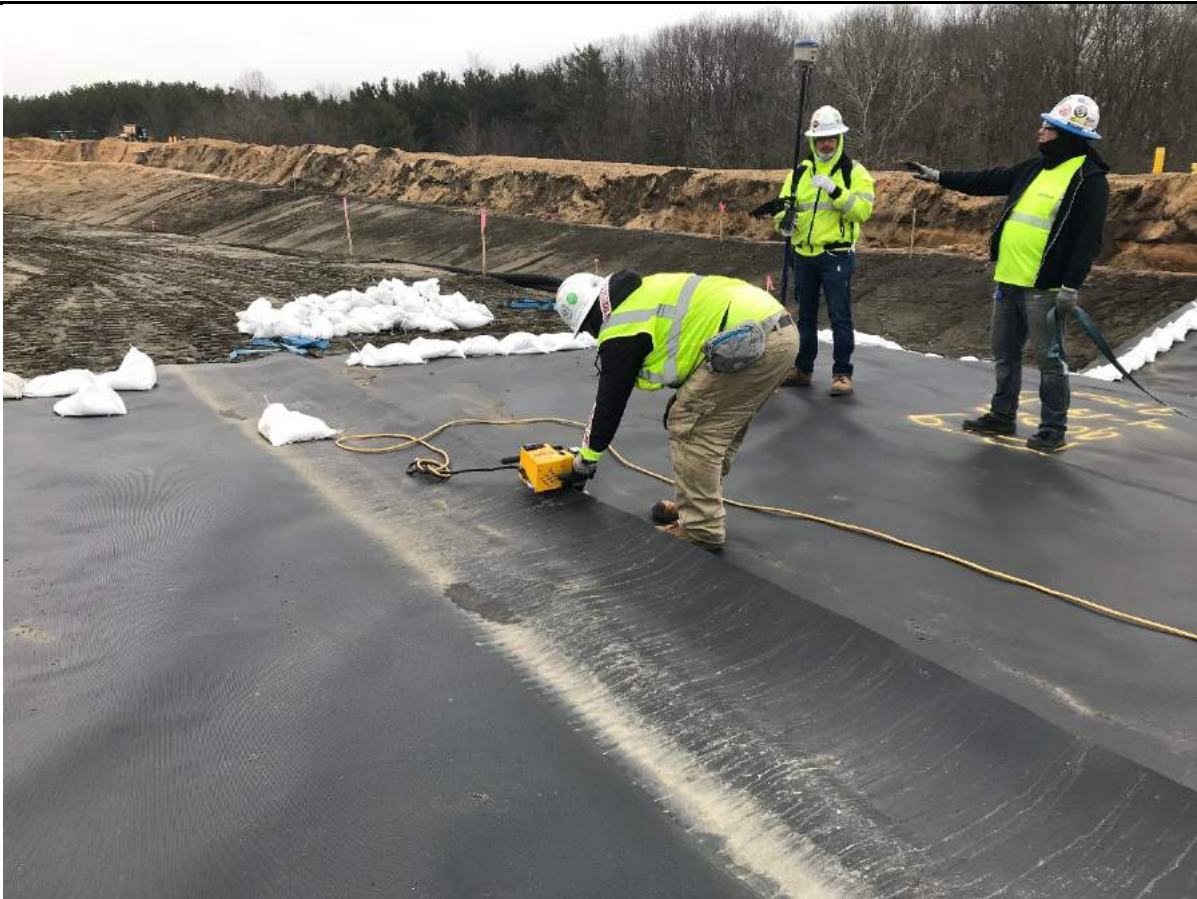
Fusion Seaming of cross seam.

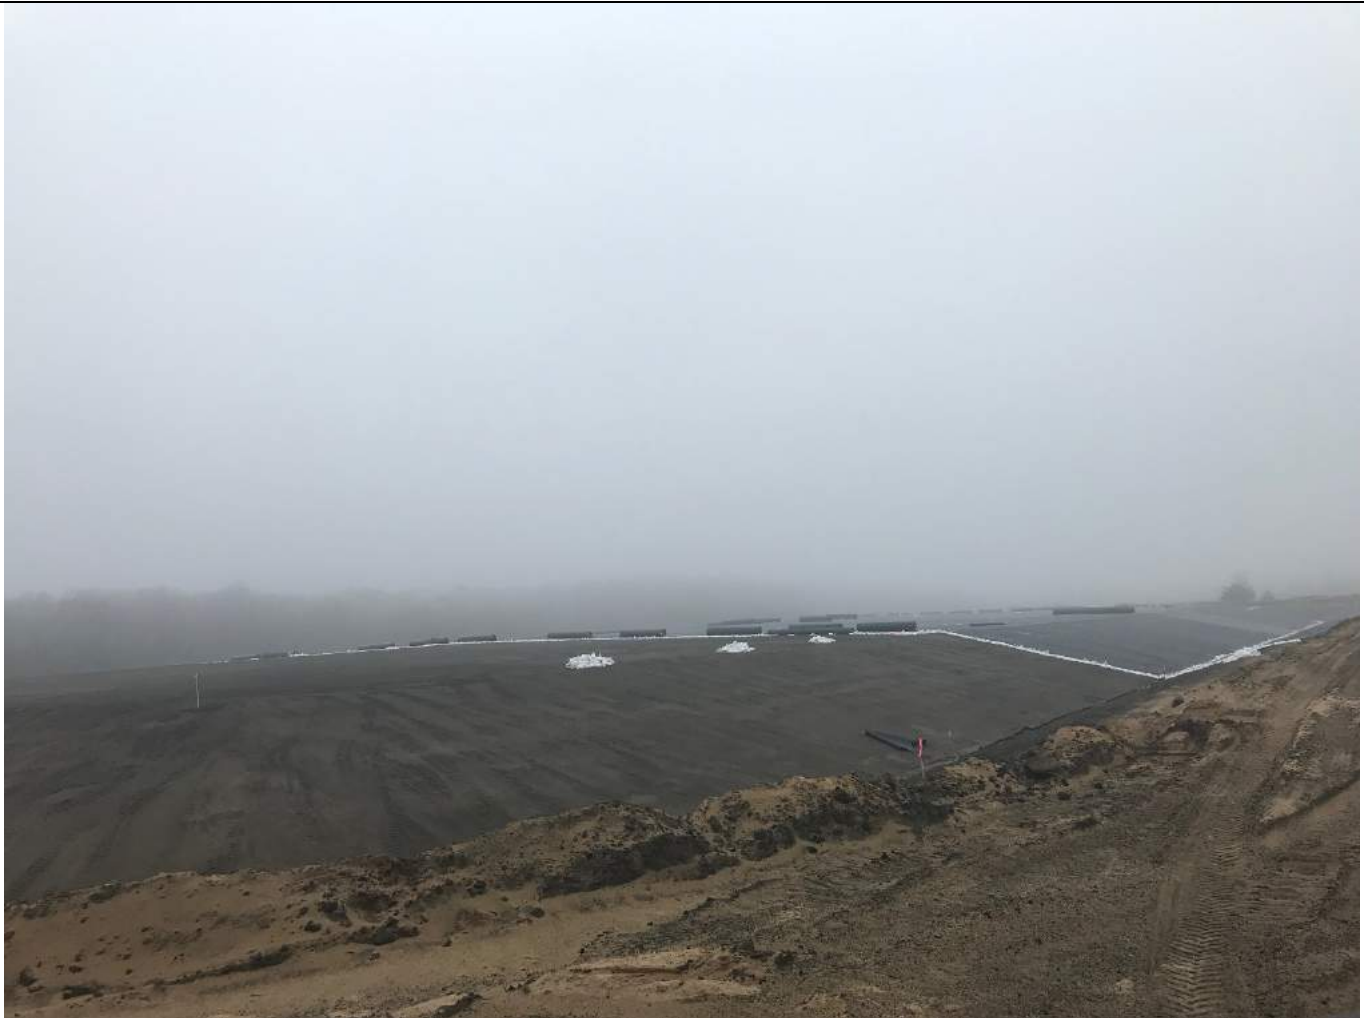
Pond A as seen from the northeast corner.

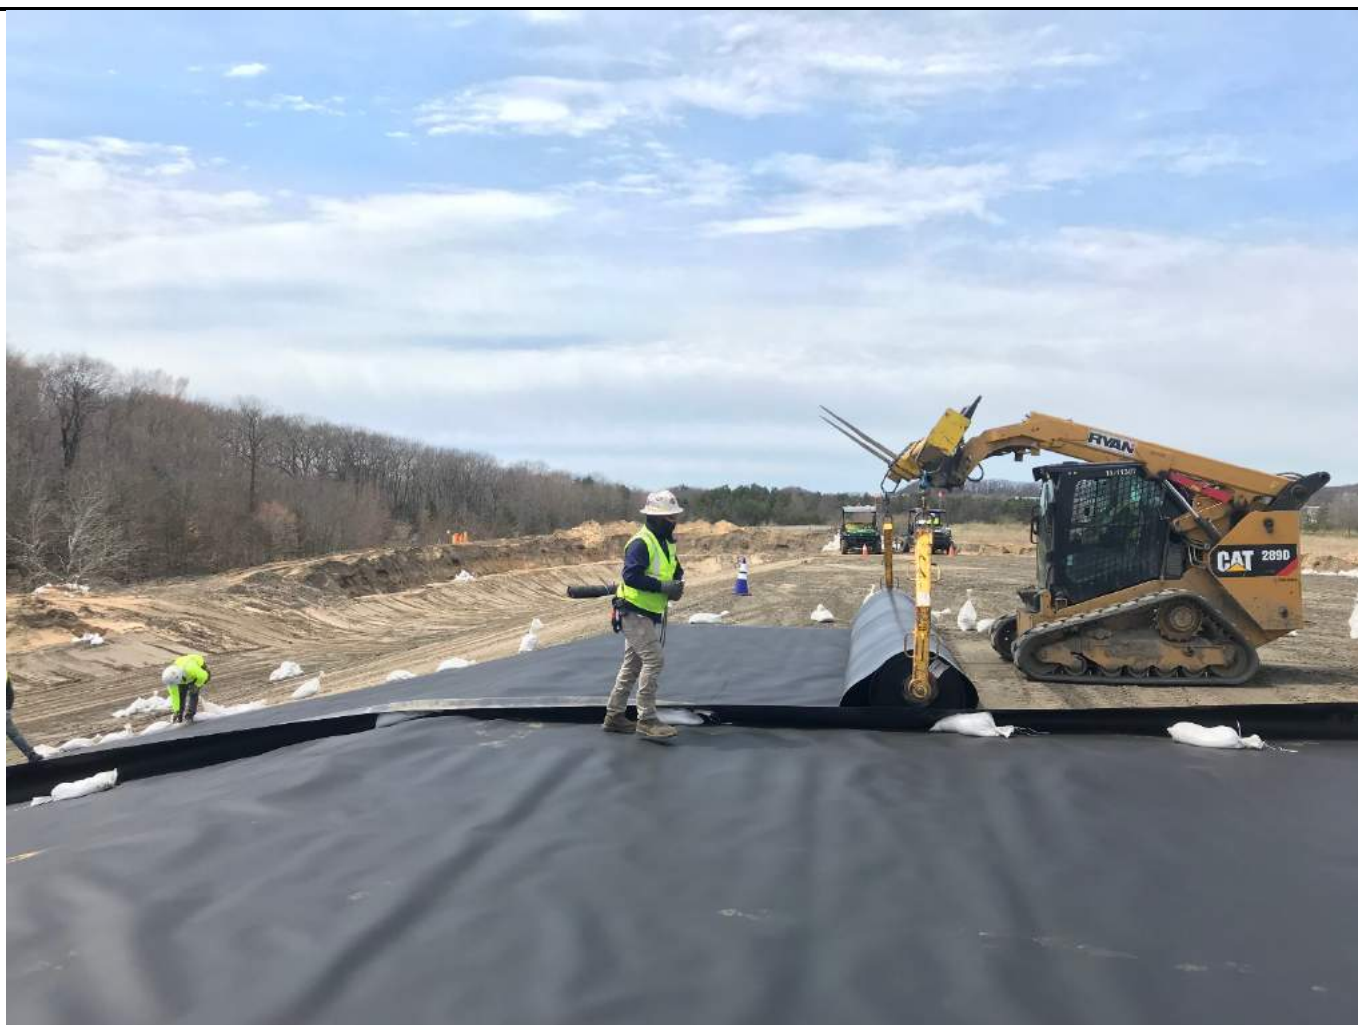
Deploying geomembrane.

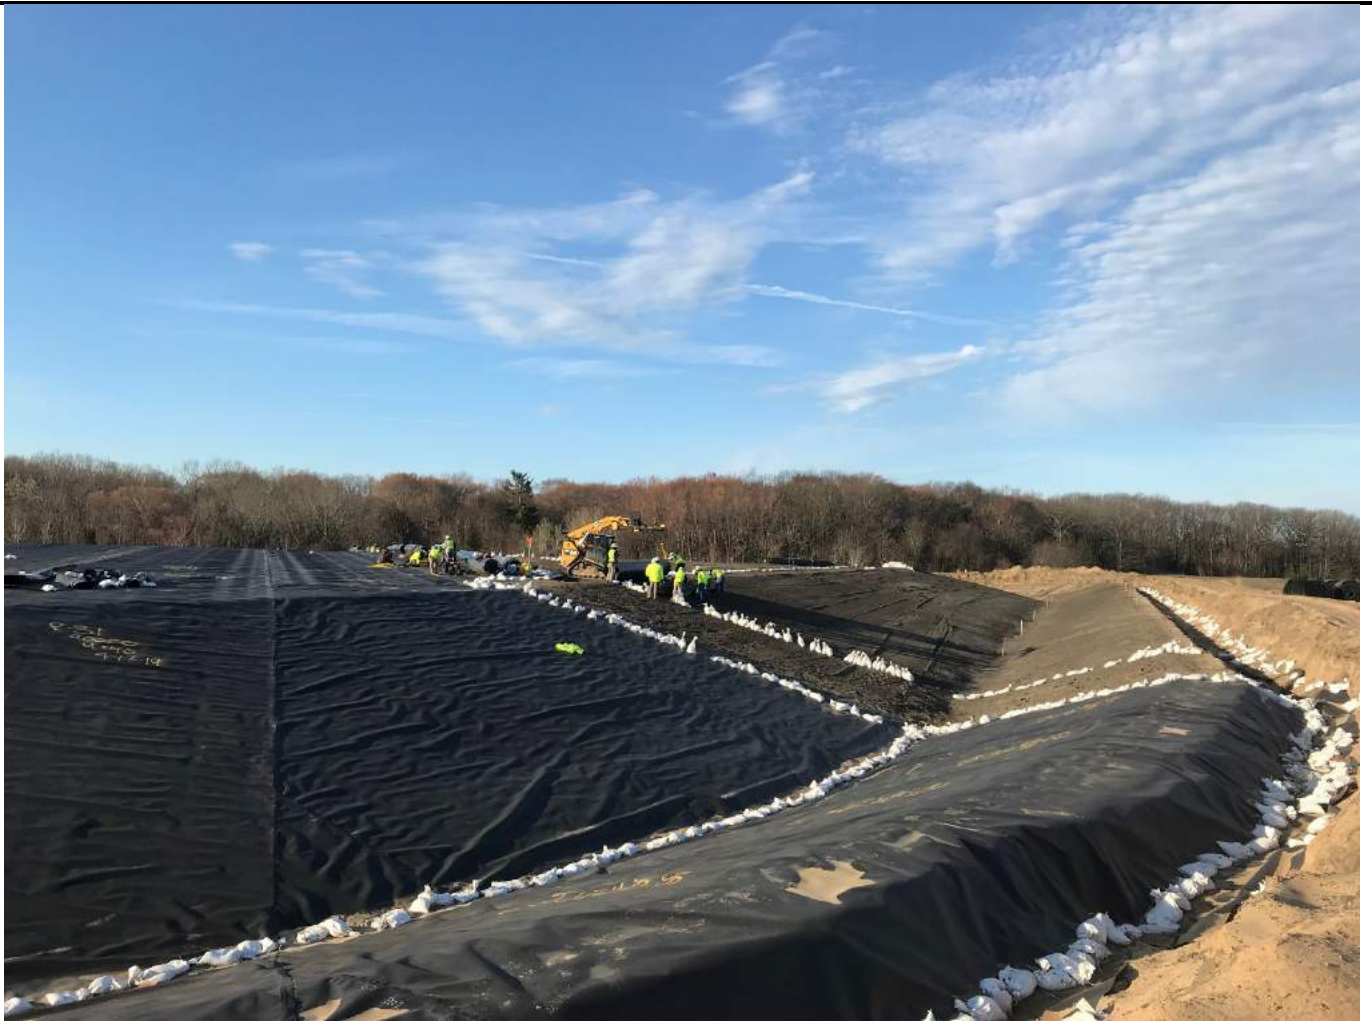
Deploying geomembrane.

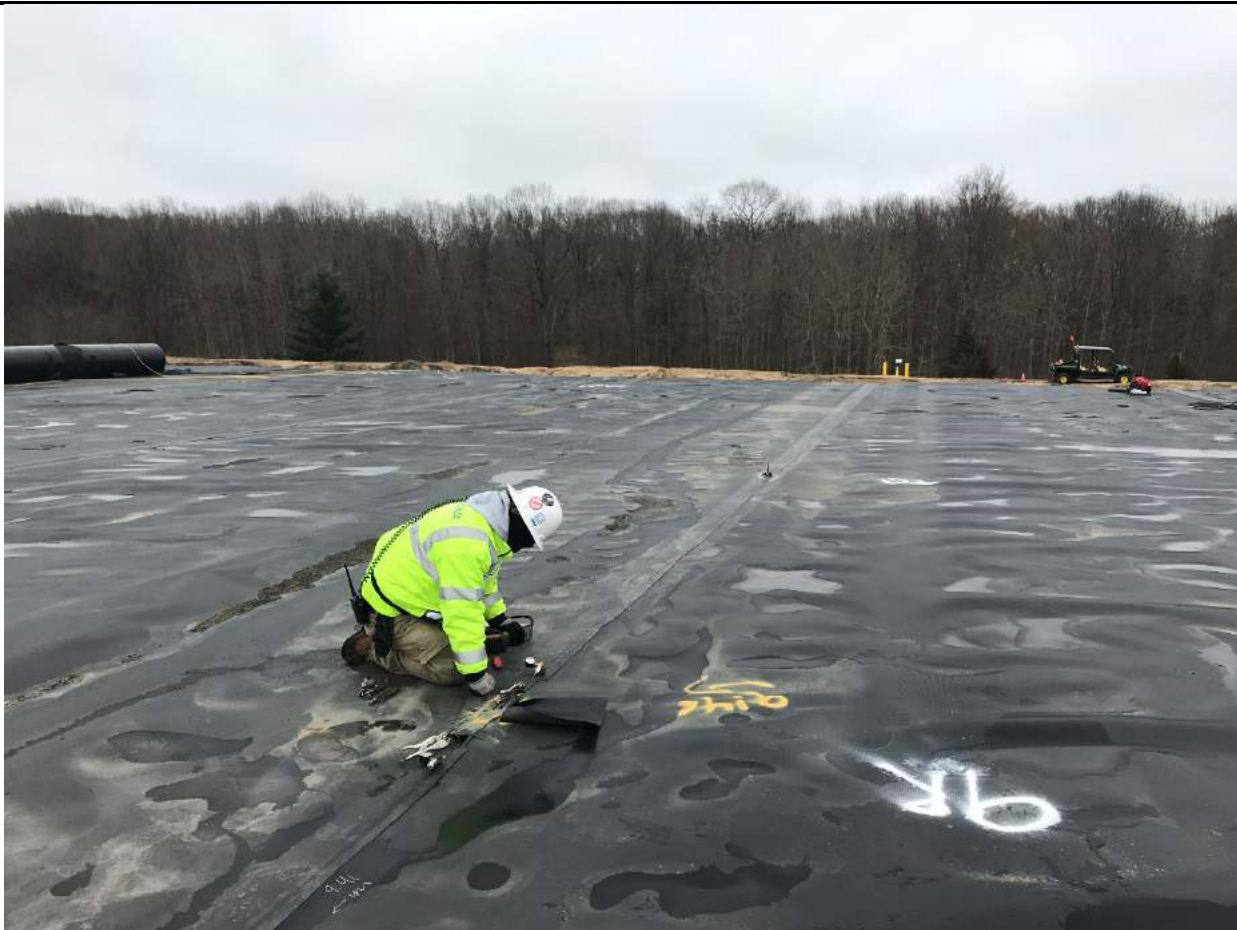
Pressure testing seams.

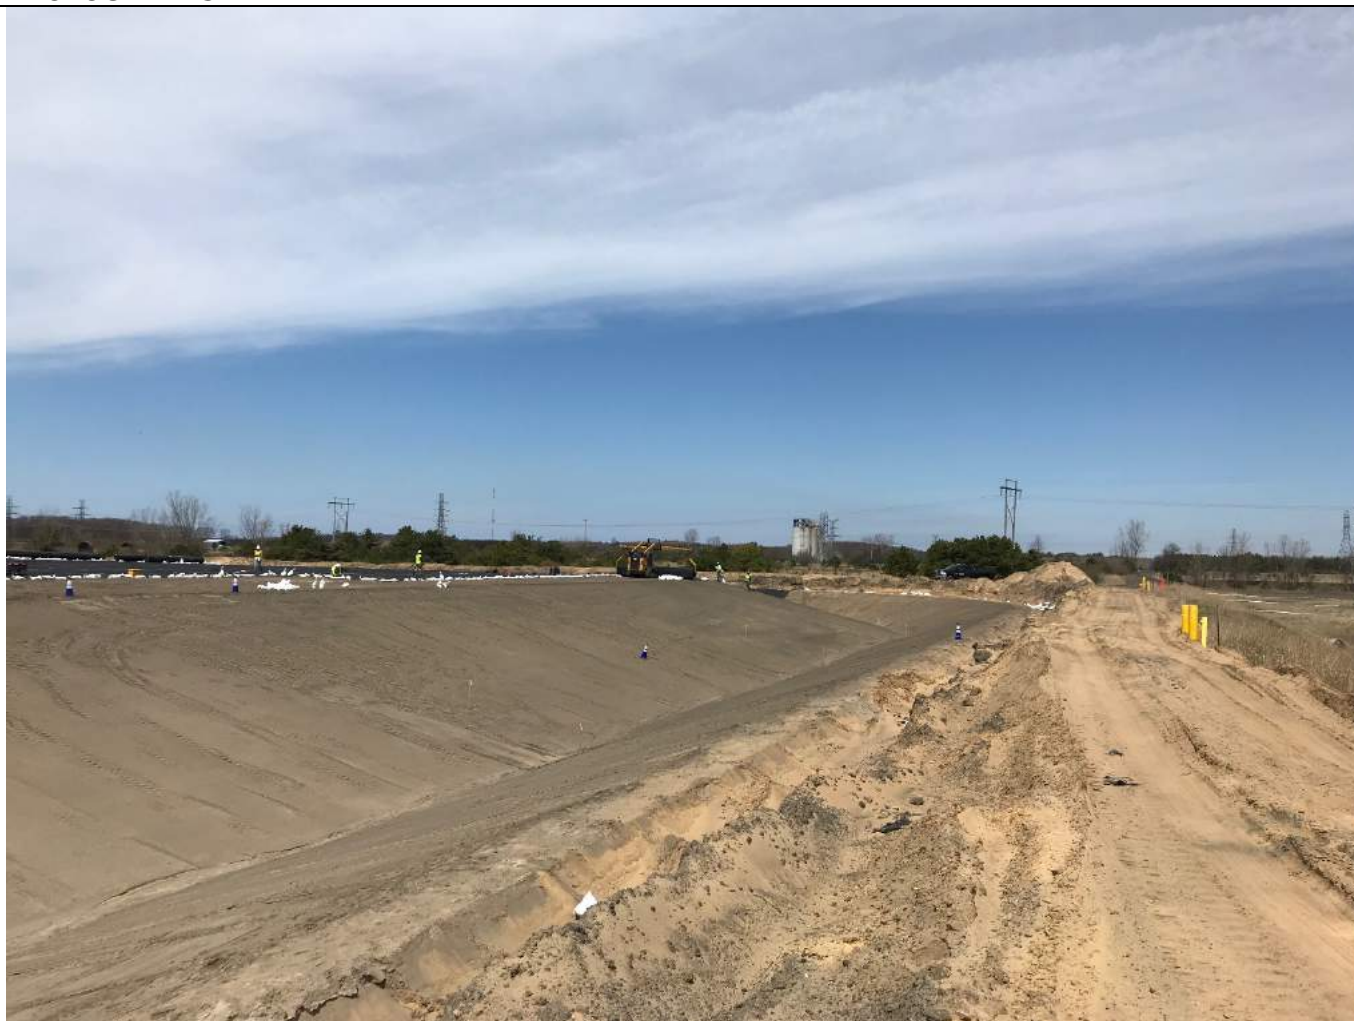
Deploying geosynthetics along the northeast corner of Pond A.
