J.H. Campbell Generating Facility

Pond A - Construction Documentation Report

Golder Associates Inc.

October 1, 2019

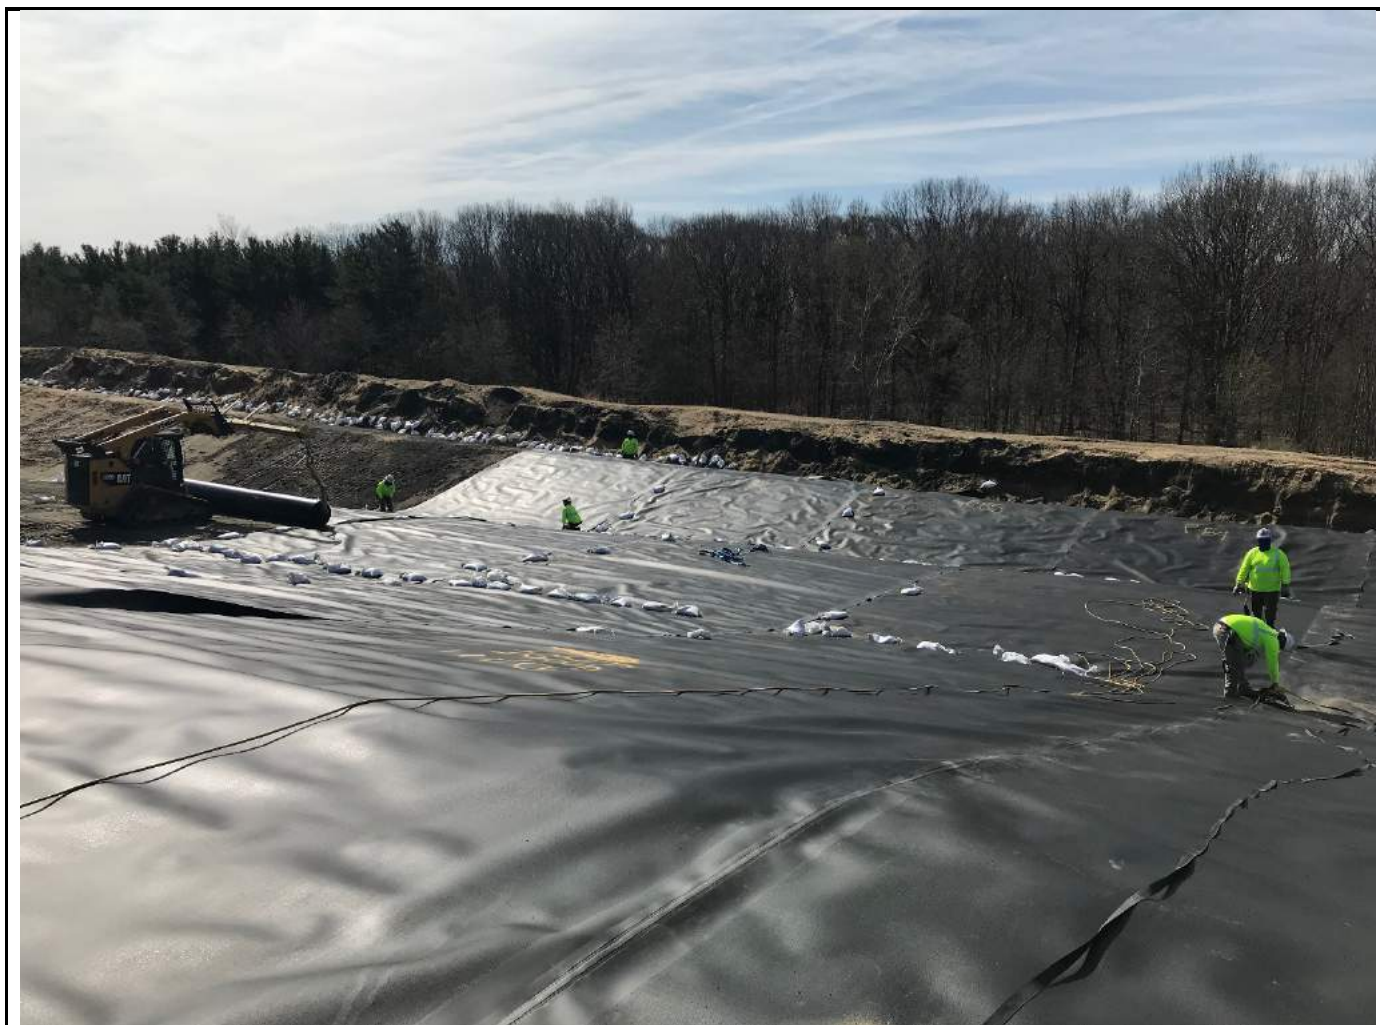
Fusion welding and deploying geosynthetics along the south side of Pond A.

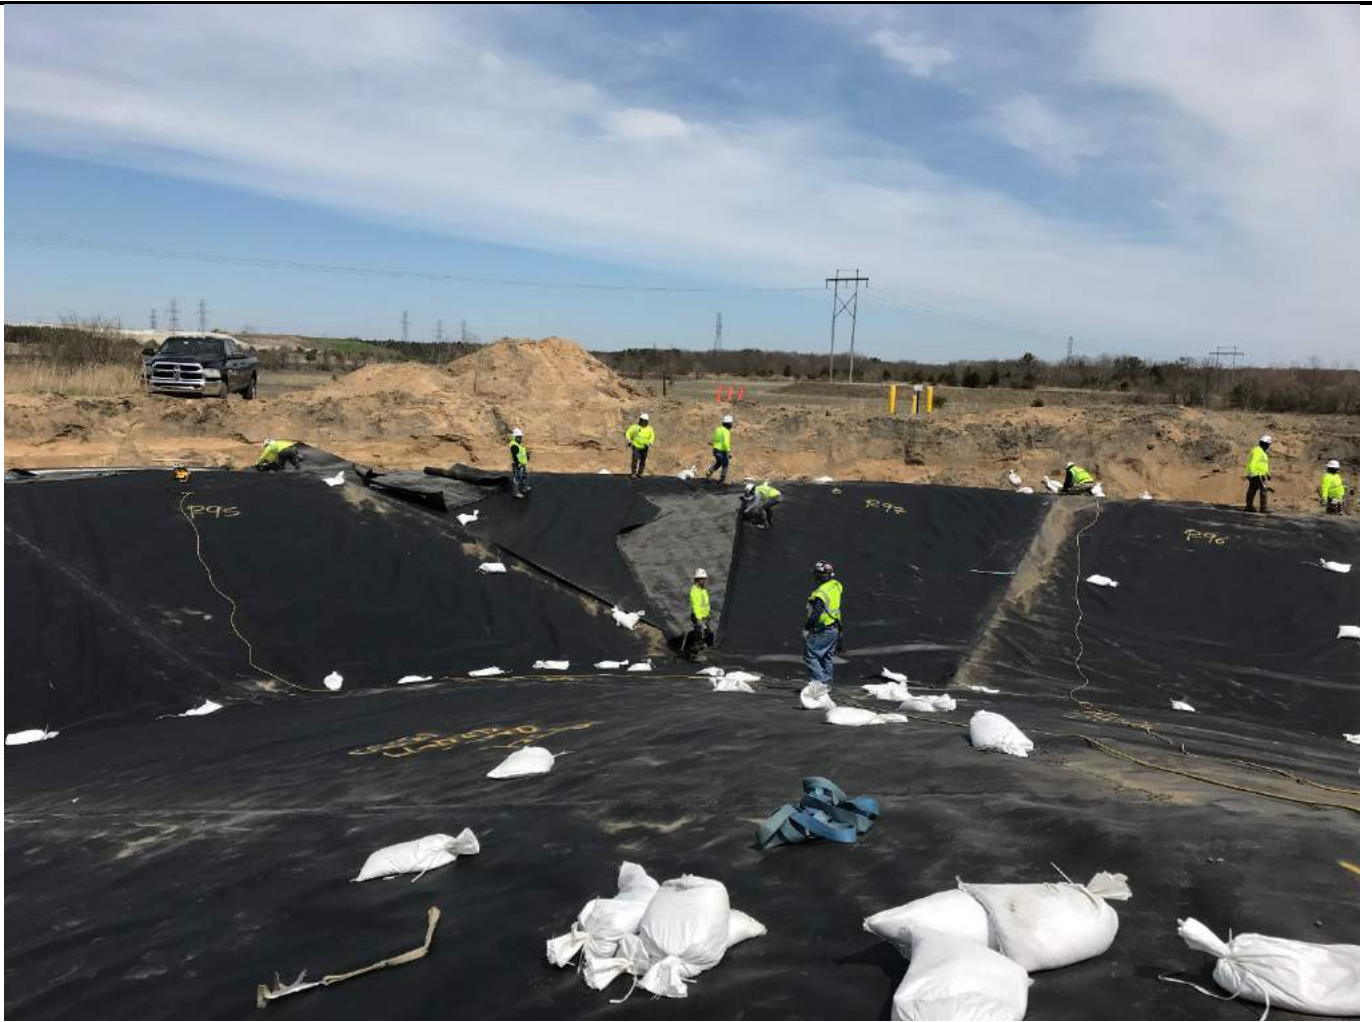
Fusion welding geosynthetics in the northeast corner of Pond A.

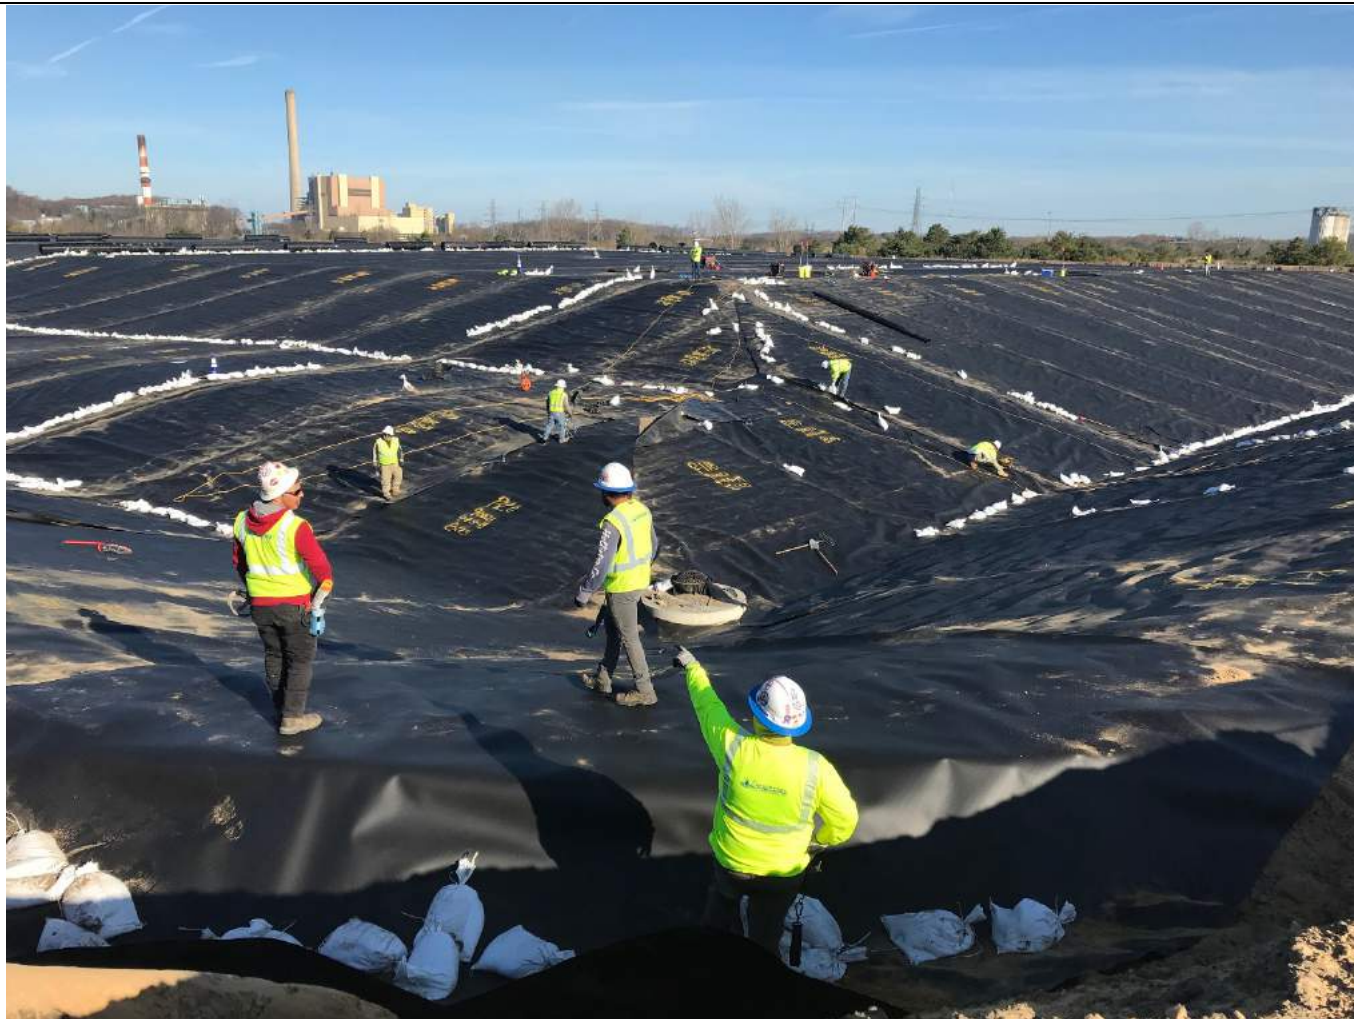
Fusion seaming the last of the geomembrane for Pond A.

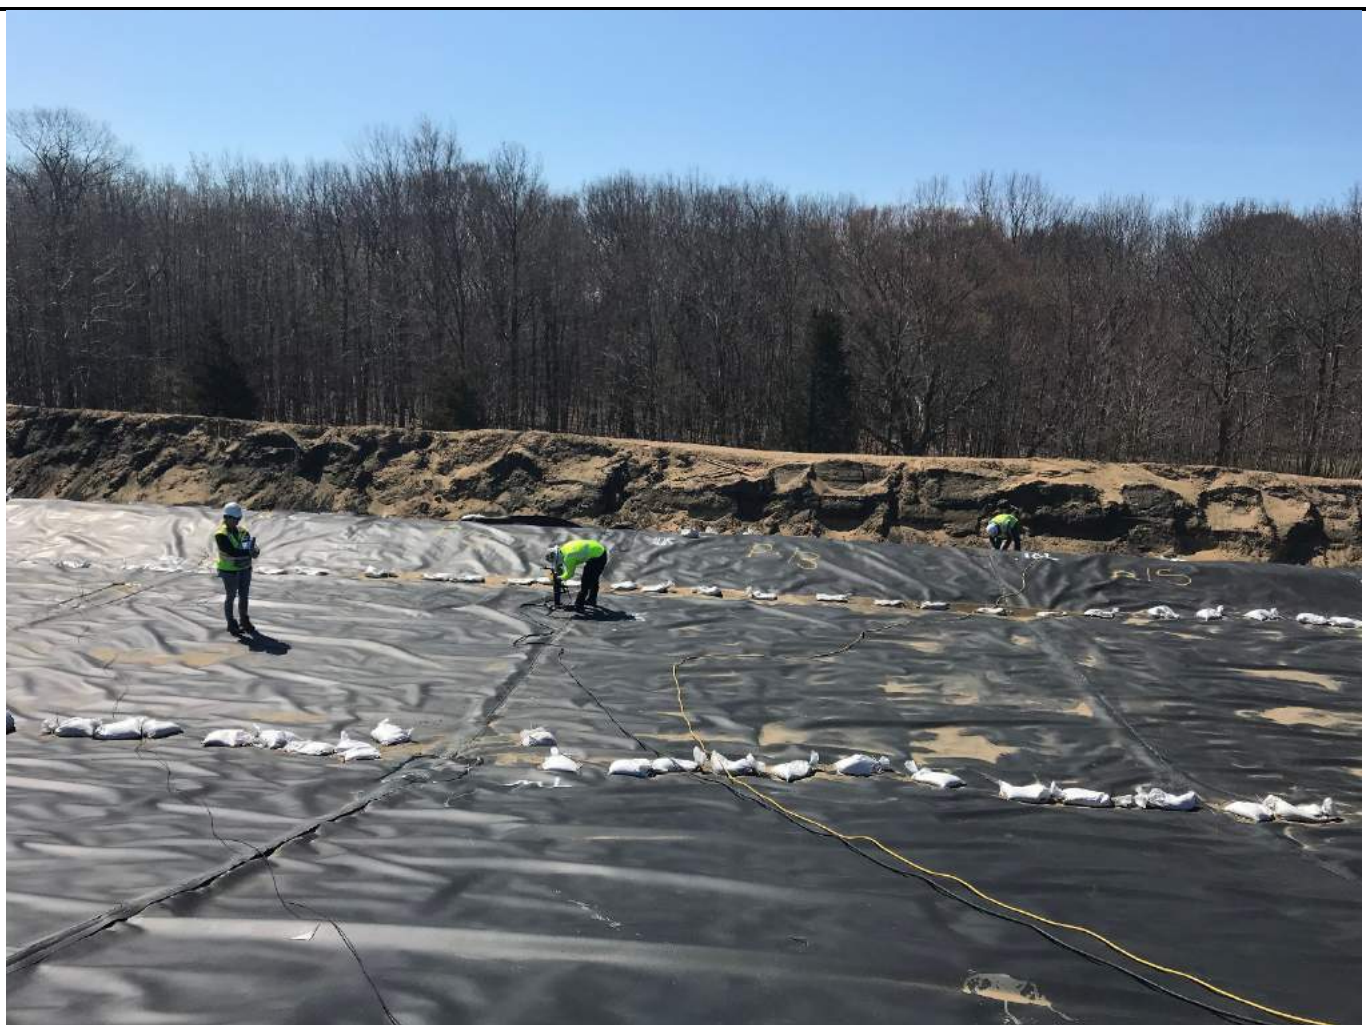
Extrusion welding repairs.

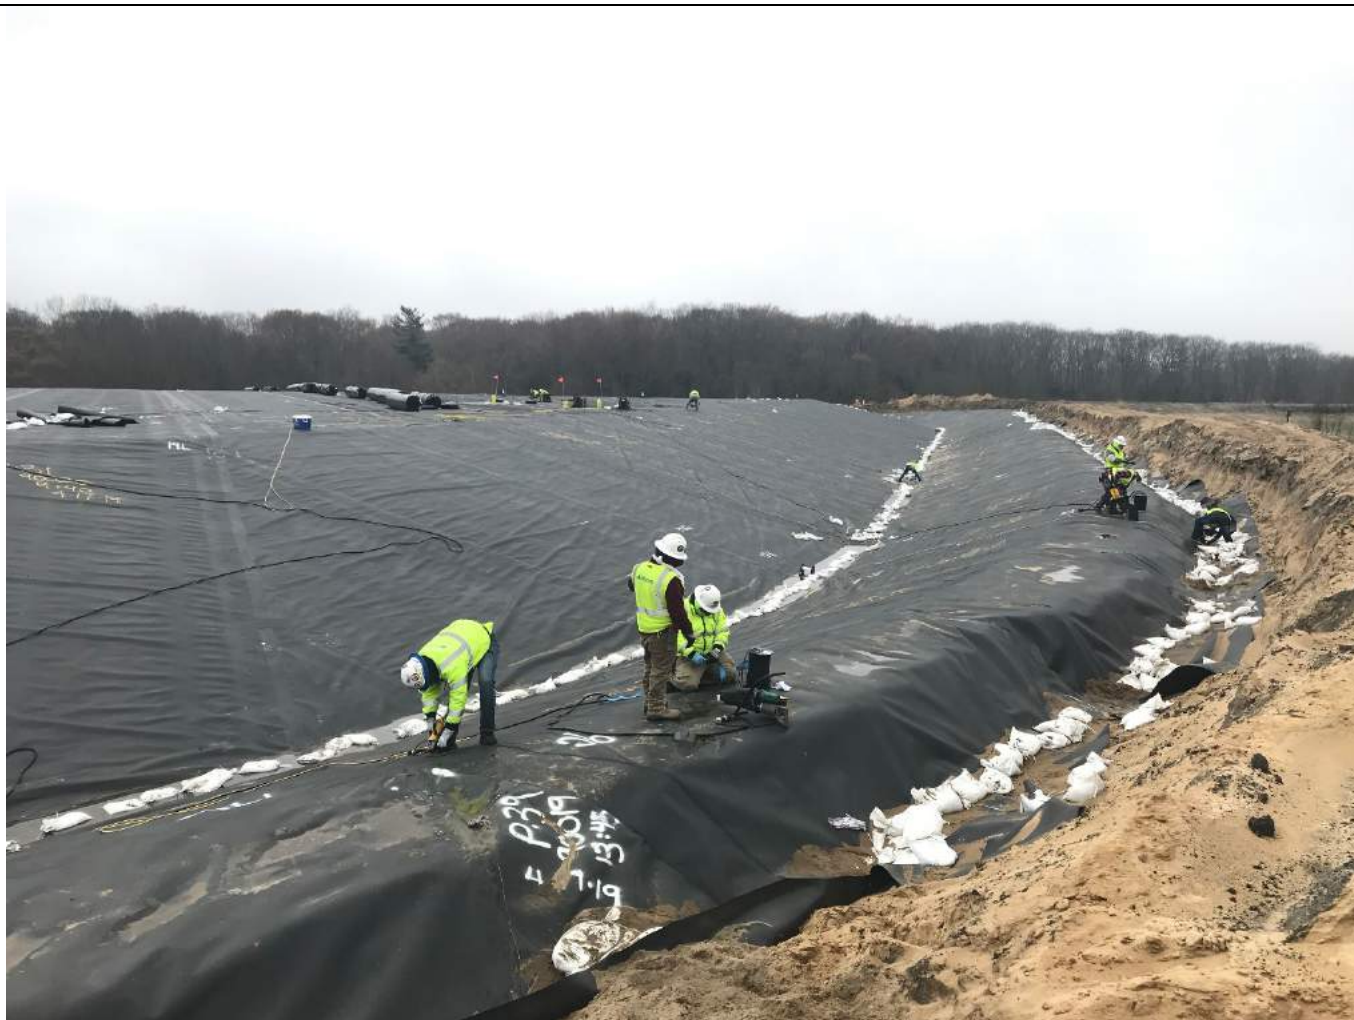
Extrusion welding of repairs.

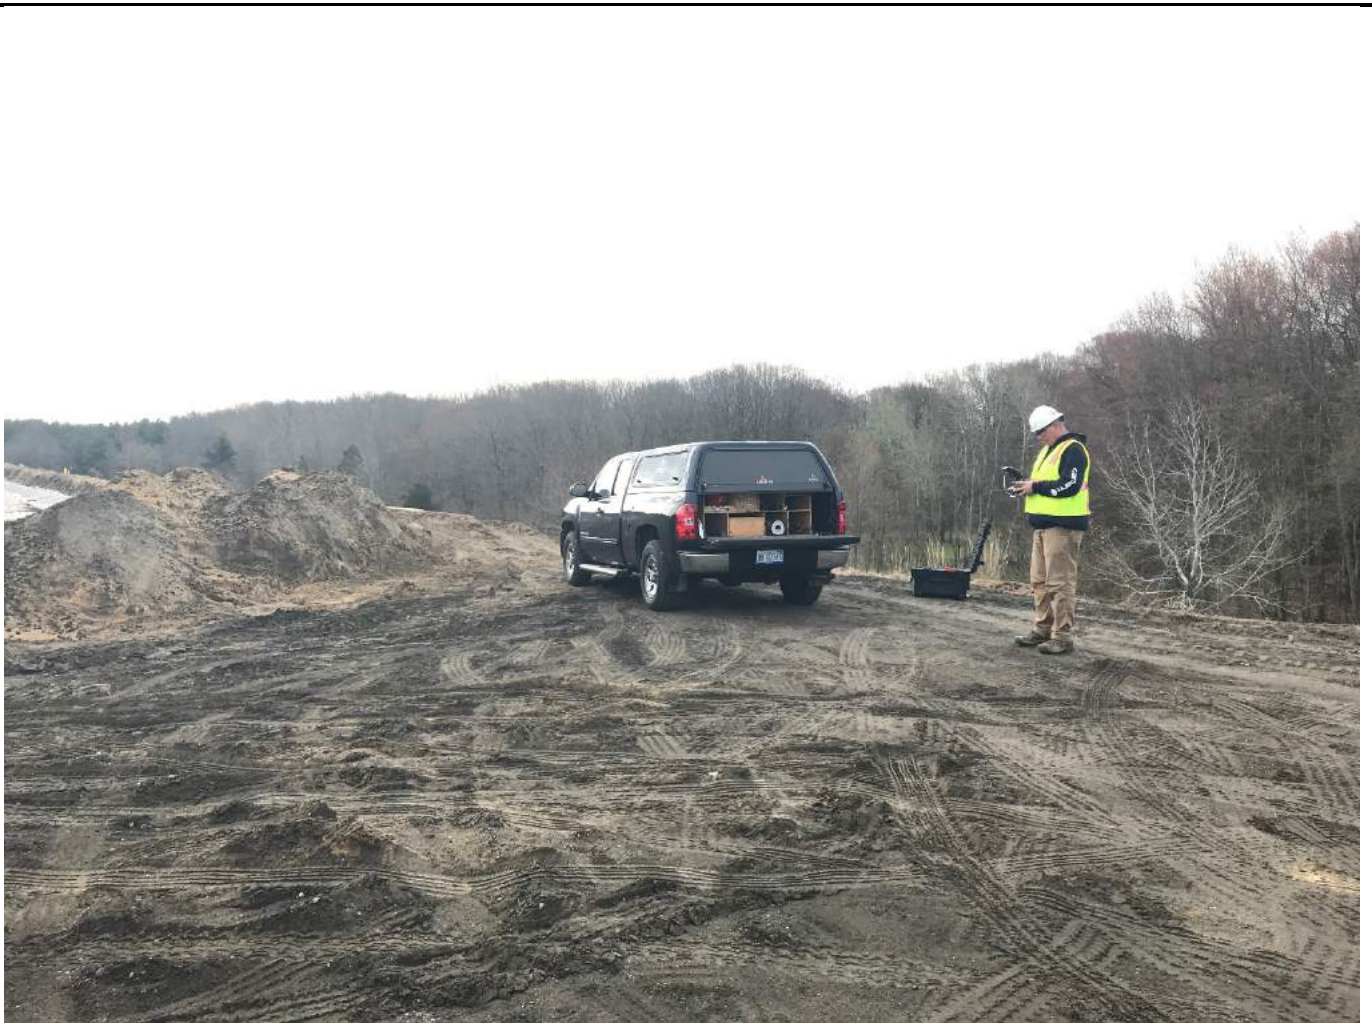
Nederveld fly drone over Pond A.

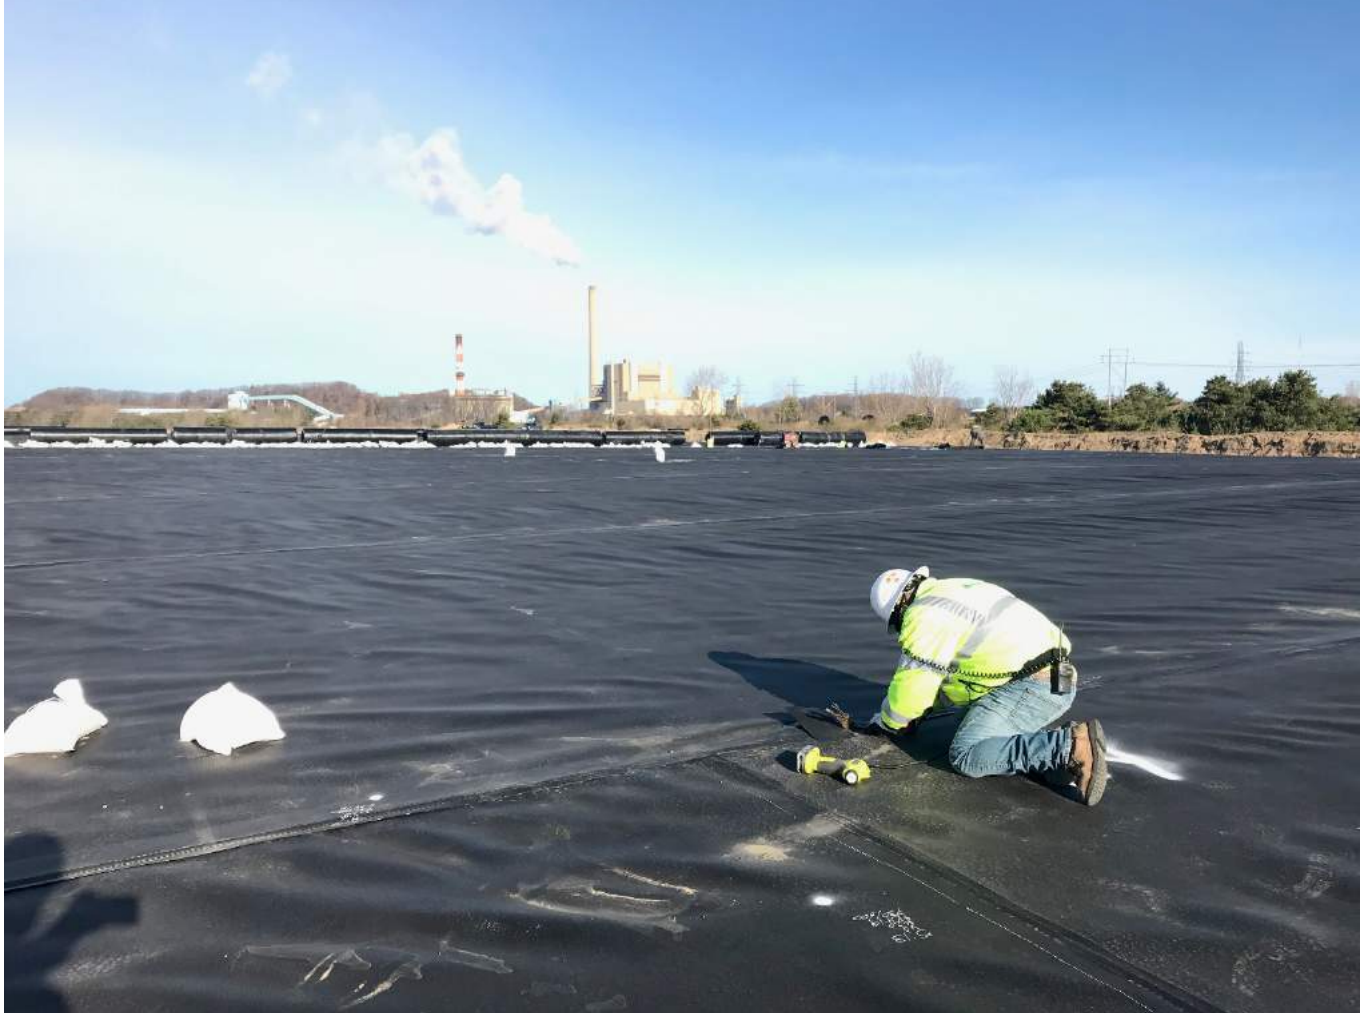
Pressure testing seams.

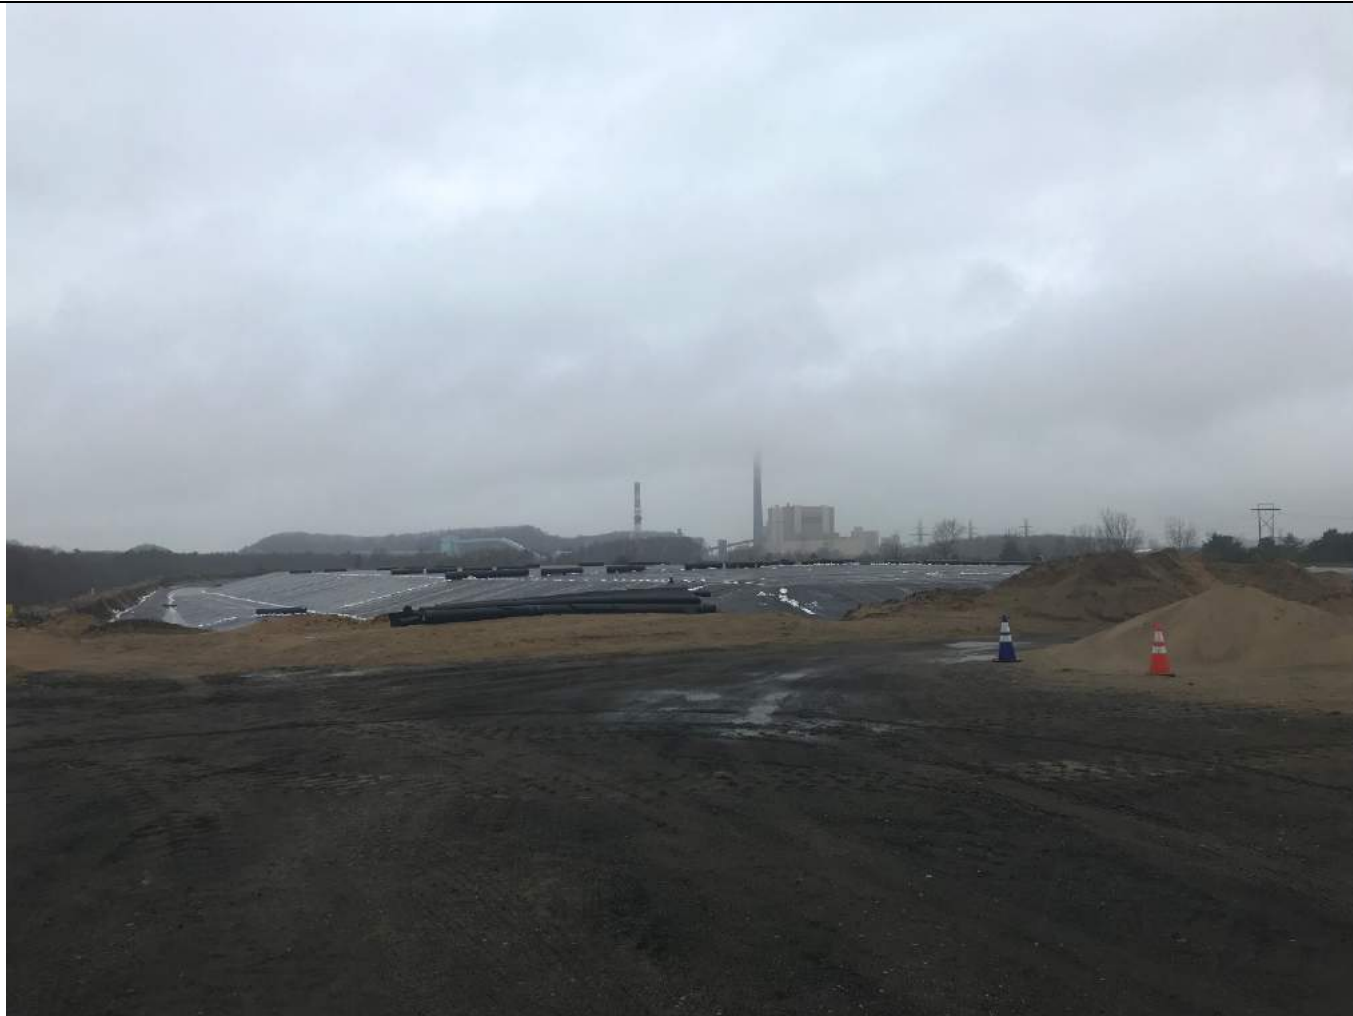
Pond A as seen from the south east corner.

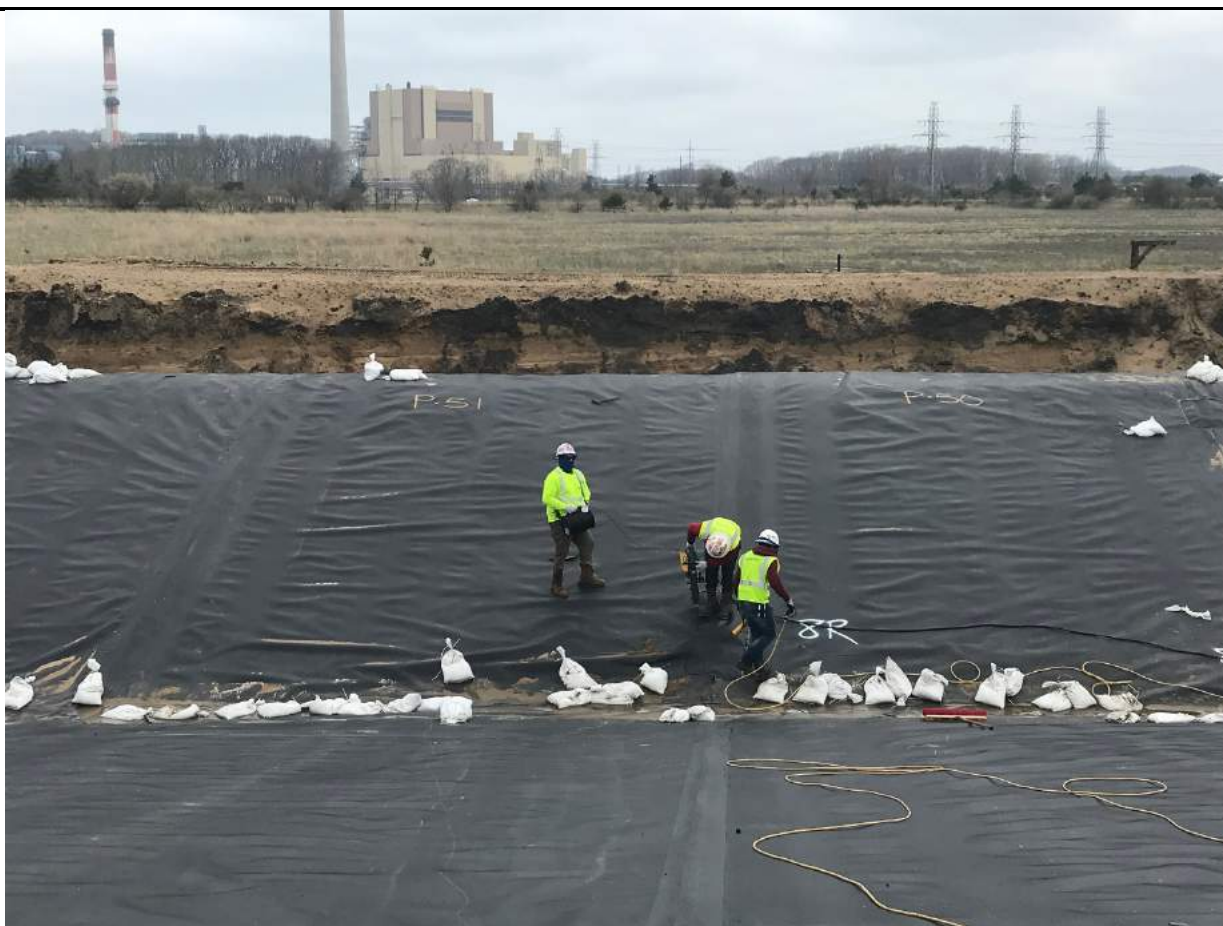
Extrusion welding repairs.

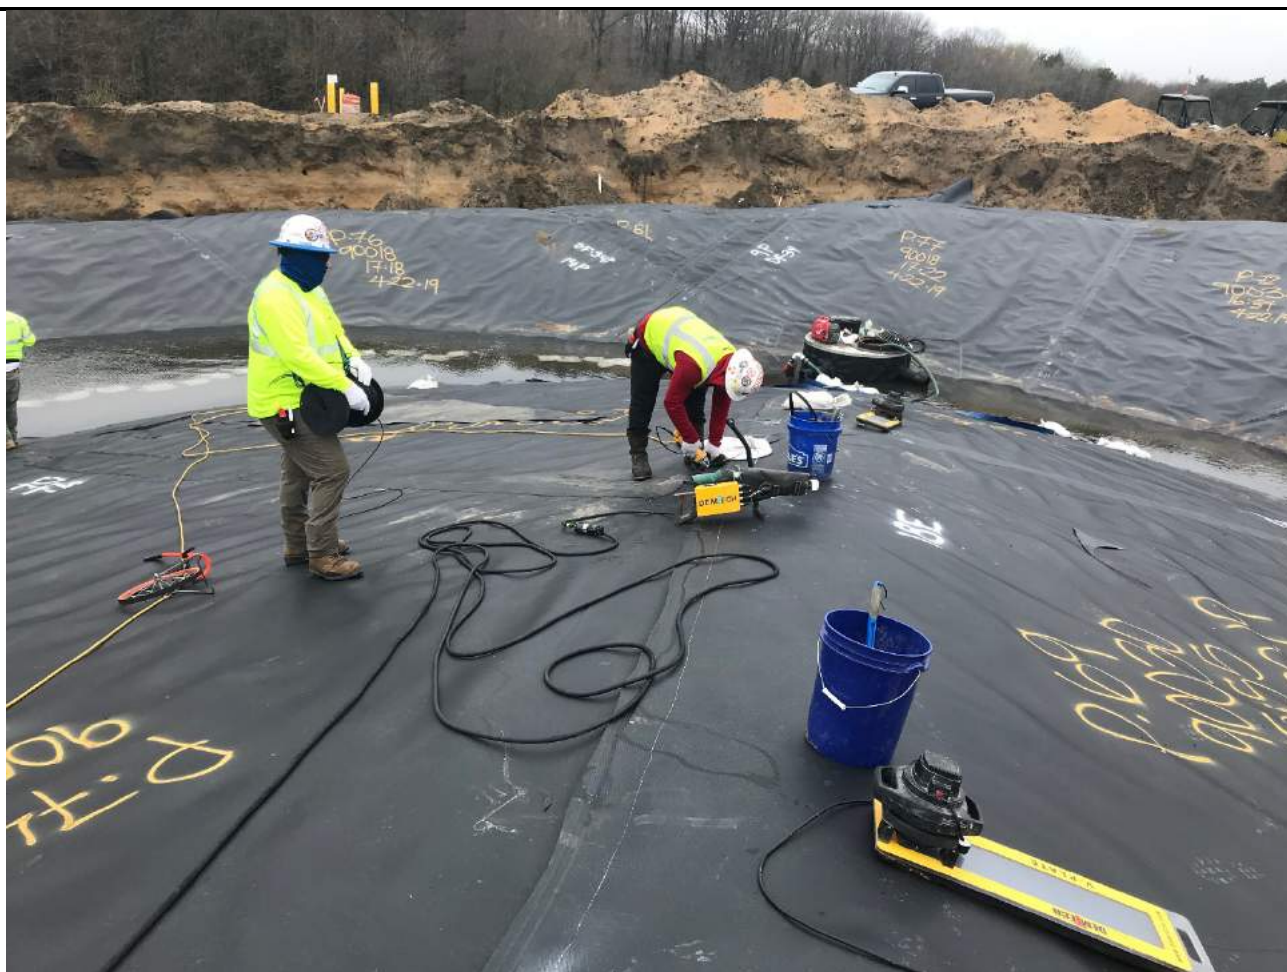
Extrusion welding repairs.

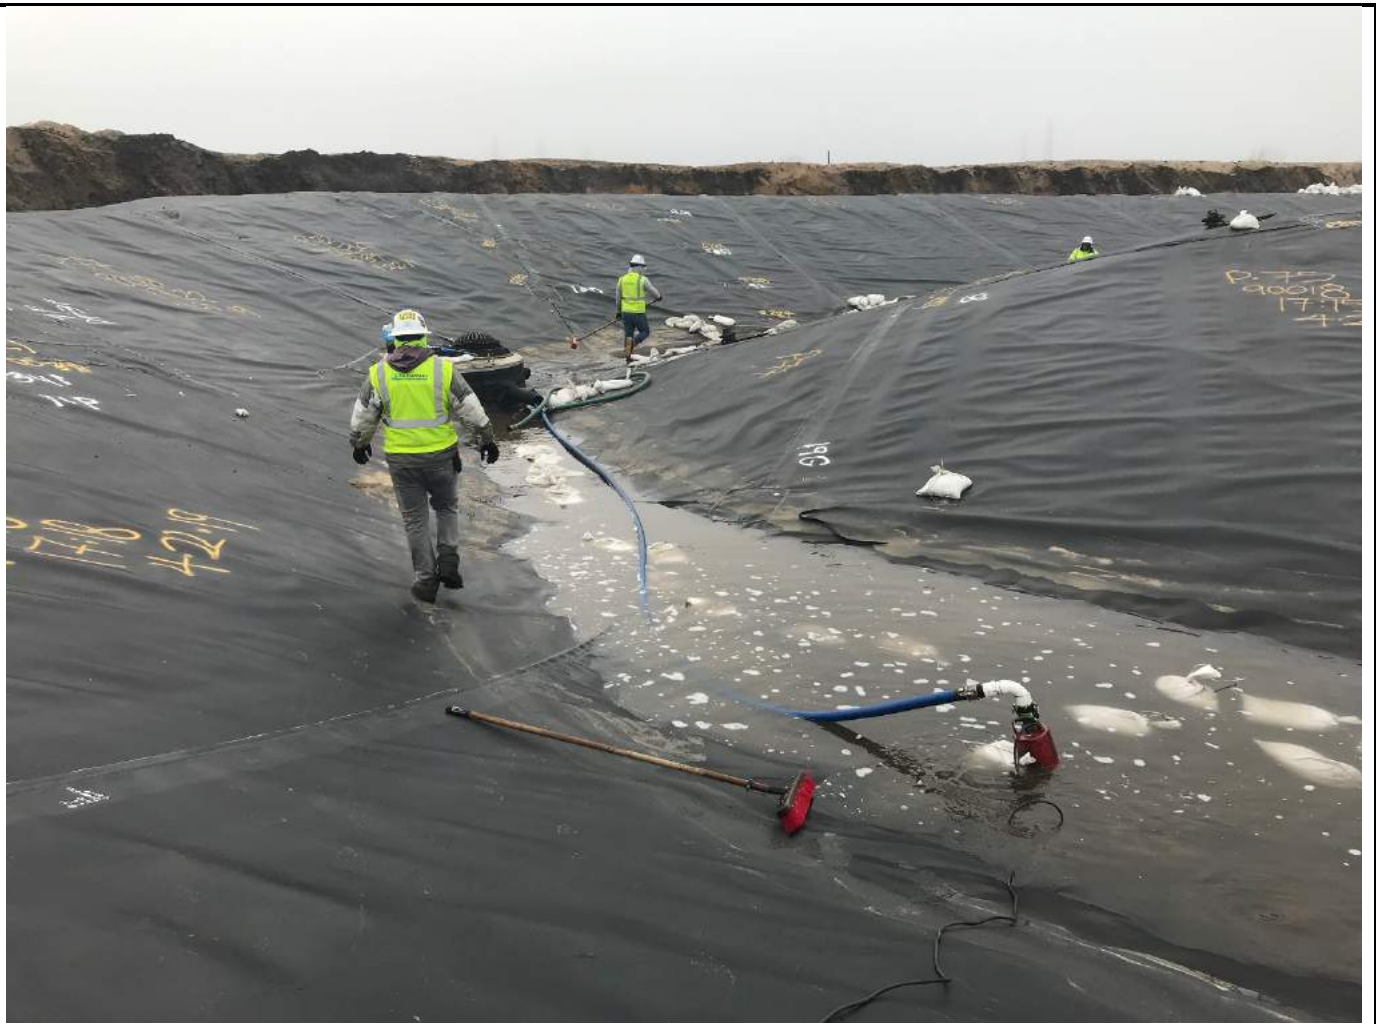
Sump-pump dewatering western end of Pond A

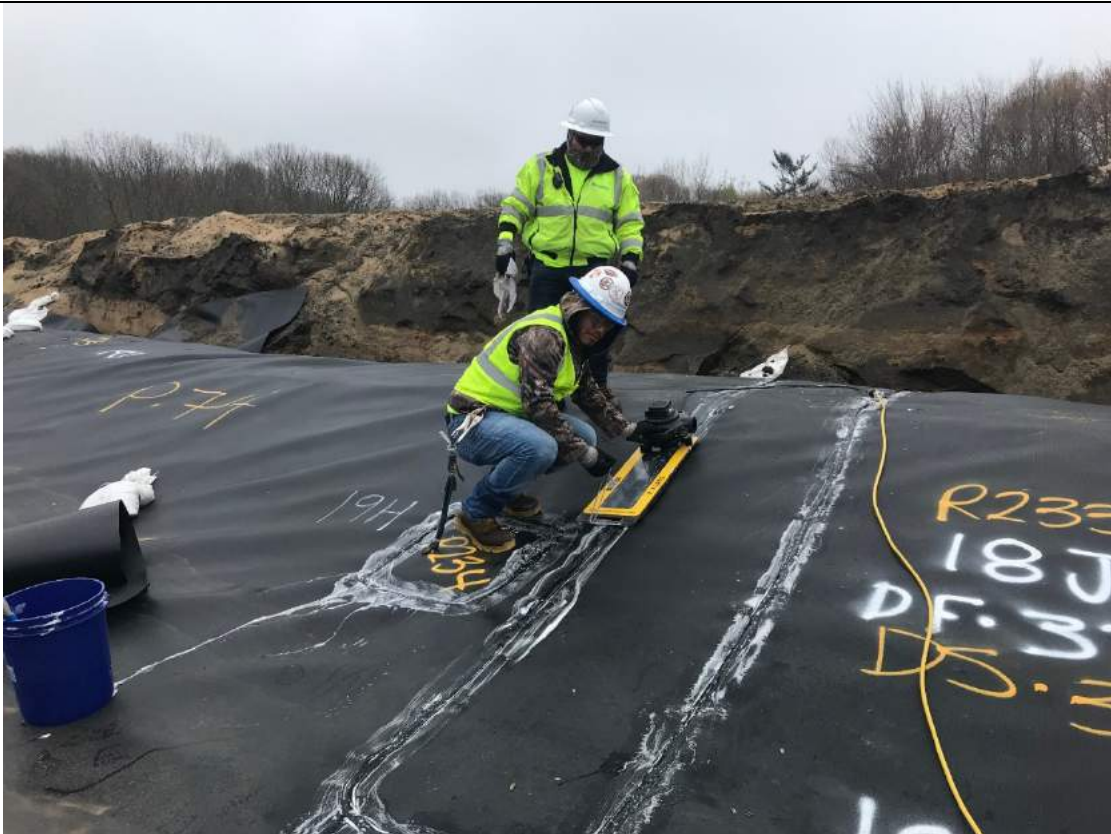
Vacuum testing repairs.

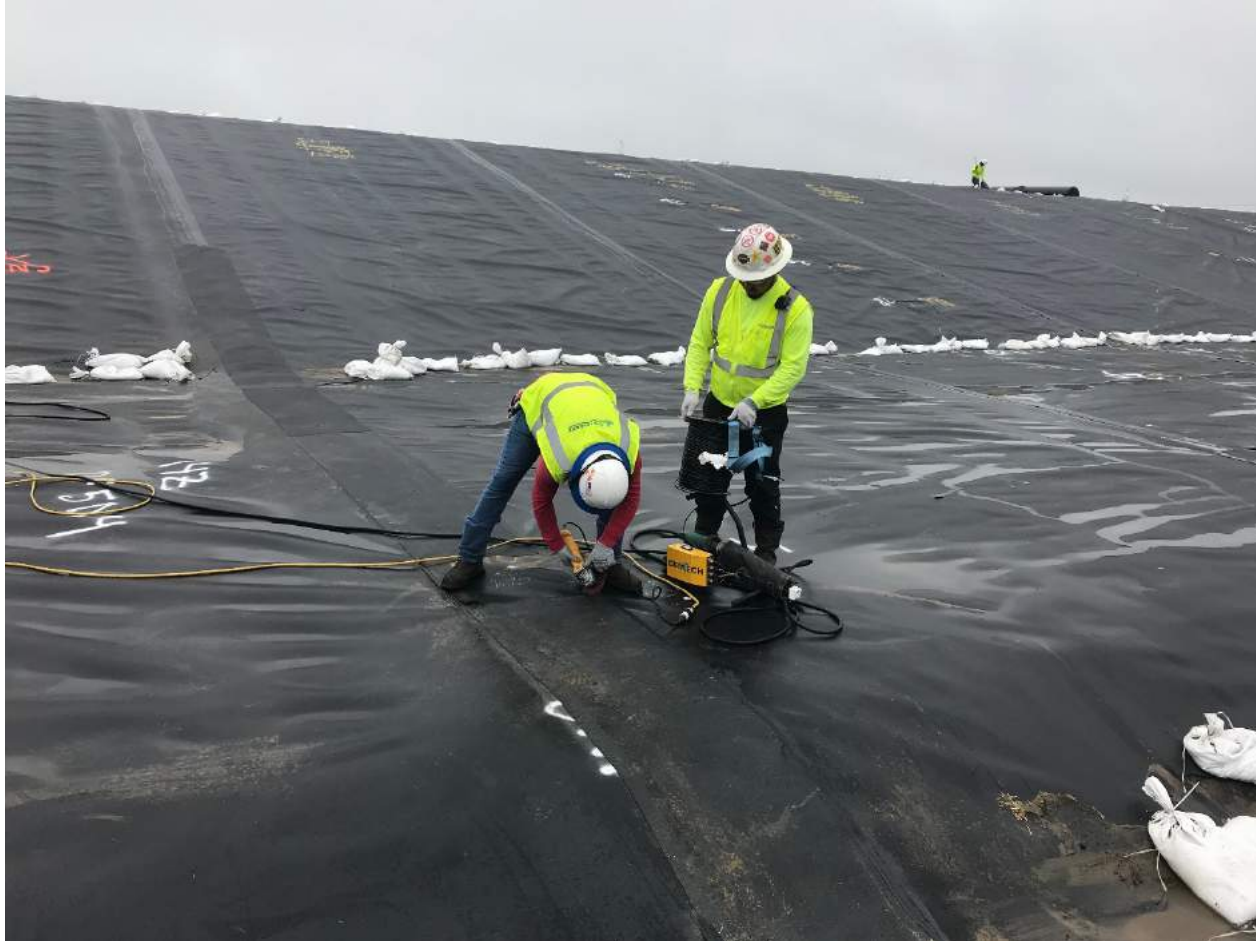
Extrusion welding repairs.

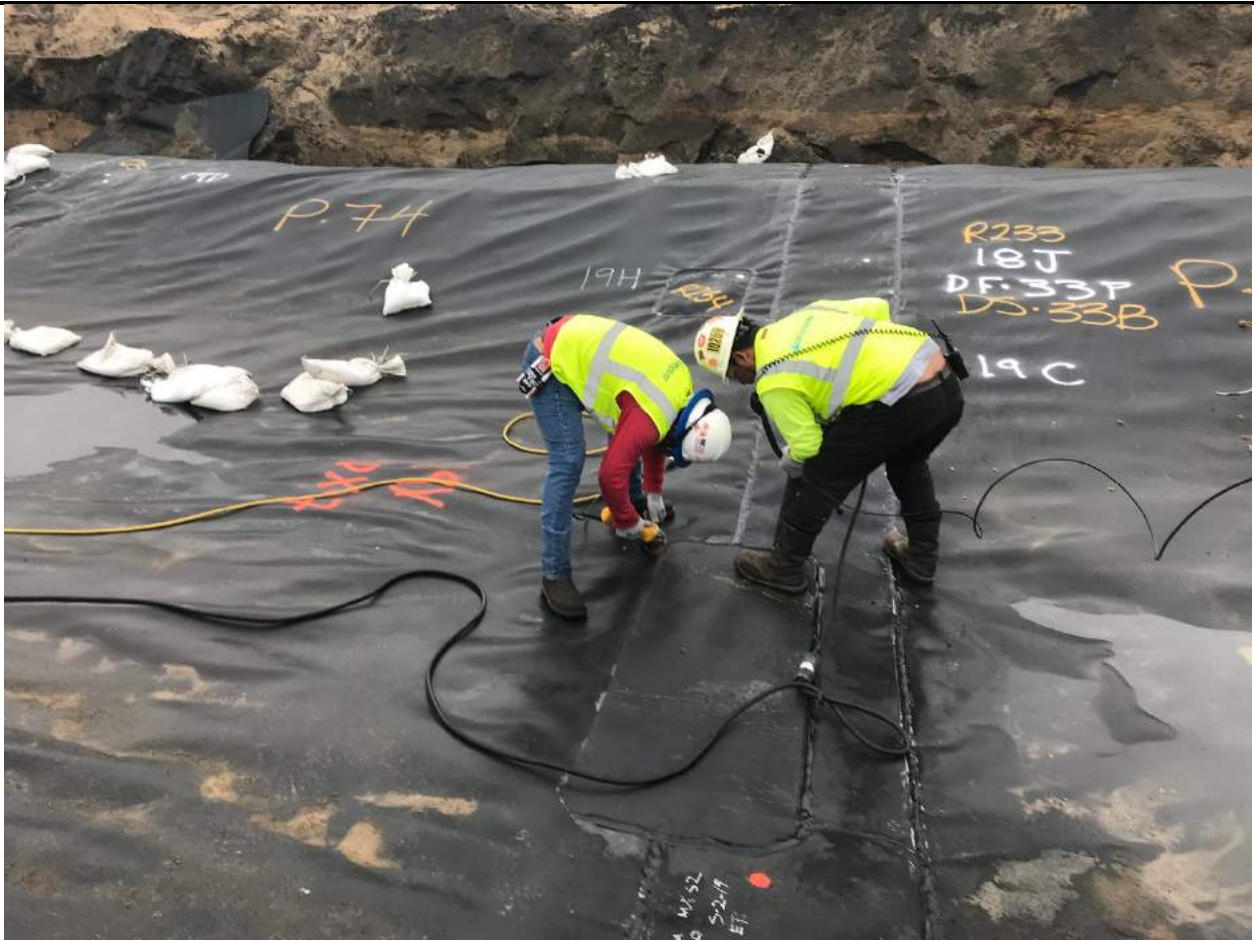
Extrusion welding repairs

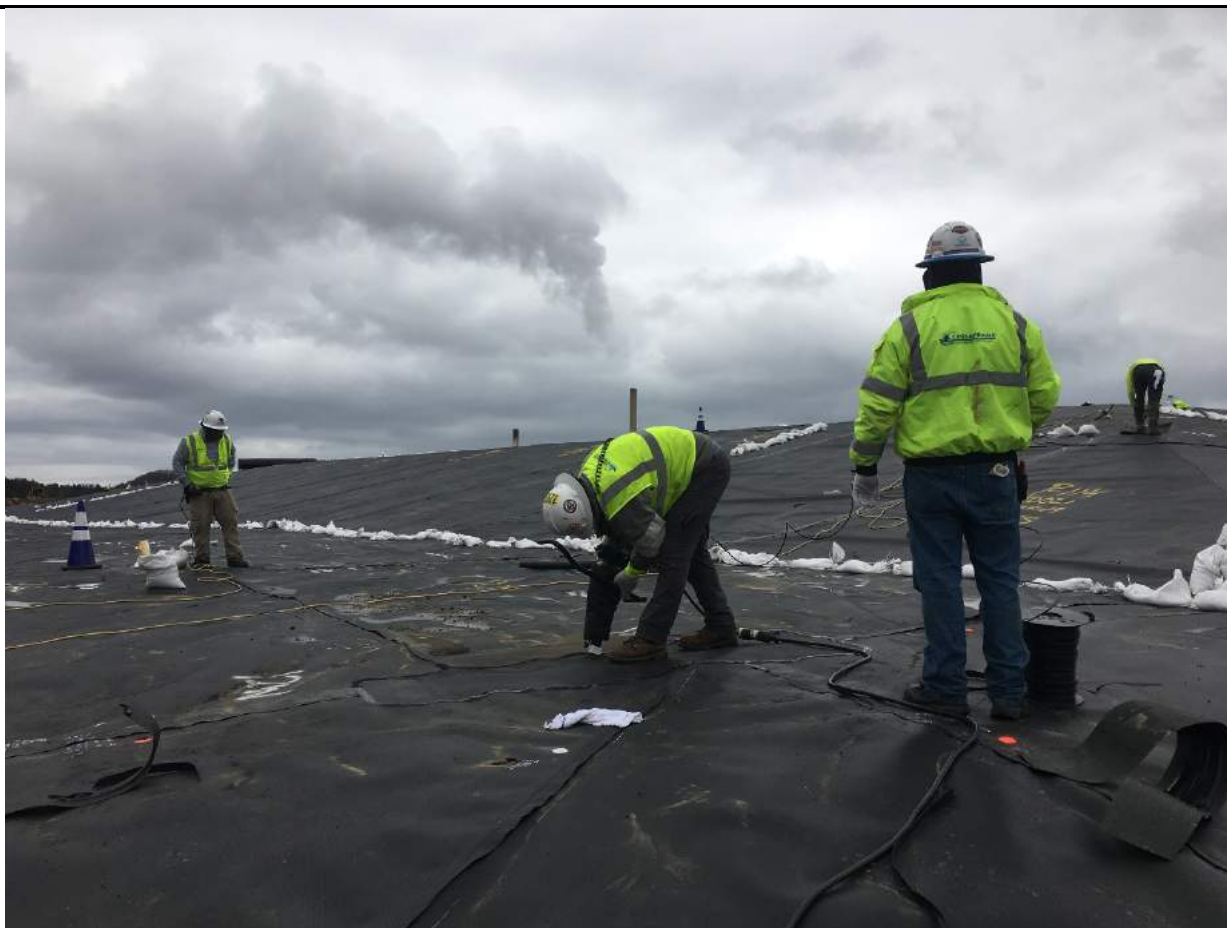
Extrusion welding repairs.

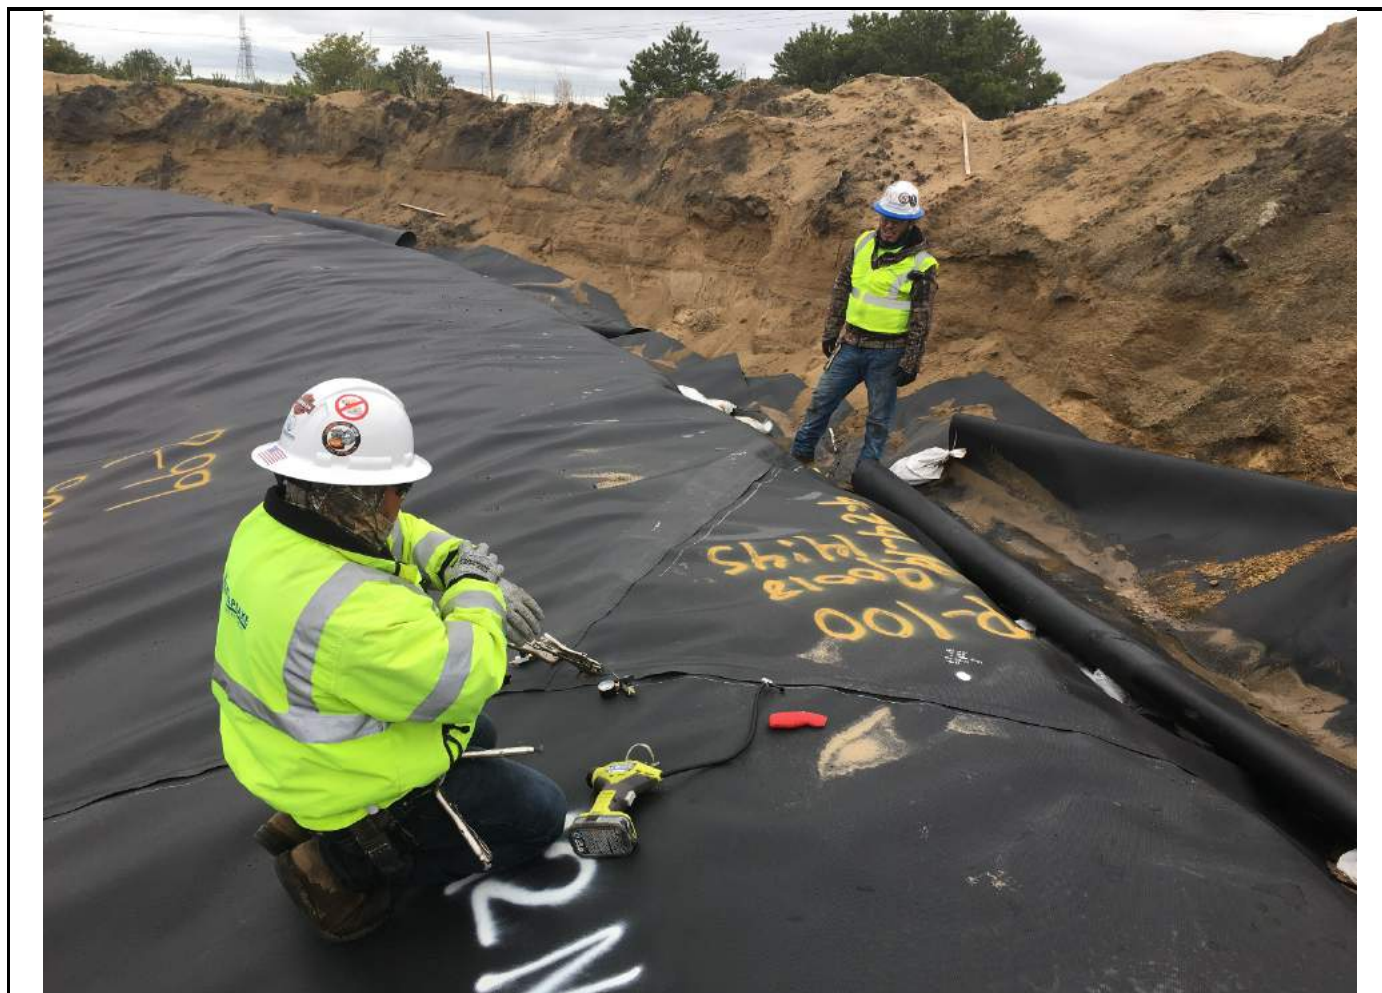
Pressure testing seams.

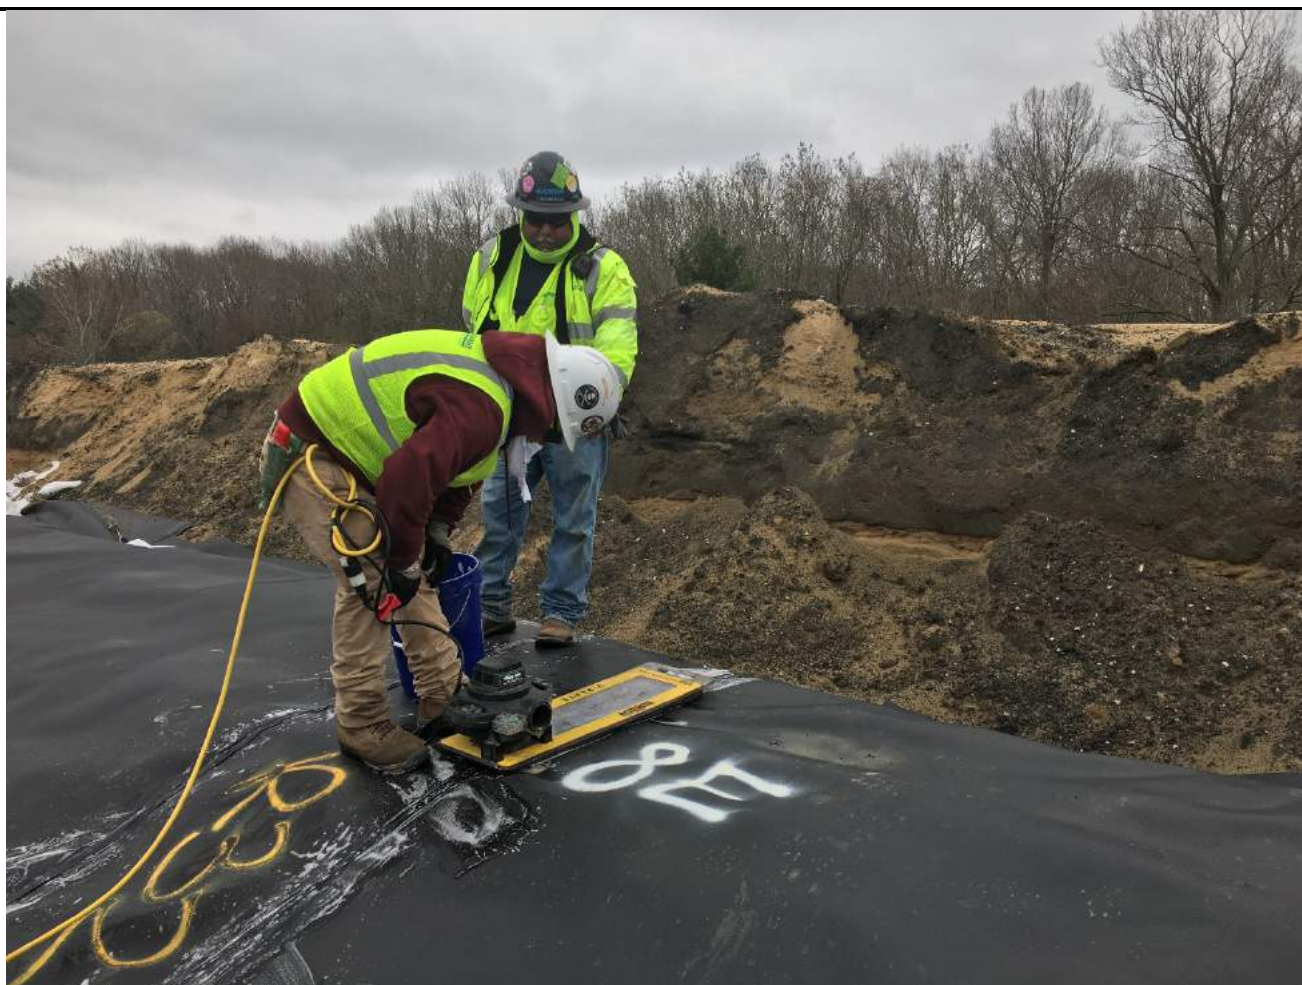
Vacuum testing repairs

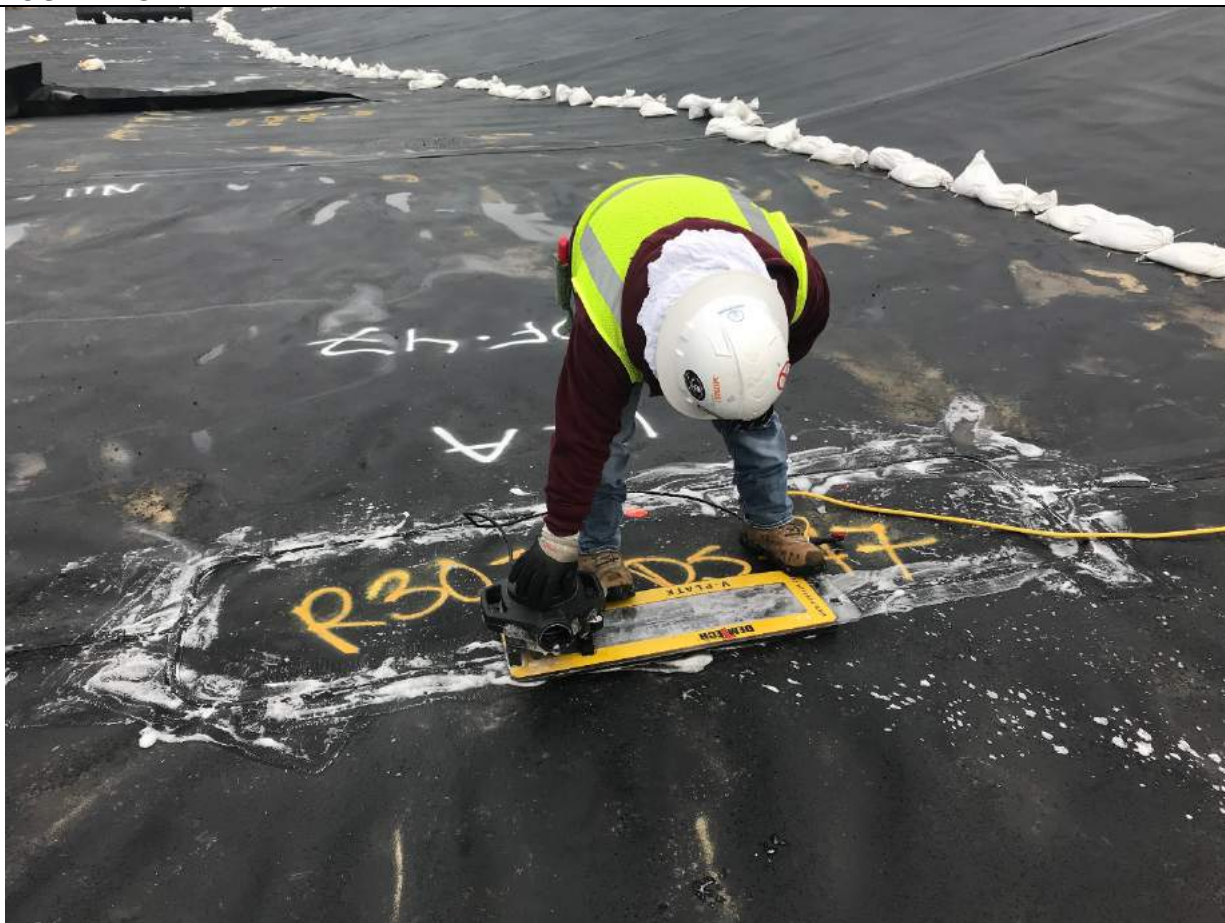
Vacuum testing repairs.
