J.H. Campbell Generating Facility

Pond A - Construction Documentation Report

Golder Associates Inc.

October 1, 2019

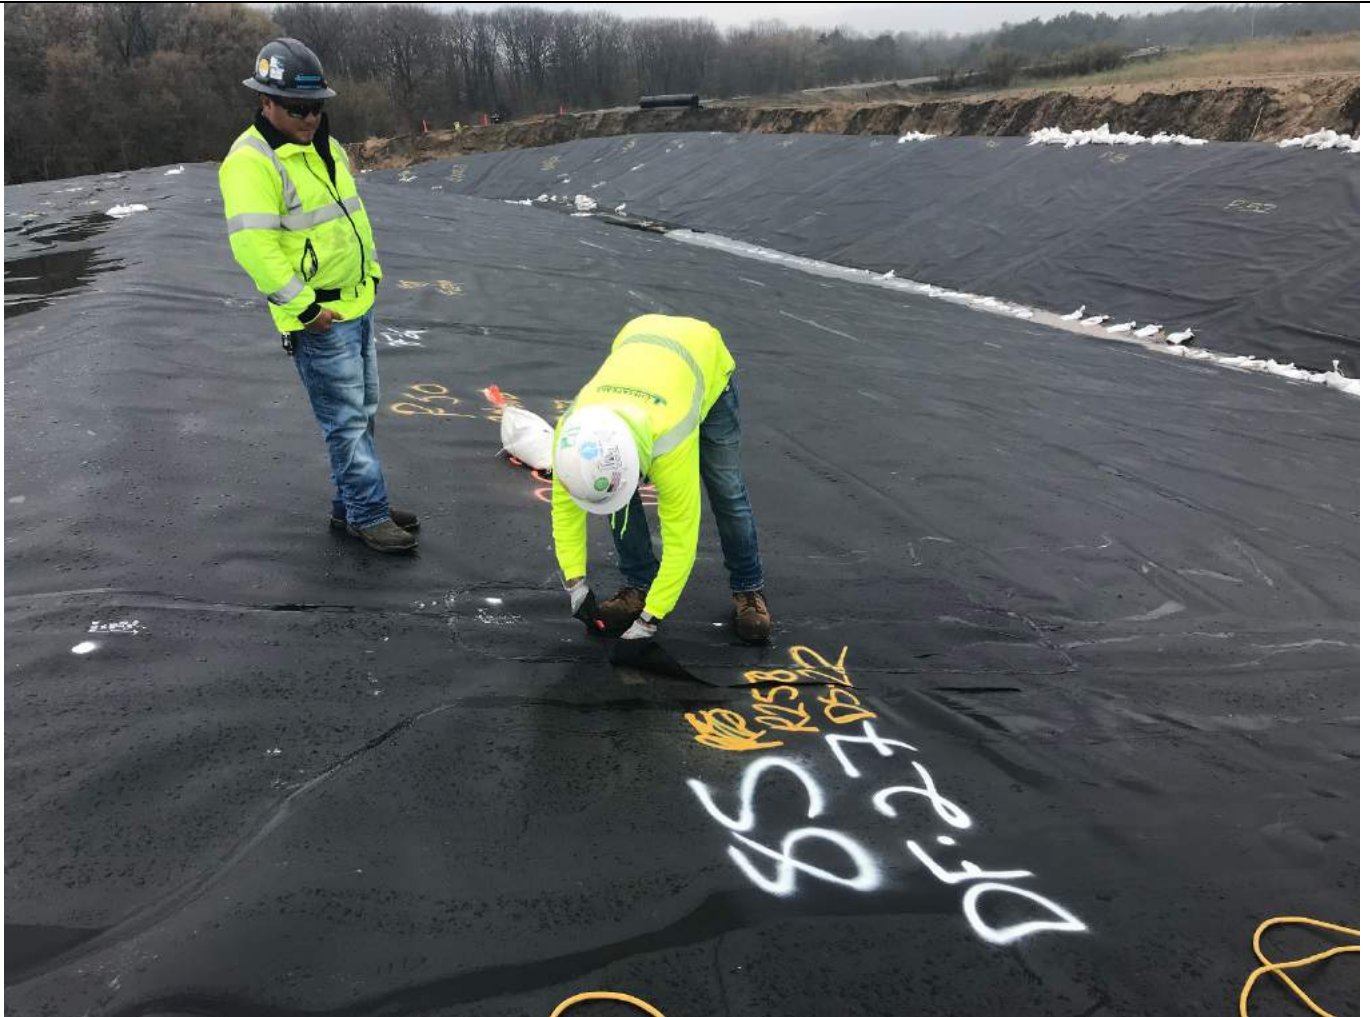
Pulling extrusion destruct DX-6P

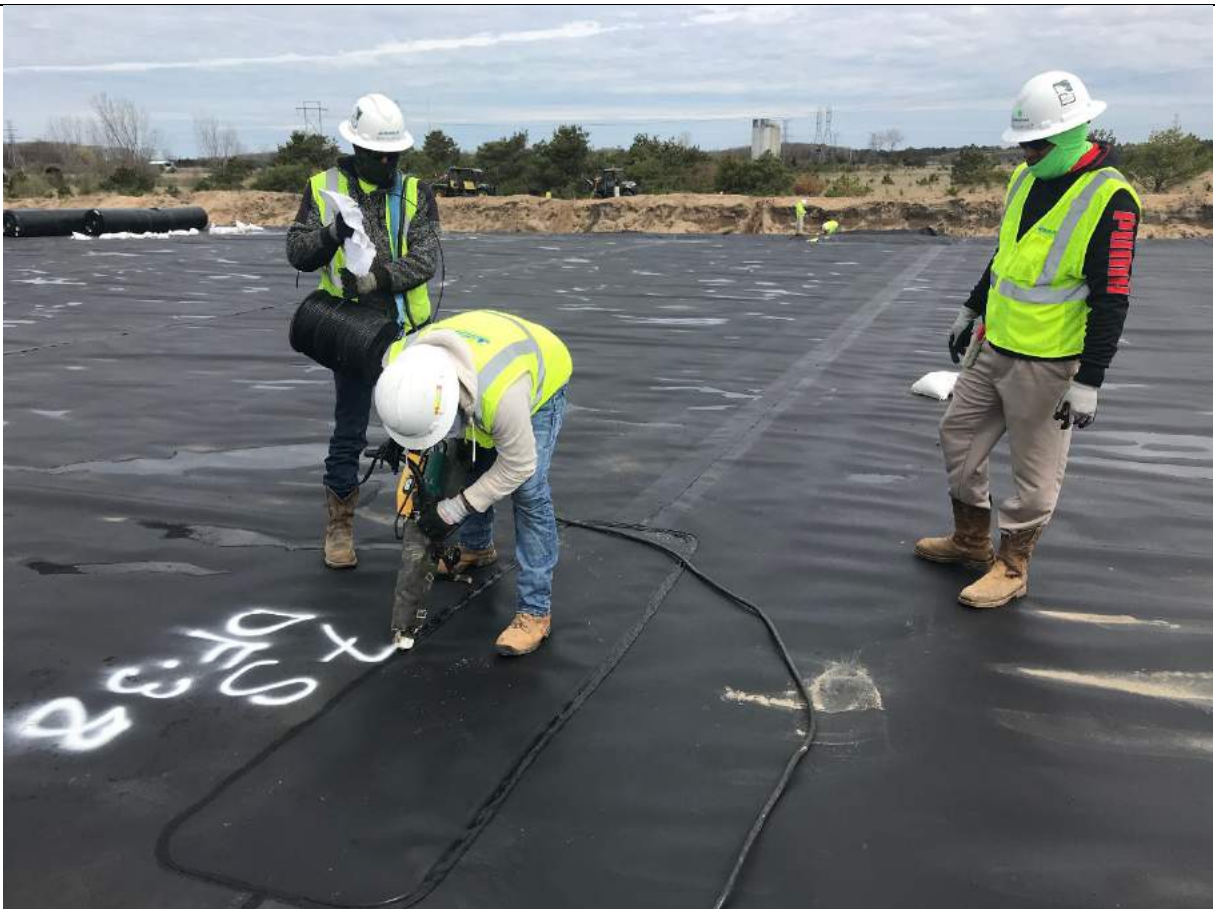
Performing extrusion welding of repairs.

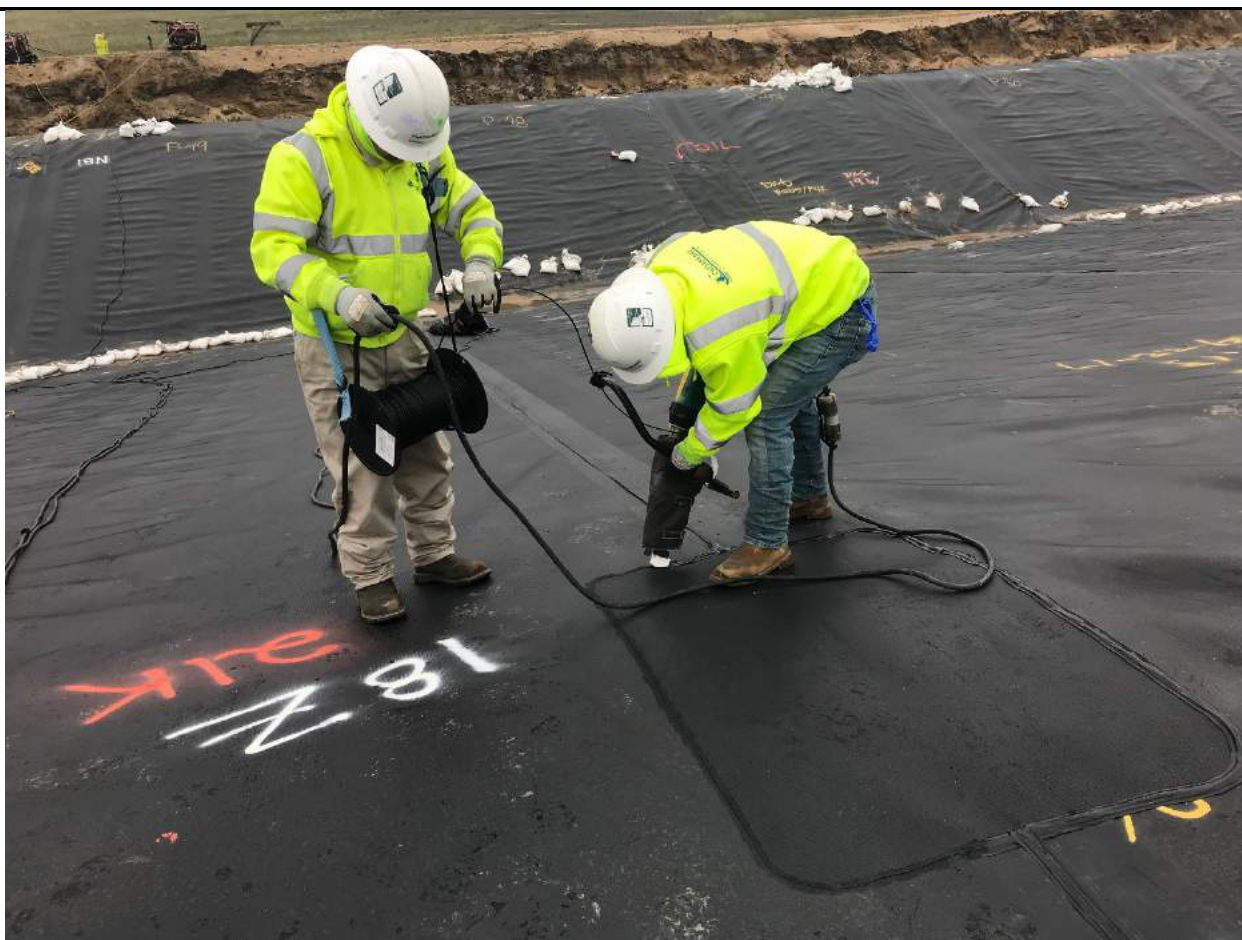
Extrusion welding repairs.

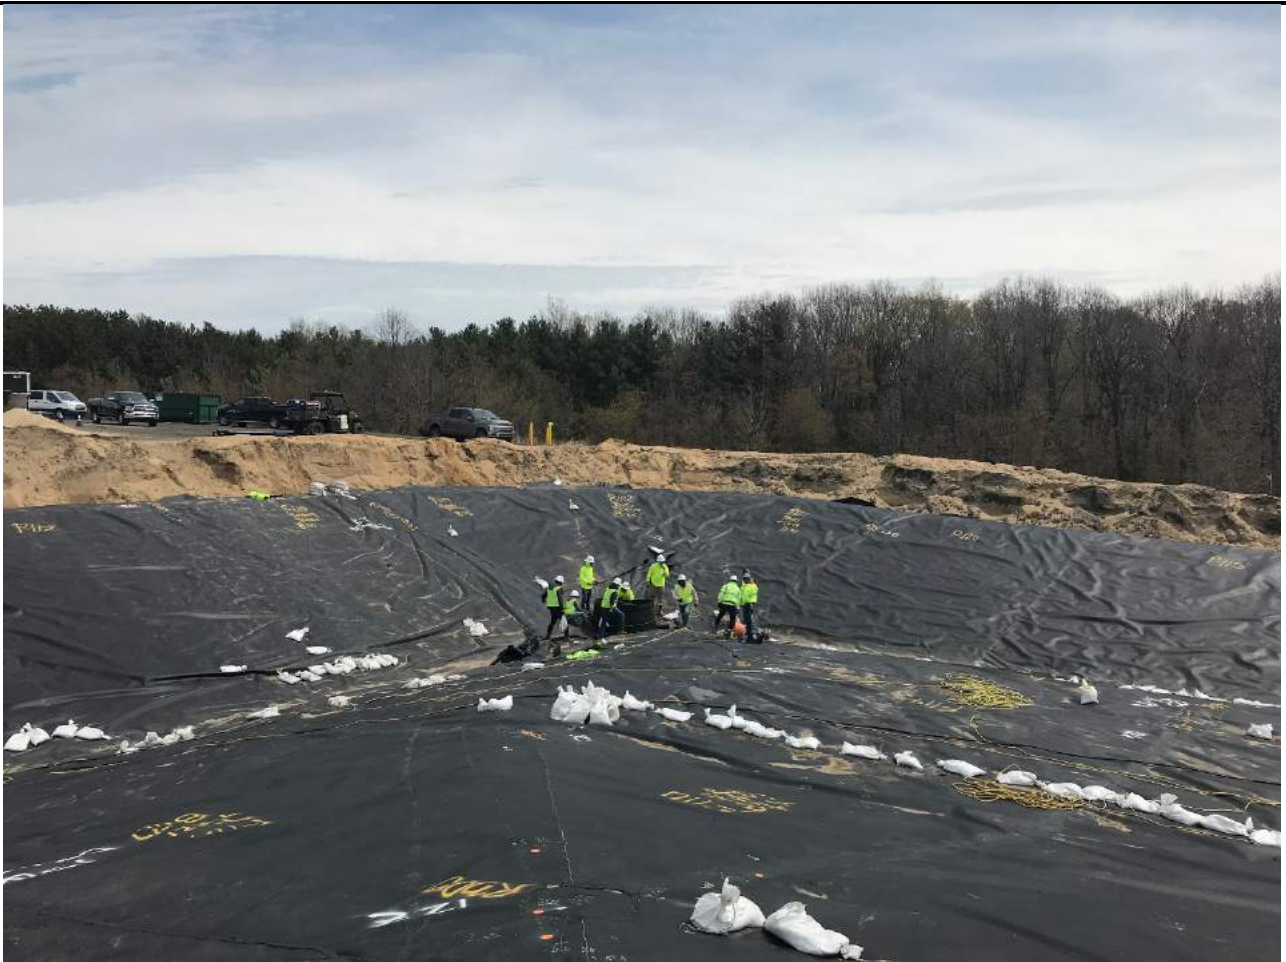
Began welding boot for eastern stormwater manhole

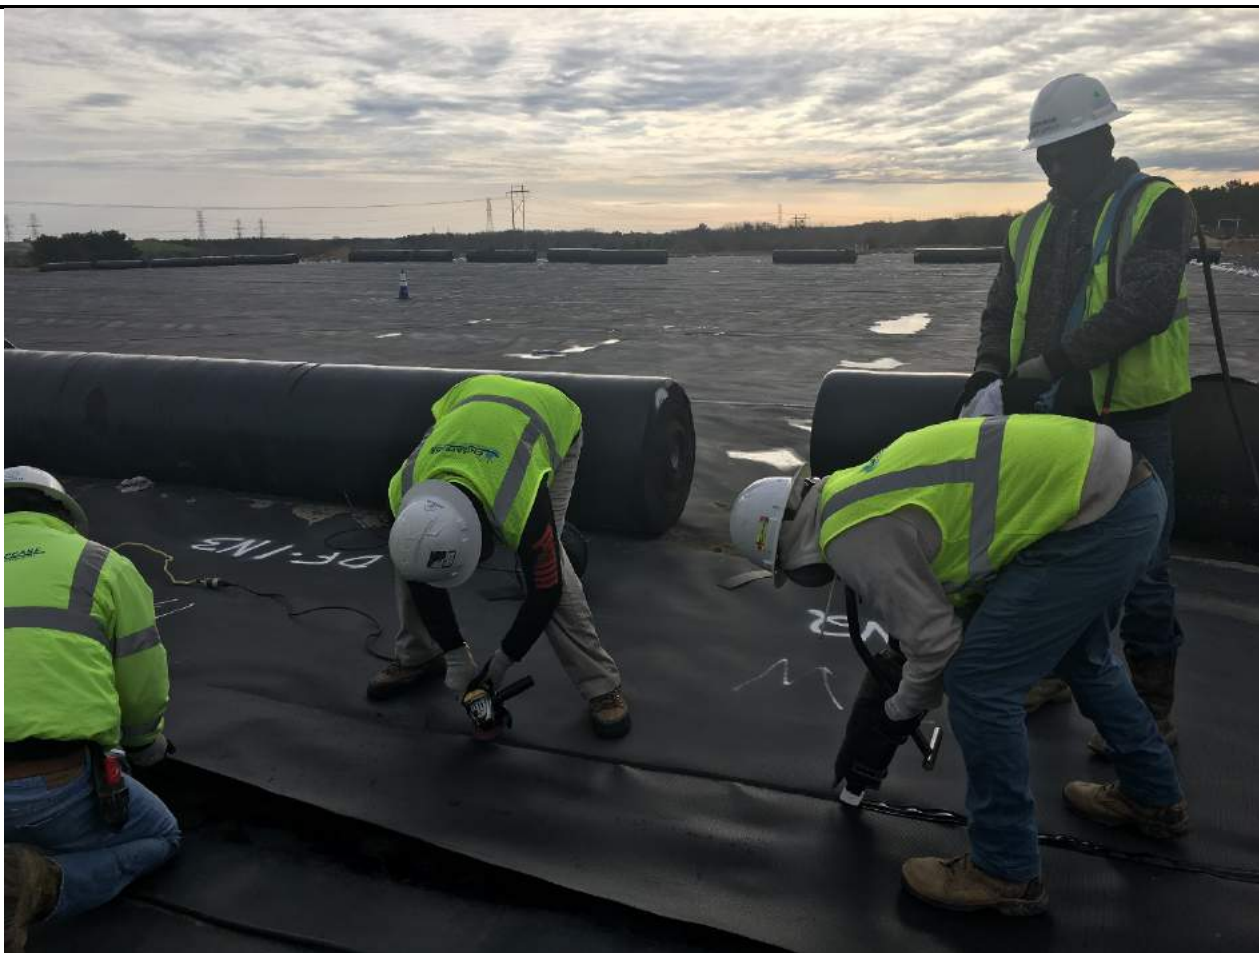
Performing extrusion welding of repairs.

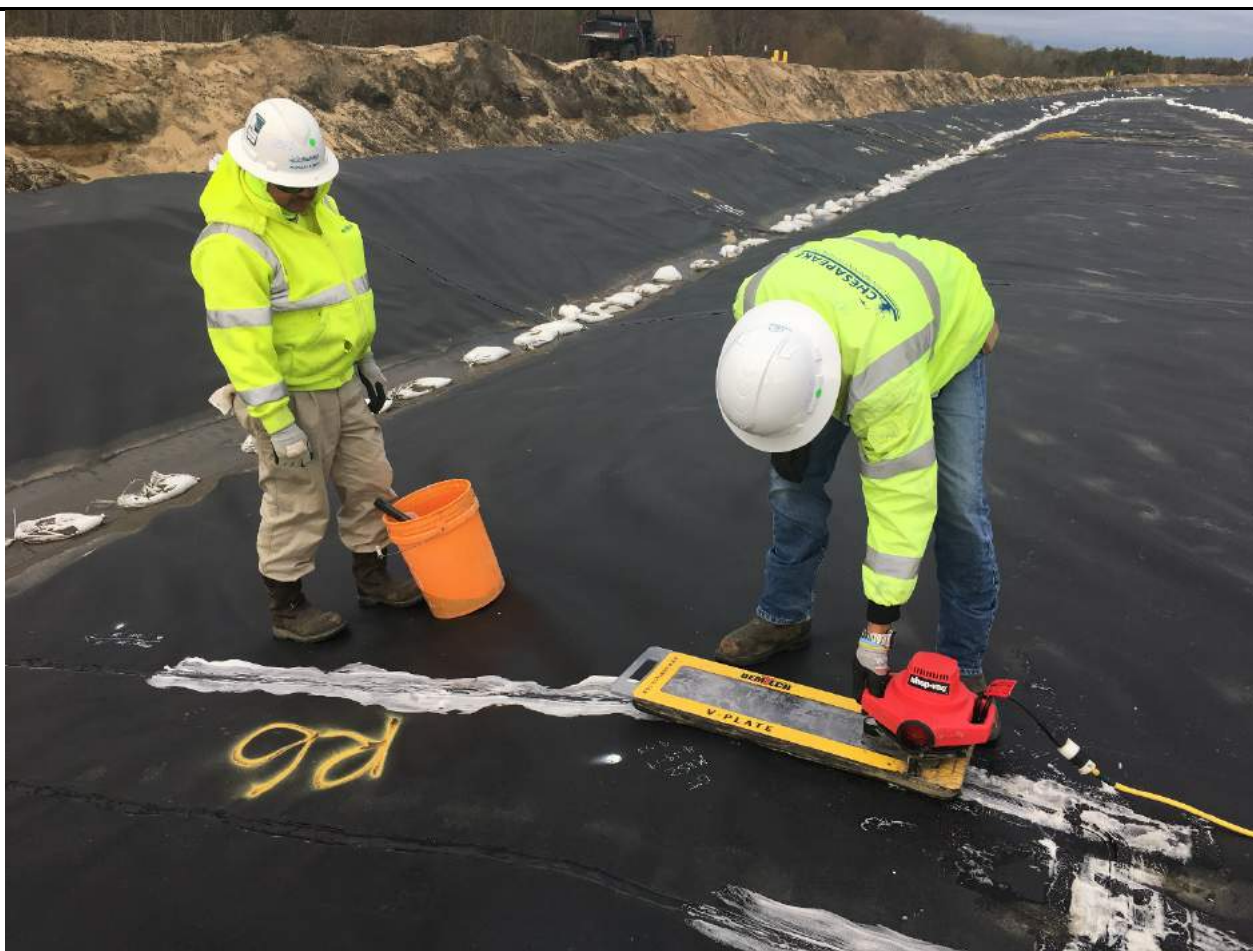
Vacuum testing of repairs.

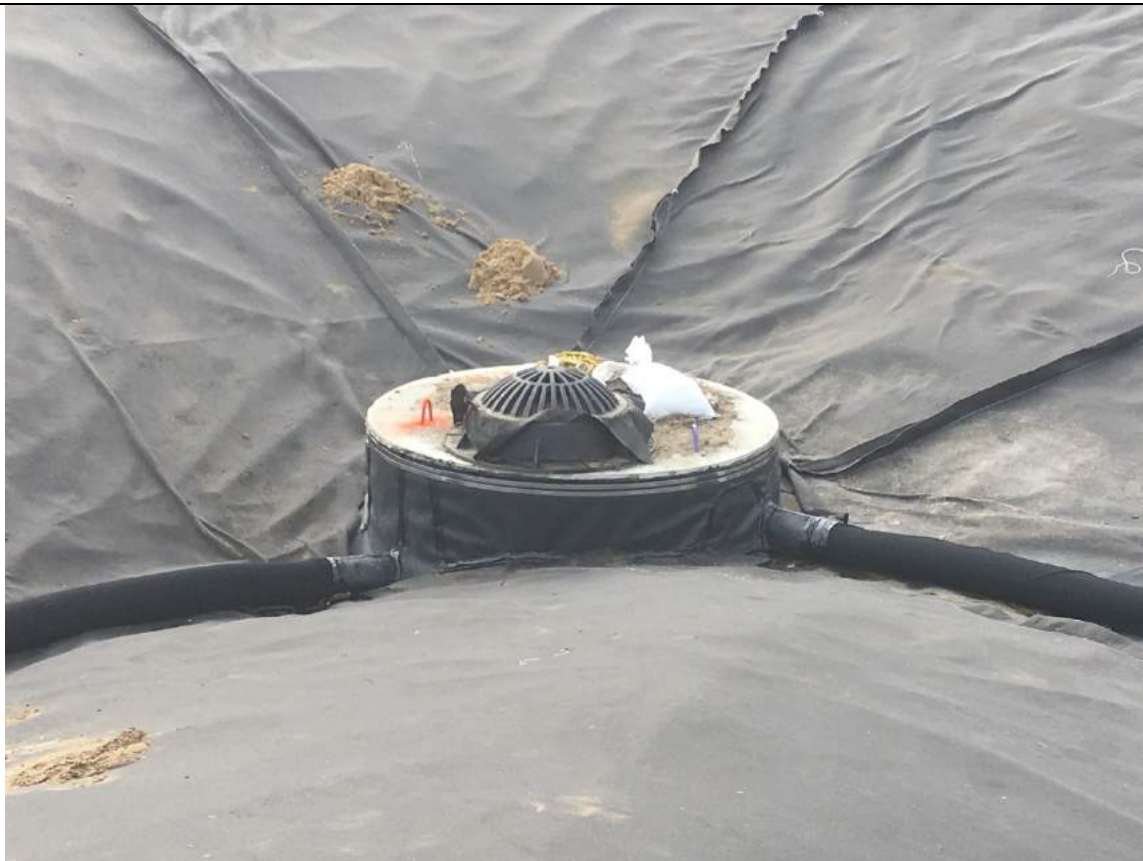
Eastern stormwater manhole without 6-inch drainage tile connected.

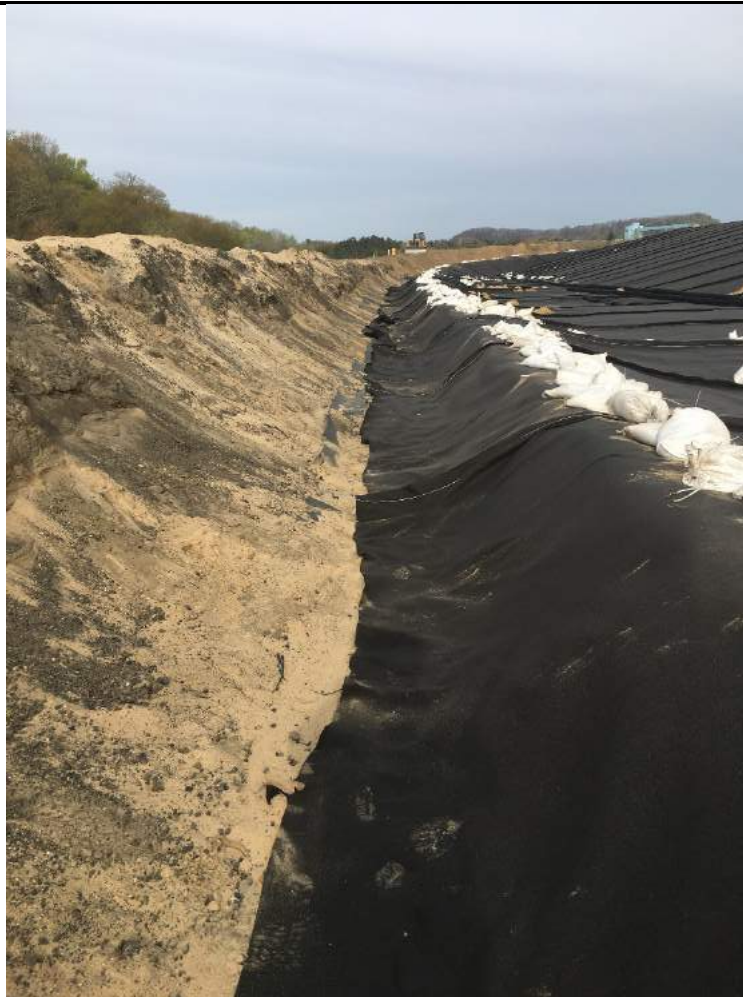
Sandbags removed from the anchor trench.

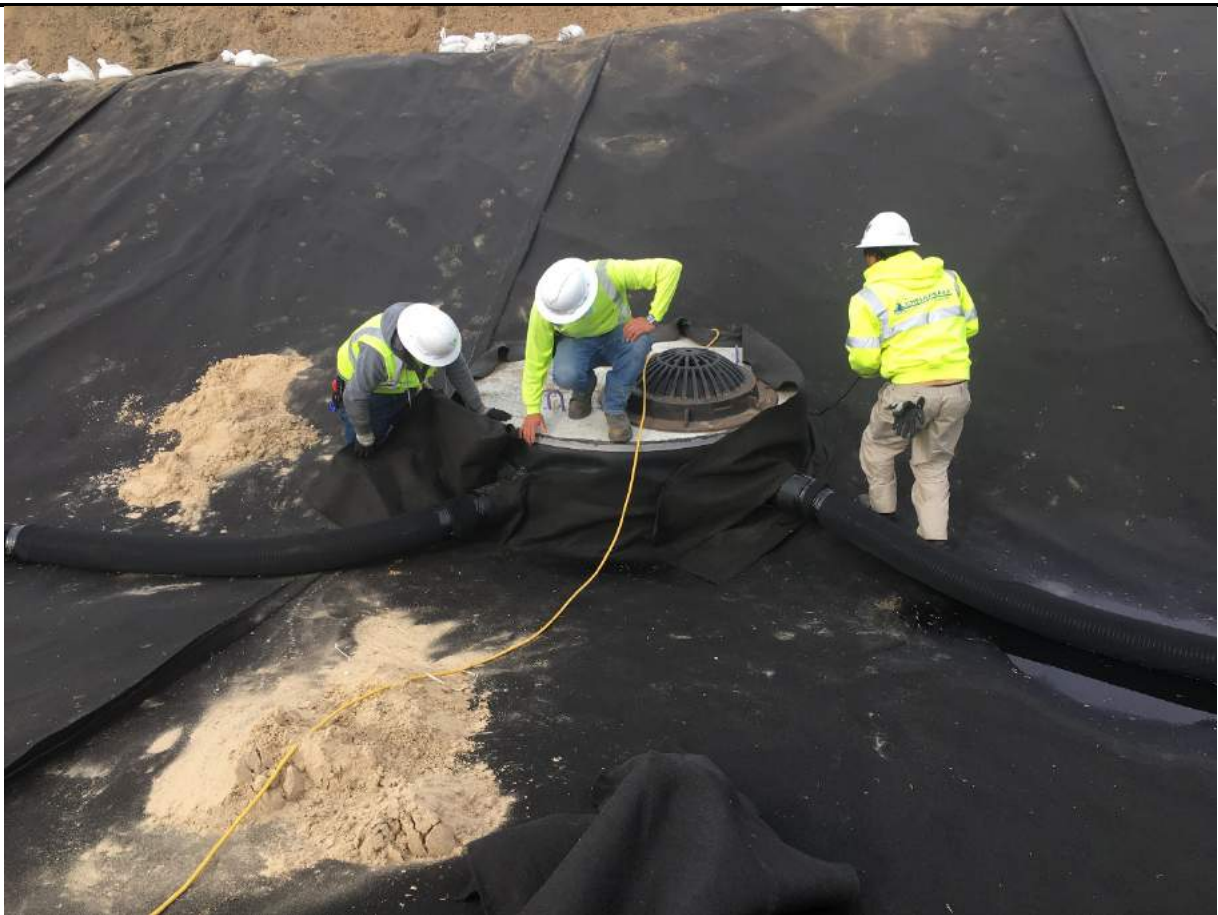
Wrapping western stormwater manhole in geotextile.

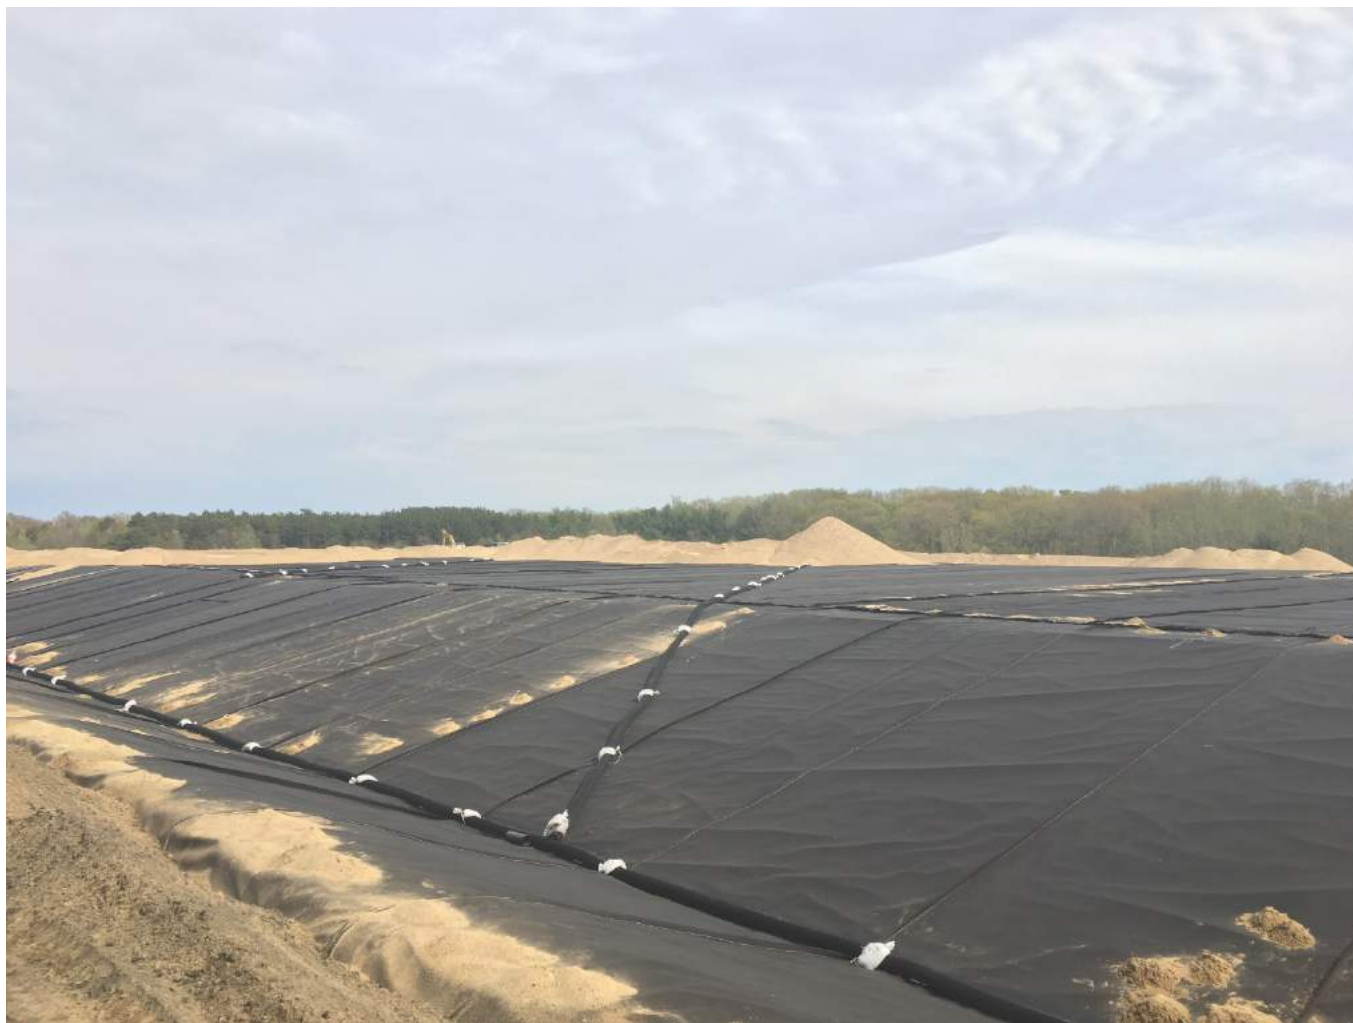
East end of Pond A.

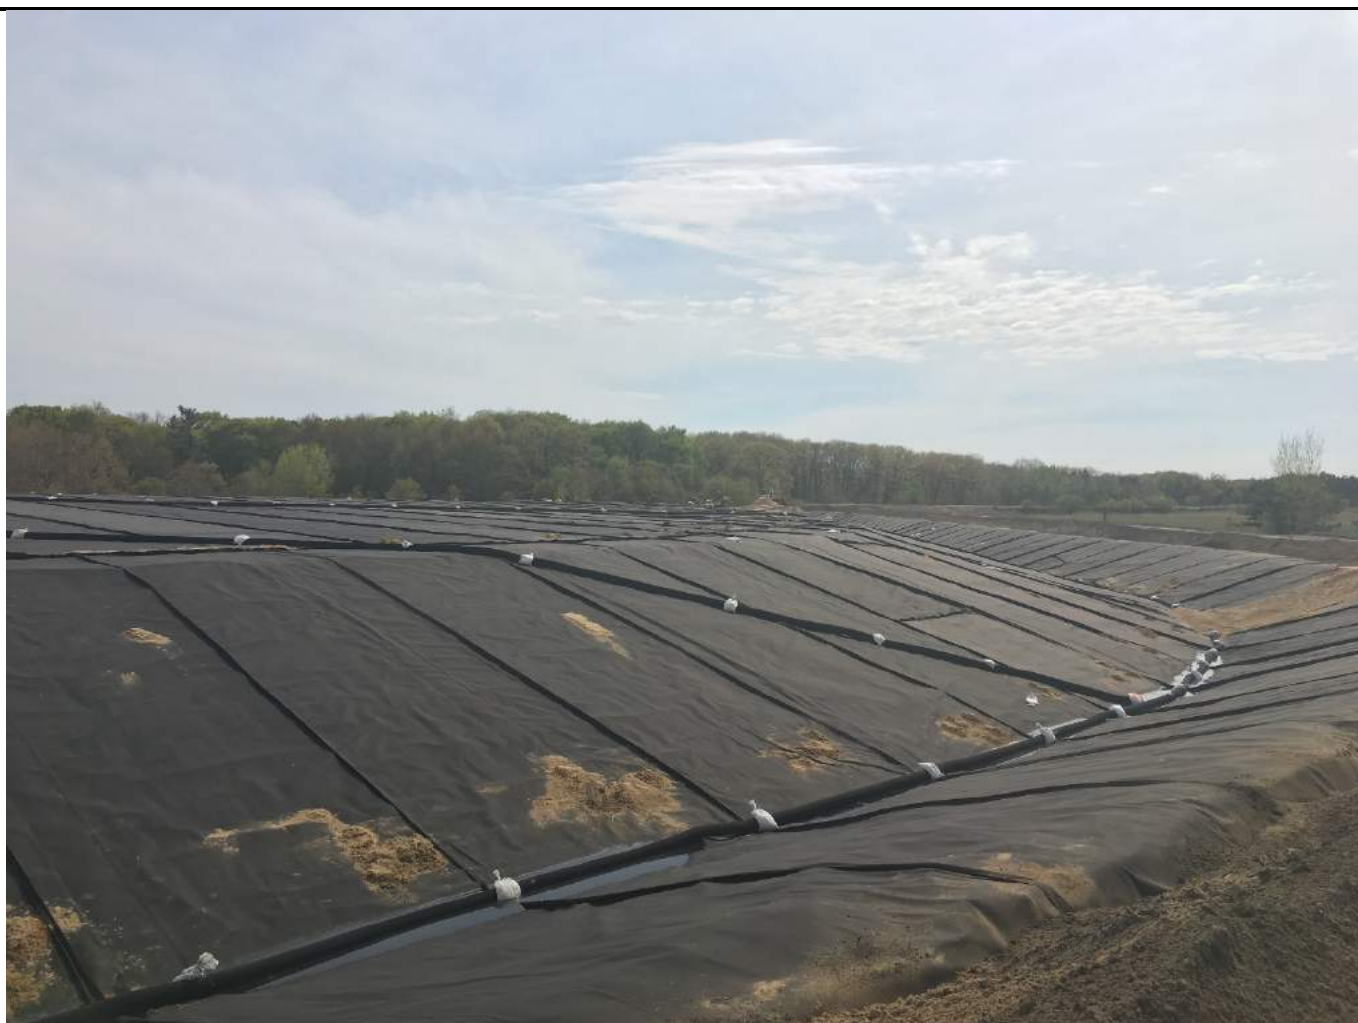
West end of Pond A.

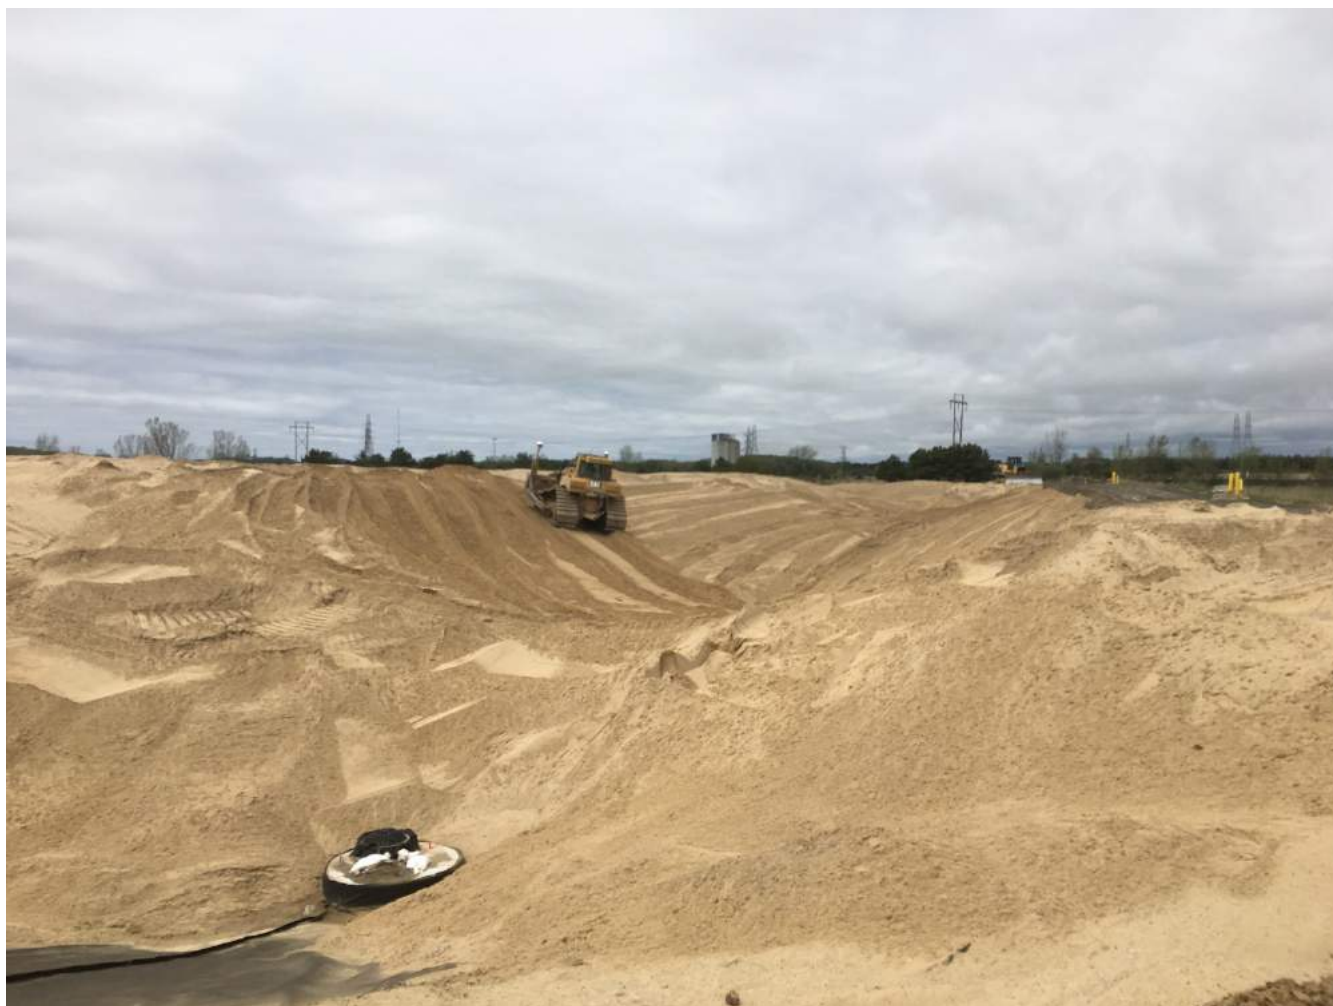
Pushing out cover material in the southeastern corner of Pond A.

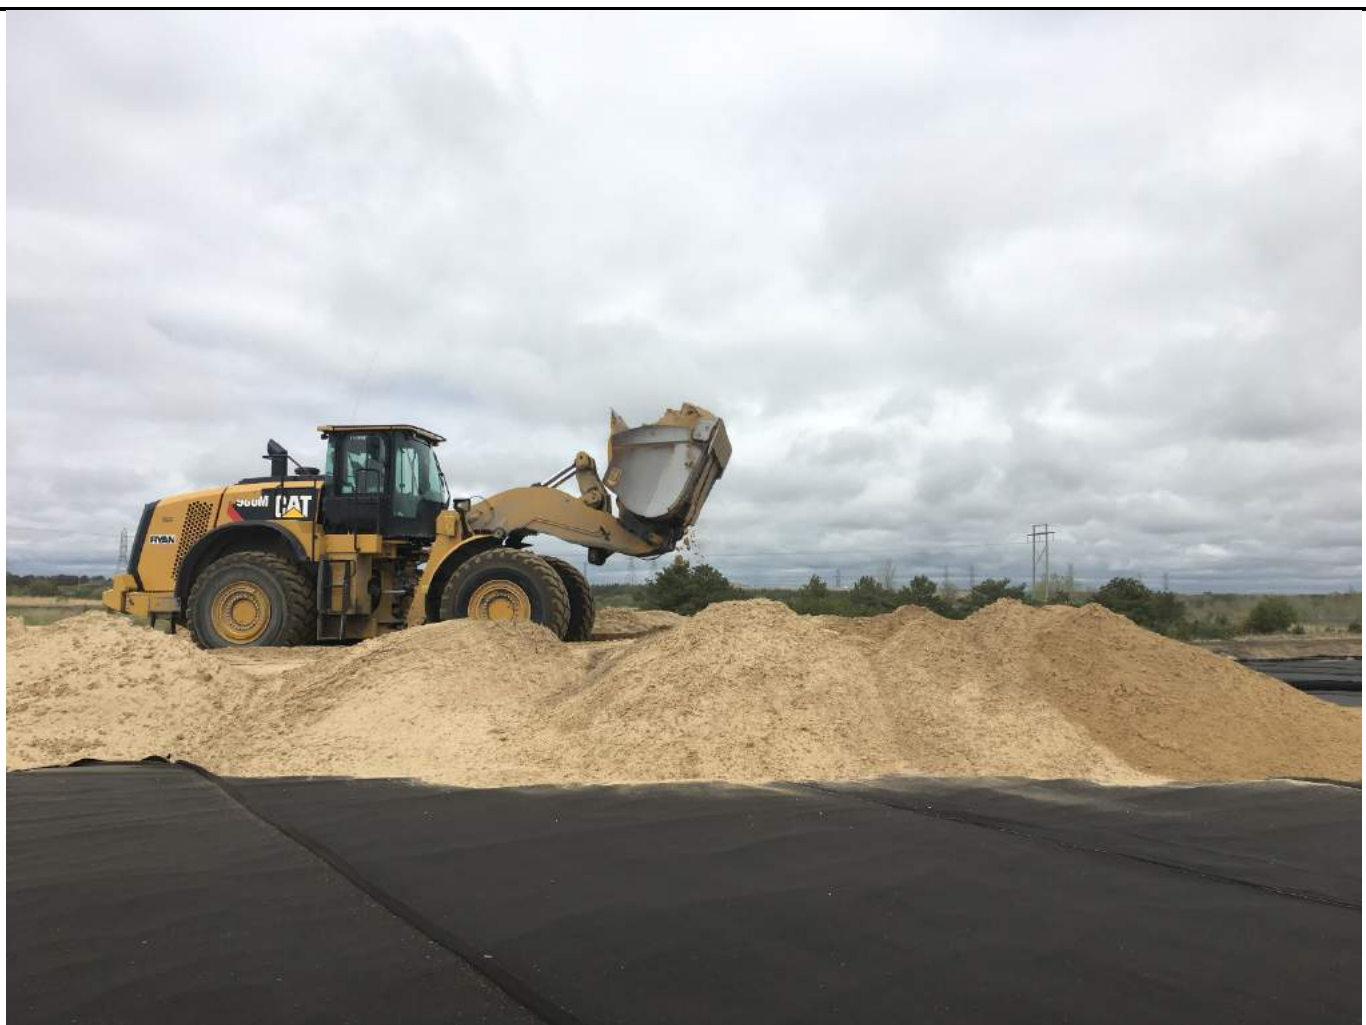
Placing cover material on top of Pond A.

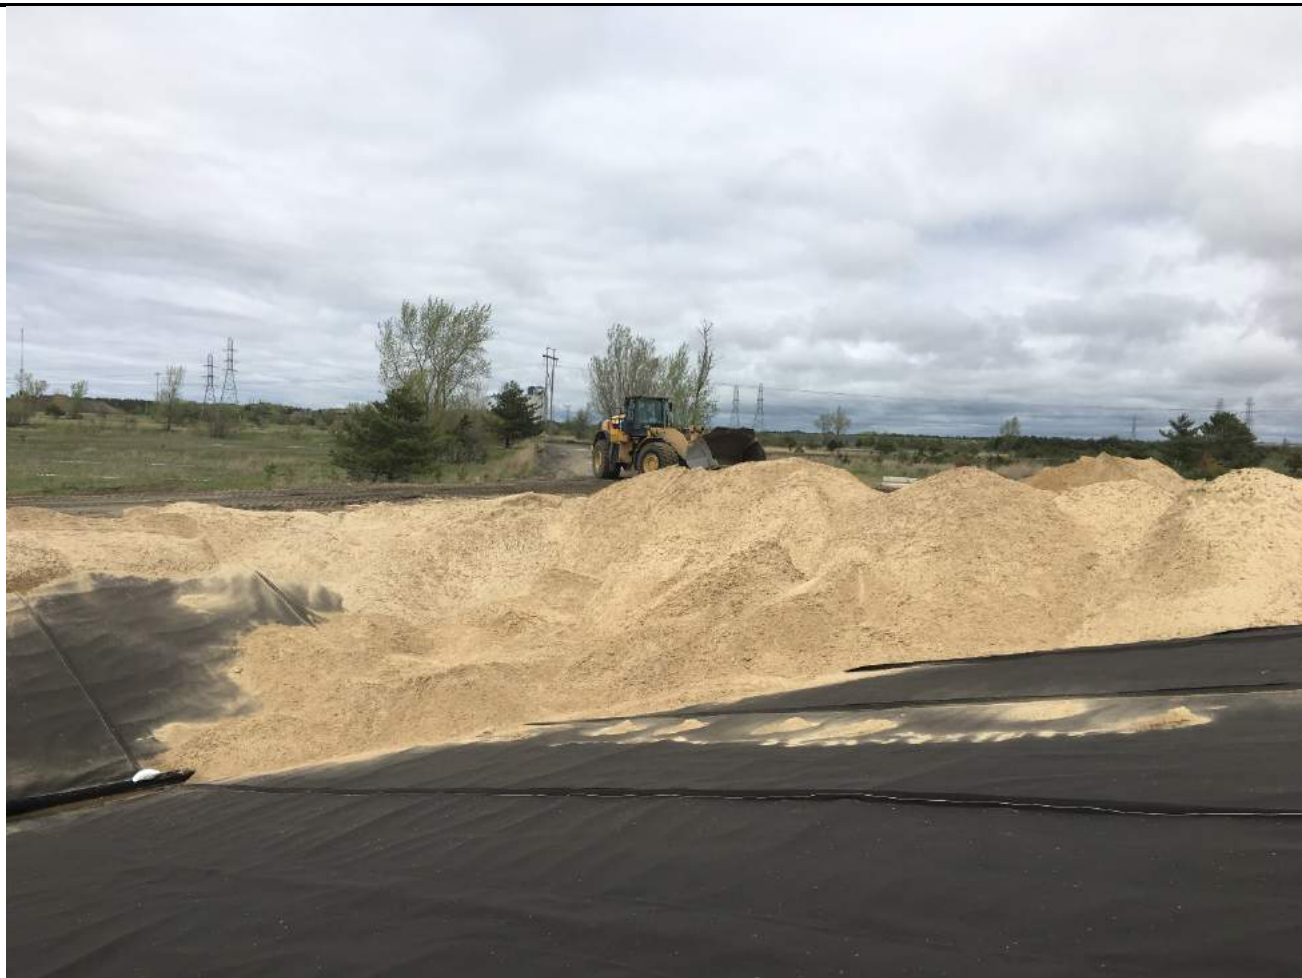
Building bridge of cover materials in the northwest corner of Pond A.

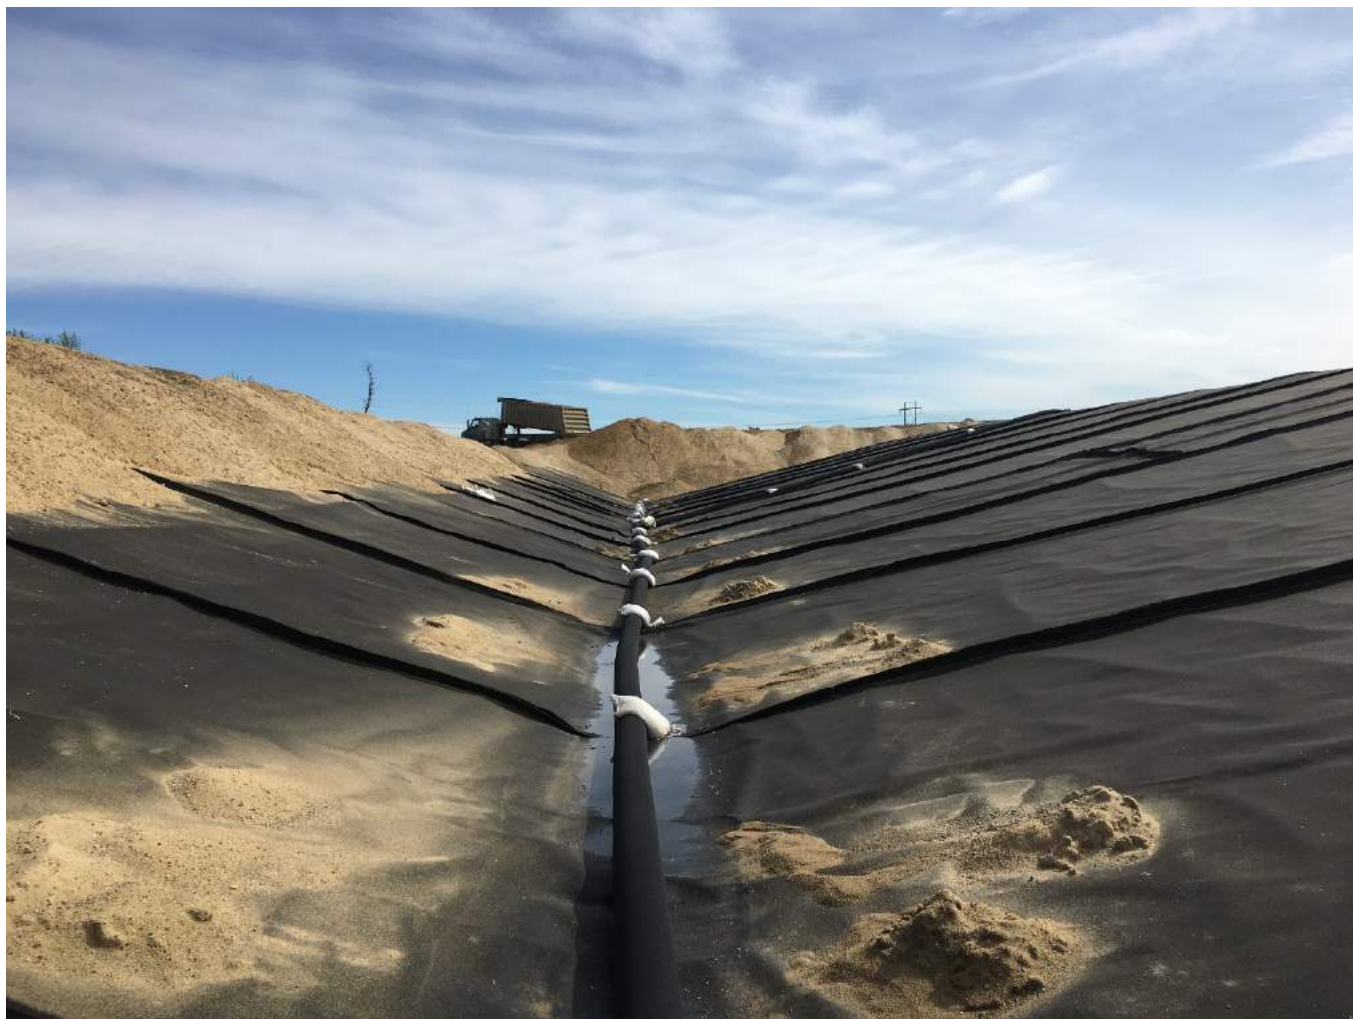
Receiving cover material in the northwest corner of Pond A.

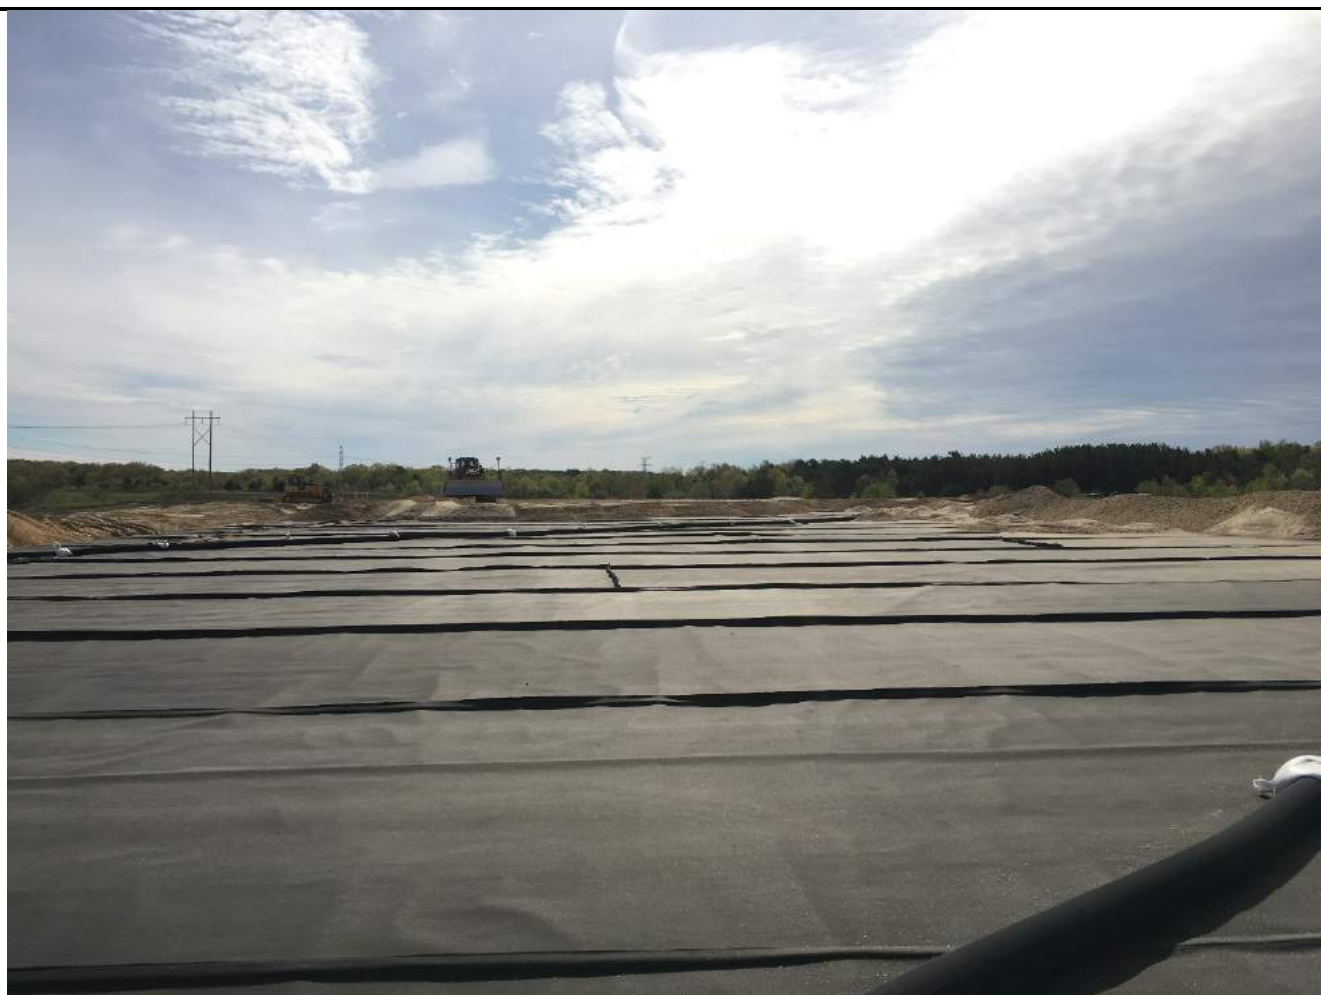
Dozer grading cover material on top of Pond A.

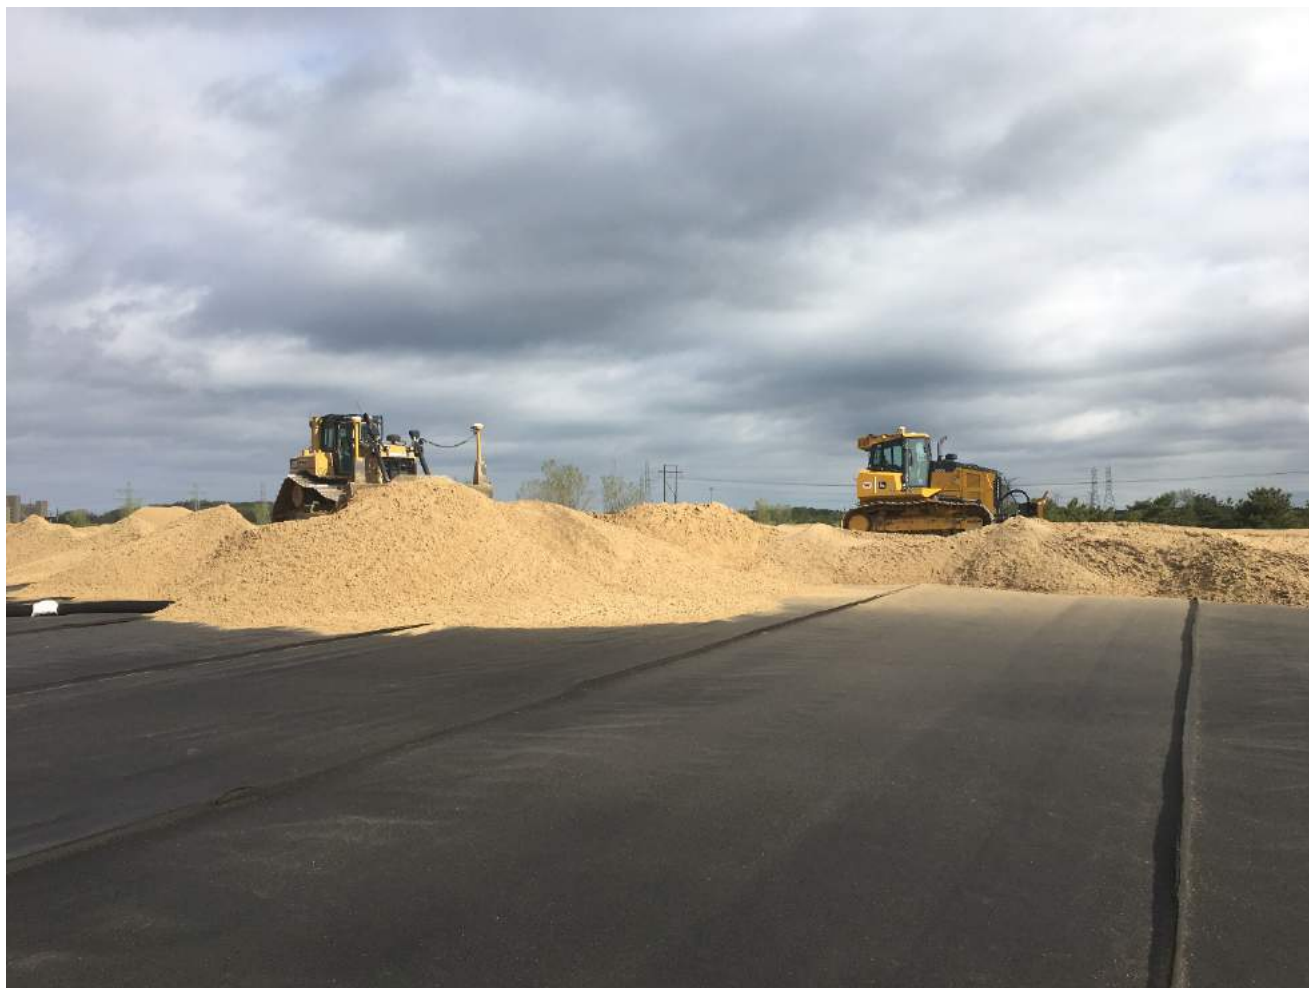
Grading cover material in the northwest corner of Pond A.

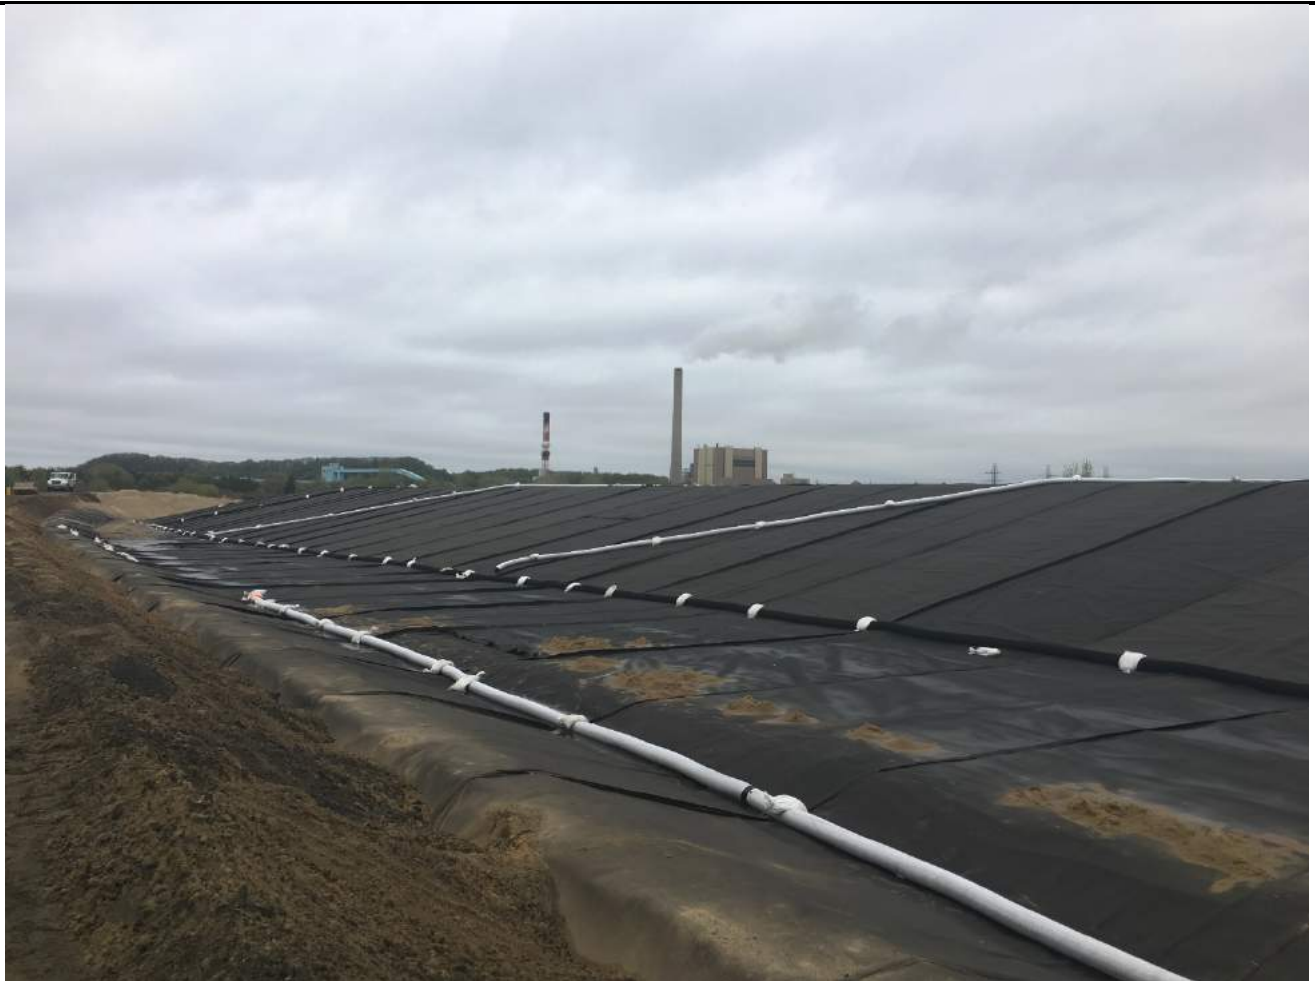
Placing 6-inch drainage tile.
