J.H. Campbell Generating Facility

Pond A - Construction Documentation Report

Golder Associates Inc.

October 1, 2019

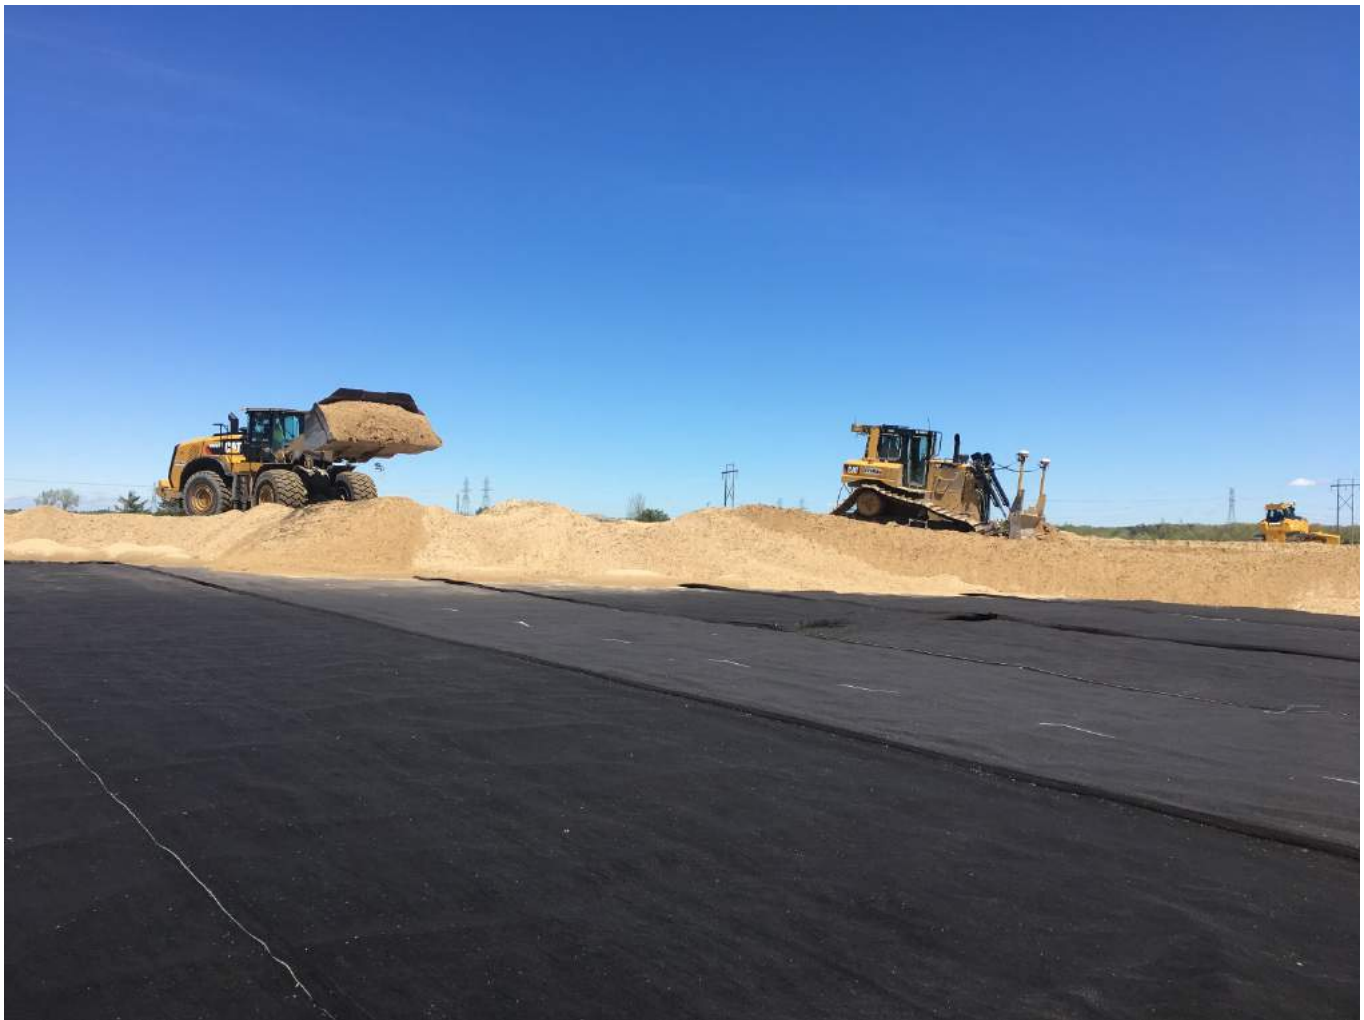
Grading and placing cover material in the northwest corner of Pond A.

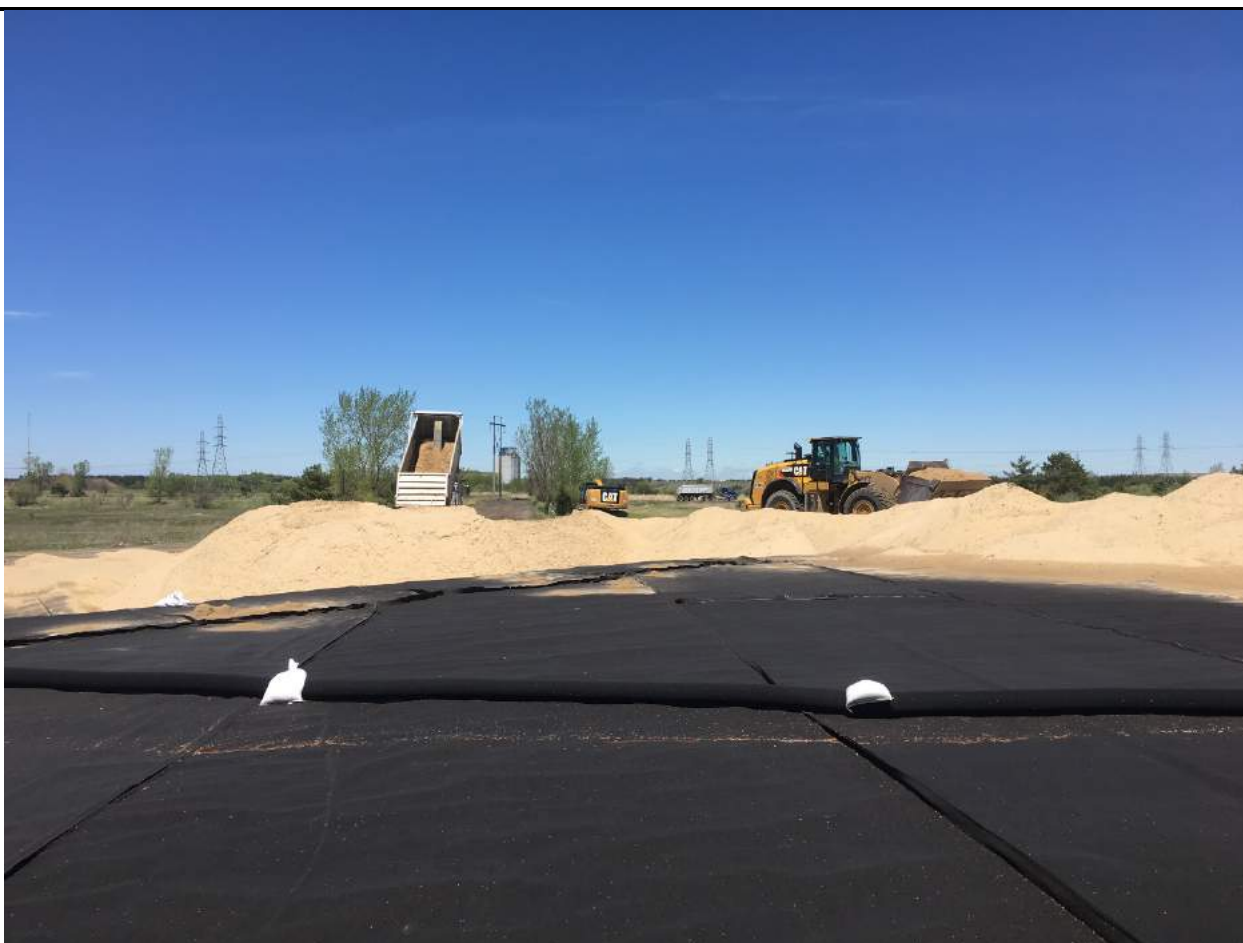
Placing and receiving cover materials in the northwest corner of Pond A.

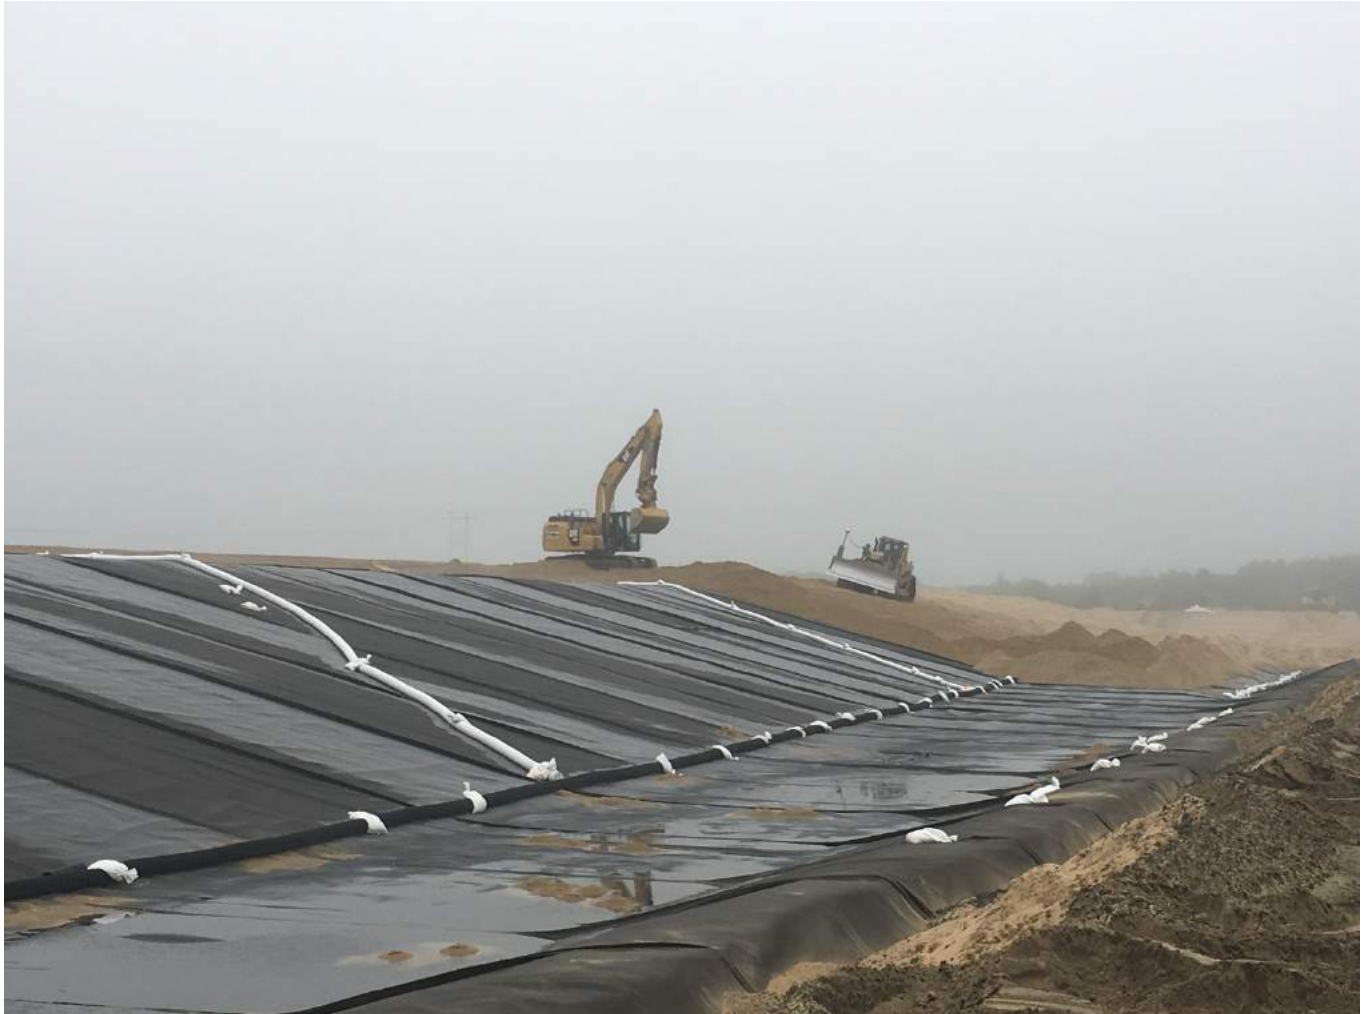
Excavator placing cover material over drainage tile and the dozer grading cover material.

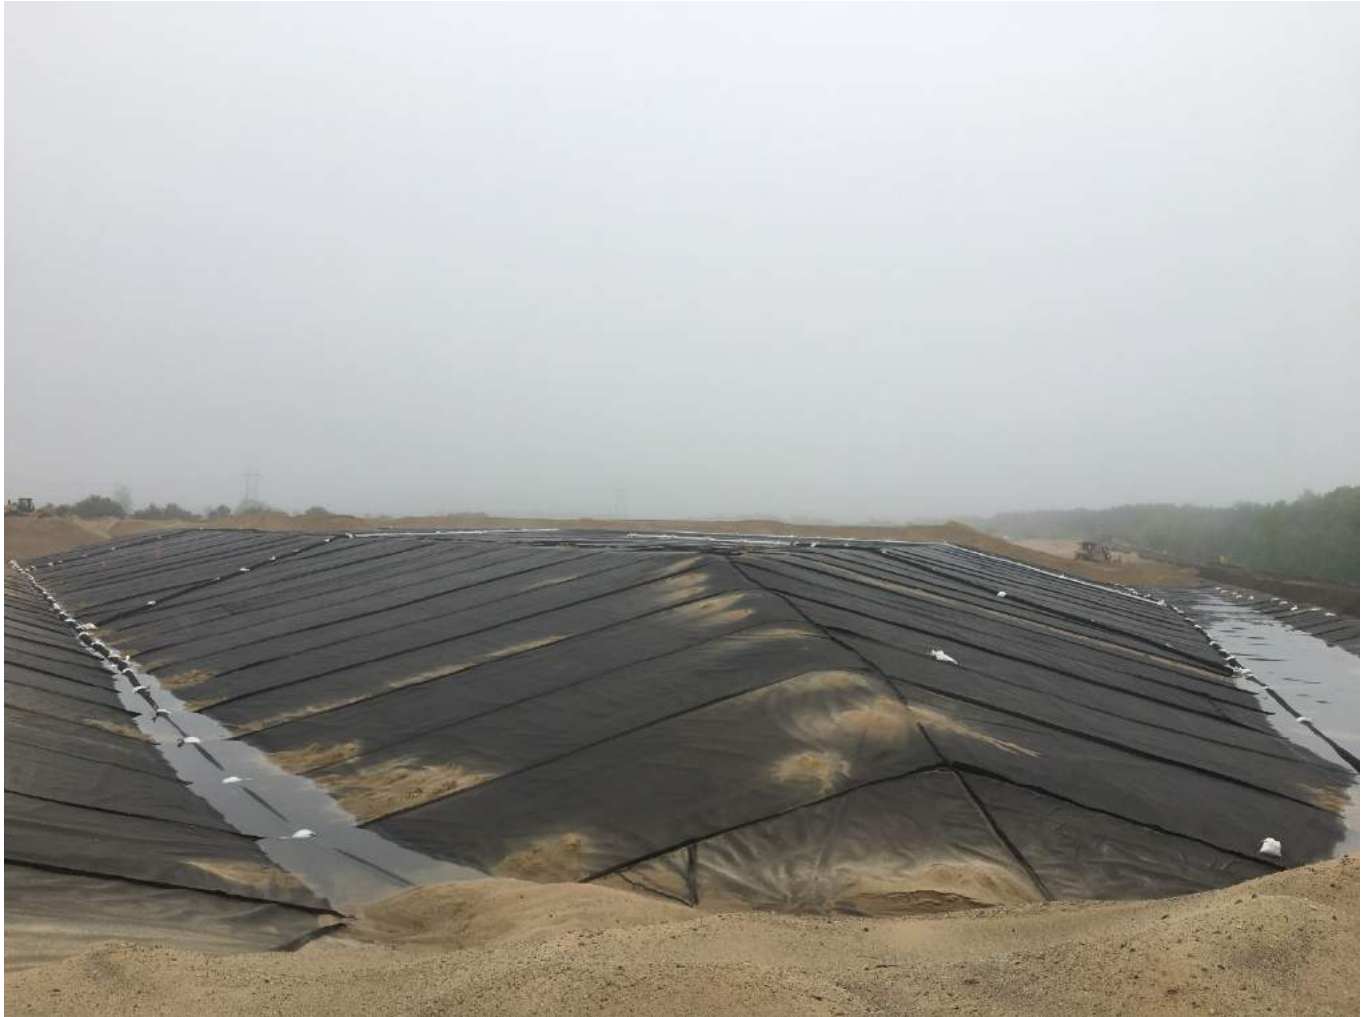
Placing and grading cover material.

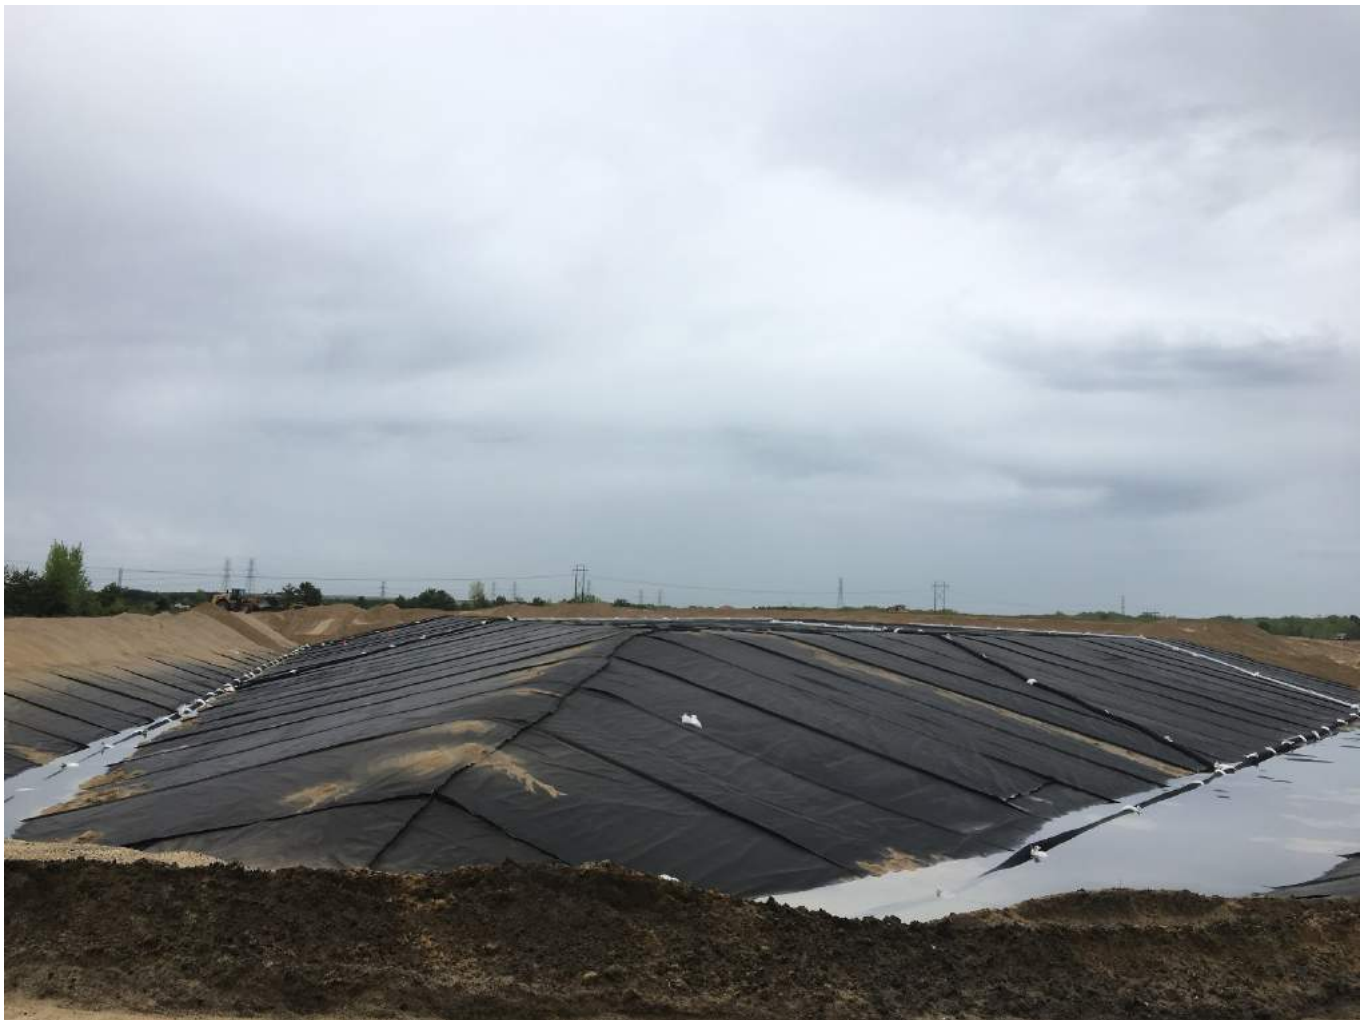
West end of Pond A.

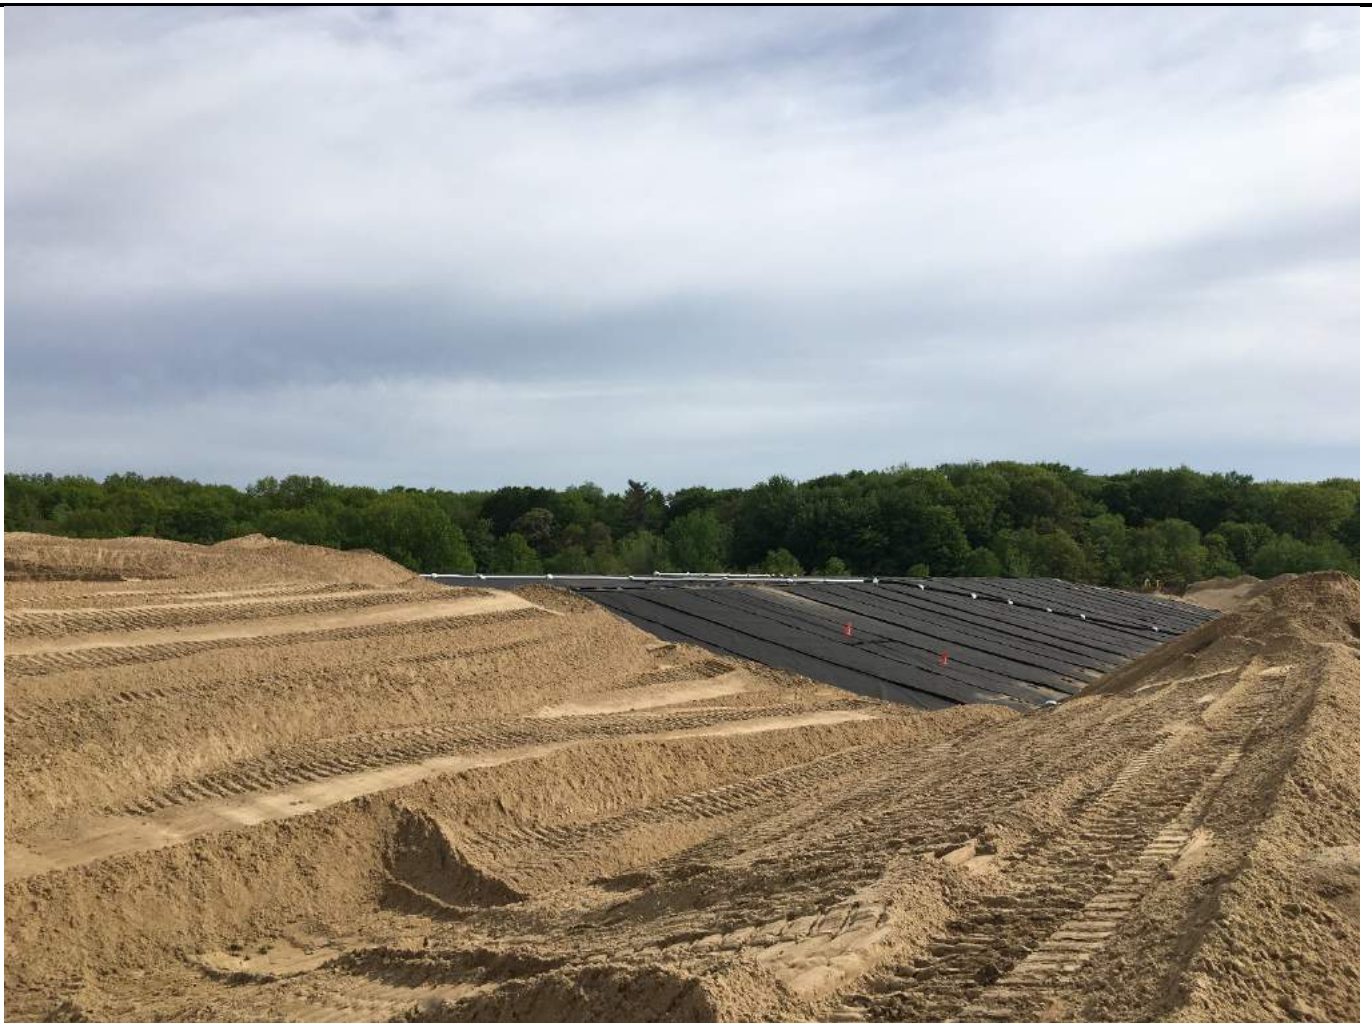
<ul style="list-style-type: none">• While grading sand along the northern edge of Pond A the dozer's blade came into contact with the geotextile and geomembrane. This resulted in a 5'x5' area of damage leaving the subgrade exposed.• This accident was the result of operator error while using a non-gps guided dozer.• The surrounding area will be exposed to verify its condition.• The geomembrane and geotextile will be repaired once Chesapeake returns to site for Phase 6.

The west end of Pond A.

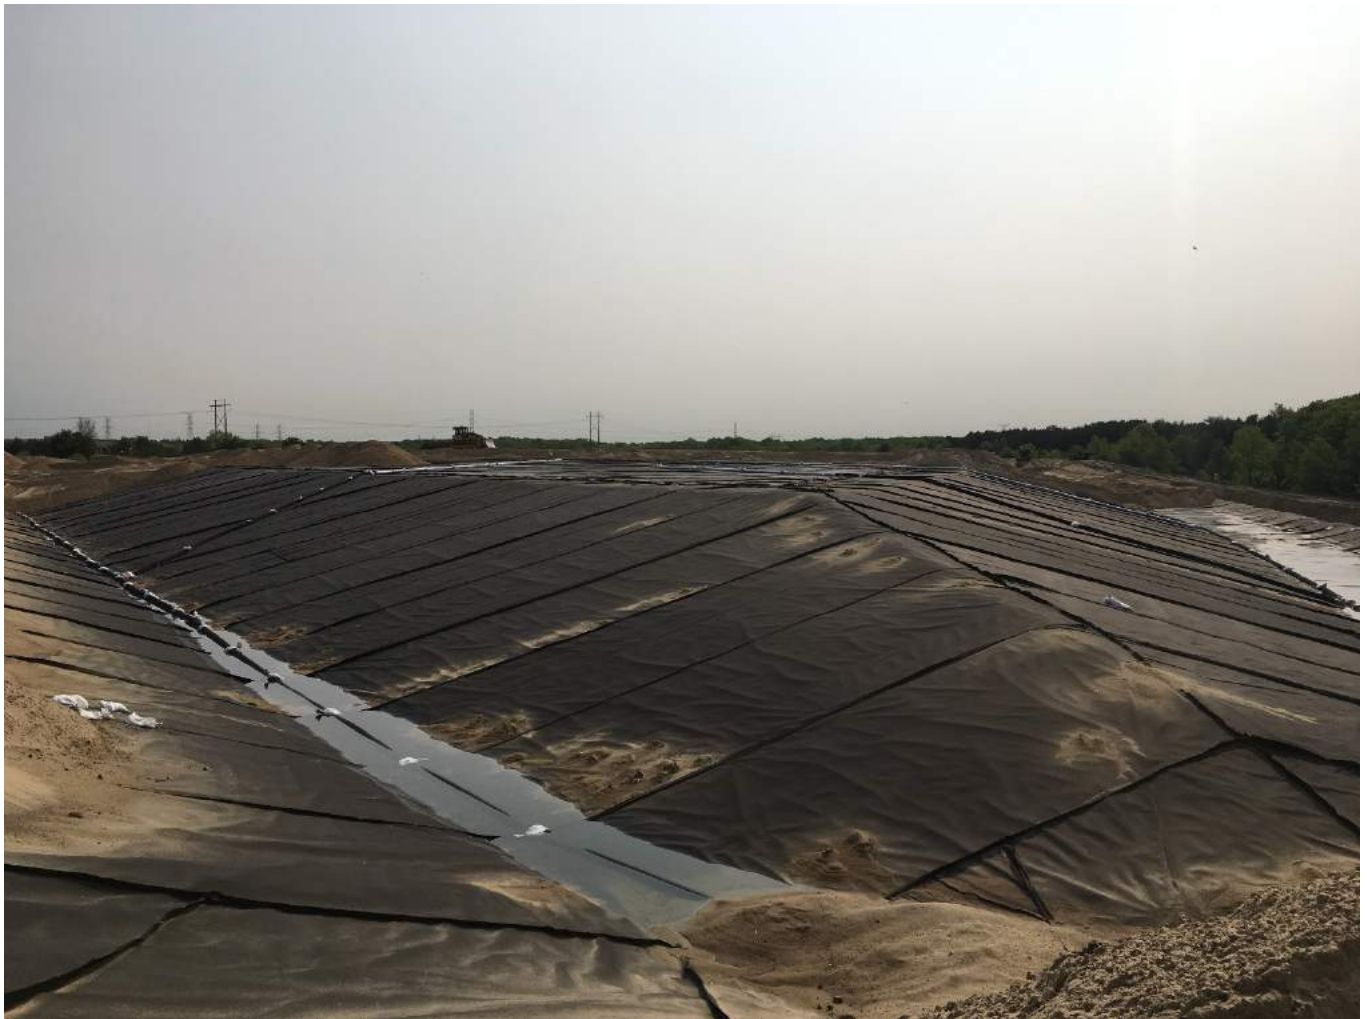
West end of Pond A.

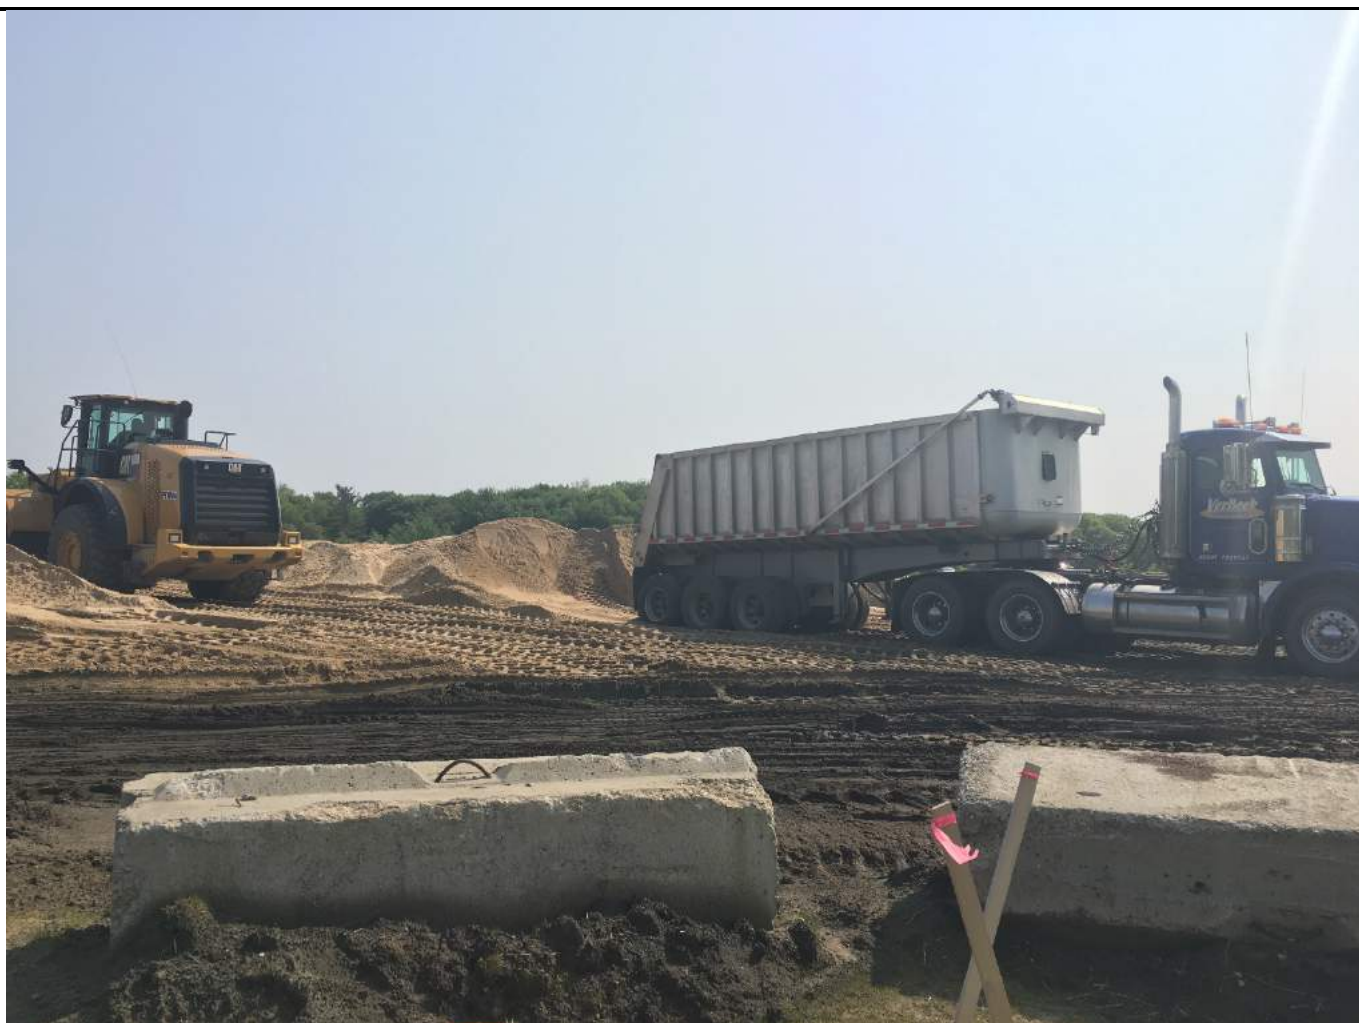
Receiving Cover Material.

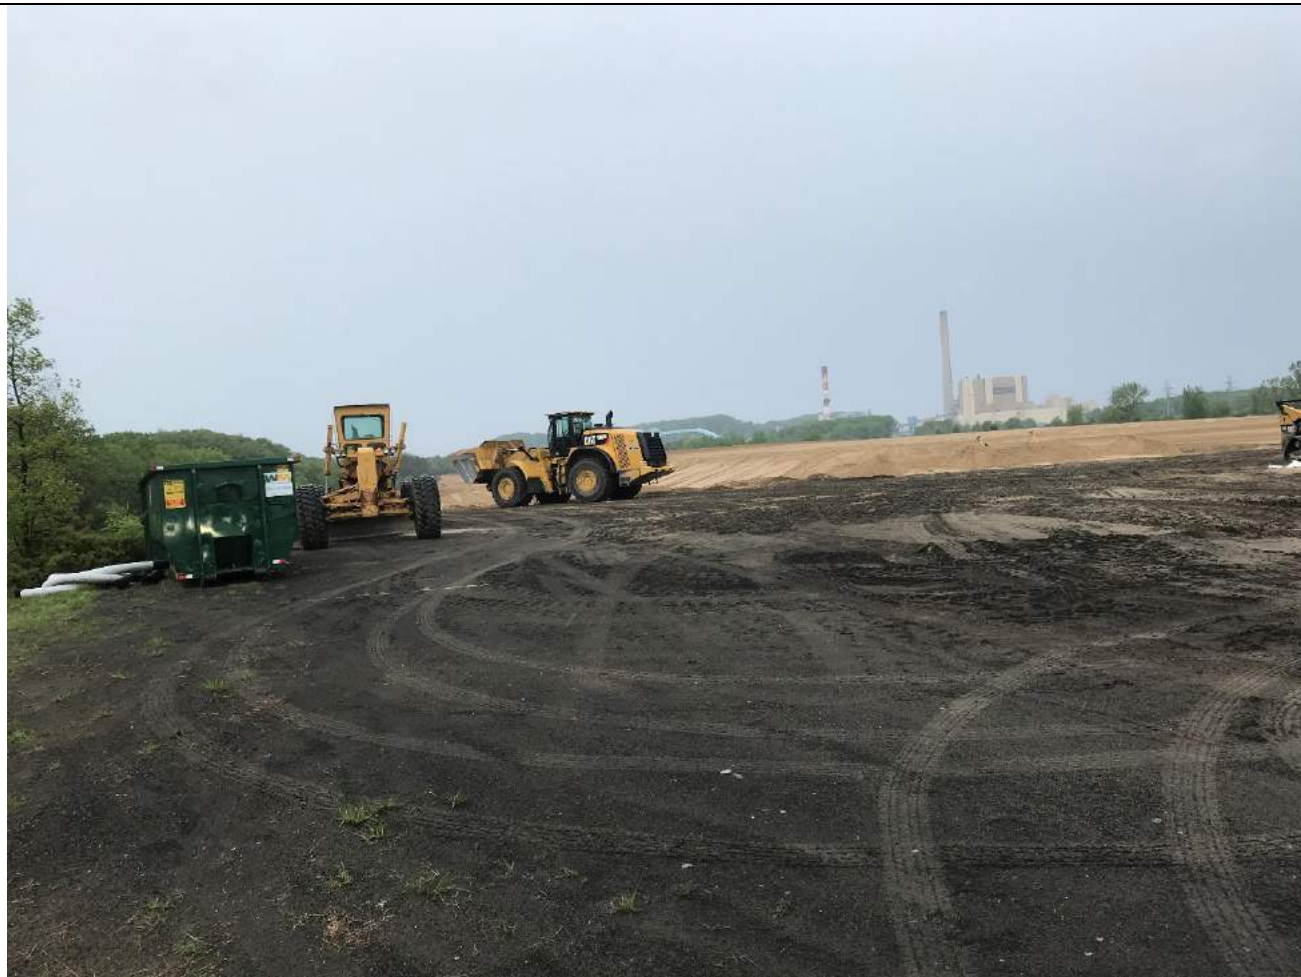
Pond A.

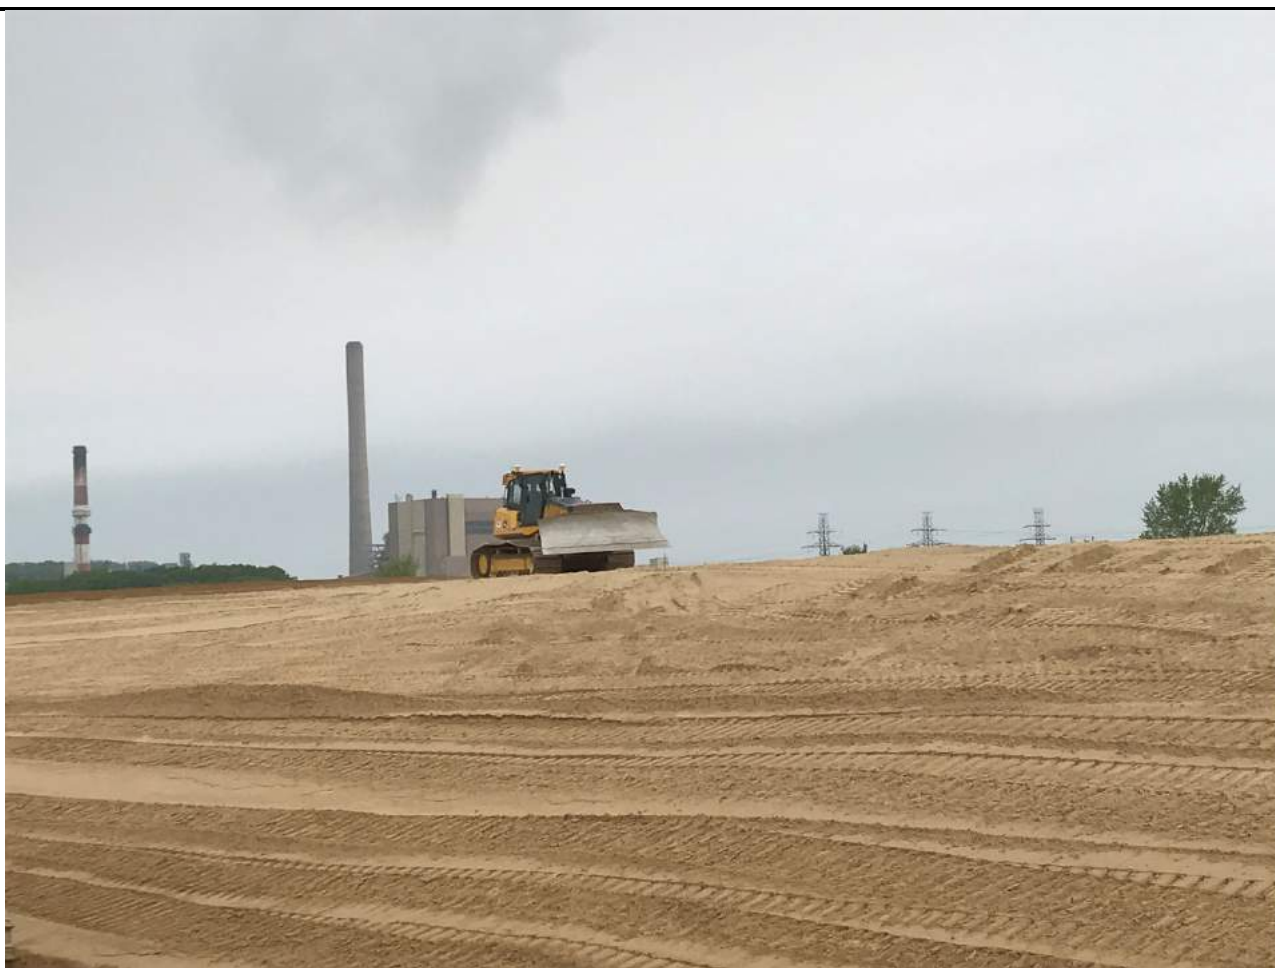
Grading cover material in Pond A.

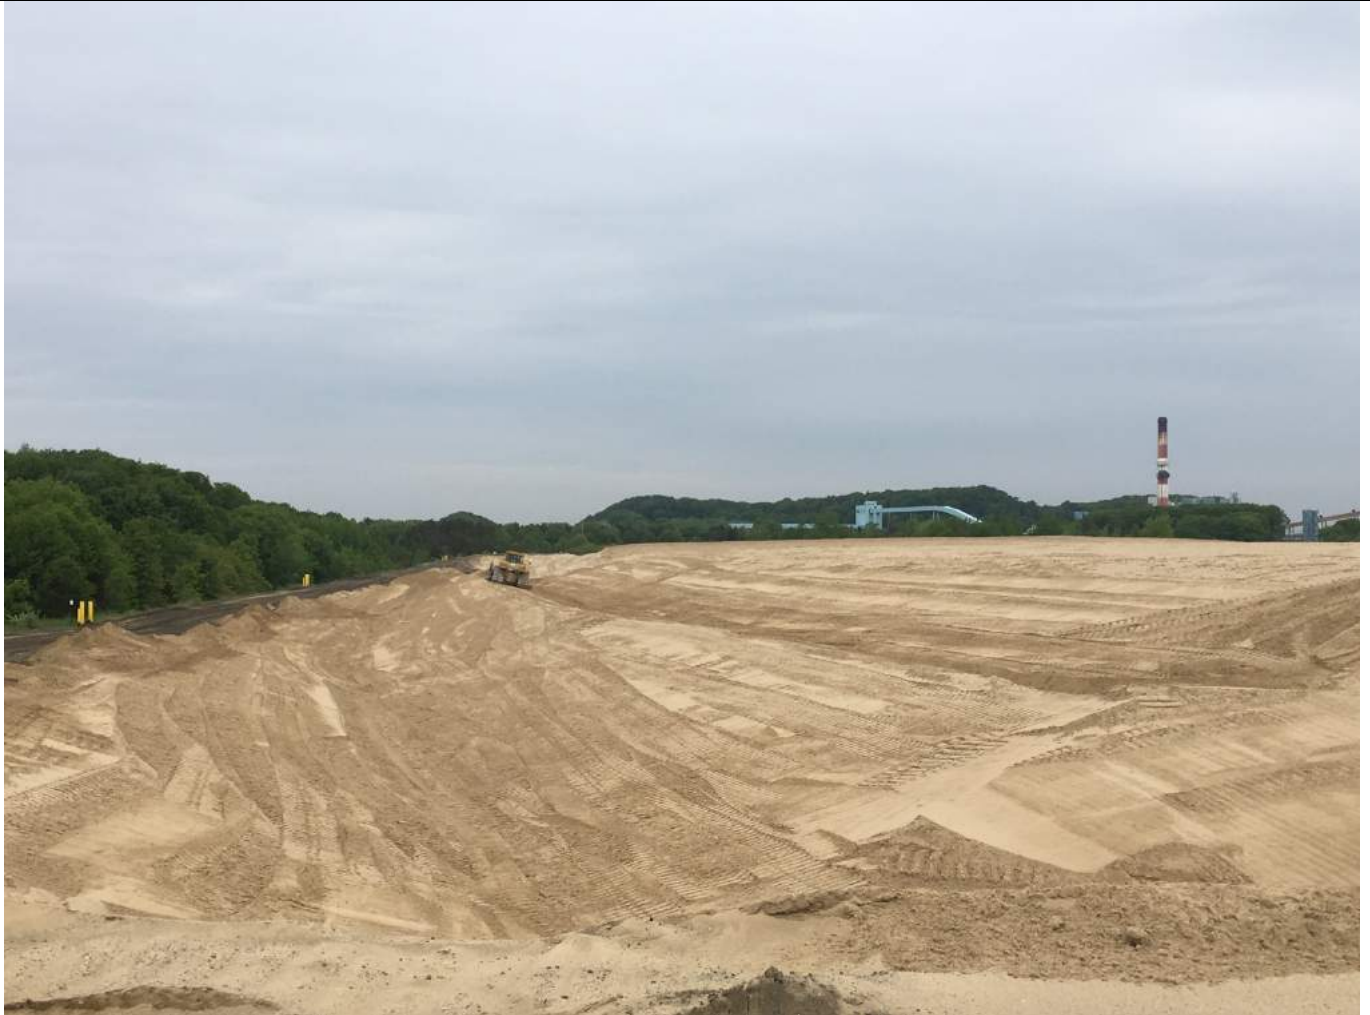
Pond A.

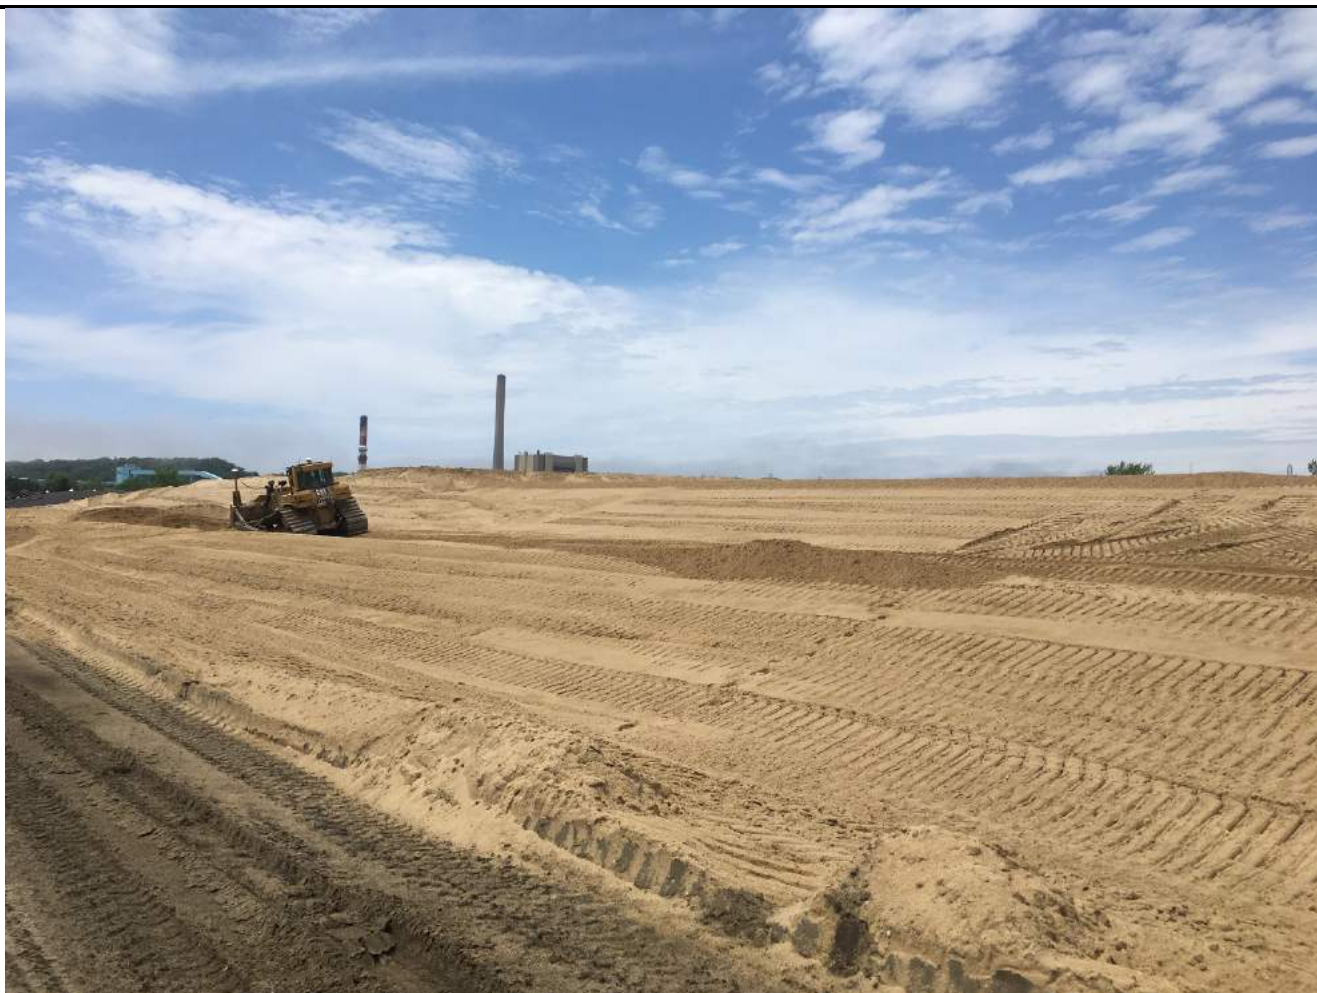
Dozer grading cover material of Pond A.

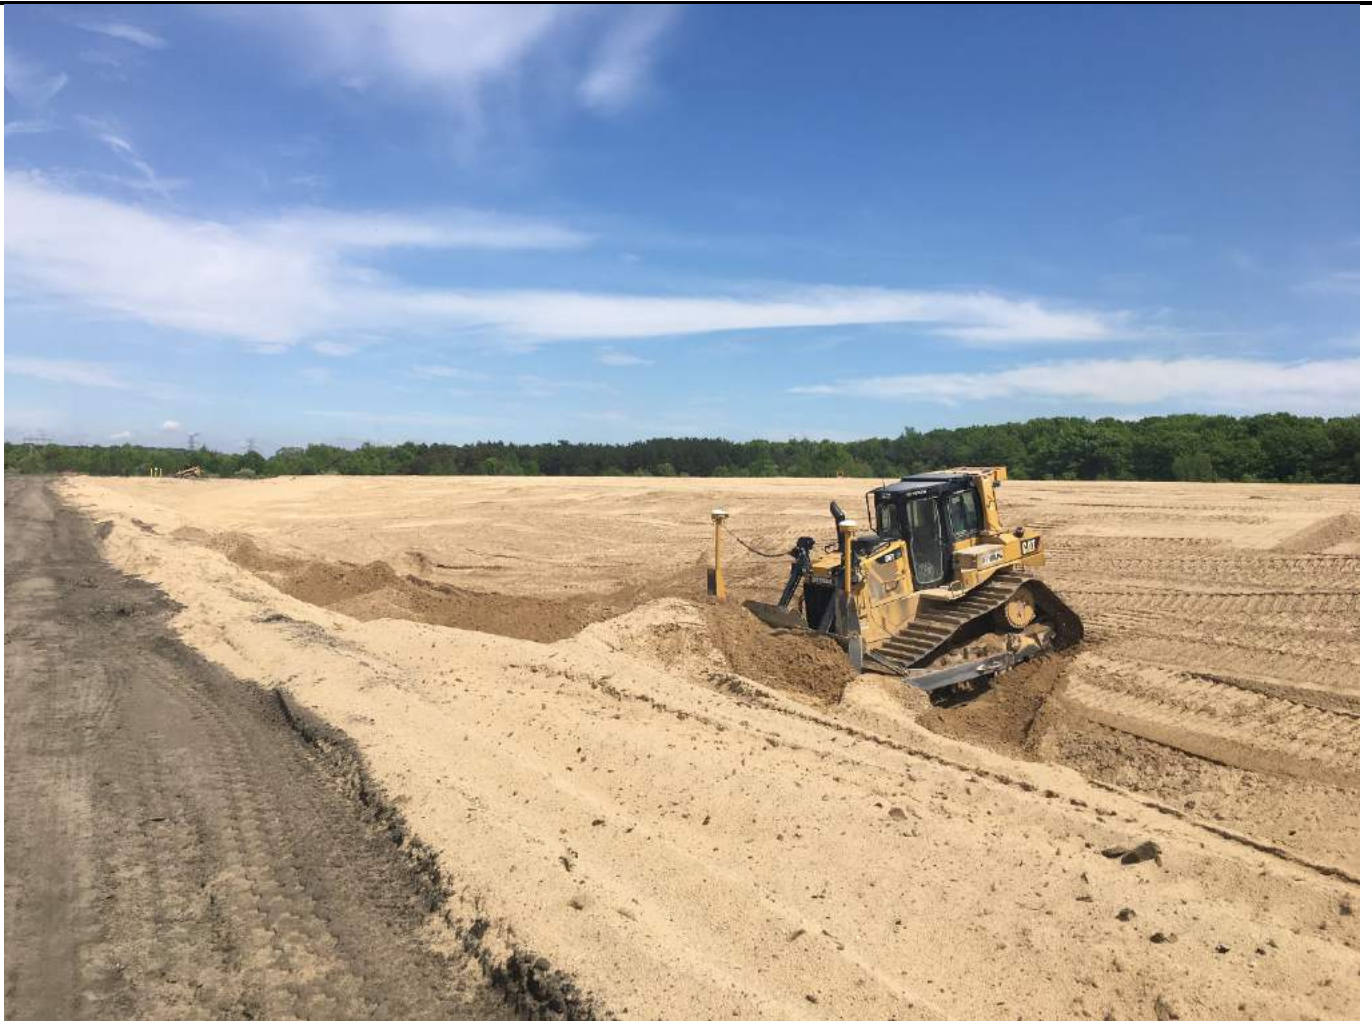
Dozer placing cover material over repaired area.

- Repaired damage to liner, which occurred on 5-30-19.
- Extrusion welded patch over damage, with one gun.
- Performed trial weld prior to welding.
- Vacuum tested repair.
- Replaced damage geotextile above repair.

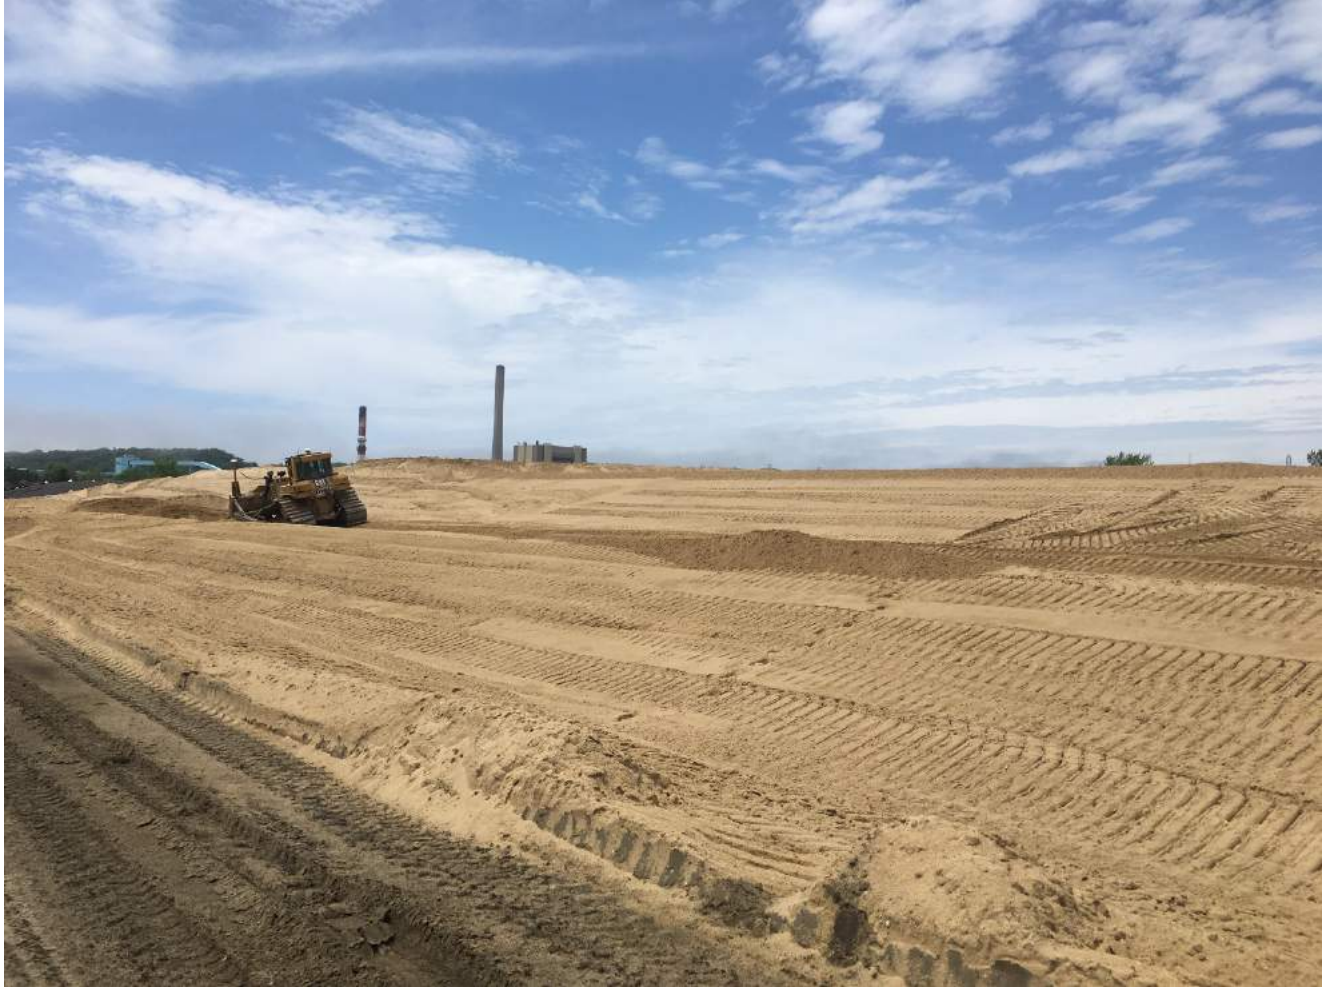
Dozer grading cover material of Pond A.

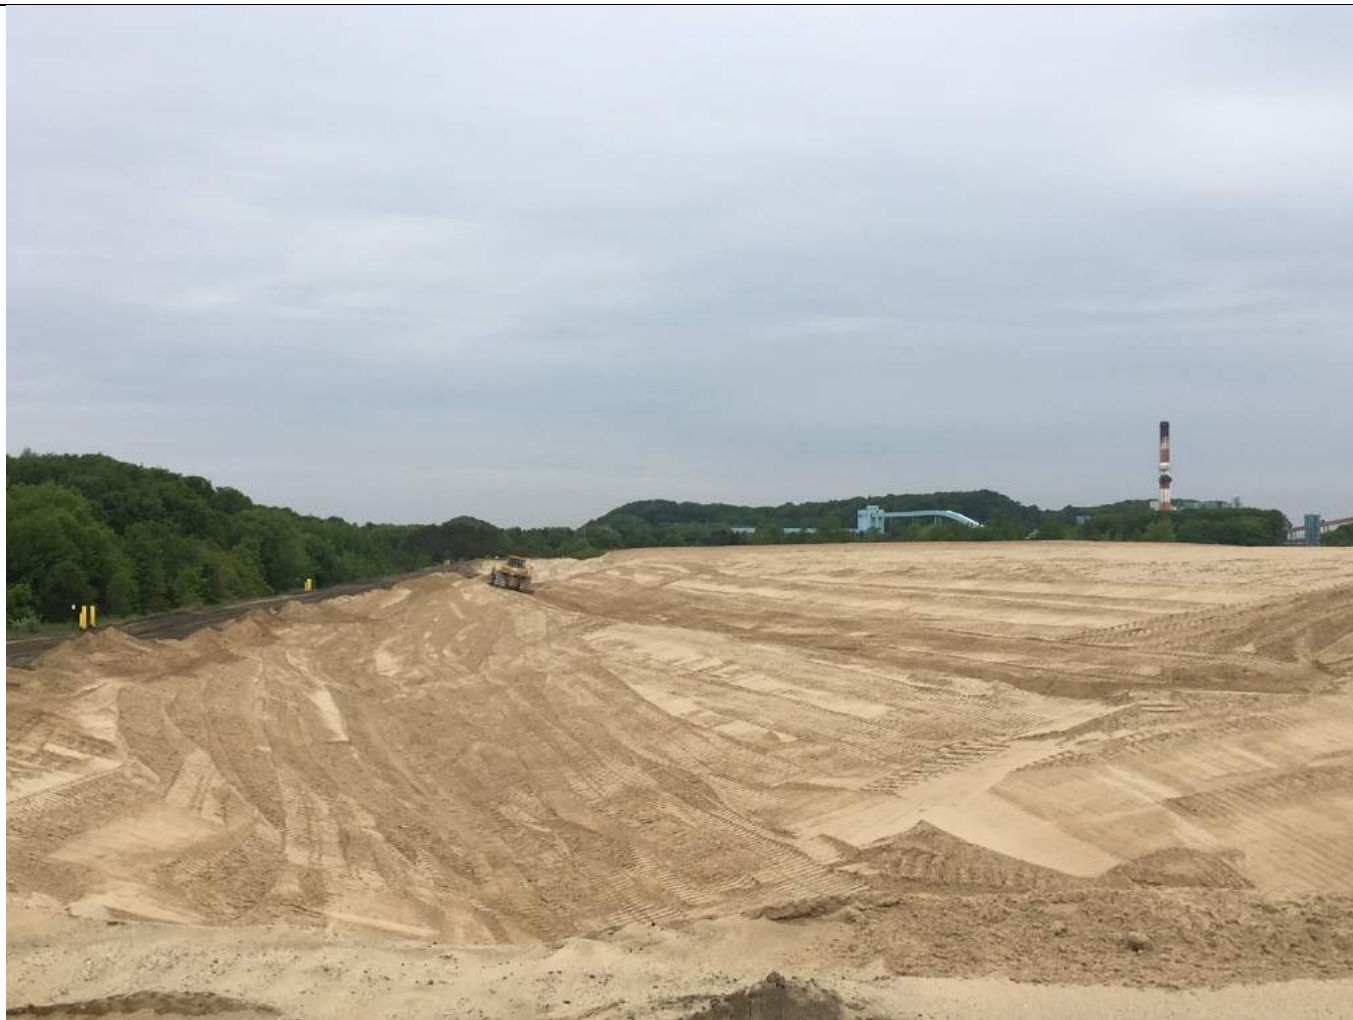
Dozer grading cover material of Pond A.

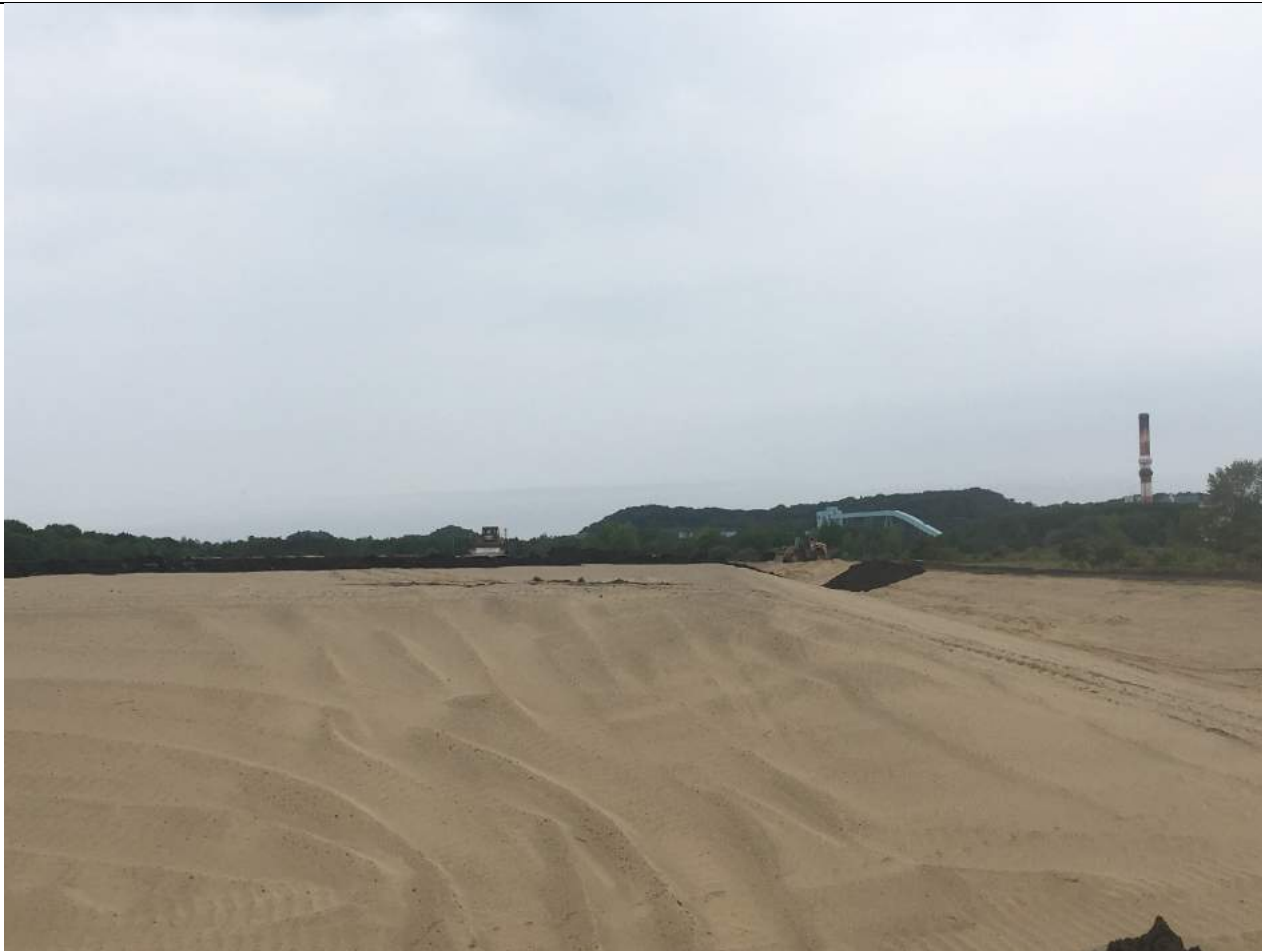
Dozer grading cover material of Pond A.

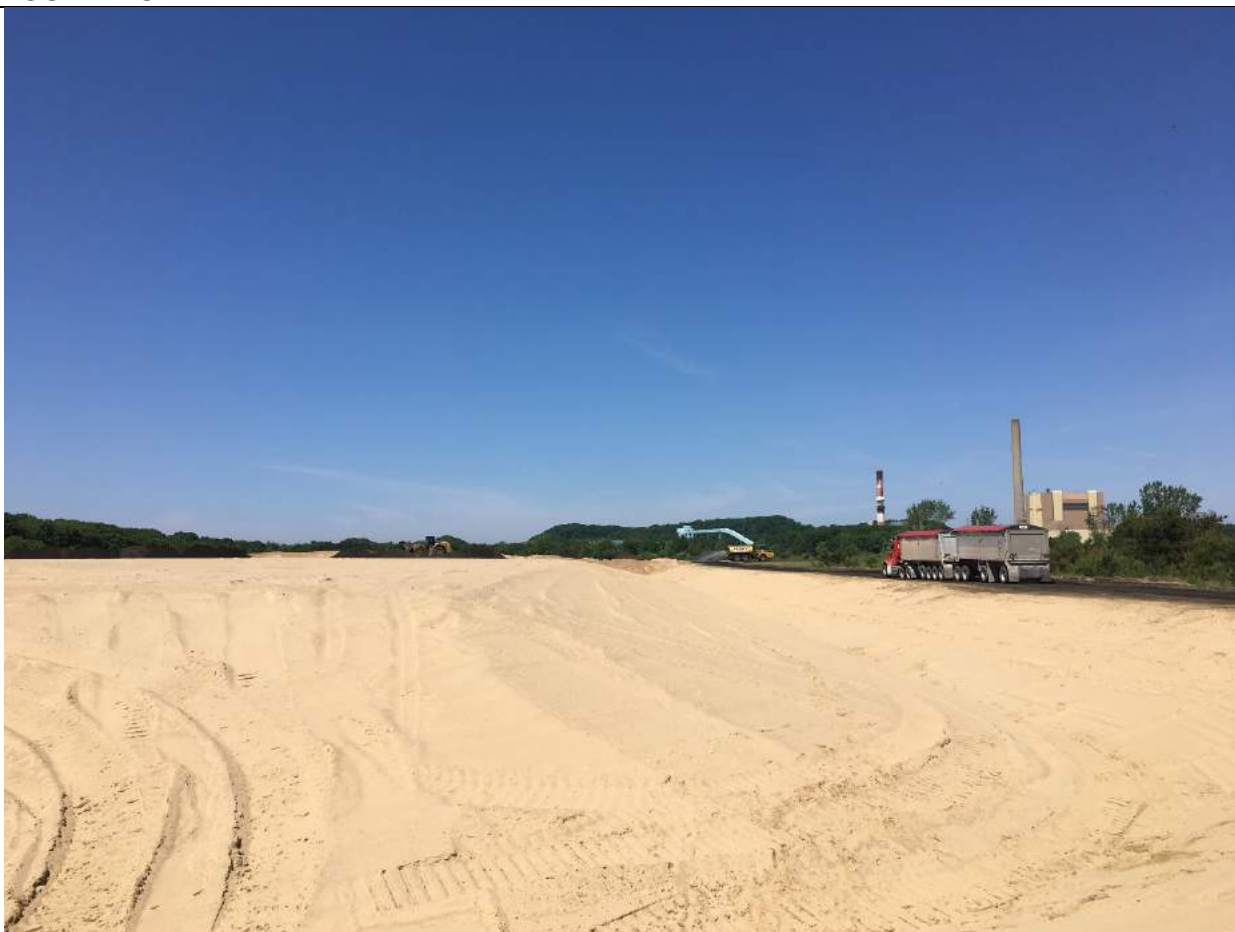
Placing and grading topsoil.
