J.H. Campbell Generating Facility

Pond A - Construction Documentation Report

Golder Associates Inc.

October 1, 2019

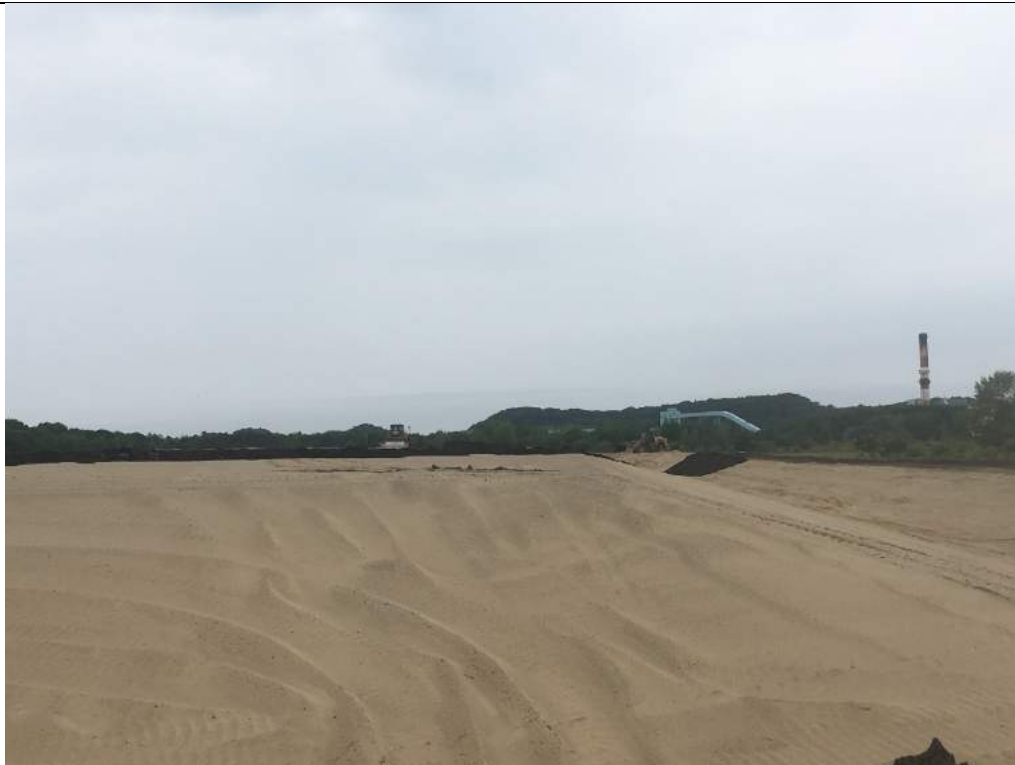
Placing and grading topsoil.

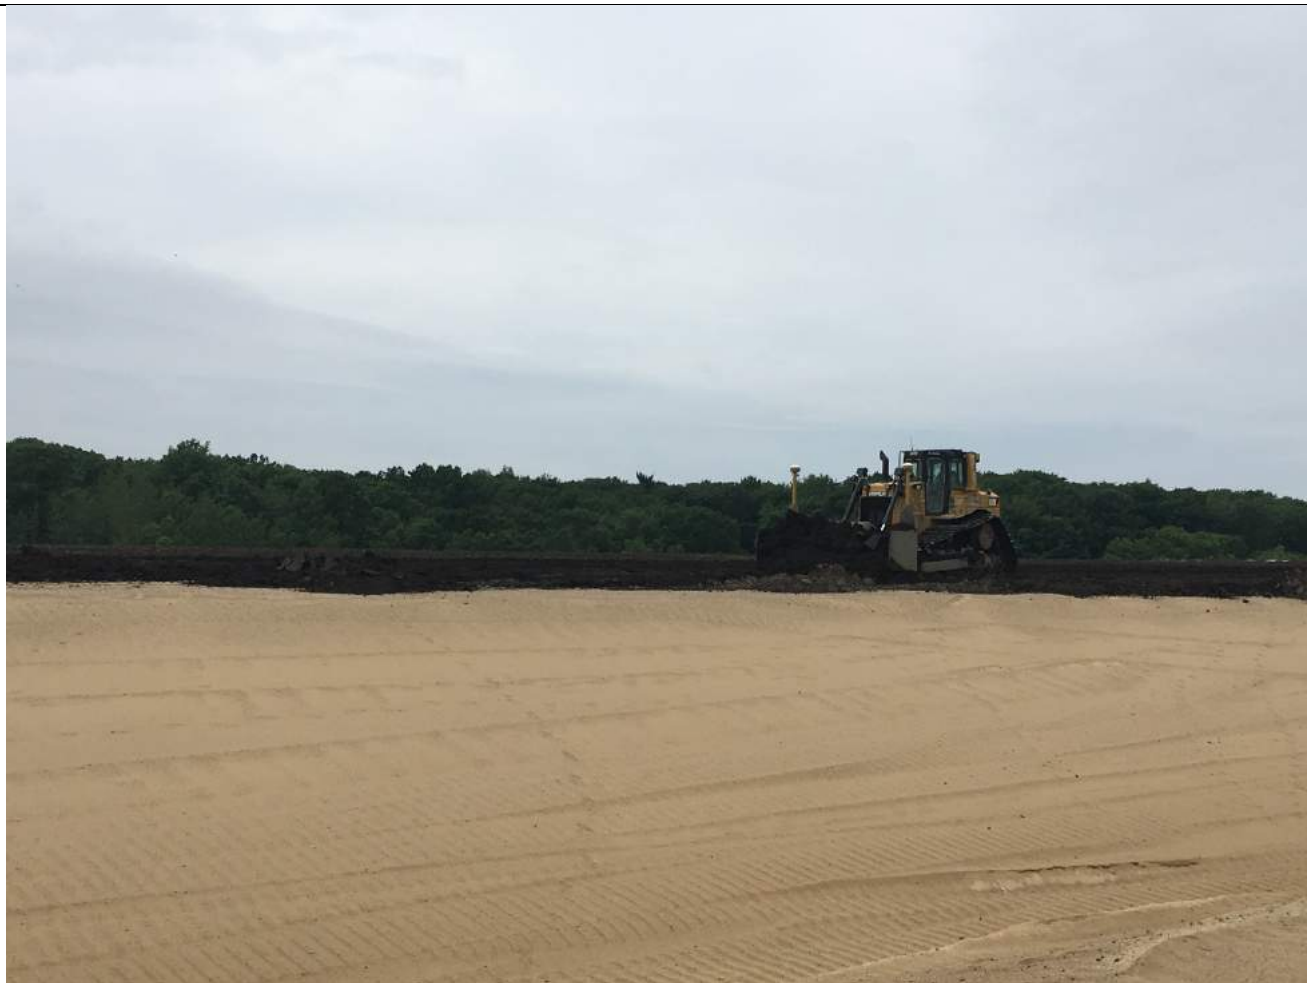
Grading topsoil.

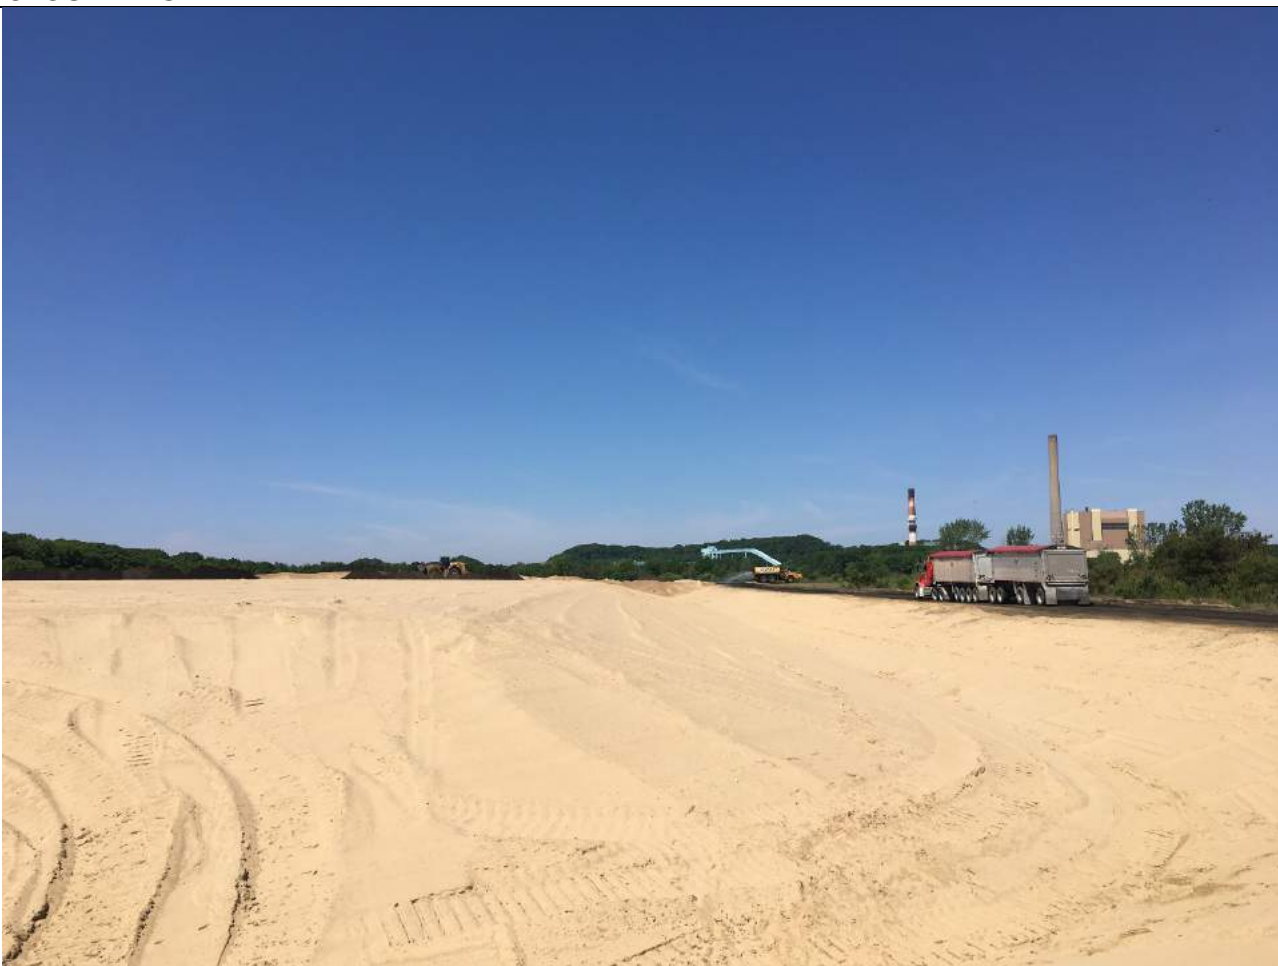
Delivery and grading of topsoil.

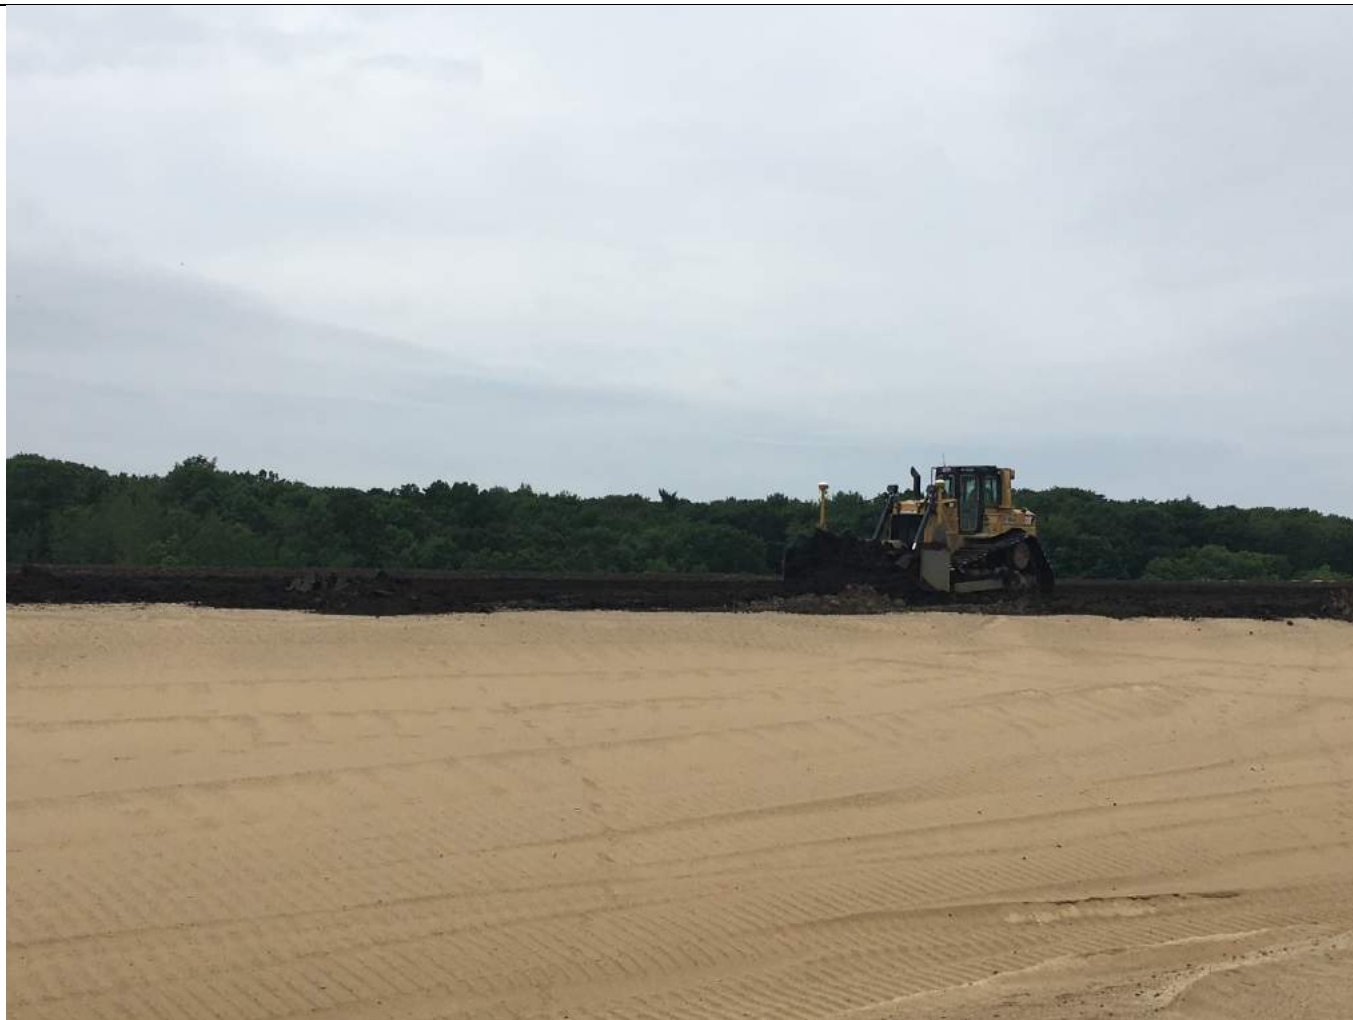
Delivery and grading of topsoil.

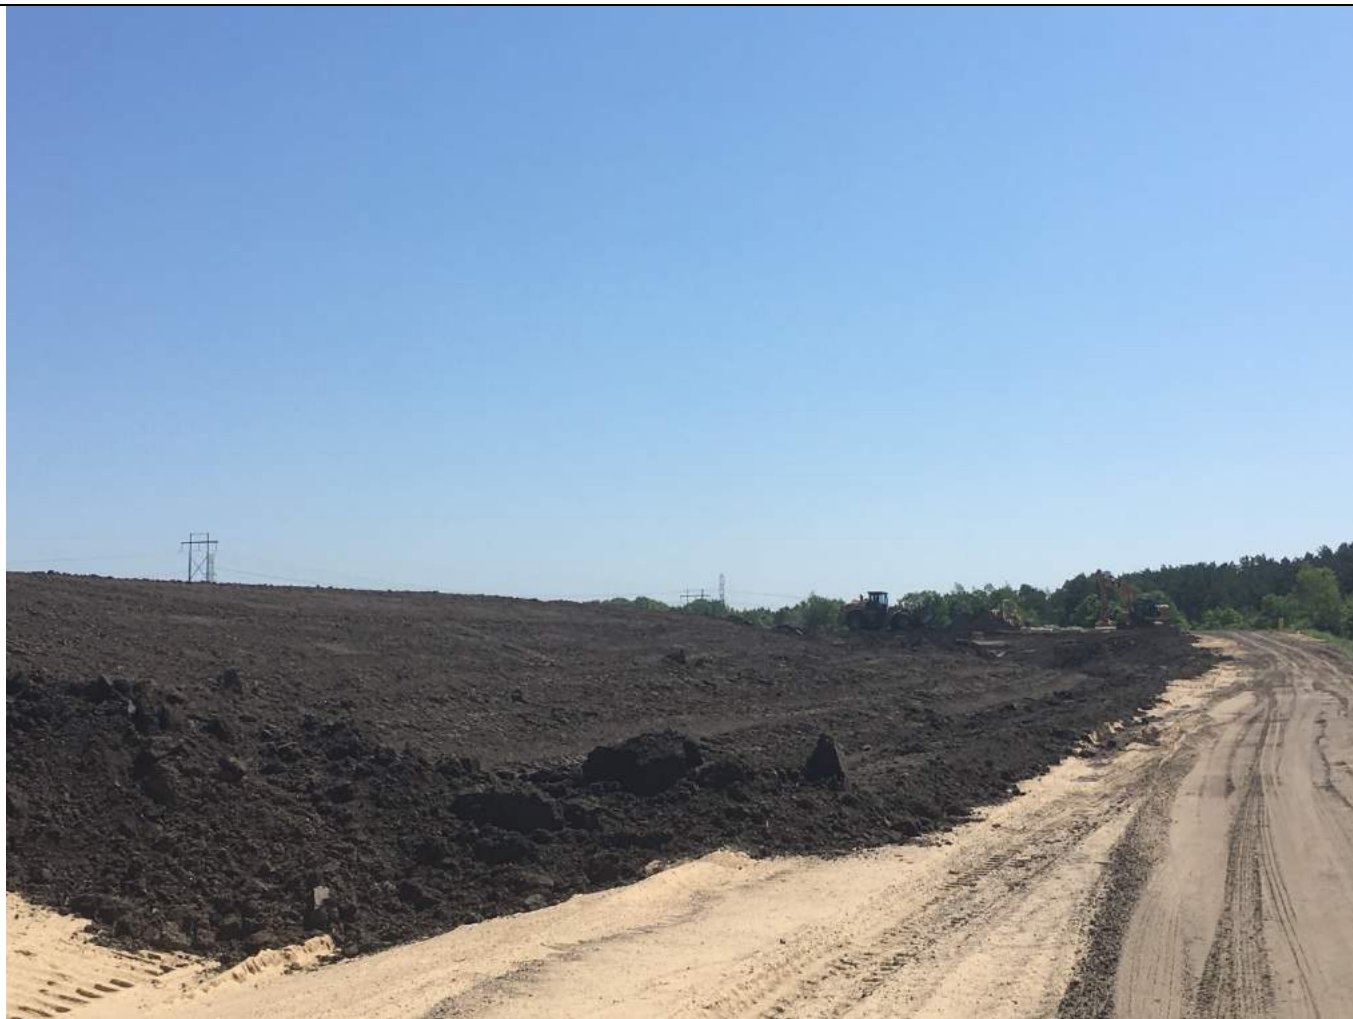
Delivery and grading of topsoil.

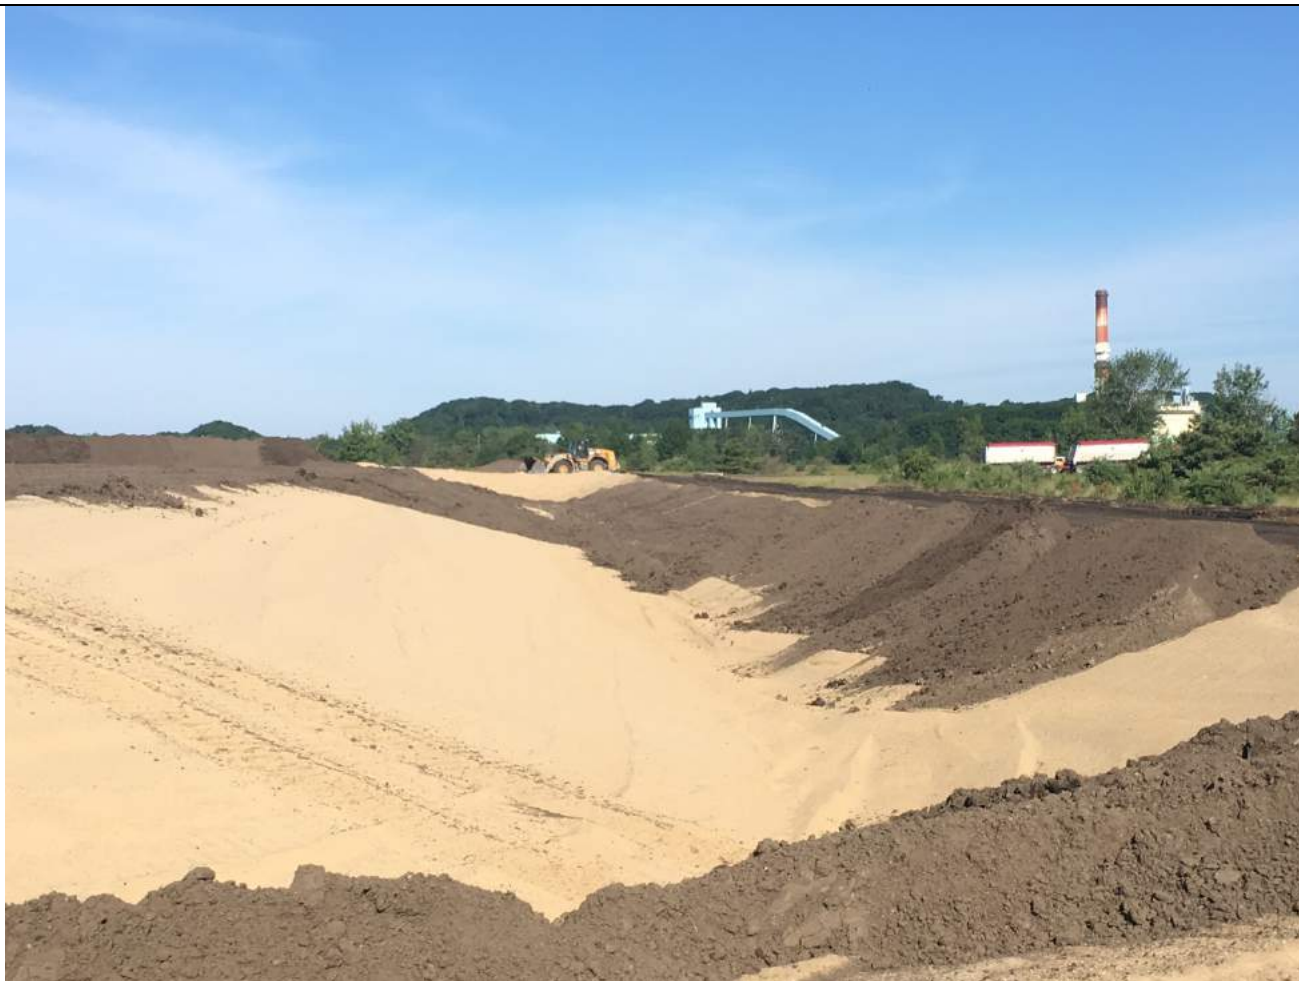
Delivery and grading of topsoil.

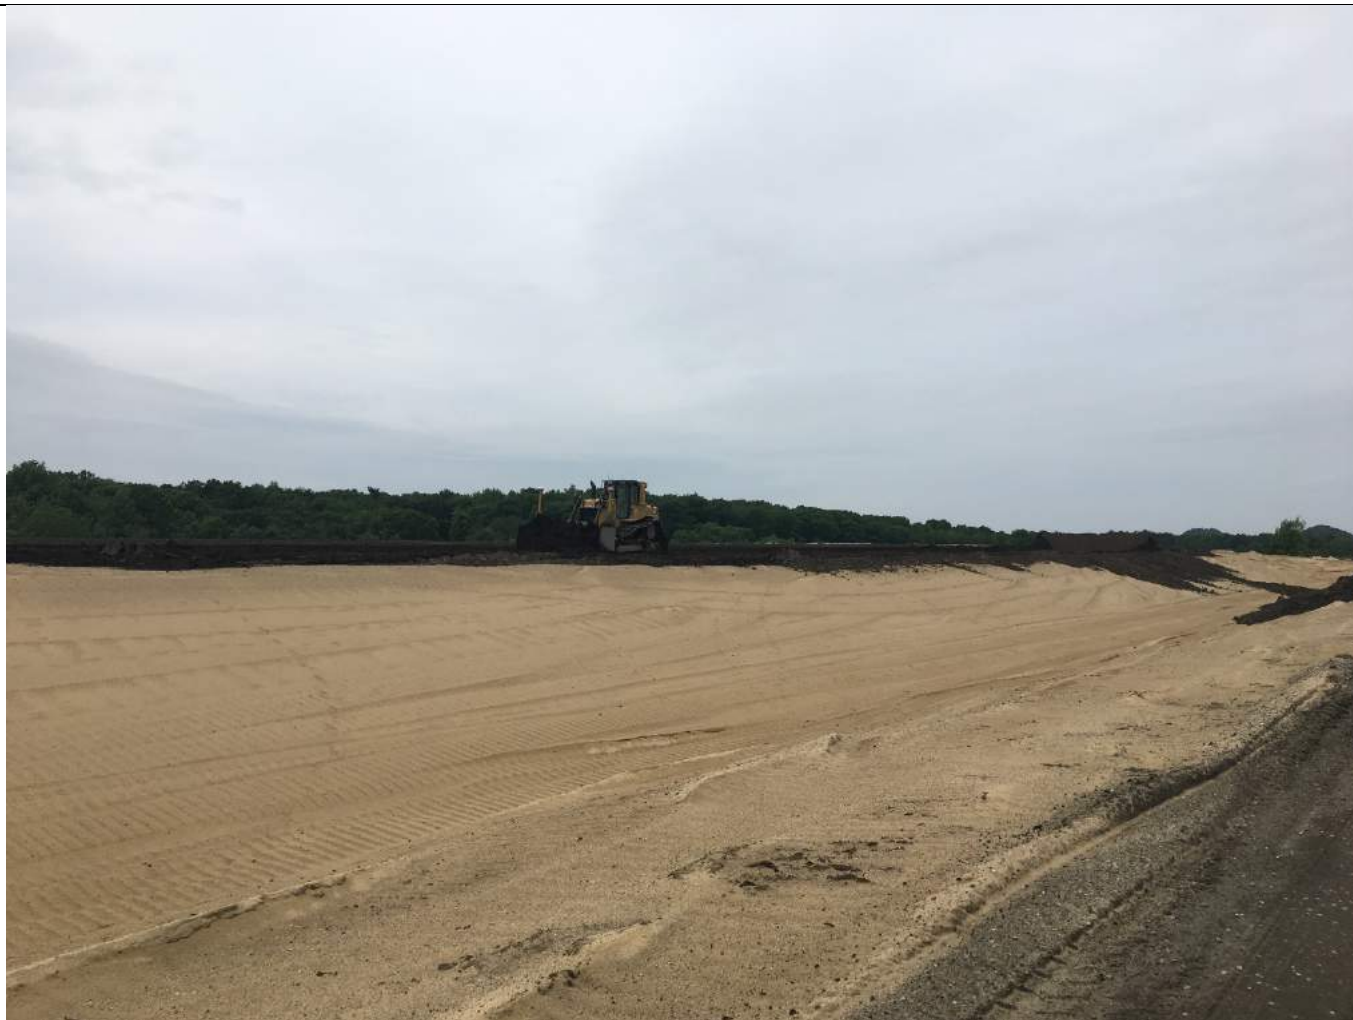
Delivery and grading of topsoil.

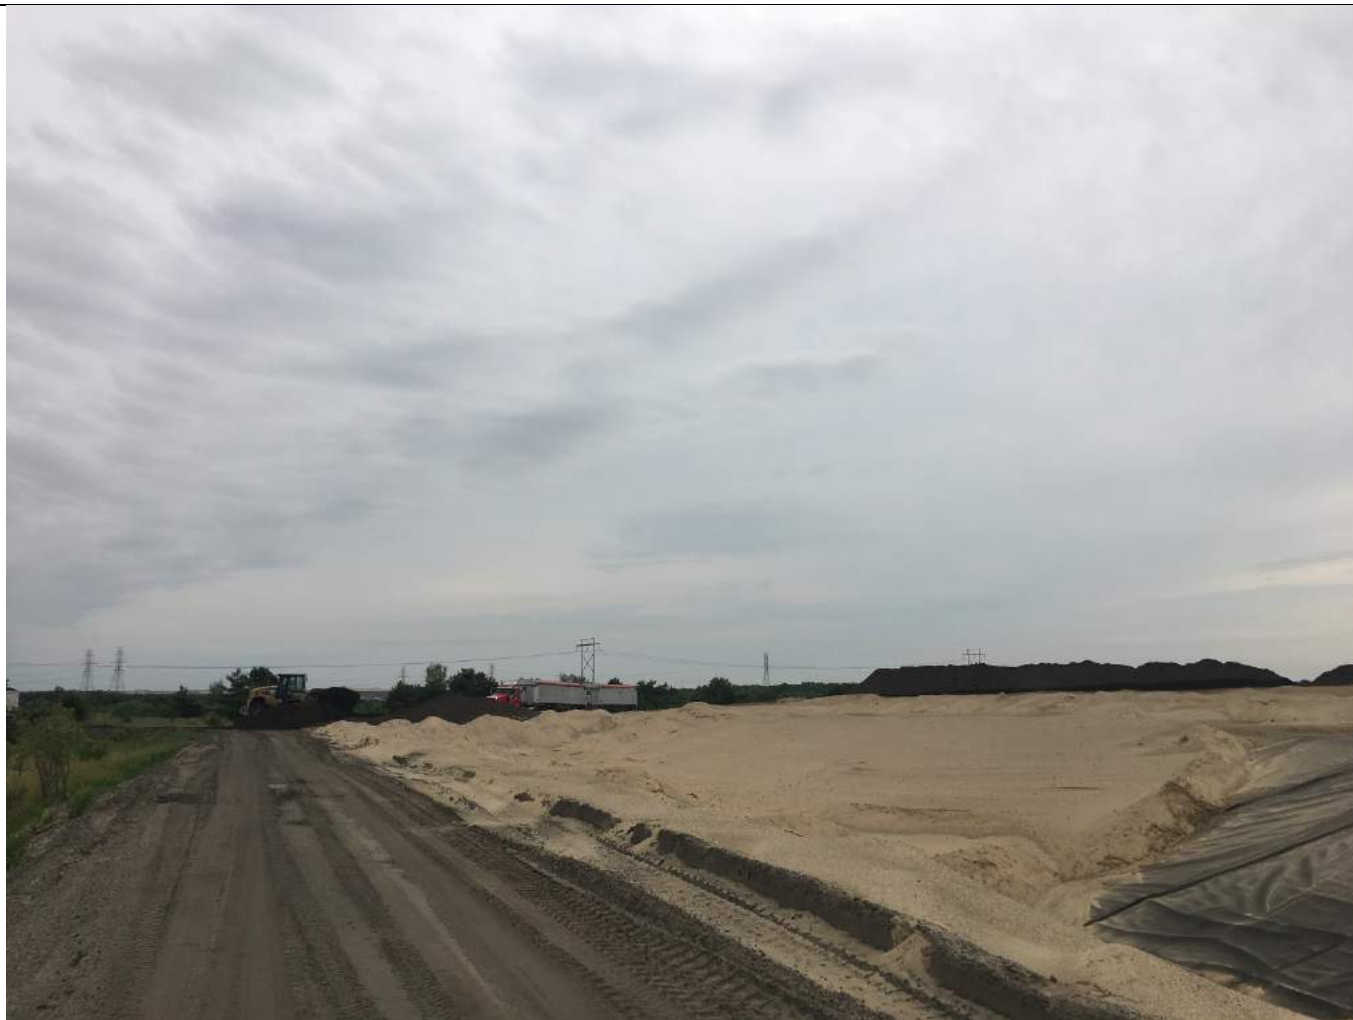
Grading of topsoil.

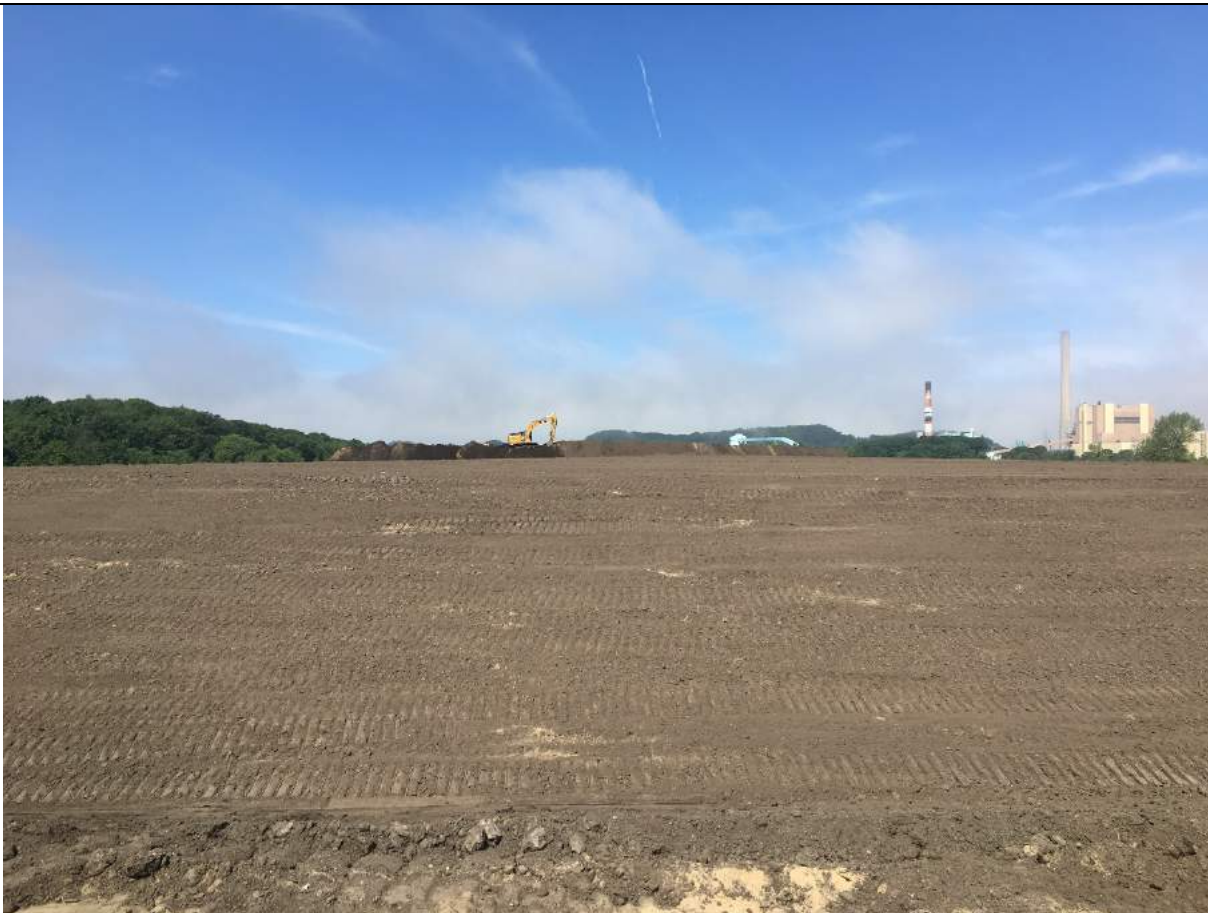
Topsoil at the east end of Pond A.

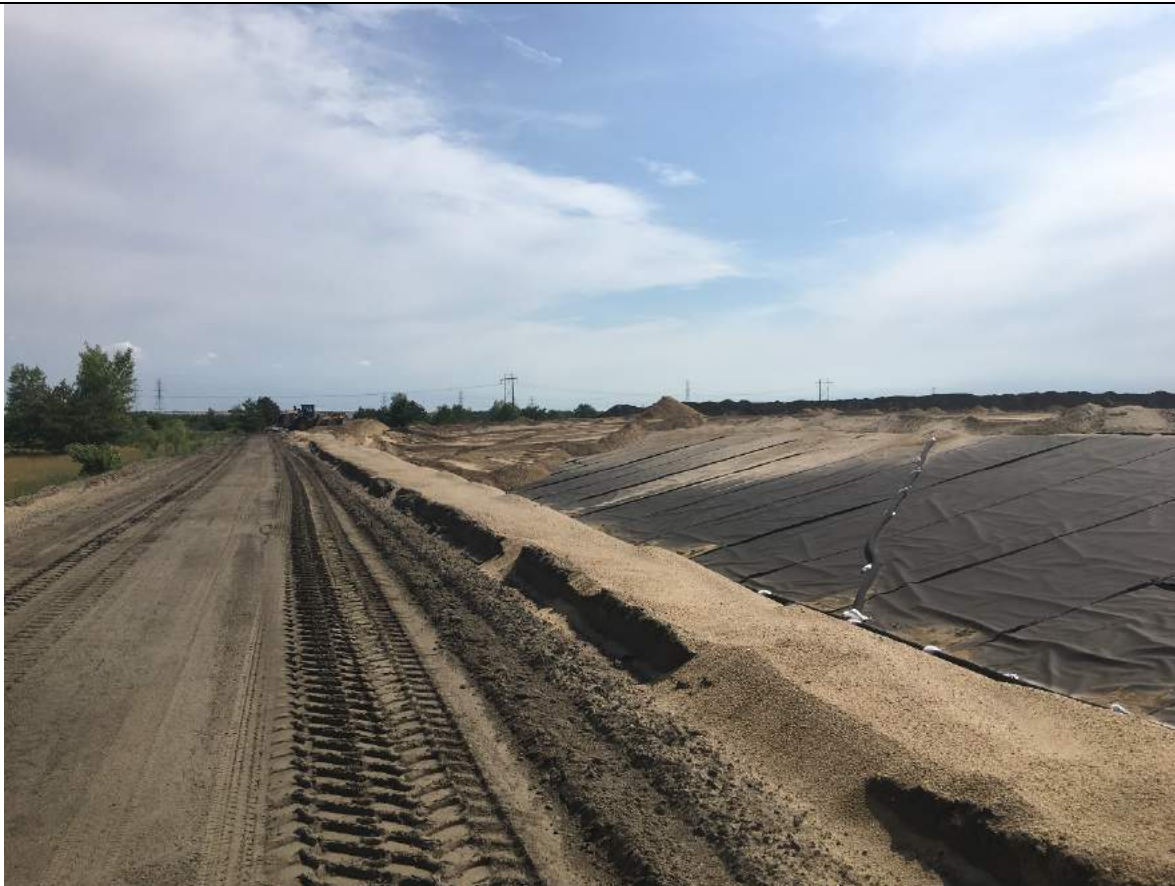
Placing cover material at the west end of Pond A.

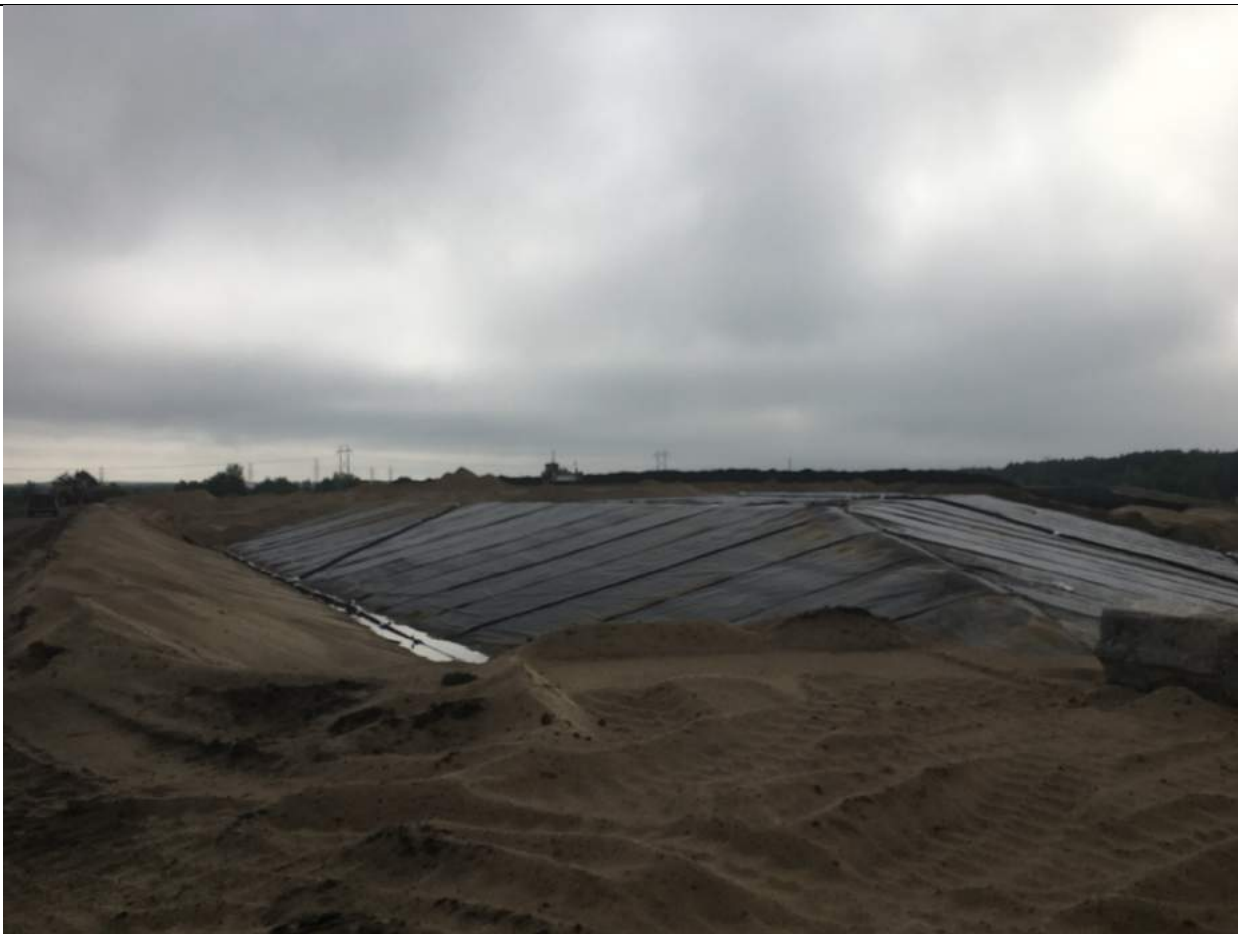
Delivery and grading of topsoil.

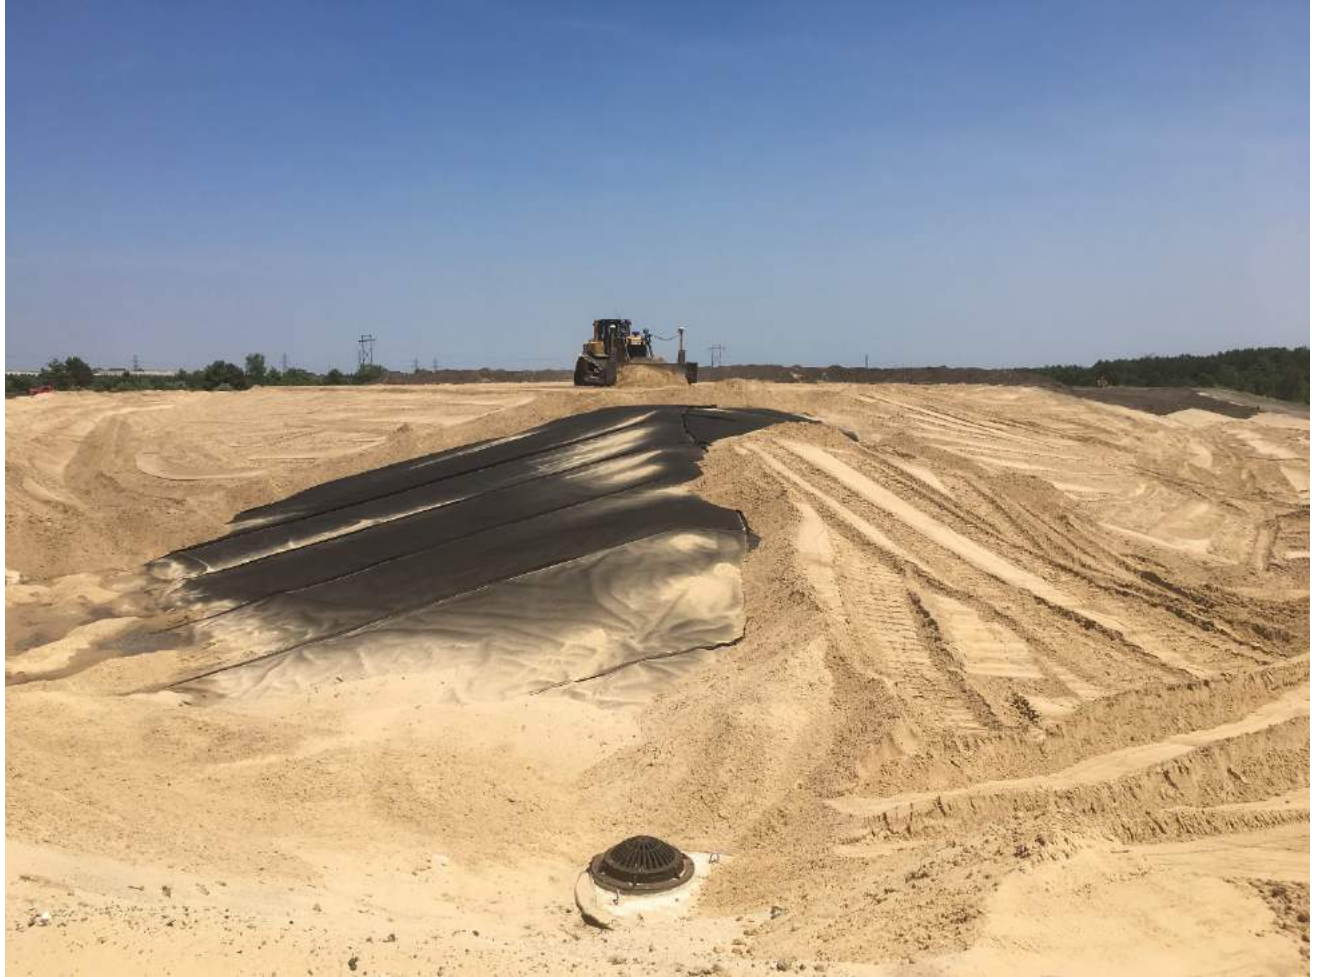
Grading cover material along the west end of Pond A.

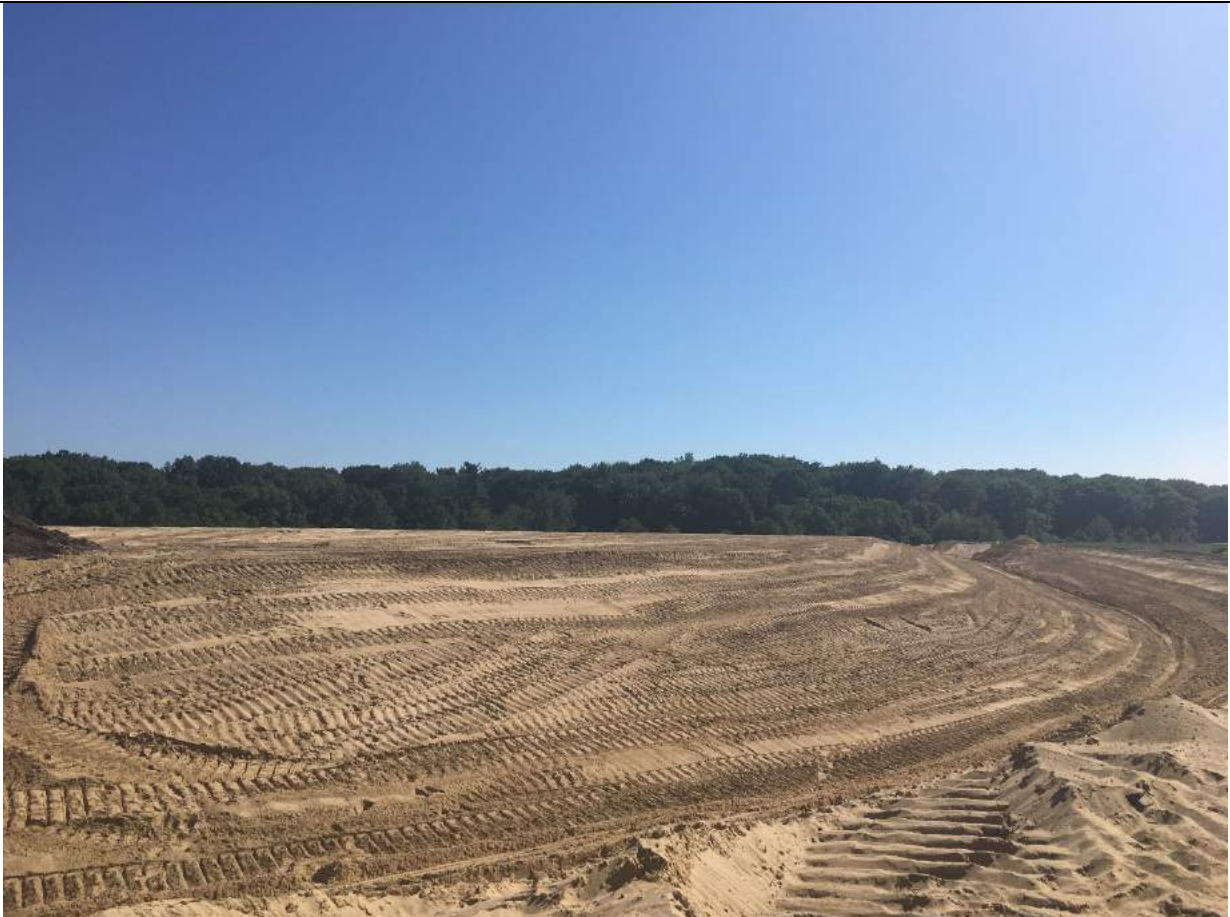
Cover material along the northwest corner of Pond A.

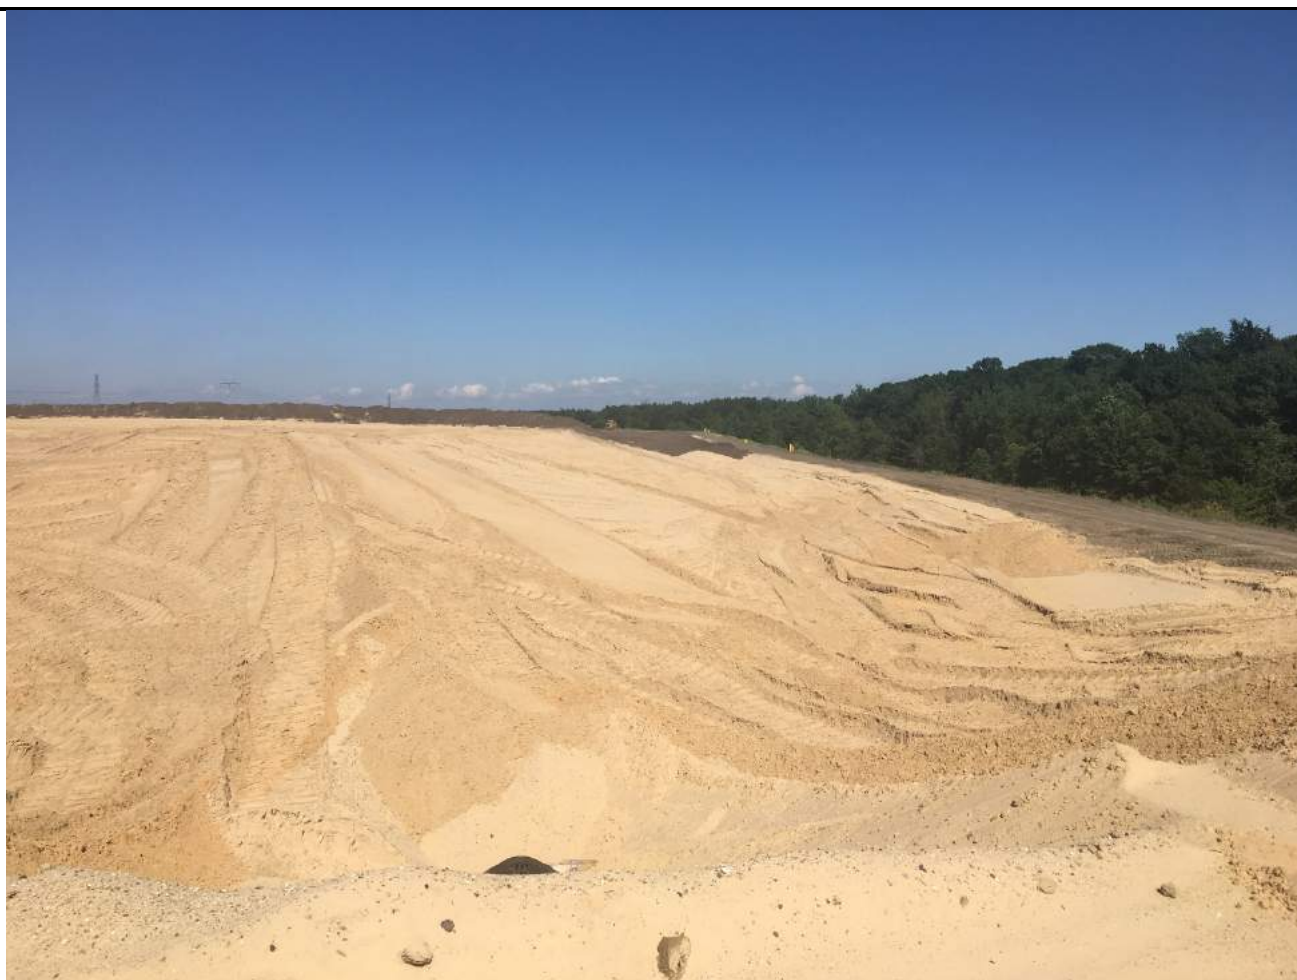
Cover material along the southwest corner of Pond A.

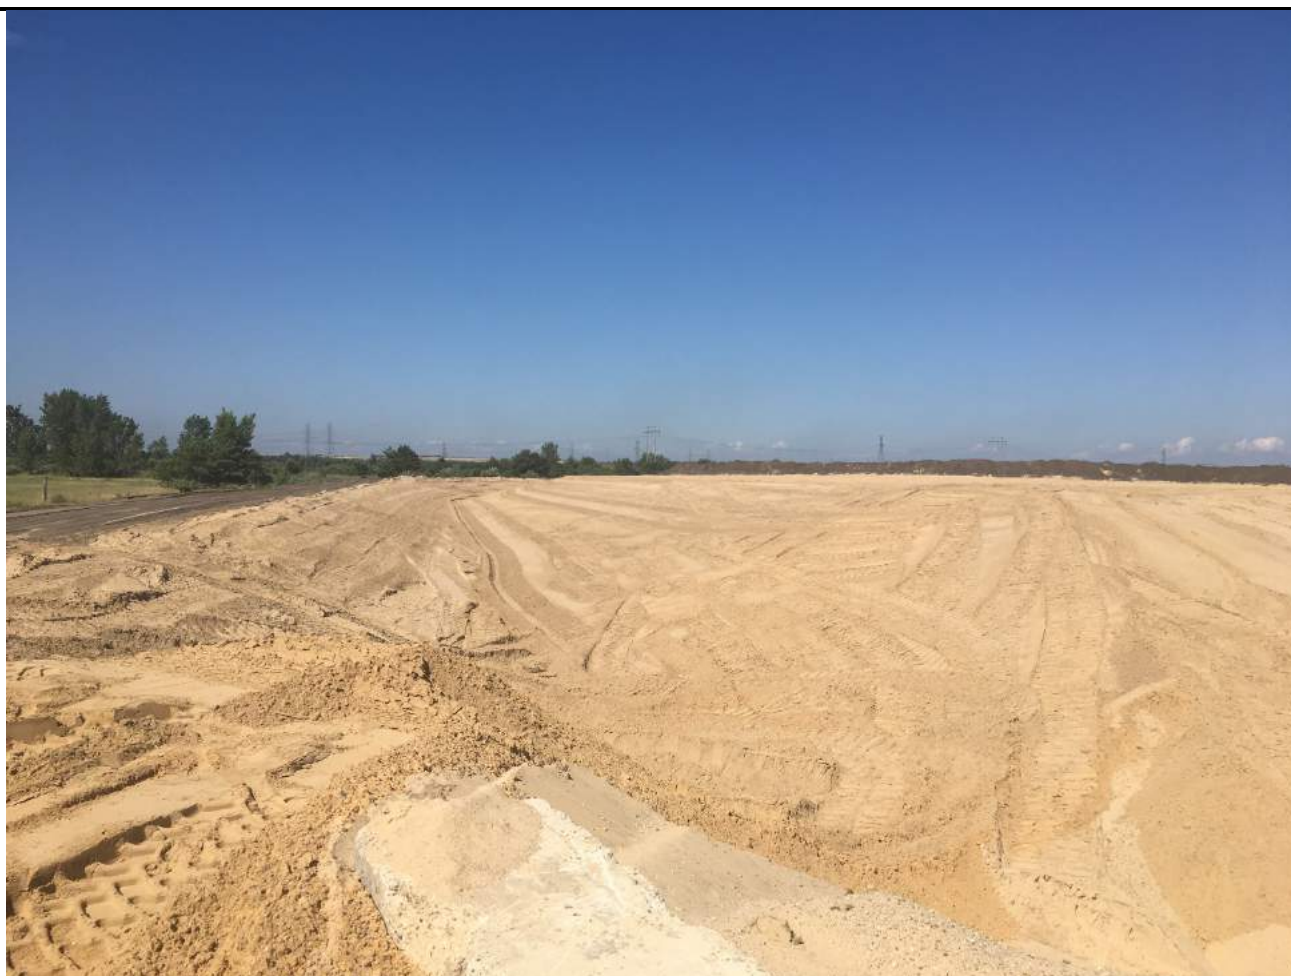
Cover material along the western edge of Pond A.

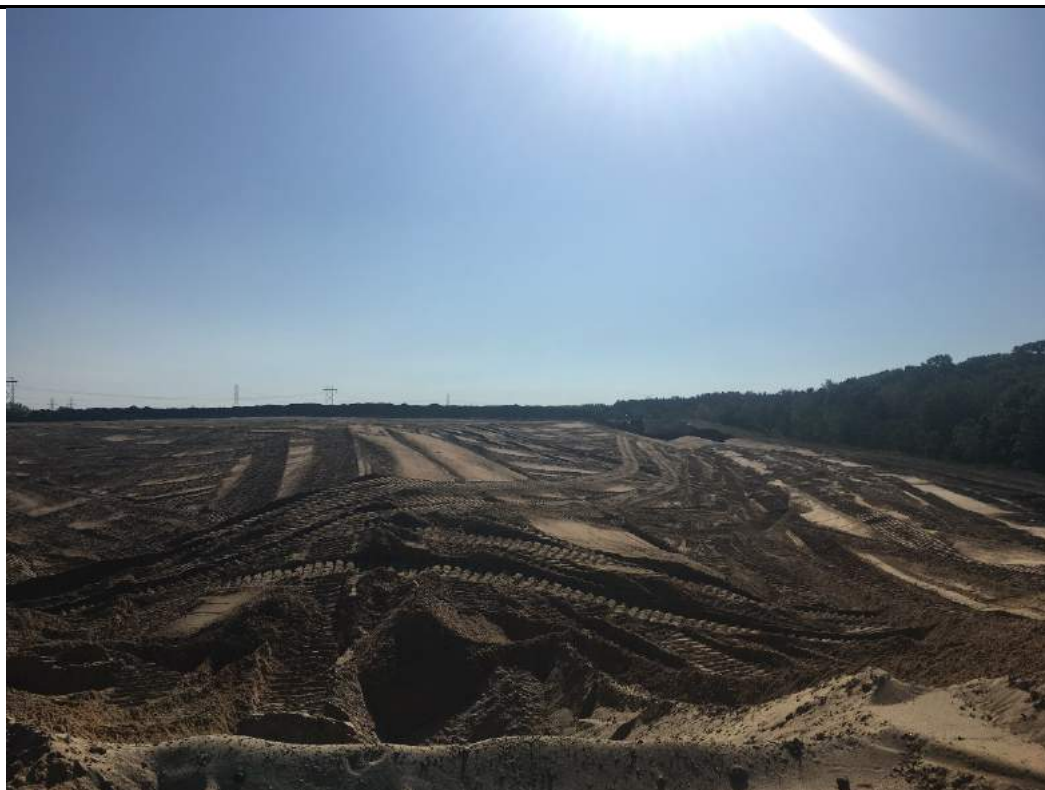
Grading cover material along the west end of Pond A.

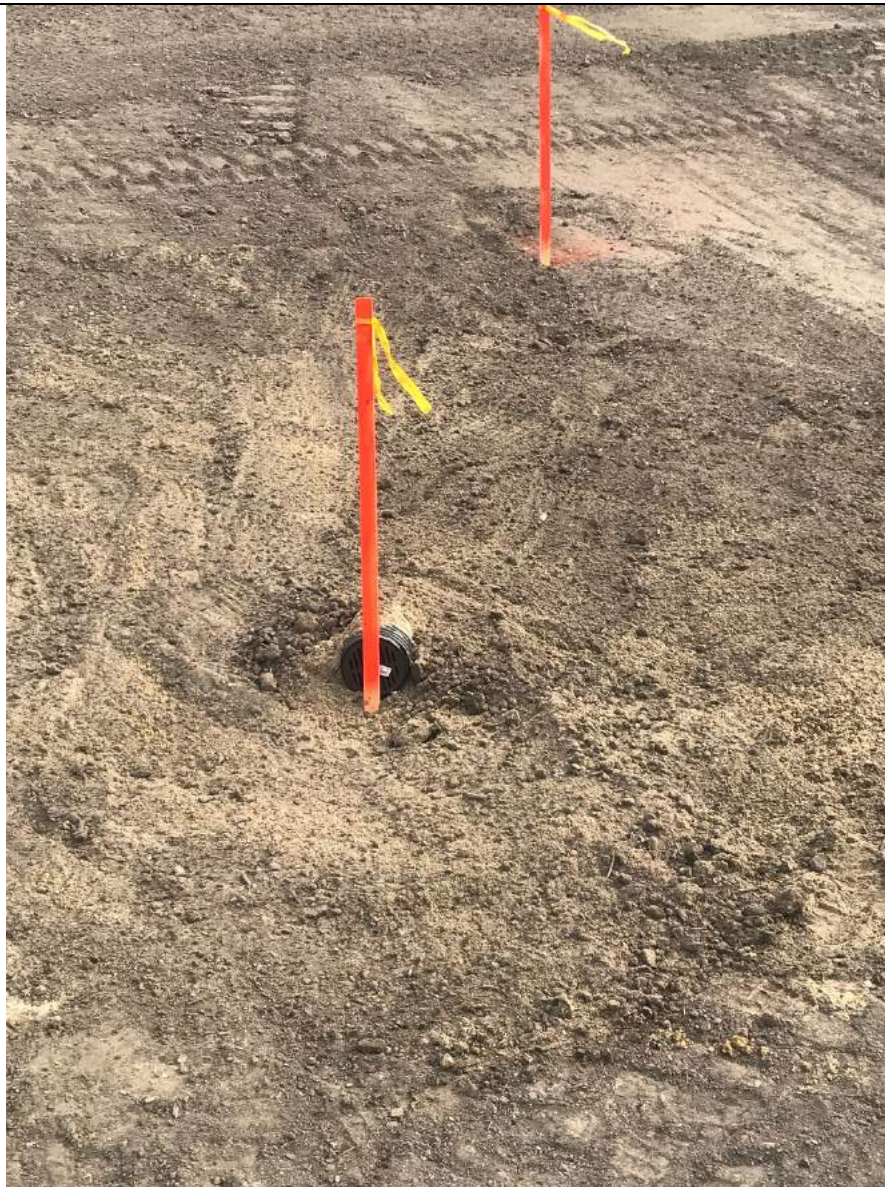
Installed screens on the drain tile.

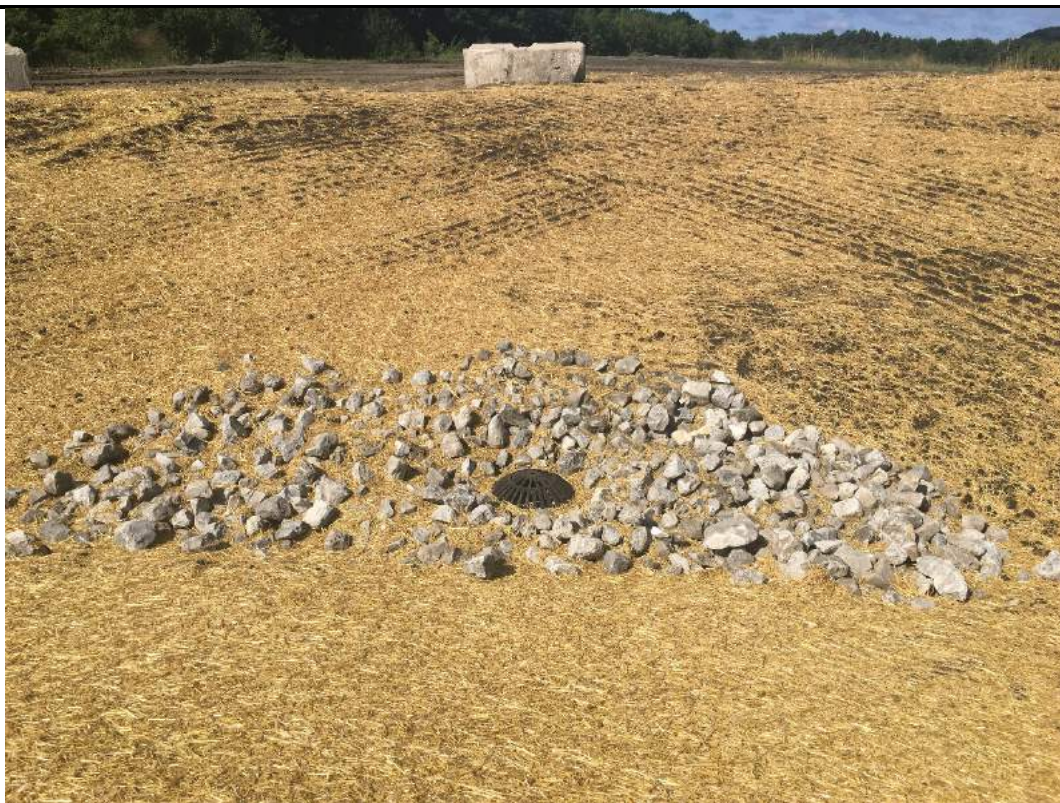
Western manhole with rip-wrap.

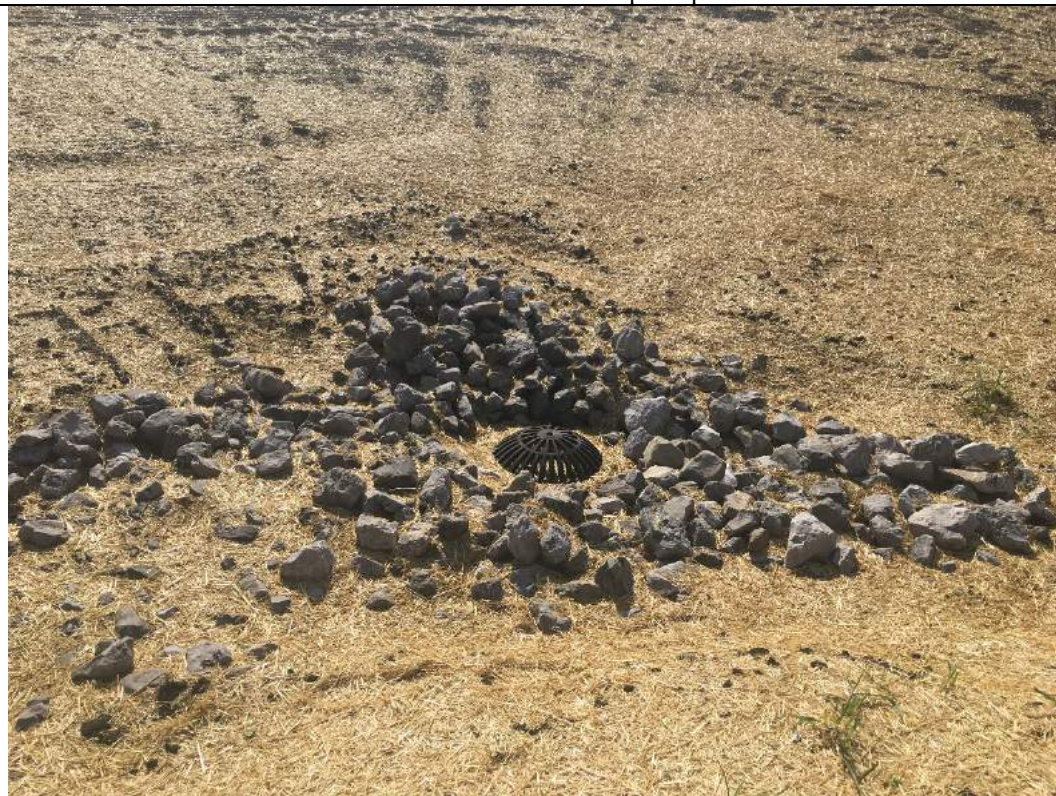
Eastern manhole with rip-wrap.

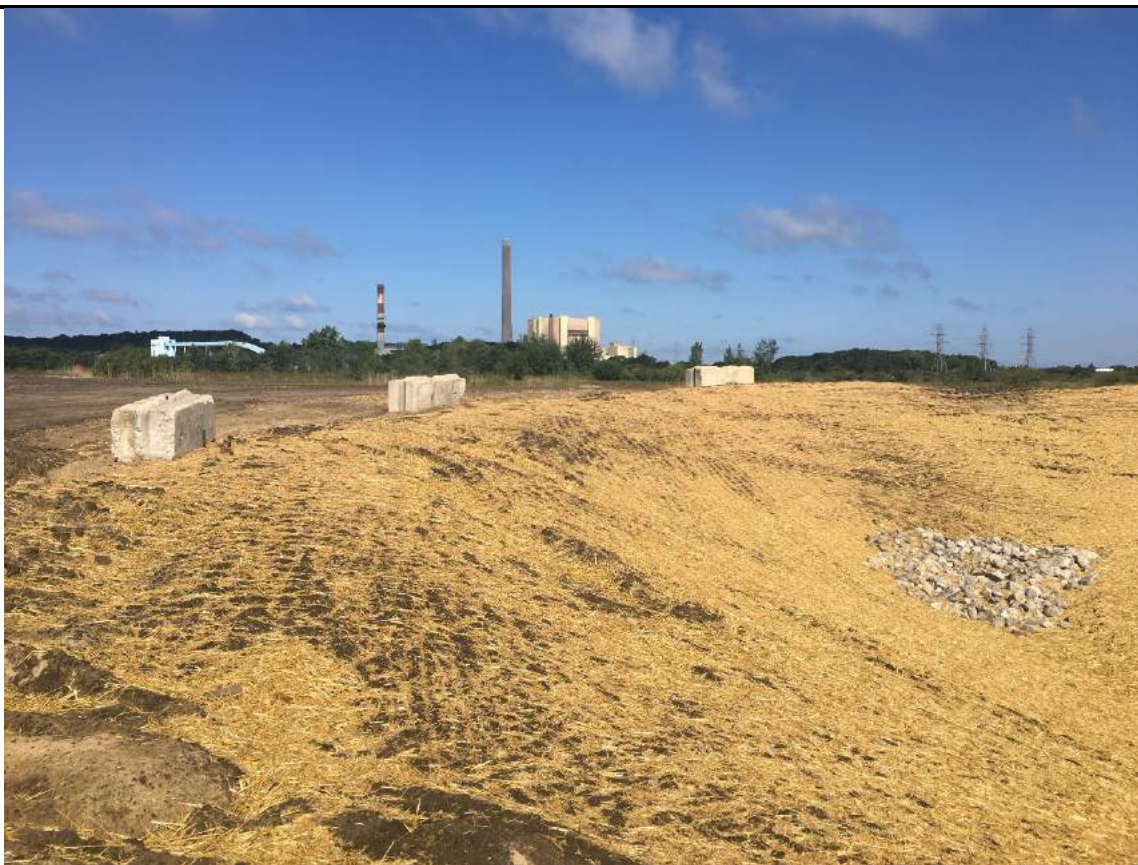
South west corner of Pond A with jersey barriers.
