Project Title: J.R. Whiting Ponds 1 Project Number: 1788523 Date: 6/24/2019

Client: Consumers Energy Site/Location: Erie, MI

and 2 Closure CQA

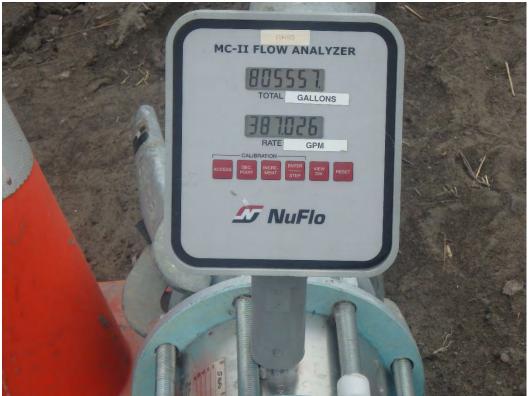
Discharge flowmeter on dewatering system in Pond 2.

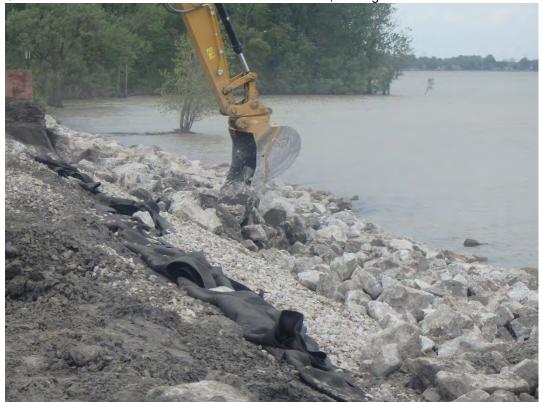
Placement of D50/30 inch riprap along shoreline, looking north.

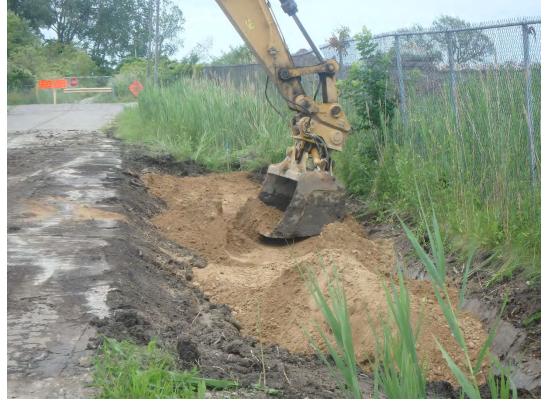
Placement of culvert bedding material, looking east.

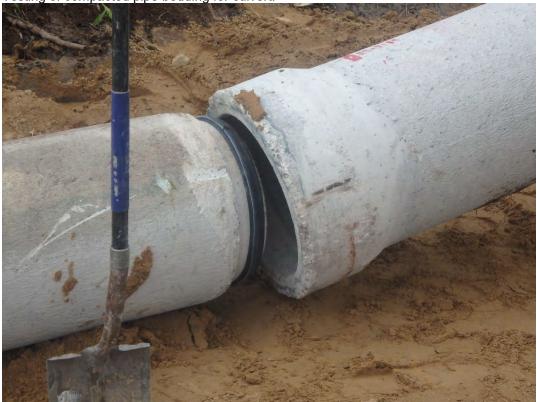
Installation of 12 inch RCP for access road culvert.

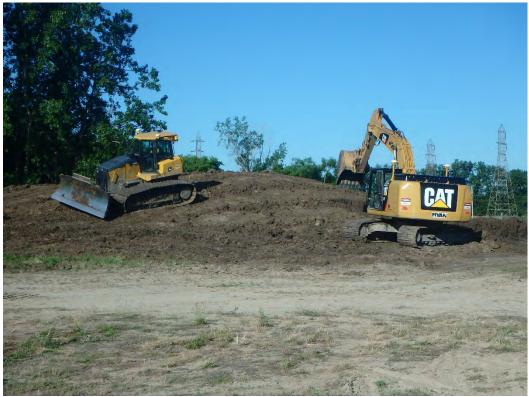
On-site structural fill stockpile stripped of vegetation, looking southwest.

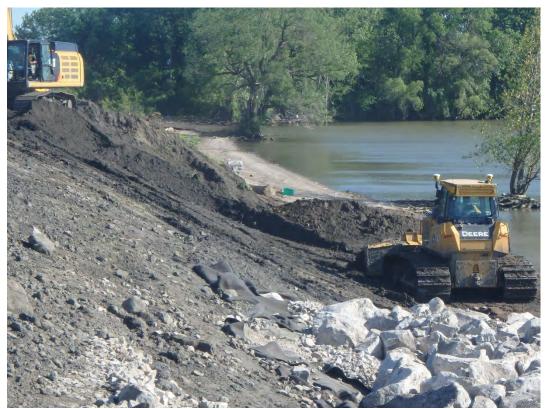
Grading shoreline slope, looking north.

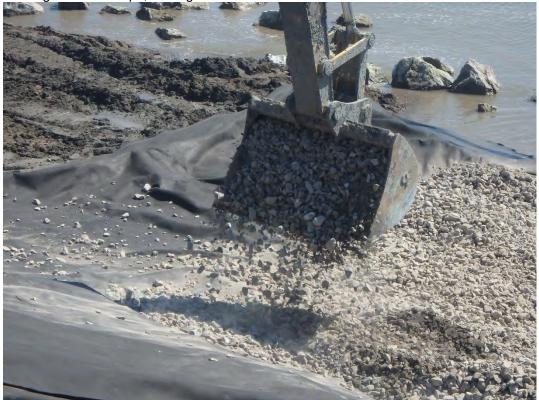
Placement of D50/2 inch cushion layer along shoreline, looking east.

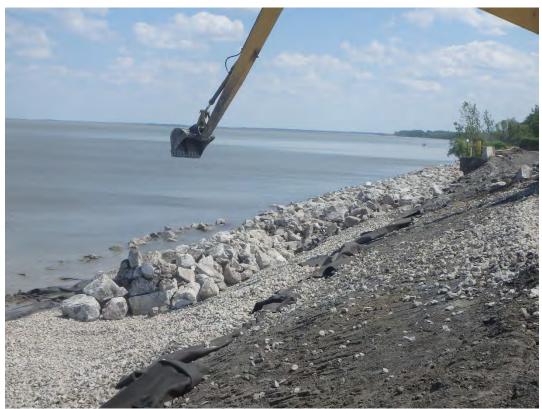
Placement of D50-30 inch riprap along shoreline, looking southeast.

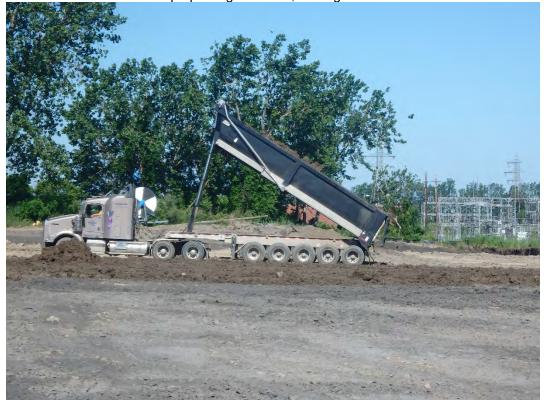
Structural fill hauled to chemical ponds, looking southeast.

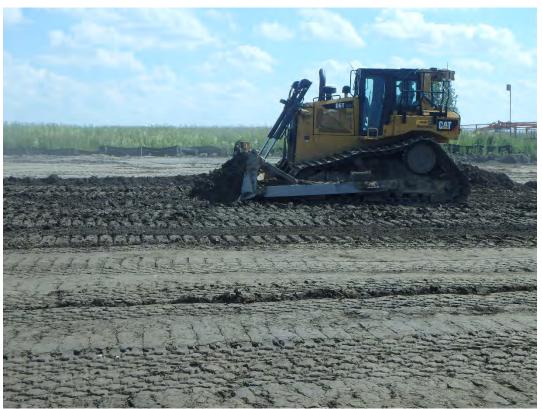
Placement of 12 inch loose lift of structural fill at chemical ponds, looking south.

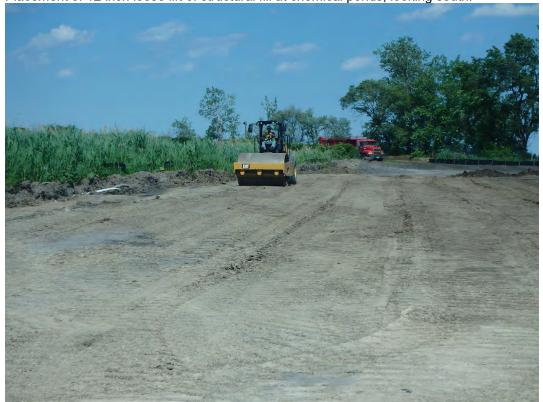
Compaction of placed structural fill at chemical ponds, looking east.

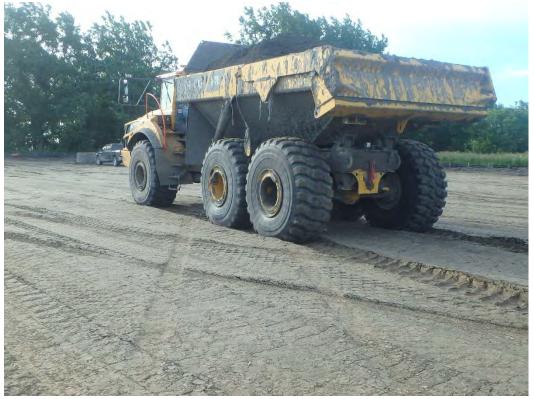
Proof roll of compacted onsite structural fill placed in Chemical Ponds Grading Area, looking west.

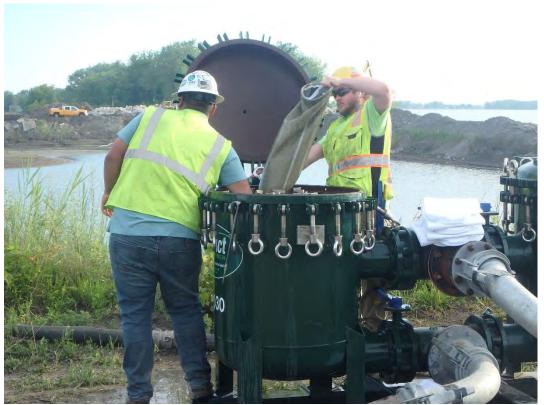
Filter change on the dewatering system for Pond 2, looking northeast.

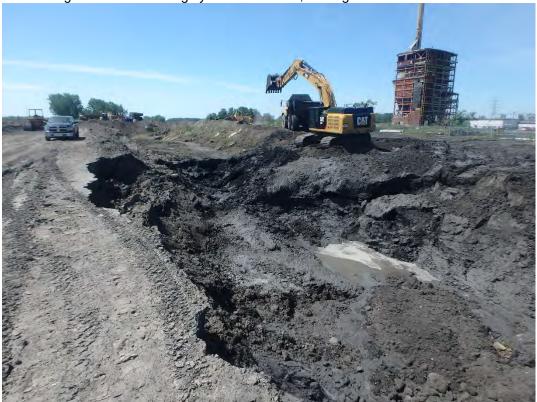
Removal of saturated material from along the west side of Pond 1, looking south.

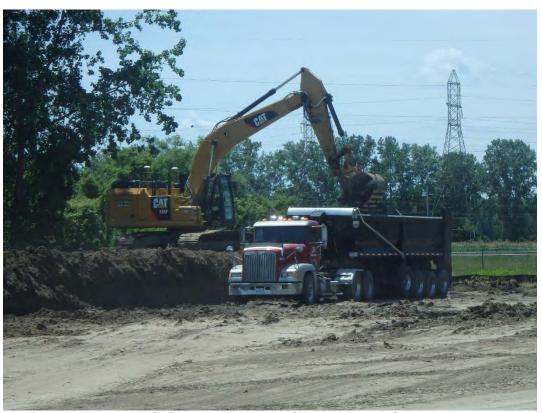
Loading onsite structural fill for stockpiling in the Chemical Ponds Grading area, looking west.

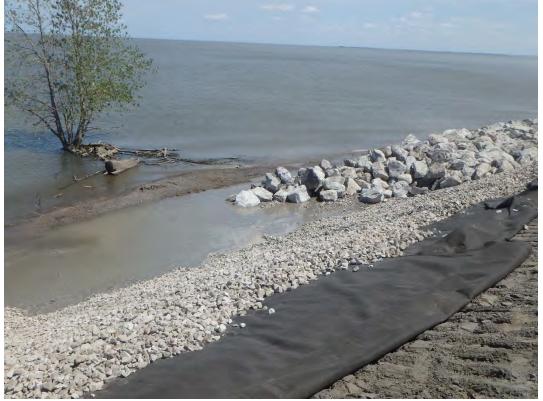
Geotextile and D50/2 inch cushion layer along shoreline, looking southeast.

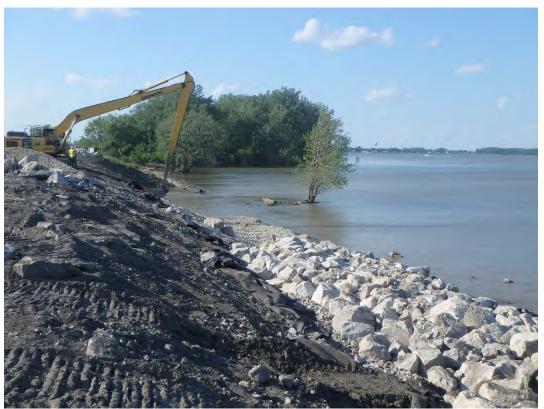
Placement of D50/30 inch riprap along shoreline, looking north.

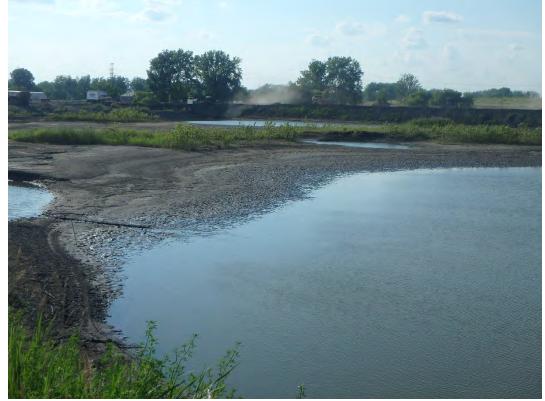
Overview and water level of Pond 2, looking northwest.

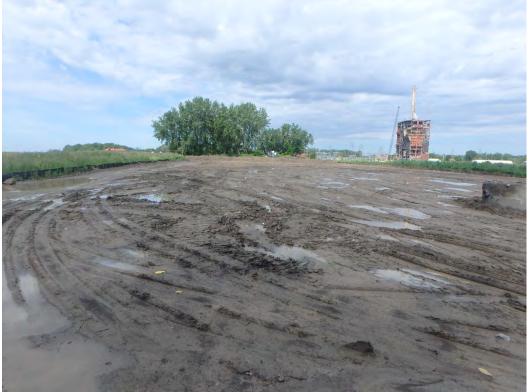
Chemical Ponds 1st lift of structural fill after previous night's rain, looking west.

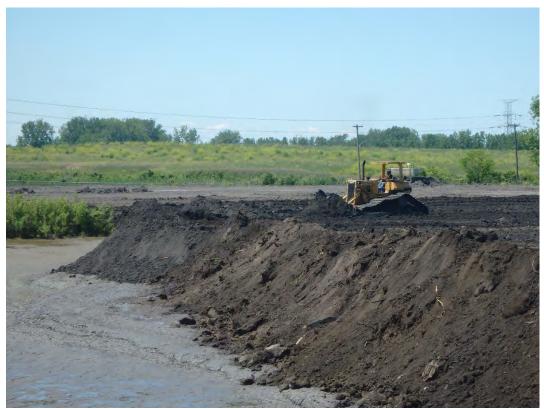
Placing bridging layer in Pond 1, looking north.

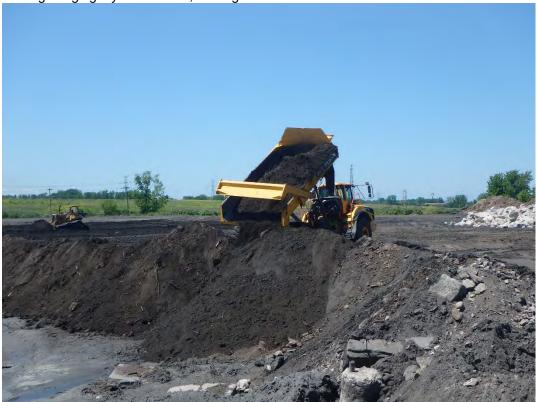
General fill from grading of shoreline being placed into Pond 1, looking north.

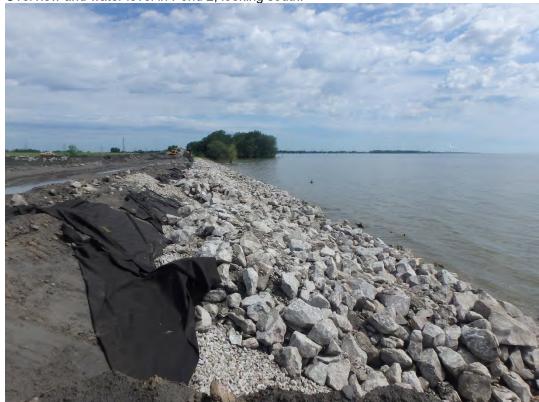
Overview of shoreline from south end, looking north.

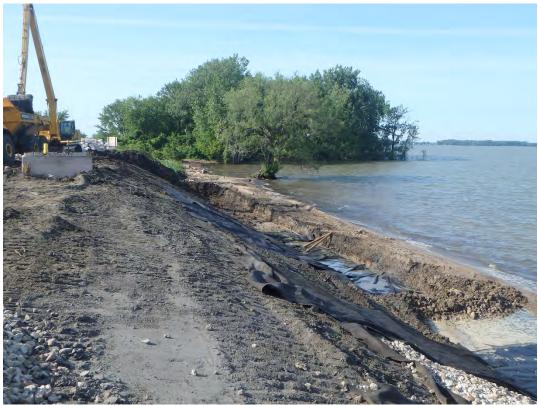
Cutting shoreline for installation of riprap, looking north.

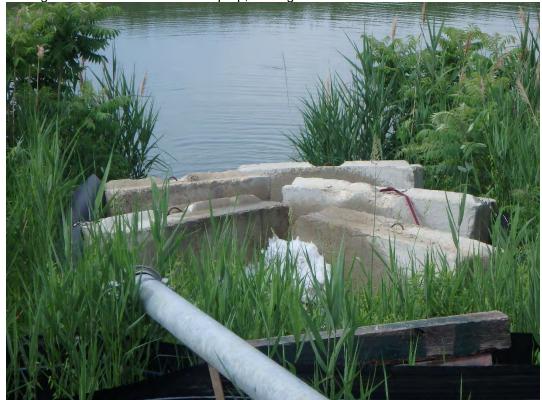
Discharge water from Pond 2, looking south.

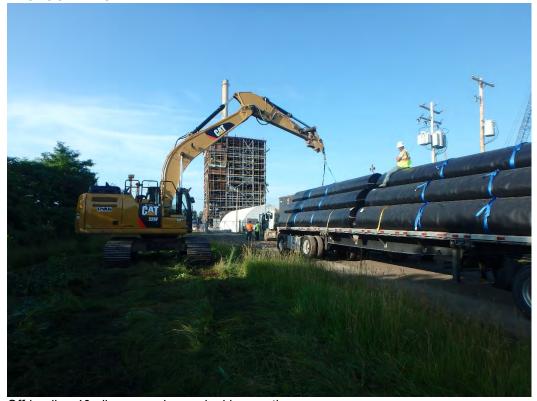
Off-loading 40mil geomembrane, looking south.

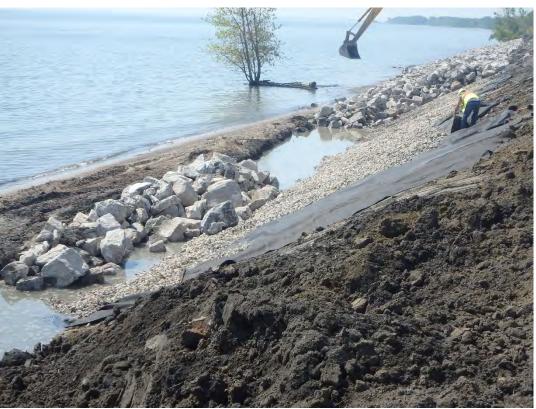
Placement of textile, 2 inch cushion material and 30 inch riprap along shoreline, looking south.

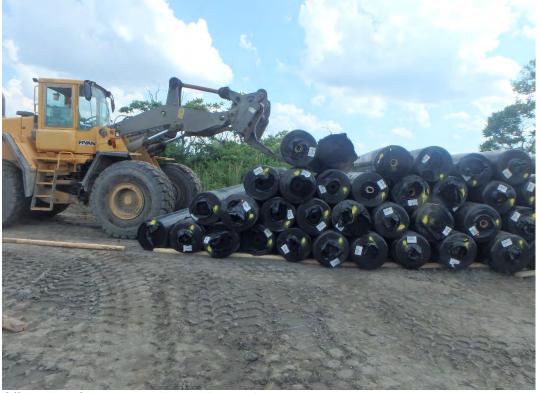
Off-loading of 8 oz. geotextile, looking south.

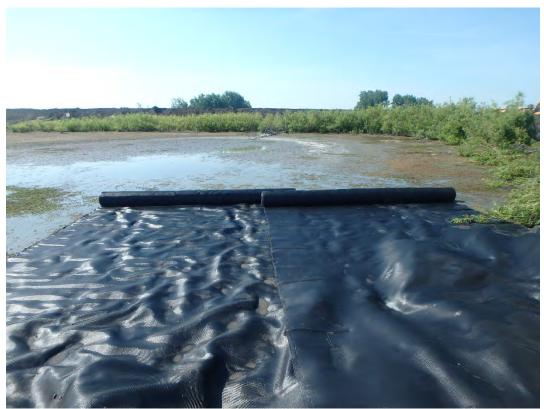
Installation of geotextile in Pond 1 prior to bridging layer, looking south.

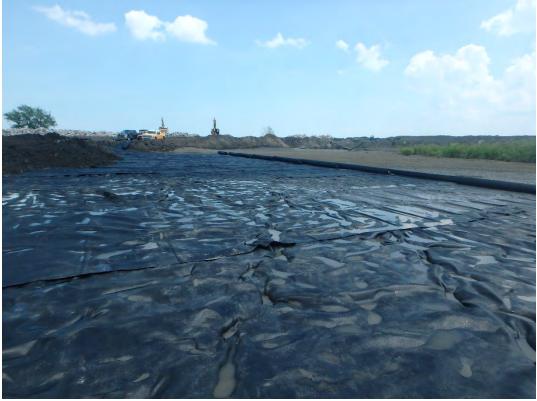
Geotextile installed across floor of Pond 1, looking east.

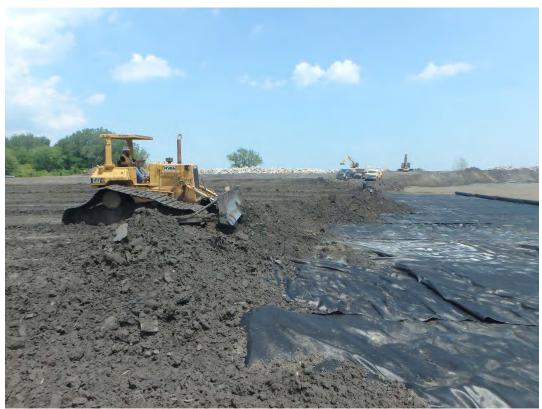
Placement of bridging layer above geotextile in Pond 1, looking east.

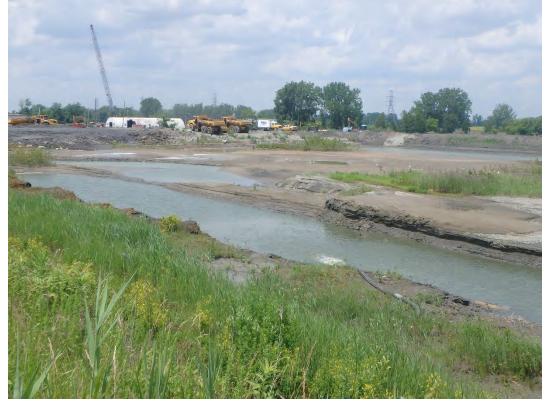
Overview and water level of Pond 2, looking west.

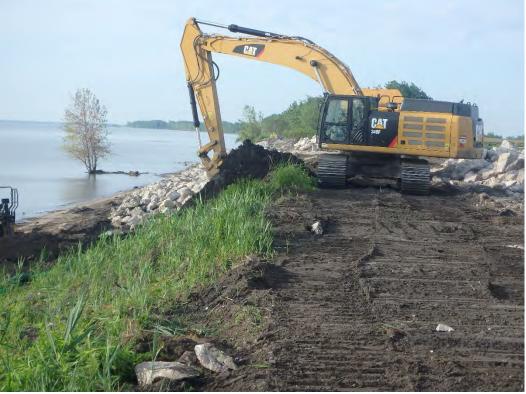
Clearing vegetation along shoreline, looking south.

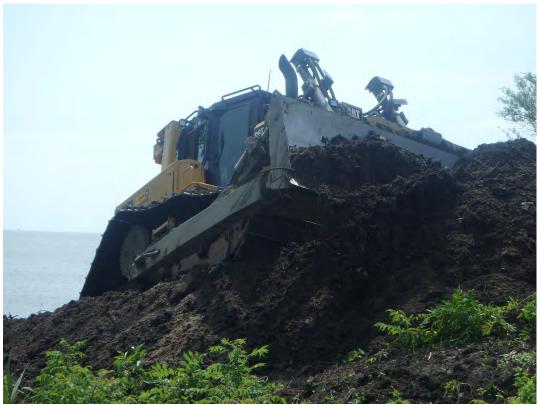
Cutting shoreline slope to sub-grade, looking east.

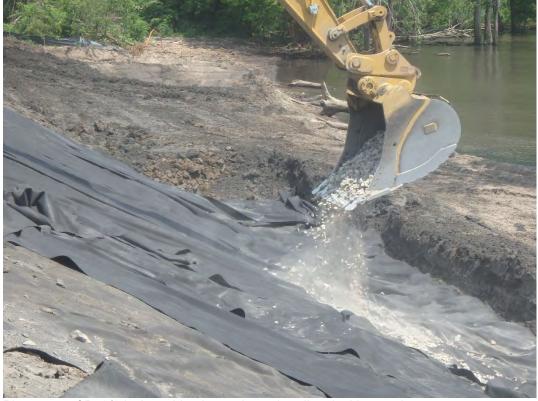
Placement of D50/2 inch cushion layer along shoreline, looking north.

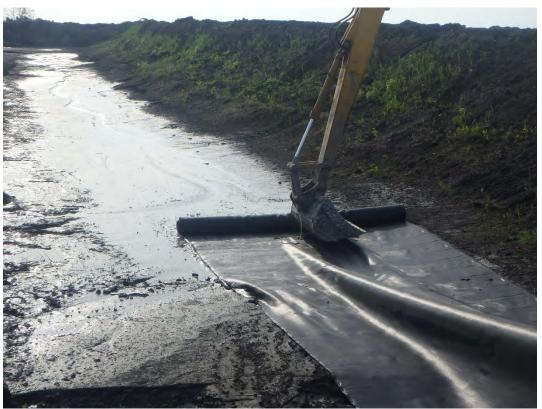
Installation of geotextile in Pond 1 prior to bridging layer, looking east.

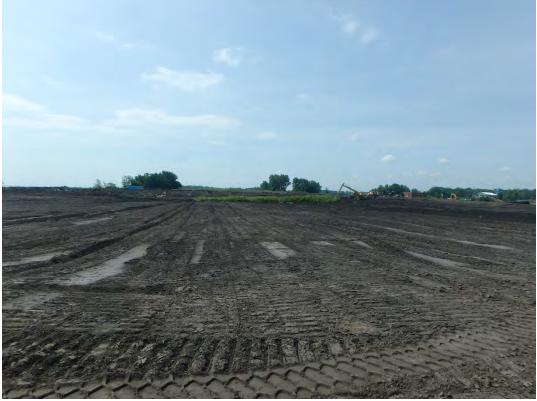
Overview of bridging layer in Pond 1, looking south.

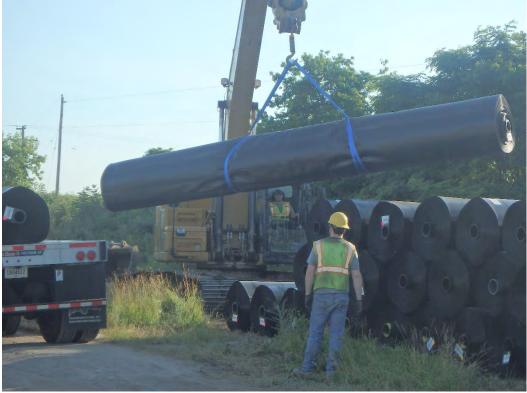
Off-loading 40mil geomembrane, looking north.

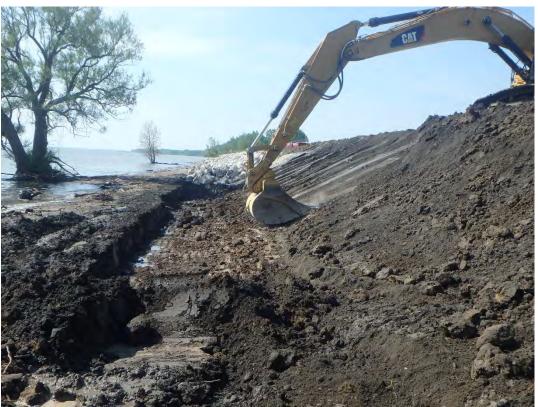
Cutting shoreline slope to sub-grade, looking south.

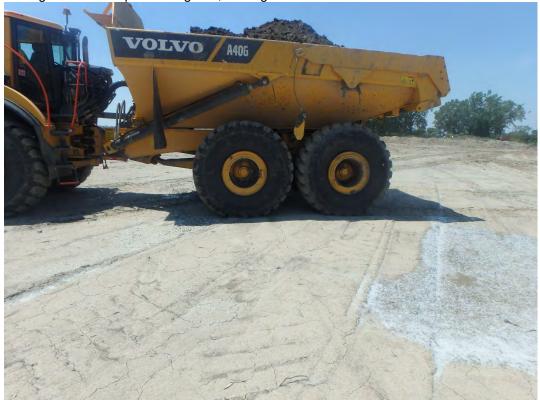
Proof roll of onsite structural fill placed over chemical ponds, looking west.

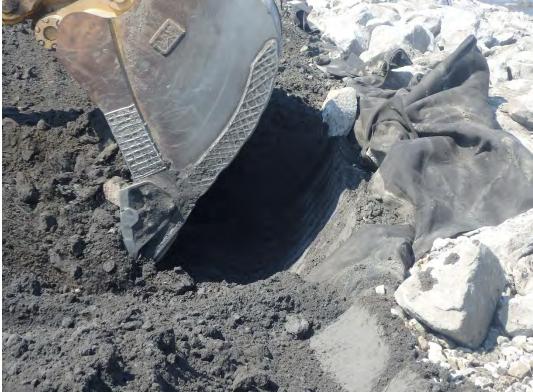
Excavating anchor trench for shoreline geotextile, looking north.

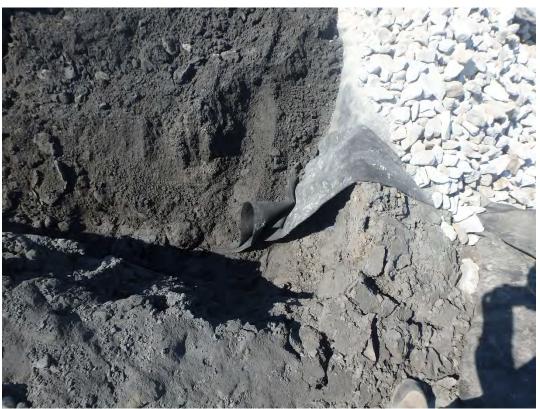
Shoreline geotextile in anchor trench with backfill.

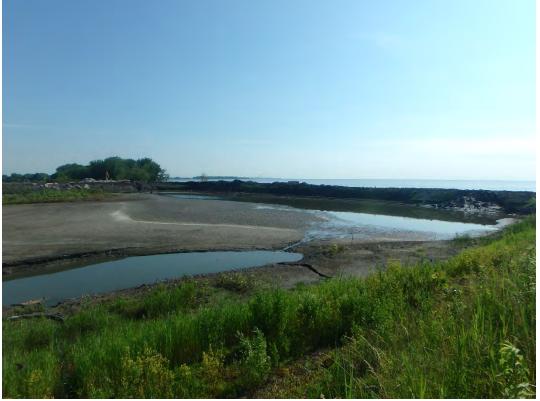
Overview and water level of Pond 2, looking northeast.

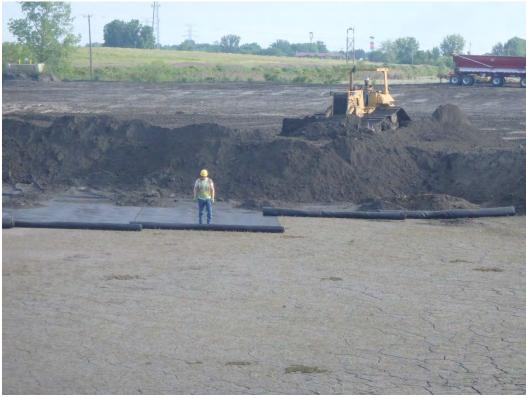
Deployment of geotextile and placement of bridging layer in Pond 1, looking north.

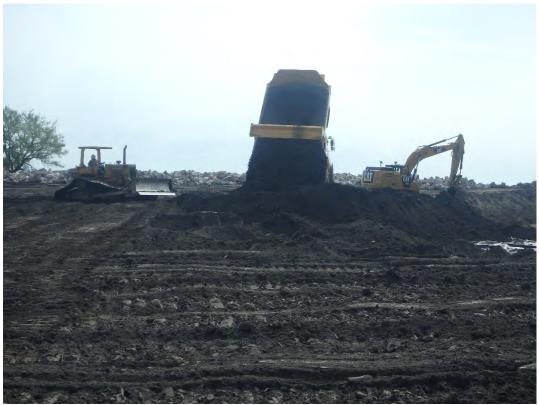
CCR regrading for bridging layer in Pond 1, looking east.

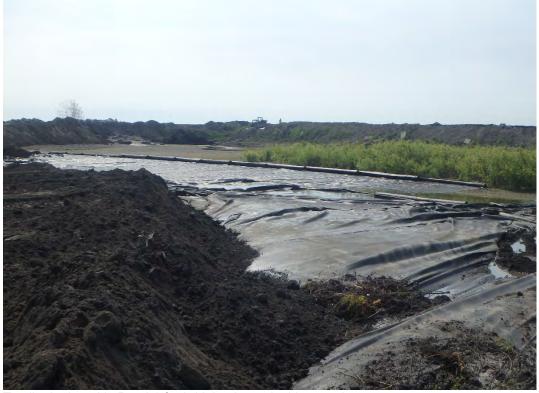
Textile deployed in Pond 1 for bridging layer, looking southeast.

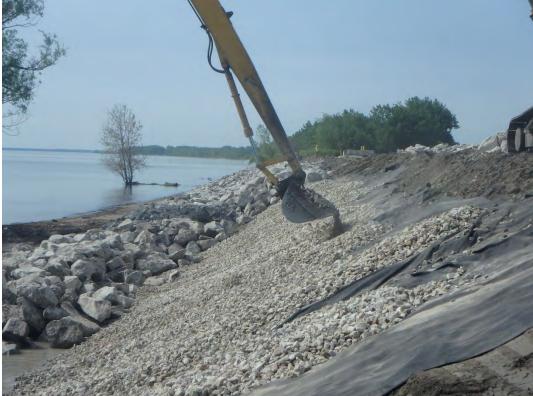
D50/2 inch cushion layer being placed atop textile along shoreline, looking south.

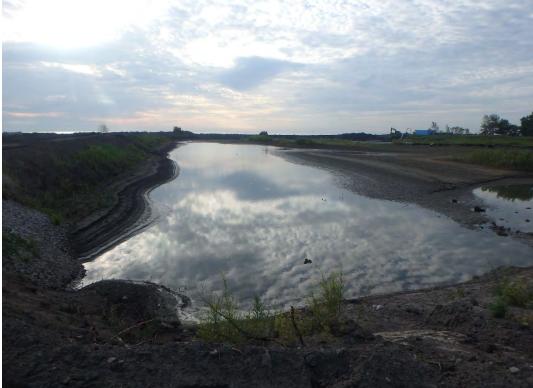
Overview and water level of Pond 2, looking west.

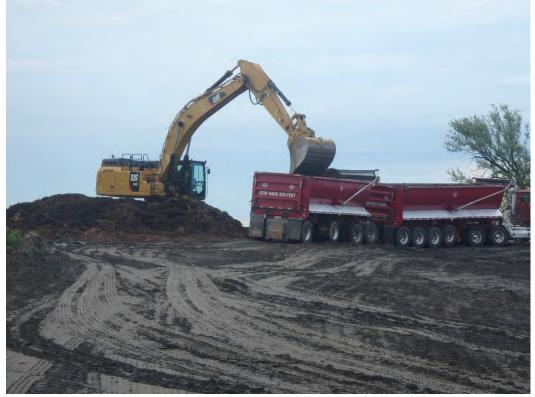
Loading of vegetation chip pile for disposal at offsite facility, looking east.

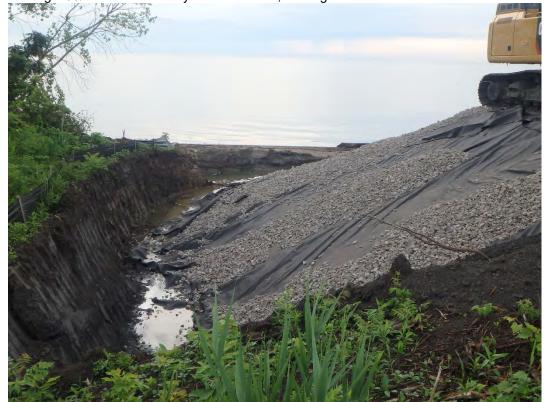
North shoreline wraparound, looking east.

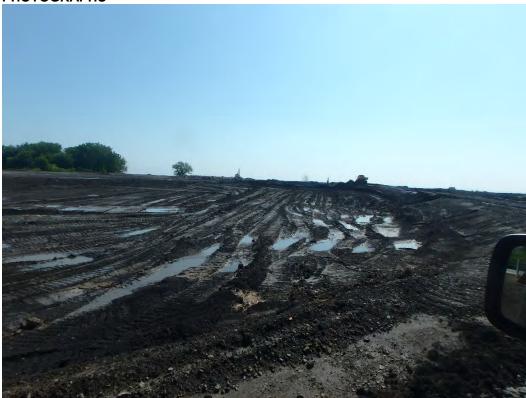
Pond 1 after the previous night's rain, looking east.

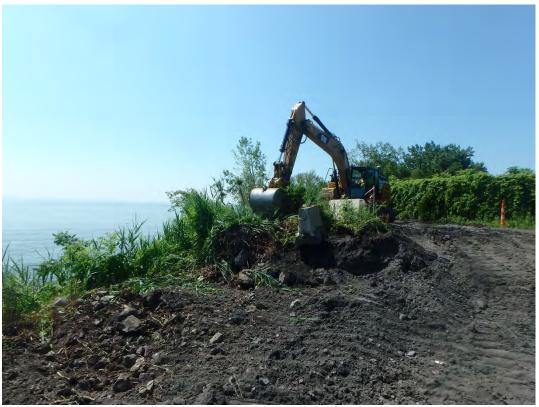
Clearing vegetation from shoreline east of Pond 2, looking south.

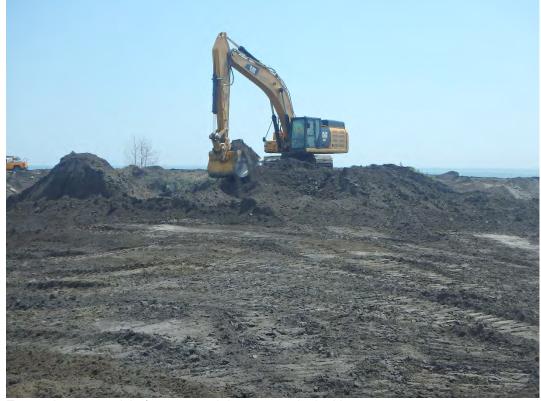
Excavating center dyke/access road down to grade, looking east.

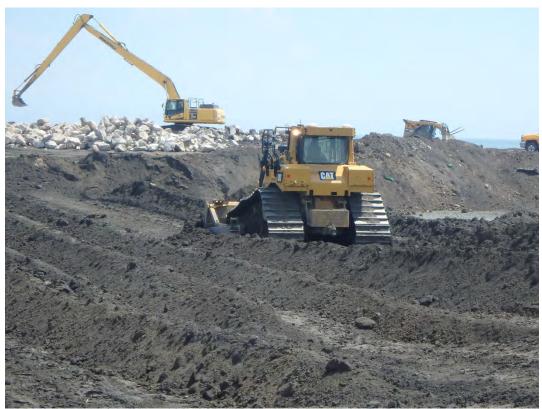
Pond 1 bridging layer being placed atop geotextile, looking east.

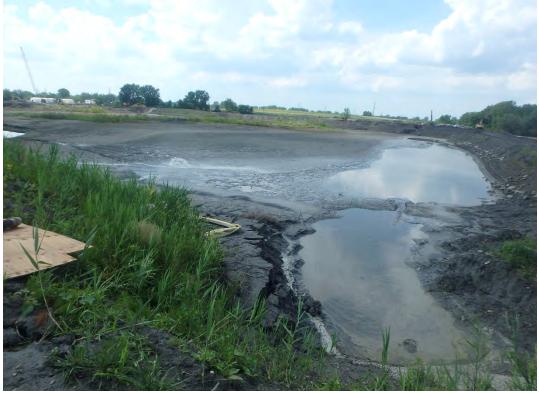
Overview and water level of Pond 2, looking north.

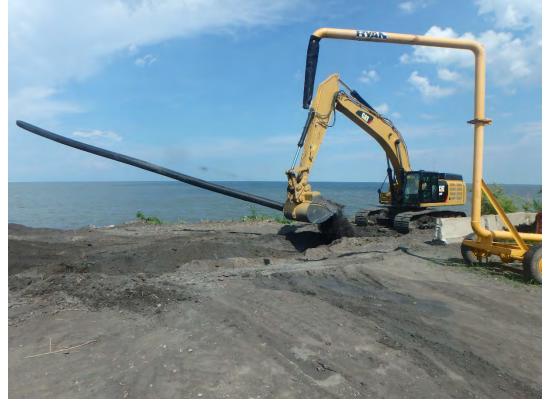
Removing utility pipe running from southeast corner of Pond 2 too Chemical Ponds, looking east.

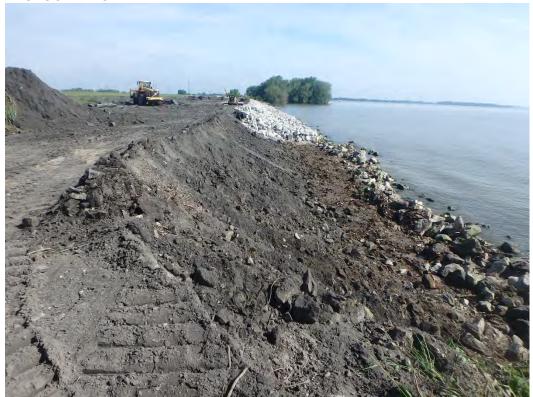
Cutting of shoreline east of Pond 2 to sub-grade, looking north.

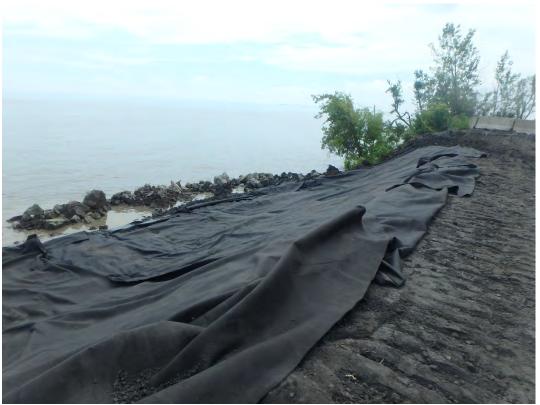
Textile deployed along shoreline, looking south.

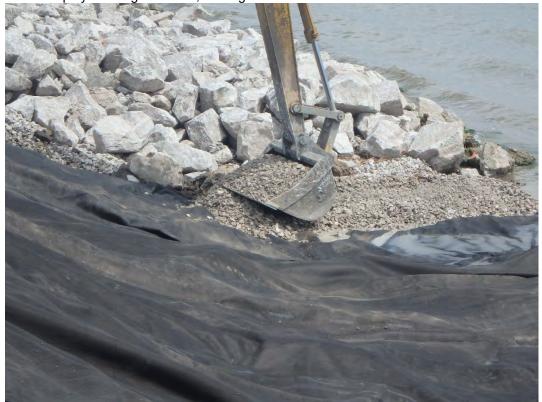
Placing D50-2 inch cushion layer atop textile on shoreline, looking north.

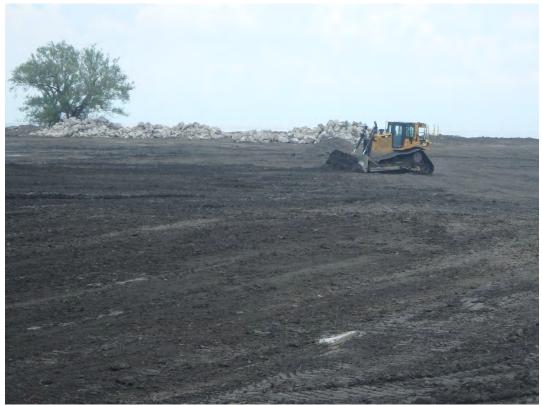
Pond 1 bridging layer being placed, looking east.

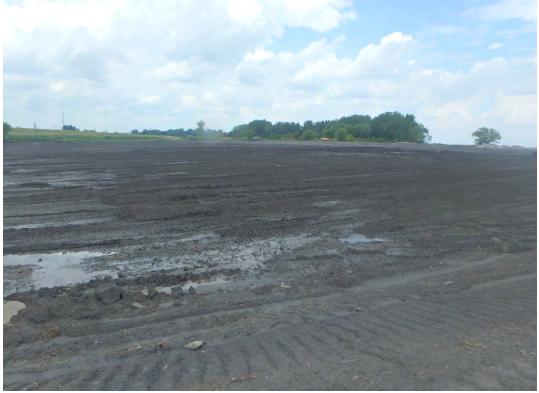
Overview of bridging layer in Pond 1, looking northeast.

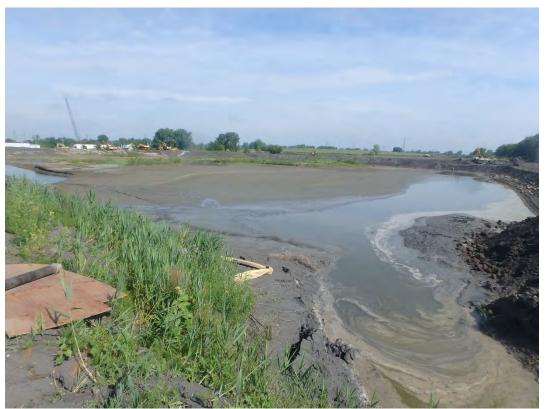
Overview and water level of Pond 2, looking northwest.

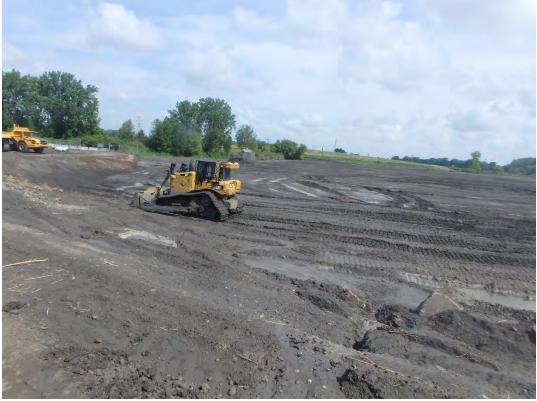
Re-grading of CCR in Pond 1 work area, looking northwest.

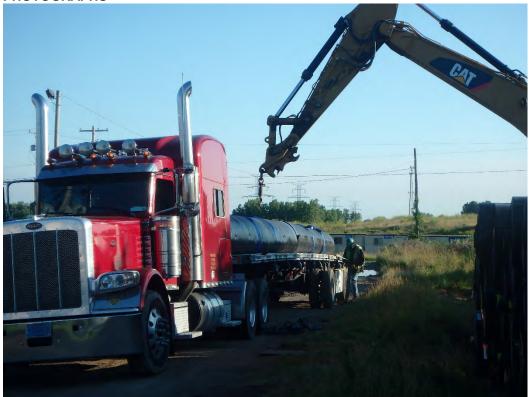
Offload of geomembrane, looking north.

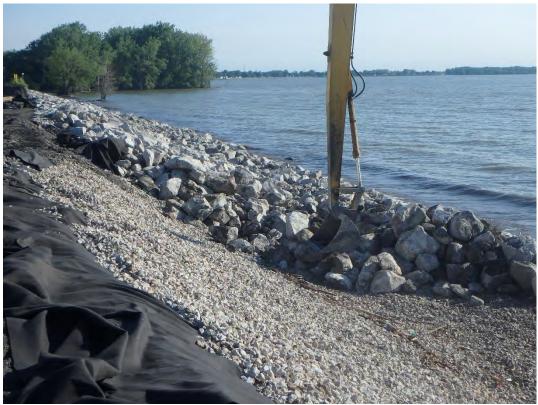
Placing D50/30 inch riprap along shoreline, looking northeast.

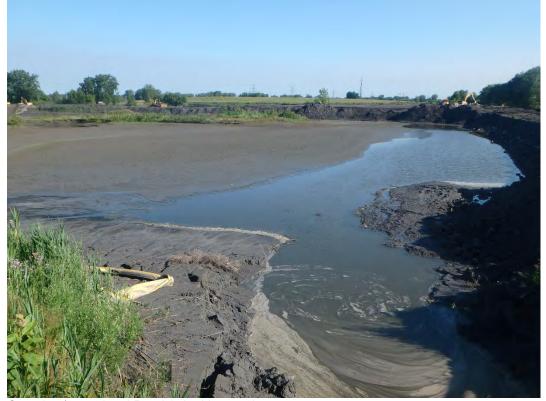
Overview/water level Pond 2, looking northern.

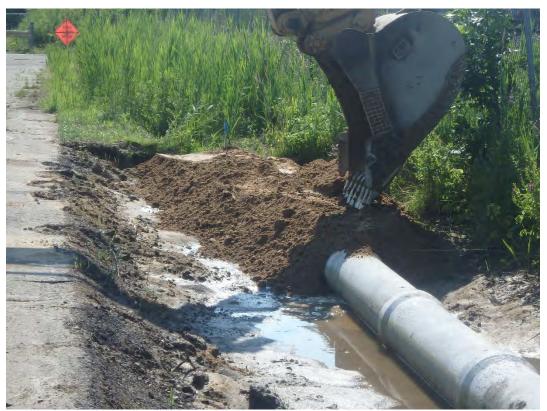
Placement of class IIIA sand for backfill over access road culvert, looking east.

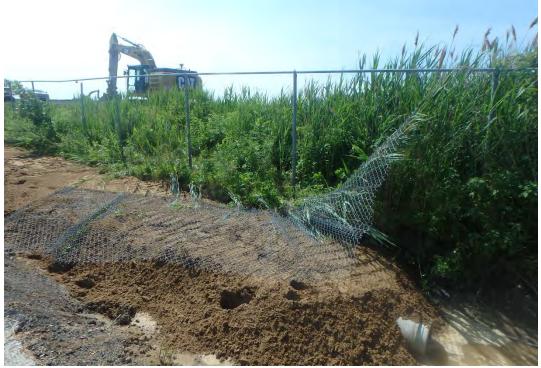
Removing fence for new entrance access road, looking southeast.

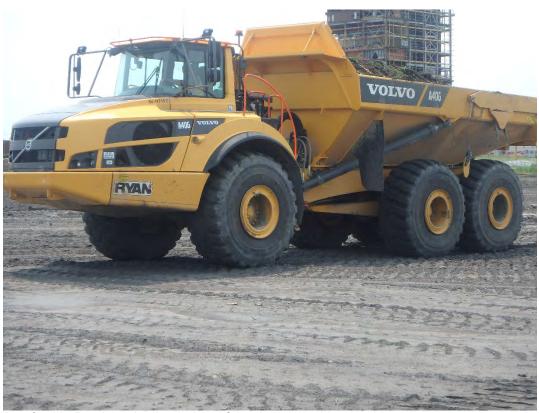
Proof roll in Pond 1 using loaded A40G haul truck, looking southwest.

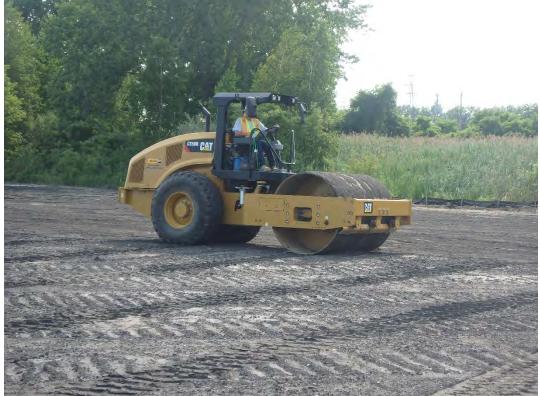
Smooth drum rolling bridging layer in Pond 1, looking west.

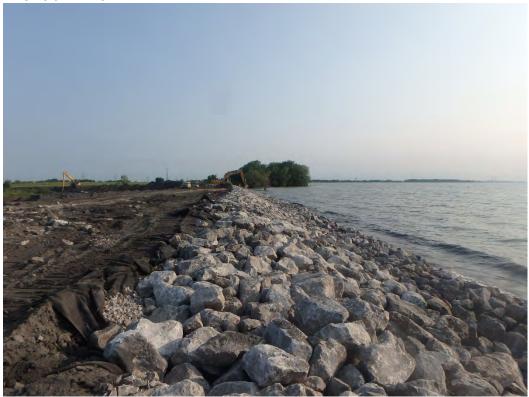
Overview of shoreline riprap, looking north.

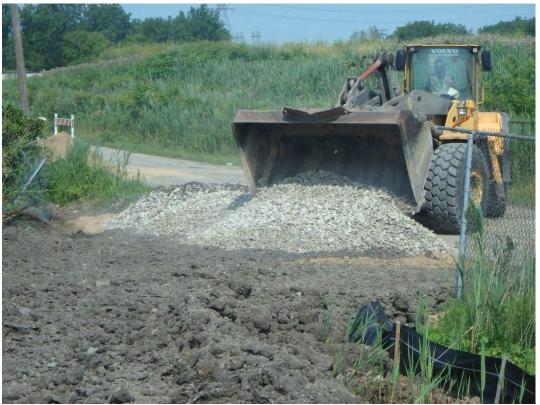
Construction of temporary access road into Pond 1 from Lake Erie RD., looking northwest.

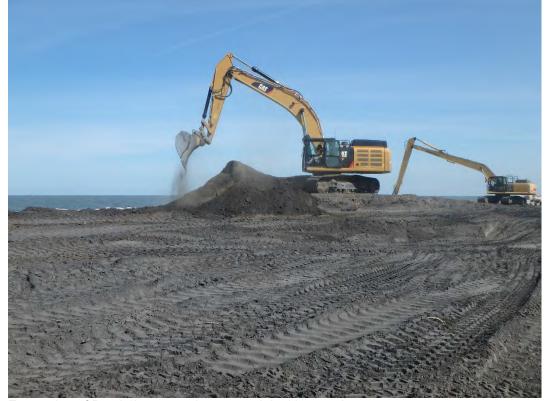
Excavating of Pond 1's east perimeter road, looking southeast.

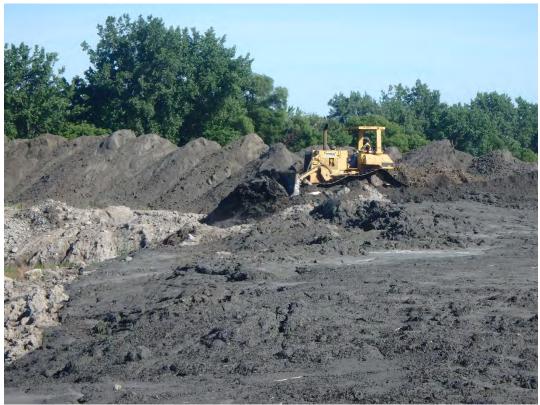
Placing bridging layer in Pond 2, looking south.

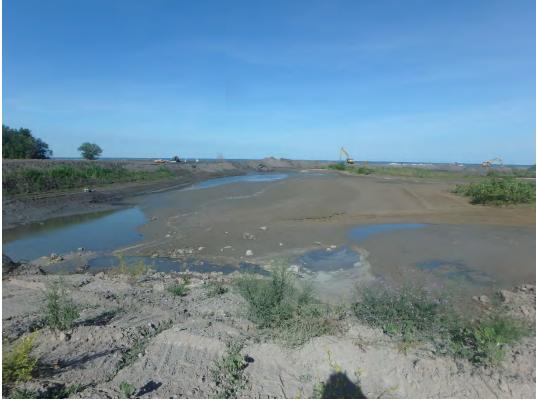
Overview/water level in Pond 2, looking east.

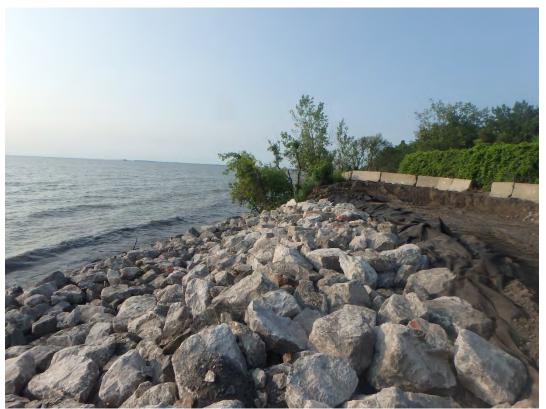
South end of shoreline riprap, looking south.

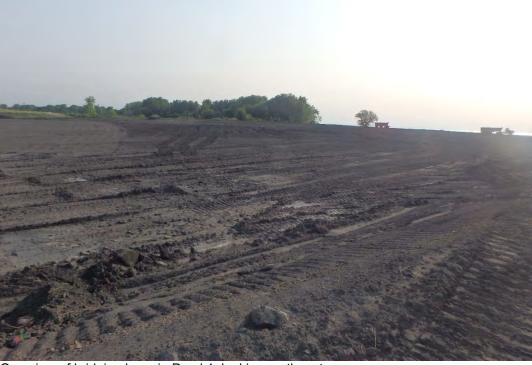
Overview of bridging layer in Pond 1, looking northeast.

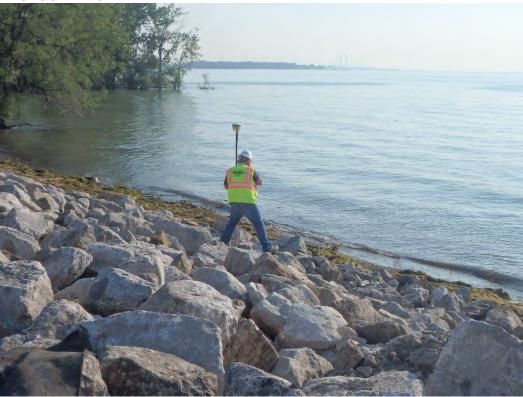
Ryan checking grade of riprap along shoreline, looking northeast.

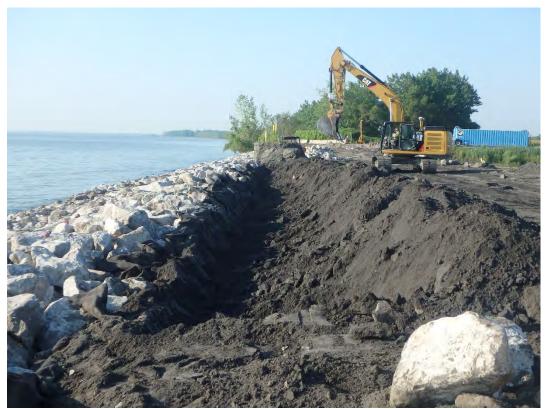
Excavating anchor trench for shoreline textile, looking south.

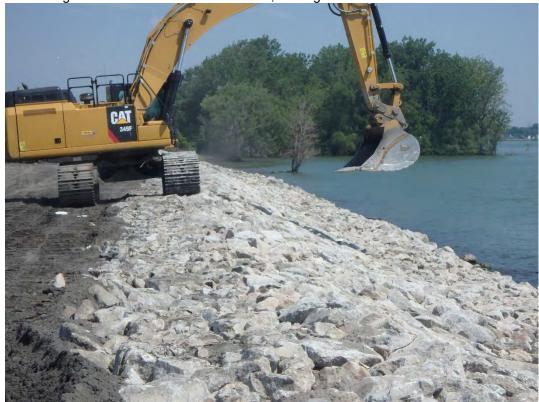
Filling voids in shoreline riprap using 8x16 inch riprap, looking north.

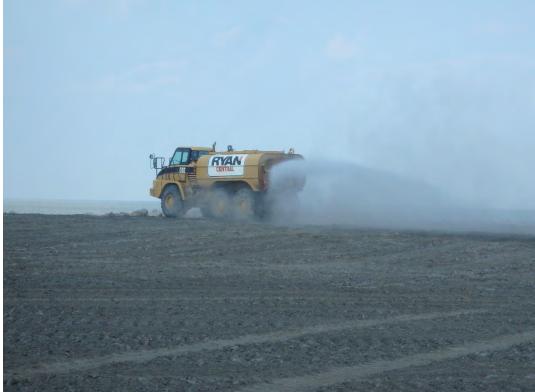
Water truck used for dust control, looking east.

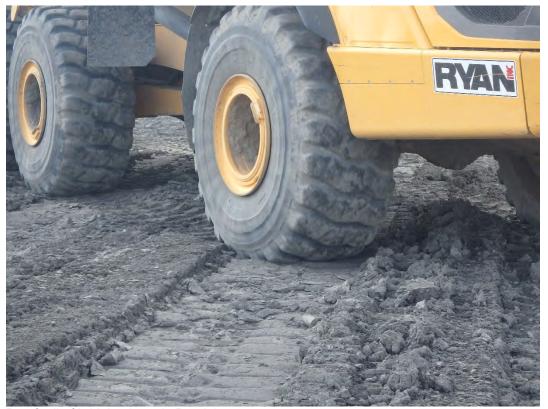
Proof roll of bridging layer in Pond 1.

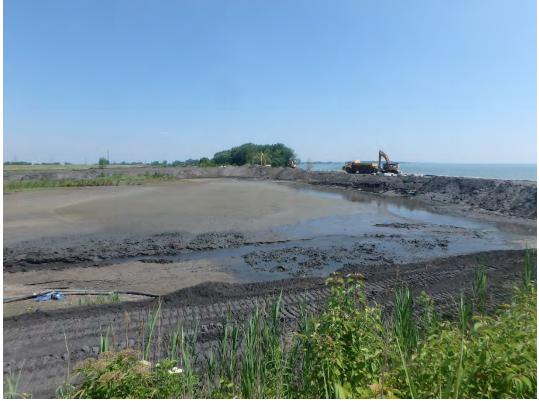
Overview/water level of Pond 2, looking north.

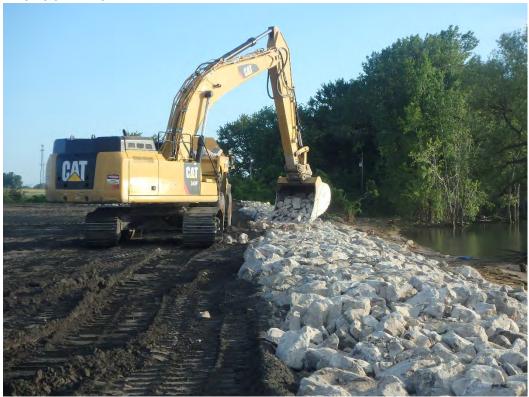
Placing 8 x 16 inch riprap to fill voids in the D50/30 inch along shoreline, looking north.

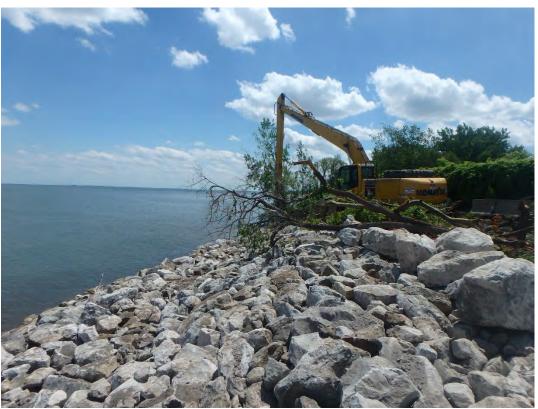
Clearing vegetation along shoreline southeast of Pond 2, looking south.

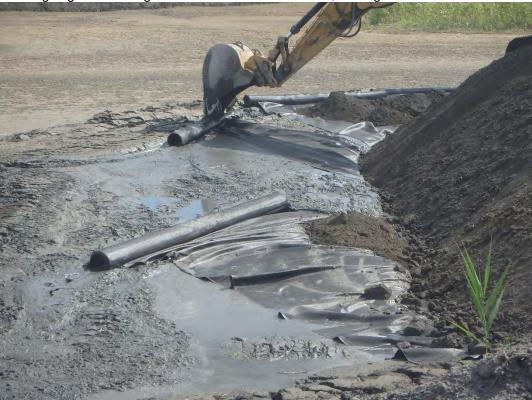
Deploying textile for bridging layer in Pond 2.

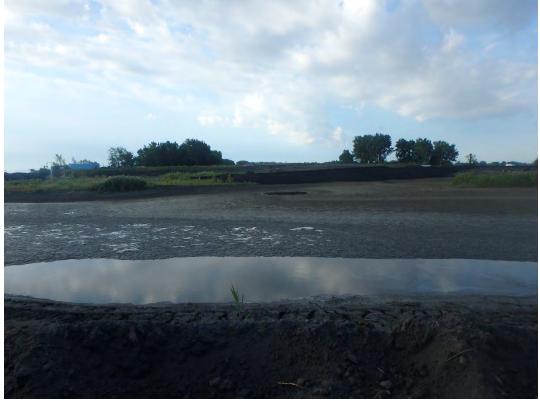
Overview/water level of Pond 2, looking north.

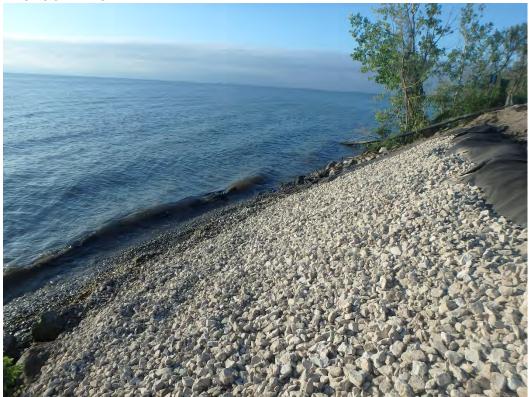
Textile and D50/2 inch cushion layer placed on shoreline southeast of Pond 2, looking south.

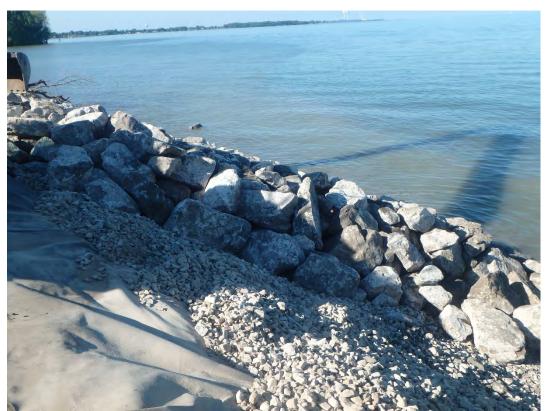
D50/30 inch riprap placed on shoreline southeast of Pond 2, looking northeast.

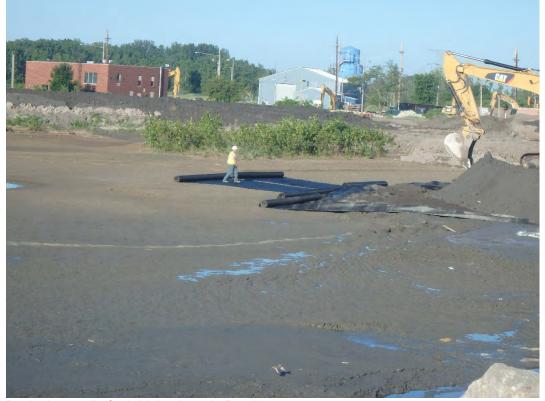
Deploying textile for bridging layer in Pond 2.

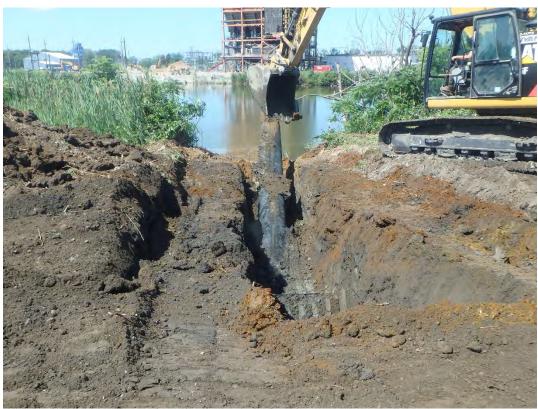
Removing standpipe into Fore Bay from Pond 1, looking west.

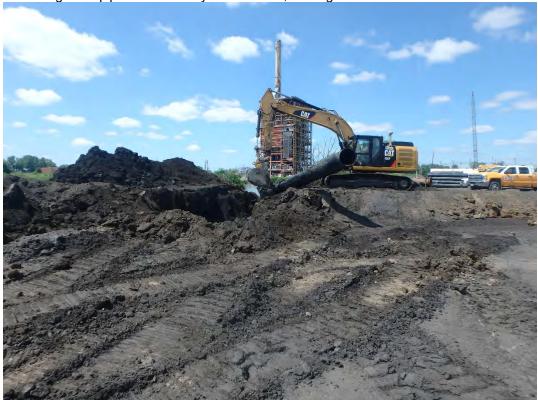
Removing standpipe running from Pond 1 to the Fore Bay, looking west.

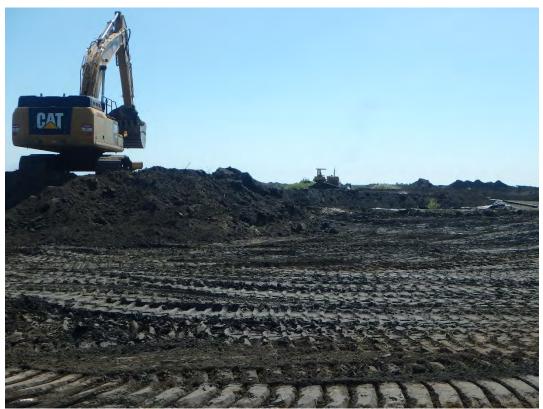
Excavation of dyke between Pond's 1 and 2, looking east.

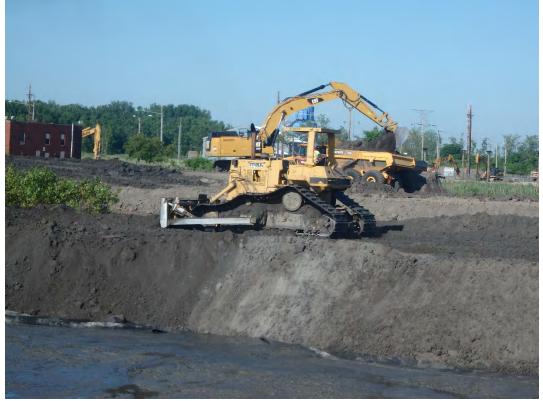
Placing bridging layer in Pond 2, looking southwest.

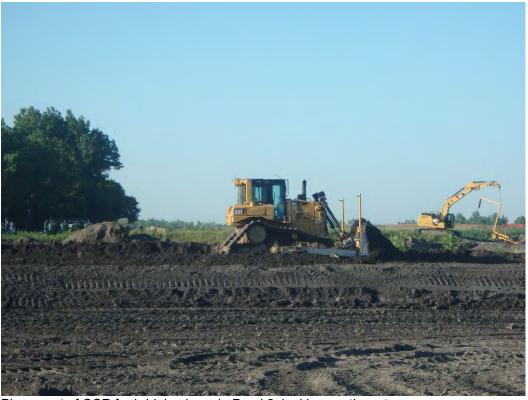
Placement of CCR for bridging layer in Pond 2, looking southwest.

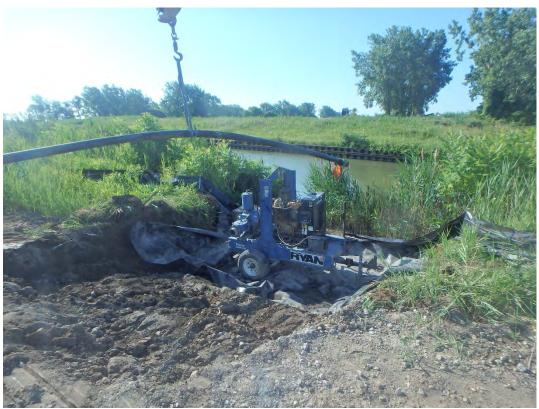
6 inch pump set southwest of Pond 2 along the discharge channel, looking south.

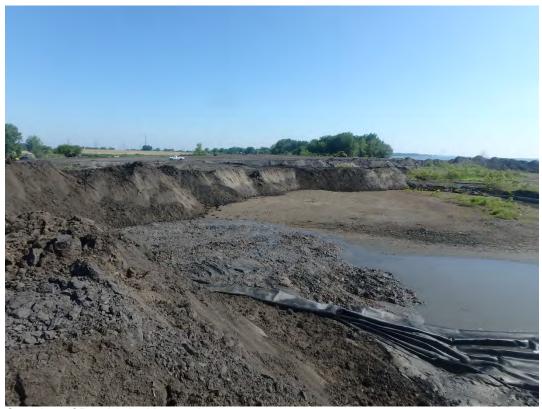
Overview of Pond 2, looking north.

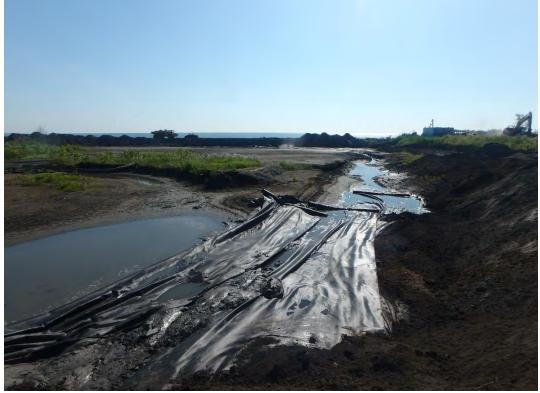
Textile for bridging layer deployed in Pond 2, looking east.

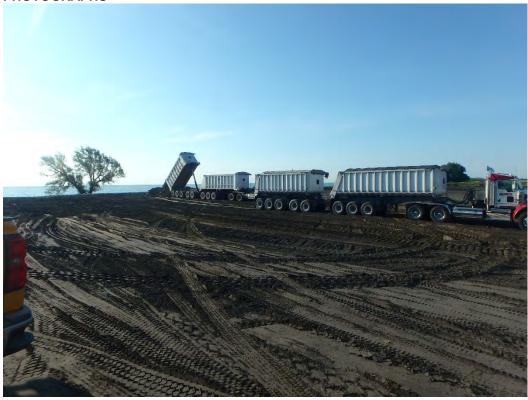
Structural fill delivered to Pond 1 by road trains, looking east.

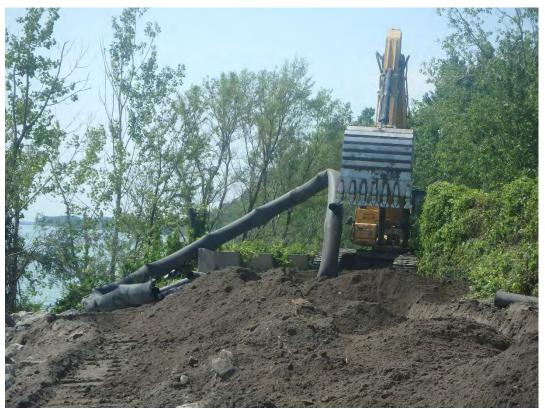
Removing utility pipe from Pond 2 to Chemical Ponds, looking south.
