Project Title: J.R. Whiting Ponds 1 Project Number: 1788523 Date: 6/24/2019

Client: Consumers Energy Site/Location: Erie, MI

and 2 Closure CQA

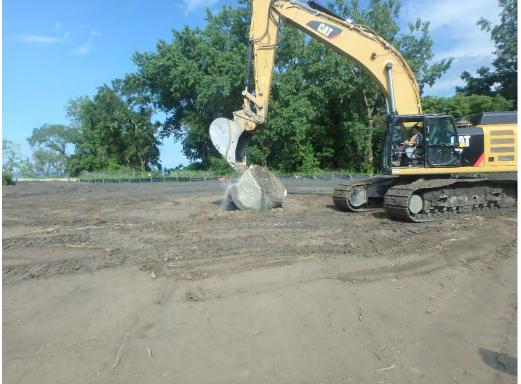
Removing utility pipe crock at the Chemical Ponds, looking east.

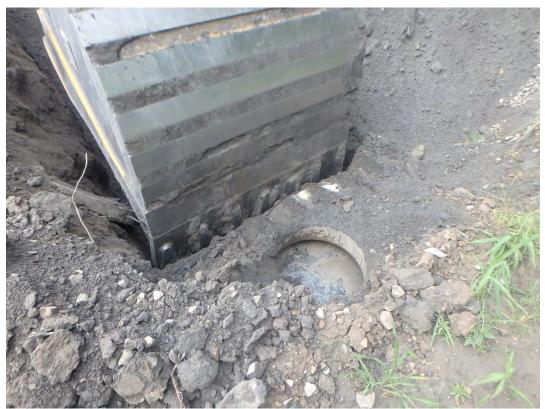
- Golder monitored removal of utility pipe that runs from the southeast corner of Pond 2 to the Chemical ponds using a Cat 349F excavator.
- Golder observed removal of previously unknown manhole and vault southeast of Chemical Pond B
 associated with the utility pipe.

Manhole and crock found in southeast of Chemical Pond B.

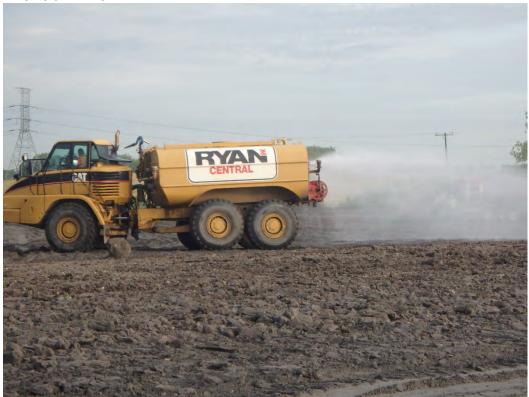
Water truck used to moisture conditioning of placed structural fill and dust control, looking west.

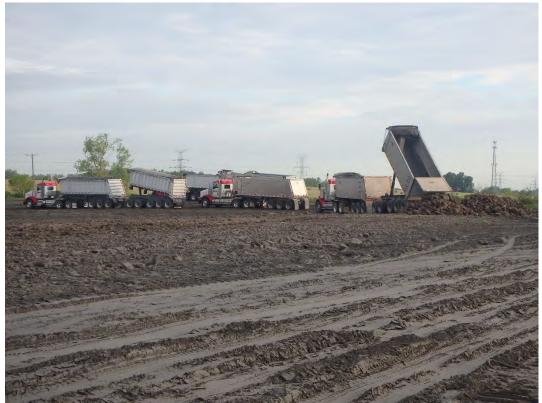
Delivery of structural fill to Pond 1, looking northwest.

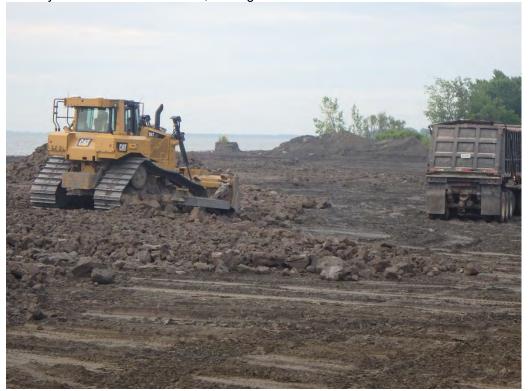
Placing lift of structural fill in Pond 1, looking southeast.

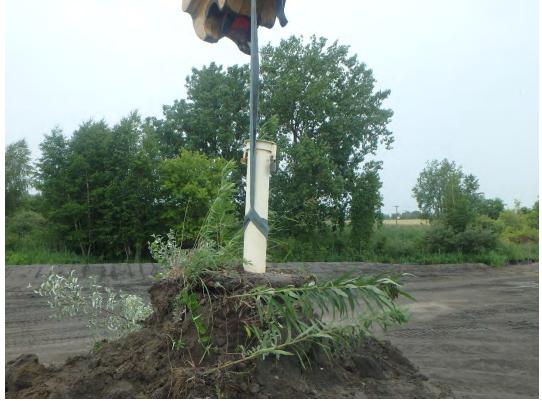
Removing the well casing from MW-15001, looking west.

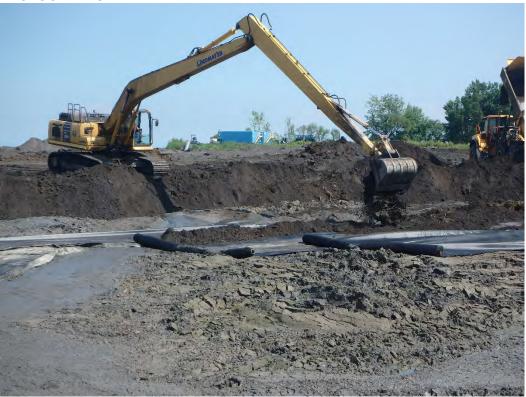
Textile placed prior to bridging layer in Pond 2, looking southeast.

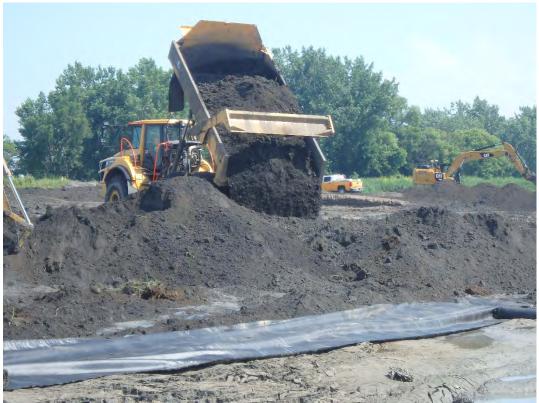
Bridging layer being placed in Pond 2, looking south.

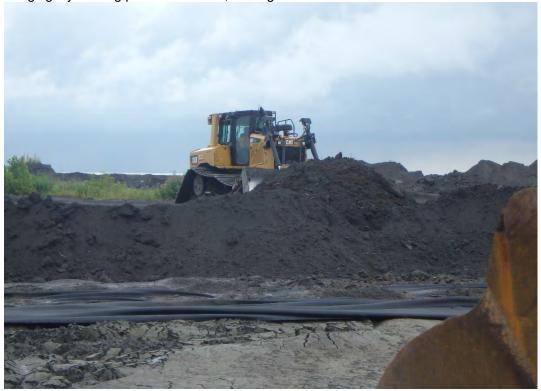
Placing bridging layer over textile in Pond 2, looking west.

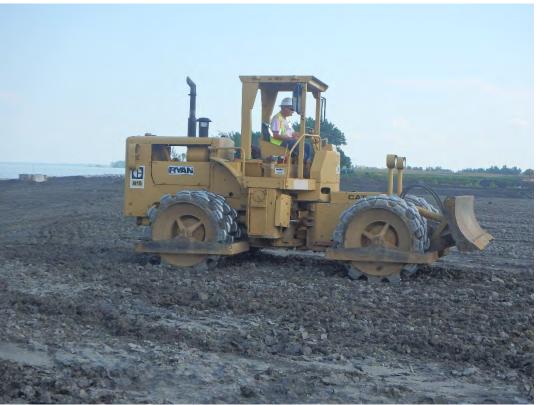
Compacting first lift of structural fill placed in Pond 1, looking south.

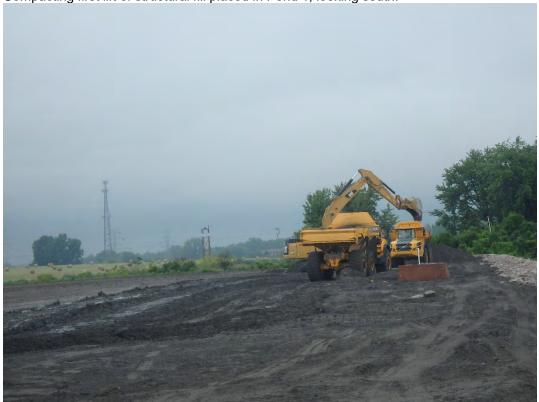
Excavating perimeter road east of Pond 1 down to sub-grade, looking north.

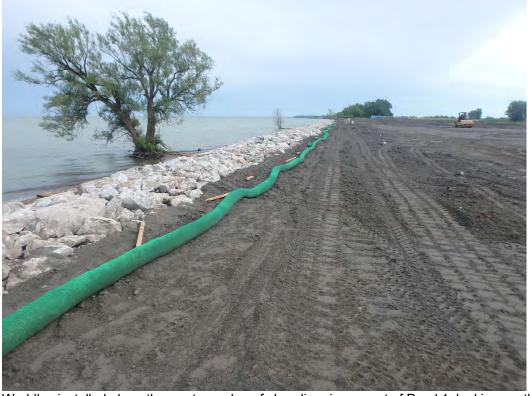
- Golder observed installation of waddles along the western edge of the shoreline riprap east of Pond
 1.
- Golder performed Standard test on Troxler 3440 prior to density testing.

Waddles installed along the western edge of shoreline riprap east of Pond 1, looking south.

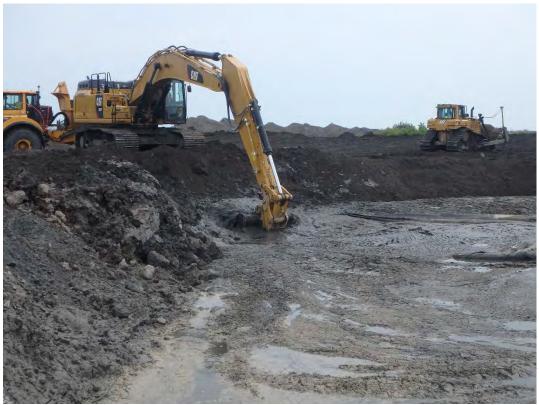
Excavation of saturated material in the northwest corner of Pond 2, looking east.

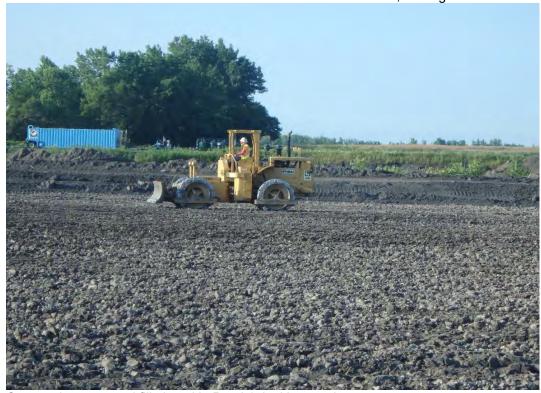
Compacting structural fill placed in Pond 1, looking south.

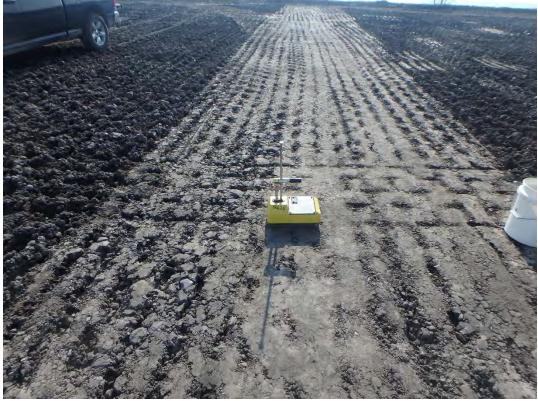
Density test of compacted structural fill in Pond 1, looking east.

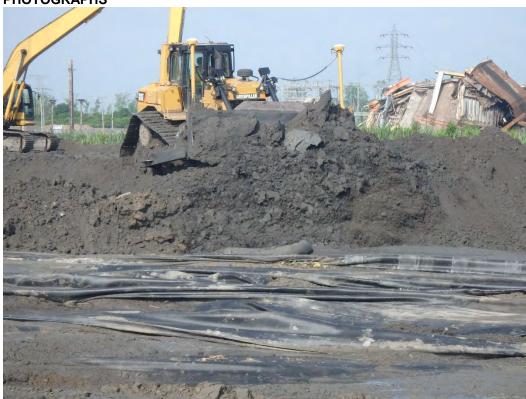
Placement of bridging layer in Pond 2, looking west.

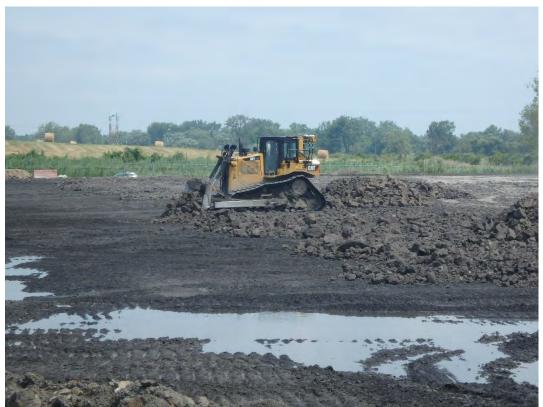
Placement of structural fill lift in Pond 1, looking north.

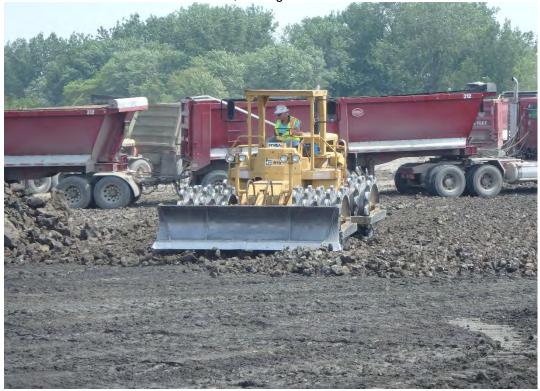
Compacting structural fill placed in Pond 1, looking northeast.

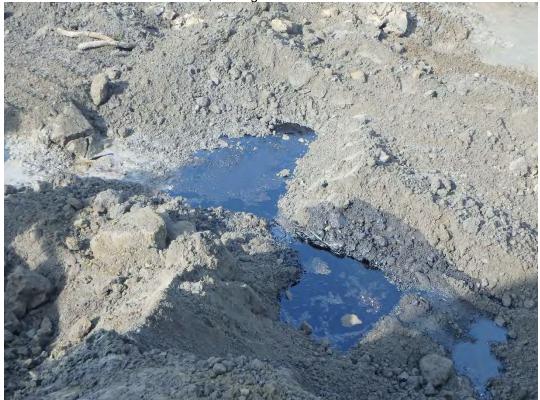
While excavating CCR west of Pond 2 and south of MW-15006 Ryan discovered a pool of liquid that appears to be oil. Also found a second smaller pool about 25 feet north and pool of standing water with oily sheen about 50 feet north. Jeff Yuchasz CEC construction manager was notified and asked how he wanted to proceed, he told Ryan to install containment around the three identified areas, obtain containment vessels for removal of contaminated soils and he would contact CEC for further direction.

Pool of suspect liquid that appears to be oil in cut west of Pond 2, looking west.

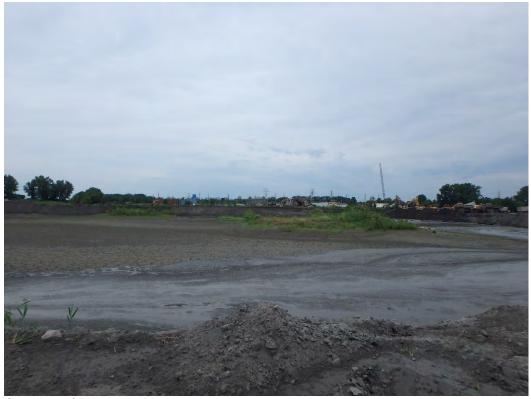
Overview of Pond 2, looking west.

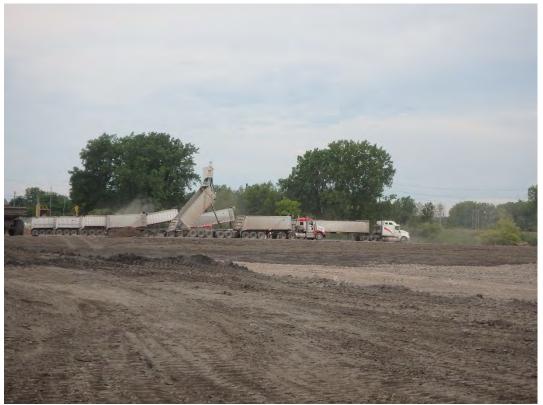
Delivery of structural fill to Pond 1, looking west.

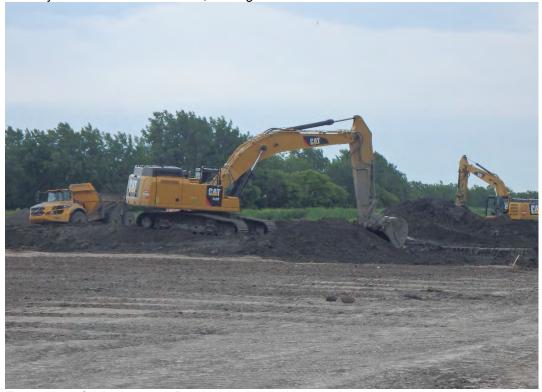
Excavation of dyke between Ponds 1 and 2, looking south.

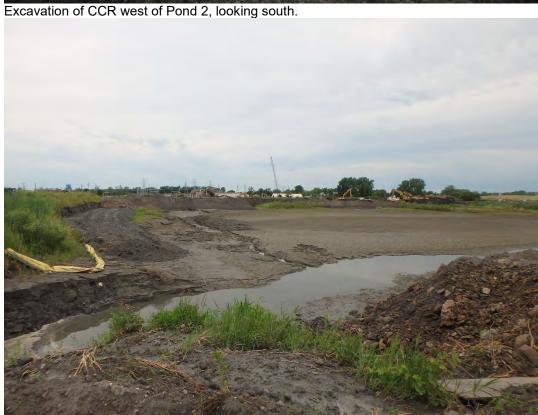
Overview of Pond 2, looking northwest.

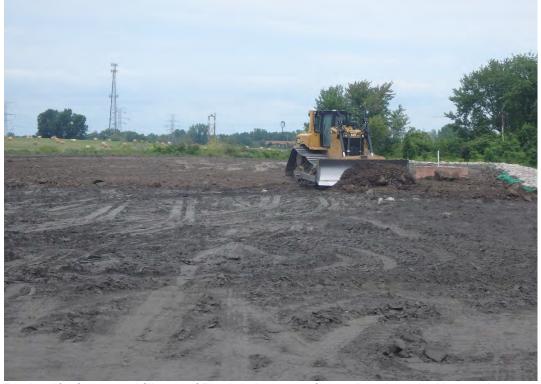
Placing lift of structural fill east of Pond 1 along top of shoreline slope, looking north.

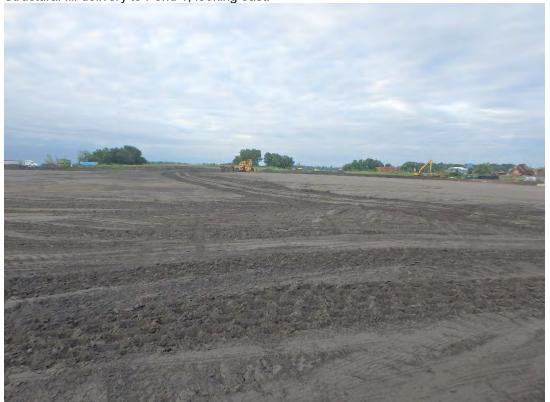
Overview of Pond 1 with single lift of structural fill, looking southwest.

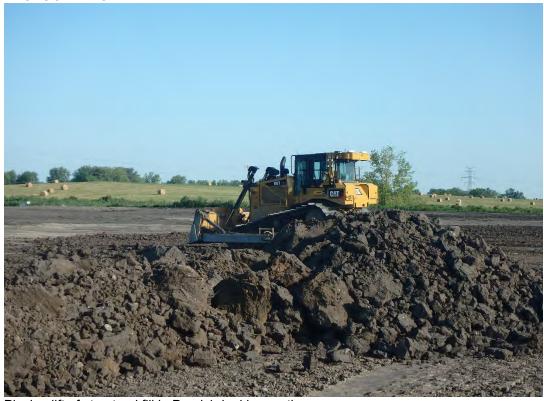
Placing lift of structural fill in Pond 1, looking north.

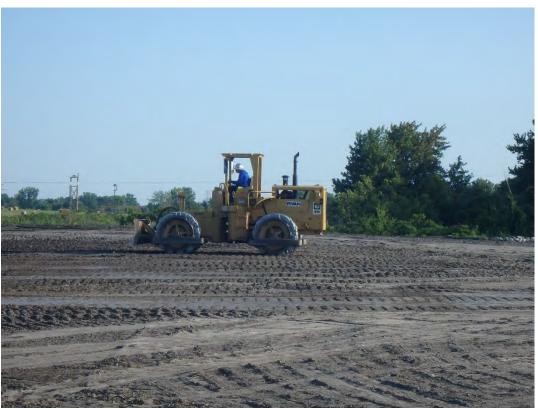
815 compacting placed structural fill in Pond 1, looking north.

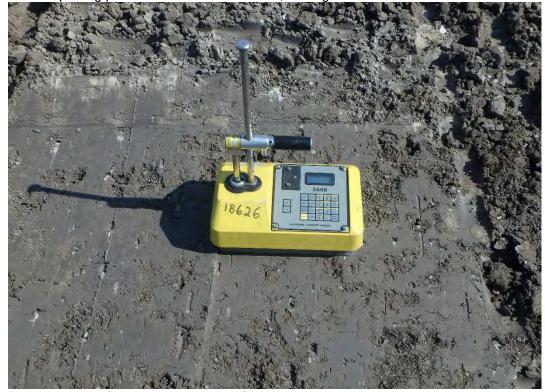
Density testing of compacted structural fill in Pond 1.

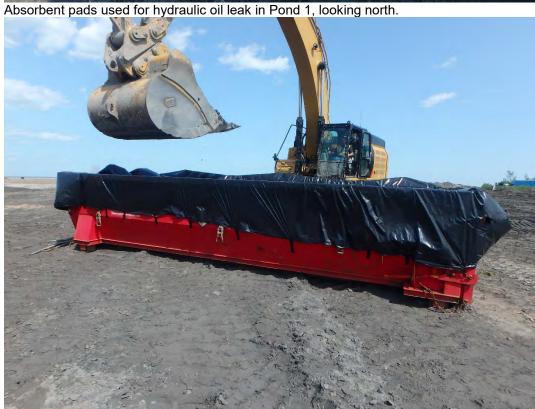
Lined dumpster used for disposal of contaminated soils excavated west of Pond 2, looking east.

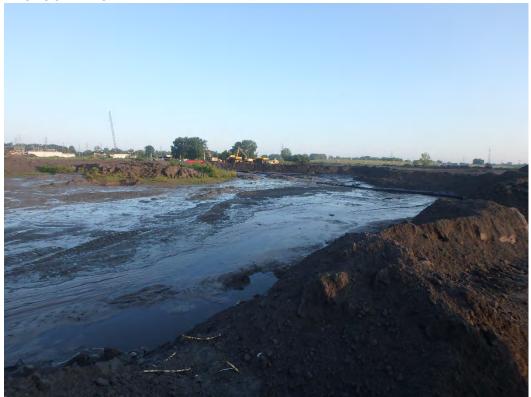
Overview of northeast corner of Pond 2, looking northwest.

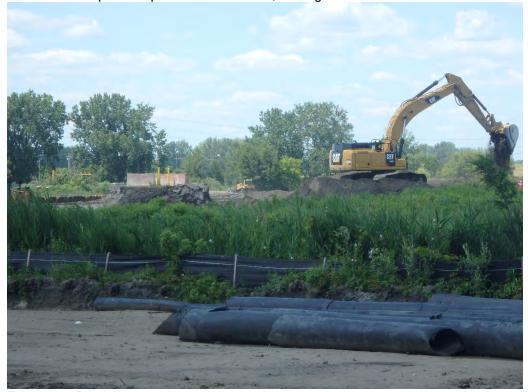
Structural fill import and placement in Pond 1, looking northeast.

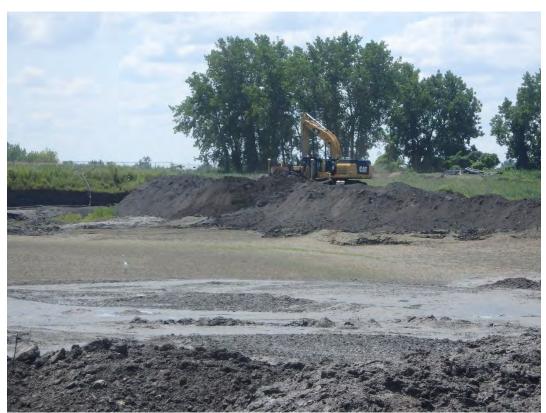
Excavating Pond 2's west dike, looking northwest.

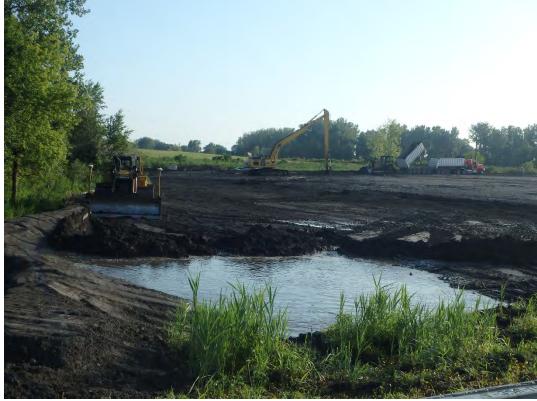
Bridging layer in Pond 2, looking south.

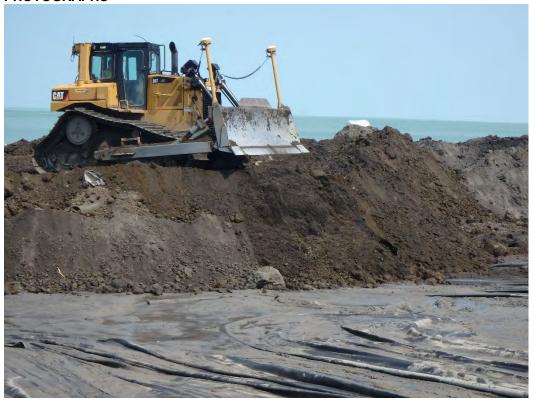
Placing bridging layer in Pond 2, looking east.

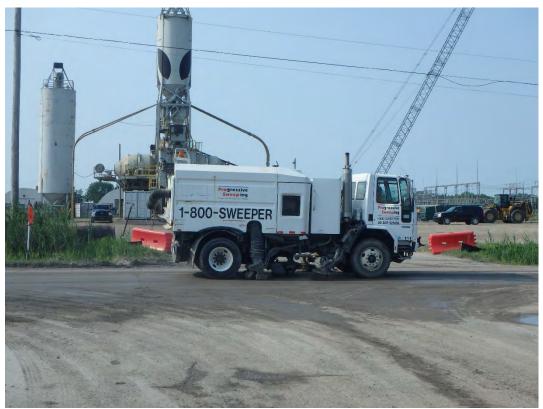
Sweeper to maintain Erie Rd., looking south.

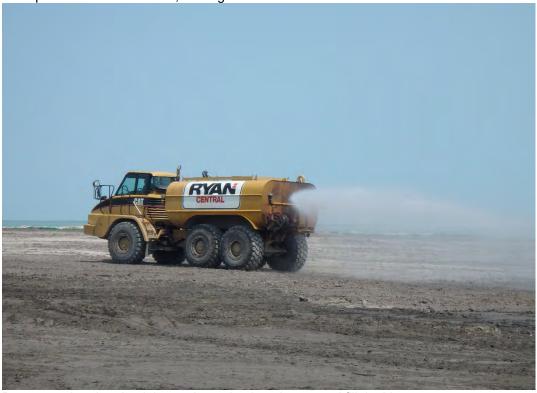
Dust control and maintaining moisture in placed structural fill, looking east.

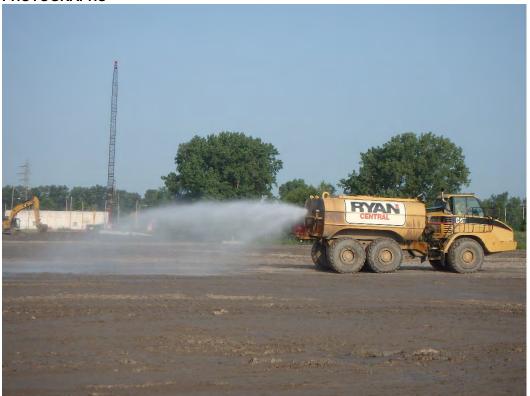
Dust control and moisture maintenance of fill placed in Pond 1, looking west.

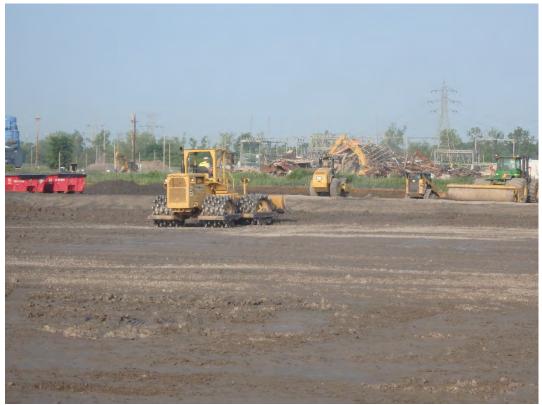
Compacting structural fill placed in Pond 1, looking southwest.

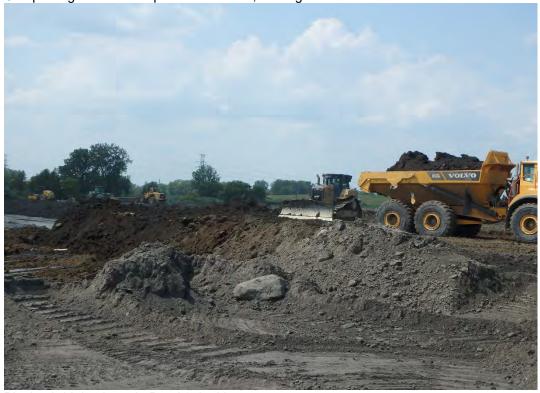
Placing bridging layer in Pond 2, looking west.

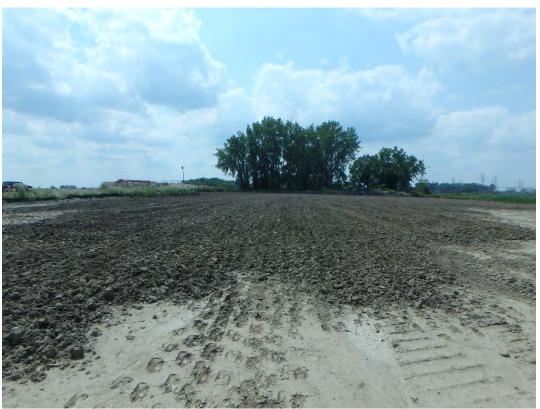
Overview of compacted structural fill at the Chemical Ponds, looking west.

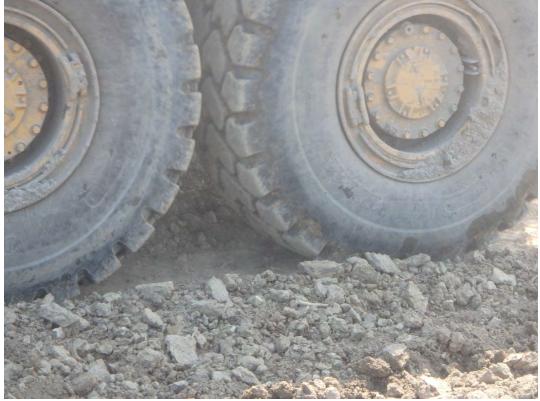
Proof roll of structural fill at the Chemical Ponds.
