**PROJECT OVERVIEW**

Project Title: J.R. Whiting Ponds 1 Project Number: 1788523 Date: 7/27/2019

and 2 Closure CQA

Client: Consumers Energy Site/Location: Erie, MI

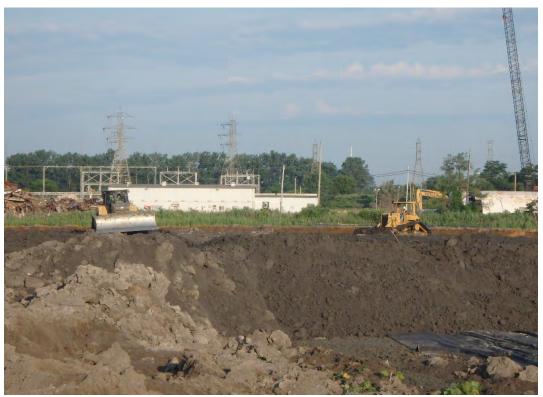
Placing structural fill in Pond 1, looking north.

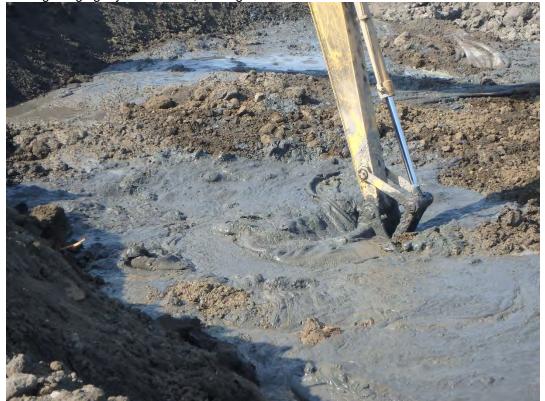
Placing bridging layer in Pond 2, looking west.

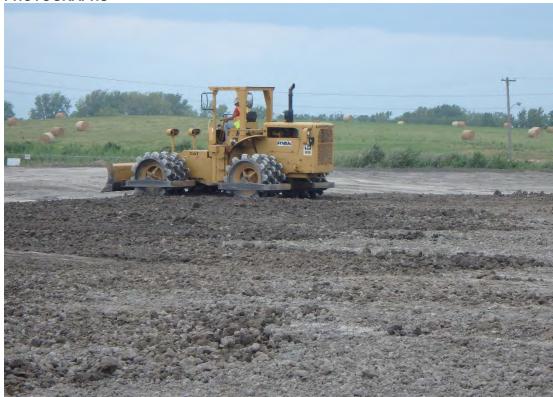
Compacting lift of structural fill in Pond 1, looking north.

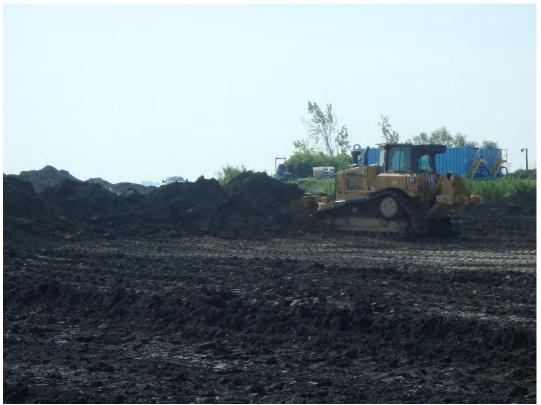
Placing bridging layer in Pond 2, looking southeast.

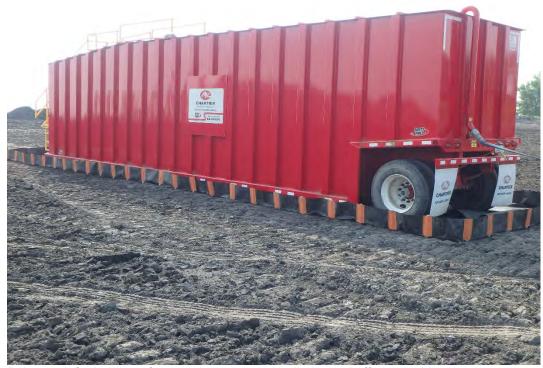
Baker tank for holding of contaminated water until disposal off-site, looking southeast.

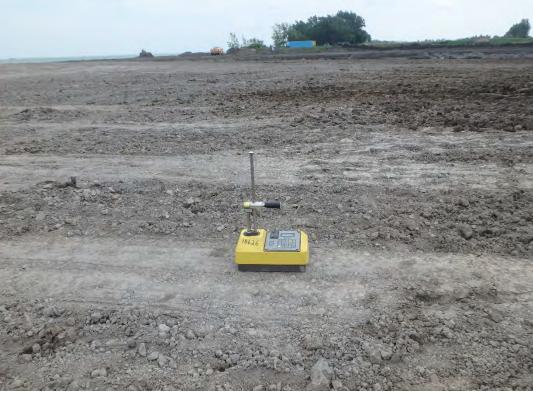
Density testing compacted lift of structural fill in Pond 1, looking south.

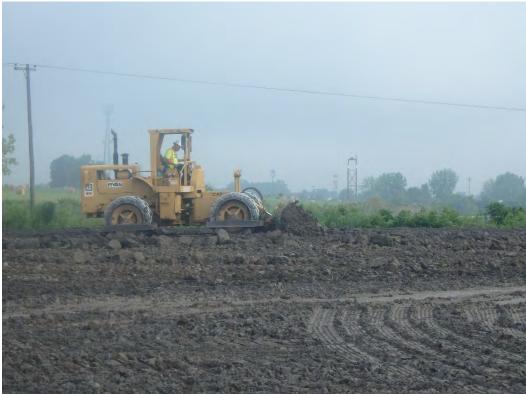
Compacting lift of structural fill in Pond 1, looking north.

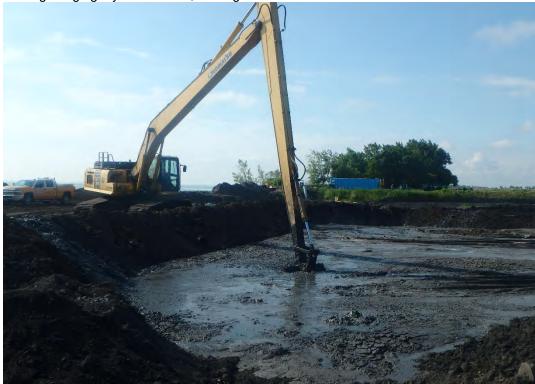
Removing saturated CCR from the northeast corner of Pond 2, looking southeast.

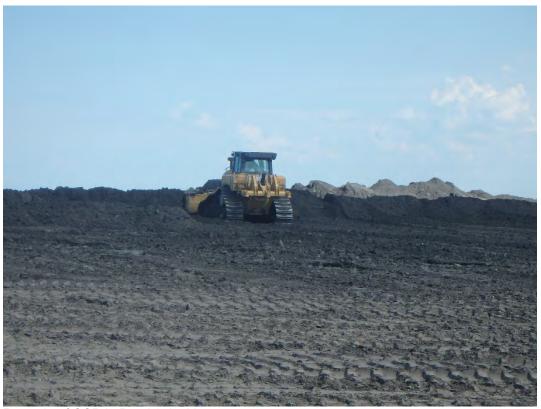
Regrade of CCR in Pond 2, looking east.

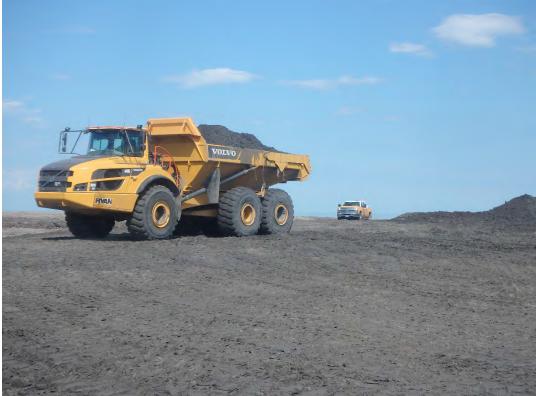
CCR excavated from south dike being placed in Pond 2 for bridging layer, looking east.

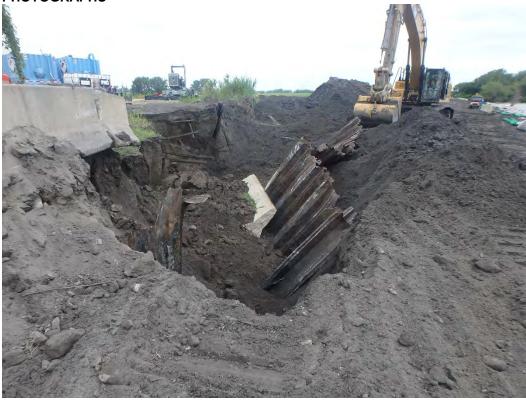
Removing sheet pylon east of Pond 2 and discharge channel, looking north.

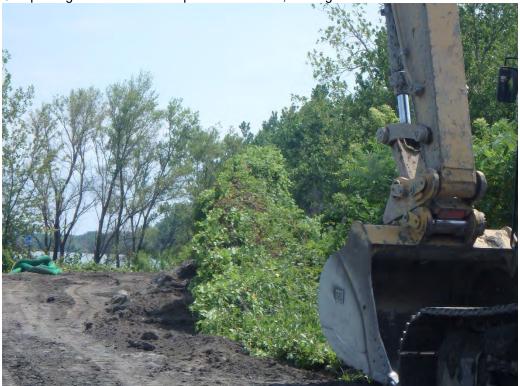
Removing fence along east side of discharge channel, looking south.

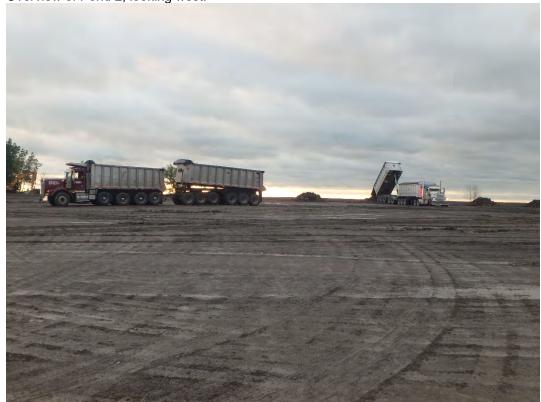
Structural fill import for Pond 1, looking east.

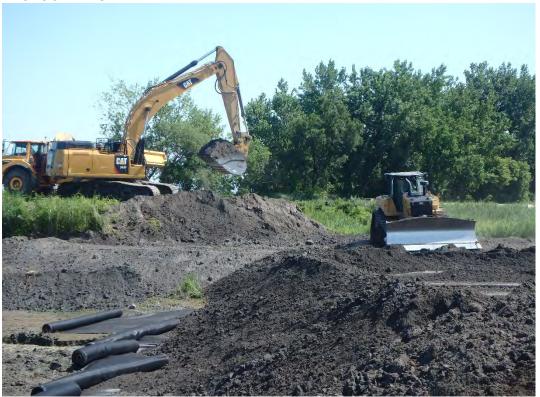
Excavation of Pond 2's south dike, looking southeast.

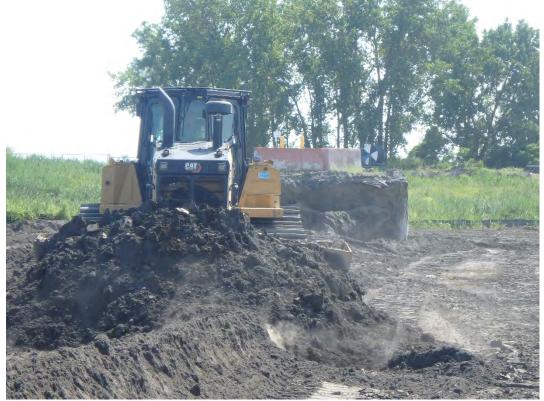
Placement of bridging layer in Pond 2, looking south.

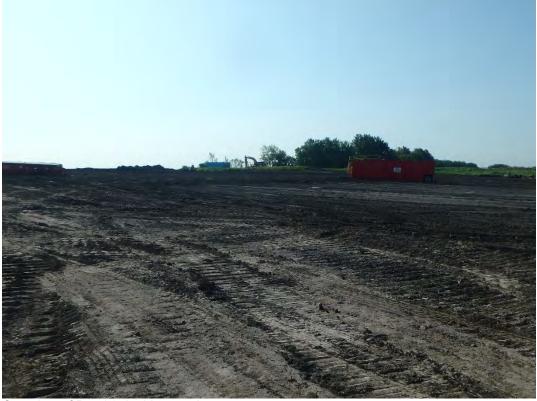
Overview of Pond 2, looking southwest.

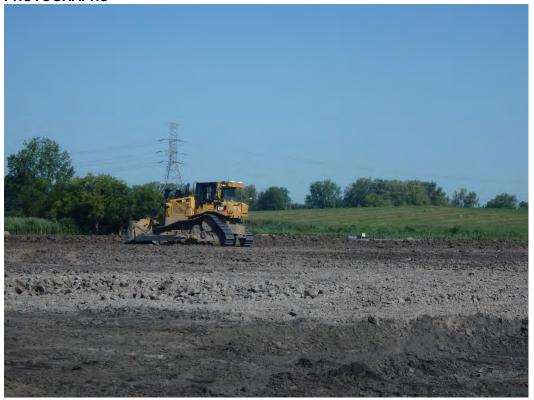
Placement of structural fill in Pond 1, looking north.

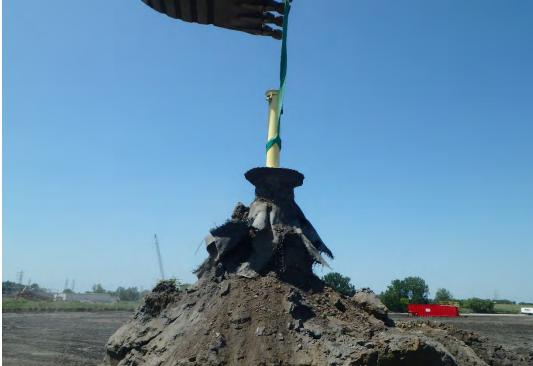
Removing protective casing from MW-15005, looking north.

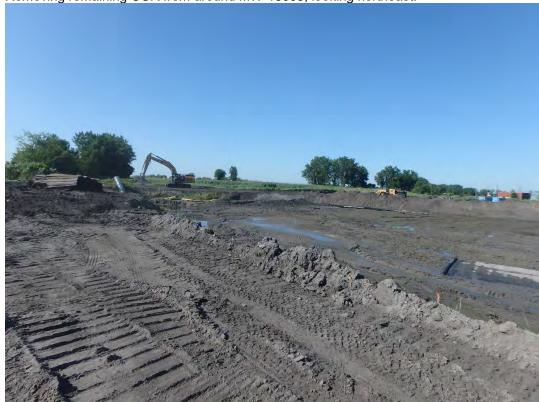
Excavation of Pond 2's south dike, looking south.

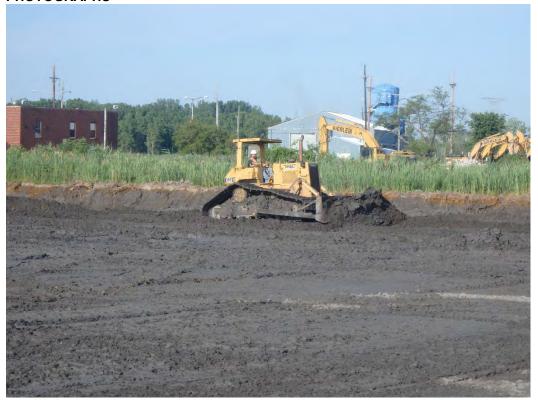
Re-grading of CCR in Pond 2, looking southwest.

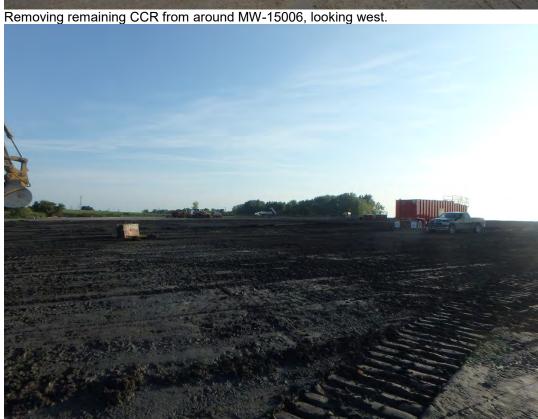
Overview of Ponds 1 and 2, looking northeast.

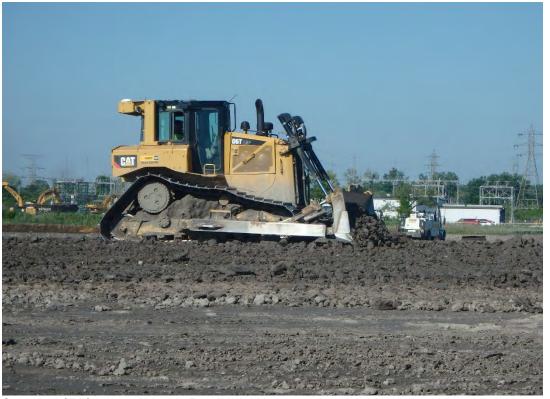
Structural fill lift being placed in Pond 1, looking west.

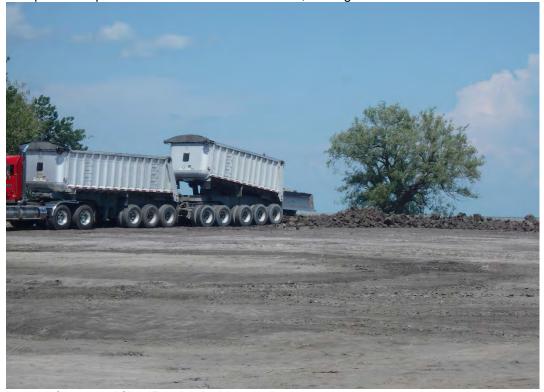
Import of structural fill to Pond 1, looking northeast.

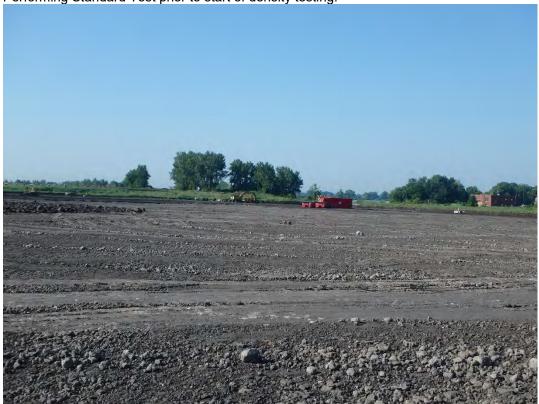
Overview of Pond 2, looking southwest.

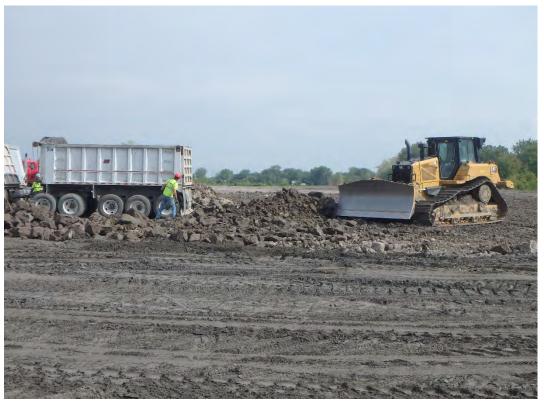
Structural fill lift being placed in Pond 1, looking west.

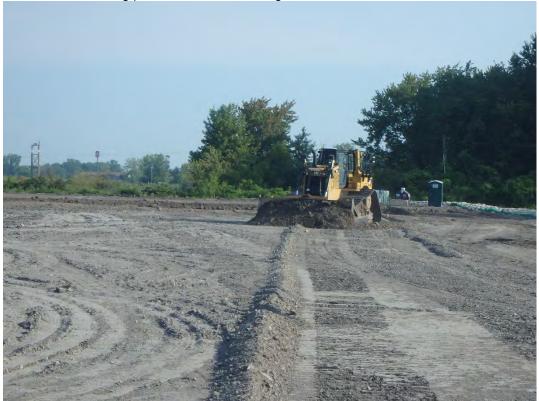
Cutting placed and compacted structural fill in Pond 1 to liner sub-grade, looking north.

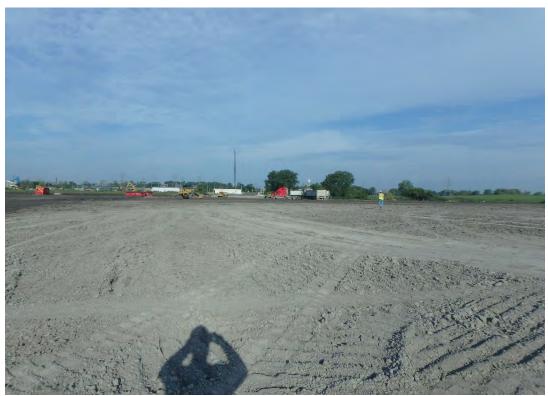
Overview of Pond 1, looking north.

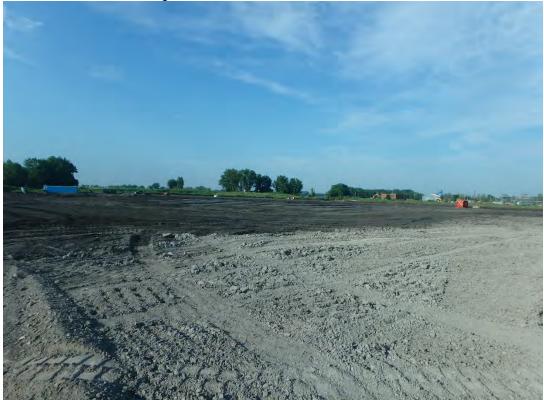
Overview of Pond 2, looking southwest.

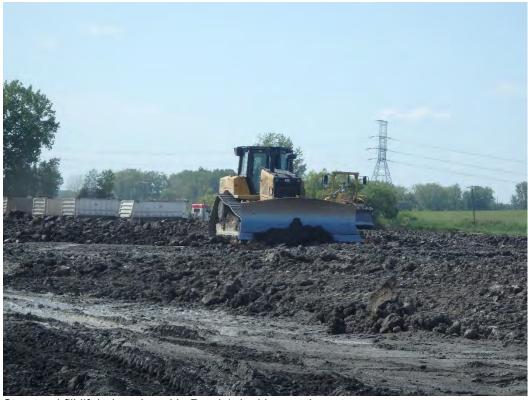
Structural fill lift being placed in Pond 1, looking northwest.

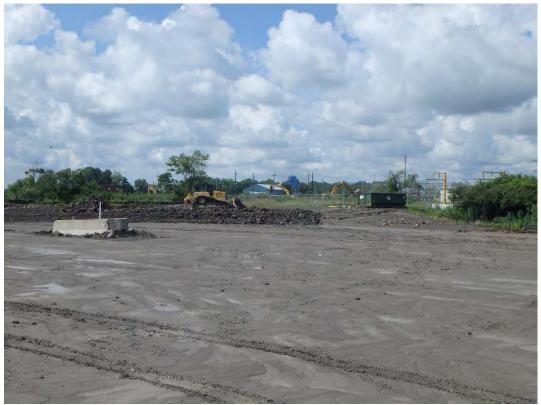
Constructing temp access road to west gate for imports, looking southwest.

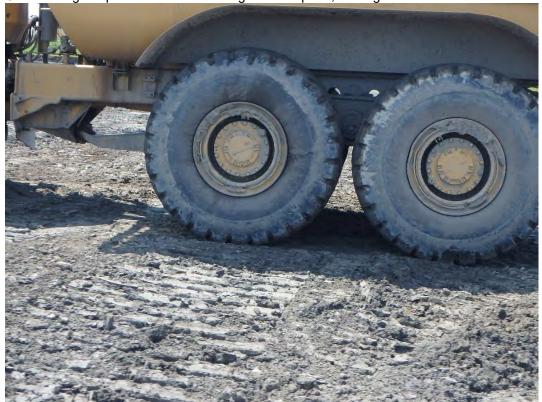
Proof rolling of bridging layer in Pond 2.

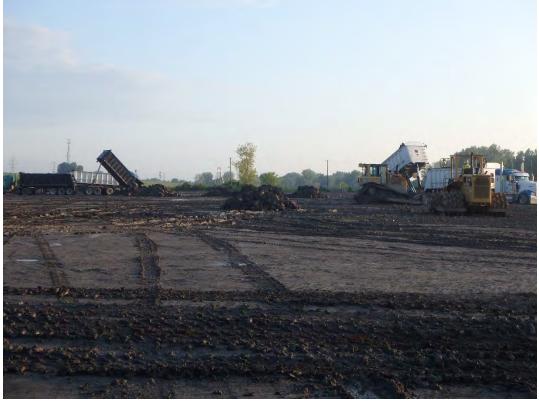
Structural fill import to Pond 1, looking north.

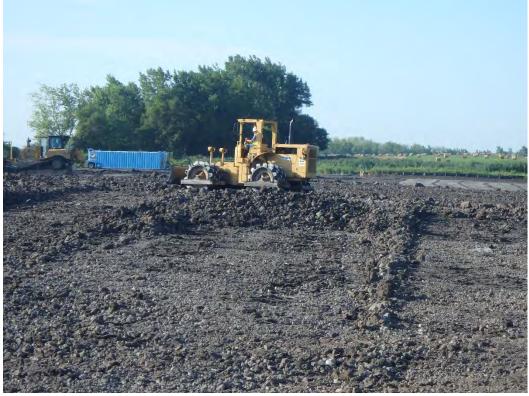
Compacting lift of structural fill in Pond 2, looking south.

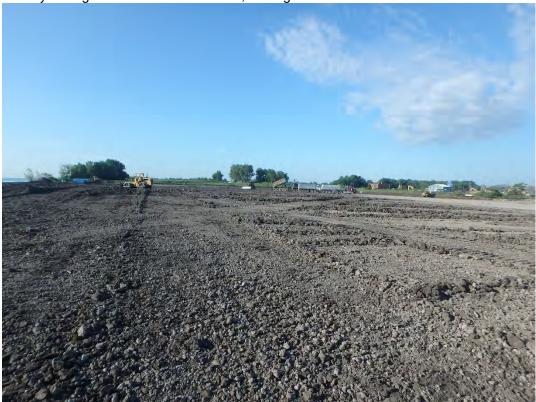
Overview of Pond 1, looking south.

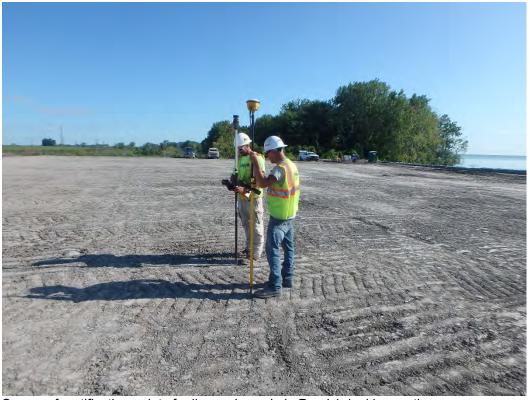
Survey of certification points for liner sub-grade in Pond 1, looking north.

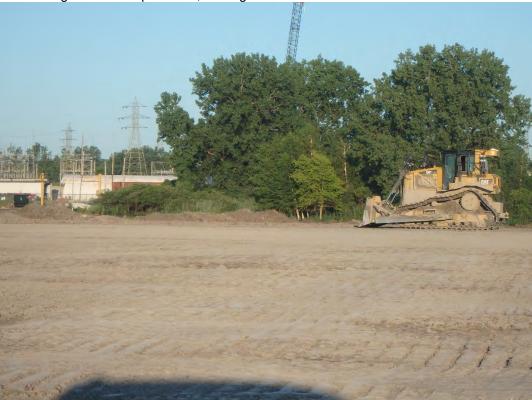
Finish grading of liner sub-grade in Pond 1, looking west.

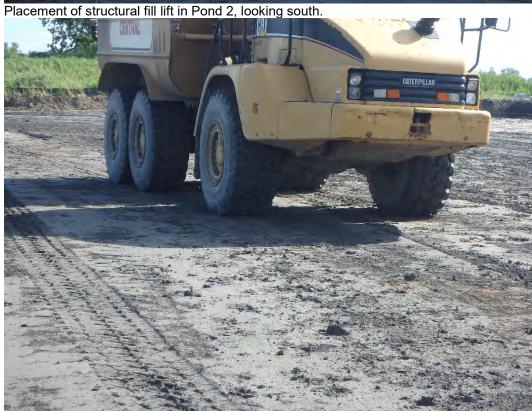
Proof roll of bridging layer in Pond 2, looking south.

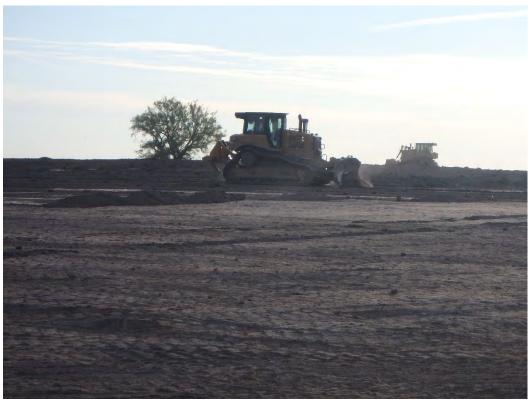
Finish grading structural fill in Pond 1, looking northeast.

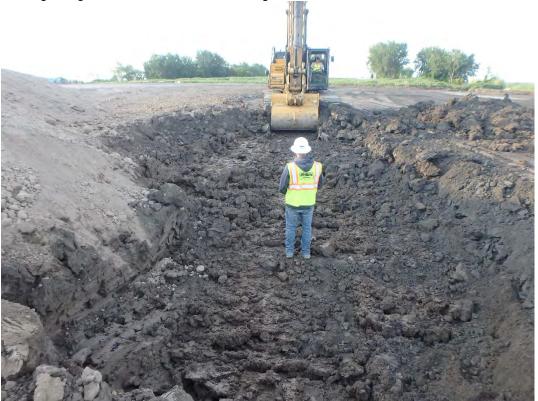
- Continued finish grading of structural fill placed in Pond 1.
- Over-Excavated soft spot in Pond 2 bridging layer and backfilled with dry material.
- Water truck for dust control and fill moisture.

Over-ex of soft spot in bridging layer of Pond 2, looking south.

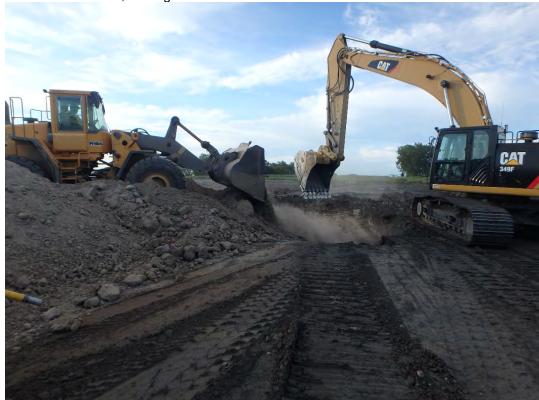
Backfill of over-ex in Pond 2, looking south.

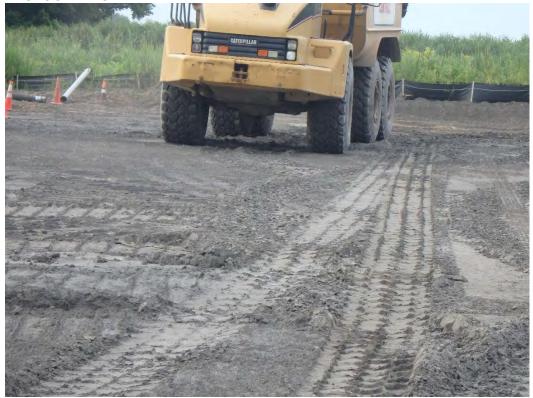
Proof roll of additional area of Pond 2 bridging layer, looking south.

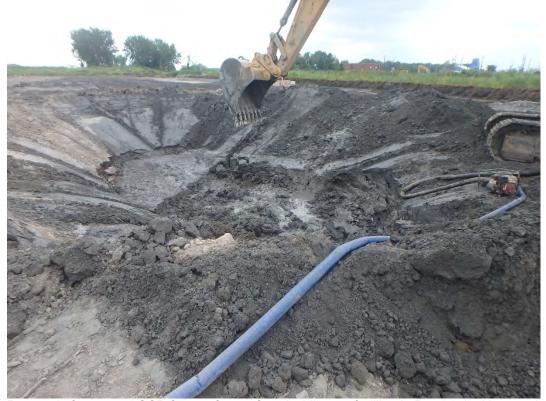
Removal of saturated CCR from soft area found while proof rolling in Pond 2, looking southwest.

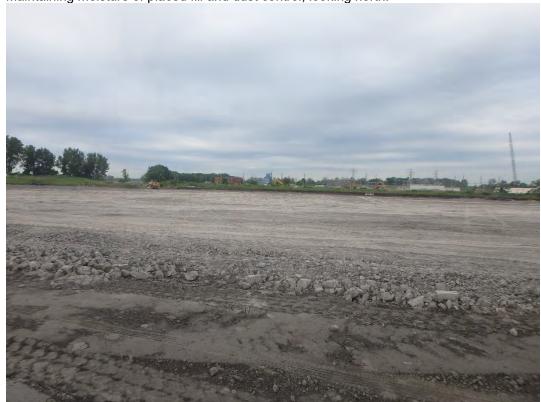
Overview of Pond 1, looking north.

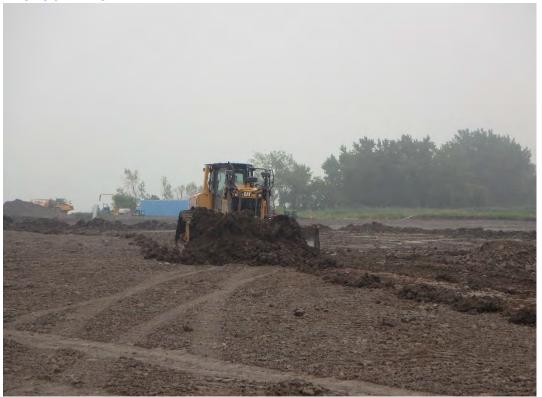
Dressing access road to Pond 2, looking southeast.

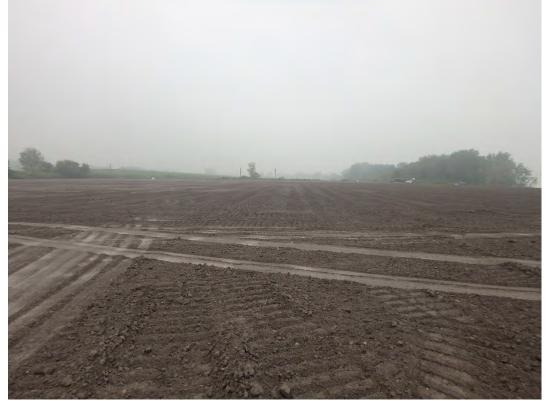
Overview of Pond 1, looking north.

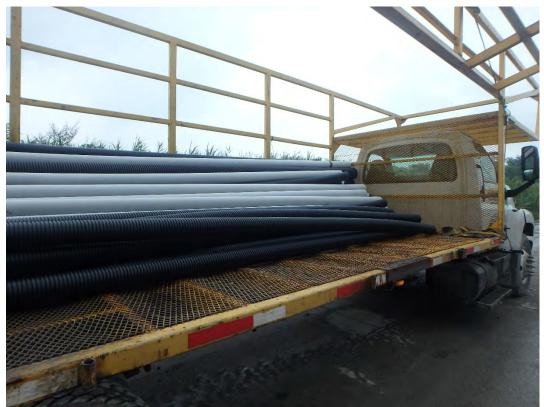
4 inch ADS pipe for above-cap drainage system.

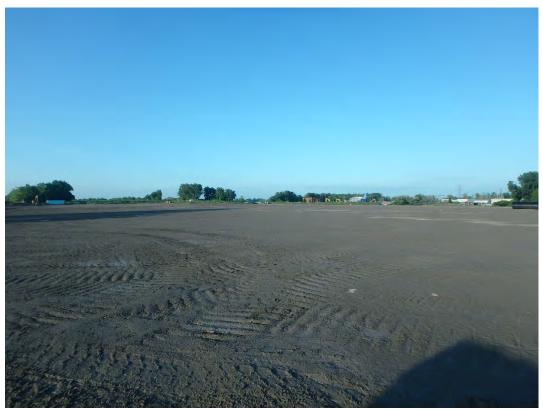
Overview of Pond 1, looking southwest.

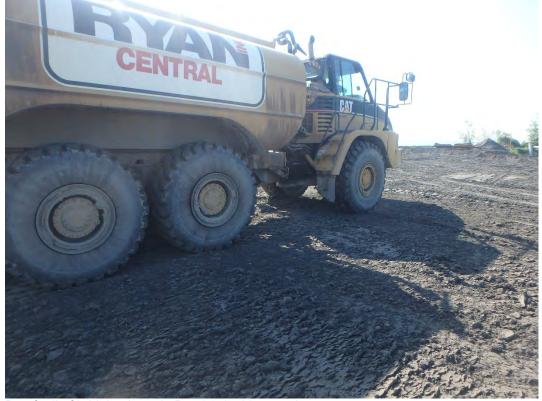
Proof roll of bridging layer in Pond 2, looking southeast.

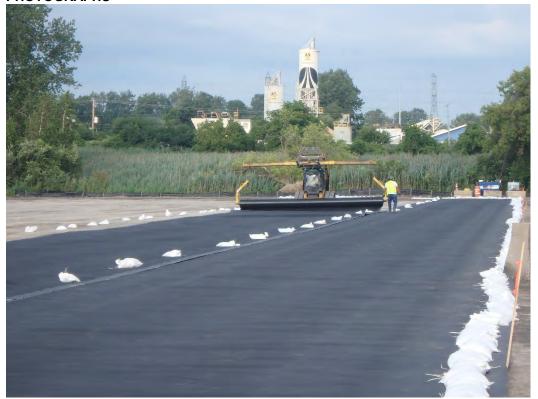
Deployment of 40mil geomembrane in Pond 1, looking west.

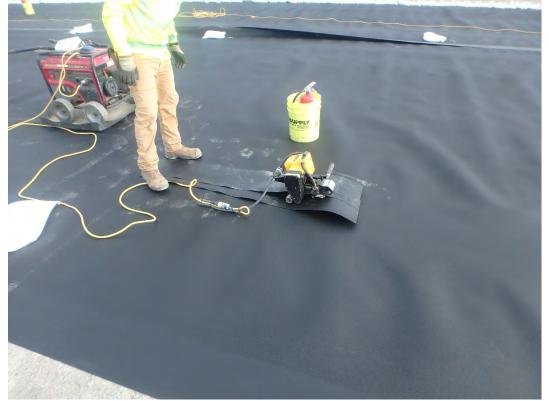
Producing trial weld for field testing.

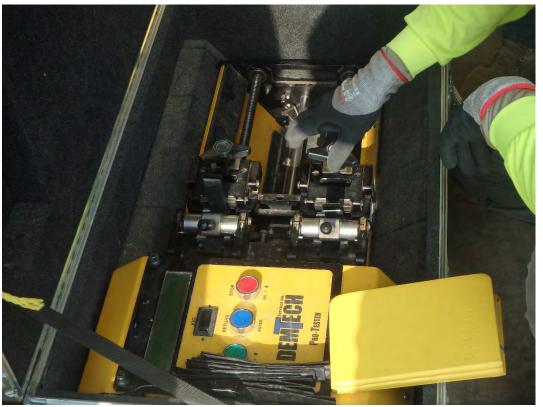
Testing of trial weld prior to start of seaming.

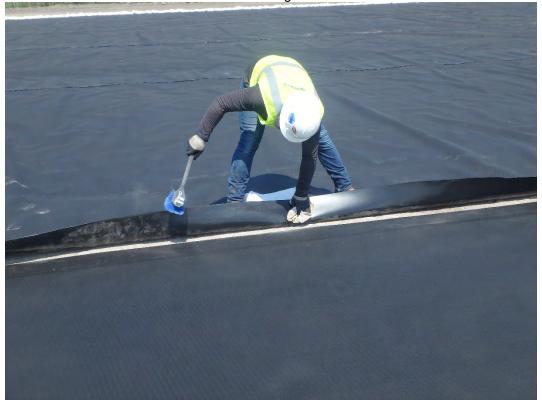
Cleaning liner overlap ahead of fusion seaming device.

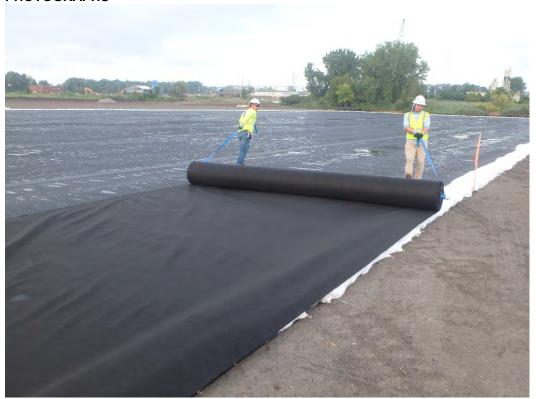
Deployment of 8oz. geotextile in Pond 1, looking west.

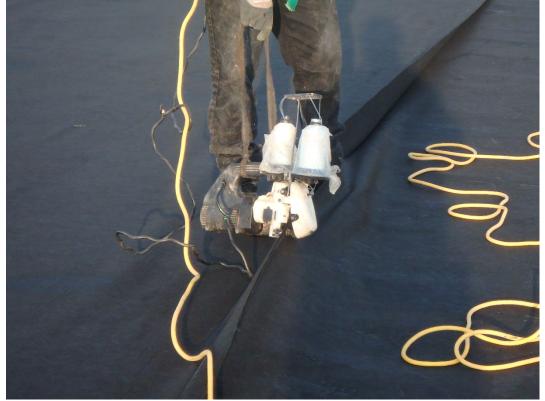
Sewing geotextile seam.

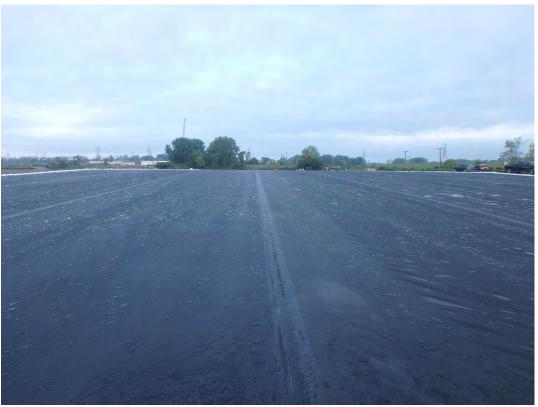
Overview of geomembrane deployed in Pond 1, looking west.

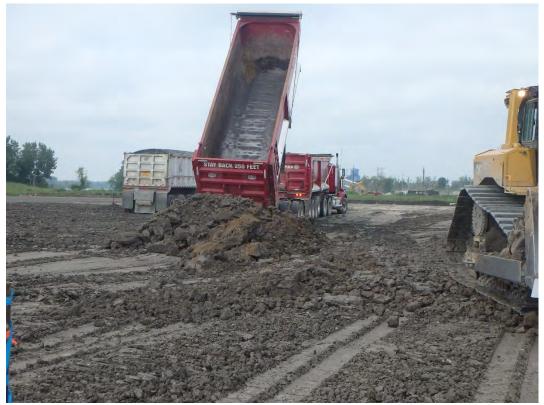
Structural fill import to Pond 2, looking west.

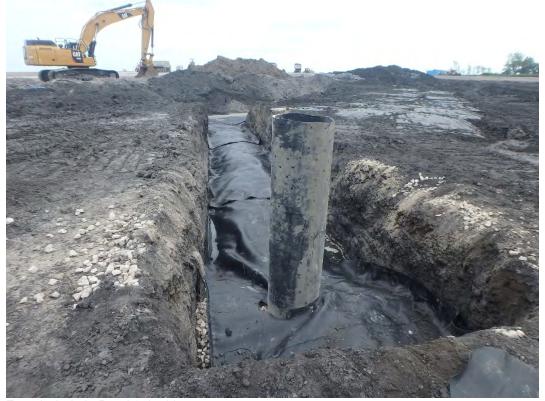
- Golder observed installation of a French Drain in Pond 2 to dewater soft area found during proof roll.
- Performed CQA oversight and documentation on geomembrane installation.

French drain in Pond 2, looking east.

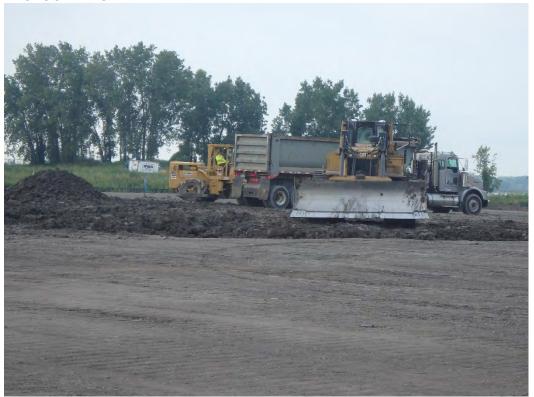
Placing structural fill lift in Pond 2, looking southwest.

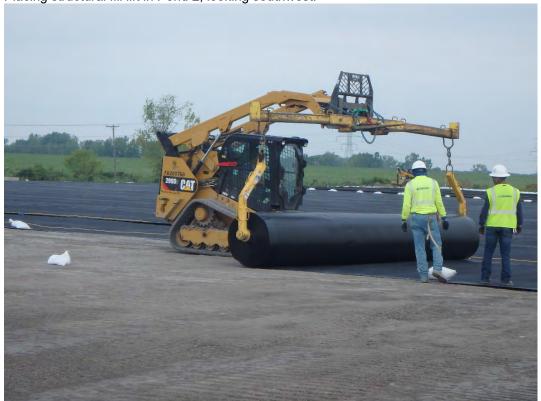
Deploying geomembrane in Pond 1, looking north.

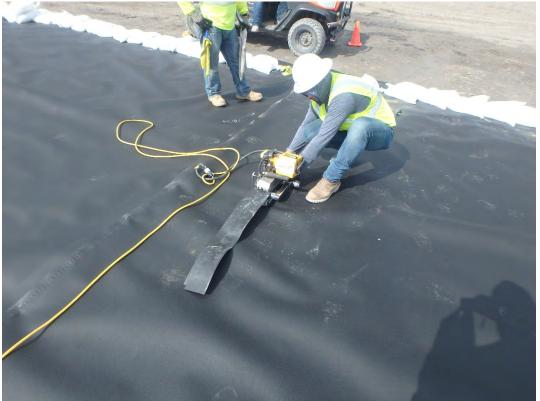
Fusion trial weld.

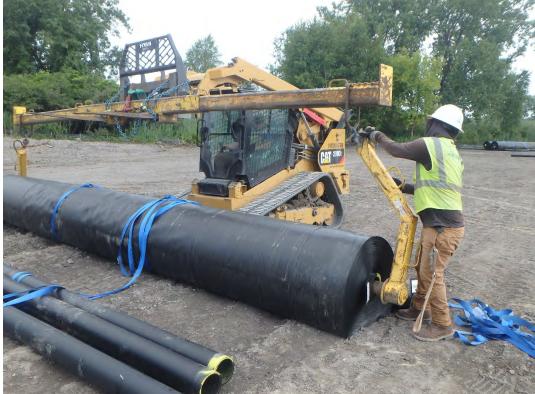
Preparing to deploy liner, looking northwest.
