PROJECT OVERVIEW

Project Title: J.R. Whiting Ponds 1 Project Number: 1788523 Date: 6/24/2019

Client: Consumers Energy Site/Location: Erie, MI

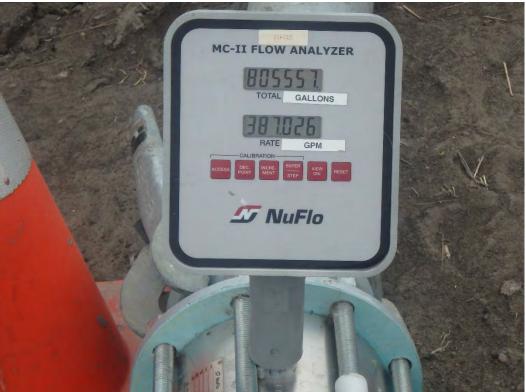
Discharge flowmeter on dewatering system in Pond 2.

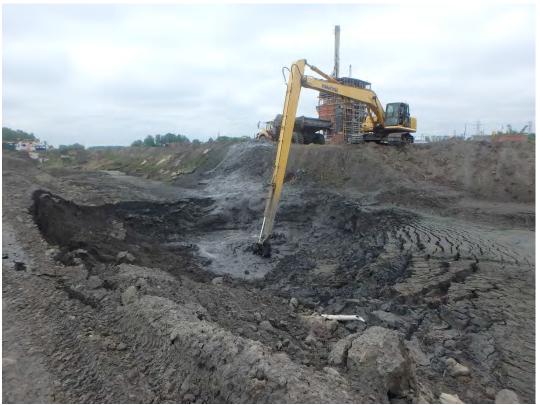
Over-Ex of saturated material from west side of Pond 1, looking south.

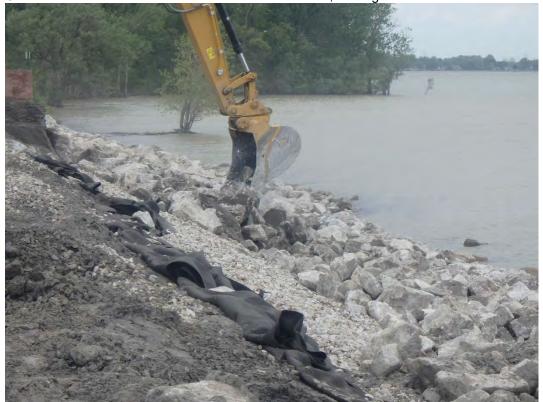
Placement of D50/30 inch riprap along shoreline, looking north.

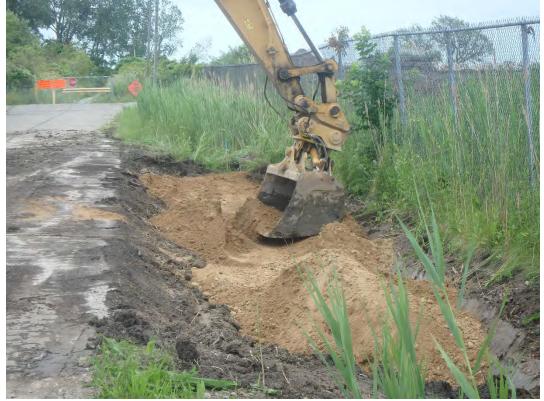
Placement of culvert bedding material, looking east.

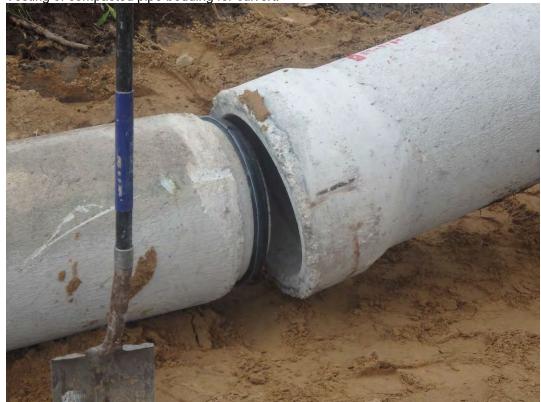
Installation of 12 inch RCP for access road culvert.

Ryan superintendent and Golder CQA met with the Monroe County Road Commission Inspector to check the culvert ditch and installed 12 inch RCP for approval for backfilling of the ditch and culvert. Inspector said we could proceed with backfilling and construction of the new access road, he also reminded Ryan they were responsible to repair cracks to the existing road caused by construction equipment used to excavate ditch and any additional damage that may be caused during construction of the access road.

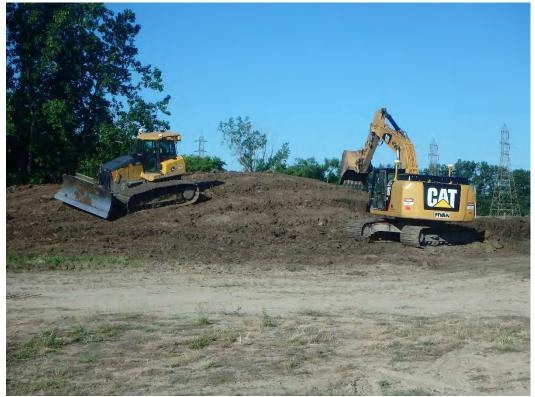
On-site structural fill stockpile stripped of vegetation, looking southwest.

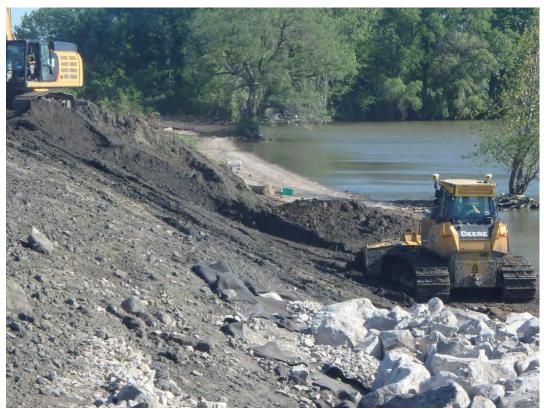
Grading shoreline slope, looking north.

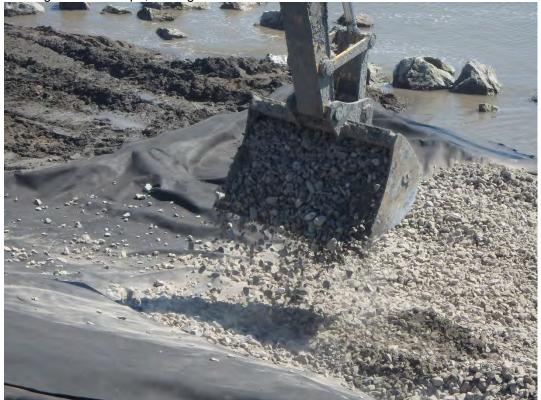
Placement of D50/2 inch cushion layer along shoreline, looking east.

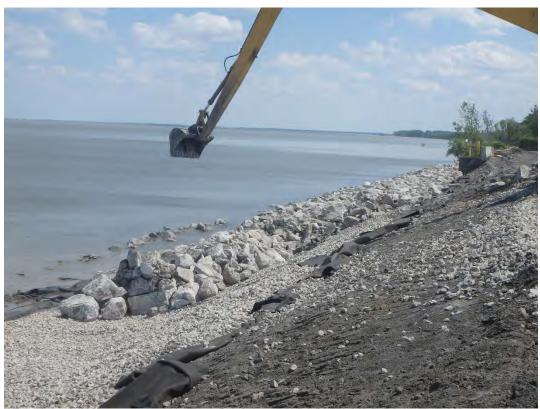
Placement of D50-30 inch riprap along shoreline, looking southeast.

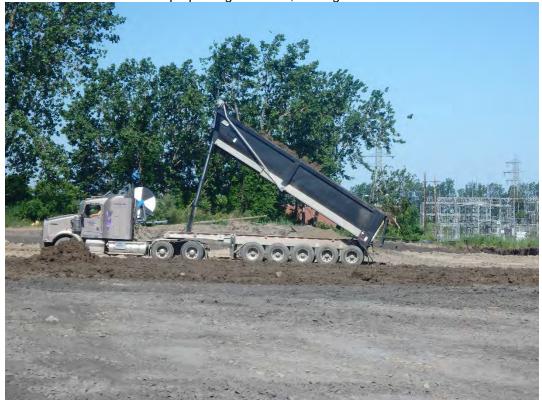
Structural fill hauled to chemical ponds, looking southeast.

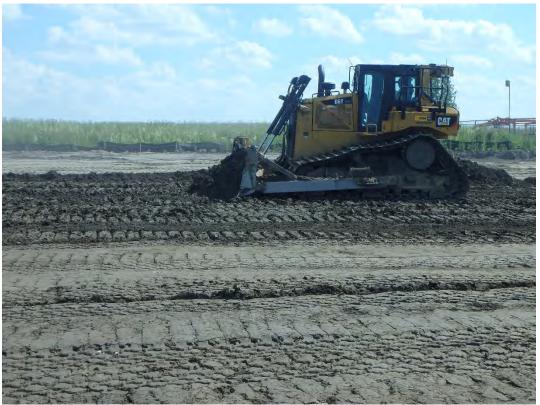
Placement of 12 inch loose lift of structural fill at chemical ponds, looking south.

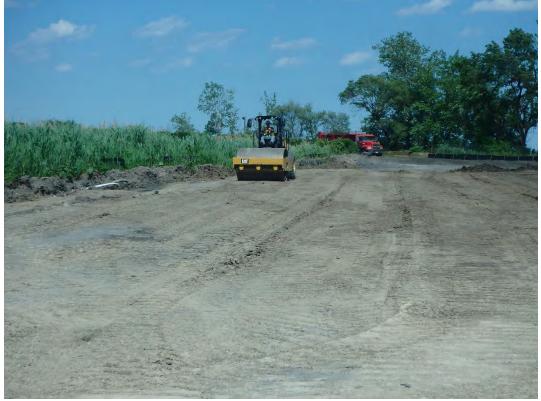
Compaction of placed structural fill at chemical ponds, looking east.

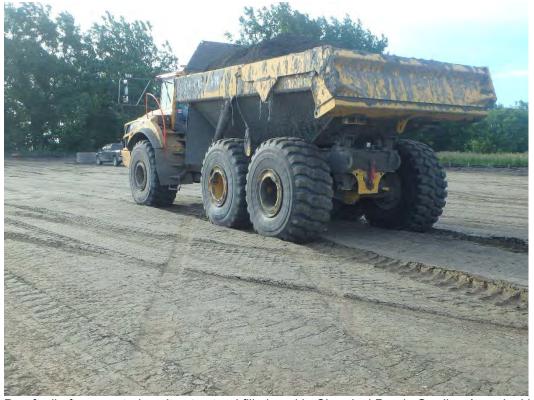
Proof roll of compacted onsite structural fill placed in Chemical Ponds Grading Area, looking west.

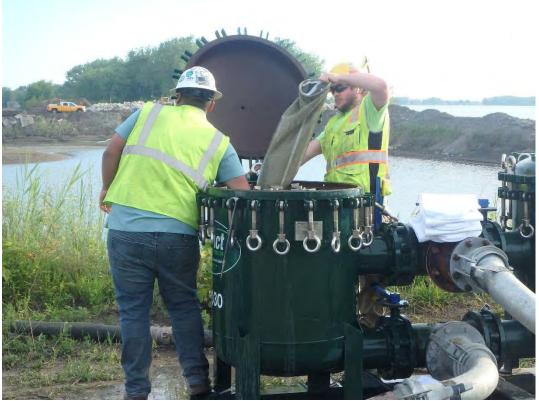
Filter change on the dewatering system for Pond 2, looking northeast.

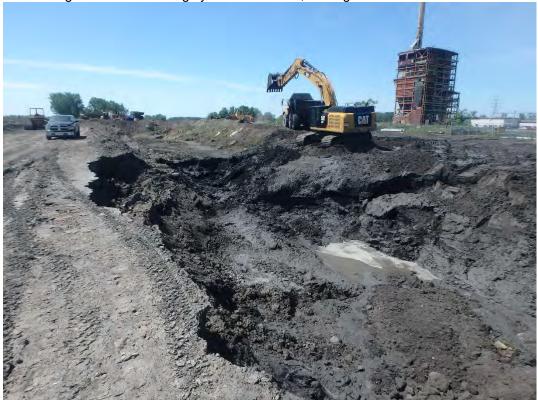
Removal of saturated material from along the west side of Pond 1, looking south.

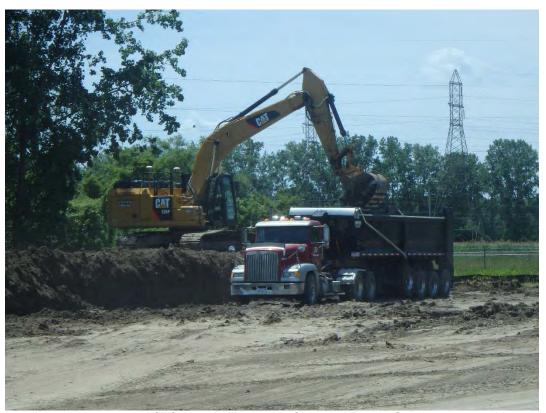
Loading onsite structural fill for stockpiling in the Chemical Ponds Grading area, looking west.

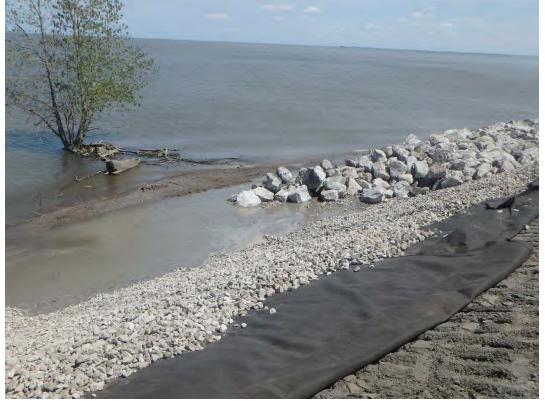
Geotextile and D50/2 inch cushion layer along shoreline, looking southeast.

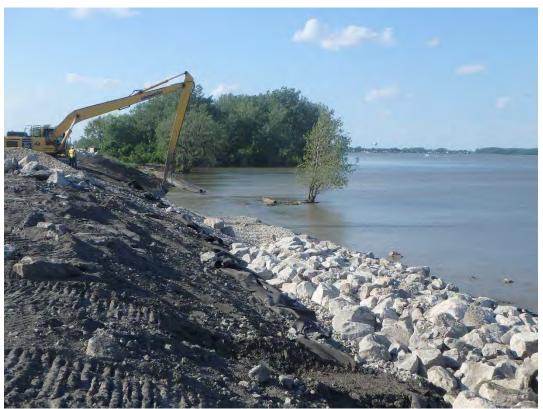
Placement of D50/30 inch riprap along shoreline, looking north.

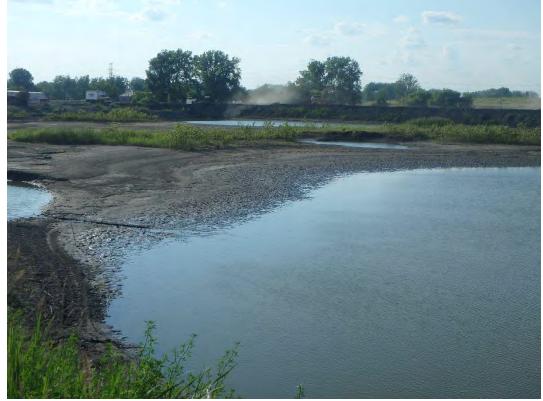
Overview and water level of Pond 2, looking northwest.

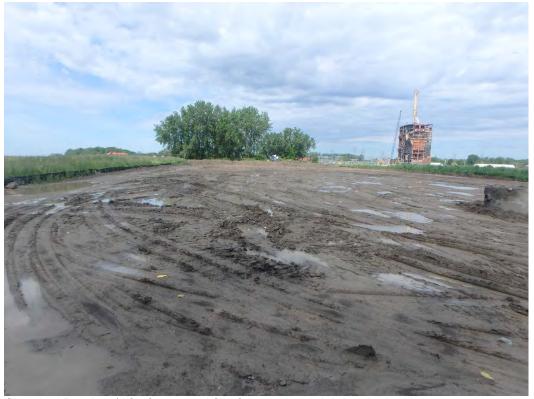
Chemical Ponds 1st lift of structural fill after previous night's rain, looking west.

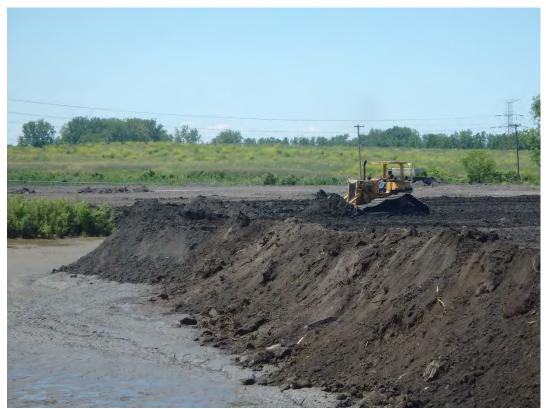
Placing bridging layer in Pond 1, looking north.

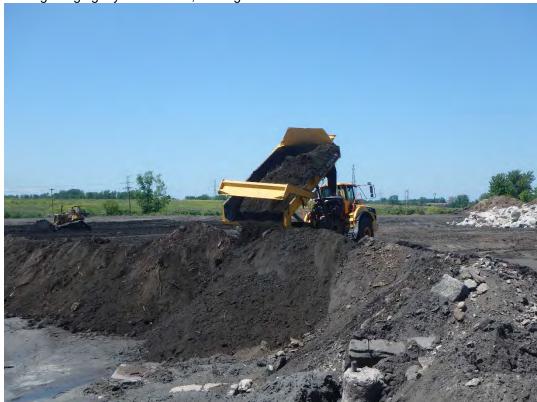
General fill from grading of shoreline being placed into Pond 1, looking north.

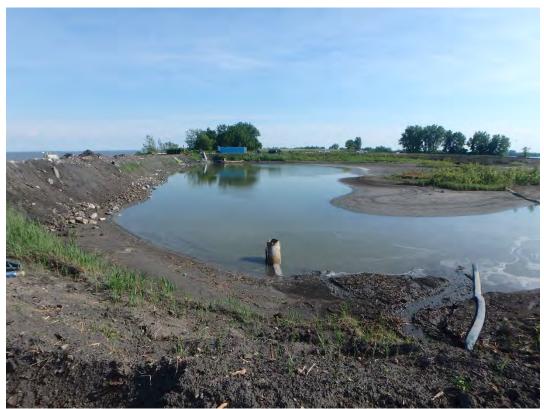
Overview and water level in Pond 2, looking south.

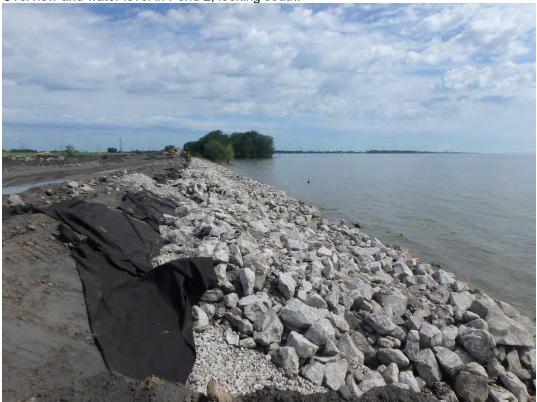
Overview of shoreline from south end, looking north.

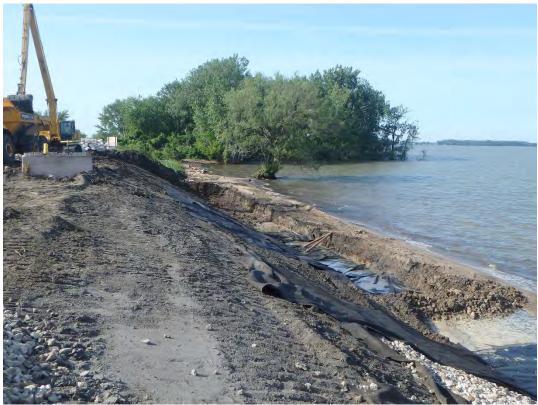
Cutting shoreline for installation of riprap, looking north.

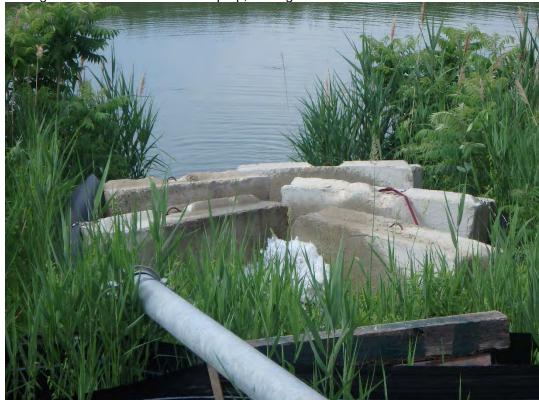
Discharge water from Pond 2, looking south.

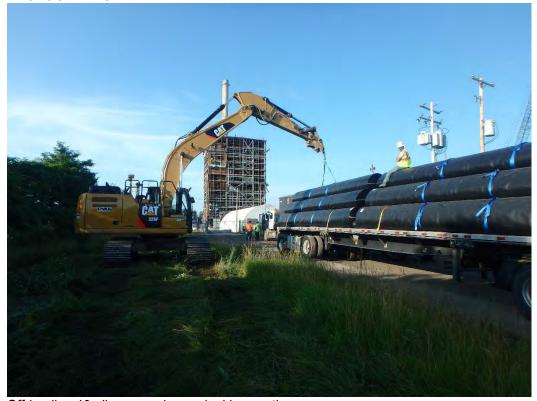
Off-loading 40mil geomembrane, looking south.

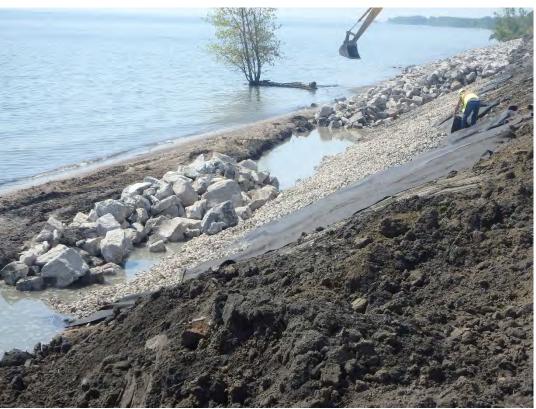
Placement of textile, 2 inch cushion material and 30 inch riprap along shoreline, looking south.

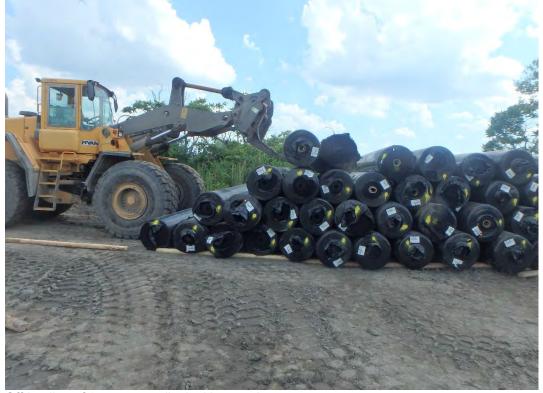
Off-loading of 8 oz. geotextile, looking south.

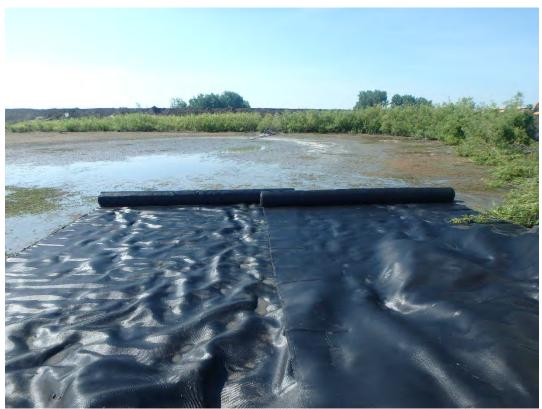
Installation of geotextile in Pond 1 prior to bridging layer, looking south.

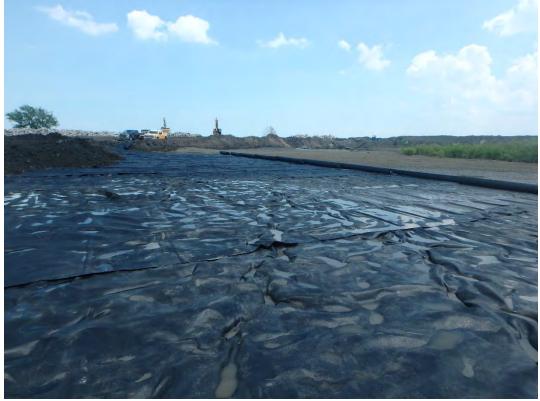
Geotextile installed across floor of Pond 1, looking east.

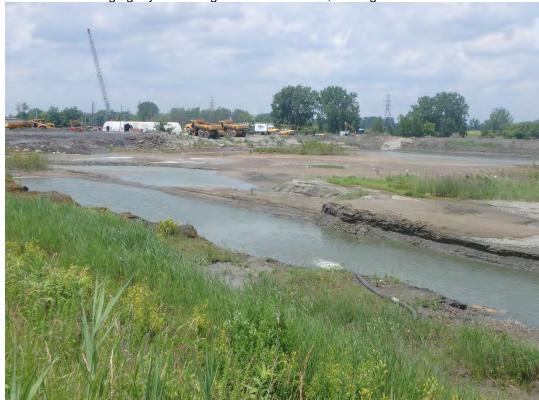
Overview and water level of Pond 2, looking west.

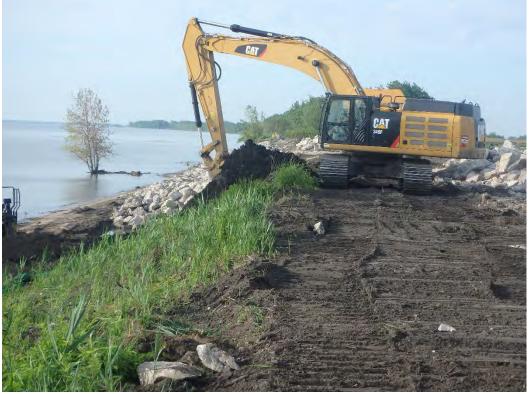
Clearing vegetation along shoreline, looking south.

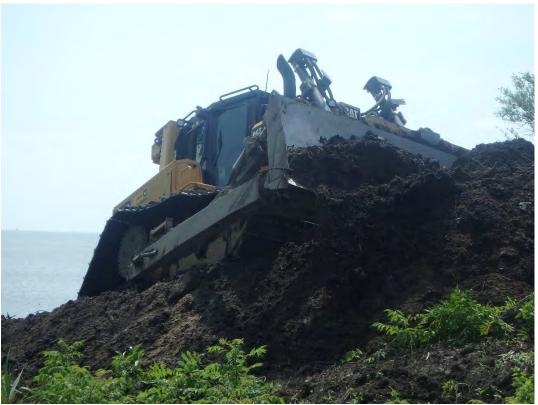
Cutting shoreline slope to sub-grade, looking east.

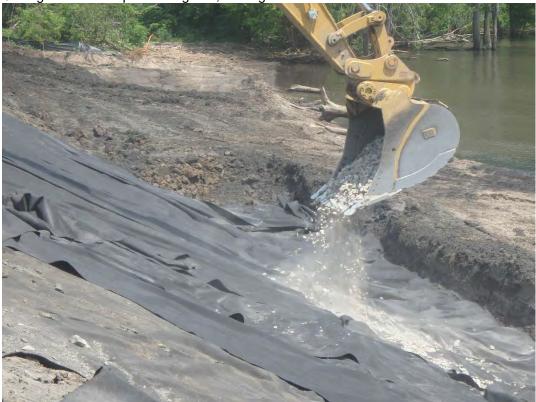
Placement of D50/2 inch cushion layer along shoreline, looking north.

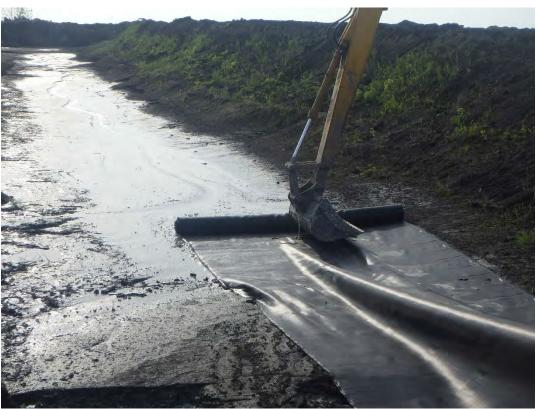
Installation of geotextile in Pond 1 prior to bridging layer, looking east.

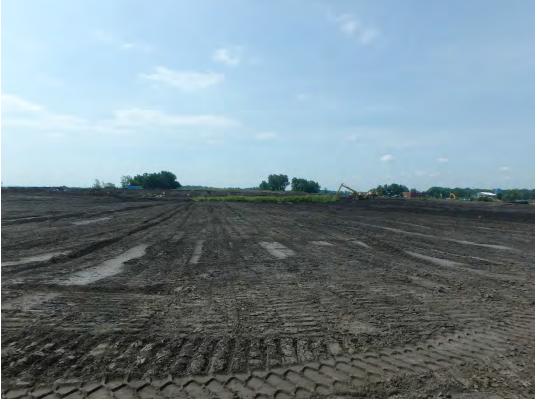
Overview of bridging layer in Pond 1, looking south.

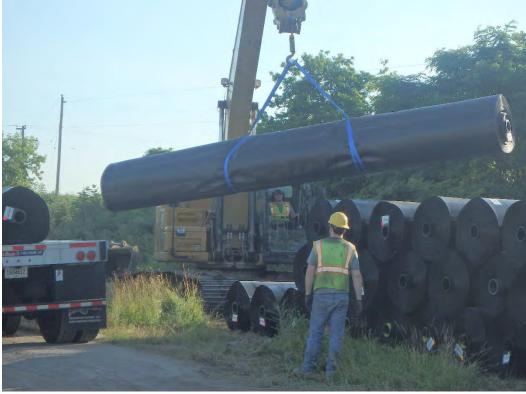
Off-loading 40mil geomembrane, looking north.

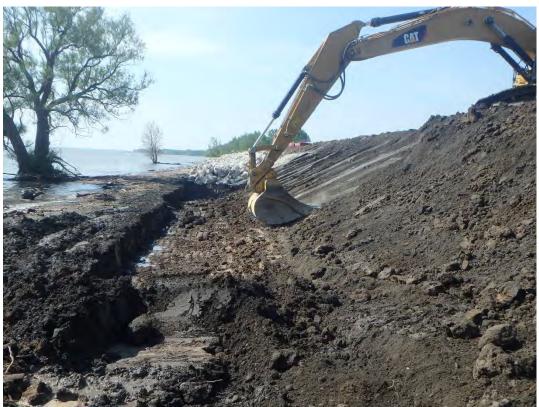
Cutting shoreline slope to sub-grade, looking south.

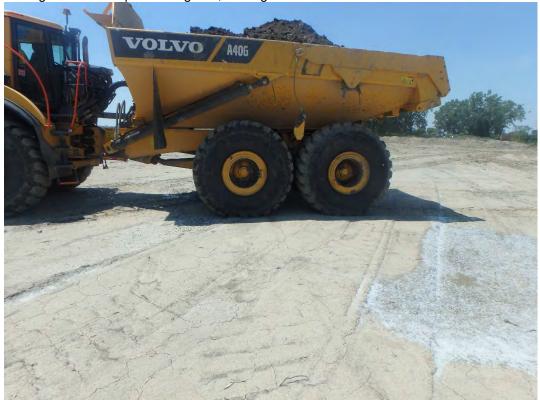
Proof roll of onsite structural fill placed over chemical ponds, looking west.

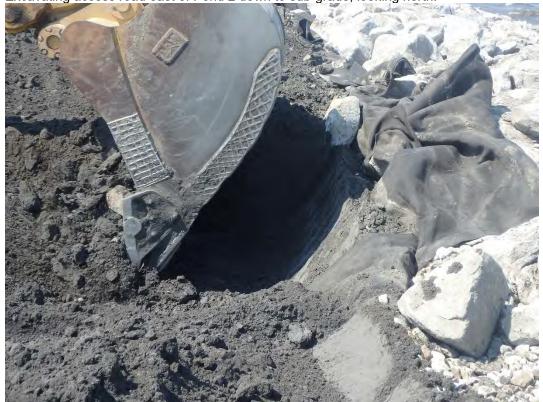
Excavating anchor trench for shoreline geotextile, looking north.

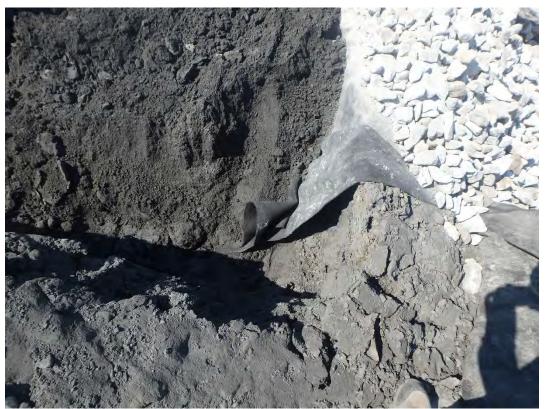
Shoreline geotextile in anchor trench with backfill.

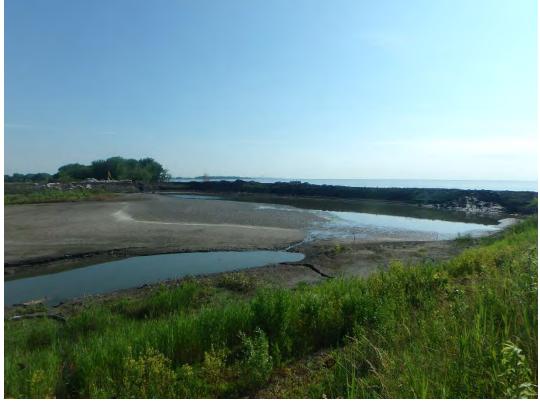
Overview and water level of Pond 2, looking northeast.

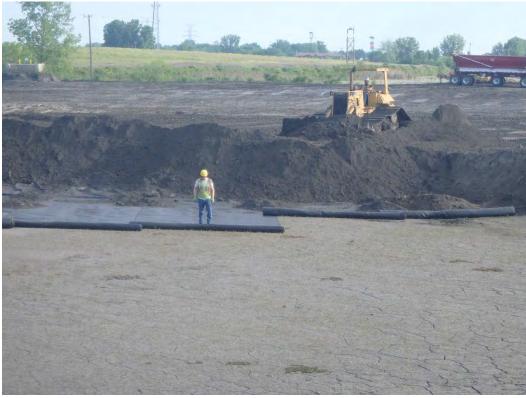
Deployment of geotextile and placement of bridging layer in Pond 1, looking north.

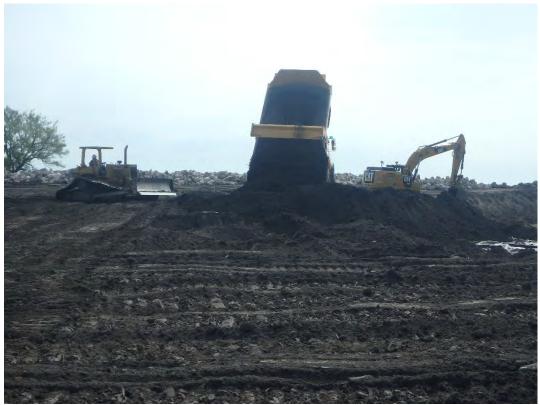
CCR regrading for bridging layer in Pond 1, looking east.

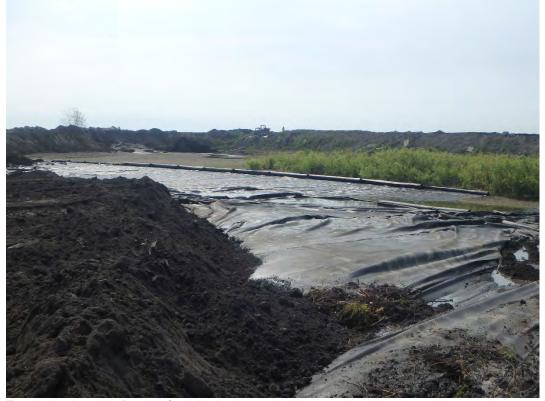
Textile deployed in Pond 1 for bridging layer, looking southeast.

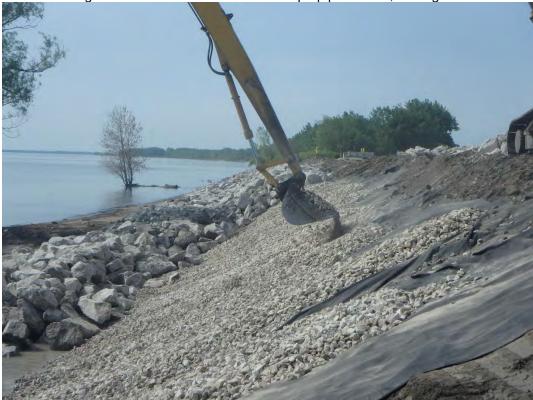
D50/2 inch cushion layer being placed atop textile along shoreline, looking south.

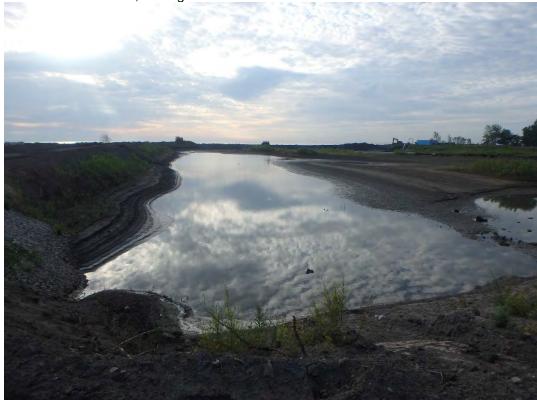
Overview and water level of Pond 2, looking west.

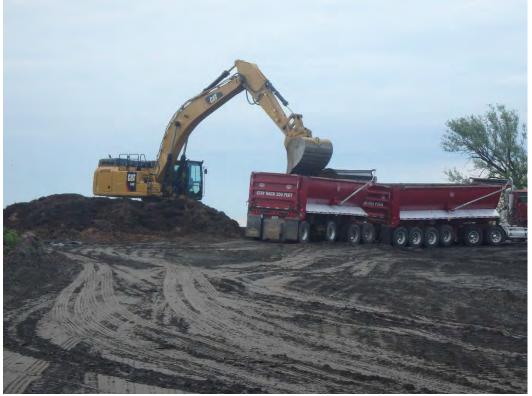
Loading of vegetation chip pile for disposal at offsite facility, looking east.

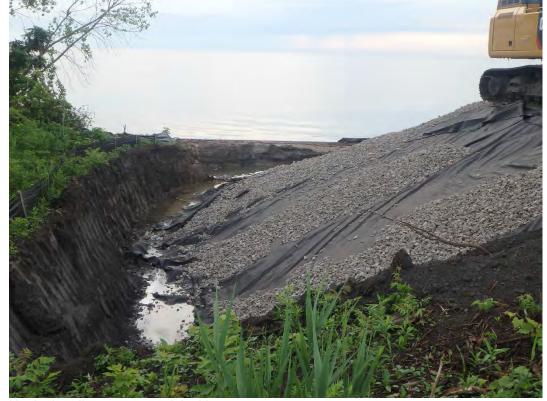
North shoreline wraparound, looking east.

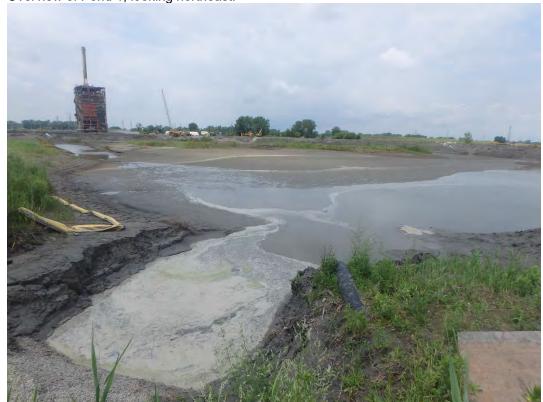
Overview and water level of Pond 2, looking northwest.

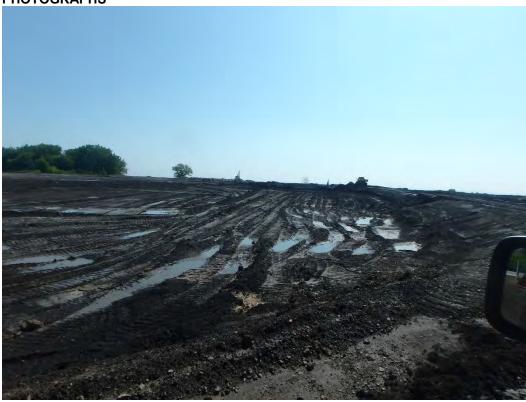
Pond 1 after the previous night's rain, looking east.

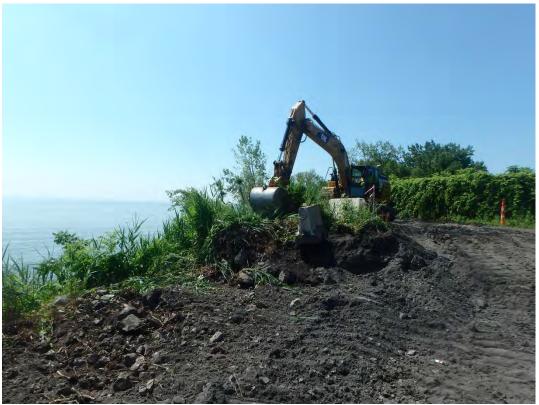
Clearing vegetation from shoreline east of Pond 2, looking south.

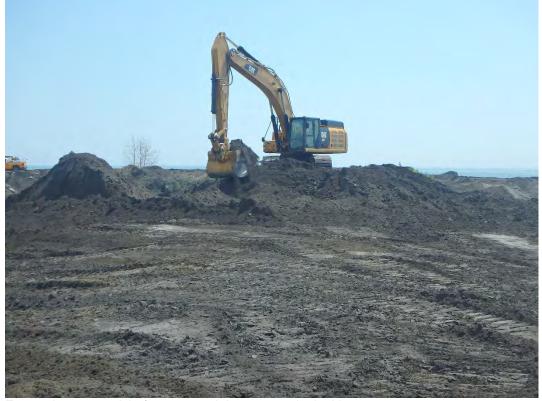
Excavating center dyke/access road down to grade, looking east.

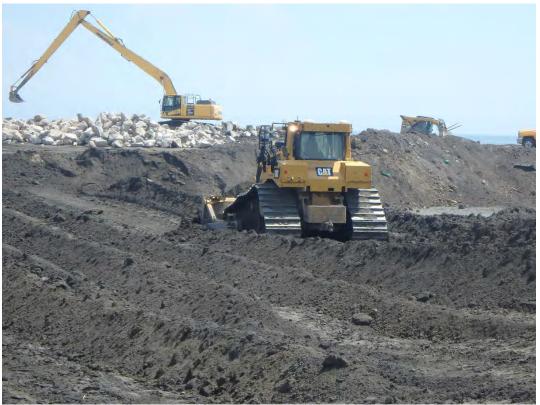
Pond 1 bridging layer being placed atop geotextile, looking east.

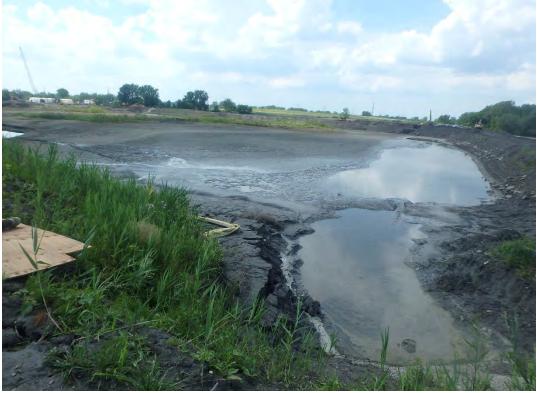
Overview and water level of Pond 2, looking north.

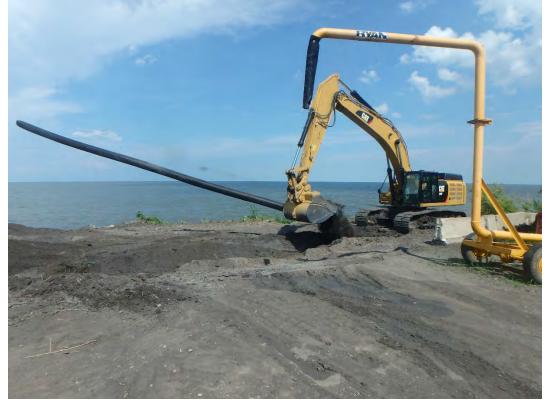
Removing utility pipe running from southeast corner of Pond 2 too Chemical Ponds, looking east.

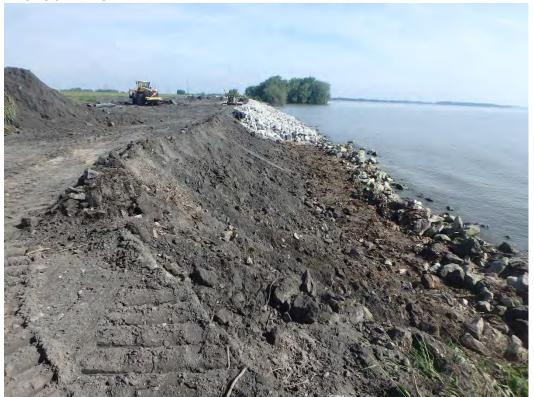
Cutting of shoreline east of Pond 2 to sub-grade, looking north.

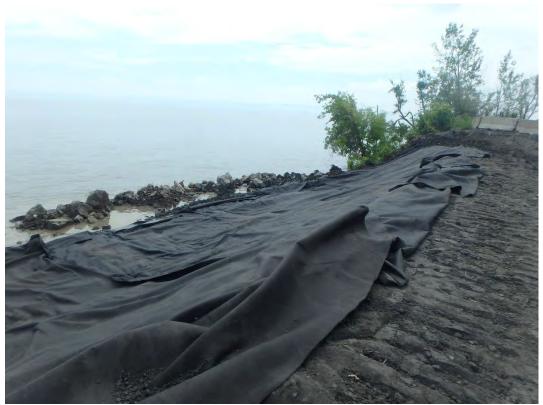
Textile deployed along shoreline, looking south.

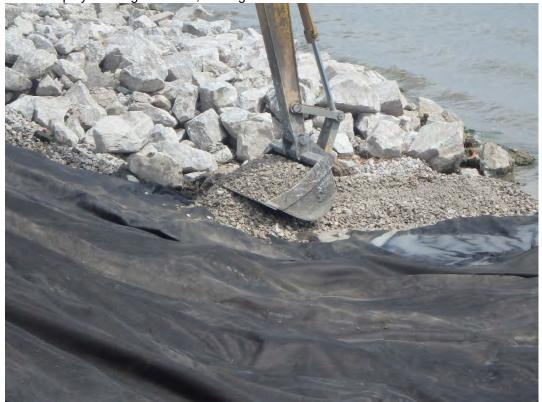
Placing D50-2 inch cushion layer atop textile on shoreline, looking north.

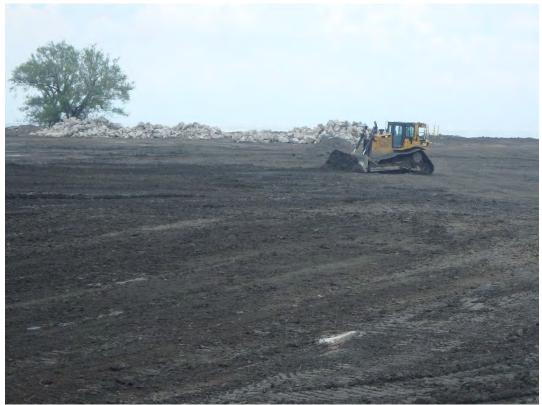
Pond 1 bridging layer being placed, looking east.

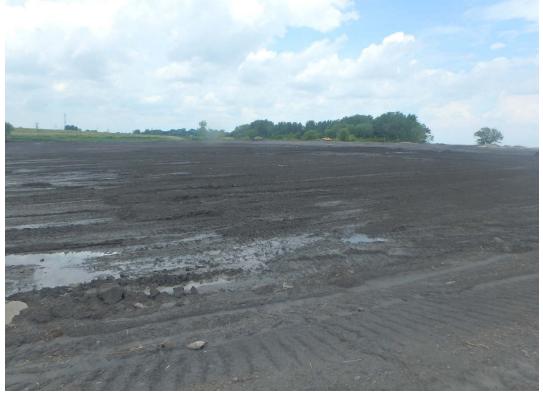
Overview of bridging layer in Pond 1, looking northeast.

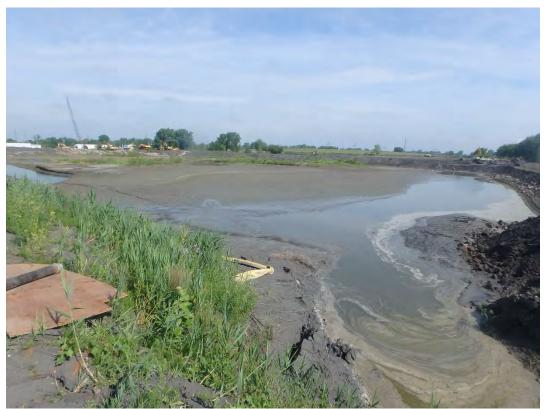
Overview and water level of Pond 2, looking northwest.

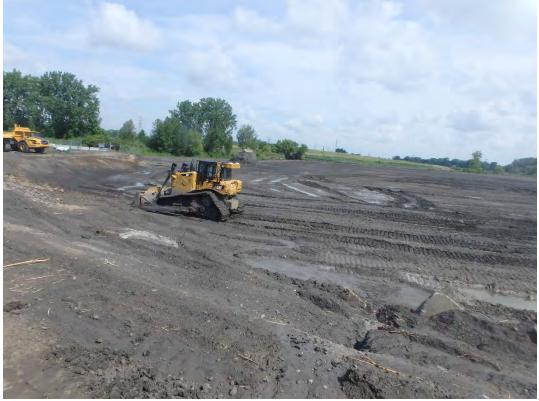
Re-grading of CCR in Pond 1 work area, looking northwest.

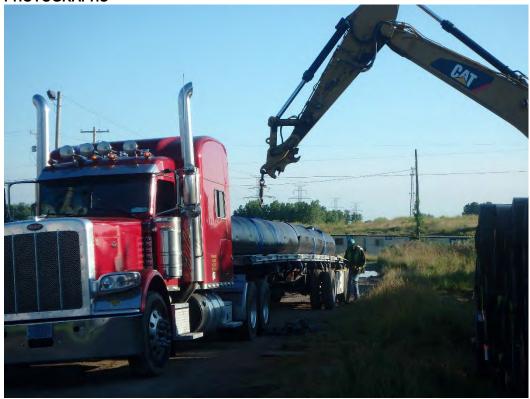
Offload of geomembrane, looking north.

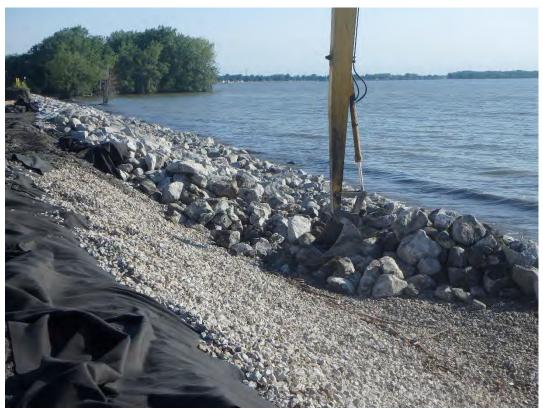
Placing D50/30 inch riprap along shoreline, looking northeast.

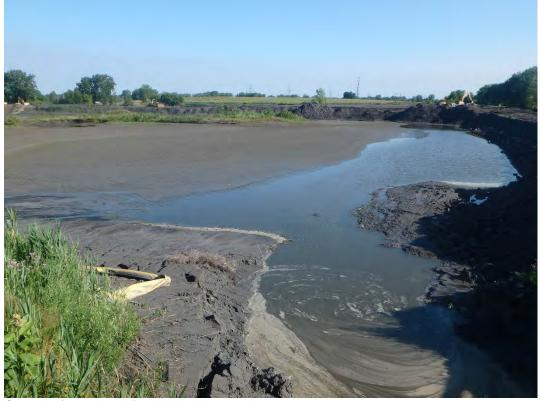
Overview/water level Pond 2, looking northern.

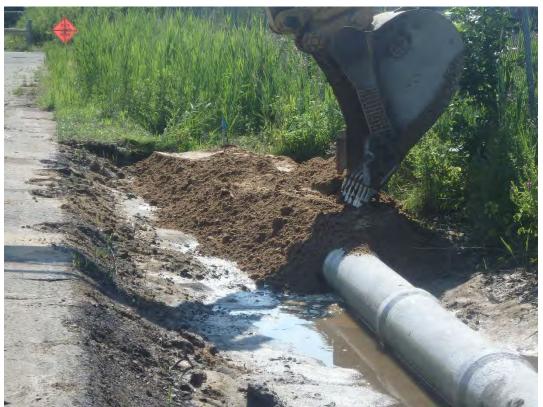
Placement of class IIIA sand for backfill over access road culvert, looking east.

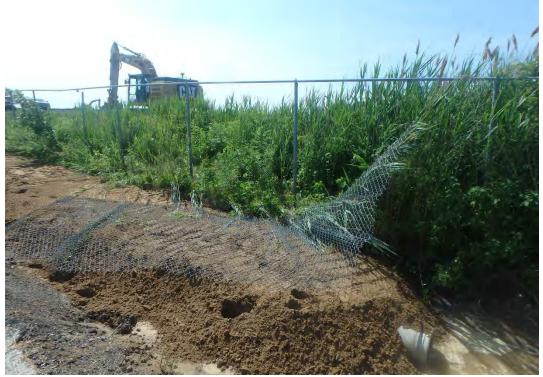
Removing fence for new entrance access road, looking southeast.

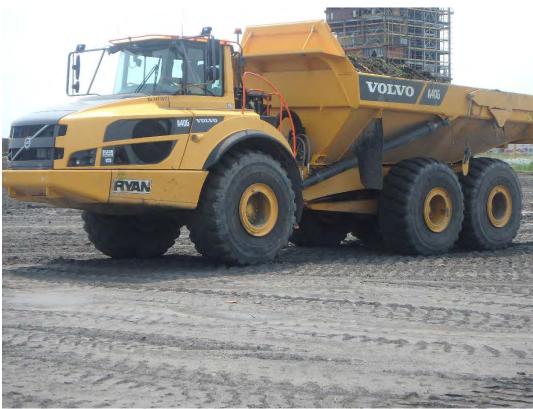
Proof roll in Pond 1 using loaded A40G haul truck, looking southwest.

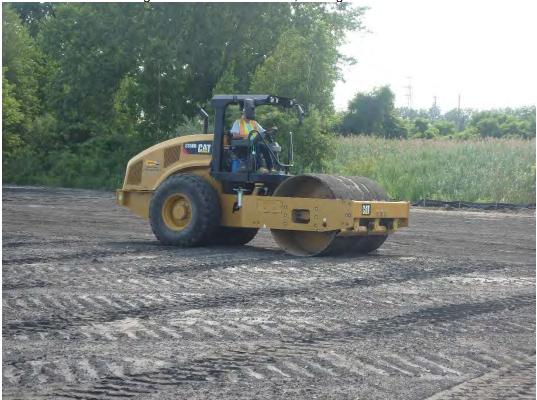
Smooth drum rolling bridging layer in Pond 1, looking west.

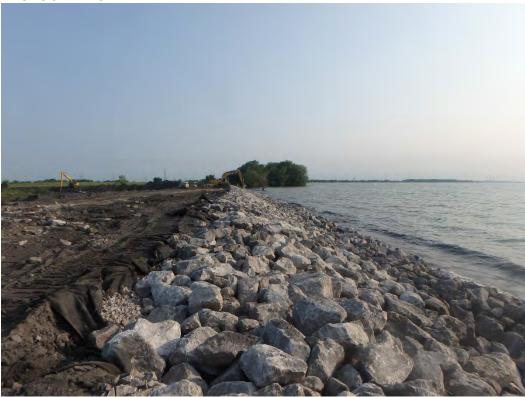
Overview of shoreline riprap, looking north.

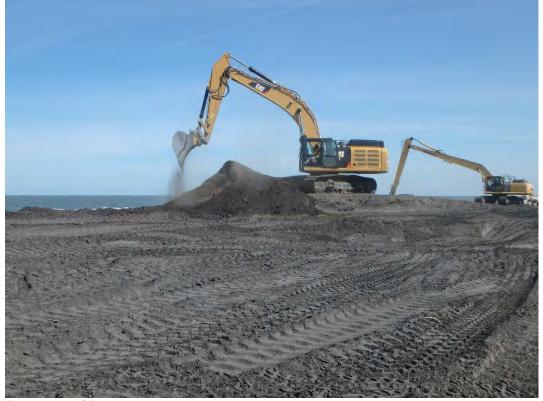
Excavating of Pond 1's east perimeter road, looking southeast.

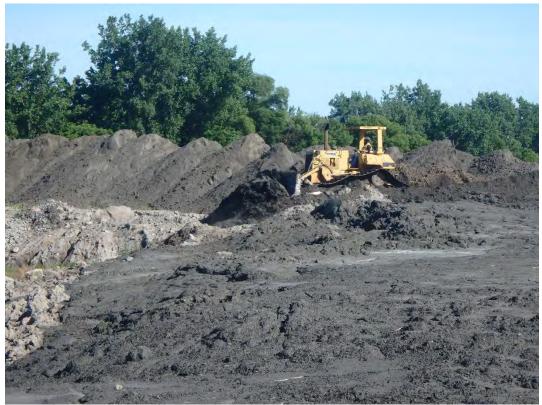
Placing bridging layer in Pond 2, looking south.

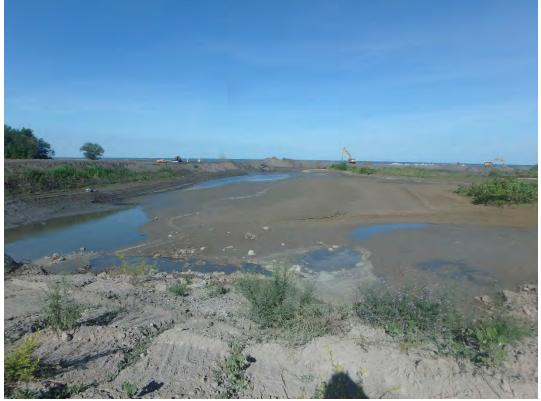
Overview/water level in Pond 2, looking east.

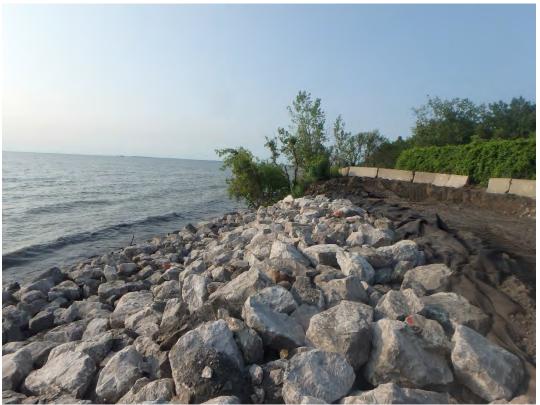
South end of shoreline riprap, looking south.

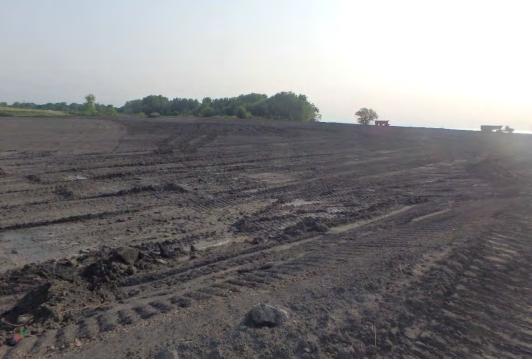
Overview of bridging layer in Pond 1, looking northeast.

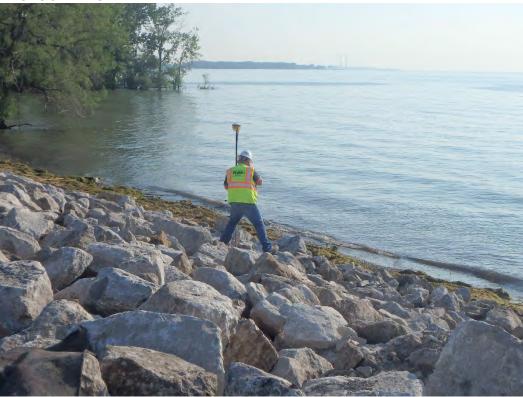
Ryan checking grade of riprap along shoreline, looking northeast.

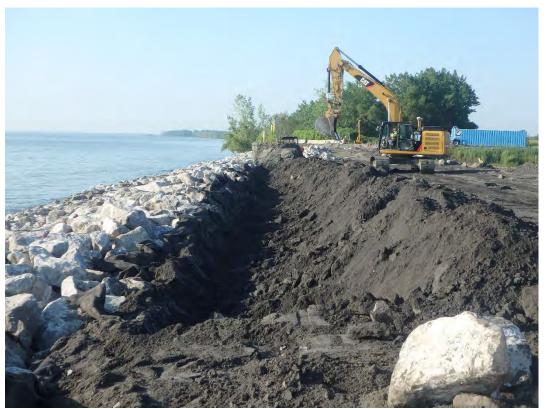
Excavating anchor trench for shoreline textile, looking south.

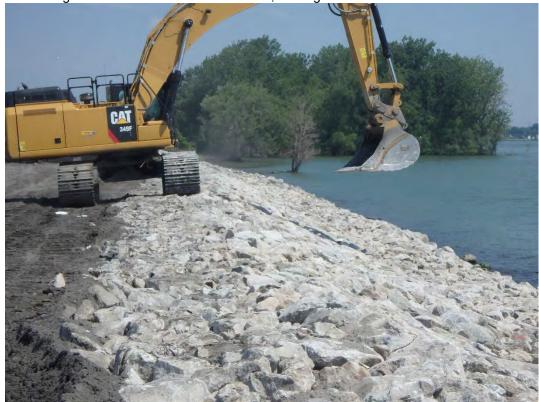
Filling voids in shoreline riprap using 8x16 inch riprap, looking north.

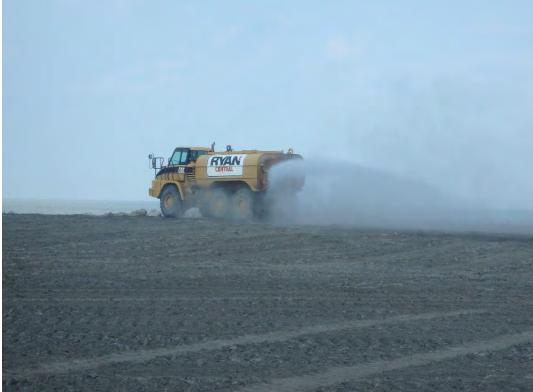
Water truck used for dust control, looking east.

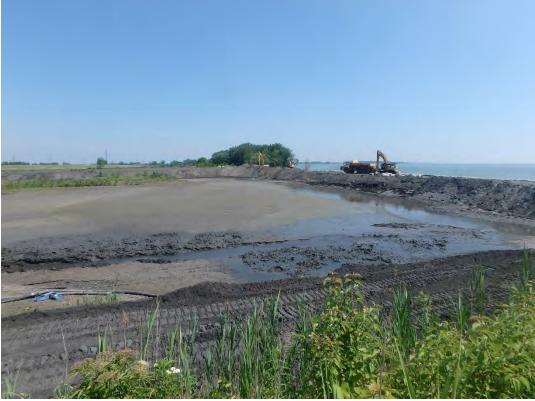
Overview/water level of Pond 2, looking north.

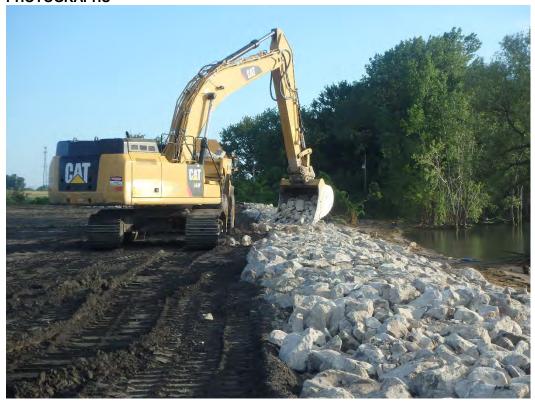
Placing 8 x 16 inch riprap to fill voids in the D50/30 inch along shoreline, looking north.

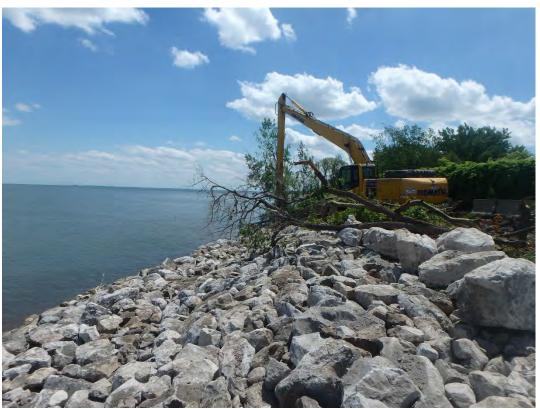
Clearing vegetation along shoreline southeast of Pond 2, looking south.

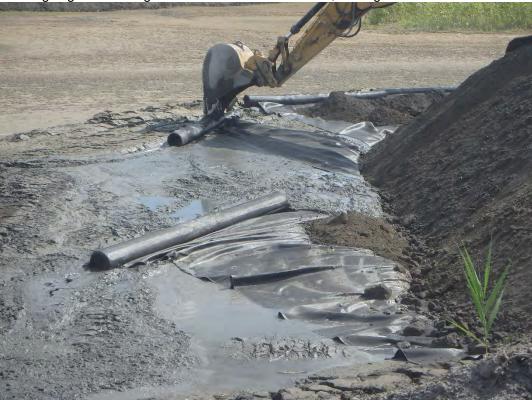
Deploying textile for bridging layer in Pond 2.

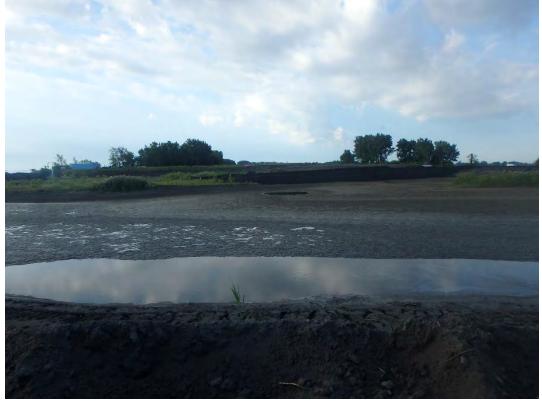
Overview/water level of Pond 2, looking north.

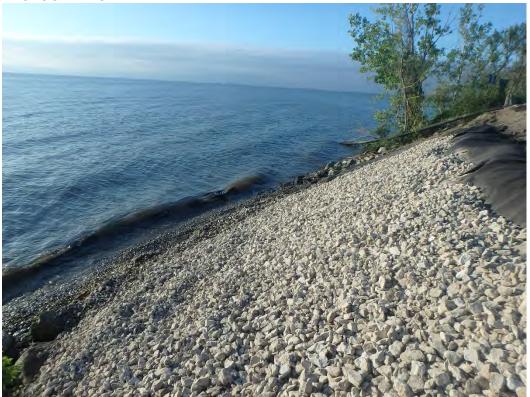
Textile and D50/2 inch cushion layer placed on shoreline southeast of Pond 2, looking south.

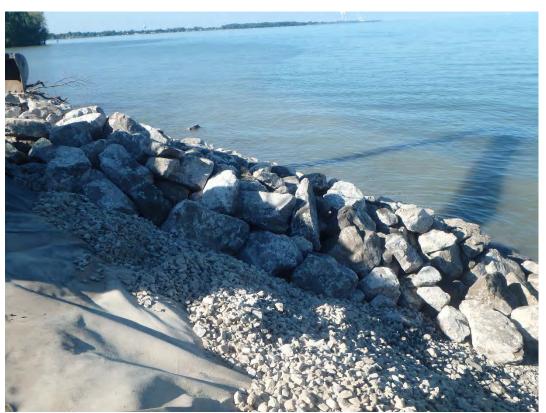
D50/30 inch riprap placed on shoreline southeast of Pond 2, looking northeast.

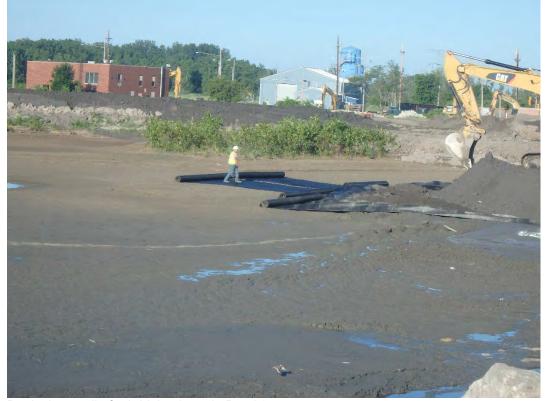
Deploying textile for bridging layer in Pond 2.

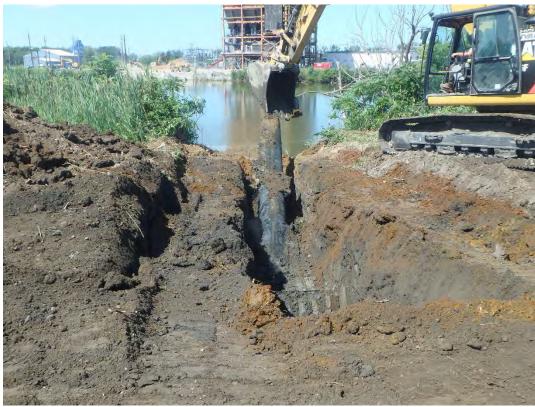
Removing standpipe into Fore Bay from Pond 1, looking west.

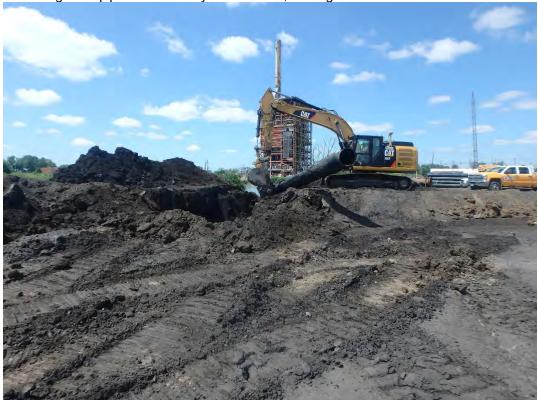
Removing standpipe running from Pond 1 to the Fore Bay, looking west.

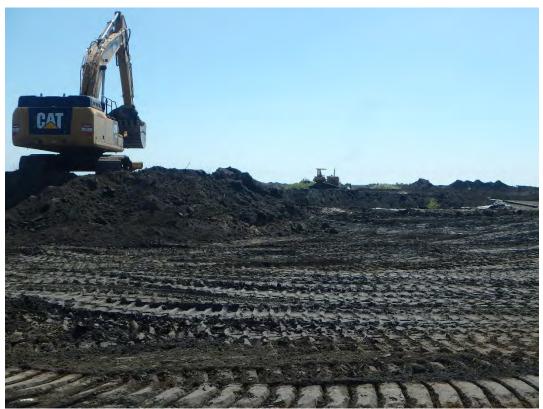
Excavation of dyke between Pond's 1 and 2, looking east.

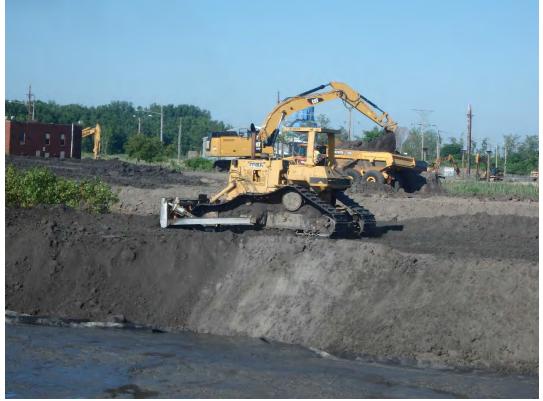
Placing bridging layer in Pond 2, looking southwest.

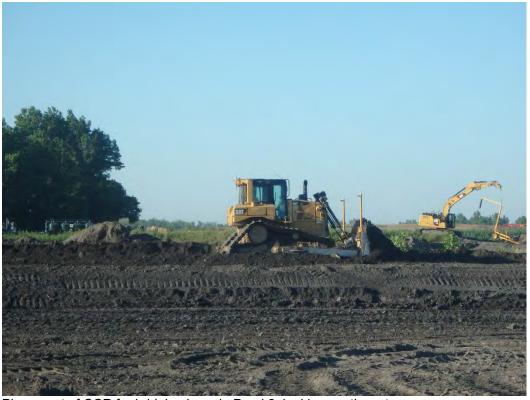
Placement of CCR for bridging layer in Pond 2, looking southwest.

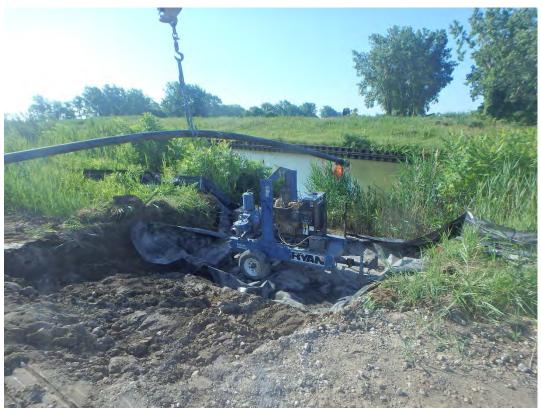
6 inch pump set southwest of Pond 2 along the discharge channel, looking south.

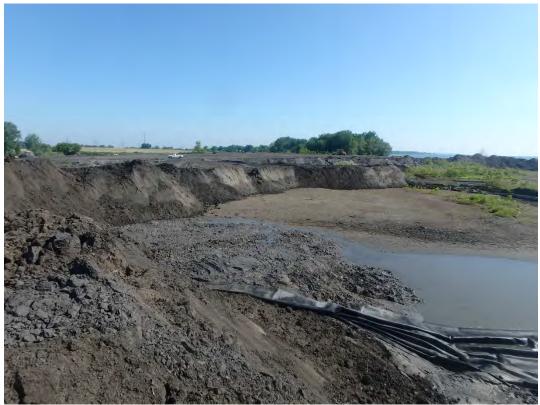
Overview of Pond 2, looking north.

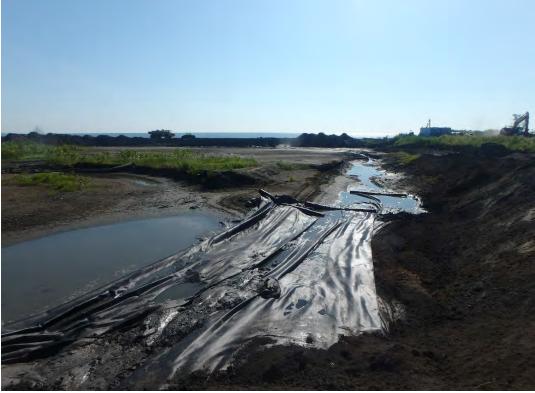
Textile for bridging layer deployed in Pond 2, looking east.

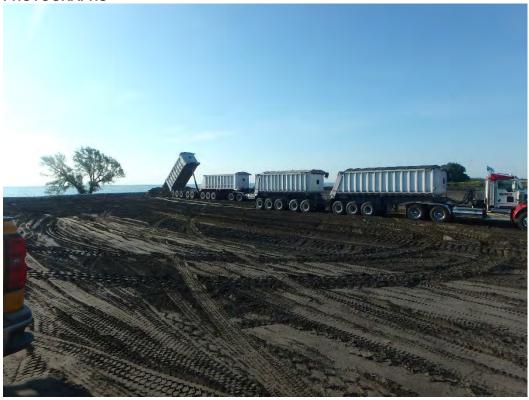
Structural fill delivered to Pond 1 by road trains, looking east.
