PROJECT OVERVIEW

Project Title: J.R. Whiting Ponds 1 Project Number: 1788523 Date: 6/24/2019

Client: Consumers Energy Site/Location: Erie, MI

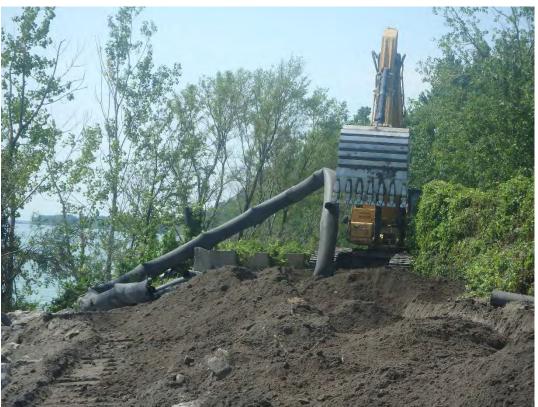
Removing utility pipe from Pond 2 to Chemical Ponds, looking south.

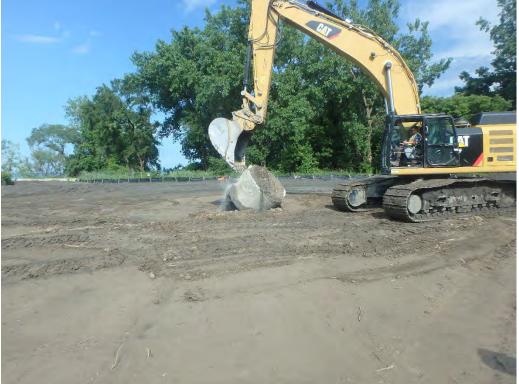
Removing utility pipe crock at the Chemical Ponds, looking east.

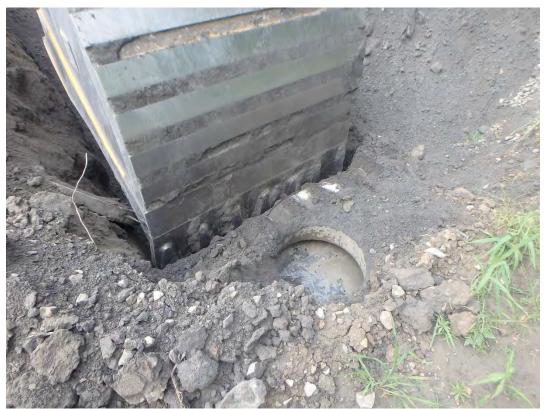
- Golder monitored removal of utility pipe that runs from the southeast corner of Pond 2 to the Chemical ponds using a Cat 349F excavator.
- Golder observed removal of previously unknown manhole and vault southeast of Chemical Pond B
  associated with the utility pipe.

Manhole and crock found in southeast of Chemical Pond B.

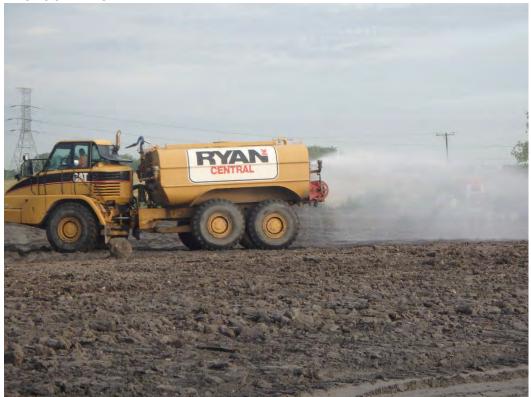
Water truck used to moisture conditioning of placed structural fill and dust control, looking west.

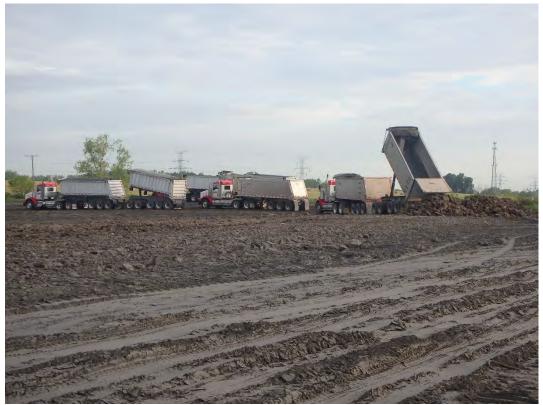
Delivery of structural fill to Pond 1, looking northwest.

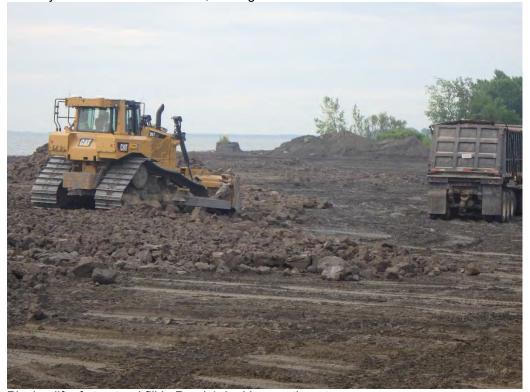
Placing lift of structural fill in Pond 1, looking southeast.

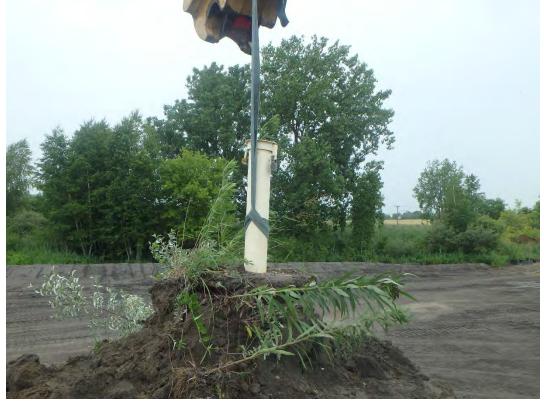
Removing the well casing from MW-15001, looking west.

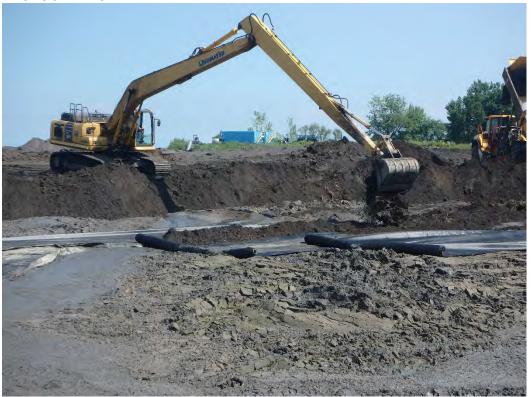
Textile placed prior to bridging layer in Pond 2, looking southeast.

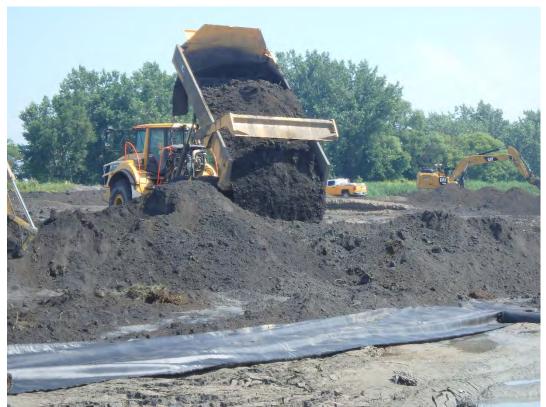
Bridging layer being placed in Pond 2, looking south.

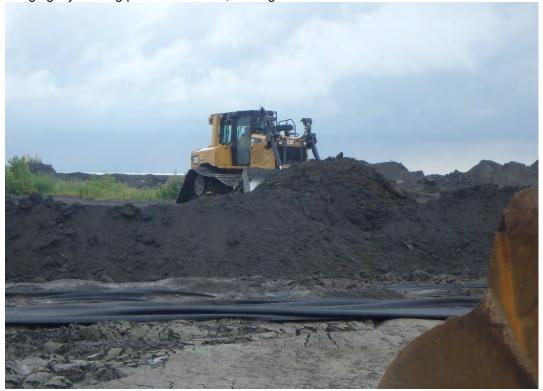
Placing bridging layer over textile in Pond 2, looking west.

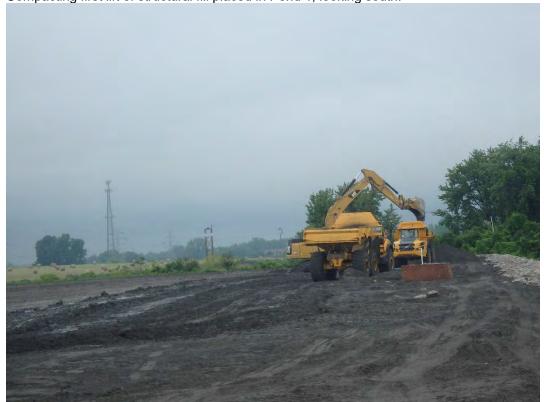
- Golder observed cutting of the east perimeter road down to 6 inches below access road sub-grade to allow placement of 6 inch lift of structural fill.

Excavating perimeter road east of Pond 1 down to sub-grade, looking north.

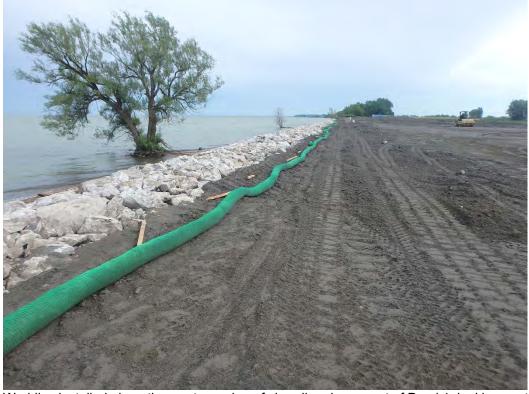
- Golder observed installation of waddles along the western edge of the shoreline riprap east of Pond
   1.
- Golder performed Standard test on Troxler 3440 prior to density testing.

Waddles installed along the western edge of shoreline riprap east of Pond 1, looking south.

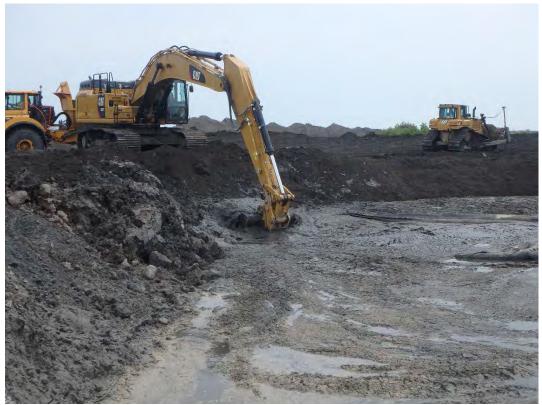
Excavation of saturated material in the northwest corner of Pond 2, looking east.

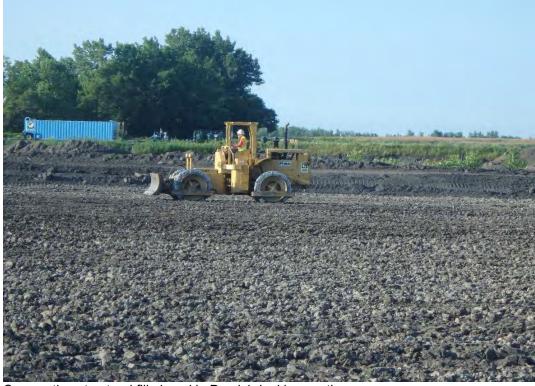
- Golder observed excavation of the area west of Pond 2 down to sub-grade and hauling material to Pond 2 for bridging layer.
- Golder monitored placement of structural fill in Pond 1, Cat D6T with GPS placed material in a single 11 to 12 inch loose lift. Cat 815 sheep foot was used to compact to 9 inches.

Compacting structural fill placed in Pond 1, looking south.

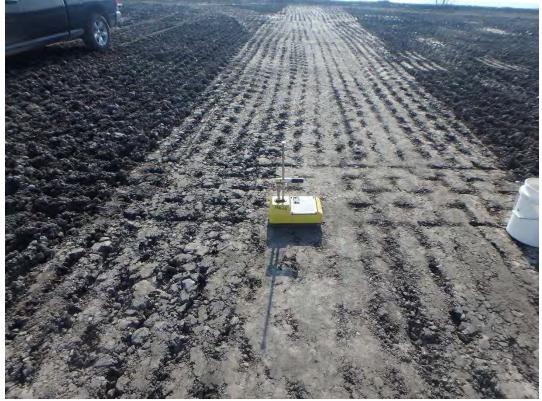
Density test of compacted structural fill in Pond 1, looking east.

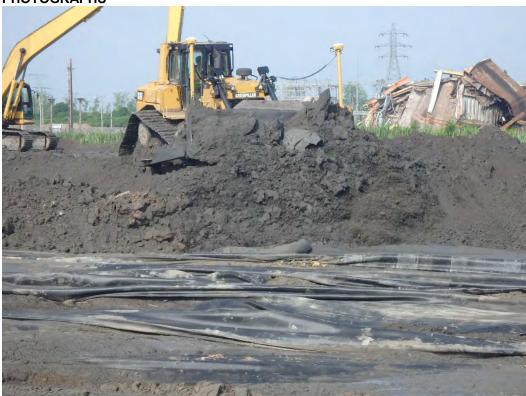
Placement of bridging layer in Pond 2, looking west.

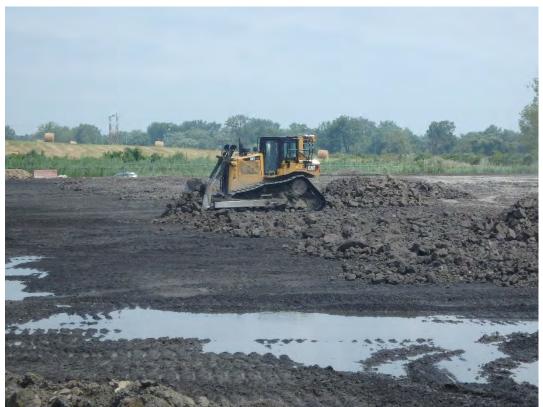
Placement of structural fill lift in Pond 1, looking north.

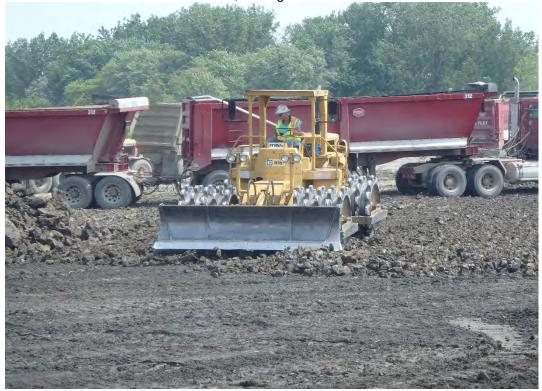
Compacting structural fill placed in Pond 1, looking northeast.

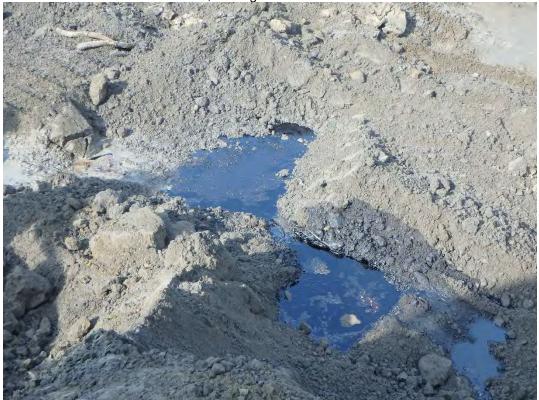
While excavating CCR west of Pond 2 and south of MW-15006 Ryan discovered a pool of liquid that appears to be oil. Also found a second smaller pool about 25 feet north and pool of standing water with oily sheen about 50 feet north. Jeff Yuchasz CEC construction manager was notified and asked how he wanted to proceed, he told Ryan to install containment around the three identified areas, obtain containment vessels for removal of contaminated soils and he would contact CEC for further direction.

Pool of suspect liquid that appears to be oil in cut west of Pond 2, looking west.

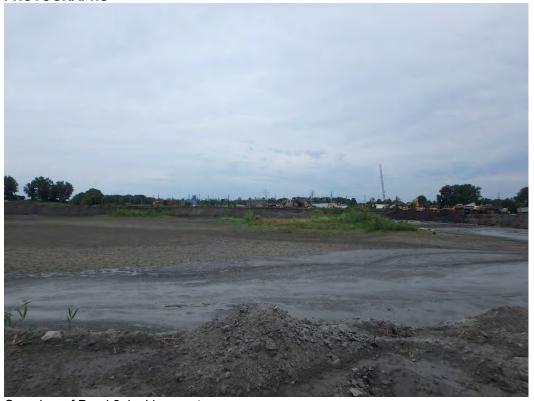
Overview of Pond 2, looking west.

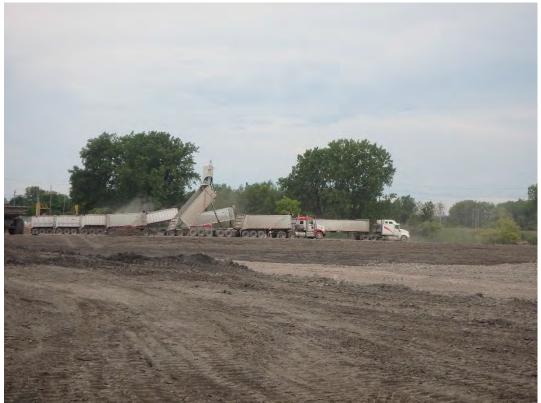
Delivery of structural fill to Pond 1, looking west.

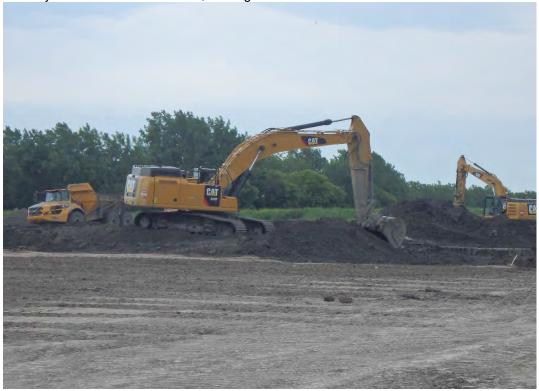
Excavation of dyke between Ponds 1 and 2, looking south.

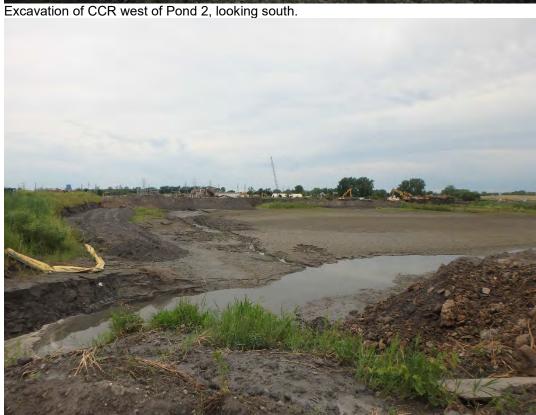
Overview of Pond 2, looking northwest.

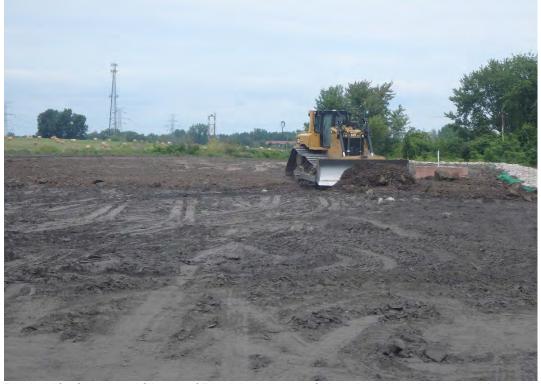
Placing lift of structural fill east of Pond 1 along top of shoreline slope, looking north.

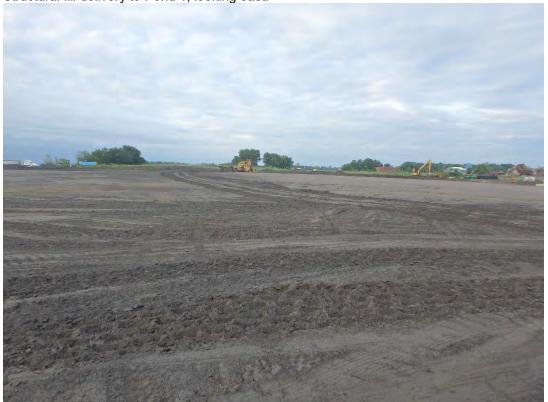
Overview of Pond 1 with single lift of structural fill, looking southwest.

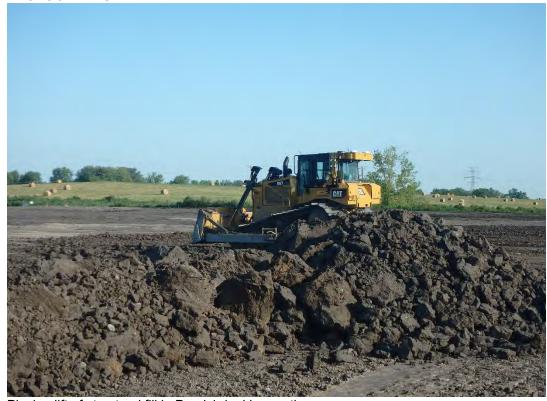
Placing lift of structural fill in Pond 1, looking north.

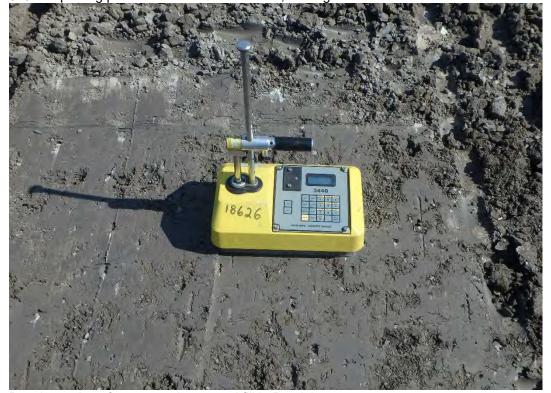
Density testing of compacted structural fill in Pond 1.

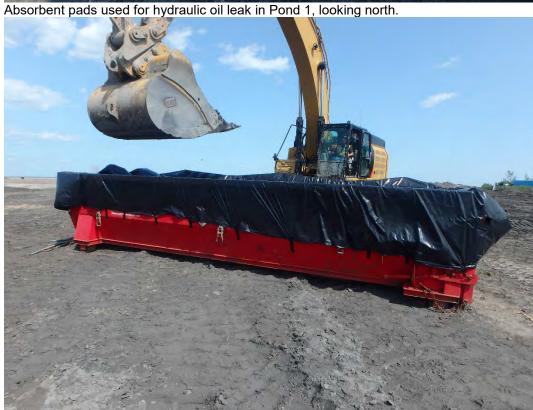
Lined dumpster used for disposal of contaminated soils excavated west of Pond 2, looking east.

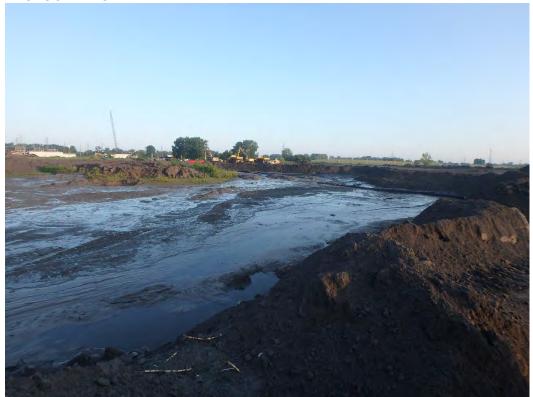
Overview of northeast corner of Pond 2, looking northwest.

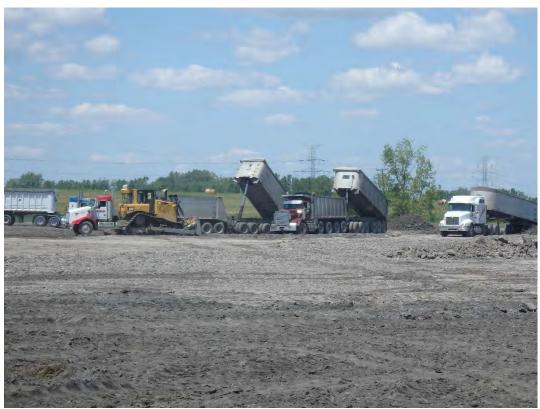
Structural fill import and placement in Pond 1, looking northeast.

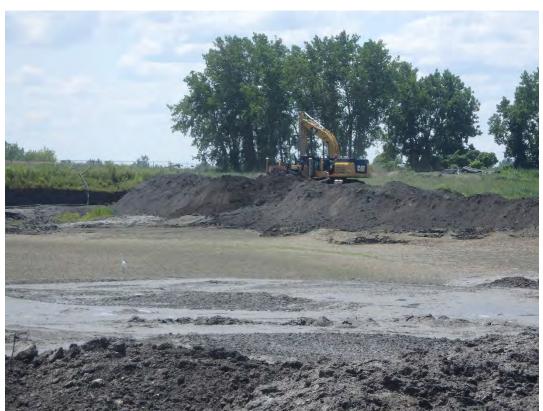
Excavating Pond 2's west dike, looking northwest.

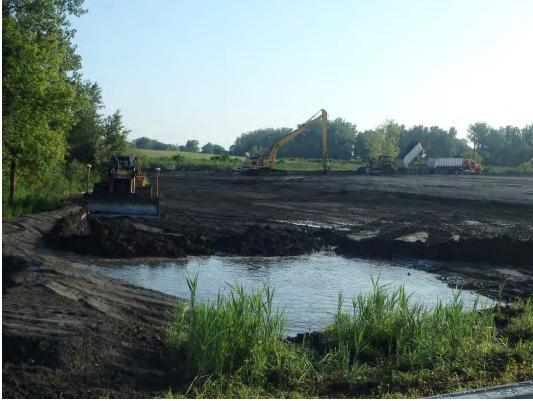
Bridging layer in Pond 2, looking south.

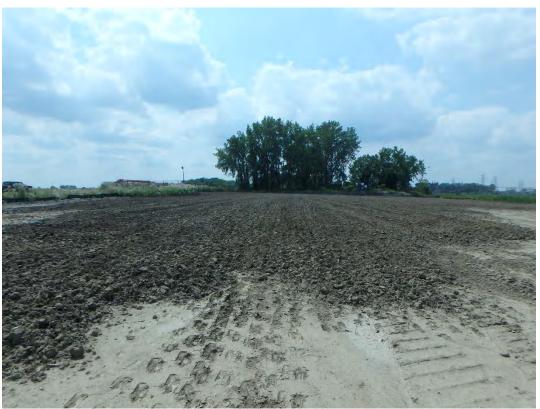
Placing bridging layer in Pond 2, looking west.
