J.R. Whiting Ponds 1 Project Number: 1788523 Date: 7/27/2019 **Project Title:**

and 2 Closure CQA

Client: Consumers Energy Site/Location: Erie, MI

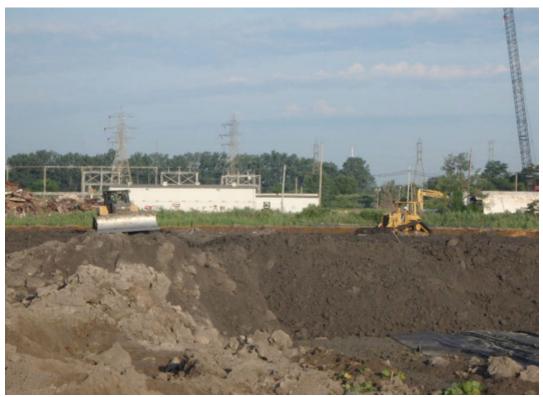
Placing structural fill in Pond 1, looking north.

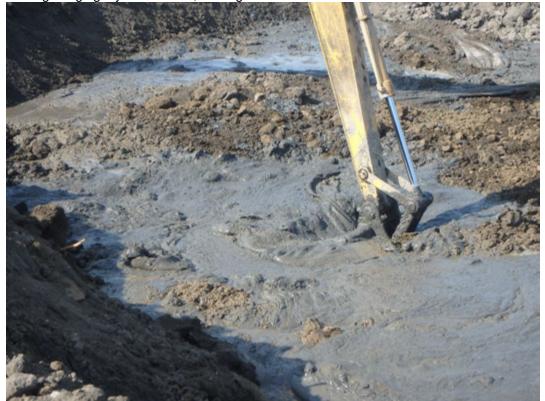
Placing bridging layer in Pond 2, looking west.

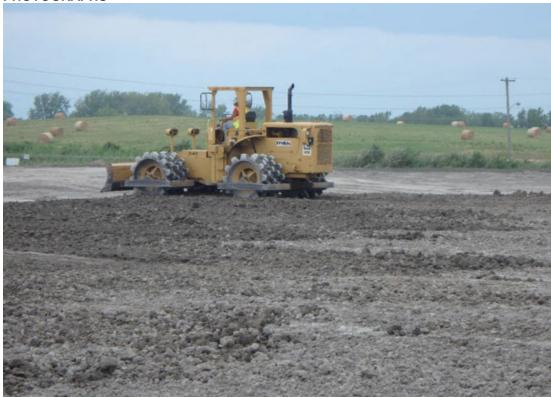
Compacting lift of structural fill in Pond 1, looking north.

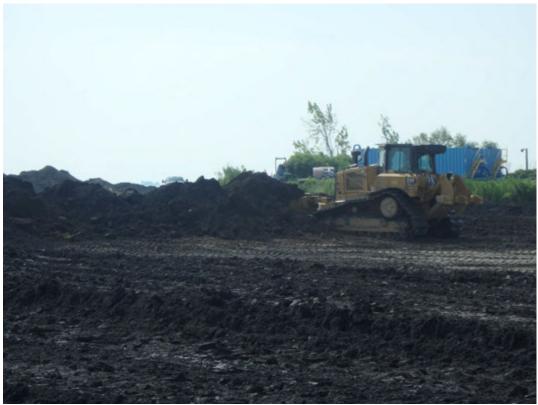
Placing bridging layer in Pond 2, looking southeast.

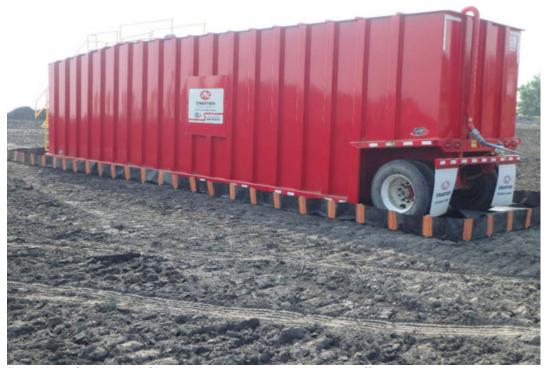
Baker tank for holding of contaminated water until disposal off-site, looking southeast.

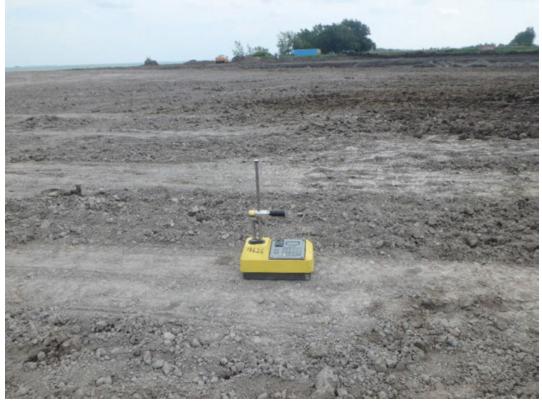
Density testing compacted lift of structural fill in Pond 1, looking south.

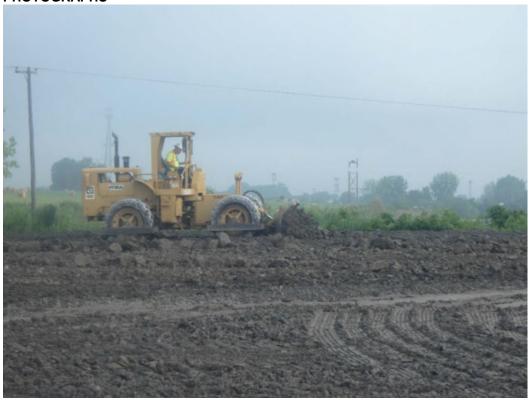
Compacting lift of structural fill in Pond 1, looking north.

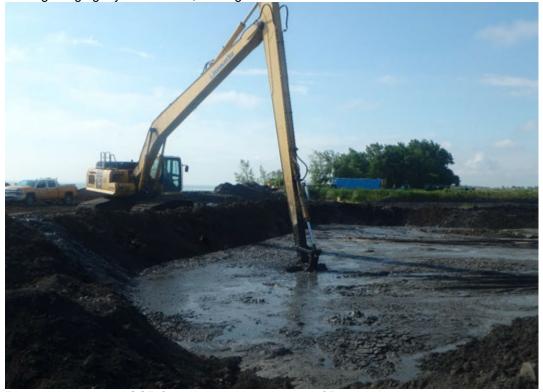
Removing saturated CCR from the northeast corner of Pond 2, looking southeast.

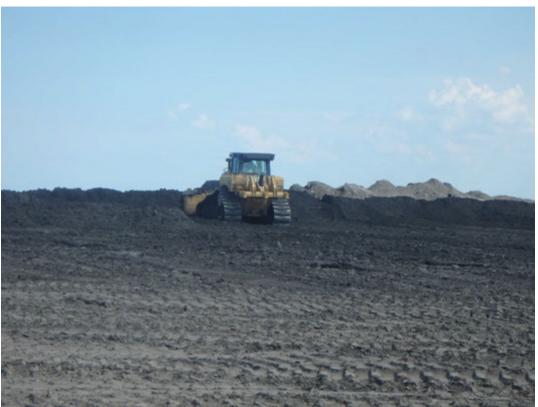
Regrade of CCR in Pond 2, looking east.

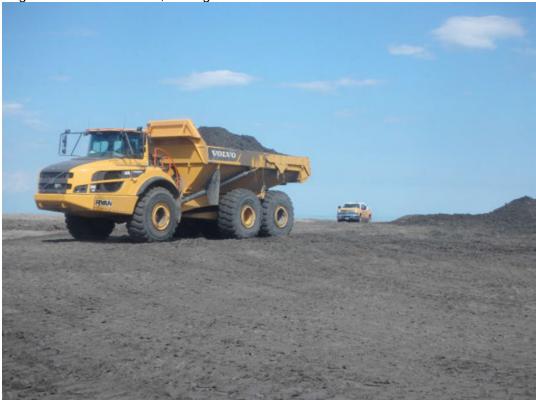
CCR excavated from south dike being placed in Pond 2 for bridging layer, looking east.

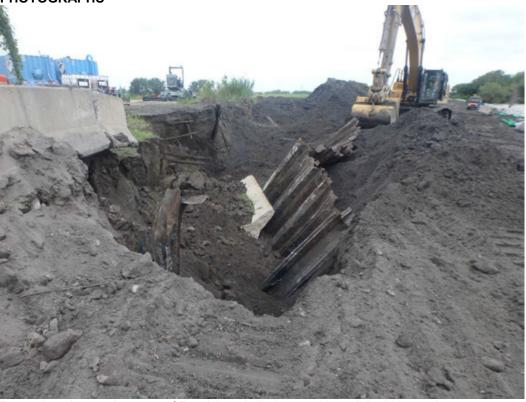
Removing sheet pylon east of Pond 2 and discharge channel, looking north.

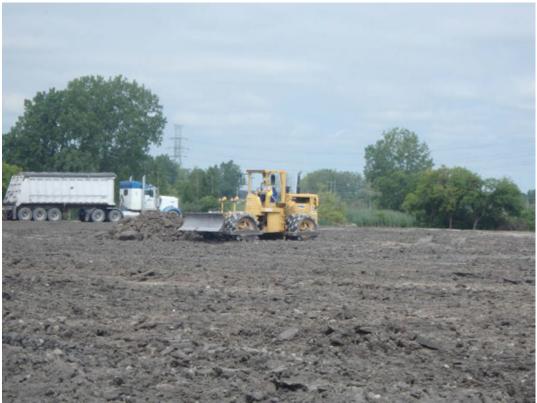
Compacting lift of structural fill placed in Pond 1, looking northeast.

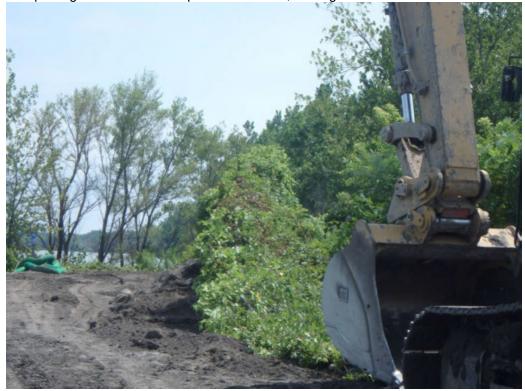
Removing fence along east side of discharge channel, looking south.

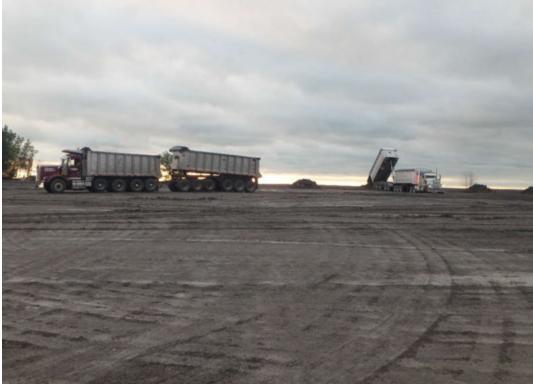
Structural fill import for Pond 1, looking east.

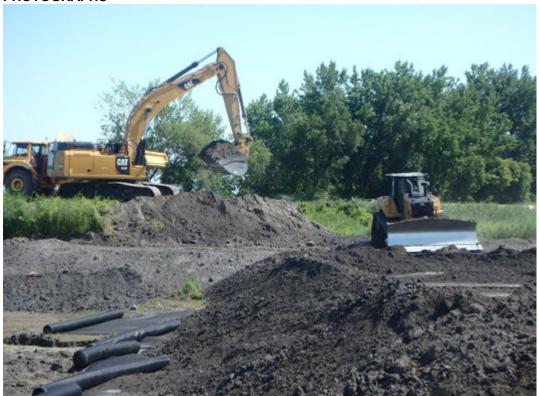
Excavation of Pond 2's south dike, looking southeast.

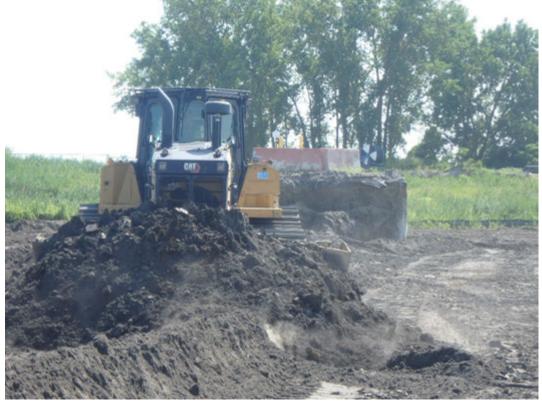
Placement of bridging layer in Pond 2, looking south.

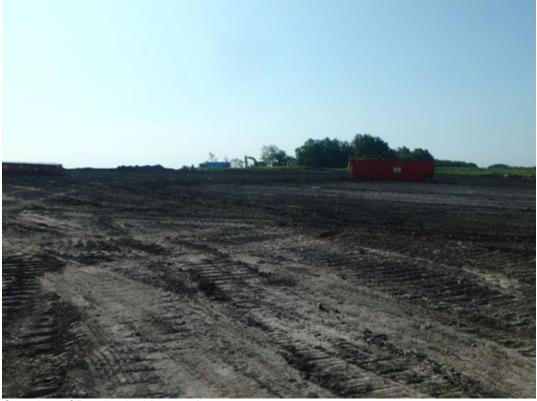
Overview of Pond 2, looking southwest.

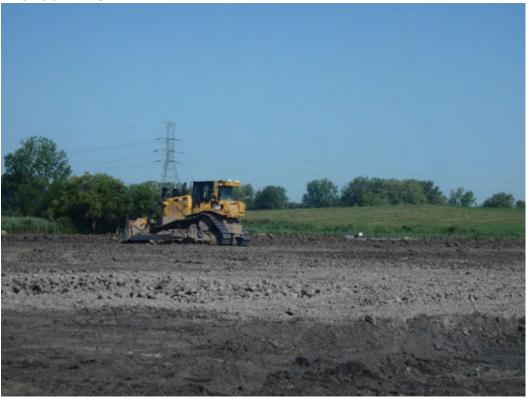
Placement of structural fill in Pond 1, looking north.

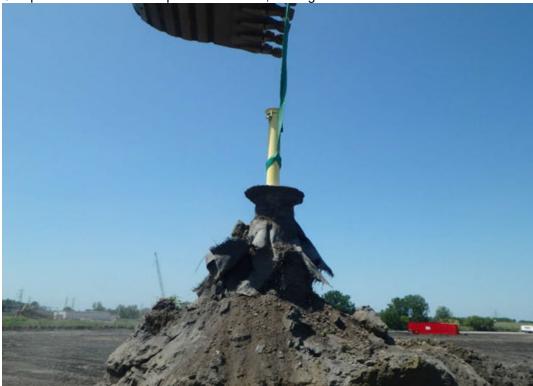
Removing protective casing from MW-15005, looking north.

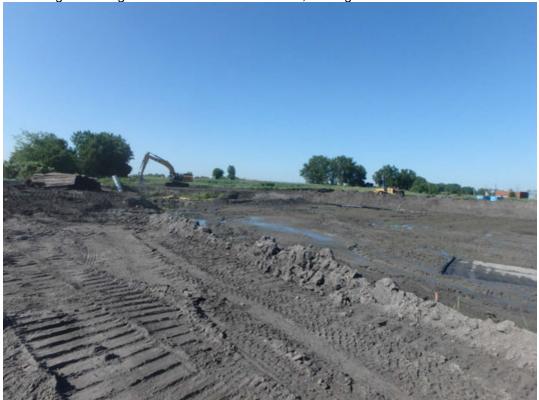
Excavation of Pond 2's south dike, looking south.

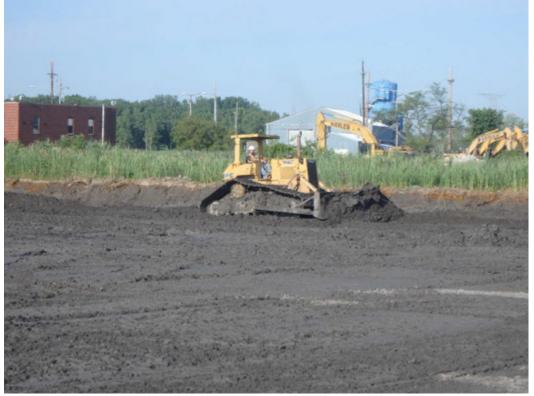
Re-grading of CCR in Pond 2, looking southwest.

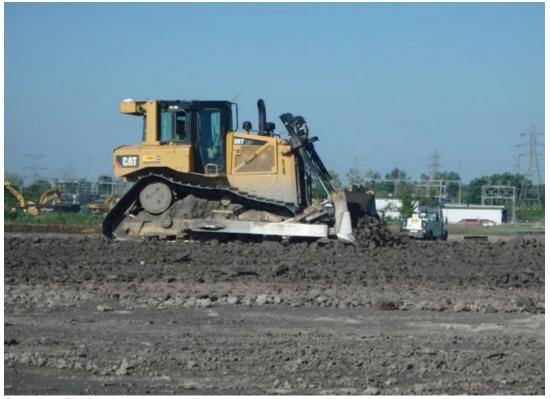
Structural fill lift being placed in Pond 1, looking west.

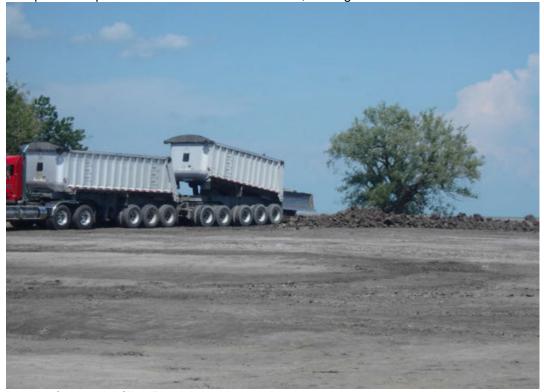
Import of structural fill to Pond 1, looking northeast.

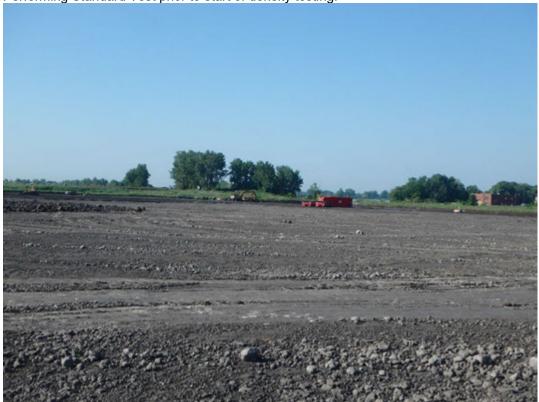
Overview of Pond 2, looking southwest.

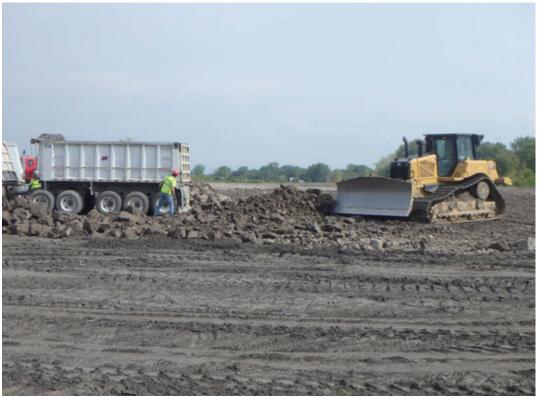
Structural fill lift being placed in Pond 1, looking west.

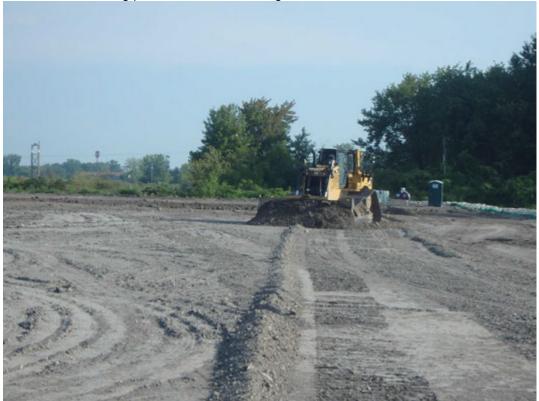
Cutting placed and compacted structural fill in Pond 1 to liner sub-grade, looking north.

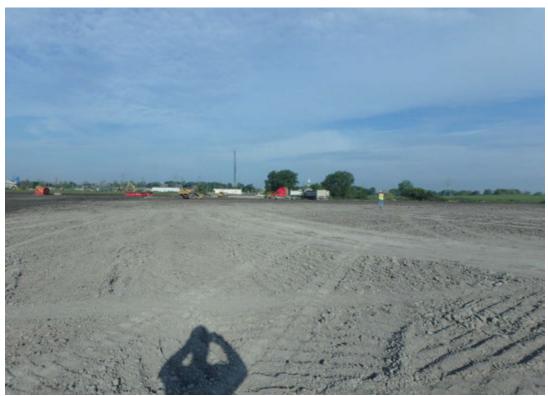
Overview of Pond 1, looking north.

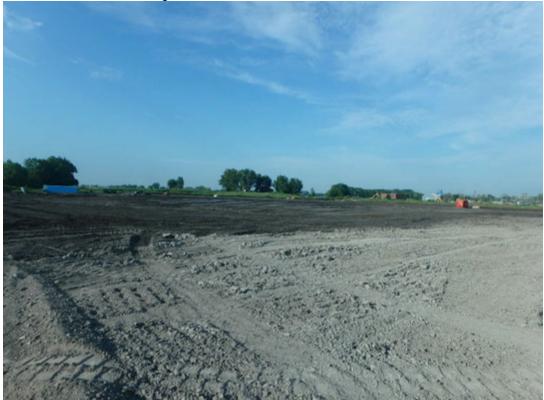
Overview of Pond 2, looking southwest.

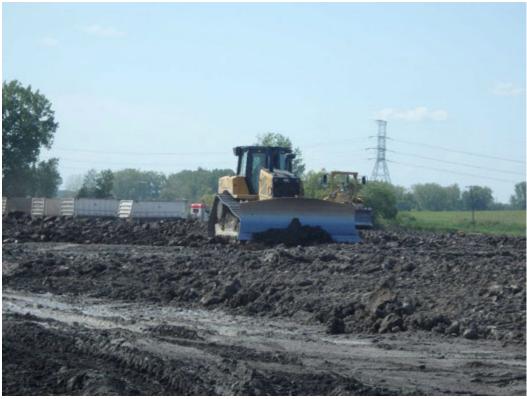
Structural fill lift being placed in Pond 1, looking northwest.

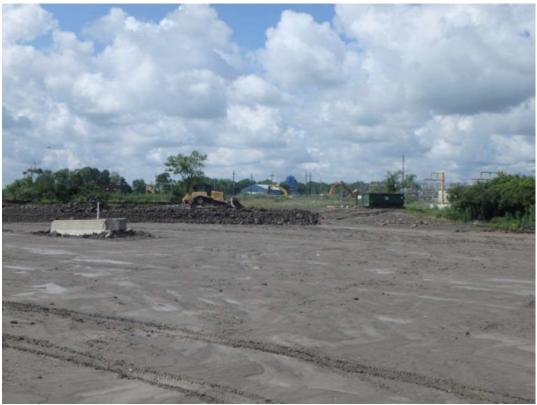
Constructing temp access road to west gate for imports, looking southwest.

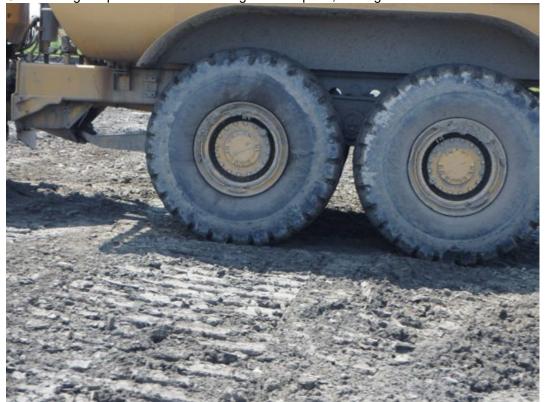
- Golder monitored proof roll of bridging layer in Pond 2 bounded by certification points; 1057, 1059, 1101 and 1103.
- Golder observed import of structural fill for Pond 1.

Proof rolling of bridging layer in Pond 2.

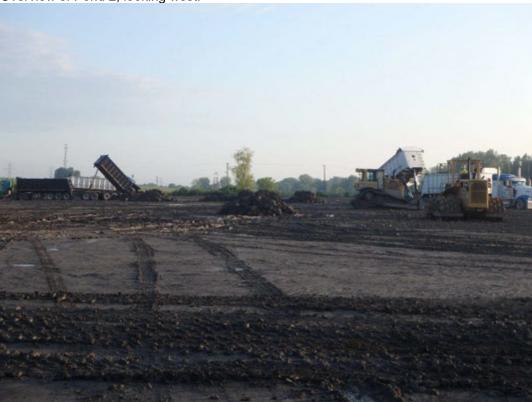
Structural fill import to Pond 1, looking north.

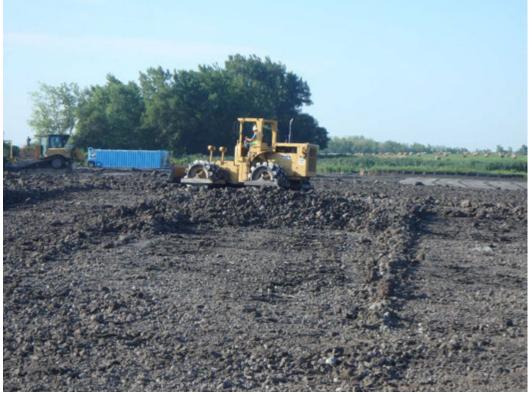
Compacting lift of structural fill in Pond 2, looking south.

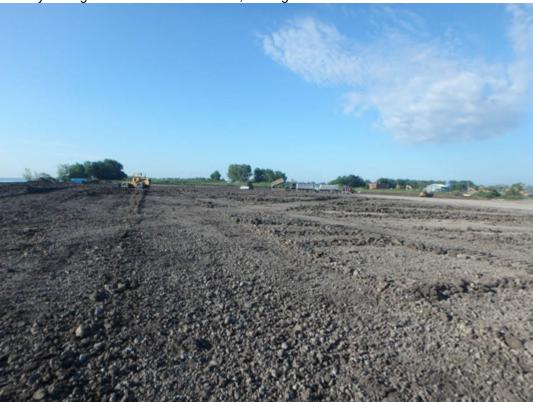
Overview of Pond 1, looking south.

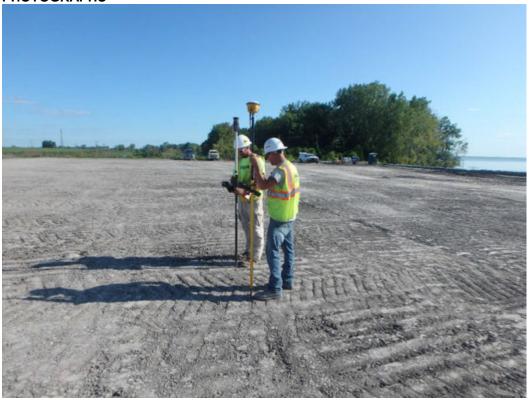
Survey of certification points for liner sub-grade in Pond 1, looking north.

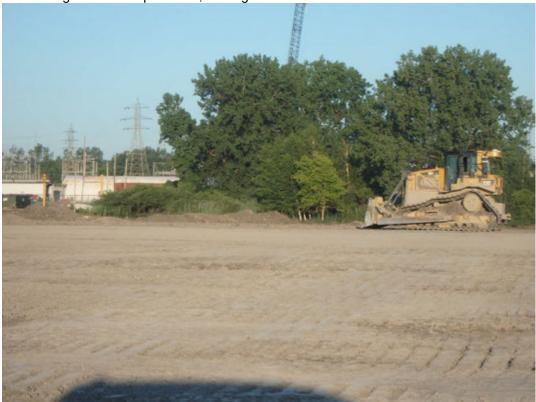
Finish grading of liner sub-grade in Pond 1, looking west.

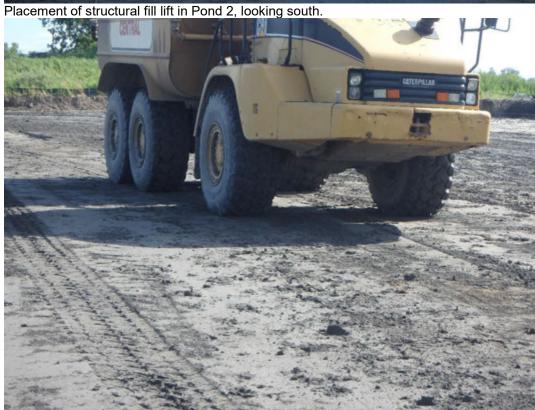
- Golder observed finish grading of placed, compacted and tested structural fill Pond 1.
- Golder monitored proof roll of bridging layer in Pond 2 bounded by certification points; 1057, 1056, 1103 and 1104.

Proof roll of bridging layer in Pond 2, looking south.

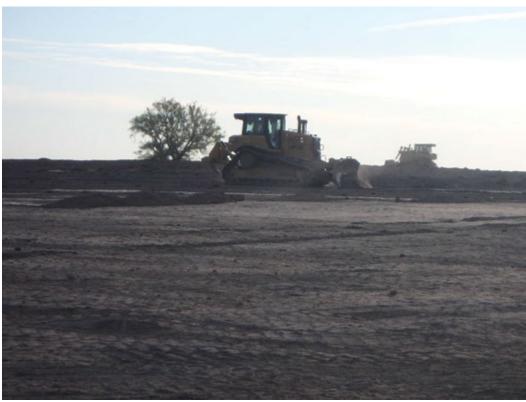
Finish grading structural fill in Pond 1, looking northeast.

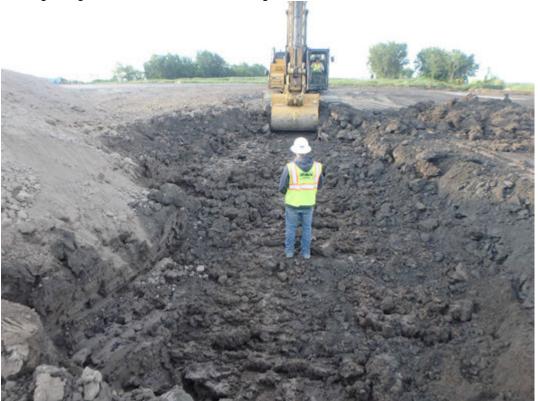
- Continued finish grading of structural fill placed in Pond 1.
- Over-Excavated soft spot in Pond 2 bridging layer and backfilled with dry material.
- Water truck for dust control and fill moisture.

Over-ex of soft spot in bridging layer of Pond 2, looking south.

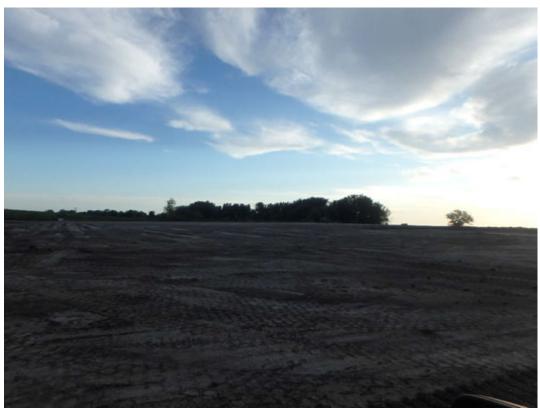
Overview of Pond 1, looking northeast.

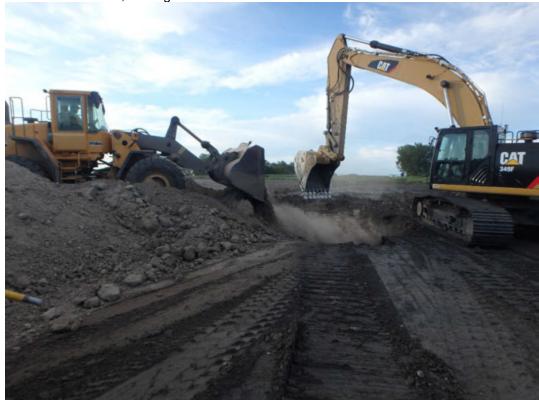
Backfill of over-ex in Pond 2, looking south.

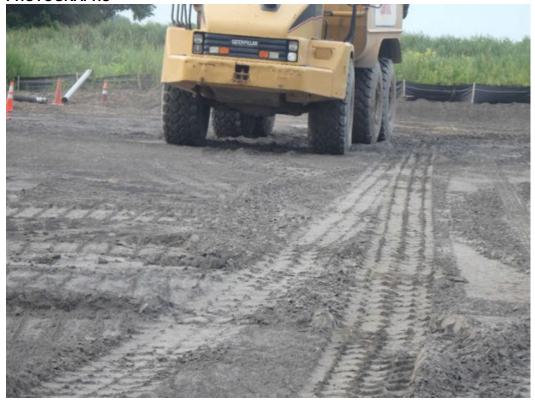
Proof roll of additional area of Pond 2 bridging layer, looking south.

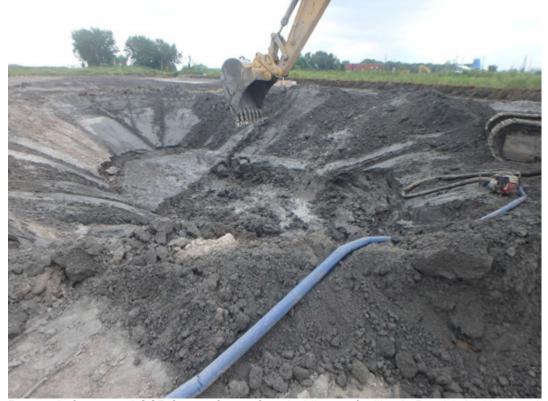
Removal of saturated CCR from soft area found while proof rolling in Pond 2, looking southwest.

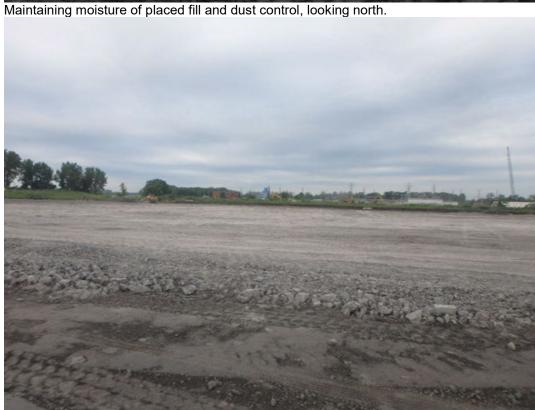
Overview of Pond 1, looking north.

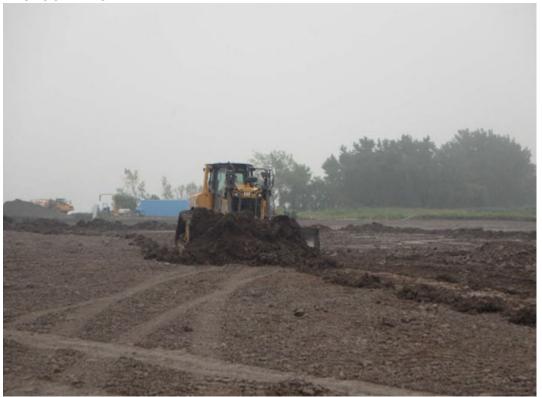
Dressing access road to Pond 2, looking southeast.

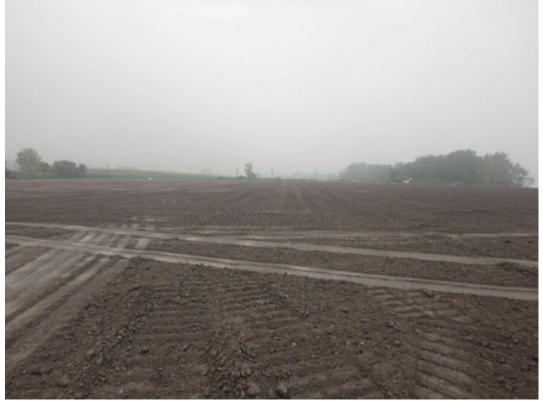
Overview of Pond 1, looking north.

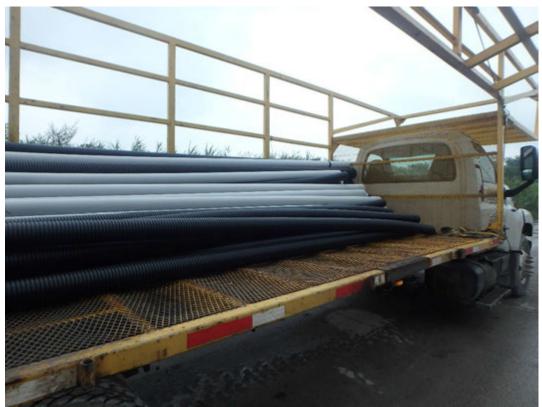
4 inch ADS pipe for above-cap drainage system.

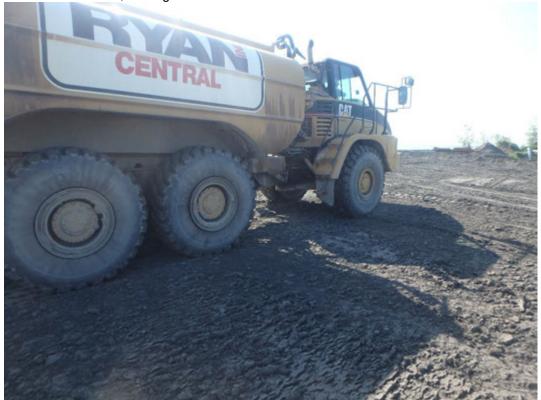
Proof roll of bridging layer in Pond 2, looking southeast.

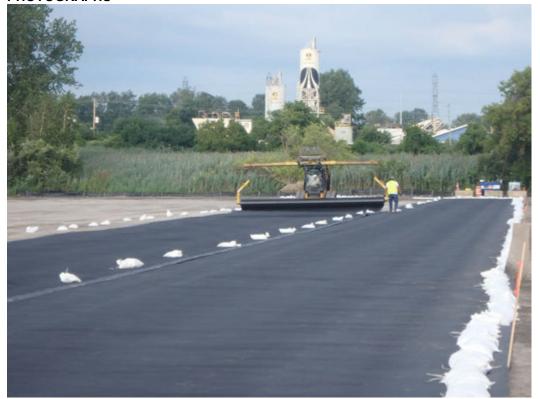
Deployment of 40mil geomembrane in Pond 1, looking west.

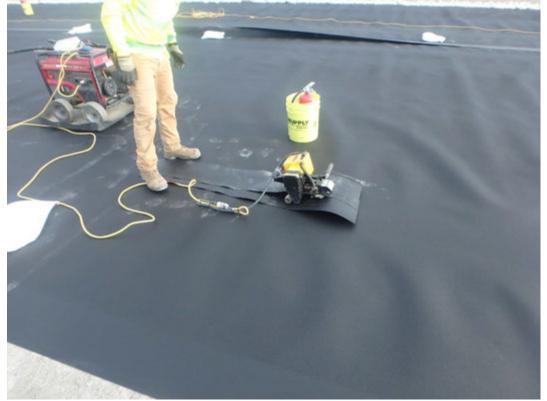
Producing trial weld for field testing.

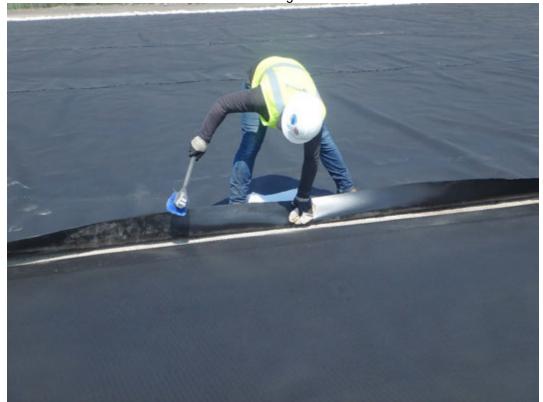
Cleaning liner overlap ahead of fusion seaming device.

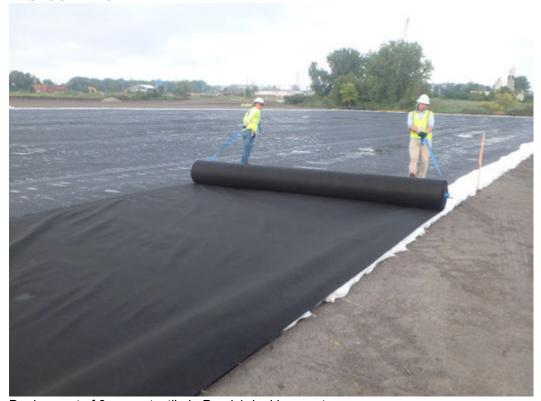
Deployment of 8oz. geotextile in Pond 1, looking west.

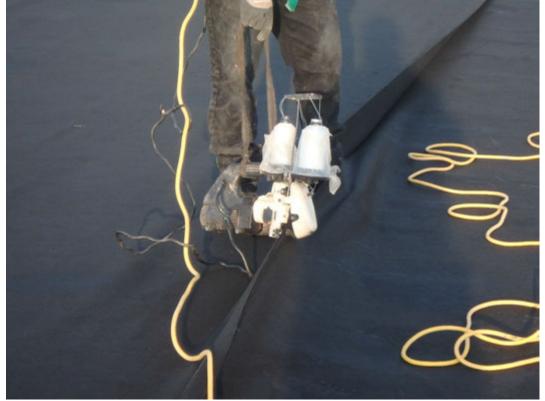
Sewing geotextile seam.

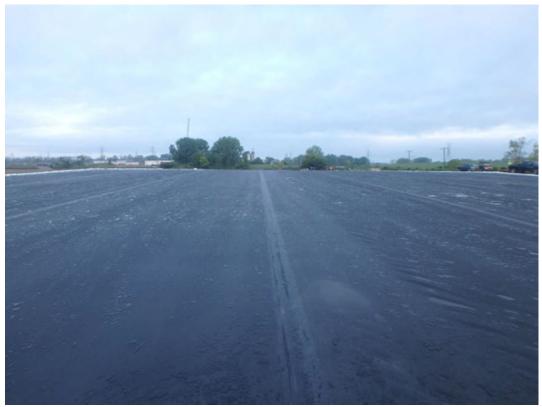
Overview of geomembrane deployed in Pond 1, looking west.

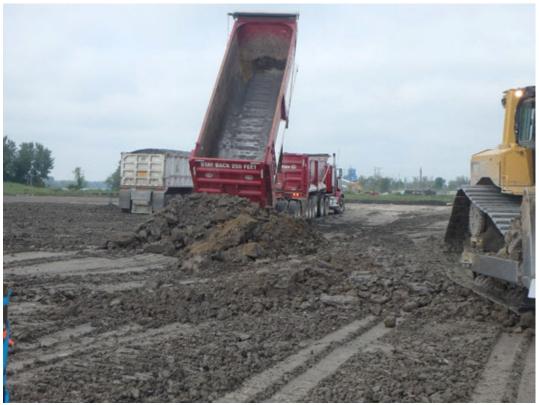
Structural fill import to Pond 2, looking west.

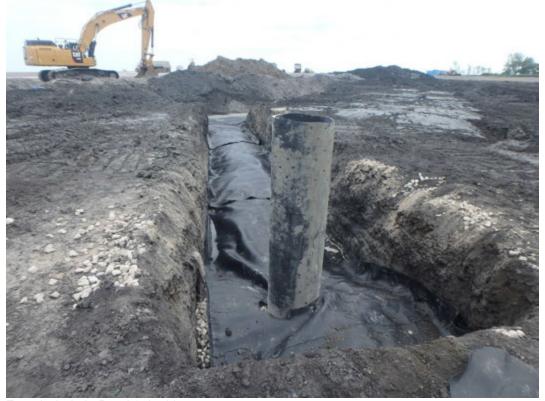
- Golder observed installation of a French Drain in Pond 2 to dewater soft area found during proof roll.
- Performed CQA oversight and documentation on geomembrane installation.

French drain in Pond 2, looking east.

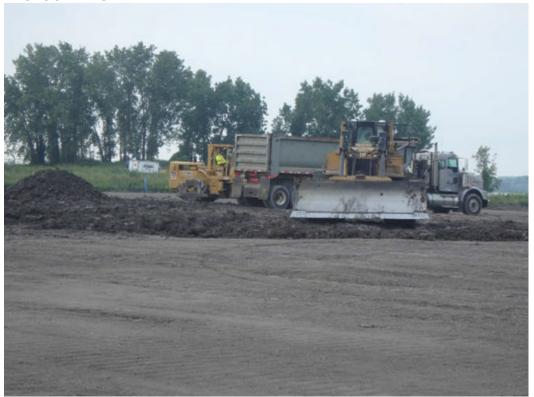
Placing structural fill lift in Pond 2, looking southwest.

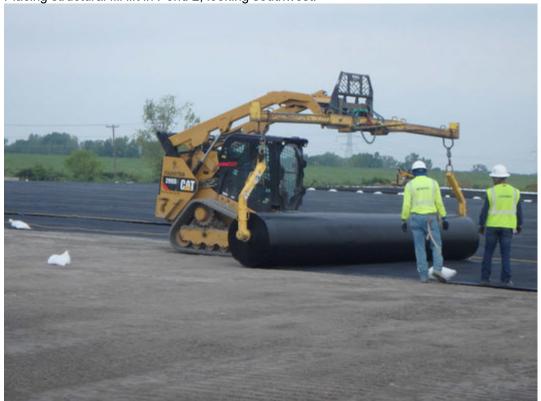
Deploying geomembrane in Pond 1, looking north.

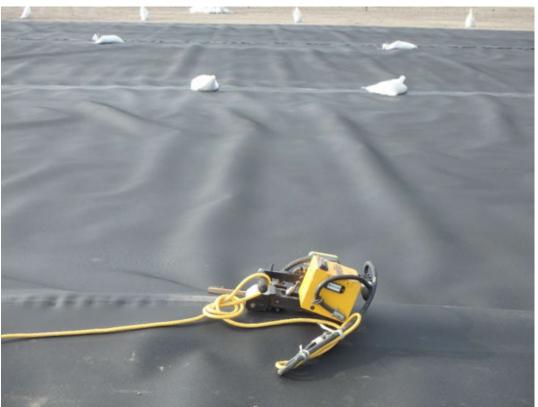
Seaming by fusion method of geomembrane.

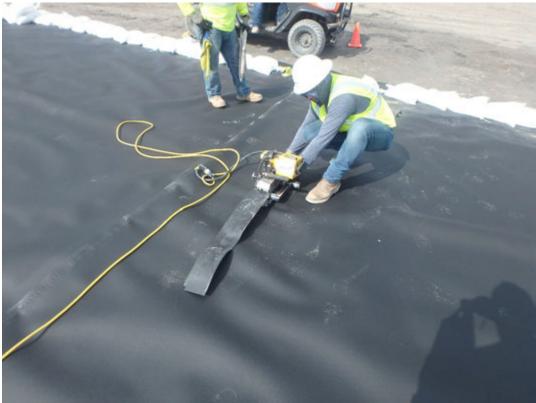
Fusion trial weld.

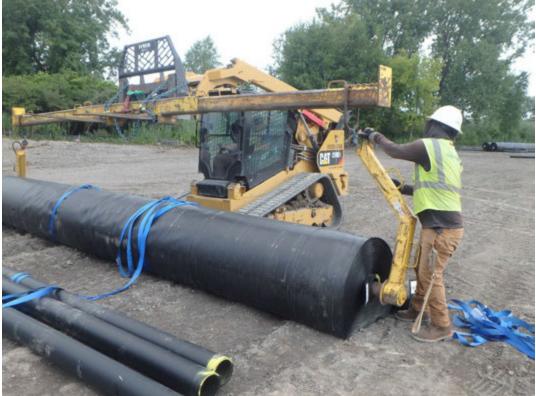
Preparing to deploy liner, looking northwest.
